Site Address:		Report Author:	
Looe Platoon, Sunrising Estate, Looe, Cornwall, PL13 1NA		Armour Analytical Services Admirals Yard Station Road Bristol BS34 6LR	
Contact Name:	Gary White	Contact Name:	Emma Humphreys
Tel: 07787558356	Fax: N/A	Mobile: 0746853	5836

Section 2: Executive Summary

Instructions were received from Sue Morrell of Wessex RFCA to carry out a Management asbestos survey at Looe Platoon, Sunrising Estate, Looe, Cornwall PL13 1NA in accordance with HSG264 and Armour Analytical's quality procedures.

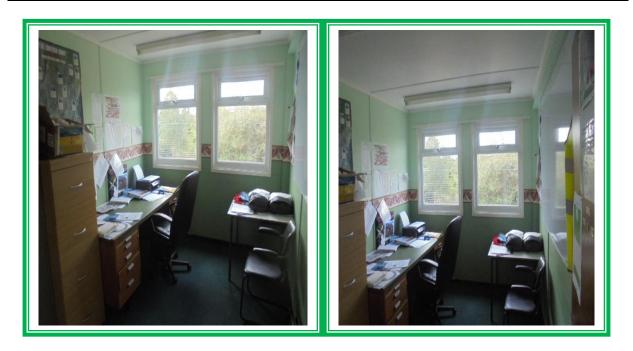
Location: Ground Floor – Office and Store

Material Description:	Visual Inspection – No Suspect Materials Found		
Identification:	N/A		
Approx. quantity:	N/A		
Accessibility	N/A	Assessment Score	
Product type:	N/A	N/A	
Extent of Damage:	N/A	N/A	
Surface Treatment:	N/A	N/A	
Asbestos type:	N/A	N/A	
	Material Assessment Score:	N/A	
	Priority Assessment Score:	N/A	
Action:	N/A		
Comments:	N/A

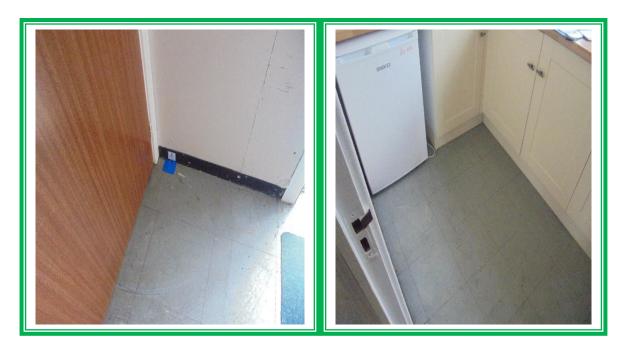
Sample No: DK/1

Material Description:	Floor Tiles		
Identification:	Sampled – No Asbestos Detected		
Approx. quantity:	12M2		
Accessibility	High	Assessment Score	
Product type:	N/A	N/A	
Extent of Damage:	N/A	N/A	
Surface Treatment:	N/A	N/A	
Asbestos type:	N/A	N/A	
	Material Assessment Score:	N/A	
	Priority Assessment Score: N/A		
Action:	N/A		
Comments:	Modern Sink Pad in Kitchen

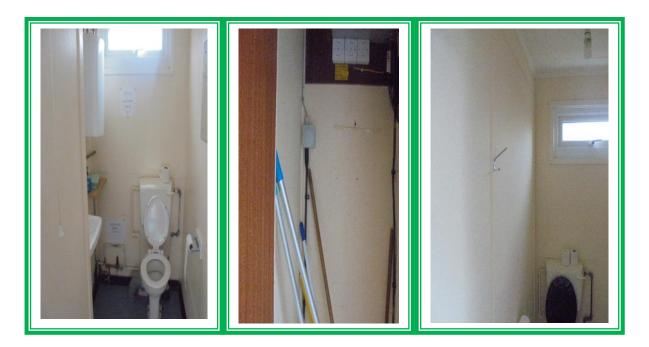
Location: Ground Floor - WC's X 2 and Cupboard

Material Description:	Visual Inspection – No Suspe	Visual Inspection – No Suspect Materials Found			
Identification:	N/A				
Approx. quantity:	N/A				
Accessibility	N/A	Assessment Score			
Product type:	N/A	N/A			
Extent of Damage:	N/A	N/A			
Surface Treatment:	N/A	N/A			
Asbestos type:	N/A	N/A			
	Material Assessment Score:	N/A			
	Priority Assessment Score: N/A				
Action:	N/A				
Comments:	Modern Toilet Seats, Flooring and Electrics

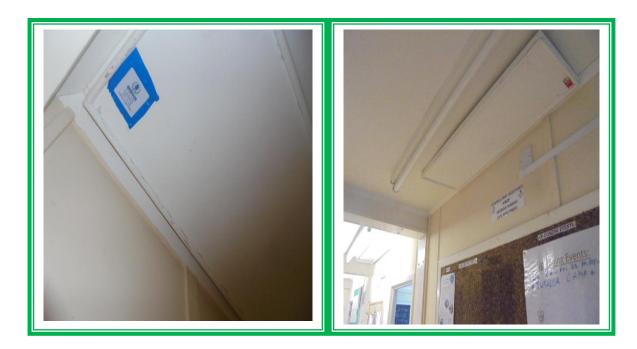
Sample No: DK/2

Material Description:	Insulation Board Panel	Insulation Board Panels on Ceiling			
Identification:	Sampled – No Asbestos Detected				
Approx. quantity:	1-2M2 – Total (4)	K Pads)			
Accessibility	Low	Assessment Score			
Product type:	N/A	N/A			
Extent of Damage:	N/A	N/A			
Surface Treatment:	N/A	N/A			
Asbestos type:	N/A N/A				
	Material Assessment Score: N/A				
Priority Assessment Score: N/A					
Action:	N/A				
Comments:	N/A

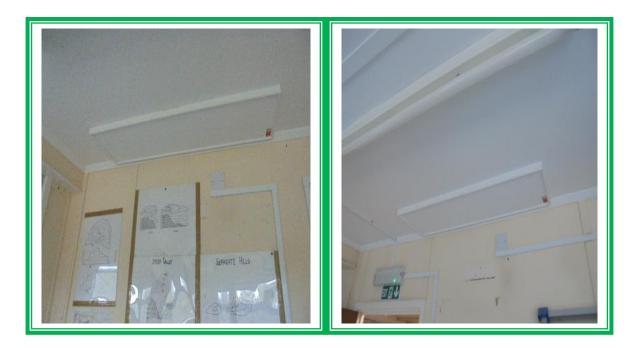
Location: Ground Floor - Classroom 1A and 1B

Material Description:	Insulation Board Panel	Insulation Board Panels on Ceiling		
Identification:	As Per Sample DK/2 – No Asbestos Detected			
Approx. quantity:	2 X Panels (1M2	Total)		
Accessibility	Low	Assessment Score		
Product type:	N/A	N/A		
Extent of Damage:	N/A	N/A		
Surface Treatment:	N/A N/A			
Asbestos type:	N/A N/A			
	Material Assessment Score:	N/A		
	Priority Assessment Score: N/A			
Action:	N/A			
Comments:	N/A

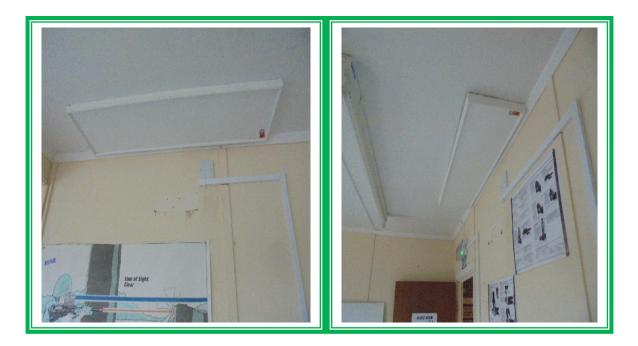
Location: Ground Floor - Classroom 2

Material Description:	Insulation Board Panels on Ceiling		
Identification:	As Per Sample DK/2 – No Asbestos Detected		
Approx. quantity:	2 X Panels (1M2	Total)	
Accessibility	Low	Low	
Product type:	N/A	N/A	
Extent of Damage:	N/A	N/A	
Surface Treatment:	N/A	N/A	
Asbestos type:	N/A	N/A	
	Material Assessment Score:	N/A	
	Priority Assessment Score: N/A		
Action:	N/A		
Comments:	N/A
