Project Number A-00405 (3700)

**Re-Inspection
Asbestos Survey Report**

**Brockworth Platoon
Gloucestershire
GL3 4JP**

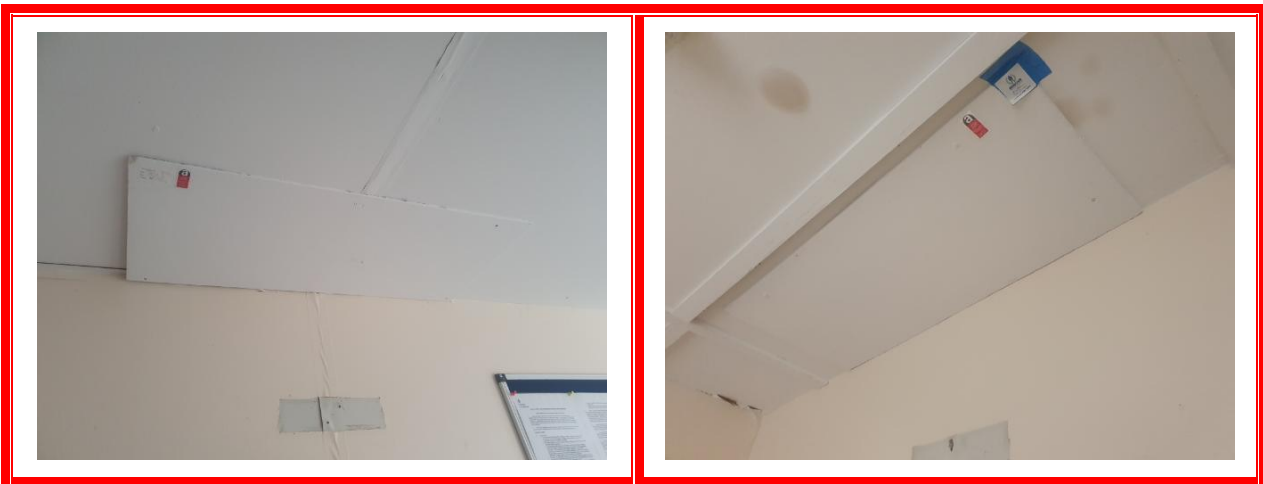
Item No:	1	Sample No:	N/A
Location:	Ground Floor - Offices x 2 001

Material Description:	Panels on Ceilings - Insulating Board	
Identification:	Previously Sampled - Asbestos Detected	
Approx. quantity:	1 m ²	
Accessibility	Difficult	<i>Assessment Score</i>
Product type:	Asbestos Insulating Board	2
Extent of Damage:	Slight / Minor Damage	1
Surface Treatment:	Encapsulated AIB	1
Asbestos type:	Amosite	2
Material Assessment Score:		6
Priority Assessment Score:		Low
Action:	Manage	
Comments:	Previously sampled ref: Armour 30/08/19 Sample DK/1. 2no panels

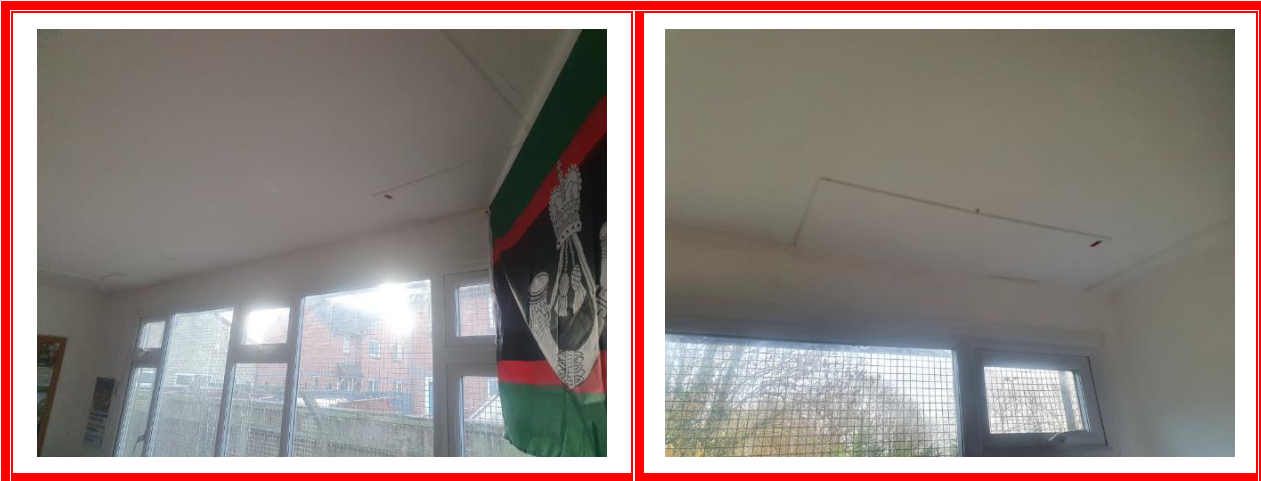
Item No:	2	Sample No:	N/A
Location:	Ground Floor - Drill Hall and Classroom 002

Material Description:	Panels on Ceilings - Insulating Board	
Identification:	Previously Sampled - Asbestos Detected	
Approx. quantity:	3 m ²	
Accessibility	Difficult	Assessment Score
Product type:	Asbestos Insulating Board	2
Extent of Damage:	Slight / Minor Damage	1
Surface Treatment:	Encapsulated AIB	1
Asbestos type:	Amosite	2
Material Assessment Score:		6
Priority Assessment Score:		Low
Action:	Manage	
Comments:	Previously sampled ref: Armour 30/08/19 Sample DK/1. 6no panels
