Project Number 2481

Management Asbestos Survey Report

Wyvern Barracks, Barrack Road, Exeter, Devon, **EX2 6AE (No Access Buildings)**

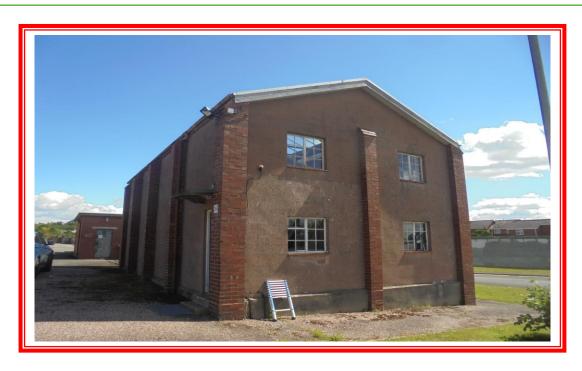
Location: Building 15 - Squash Court

Material Description:	No access within building as locked			
Identification:	Presumed to Contain Asbestos			
Approx. quantity:	X 1 Building			
Accessibility	Low Assessment Score			
Product type:	No Access 3			
Extent of Damage:	No Access 3			
Surface Treatment:	No Access	3		
Asbestos type:	No Access 3			
	Material Assessment Score:	12		
	Priority Assessment Score:	High		
Action:	Further Investigation Needed			
Comments:	Access could only be gained through yeomanry, as advised by Andy Palmer. Despite several attempts over a week period the yeomanry could not be located.

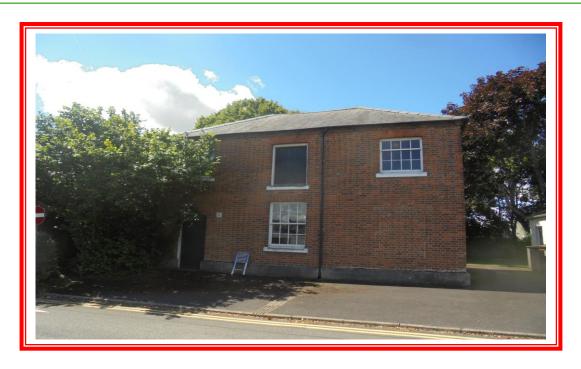
Location: Building 12

Material Description:	No access within building as locked				
Identification:	Presumed to Contain Asb	estos			
Approx. quantity:	quantity: X 1 Building				
Accessibility	Low	Assessment Score			
Product type:	No Access	3			
Extent of Damage:	No Access	3			
Surface Treatment:	No Access	3			
Asbestos type:	No Access	3			
	Material Assessment Score:	12			
	Priority Assessment Score:	High			
Action:	Further Investigation Nee	eded			
Comments:	Access could only be gained through yeomanry, as advised by Andy Palmer. Despite several attempts over a week period the yeomanry could not be located.

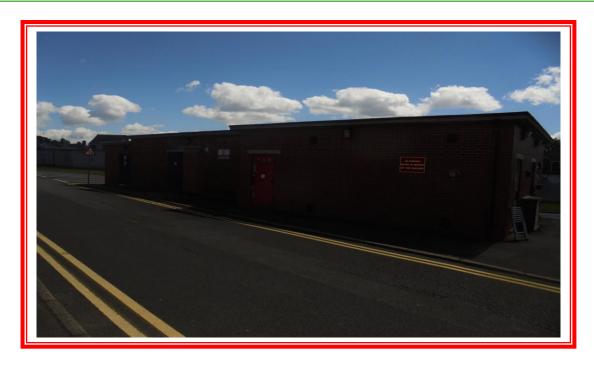
Location: Building 16 - Armoury

Material Description:	No access within building as	locked		
Identification: Presumed to Contain Asbestos				
Approx. quantity:	Approx. quantity: X 1 Building			
Accessibility	Low	Assessment Score		
Product type:	No Access	3		
Extent of Damage:	No Access	3		
Surface Treatment:	No Access	3		
Asbestos type:	No Access	3		
	Material Assessment Score:	12		
	Priority Assessment Score:	High		
Action:	Further Investigation Nee	eded		
Comments:	This building is a secure store and there was no officer on site during the week of the survey that had access to this building, as advised by Andy Palmer.
