**Project Number 2481**

**Management  
Asbestos Survey Report**

**Tewksbury Platoon, Red Lane  
Gloucestershire, GL20 5BQ**

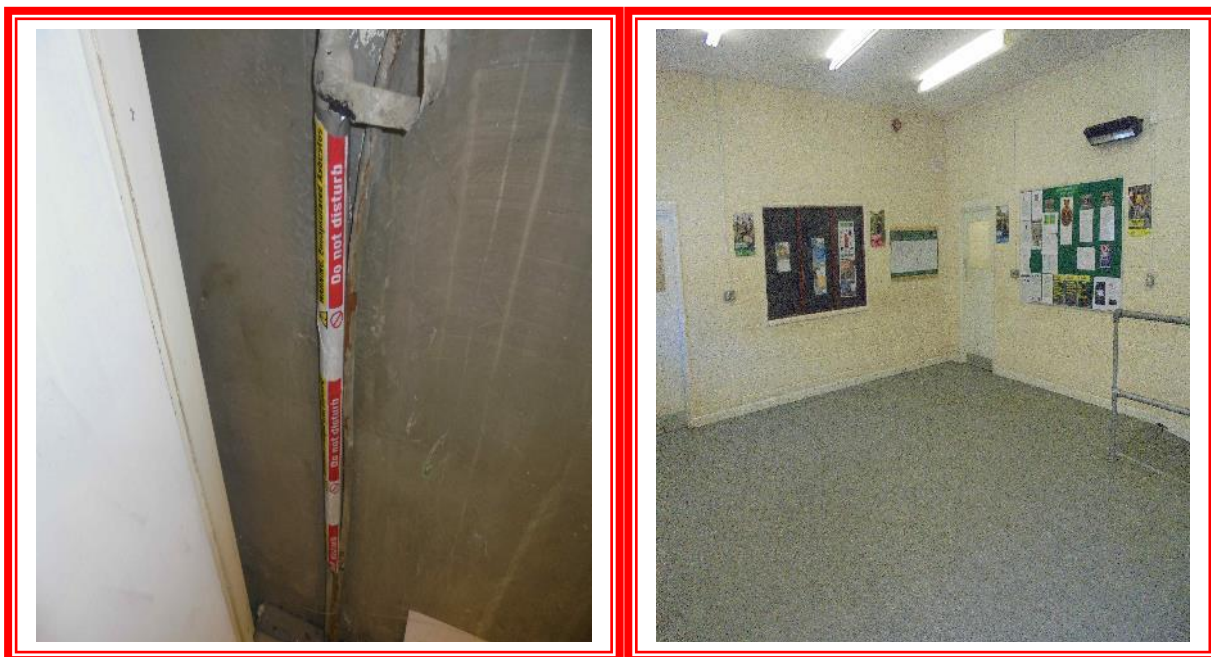
**Item No: 4**

**Item 4 – Drill Hall & Cupboard – Bitumen Wrap to Mains Cable – Unable to sample as live**

**Location: Drill Hall & Cupboard – Ground Floor**

| <b>Material Description:</b> | Bitumen Wrap to Mains Cable | |
| <b>Identification:</b> | Presumed to Contain Asbestos | |
| <b>Approx. quantity:</b> | 1LM | |
| <b>Extent of Damage:</b> | Minor | 1 |
| <b>Asbestos type:</b> | Chrysotile | 1 |
| <b>Material Assessment Score:</b> | | 3 |
| <b>Priority Assessment Score:</b> | | Negligible |

| <b>Action:</b> | Manage | |

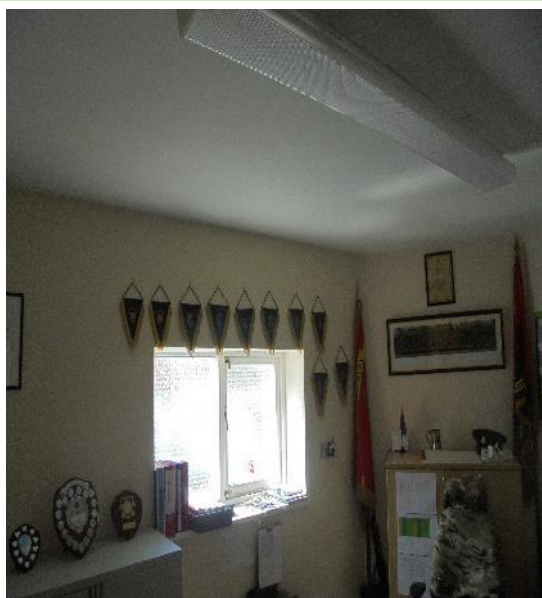
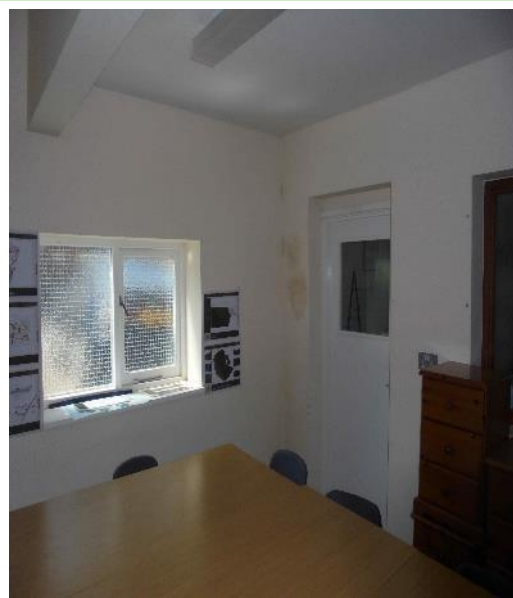
**Item No: 1**

**Location: Office & Classroom – Ground Floor**

| <b>Material Description:</b> | Visual Inspection – No Suspect Materials Found | |

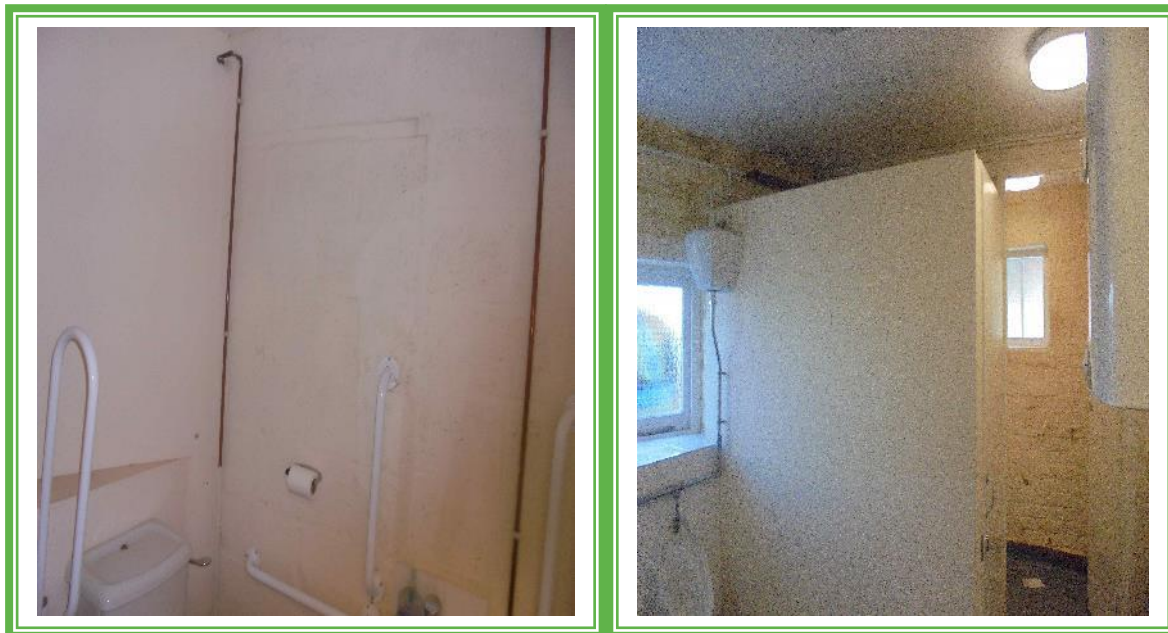
**Item No: 2**

**Location: WC's x 2 – Ground Floor**

| <b>Material Description:</b> | Visual Inspection – No Suspect Materials Found | |

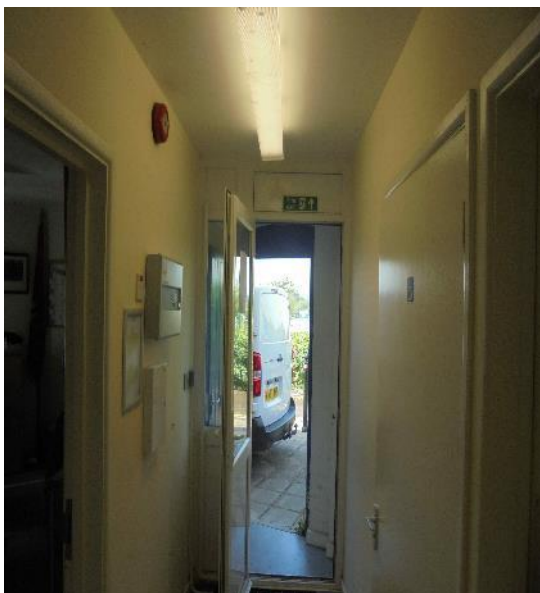
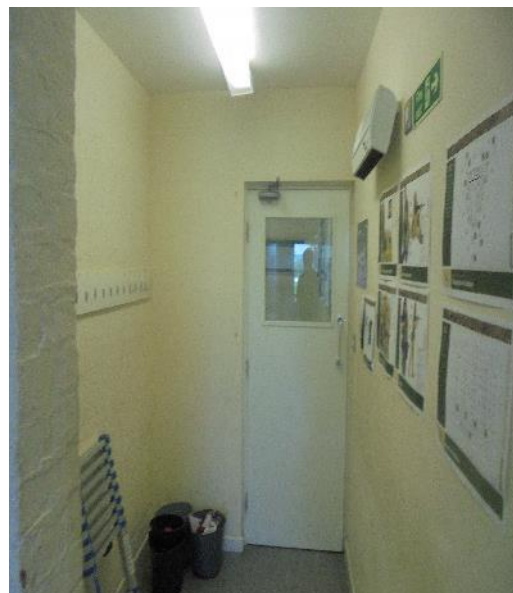
**Item No: 3**

**Location: Lobby – Ground Floor**

| <b>Material Description:</b> | Visual Inspection – No Suspect Materials Found | |
| <b>Comments:</b> | Modern sink pad | |

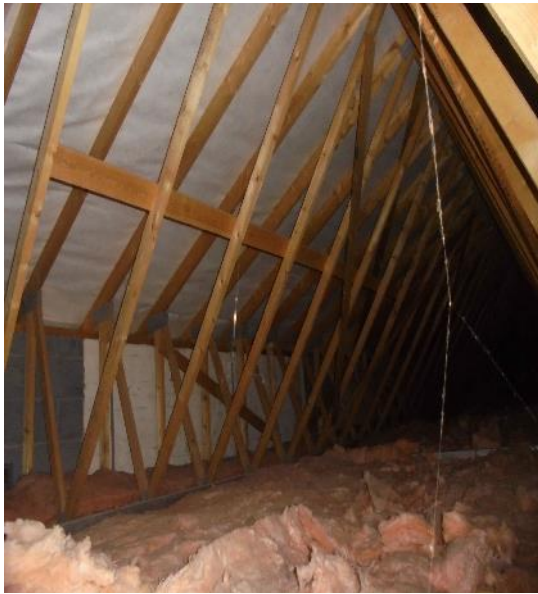
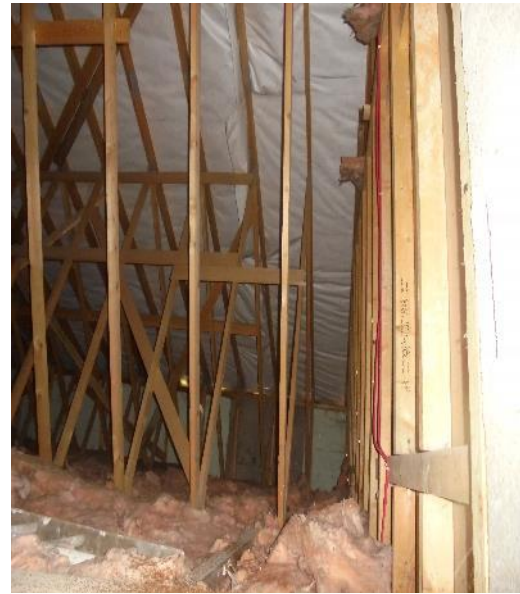
**Item No: 5**

**Location: Loft Space**

| <b>Material Description:</b> | Visual Inspection – No Suspect Materials Found | |
| <b>Comments:</b> | Limited access to inspect as no crawlboards were available | |

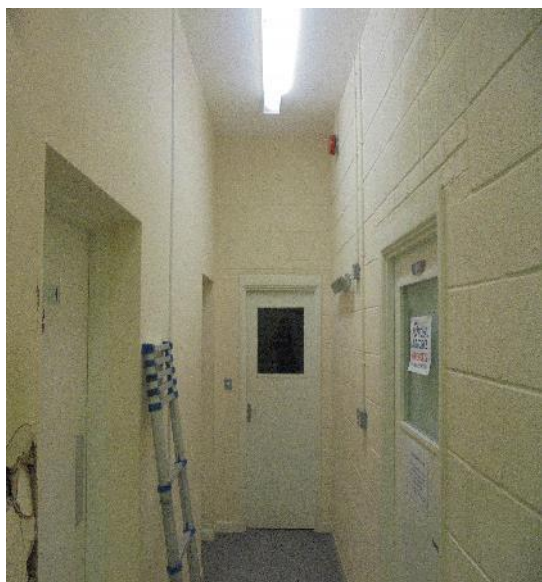
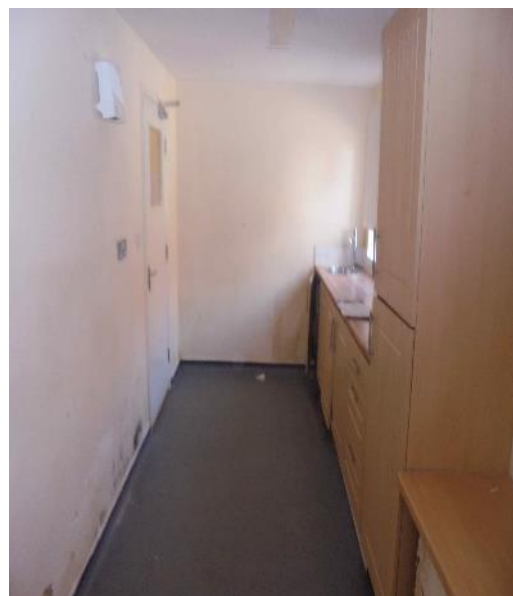
**Item No: 6**

**Location: Corridor, Kitchen & Female WC – Ground Floor**

| <b>Material Description:</b> | Visual Inspection – No Suspect Materials Found | |
| <b>Comments:</b> | Modern sink pad in kitchen | |

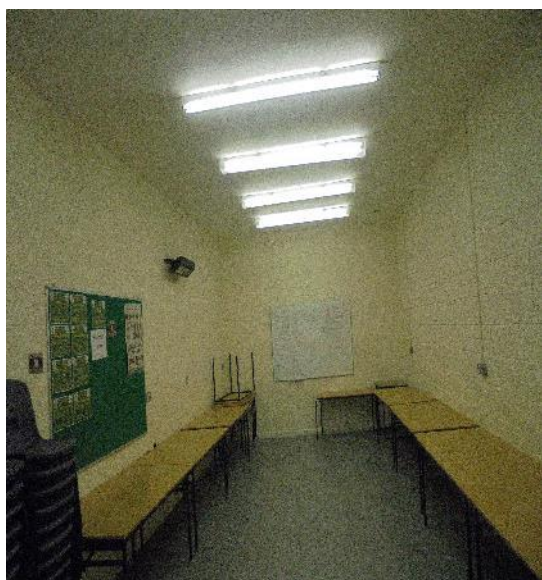
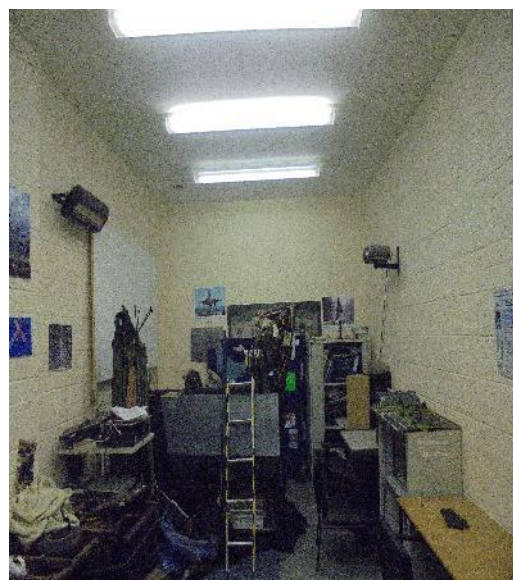
**Item No: 7**

**Location: Classrooms x 3 – Ground Floor**

| <b>Material Description:</b> | Visual Inspection – No Suspect Materials Found | |

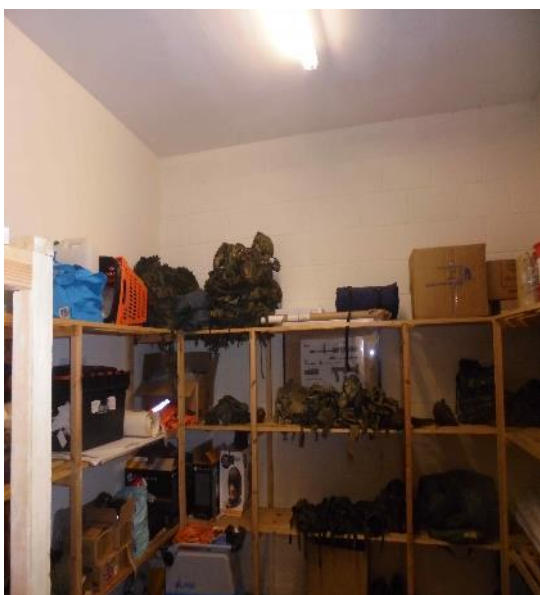
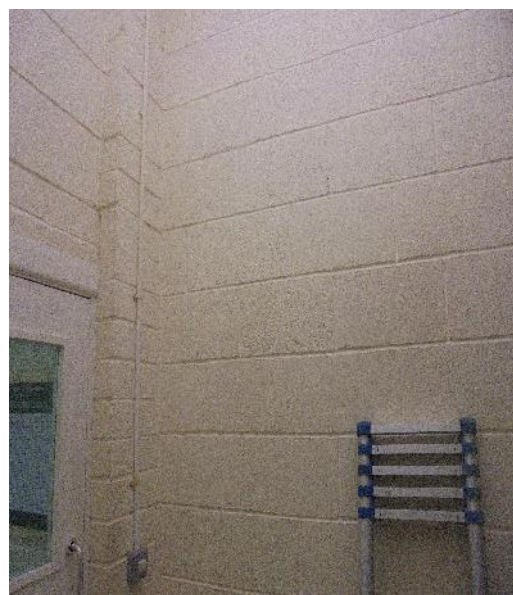
**Item No: 8**

**Location: Stores x 2 & Lobby – Ground Floor**

| <b>Material Description:</b> | Visual Inspection – No Suspect Materials Found | |
| <b>Comments:</b> | Modern heaters throughout | |

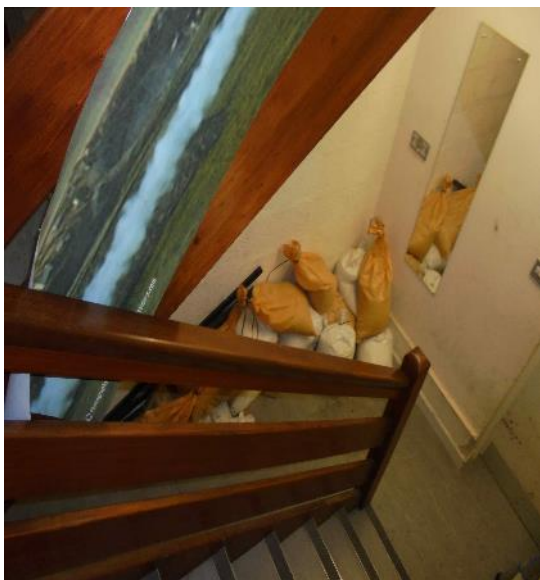
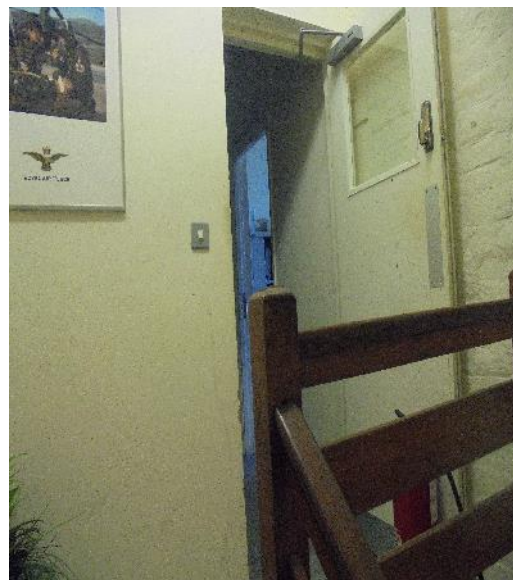
**Item No: 9**

**Location: Stairwell & Landing – First Floor**

| <b>Material Description:</b> | Visual Inspection – No Suspect Materials Found | |
| <b>Comments:</b> | Non-Asbestos stair nosing | |

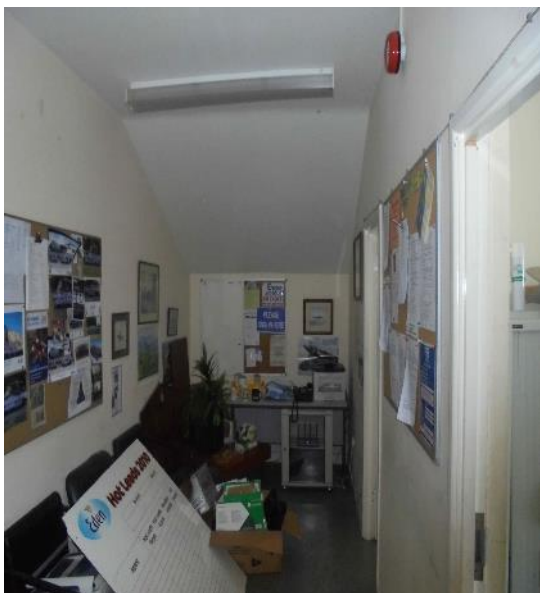
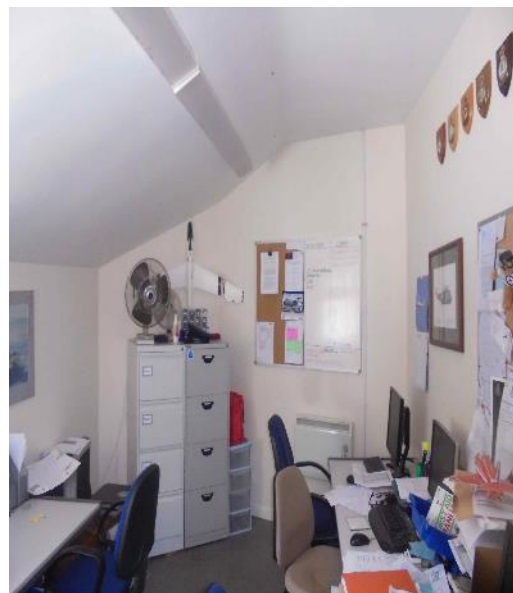
**Item No: 10**

**Location: Corridor & Offices x 2 – First Floor**

| <b>Material Description:</b> | Visual Inspection – No Suspect Materials Found | |

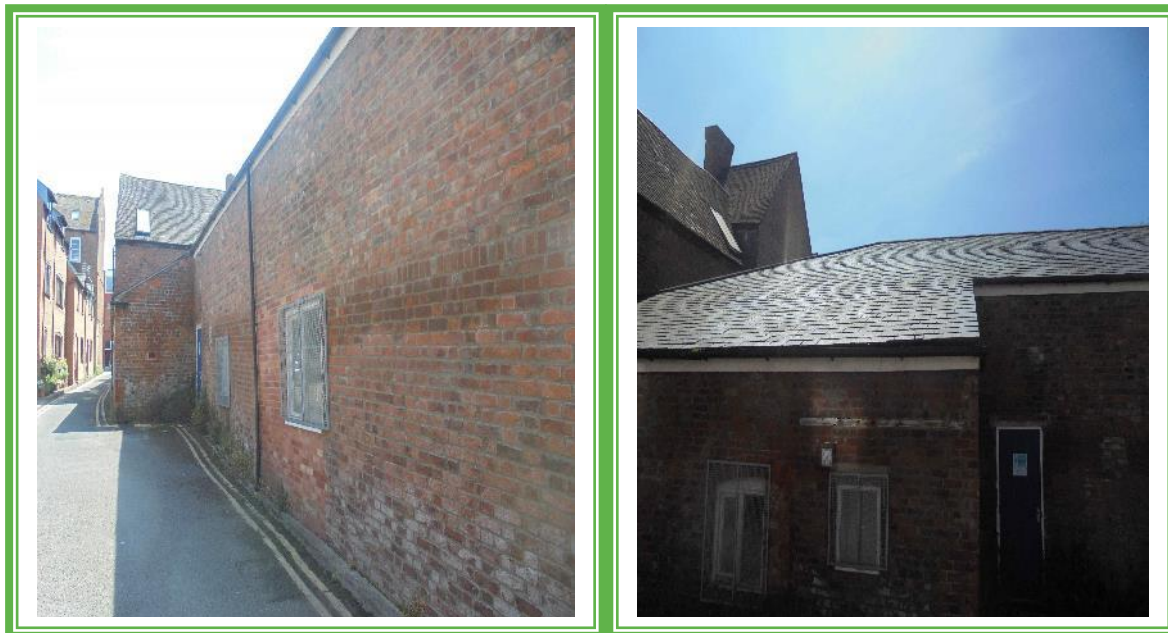
**Item No: 11****Sample No: N/A****Location: External**

| <b>Material Description:</b> | Visual Inspection – No Suspect Materials Found | |
| <b>Comments:</b> | Natural slate roof tiles. No damp proof course visible. | |
