Project Number 2481

**Management
Asbestos Survey Report**

**Isles of Scilly Platoon, The Garrison,
St Marys, Isles of Scilly, TR21 0LS**

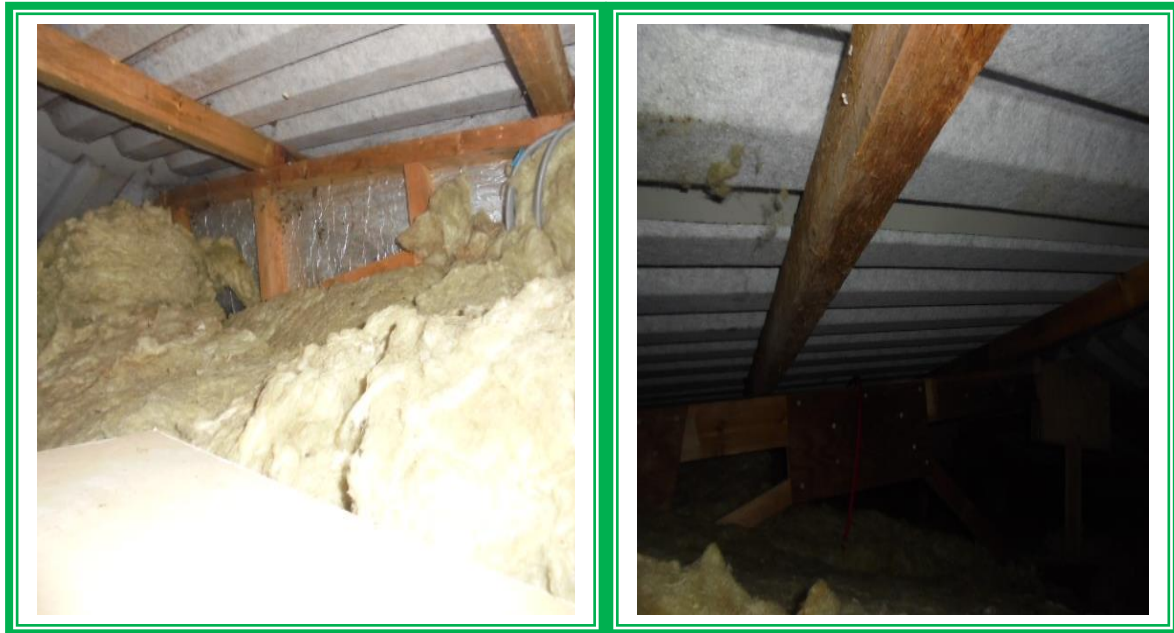
Item No: 1

Location: Loft Space

Material Description:	Visual Inspection – No Suspect Materials Found	
Identification:	N/A	
Approx. quantity:	N/A	
Accessibility	N/A	<i>Assessment Score</i>
Product type:	N/A	N/A
Extent of Damage:	N/A	N/A
Surface Treatment:	N/A	N/A
Asbestos type:	N/A	N/A
Material Assessment Score:		N/A
Priority Assessment Score:		N/A
Action:	N/A	
Comments:	N/A

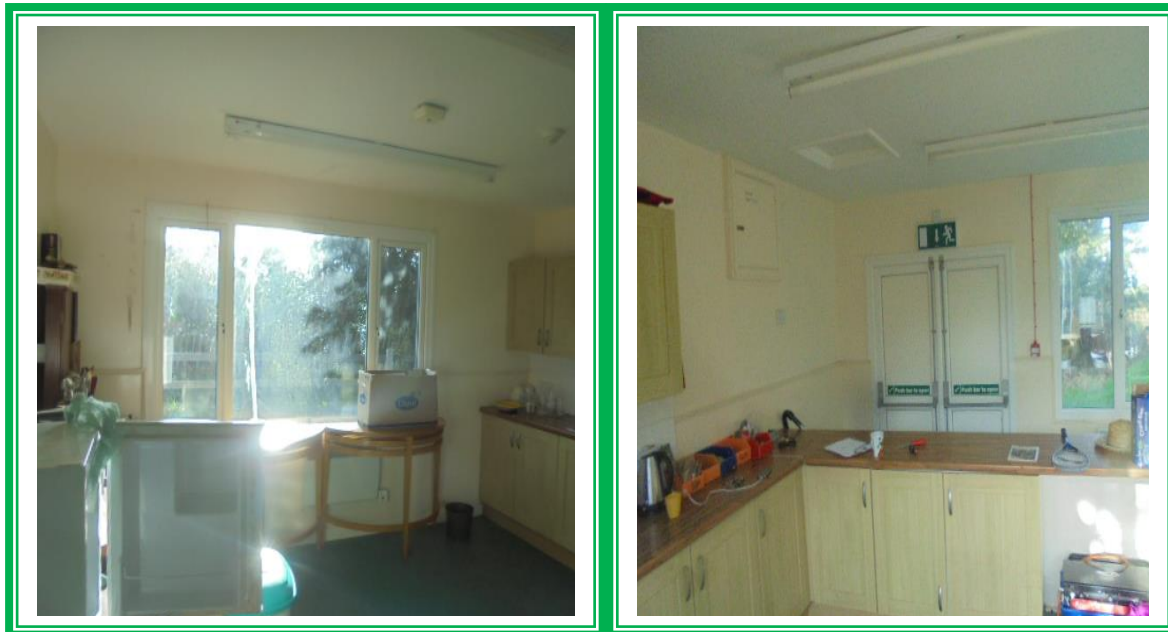
Item No: 2

Location: Kitchen

Material Description:	Visual Inspection – No Suspect Materials Found	
Identification:	N/A	
Approx. quantity:	N/A	
Accessibility	N/A	<i>Assessment Score</i>
Product type:	N/A	N/A
Extent of Damage:	N/A	N/A
Surface Treatment:	N/A	N/A
Asbestos type:	N/A	N/A
Material Assessment Score:		N/A
Priority Assessment Score:		N/A
Action:	N/A	
Comments:	Modern sink pad

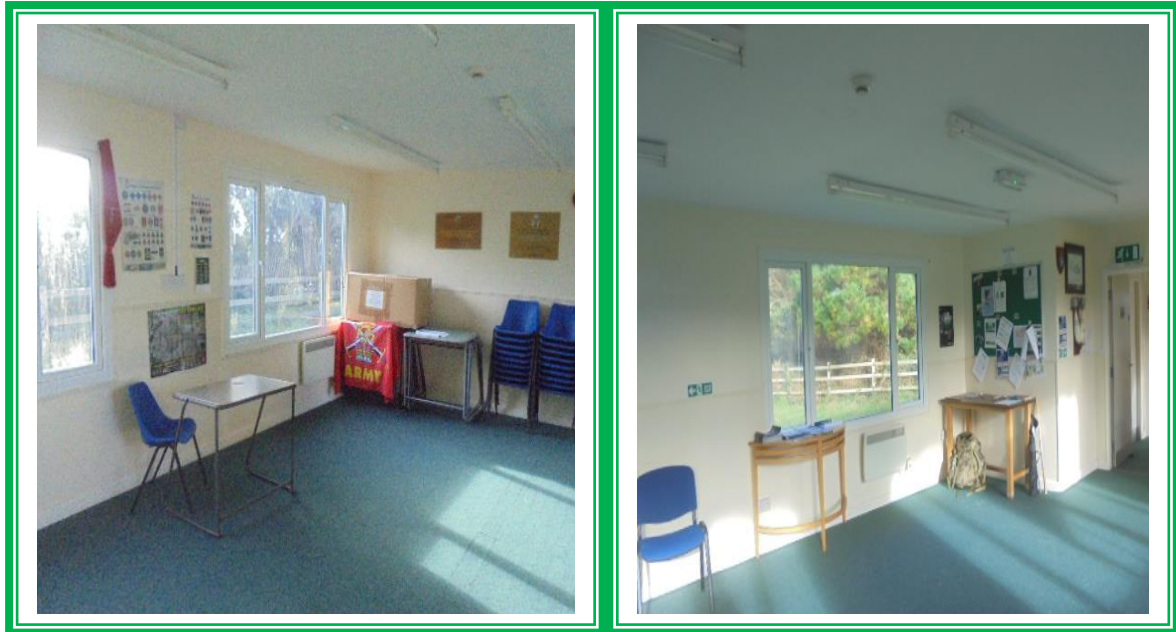
Item No: 3

Location: Drill Hall

Material Description:	Visual Inspection – No Suspect Materials Found	
Identification:	N/A	
Approx. quantity:	N/A	
Accessibility	N/A	<i>Assessment Score</i>
Product type:	N/A	N/A
Extent of Damage:	N/A	N/A
Surface Treatment:	N/A	N/A
Asbestos type:	N/A	N/A
Material Assessment Score:		N/A
Priority Assessment Score:		N/A
Action:	N/A	
Comments:	N/A

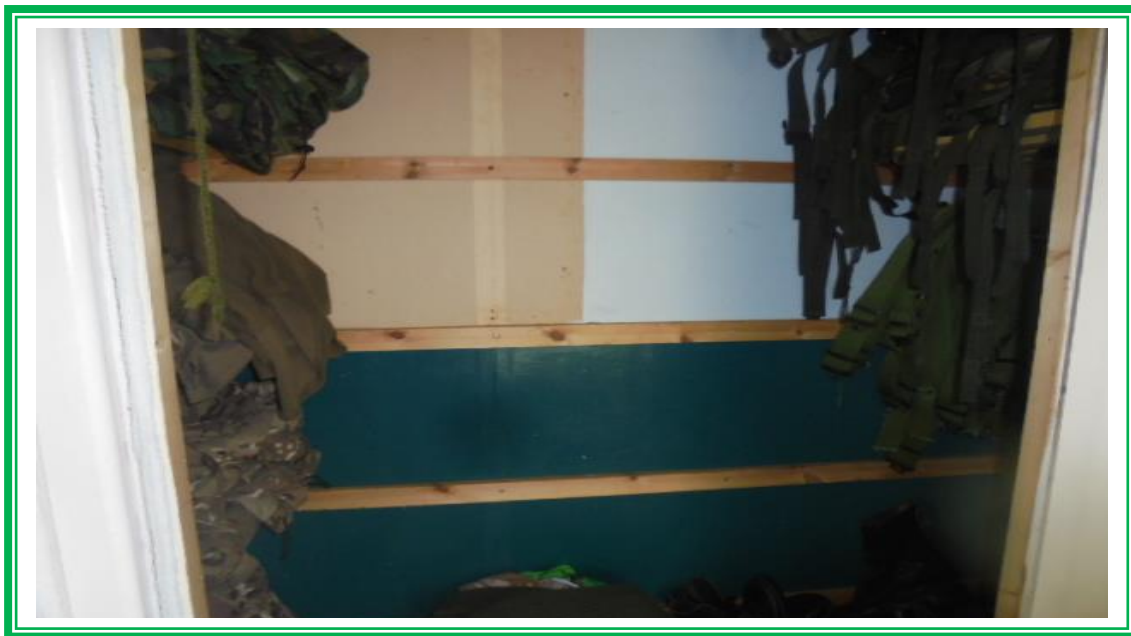
Item No: 4

Location: Store

Material Description:	Visual Inspection – No Suspect Materials Found	
Identification:	N/A	
Approx. quantity:	N/A	
Accessibility	N/A	<i>Assessment Score</i>
Product type:	N/A	N/A
Extent of Damage:	N/A	N/A
Surface Treatment:	N/A	N/A
Asbestos type:	N/A	N/A
Material Assessment Score:		N/A
Priority Assessment Score:		N/A
Action:	N/A	
Comments:	N/A

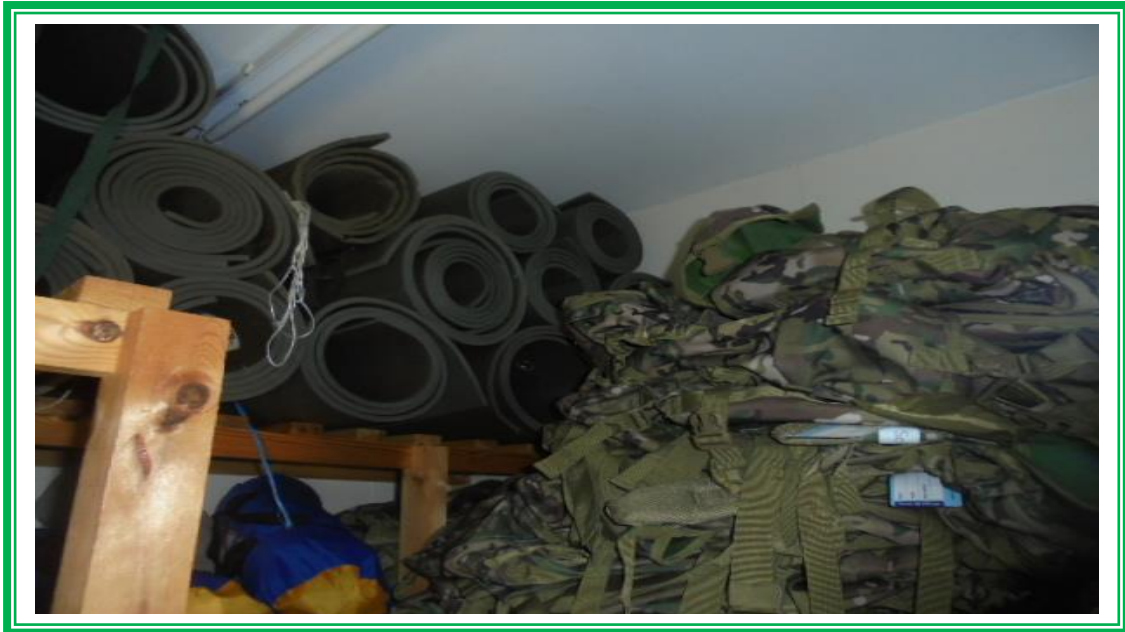
Item No: 5

Location: Store

Material Description:	Visual Inspection – No Suspect Materials Found	
Identification:	N/A	
Approx. quantity:	N/A	
Accessibility	N/A	<i>Assessment Score</i>
Product type:	N/A	N/A
Extent of Damage:	N/A	N/A
Surface Treatment:	N/A	N/A
Asbestos type:	N/A	N/A
Material Assessment Score:		N/A
Priority Assessment Score:		N/A
Action:	N/A	
Comments:	N/A

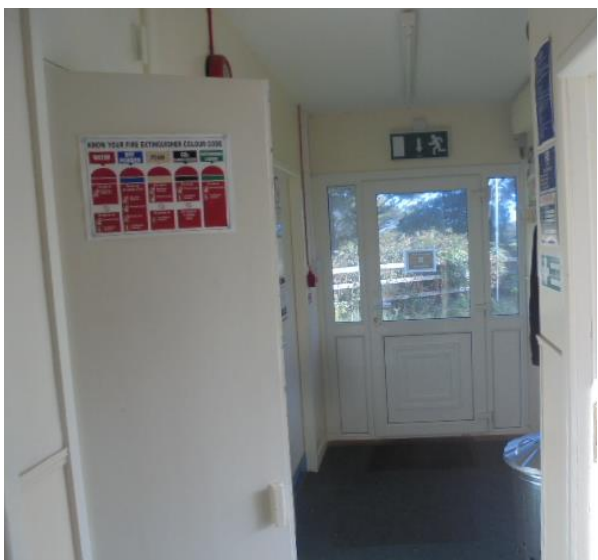
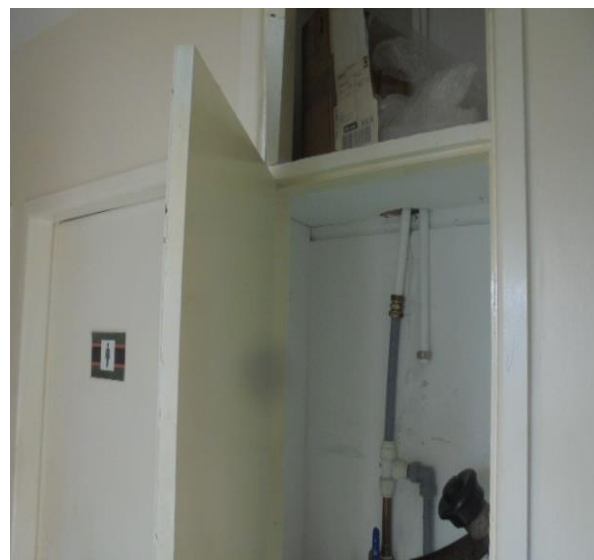
Item No: 6

Location: Lobby & Cupboard

Material Description:	Visual Inspection – No Suspect Materials Found	
Identification:	N/A	
Approx. quantity:	N/A	
Accessibility	N/A	Assessment Score
Product type:	N/A	N/A
Extent of Damage:	N/A	N/A
Surface Treatment:	N/A	N/A
Asbestos type:	N/A	N/A
Material Assessment Score:		N/A
Priority Assessment Score:		N/A
Action:	N/A	
Comments:	N/A

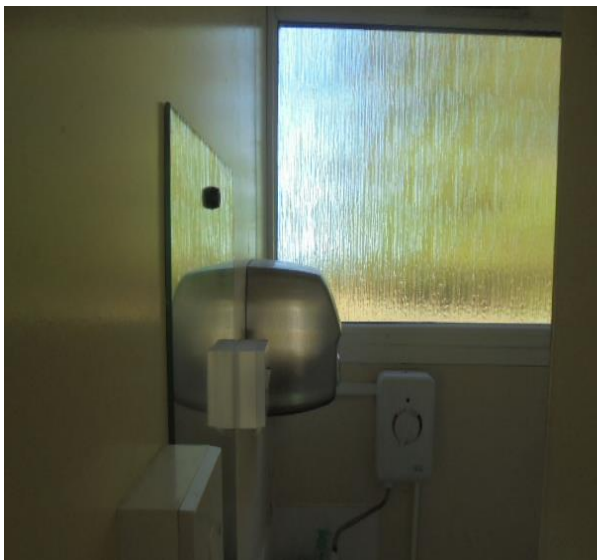
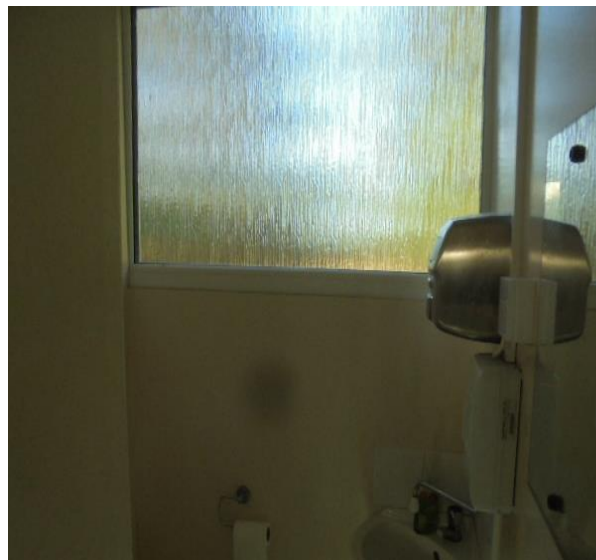
Item No: 7

Location: WC's x 2

Material Description:	Visual Inspection – No Suspect Materials Found	
Identification:	N/A	
Approx. quantity:	N/A	
Accessibility	N/A	<i>Assessment Score</i>
Product type:	N/A	N/A
Extent of Damage:	N/A	N/A
Surface Treatment:	N/A	N/A
Asbestos type:	N/A	N/A
Material Assessment Score:		N/A
Priority Assessment Score:		N/A
Action:	N/A	
Comments:	N/A

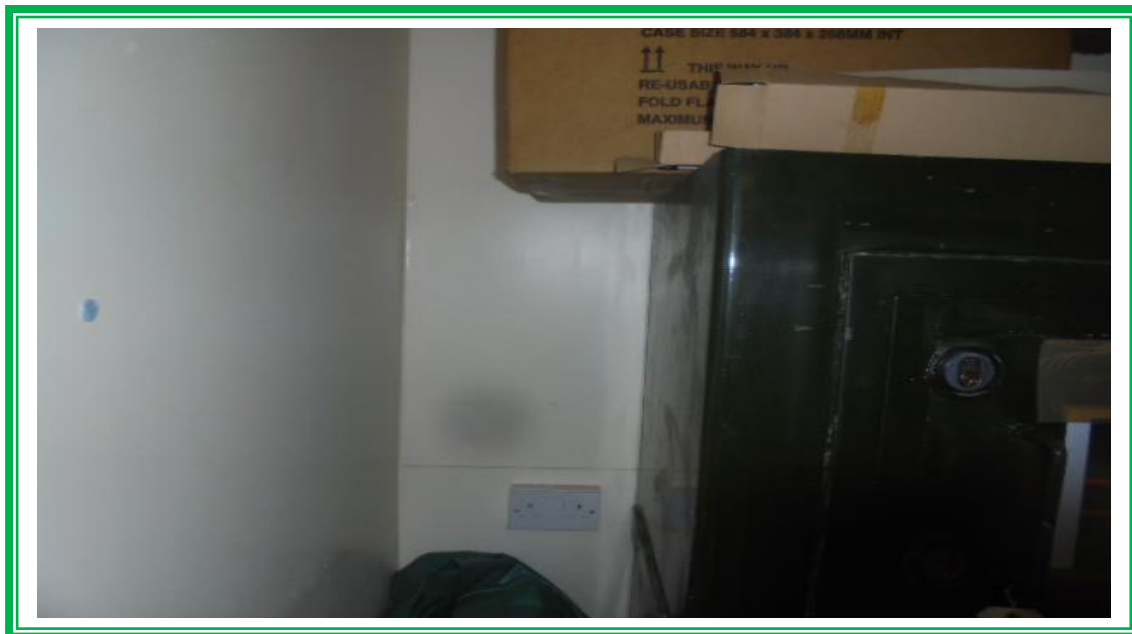
Item No: 8

Location: Armoury

Material Description:	Visual Inspection – No Suspect Materials Found	
Identification:	N/A	
Approx. quantity:	N/A	
Accessibility	N/A	<i>Assessment Score</i>
Product type:	N/A	N/A
Extent of Damage:	N/A	N/A
Surface Treatment:	N/A	N/A
Asbestos type:	N/A	N/A
Material Assessment Score:		N/A
Priority Assessment Score:		N/A
Action:	N/A	
Comments:	N/A

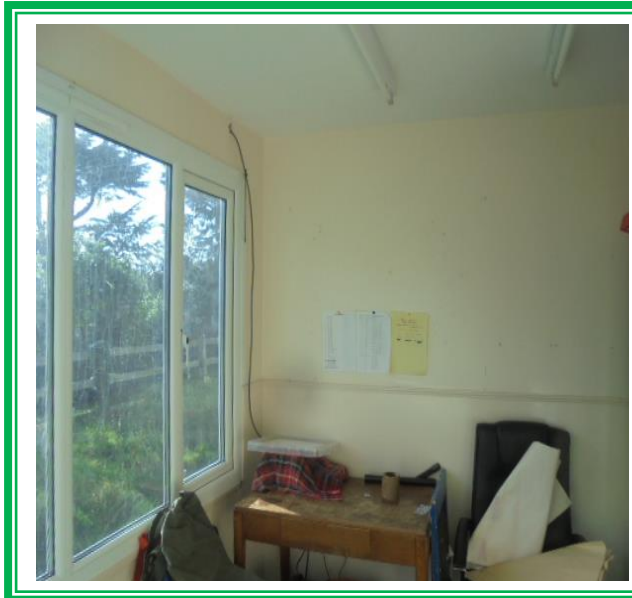
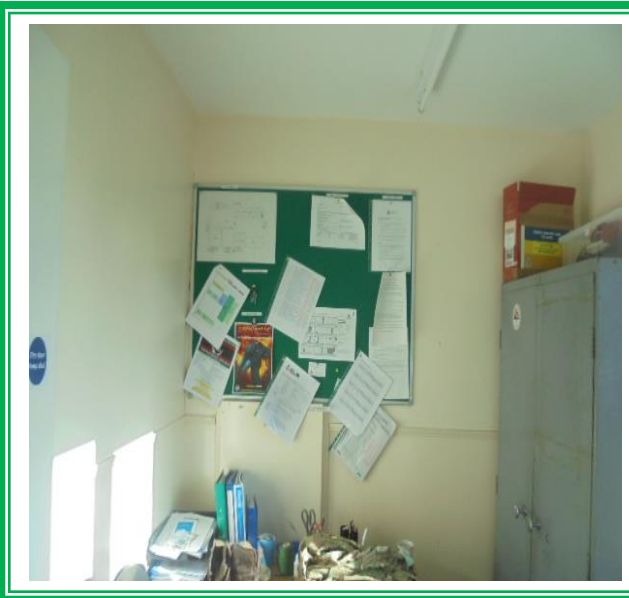
Item No: 9

Location: Offices x 2

Material Description:	Visual Inspection – No Suspect Materials Found	
Identification:	N/A	
Approx. quantity:	N/A	
Accessibility	N/A	<i>Assessment Score</i>
Product type:	N/A	N/A
Extent of Damage:	N/A	N/A
Surface Treatment:	N/A	N/A
Asbestos type:	N/A	N/A
Material Assessment Score:		N/A
Priority Assessment Score:		N/A
Action:	N/A	
Comments:	N/A

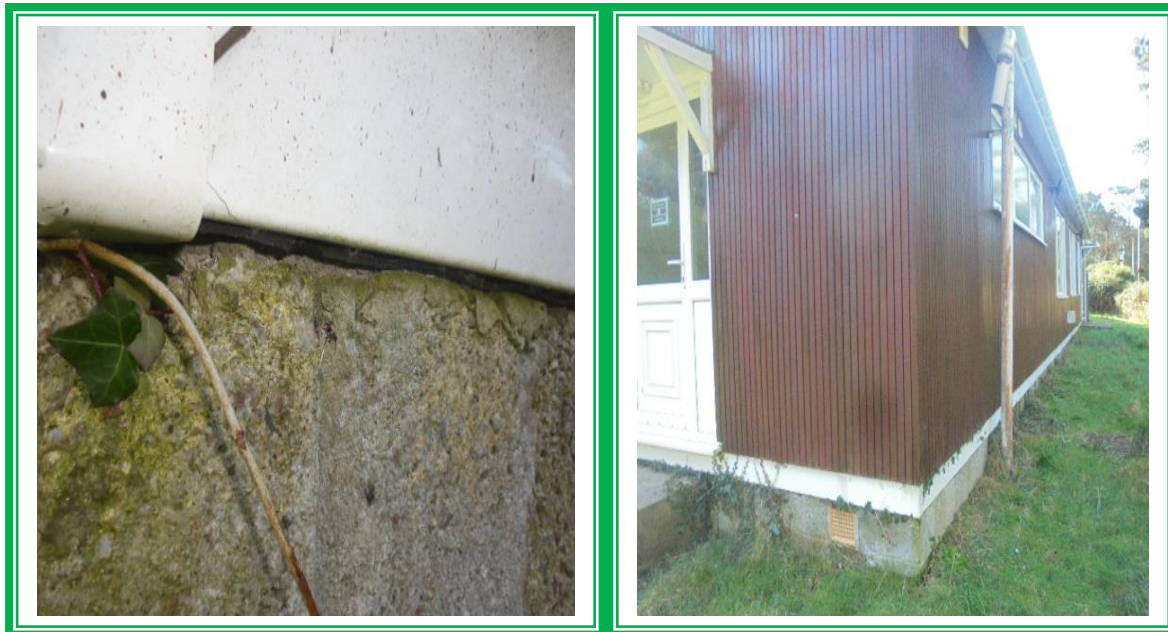
Item No: 10

Sample No: DK/1

Location: External

Material Description:	Damp Proof Course	
Identification:	Sampled – No Asbestos Detected	
Approx. quantity:	50LM - Entire perimeter of building	
Accessibility	N/A	<i>Assessment Score</i>
Product type:	N/A	N/A
Extent of Damage:	N/A	N/A
Surface Treatment:	N/A	N/A
Asbestos type:	N/A	N/A
Material Assessment Score:		N/A
Priority Assessment Score:		N/A
Action:	N/A	
Comments:	N/A

Sample No.	Sample Ref.	Location	Asbestos Detected	Asbestos Type
DK/1	BS600737	Externals - Damp Proof Course	No

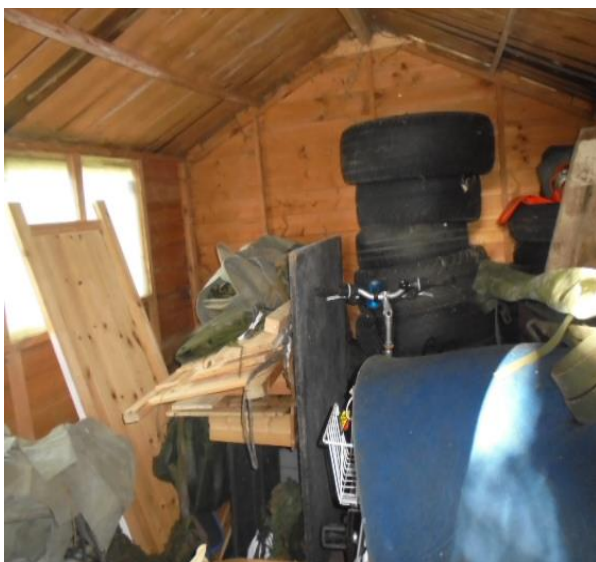
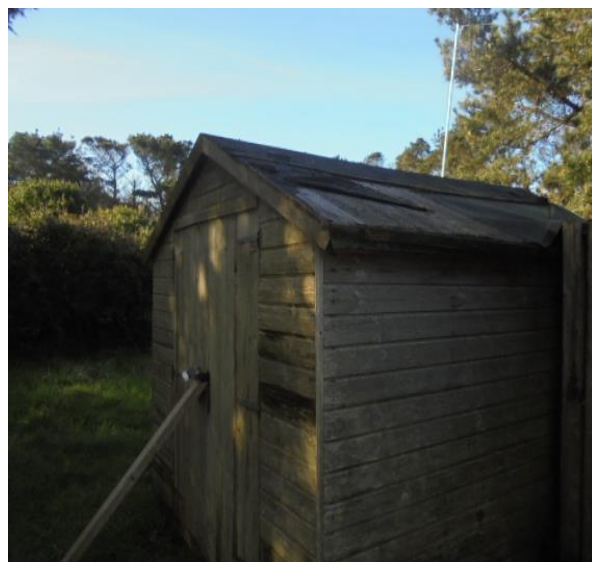
Item No: 11

Location: Shed

Material Description:	Visual Inspection – No Suspect Materials Found	
Identification:	N/A	
Approx. quantity:	N/A	
Accessibility	N/A	<i>Assessment Score</i>
Product type:	N/A	N/A
Extent of Damage:	N/A	N/A
Surface Treatment:	N/A	N/A
Asbestos type:	N/A	N/A
Material Assessment Score:		N/A
Priority Assessment Score:		N/A
Action:	N/A	
Comments:	Non asbestos roof felt
