Project Number A-00369 (3700)

**Re-Inspection
Asbestos Survey Report**

**992 Malmesbury
Wiltshire
SN16 9JR**

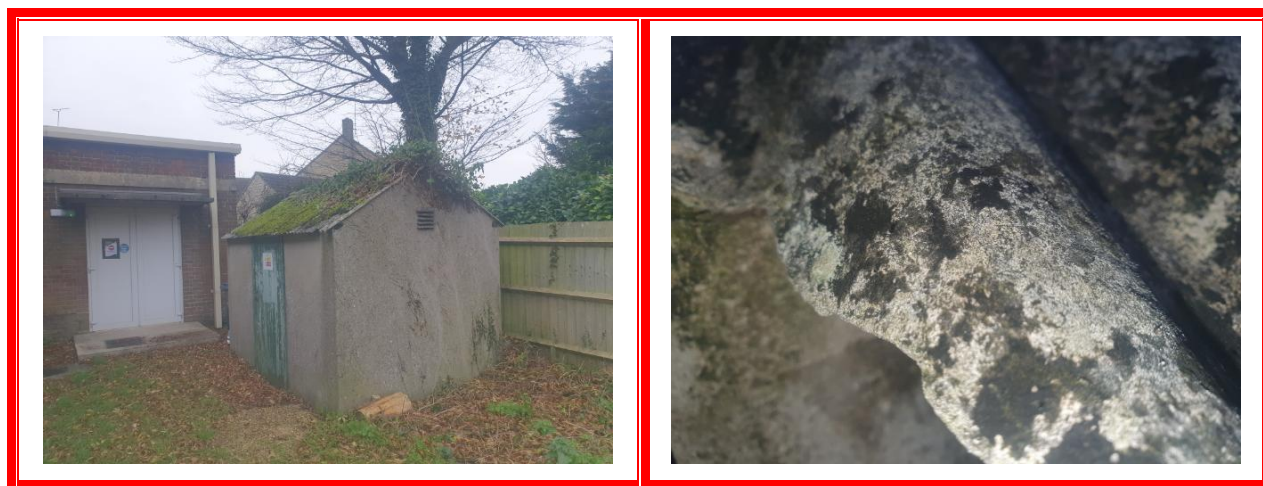
Item No:	1	Sample No:	N/A
Location:	Ground Floor - Shed 001

Material Description:	Cement Product	
Identification:	Previously Sampled - Asbestos Detected	
Approx. quantity:	4 m ²	
Accessibility	Easy	Assessment Score
Product type:	Vinyl, 'Bakelite', Cement	1
Extent of Damage:	Slight / minor damage	1
Surface Treatment:	Encapsulated AIB, Unsealed Cement, Rope Seal	1
Asbestos type:	Chrysotile	1
Material Assessment Score:		4
Priority Assessment Score:		Negligible
Action:	Manage	
Comments:	Previously sampled - DK/1

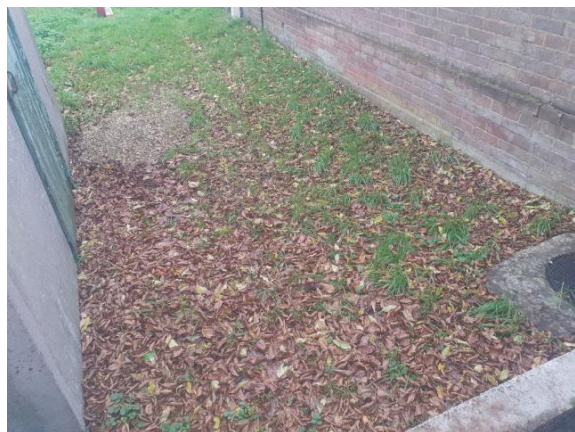
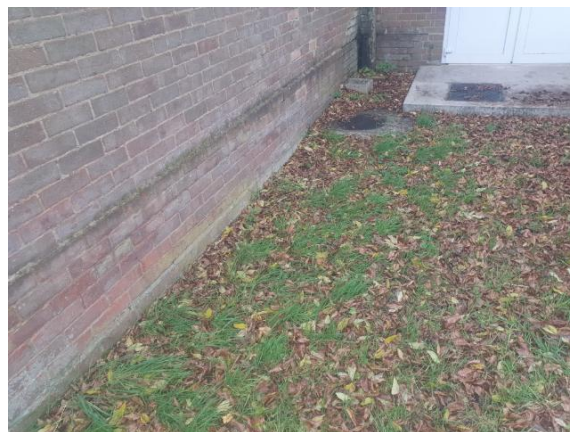
Location: Ground Floor External - Old Boiler Room 002

Material Description:	Lagging to Boiler and pipes - Insulation	
Identification:	Strongly Presumed to Contain Asbestos	
Approx. quantity:	100m2	
Accessibility	Difficult	<i>Assessment Score</i>
Product type:	Pipe insulation, spray coating, friable debris	3
Extent of Damage:	Major damage	3
Surface Treatment:	Unsealed Pipe Insulation or Spray Coating	3
Asbestos type:	Presumed	3
Material Assessment Score:		12
Priority Assessment Score:		High
Action:	Manage	
Comments:	Old Boiler room contained asbestos Boiler and pipework lagging, but boiler room has been filled in with concrete as stated in last survey information was supplied via site Contact

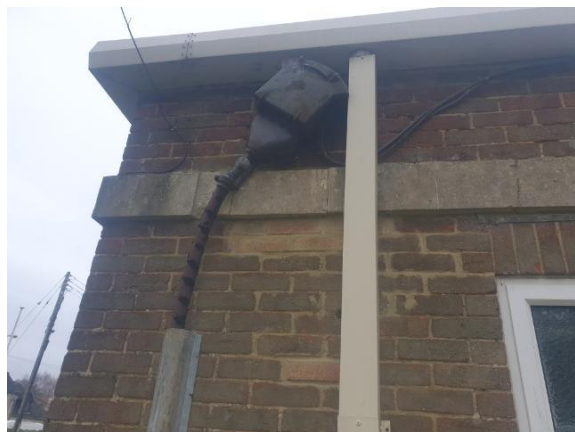
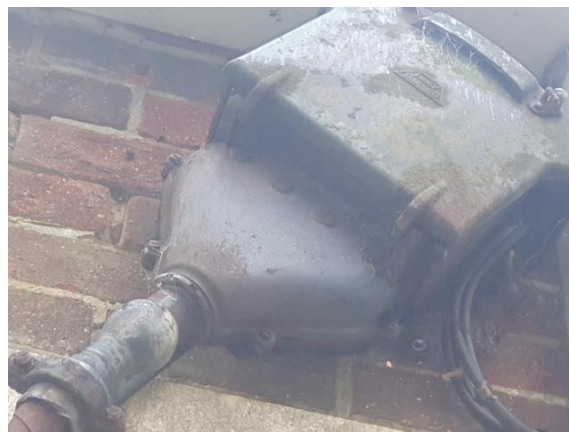
Location: External - 003

Material Description:	Electrical box - No Access Gained	
Identification:	Strongly Presumed to Contain Asbestos	
Approx. quantity:	1 no	
Accessibility	Difficult	<i>Assessment Score</i>
Product type:	Asbestos insulating board, paper, rope	2
Extent of Damage:	Good	0
Surface Treatment:	Encapsulated AIB, Unsealed Cement, Rope Seal	1
Asbestos type:	Presumed	3
Material Assessment Score:		6
Priority Assessment Score:		Low
Action:	Manage	
Comments:	No Access Gained into Electricity box as box is live

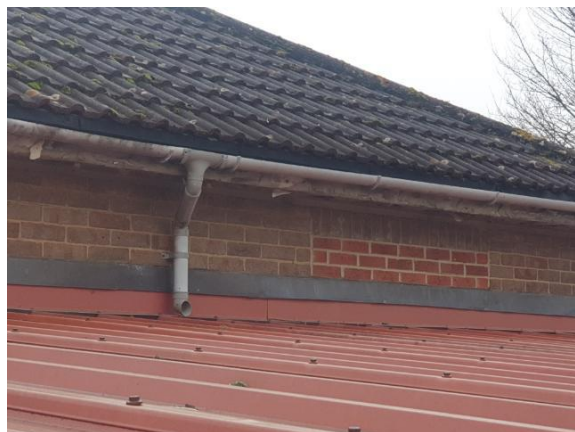
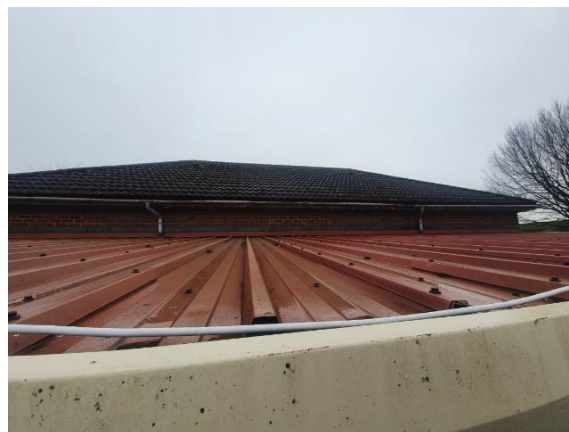
Location: External - Drill Hall 004

Material Description:	Soffits - Insulating Board	
Identification:	Strongly Presumed to Contain Asbestos	
Approx. quantity:	40 m ²	
Accessibility	Difficult	<i>Assessment Score</i>
Product type:	Asbestos insulating board, paper, rope	2
Extent of Damage:	Good	0
Surface Treatment:	Encapsulated AIB, Unsealed Cement, Rope Seal	1
Asbestos type:	Presumed	3
Material Assessment Score:		6
Priority Assessment Score:		Low
Action:	Manage	
Comments:	Soffits at high level around top of Drill hall unable to sample due to unsalability of roof and hight

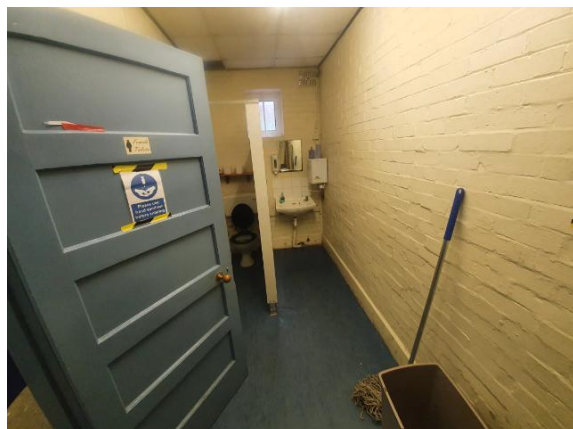
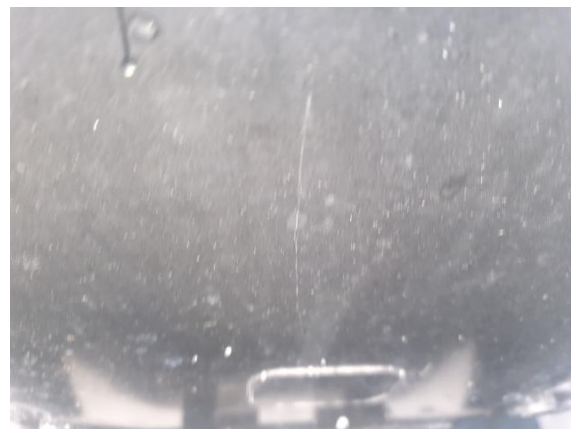
Location: Ground Floor - Female Toilets 010

Material Description:	Toilet Seat - PVC / Reinforced Plastics	
Identification:	Strongly Presumed to Contain Asbestos	
Approx. quantity:	1 no	
Accessibility	Easy	<i>Assessment Score</i>
Product type:	Vinyl, 'Bakelite', Cement	1
Extent of Damage:	Good	0
Surface Treatment:	Non-friable, Sealed Cement, Floor Tiles	0
Asbestos type:	Chrysotile	1
Material Assessment Score:		2
Priority Assessment Score:		Negligible
Action:	Manage	
Comments:	Female Toilets seat was unable to sample due to integrity of the seat

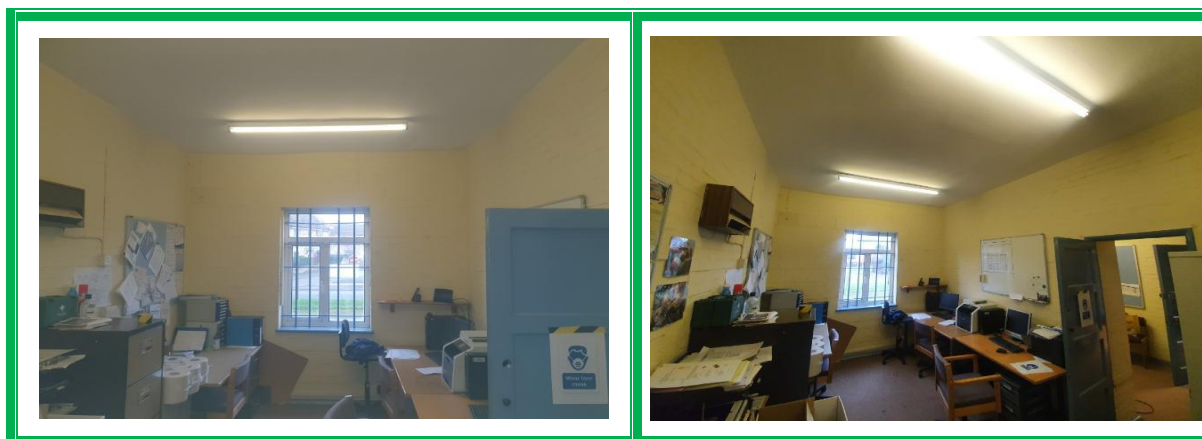
Item No:	6	Sample No:	N/A
Location:	Ground Floor - Office 007

Material Description:	No Suspect Materials Found	
Identification:	N/A	
Approx. quantity:	N/A	
Accessibility	N/A	<i>Assessment Score</i>
Product type:	N/A	N/A
Extent of Damage:	N/A	N/A
Surface Treatment:	N/A	N/A
Asbestos type:	N/A	N/A
Material Assessment Score:		
Priority Assessment Score:		
Action:	N/A	
Comments:	This office has plasterboard ceilings brick work walls and concrete floor also Checked heater on wall which was a presumed item on the last survey
