**ARMOUR**  
ANALYTICAL SERVICES

**Project Number 2481**

**Management  
Asbestos Survey Report**

**6<sup>th</sup> Battalion, Eastern Avenue, Gloucestershire  
GL4 3BD**

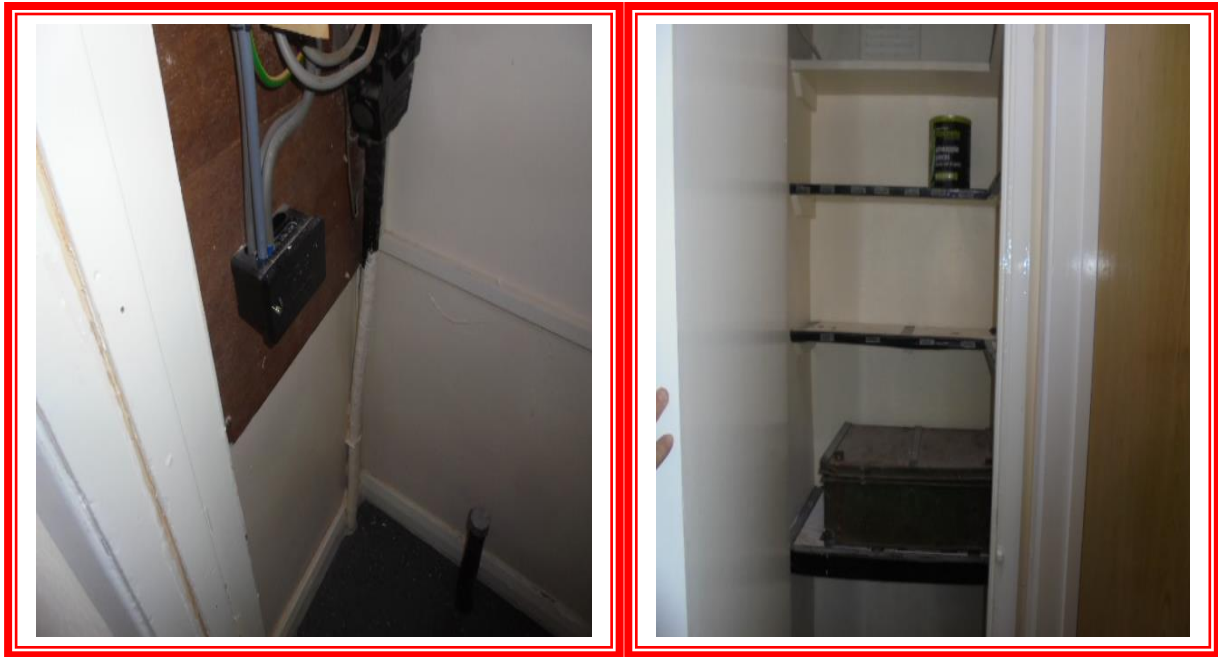
<b>Material Description:</b>	Bitumen Wrap to Mains Cable	
<b>Identification:</b>	Presumed to Contain Asbestos	
<b>Approx. quantity:</b>	<1LM	
<b>Accessibility</b>	Low	<i>Assessment Score</i>
<b>Product type:</b>	Bitumen	1
<b>Extent of Damage:</b>	Minor	1
<b>Surface Treatment:</b>	Non-Friable	0
<b>Asbestos type:</b>	Chrysotile	1
<b>Material Assessment Score:</b>		3
<b>Priority Assessment Score:</b>		Negligible
<b>Action:</b>	Manage	
<b>Comments:</b>	Modern Electrics

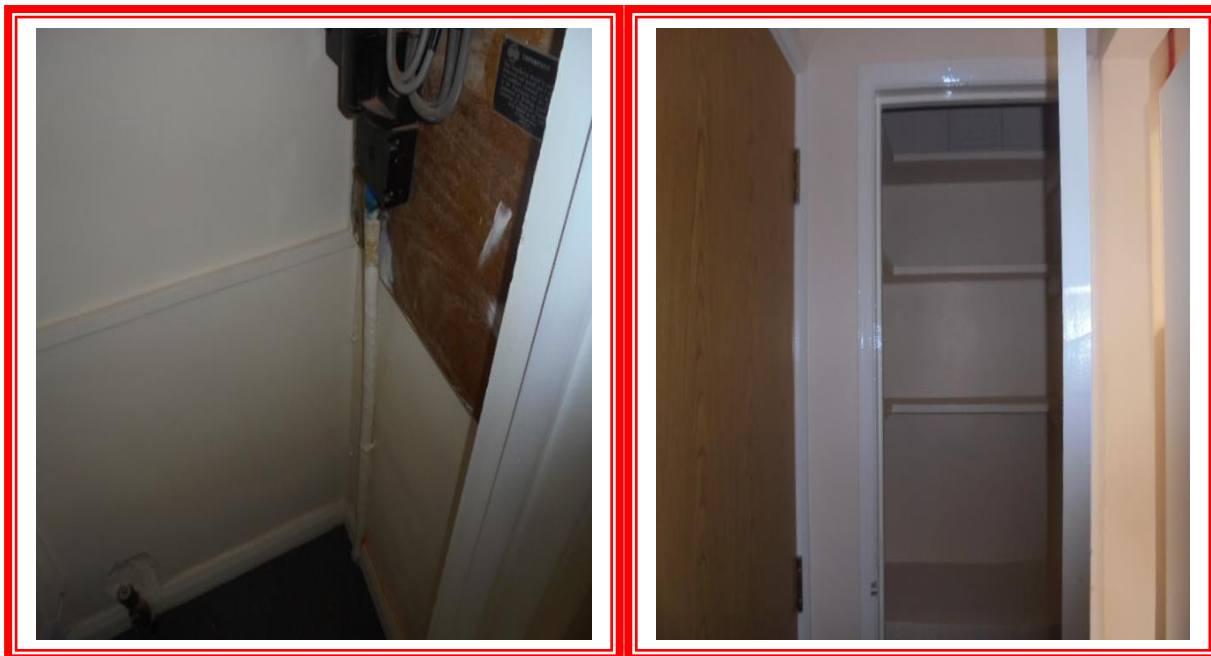
<b>Material Description:</b>	Bitumen Wrap to Mains Cable	
<b>Identification:</b>	Presumed to Contain Asbestos	
<b>Approx. quantity:</b>	<1LM	
<b>Accessibility</b>	Low	<i>Assessment Score</i>
<b>Product type:</b>	Bitumen	1
<b>Extent of Damage:</b>	Minor	1
<b>Surface Treatment:</b>	Non-Friable	0
<b>Asbestos type:</b>	Chrysotile	1
<b>Material Assessment Score:</b>		3
<b>Priority Assessment Score:</b>		Negligible
<b>Action:</b>	Manage	
<b>Comments:</b>	Modern Electrics

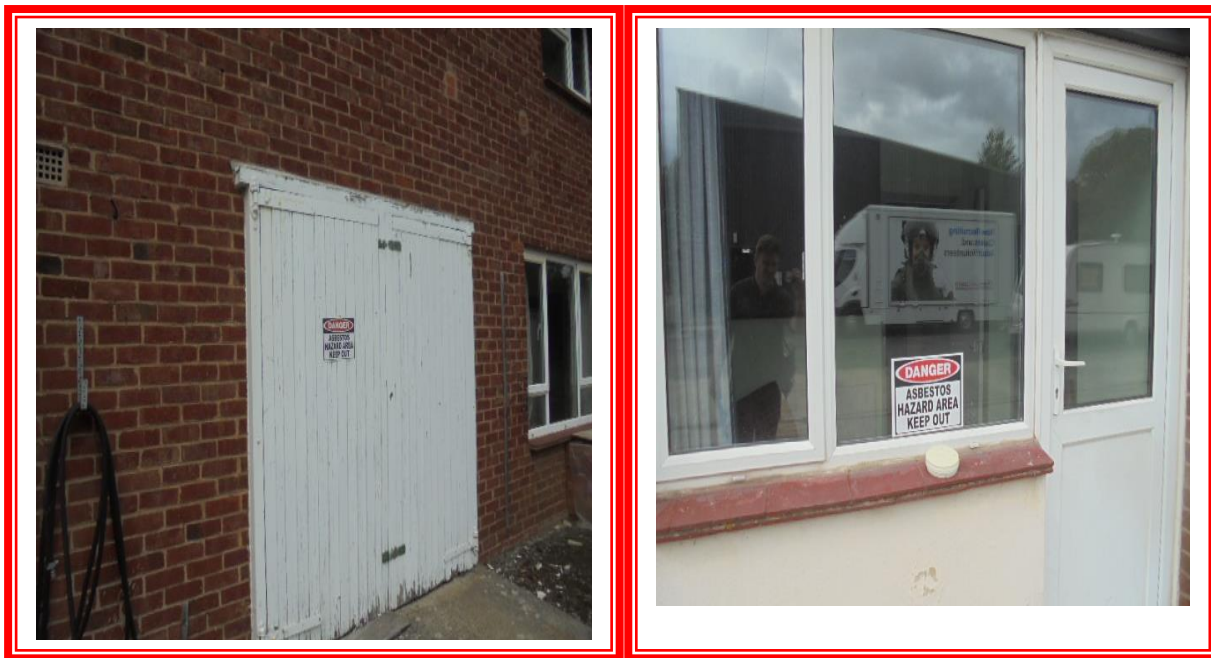
<b>Material Description:</b>	No Access	
<b>Identification:</b>	Presumed to Contain Asbestos	
<b>Approx. quantity:</b>	Unknown	
<b>Accessibility</b>	High	Assessment Score
<b>Product type:</b>	No Access	3
<b>Extent of Damage:</b>	No Access	3
<b>Surface Treatment:</b>	No Access	3
<b>Asbestos type:</b>	No Access	3
<b>Material Assessment Score:</b>		12
<b>Priority Assessment Score:</b>		High
<b>Action:</b>	Remove	
<b>Comments:</b>	No Access Possible within Houses 1 and 2 on Request of Site Contact. Pipework lagging dust has contaminated both Houses and must not be Entered

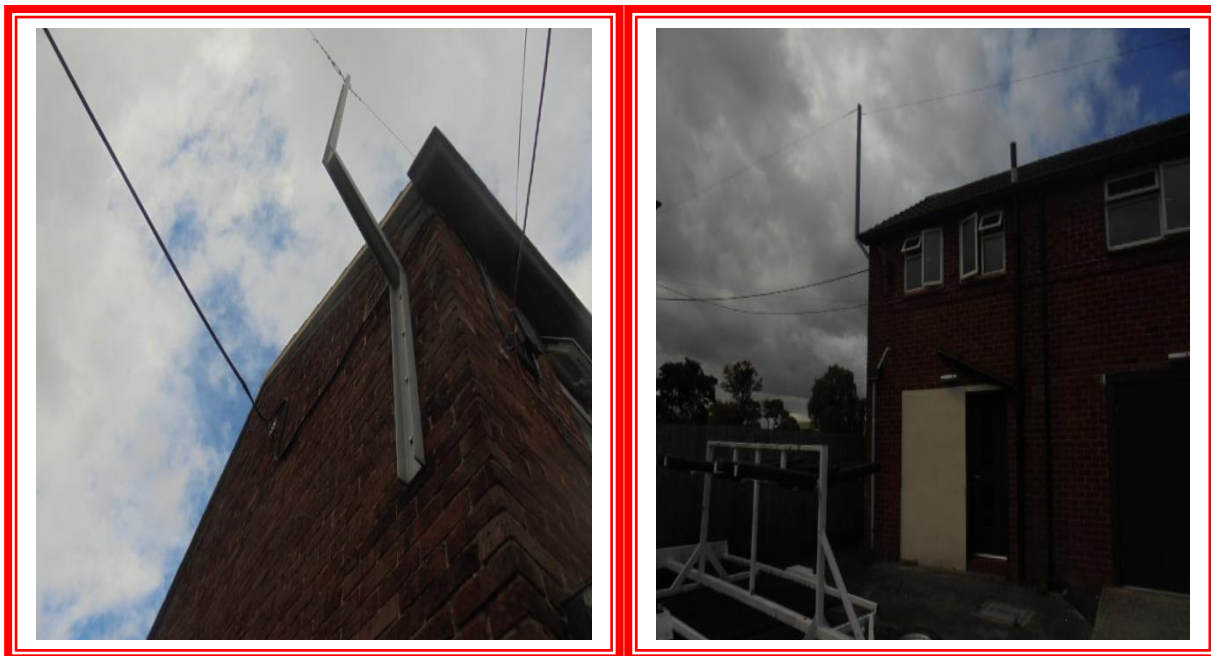
<b>Material Description:</b>	Cement Undercloaking	
<b>Identification:</b>	Presumed to Contain Asbestos	
<b>Approx. quantity:</b>	8LM	
<b>Accessibility</b>	Low	Assessment Score
<b>Product type:</b>	Cement	1
<b>Extent of Damage:</b>	Minor	1
<b>Surface Treatment:</b>	Unsealed	1
<b>Asbestos type:</b>	Chrysotile	1
<b>Material Assessment Score:</b>		4
<b>Priority Assessment Score:</b>		Negligible
<b>Action:</b>	Manage	
<b>Comments:</b>	N/A

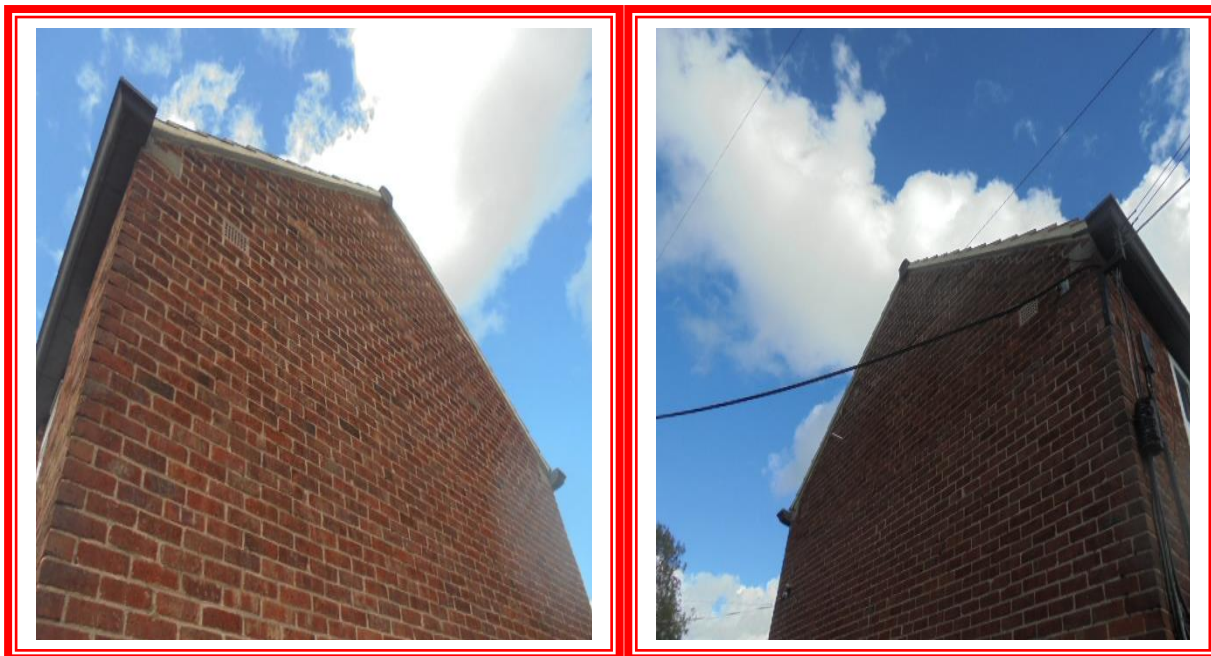
<b>Material Description:</b>	Cement Undercloaking	
<b>Identification:</b>	Presumed to Contain Asbestos	
<b>Approx. quantity:</b>	16LM	
<b>Accessibility</b>	Low	Assessment Score
<b>Product type:</b>	Cement	1
<b>Extent of Damage:</b>	Minor	1
<b>Surface Treatment:</b>	Unsealed	1
<b>Asbestos type:</b>	Chrysotile	1
<b>Material Assessment Score:</b>		4
<b>Priority Assessment Score:</b>		Negligible
<b>Action:</b>	Manage	
<b>Comments:</b>	N/A

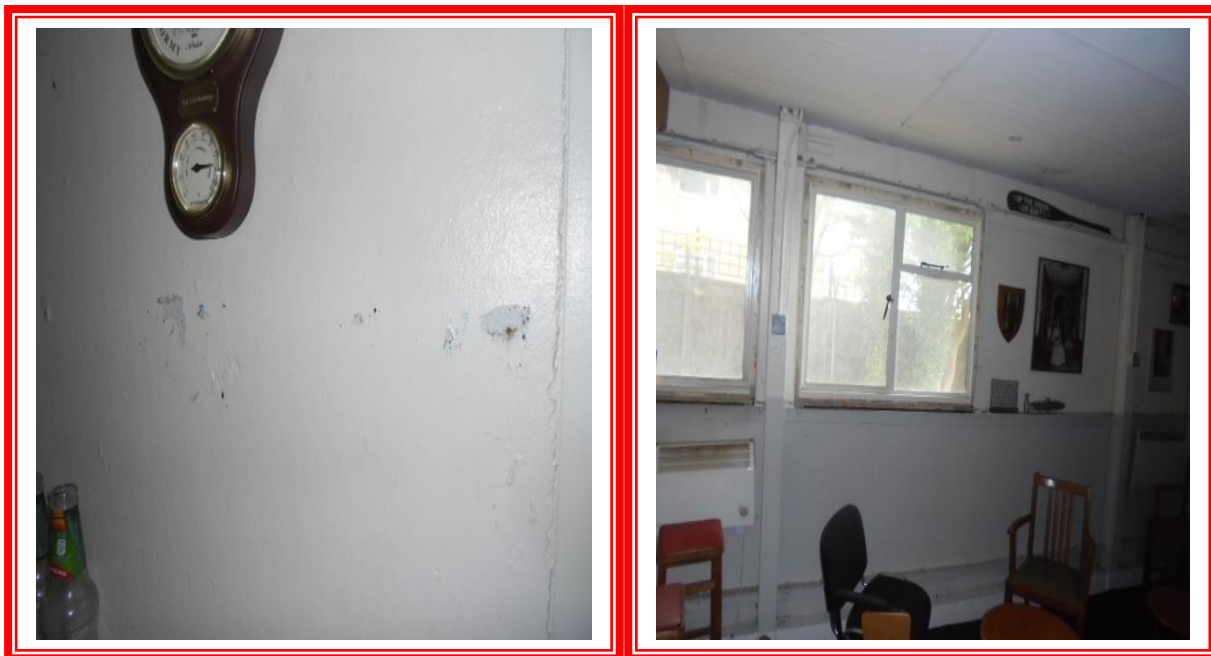
<b>Material Description:</b>	Paper Lining to Fibreboard Wall Panels	
<b>Identification:</b>	As Per Sampled DK/5 – Asbestos Detected	
<b>Approx. quantity:</b>	14M2	
<b>Accessibility</b>	High	Assessment Score
<b>Product type:</b>	Paper	2
<b>Extent of Damage:</b>	Minor	1
<b>Surface Treatment:</b>	Unsealed	1
<b>Asbestos type:</b>	Chrysotile	1
<b>Material Assessment Score:</b>		5
<b>Priority Assessment Score:</b>		High
<b>Action:</b>	Encapsulate/Remove	
<b>Comments:</b>	Located to One Wall. Several areas of minor damage.

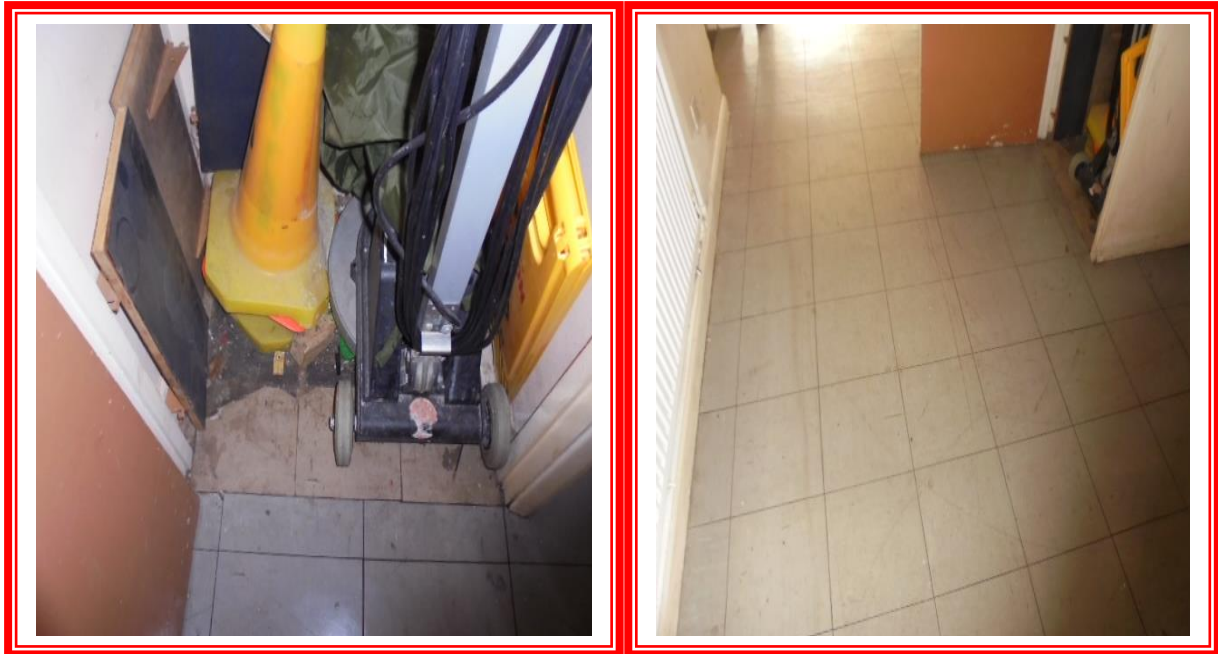
<b>Material Description:</b>	Cream and Grey Floor Tiles and Adhesive	
<b>Identification:</b>	Sampled – Asbestos Detected	
<b>Approx. quantity:</b>	8M2	
<b>Accessibility</b>	High	Assessment Score
<b>Product type:</b>	Cement	1
<b>Extent of Damage:</b>	Moderate	2
<b>Surface Treatment:</b>	Non-Friable	0
<b>Asbestos type:</b>	Chrysotile	1
<b>Material Assessment Score:</b>		4
<b>Priority Assessment Score:</b>		Negligible
<b>Action:</b>	Manage	
<b>Comments:</b>	N/A

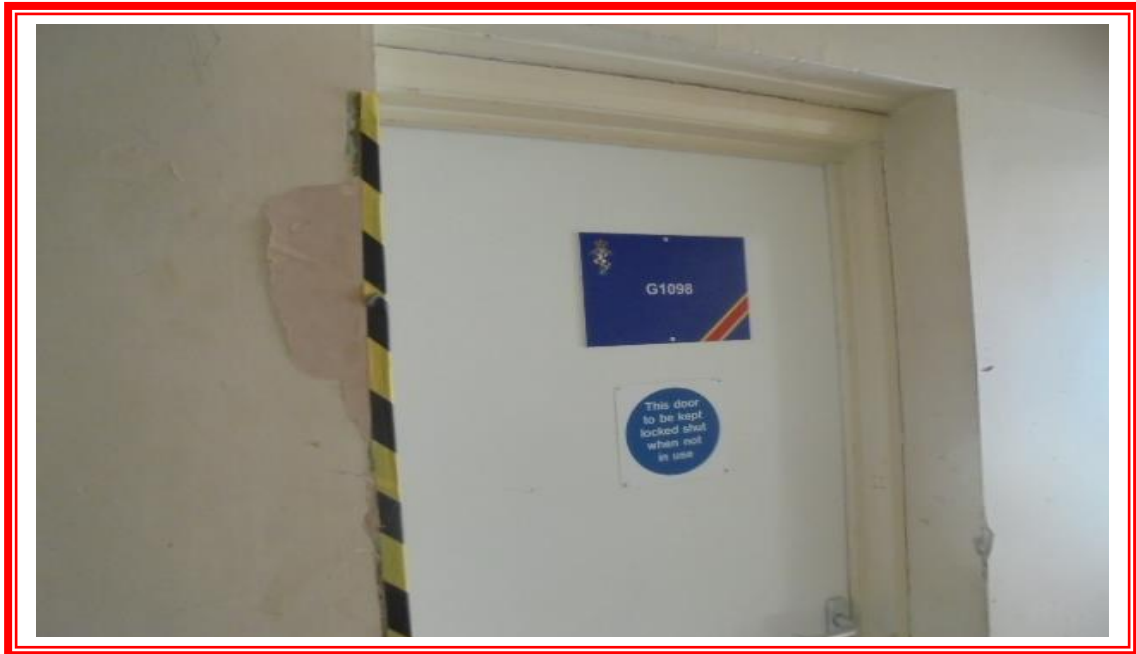
<b>Material Description:</b>	No Access	
<b>Identification:</b>	Presumed to Contain Asbestos	
<b>Approx. quantity:</b>	1 X Room & Mezzanine	
<b>Accessibility</b>	Low	Assessment Score
<b>Product type:</b>	No Access	3
<b>Extent of Damage:</b>	No Access	3
<b>Surface Treatment:</b>	No Access	3
<b>Asbestos type:</b>	No Access	3
<b>Material Assessment Score:</b>		12
<b>Priority Assessment Score:</b>		High
<b>Action:</b>	Further Investigation Required	
<b>Comments:</b>	No Access within store or mezzanine accessed throughout store – Locked and Key has been Lost as advised by site contact

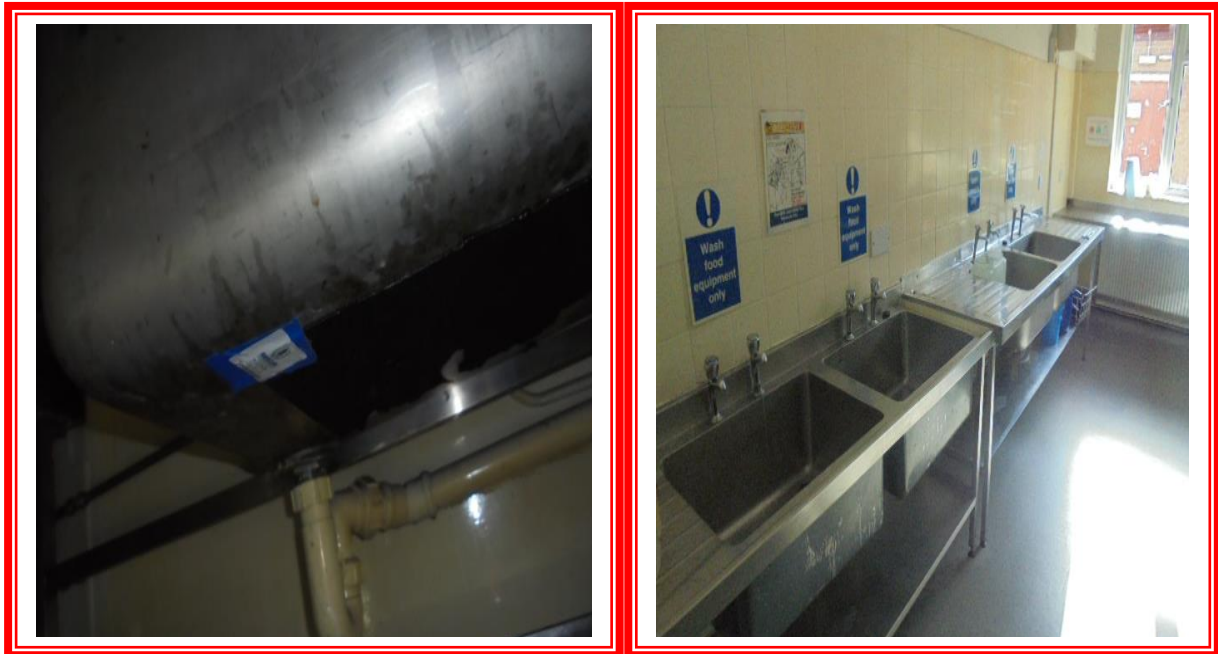
<b>Material Description:</b>	Sink Pads	
<b>Identification:</b>	Sampled – Asbestos Detected	
<b>Approx. quantity:</b>	X 4 Sinks	
<b>Accessibility</b>	Low	<i>Assessment Score</i>
<b>Product type:</b>	Bitumen	1
<b>Extent of Damage:</b>	Moderate	2
<b>Surface Treatment:</b>	Non-Friable	0
<b>Asbestos type:</b>	Chrysotile	1
<b>Material Assessment Score:</b>		4
<b>Priority Assessment Score:</b>		Negligible
<b>Action:</b>	Manage	
<b>Comments:</b>	N/A

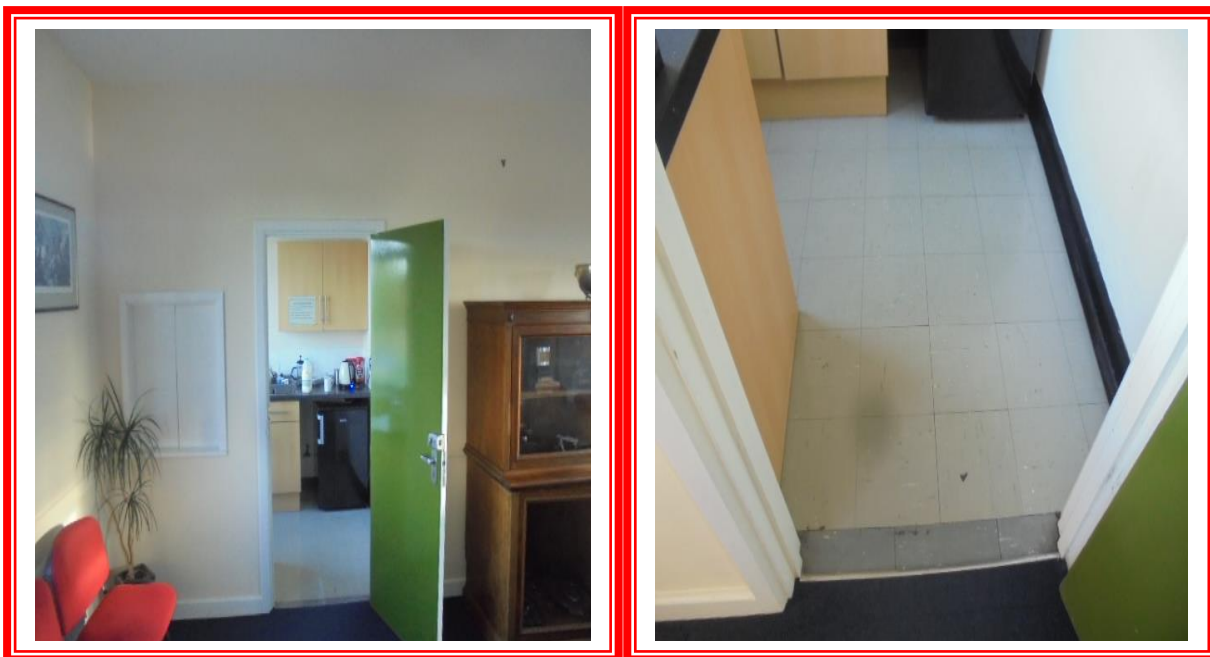
<b>Material Description:</b>	Floor Tiles and Adhesive	
<b>Identification:</b>	Sampled – Asbestos Detected	
<b>Approx. quantity:</b>	4M2	
<b>Accessibility</b>	High	Assessment Score
<b>Product type:</b>	Composite	1
<b>Extent of Damage:</b>	Minor	1
<b>Surface Treatment:</b>	Non-Friable	0
<b>Asbestos type:</b>	Chrysotile	1
<b>Material Assessment Score:</b>		3
<b>Priority Assessment Score:</b>		Negligible
<b>Action:</b>	Manage	
<b>Comments:</b>	No Access Under Lino Under Carpet in Conference Room – Apply Caution

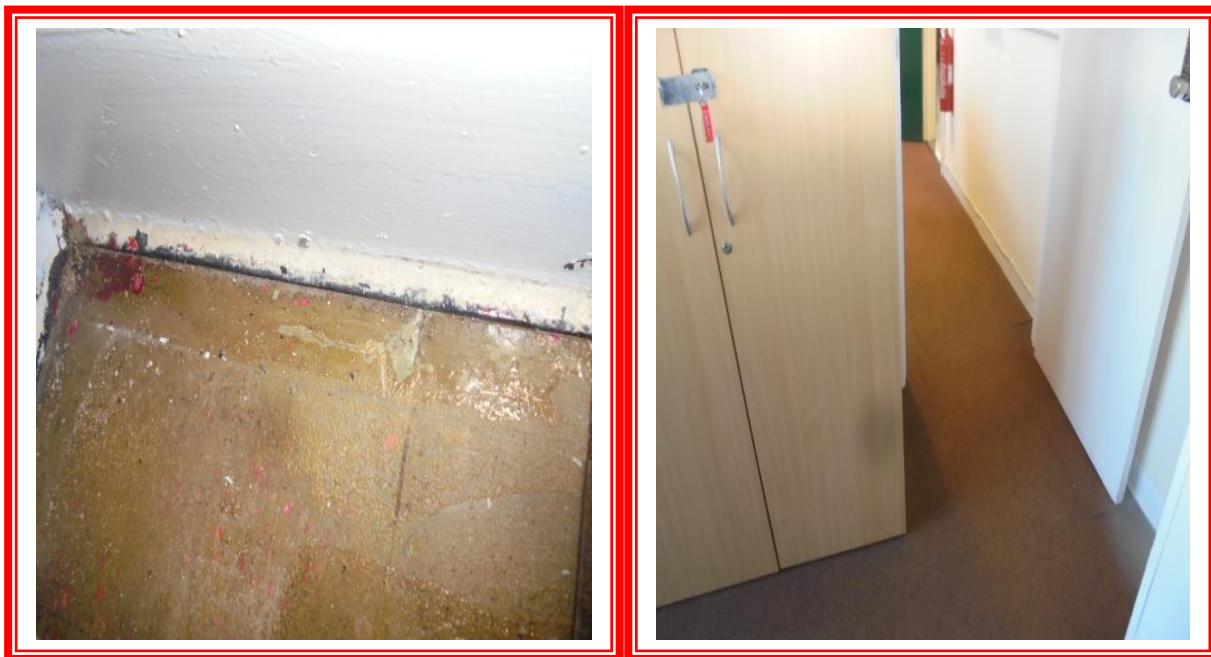
<b>Material Description:</b>	Floor Tiles and Adhesive	
<b>Identification:</b>	Sampled – Asbestos Detected	
<b>Approx. quantity:</b>	24M2	
<b>Accessibility</b>	Low	<i>Assessment Score</i>
<b>Product type:</b>	Composite	1
<b>Extent of Damage:</b>	Minor	1
<b>Surface Treatment:</b>	Non-Friable	0
<b>Asbestos type:</b>	Chrysotile	1
<b>Material Assessment Score:</b>		3
<b>Priority Assessment Score:</b>		Negligible
<b>Action:</b>	Manage	
<b>Comments:</b>	Located Under Carpet

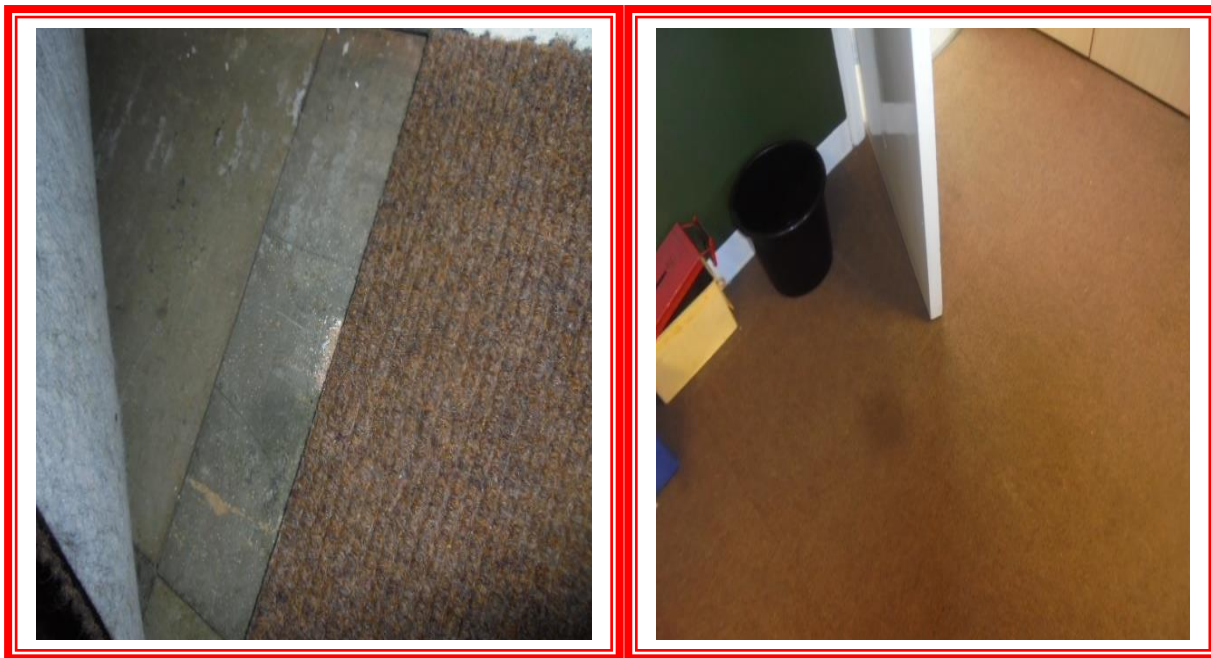
<b>Material Description:</b>	Floor Tiles and Adhesive	
<b>Identification:</b>	As Per Sample DK/20 – Asbestos Detected	
<b>Approx. quantity:</b>	20M2	
<b>Accessibility</b>	Low	Assessment Score
<b>Product type:</b>	Composite	1
<b>Extent of Damage:</b>	Minor	1
<b>Surface Treatment:</b>	Non-Friable	0
<b>Asbestos type:</b>	Chrysotile	1
<b>Material Assessment Score:</b>		3
<b>Priority Assessment Score:</b>		Negligible
<b>Action:</b>	Manage	
<b>Comments:</b>	Located Under Carpet

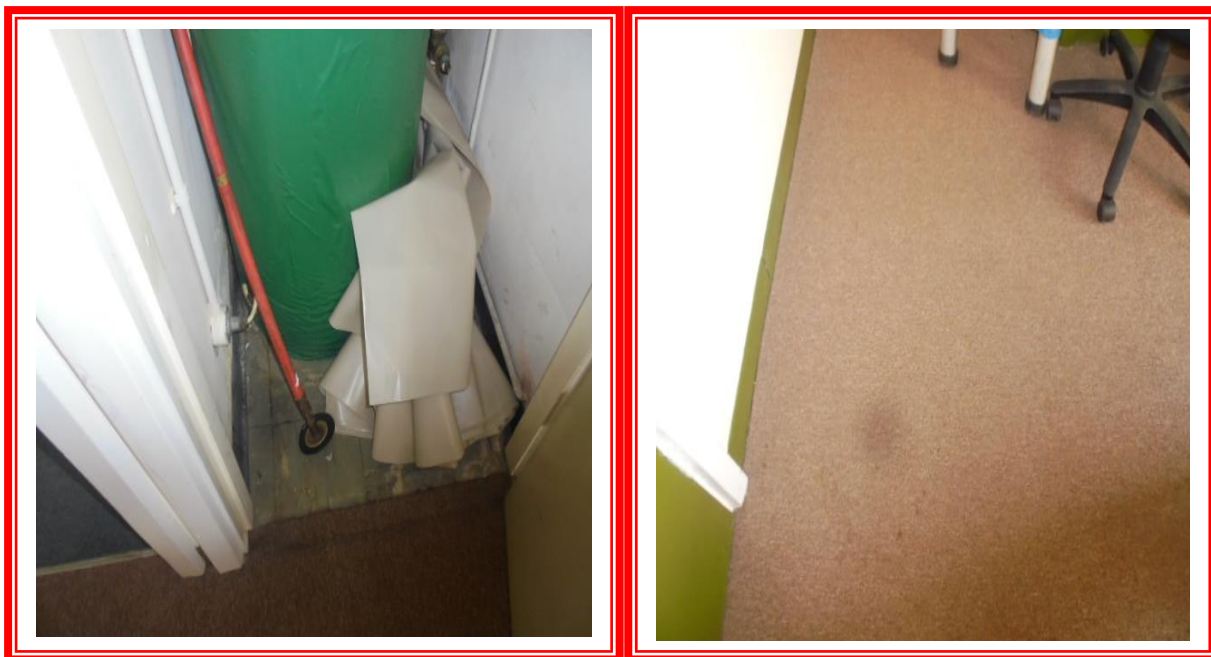
<b>Material Description:</b>	Floor Tiles and Adhesive	
<b>Identification:</b>	Sampled – Asbestos Detected	
<b>Approx. quantity:</b>	14M2	
<b>Accessibility</b>	Medium	Assessment Score
<b>Product type:</b>	Composite	1
<b>Extent of Damage:</b>	Minor	1
<b>Surface Treatment:</b>	Non-Friable	0
<b>Asbestos type:</b>	Chrysotile	1
<b>Material Assessment Score:</b>		3
<b>Priority Assessment Score:</b>		Negligible
<b>Action:</b>	Manage	
<b>Comments:</b>	Under Carpet in Office

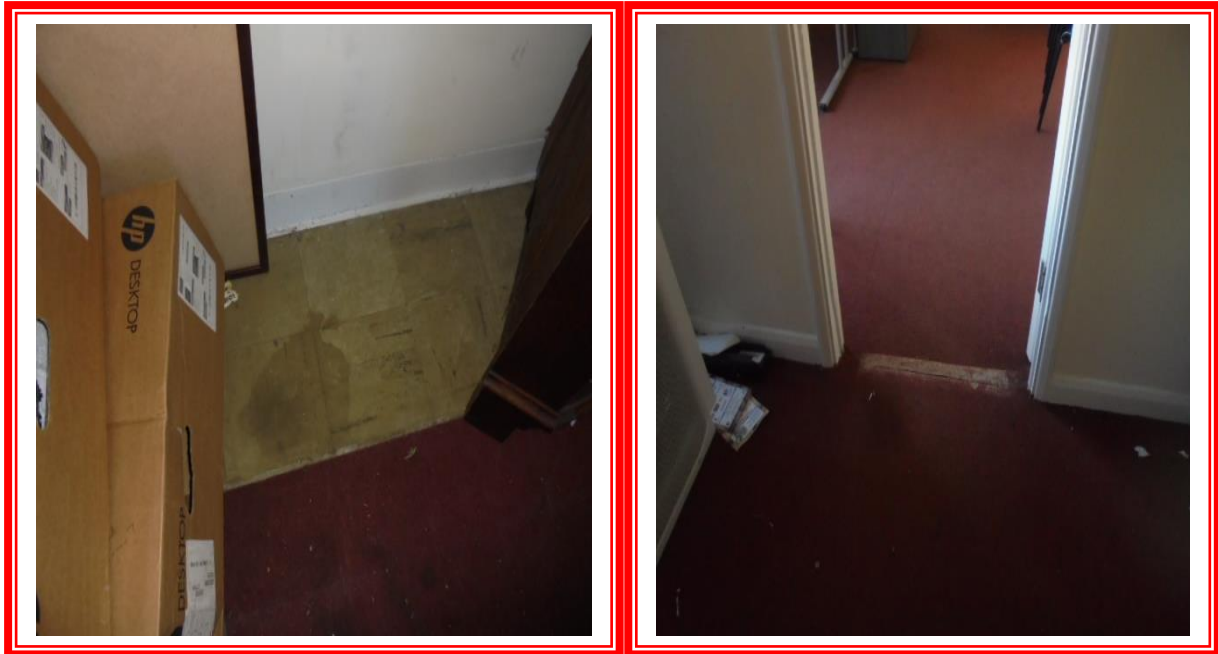
<b>Material Description:</b>	Floor Tiles and Adhesive	
<b>Identification:</b>	A Per Sample DK/23 – Asbestos Detected	
<b>Approx. quantity:</b>	35M2	
<b>Accessibility</b>	High	<i>Assessment Score</i>
<b>Product type:</b>	Composite	1
<b>Extent of Damage:</b>	Minor	1
<b>Surface Treatment:</b>	Non-Friable	0
<b>Asbestos type:</b>	Chrysotile	1
<b>Material Assessment Score:</b>		3
<b>Priority Assessment Score:</b>		Negligible
<b>Action:</b>	Manage	
<b>Comments:</b>	Located under carpet

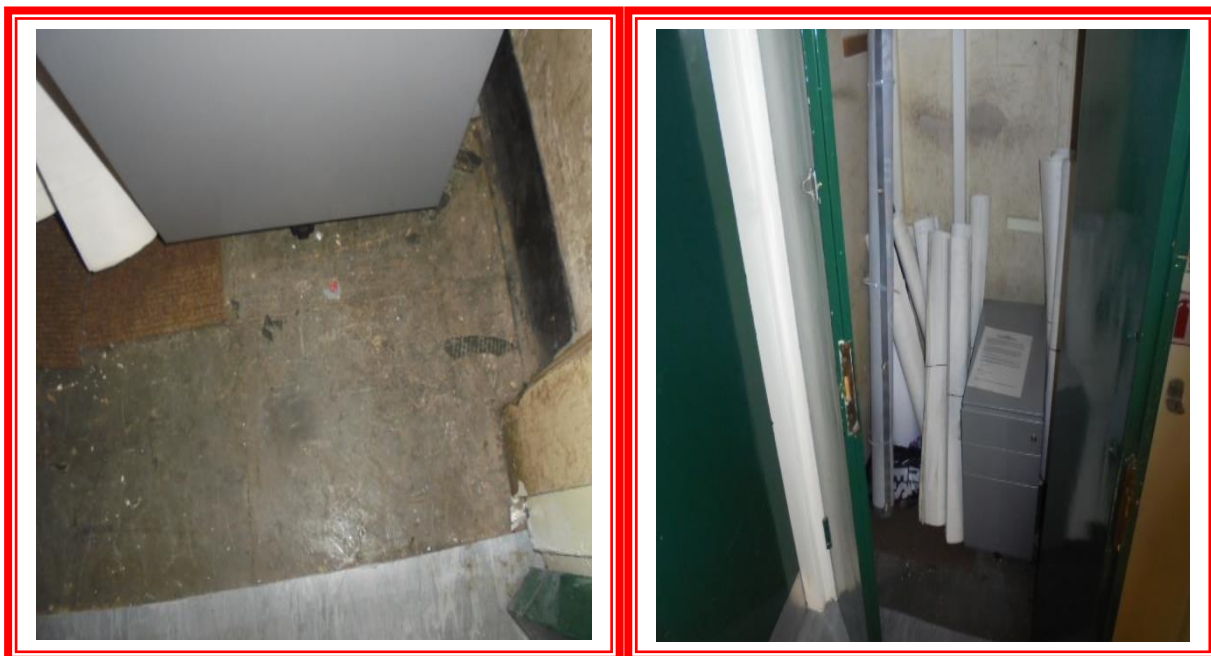
<b>Material Description:</b>	Floor Tiles and Adhesive and Debris	
<b>Identification:</b>	Sampled – Asbestos Detected	
<b>Approx. quantity:</b>	1M2	
<b>Accessibility</b>	Medium	<i>Assessment Score</i>
<b>Product type:</b>	Composite	1
<b>Extent of Damage:</b>	Moderate	2
<b>Surface Treatment:</b>	Non-Friable	0
<b>Asbestos type:</b>	Chrysotile	1
<b>Material Assessment Score:</b>		4
<b>Priority Assessment Score:</b>		Negligible
<b>Action:</b>	Manage/Remove Debris	
<b>Comments:</b>	Tiles broken and fragments are on floor in cupboard

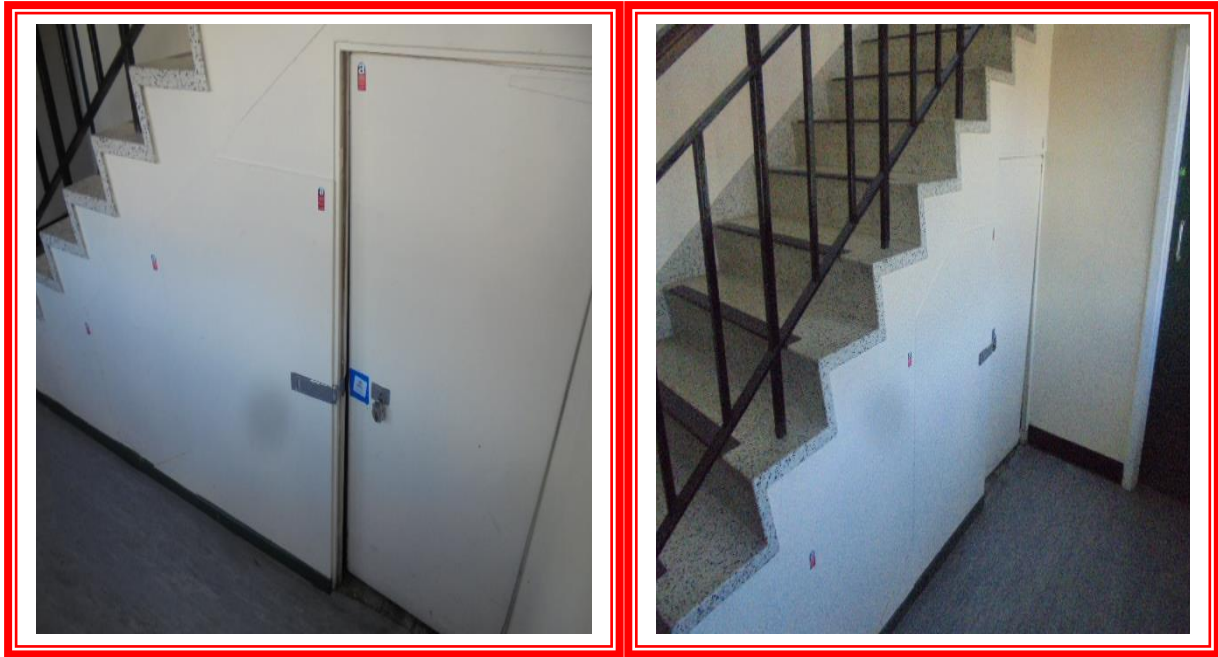
<b>Material Description:</b>	Insulation Board Wall Panels and Door Panel	
<b>Identification:</b>	Sampled – Asbestos Detected	
<b>Approx. quantity:</b>	5M2	
<b>Accessibility</b>	High	Assessment Score
<b>Product type:</b>	Insulation Board	2
<b>Extent of Damage:</b>	Minor	1
<b>Surface Treatment:</b>	Unsealed	2
<b>Asbestos type:</b>	Amosite	2
<b>Material Assessment Score:</b>		7
<b>Priority Assessment Score:</b>		Medium
<b>Action:</b>	Encapsulate/Remove/Restrict Access to Cupboard	
<b>Comments:</b>	Located to Understairs Cupboard and Door. No Access within Cupboard without Damaging Panels

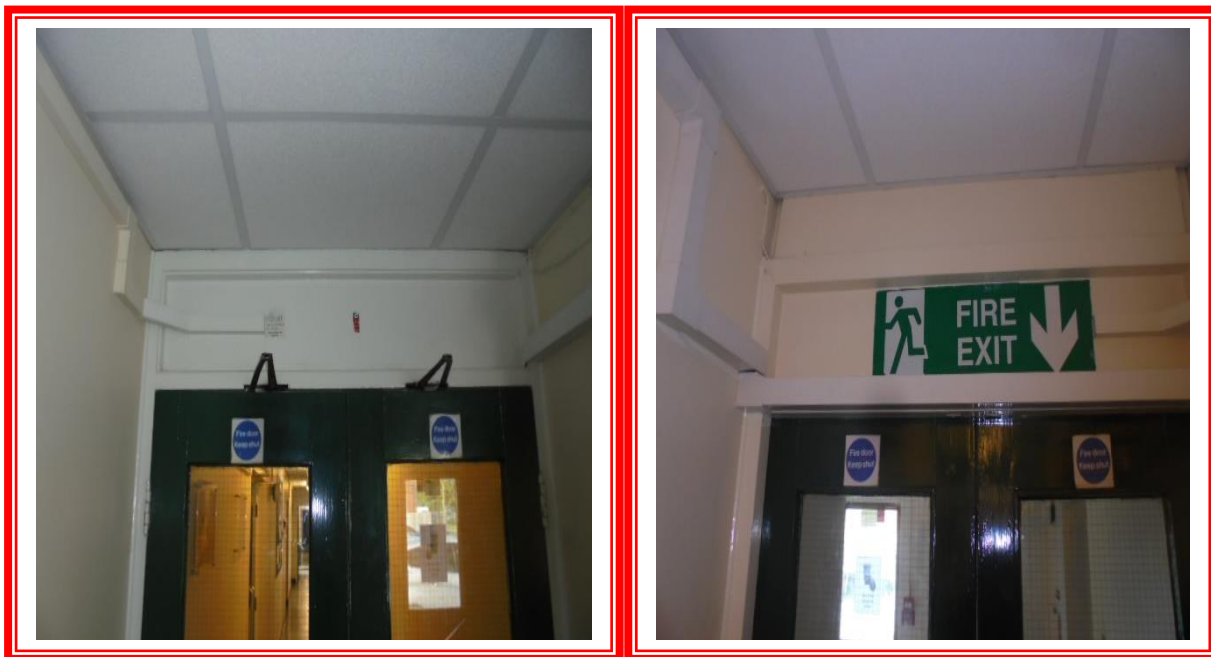
<b>Material Description:</b>	Insulation Board Door Header Panel	
<b>Identification:</b>	As per Sample DK/24 – Asbestos Detected	
<b>Approx. quantity:</b>	1LM	
<b>Accessibility</b>	Low	Assessment Score
<b>Product type:</b>	Insulation Board	2
<b>Extent of Damage:</b>	Minor	1
<b>Surface Treatment:</b>	Sealed	1
<b>Asbestos type:</b>	Amosite	2
<b>Material Assessment Score:</b>		6
<b>Priority Assessment Score:</b>		Low
<b>Action:</b>	Manage	
<b>Comments:</b>	Labelled Asbestos on One Side and has a Fire Exit Sign on the other Side

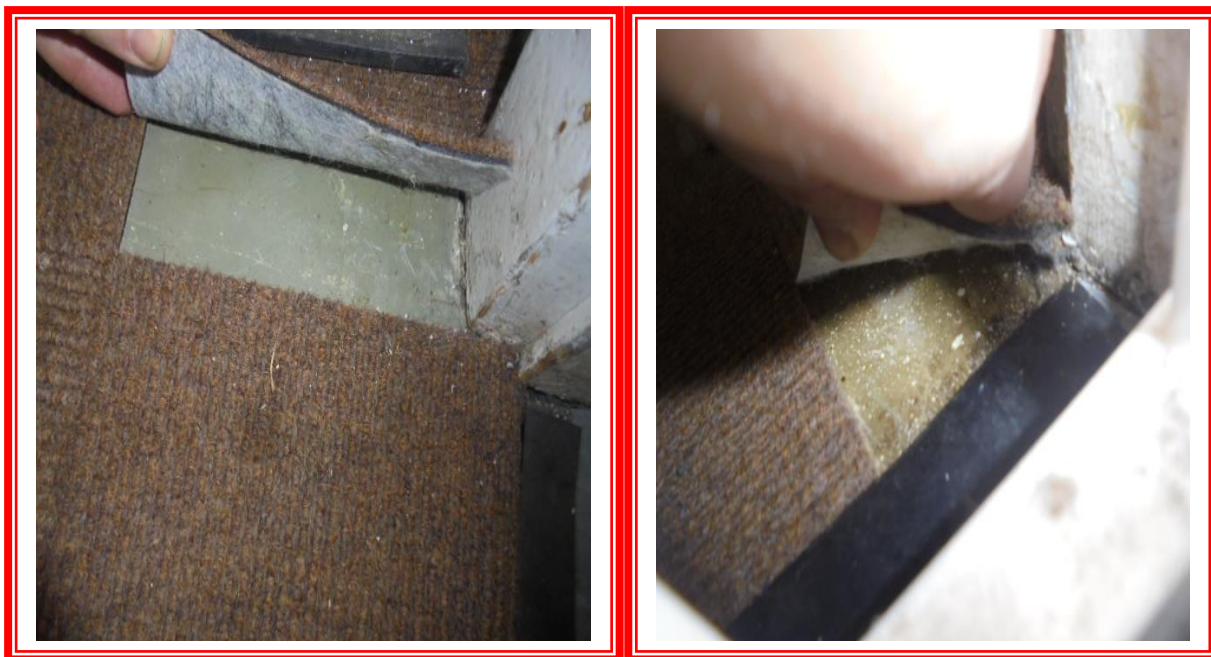
<b>Material Description:</b>	Floor Tiles and Adhesive Under Carpet	
<b>Identification:</b>	As Per Sample DK/23 – Asbestos Detected	
<b>Approx. quantity:</b>	24M2	
<b>Accessibility</b>	Low	<i>Assessment Score</i>
<b>Product type:</b>	Composite	1
<b>Extent of Damage:</b>	Minor	1
<b>Surface Treatment:</b>	Non-Friable	0
<b>Asbestos type:</b>	Chrysotile	1
<b>Material Assessment Score:</b>		3
<b>Priority Assessment Score:</b>		Negligible
<b>Action:</b>	Manage	
<b>Comments:</b>	Located under carpet

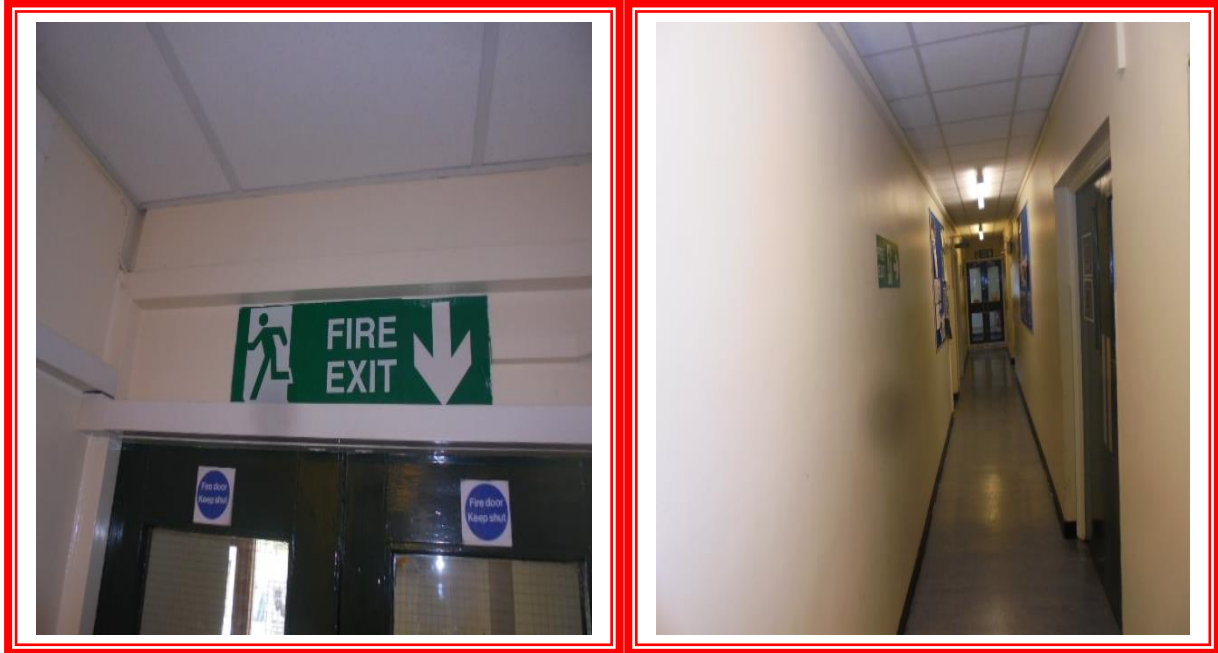
<b>Material Description:</b>	Insulation Board Door Header Panel	
<b>Identification:</b>	As Per Sample DK/24 – Asbestos Detected	
<b>Approx. quantity:</b>	1LM	
<b>Accessibility</b>	Low	<i>Assessment Score</i>
<b>Product type:</b>	Insulation Board	2
<b>Extent of Damage:</b>	Minor	1
<b>Surface Treatment:</b>	Sealed	1
<b>Asbestos type:</b>	Amosite	2
<b>Material Assessment Score:</b>		6
<b>Priority Assessment Score:</b>		Low
<b>Action:</b>	Manage	
<b>Comments:</b>	N/A

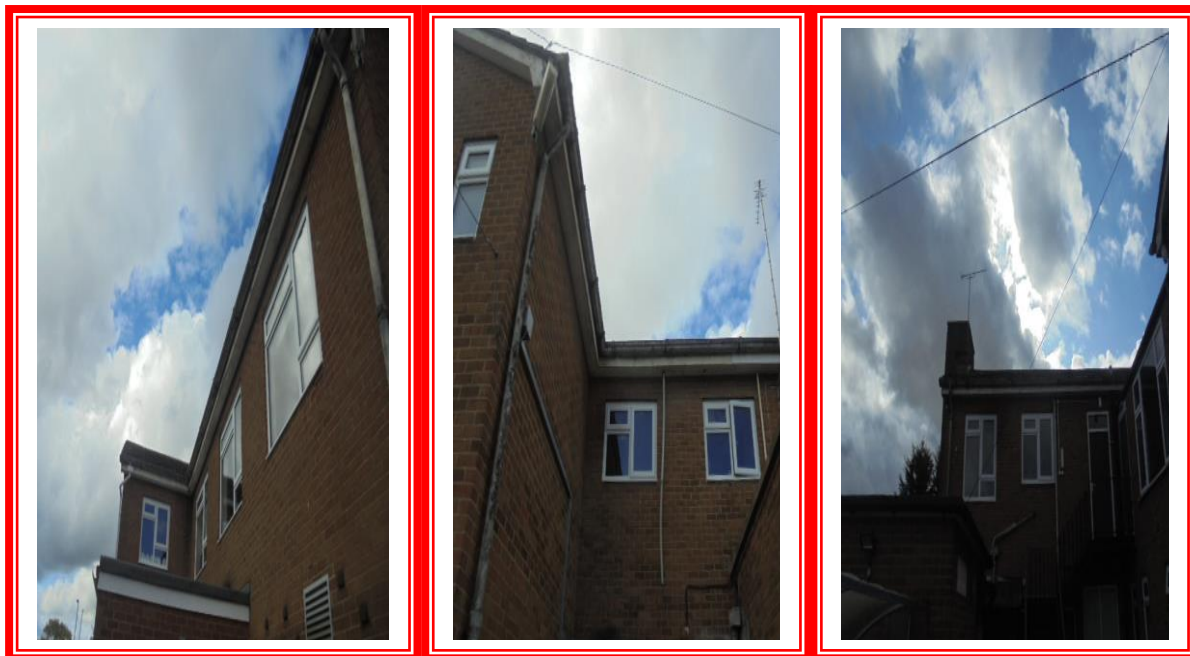
<b>Material Description:</b>	Cement Guttering	
<b>Identification:</b>	As Per Sample DK/25 – Asbestos Detected	
<b>Approx. quantity:</b>	4 X Sections of Guttering (126LM Total)	
<b>Accessibility</b>	Low	<i>Assessment Score</i>
<b>Product type:</b>	Cement	1
<b>Extent of Damage:</b>	Minor	1
<b>Surface Treatment:</b>	Unsealed	1
<b>Asbestos type:</b>	Chrysotile/Amosite	2
<b>Material Assessment Score:</b>		5
<b>Priority Assessment Score:</b>		Low
<b>Action:</b>	Manage	
<b>Comments:</b>	N/A

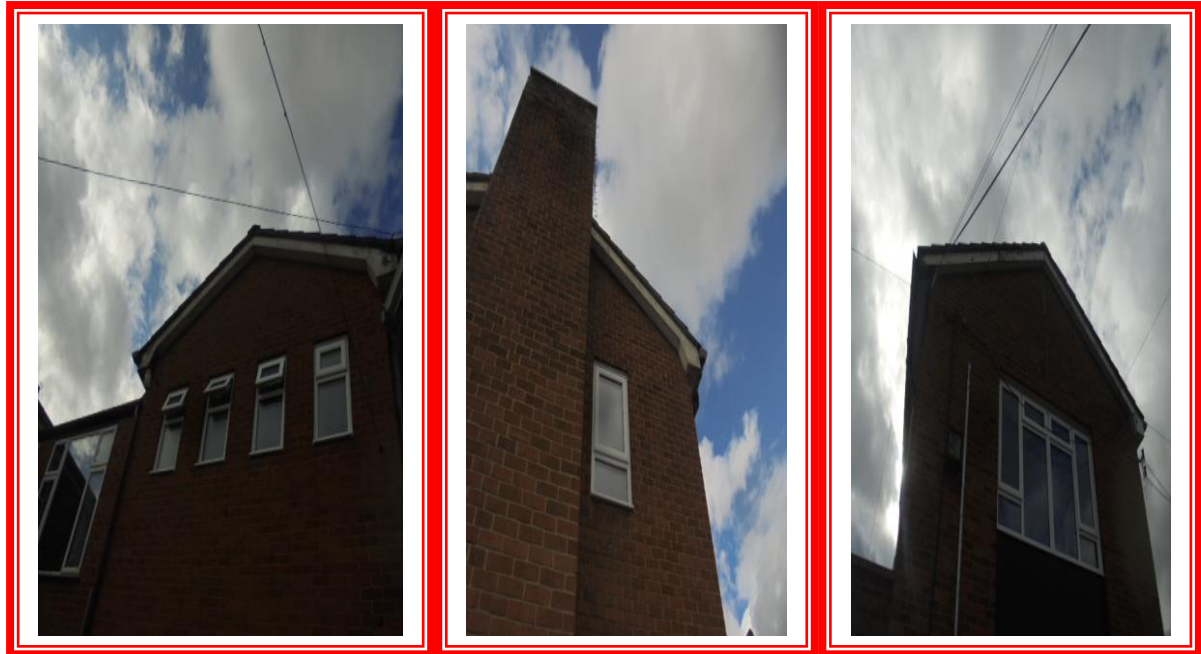
<b>Material Description:</b>	Cement Undercloaking to Gable Ends	
<b>Identification:</b>	Presumed to Contain Asbestos	
<b>Approx. quantity:</b>	4 X Sections of Undercloaking	
<b>Accessibility</b>	Low	Assessment Score
<b>Product type:</b>	Cement	1
<b>Extent of Damage:</b>	Minor	1
<b>Surface Treatment:</b>	Unsealed	1
<b>Asbestos type:</b>	Chrysotile	1
<b>Material Assessment Score:</b>		4
<b>Priority Assessment Score:</b>		Negligible
<b>Action:</b>	Manage	
<b>Comments:</b>	No access to sample due to height
