**ARMOUR**  
ANALYTICAL SERVICES

**Management  
Asbestos Survey Report**

**Torrington Platoon ACF, Great Torrington,  
Devon, EX38 7OJ**

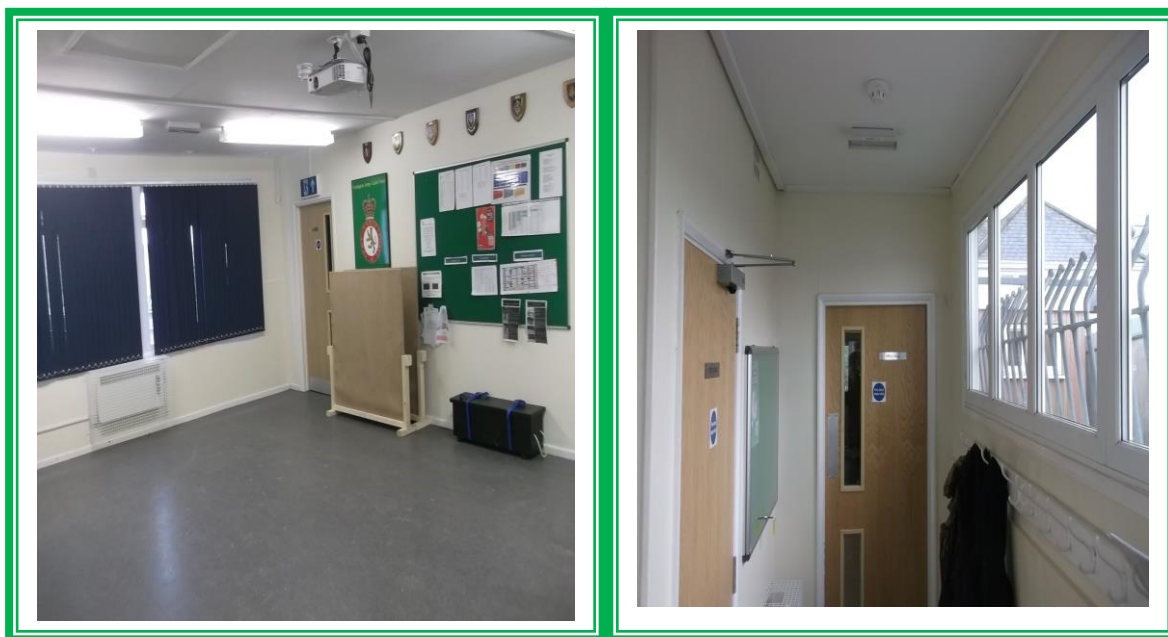
**Item No: 1**
**Sample No: N/A**
**Location: Cadet Hut Internals Throughout**

| <b>Material Description:</b> | Visual Inspection – No Suspect Materials Found | |
| <b>Comments:</b> | Fully refurbished and modernized | |

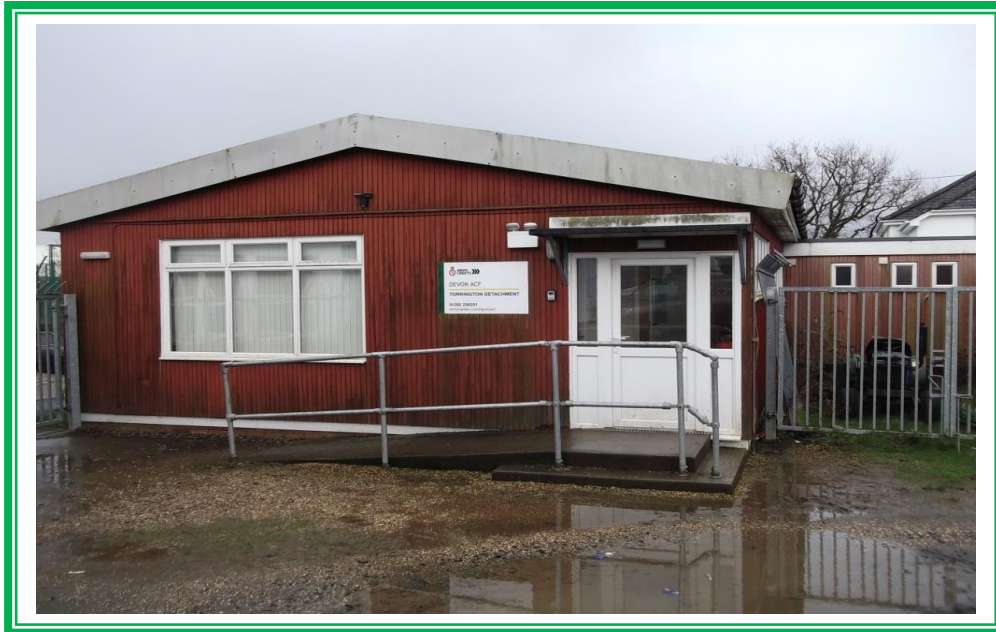
**Location: Cadet Hut Externals**

| <b>Material Description:</b> | Visual Inspection – No Suspect Materials Found | |

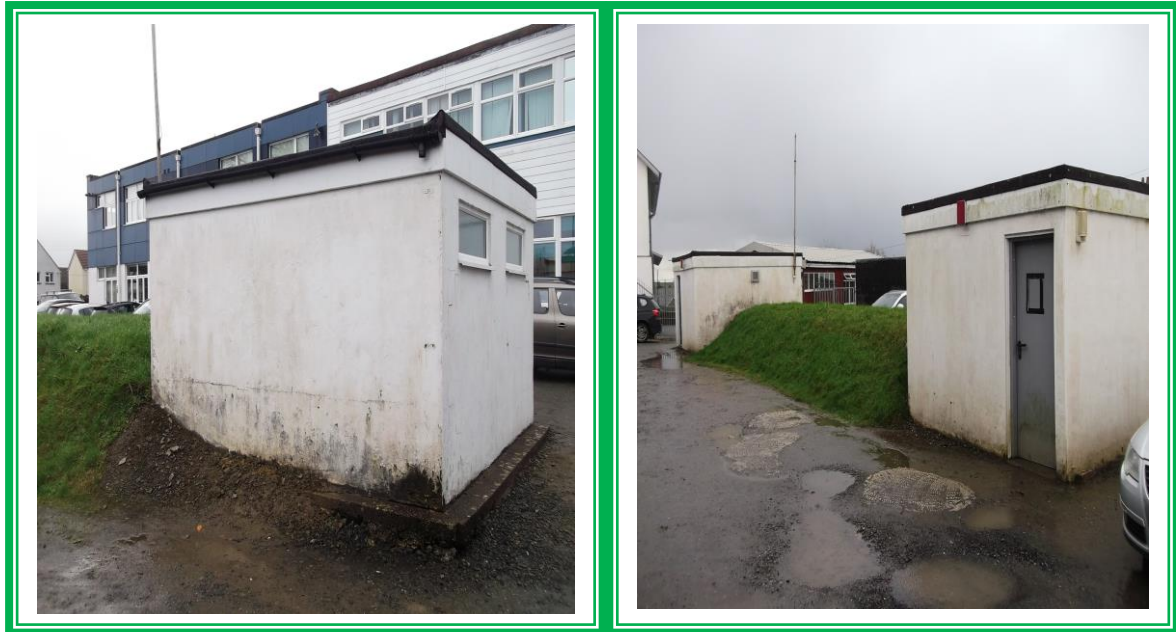
**Location: Pipe Range**

| <b>Material Description:</b> | Visual Inspection – No Suspect Materials Found | |
