Project Number 2481

**Management
Asbestos Survey Report**

**326 Hartland, East Down, Bideford,
Devon, EX39 6AQ**

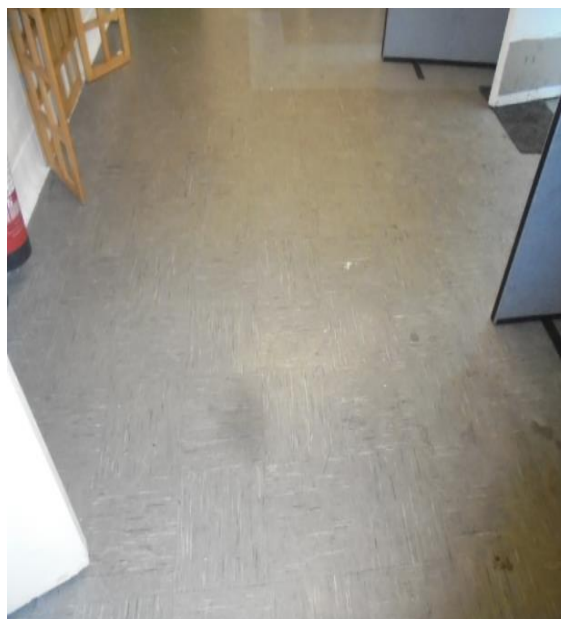
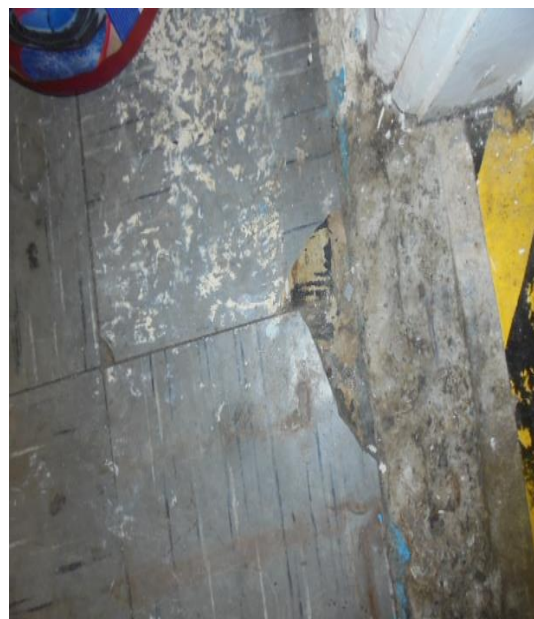
Item No: 2
Sample No: DK/1
Location: Entrance Hall

Material Description:	Floor Tiles and Adhesive	
Identification:	Sampled – Asbestos Detected	
Approx. quantity:	20M2	
Accessibility	High	Assessment Score
Product type:	Composite	1
Extent of Damage:	Minor	1
Surface Treatment:	Non-Friable	0
Asbestos type:	Chrysotile	1
Material Assessment Score:		3
Priority Assessment Score:		Negligible
Action:	Manage	
Comments:	N/A

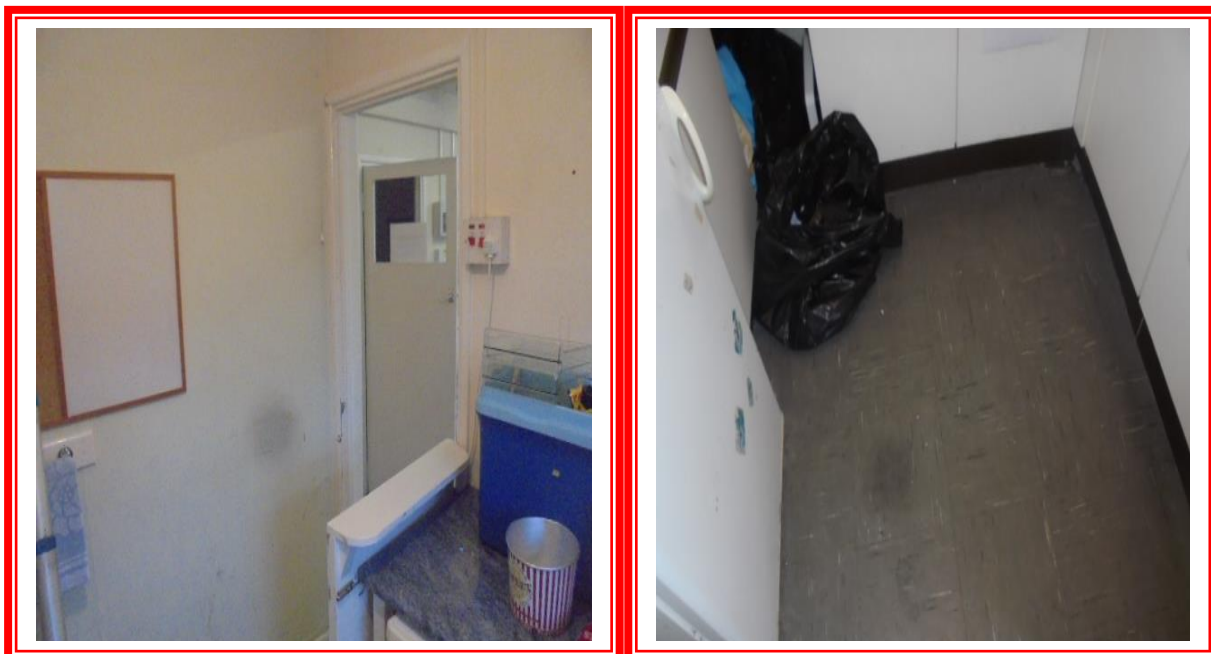
Item No: 4
Sample No: N/A
Location: Canteen

Material Description:	Floor Tiles and Adhesive	
Identification:	As Per Sample DK/1 – Asbestos Detected	
Approx. quantity:	9M2	
Accessibility	High	<i>Assessment Score</i>
Product type:	Composite	1
Extent of Damage:	Minor	1
Surface Treatment:	Non-Friable	0
Asbestos type:	Chrysotile	1
Material Assessment Score:		3
Priority Assessment Score:		Negligible
Action:	Manage	
Comments:	N/A

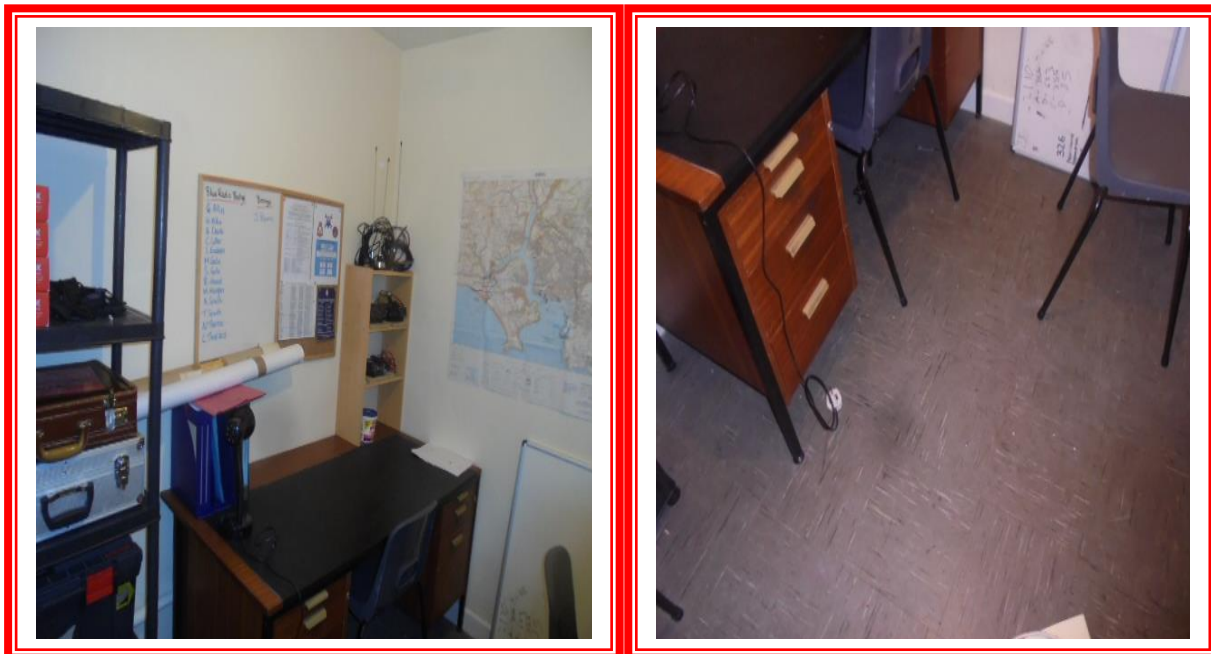
Item No: 6
Sample No: N/A
Location: Radio Room

Material Description:	Floor Tiles and Adhesive	
Identification:	As Per Sample DK/1 – Asbestos Detected	
Approx. quantity:	6M2	
Accessibility	High	Assessment Score
Product type:	Composite	1
Extent of Damage:	Minor	1
Surface Treatment:	Non-Friable	0
Asbestos type:	Chrysotile	1
Material Assessment Score:		3
Priority Assessment Score:		Negligible
Action:	Manage	
Comments:	N/A

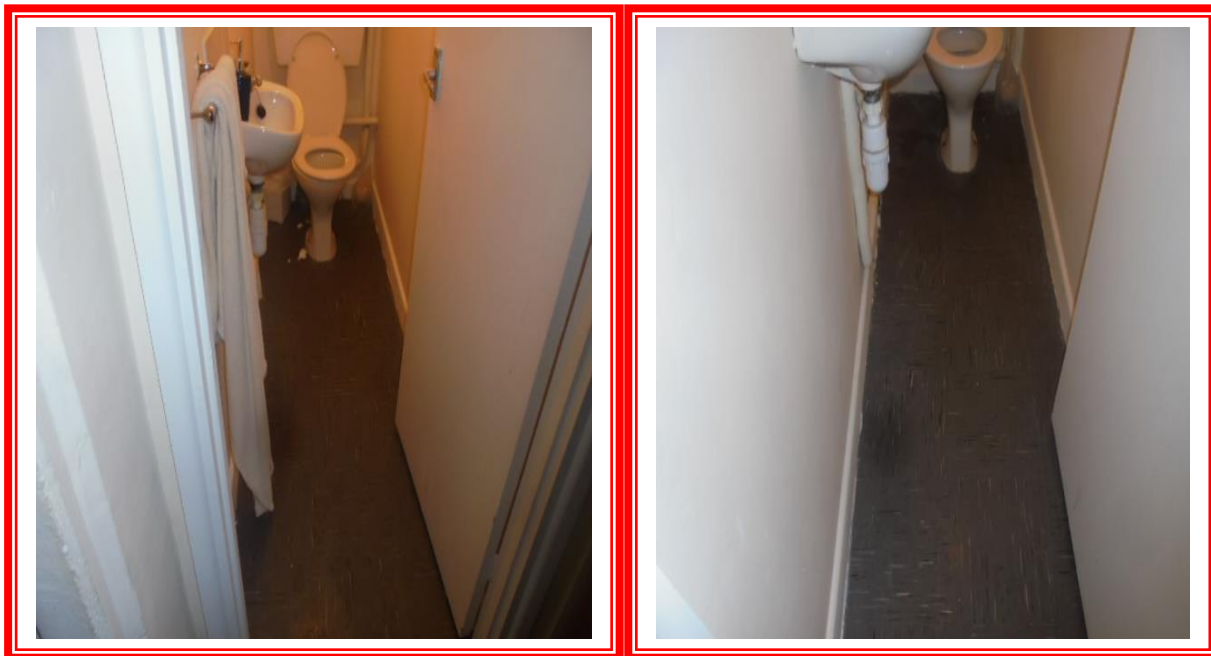
Item No: 8

Material Description:	Floor Tiles and Adhesive	
Identification:	As Per Sample DK/1 – Asbestos Detected	
Approx. quantity:	4M2	
Accessibility	High	Assessment Score
Product type:	Composite	1
Extent of Damage:	Minor	1
Surface Treatment:	Non-Friable	0
Asbestos type:	Chrysotile	1
Material Assessment Score:		3
Priority Assessment Score:		Negligible
Action:	Manage	
Comments:	N/A

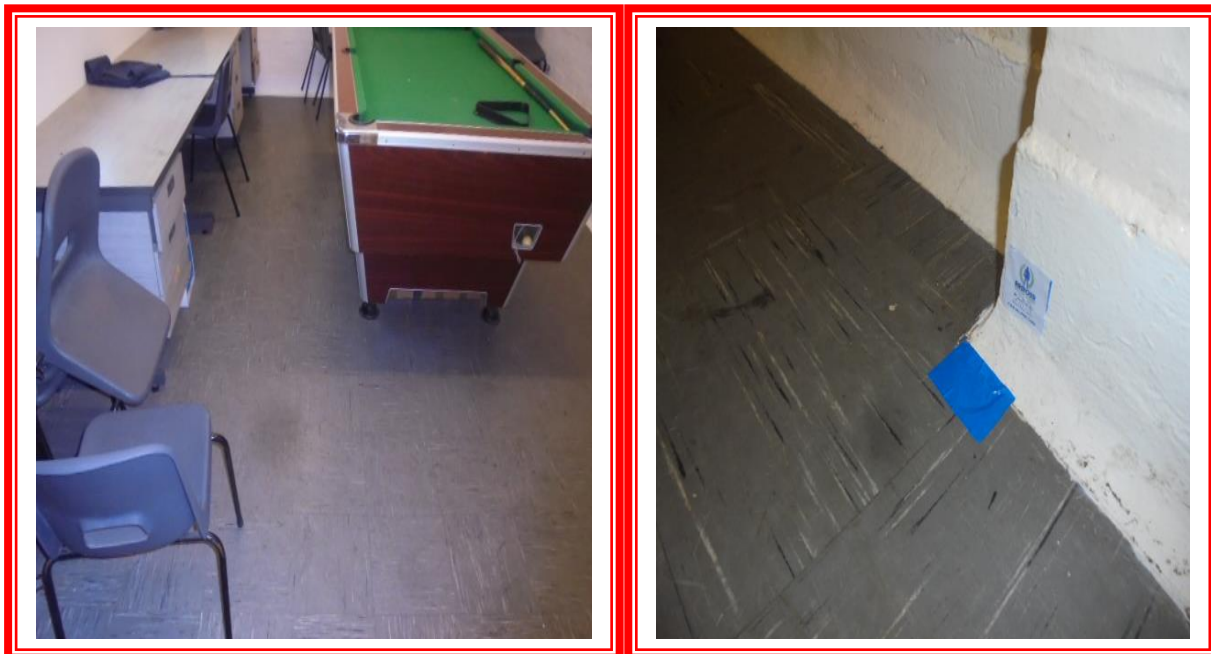
Item No: 9
Sample No: DK/4
Location: Training Room 1

Material Description:	Floor Tiles and Adhesive	
Identification:	Sampled – Asbestos Detected	
Approx. quantity:	20M2	
Accessibility	High	Assessment Score
Product type:	Composite	1
Extent of Damage:	Minor	1
Surface Treatment:	Non-Friable	0
Asbestos type:	Chrysotile	1
Material Assessment Score:		3
Priority Assessment Score:		Negligible
Action:	Manage	
Comments:	N/A

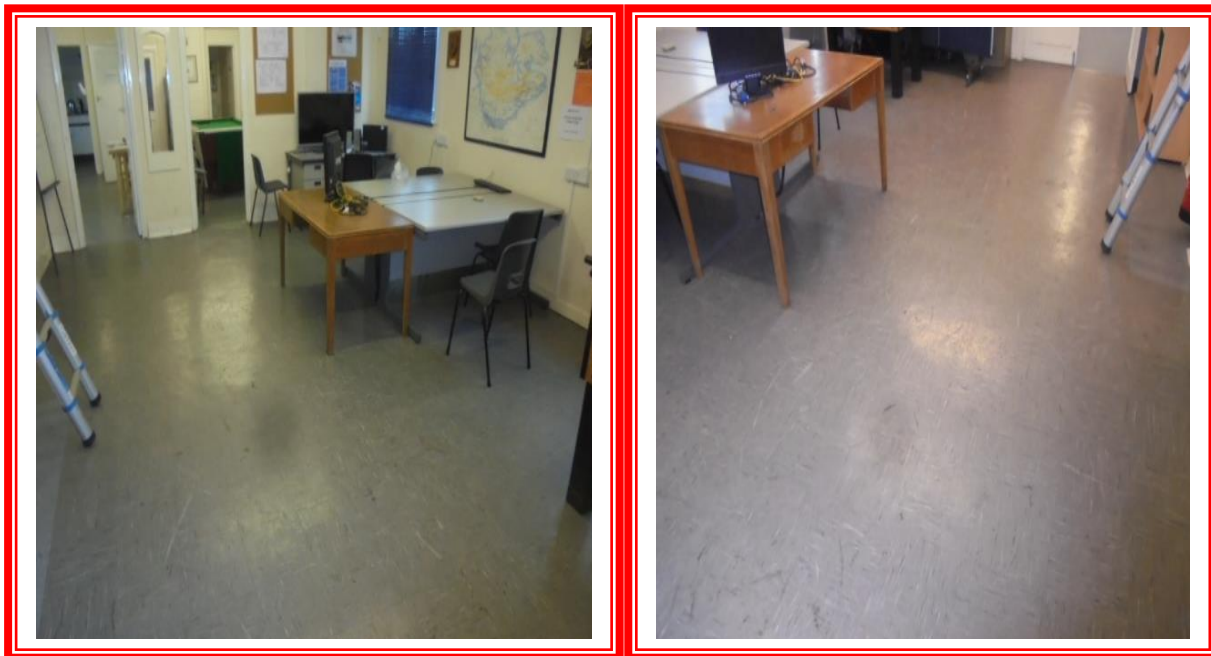
Item No: 11
Sample No: N/A
Location: Training Room 2

Material Description:	Floor Tiles and Adhesive	
Identification:	As Per Sample DK/4 – Asbestos Detected	
Approx. quantity:	35M2	
Accessibility	High	Assessment Score
Product type:	Composite	1
Extent of Damage:	Minor	1
Surface Treatment:	Non-Friable	0
Asbestos type:	Chrysotile	1
Material Assessment Score:		3
Priority Assessment Score:		Negligible
Action:	Manage	
Comments:	N/A

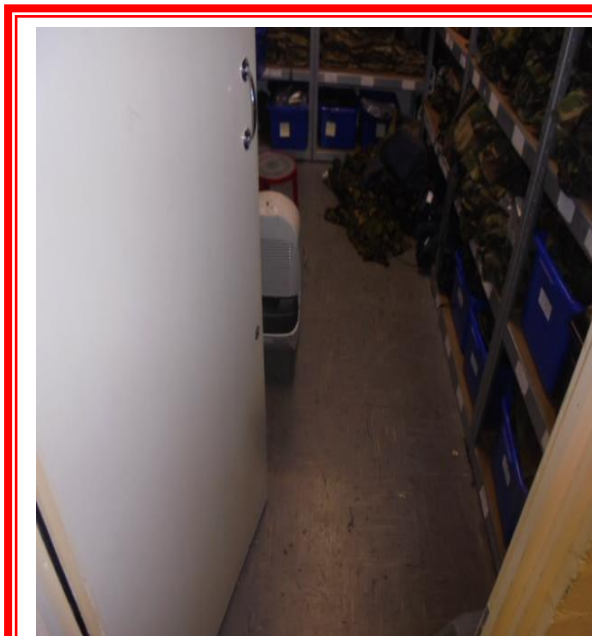
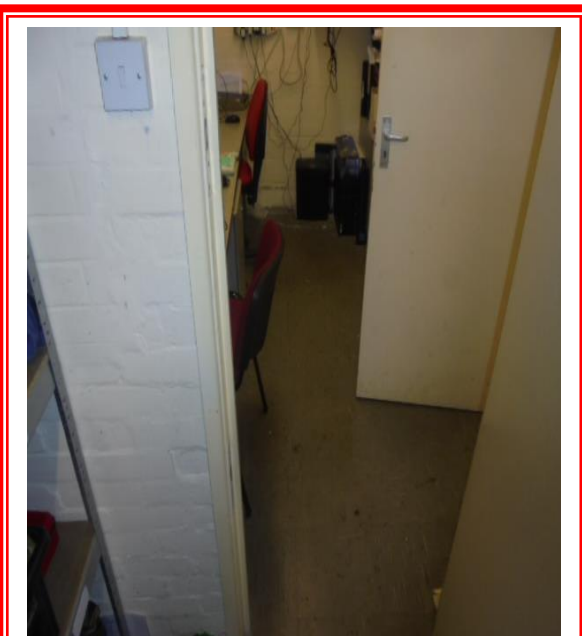
Item No: 12
Sample No: N/A
Location: Store and Office

Material Description:	Floor Tiles and Adhesive	
Identification:	As Per Sample DK/4 – Asbestos Detected	
Approx. quantity:	14M2	
Accessibility	High	<i>Assessment Score</i>
Product type:	Composite	1
Extent of Damage:	Minor	1
Surface Treatment:	Non-Friable	0
Asbestos type:	Chrysotile	1
Material Assessment Score:		3
Priority Assessment Score:		Negligible
Action:	Manage	
Comments:	N/A

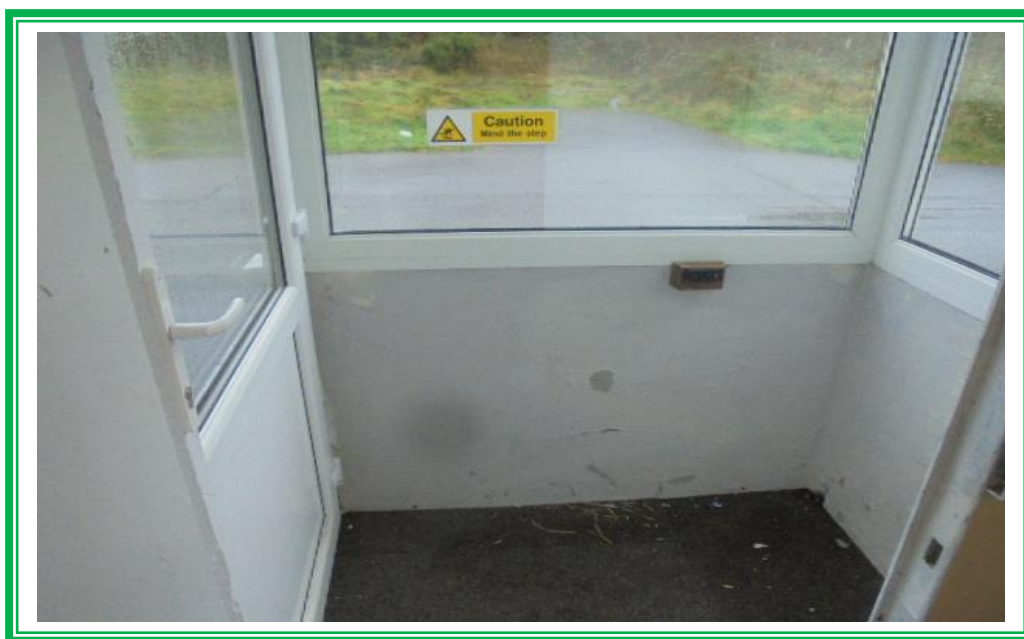
Item No: 1
Sample No: N/A
Location: Lobby

Material Description:	Visual Inspection – No Suspect Materials Found	
Identification:	N/A	
Approx. quantity:	N/A	
Accessibility	N/A	<i>Assessment Score</i>
Product type:	N/A	N/A
Extent of Damage:	N/A	N/A
Surface Treatment:	N/A	N/A
Asbestos type:	N/A	N/A
Material Assessment Score:		N/A
Priority Assessment Score:		N/A
Action:	N/A	
Comments:	N/A

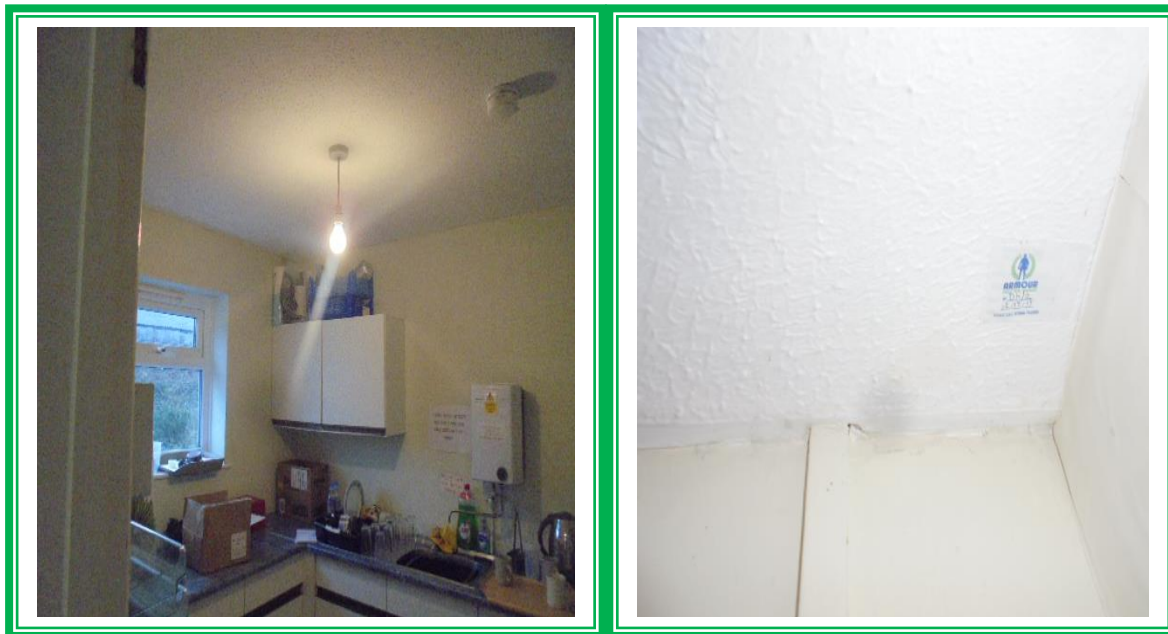
Item No: 3

Material Description:	Textured Coating to Ceiling	
Identification:	Sampled – No Asbestos Detected	
Approx. quantity:	9M2	
Accessibility	N/A	<i>Assessment Score</i>
Product type:	N/A	N/A
Extent of Damage:	N/A	N/A
Surface Treatment:	N/A	N/A
Asbestos type:	N/A	N/A
Material Assessment Score:		N/A
Priority Assessment Score:		N/A
Action:	N/A	
Comments:	N/A

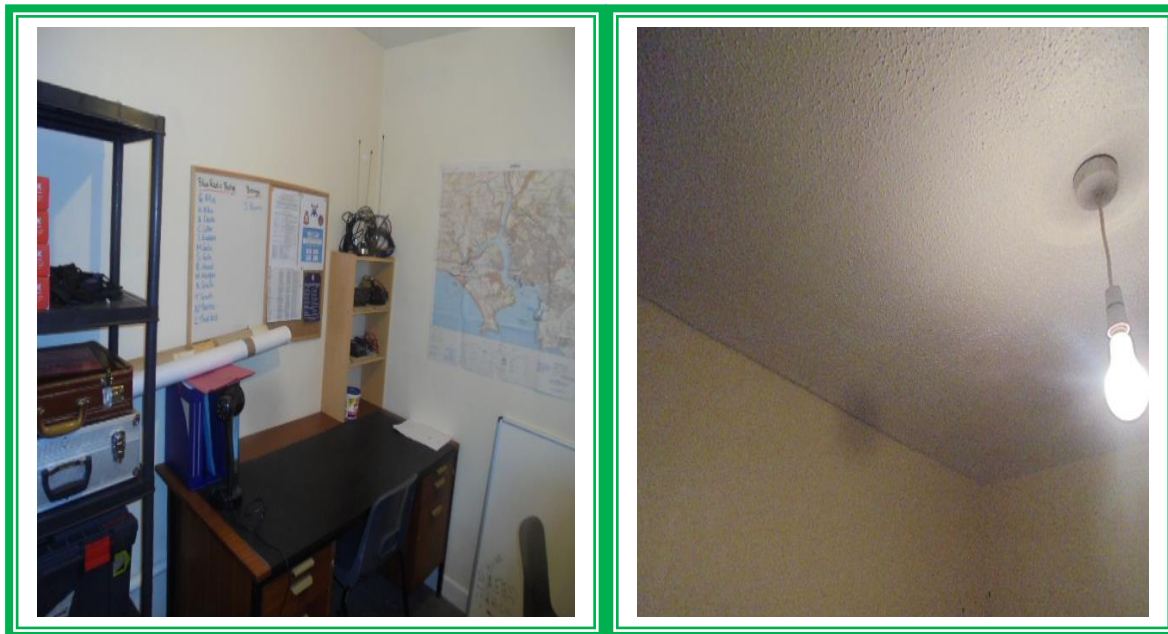
Item No: 5

Material Description:	Textured Coating to Ceiling	
Identification:	As Per Sample DK/2 – No Asbestos Detected	
Approx. quantity:	6M2	
Accessibility	N/A	Assessment Score
Product type:	N/A	N/A
Extent of Damage:	N/A	N/A
Surface Treatment:	N/A	N/A
Asbestos type:	N/A	N/A
Material Assessment Score:		N/A
Priority Assessment Score:		N/A
Action:	N/A	
Comments:	N/A

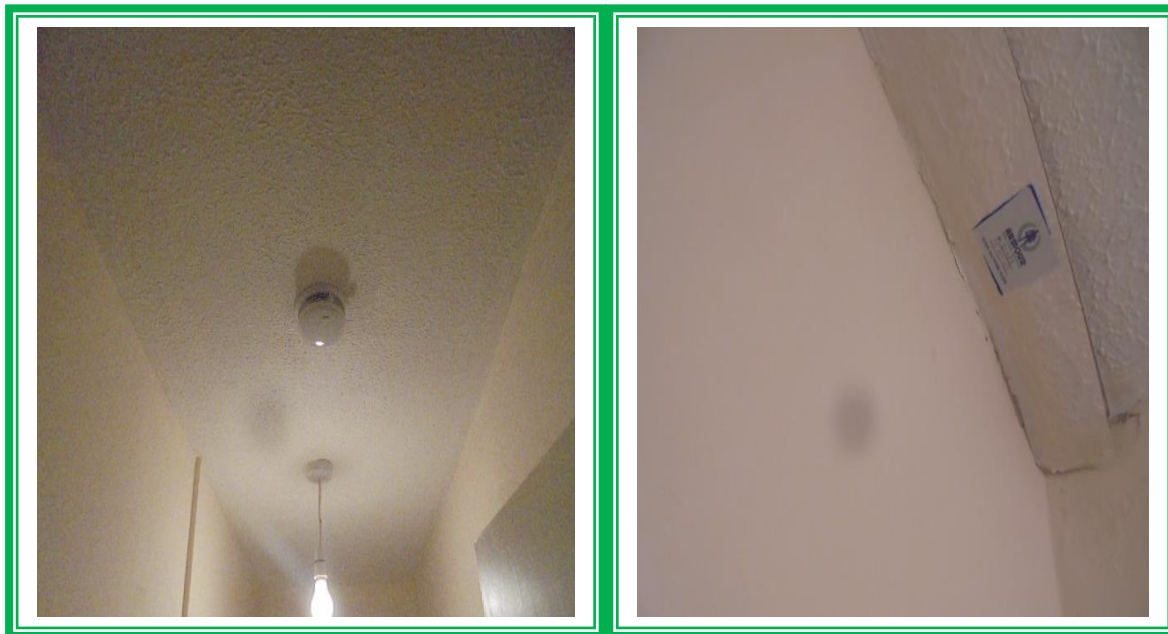
Item No: 7

Material Description:	Textured Coating to Ceilings	
Identification:	Sampled – No Asbestos Detected	
Approx. quantity:	4M2	
Accessibility	N/A	<i>Assessment Score</i>
Product type:	N/A	N/A
Extent of Damage:	N/A	N/A
Surface Treatment:	N/A	N/A
Asbestos type:	N/A	N/A
Material Assessment Score:		N/A
Priority Assessment Score:		N/A
Action:	N/A	
Comments:	N/A

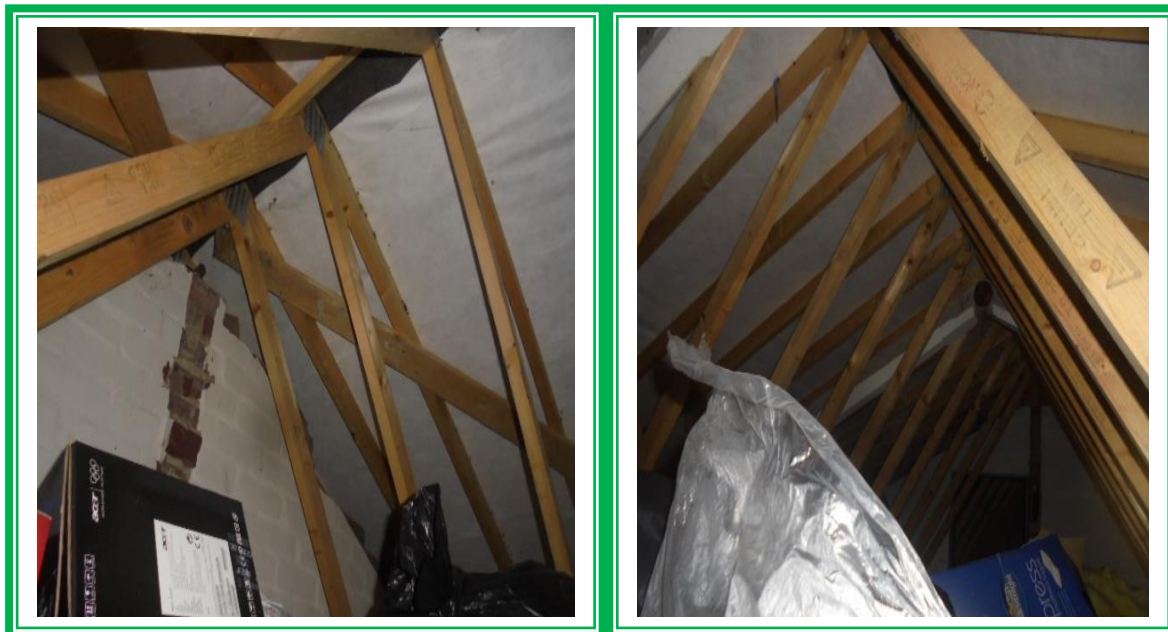
Item No: 10

Material Description:	Visual Inspection – No Suspect Materials Found	
Identification:	N/A	
Approx. quantity:	N/A	
Accessibility	N/A	<i>Assessment Score</i>
Product type:	N/A	N/A
Extent of Damage:	N/A	N/A
Surface Treatment:	N/A	N/A
Asbestos type:	N/A	N/A
Material Assessment Score:		N/A
Priority Assessment Score:		N/A
Action:	N/A	
Comments:	N/A

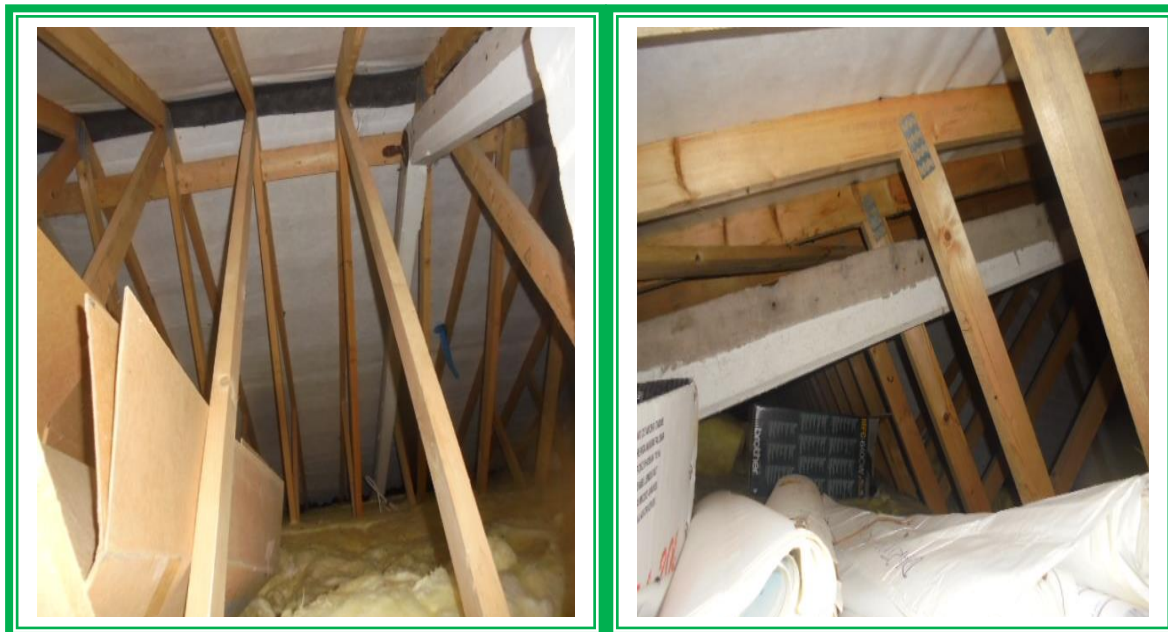
Item No: 13

Material Description:	Visual Inspection – No Suspect Materials Found	
Identification:	N/A	
Approx. quantity:	N/A	
Accessibility	N/A	<i>Assessment Score</i>
Product type:	N/A	N/A
Extent of Damage:	N/A	N/A
Surface Treatment:	N/A	N/A
Asbestos type:	N/A	N/A
Material Assessment Score:		N/A
Priority Assessment Score:		N/A
Action:	N/A	
Comments:	N/A

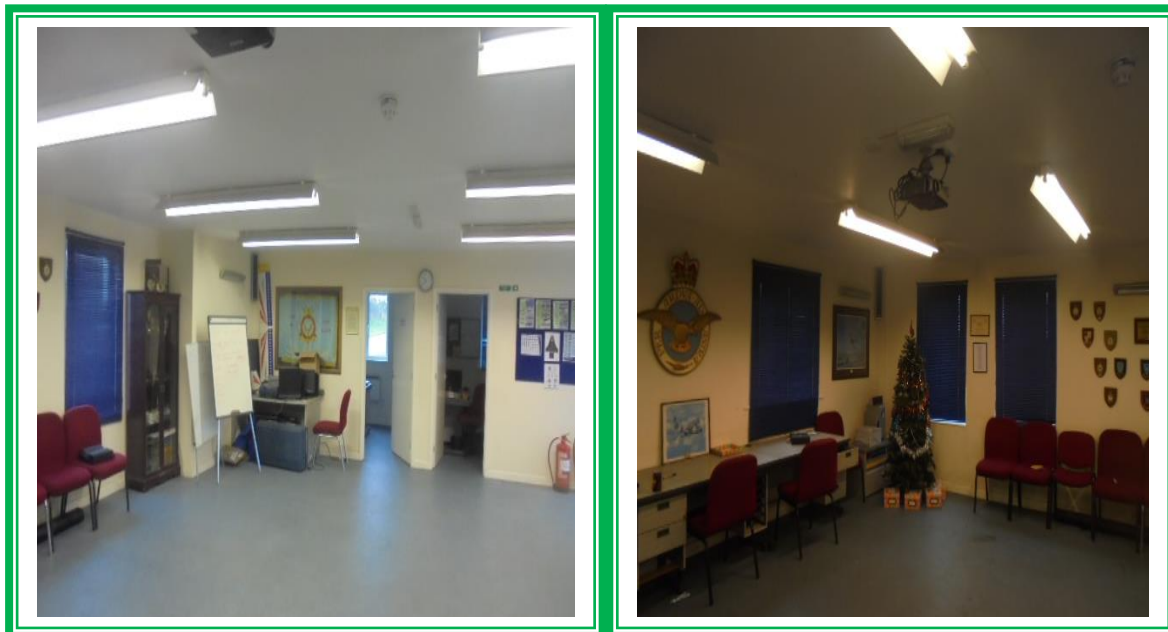
Item No: 14
Sample No: N/A
Location: Main Room

Material Description:	Visual Inspection – No Suspect Materials Found	
Identification:	N/A	
Approx. quantity:	N/A	
Accessibility	N/A	<i>Assessment Score</i>
Product type:	N/A	N/A
Extent of Damage:	N/A	N/A
Surface Treatment:	N/A	N/A
Asbestos type:	N/A	N/A
Material Assessment Score:		N/A
Priority Assessment Score:		N/A
Action:	N/A	
Comments:	N/A

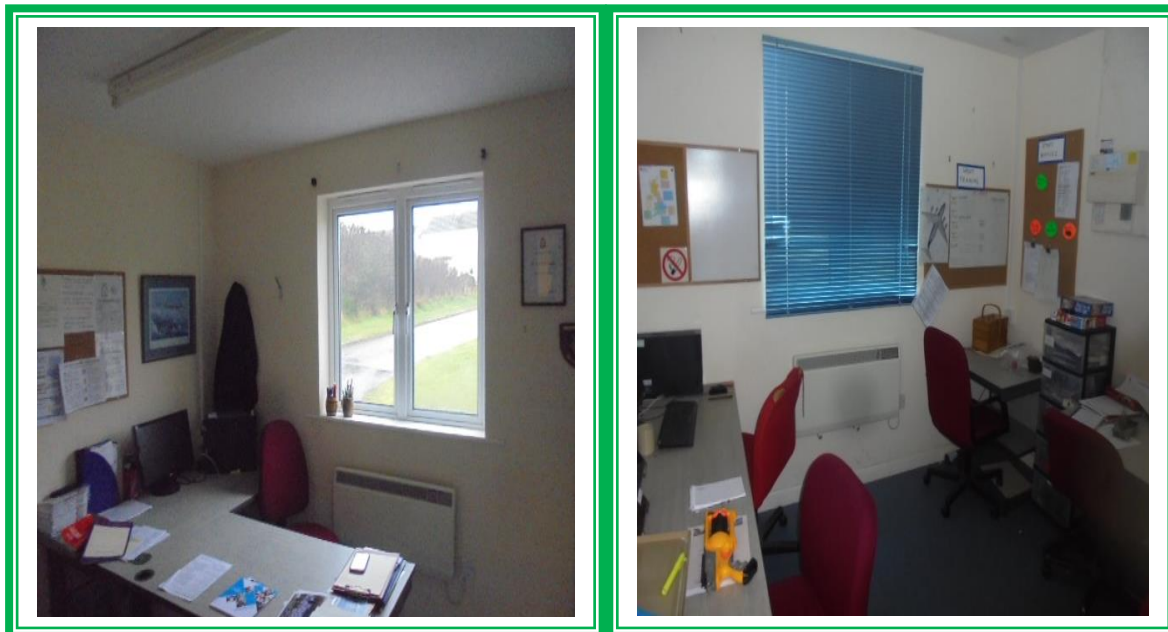
Item No: 15

Material Description:	Visual Inspection – No Suspect Materials Found	
Identification:	N/A	
Approx. quantity:	N/A	
Accessibility	N/A	<i>Assessment Score</i>
Product type:	N/A	N/A
Extent of Damage:	N/A	N/A
Surface Treatment:	N/A	N/A
Asbestos type:	N/A	N/A
Material Assessment Score:		N/A
Priority Assessment Score:		N/A
Action:	N/A	
Comments:	N/A

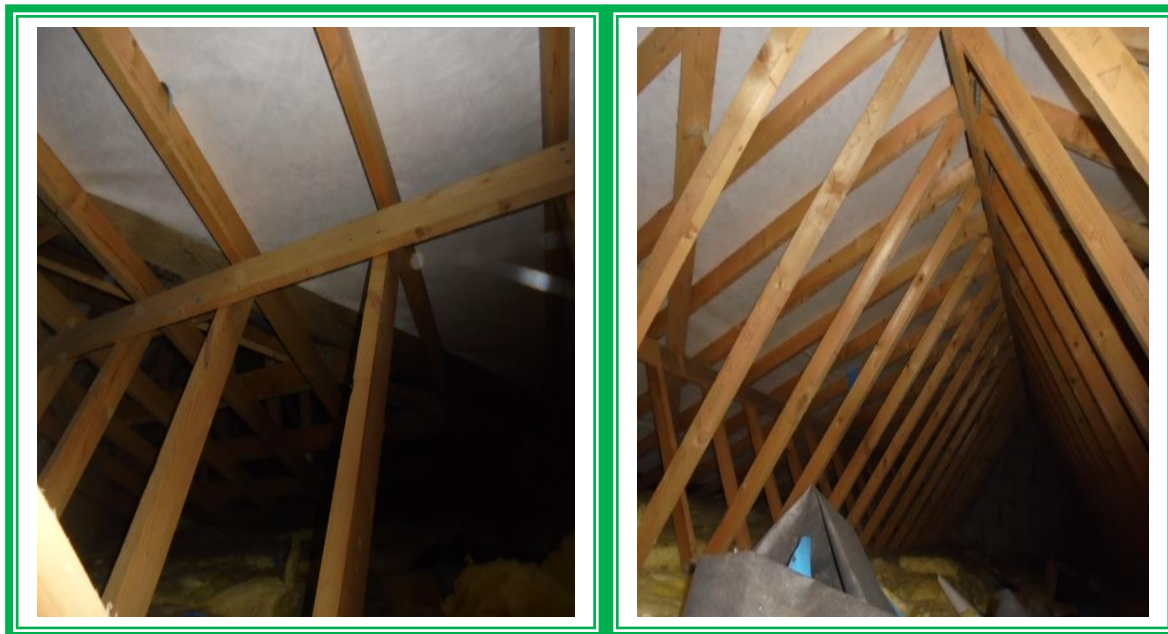
Item No: 16

Material Description:	Visual Inspection – No Suspect Materials Found	
Identification:	N/A	
Approx. quantity:	N/A	
Accessibility	N/A	<i>Assessment Score</i>
Product type:	N/A	N/A
Extent of Damage:	N/A	N/A
Surface Treatment:	N/A	N/A
Asbestos type:	N/A	N/A
Material Assessment Score:		N/A
Priority Assessment Score:		N/A
Action:	N/A	
Comments:	N/A

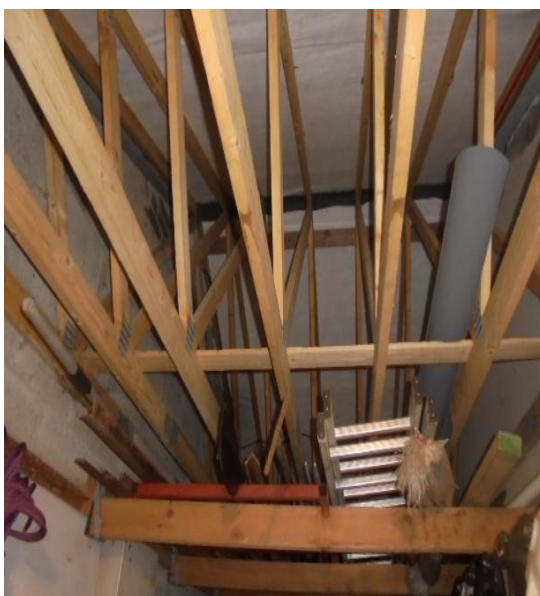
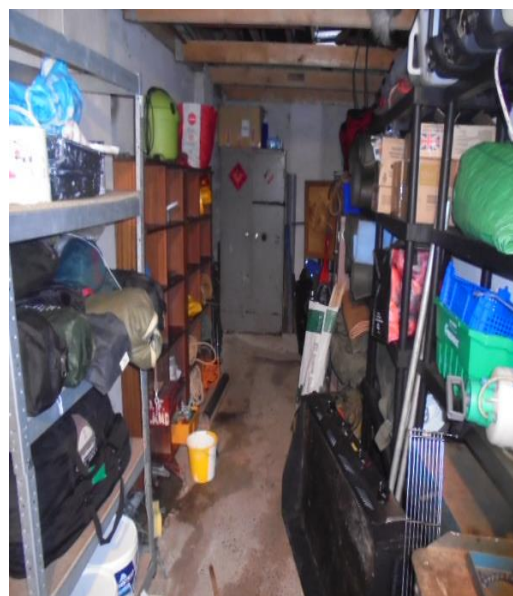
Item No: 17
Sample No: N/A
Location: Store

Material Description:	Visual Inspection – No Suspect Materials Found	
Identification:	N/A	
Approx. quantity:	N/A	
Accessibility	N/A	<i>Assessment Score</i>
Product type:	N/A	N/A
Extent of Damage:	N/A	N/A
Surface Treatment:	N/A	N/A
Asbestos type:	N/A	N/A
Material Assessment Score:		N/A
Priority Assessment Score:		N/A
Action:	N/A	
Comments:	N/A

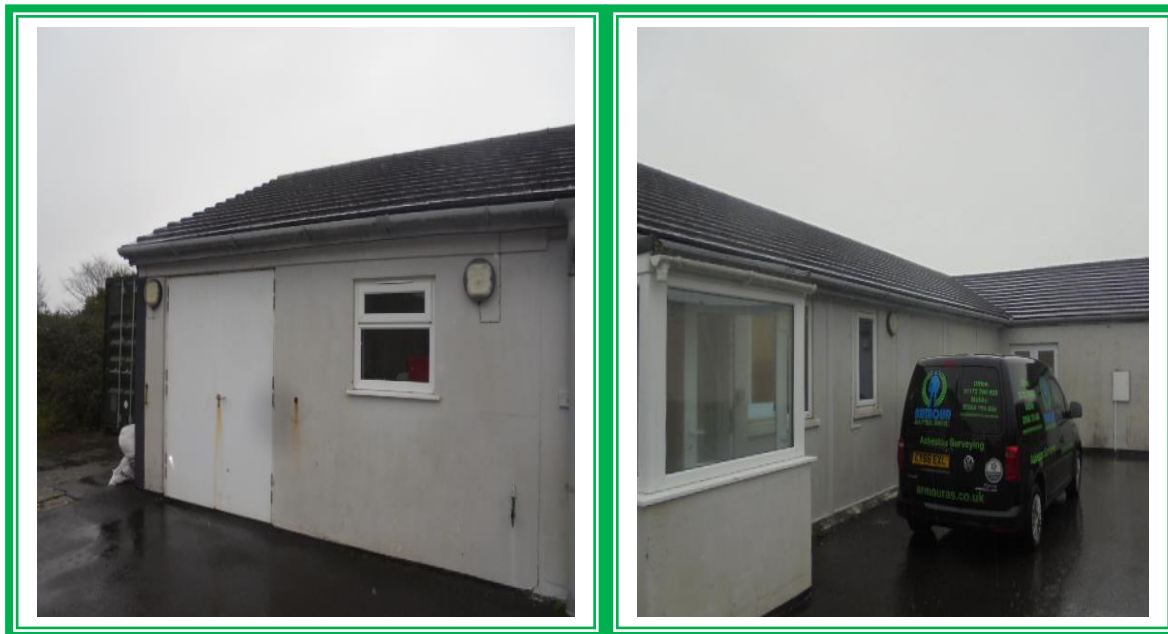
Item No: 18

Material Description:	Visual Inspection – No Suspect Materials Found	
Identification:	N/A	
Approx. quantity:	N/A	
Accessibility	N/A	<i>Assessment Score</i>
Product type:	N/A	N/A
Extent of Damage:	N/A	N/A
Surface Treatment:	N/A	N/A
Asbestos type:	N/A	N/A
Material Assessment Score:		N/A
Priority Assessment Score:		N/A
Action:	N/A	
Comments:	N/A
