ARMOUR
ANALYTICAL SERVICES

Project Number 2481

**Management
Asbestos Survey Report**

**Plymstock Platoon, Pomphlett Close,
Plymstock, PL1 7QT**

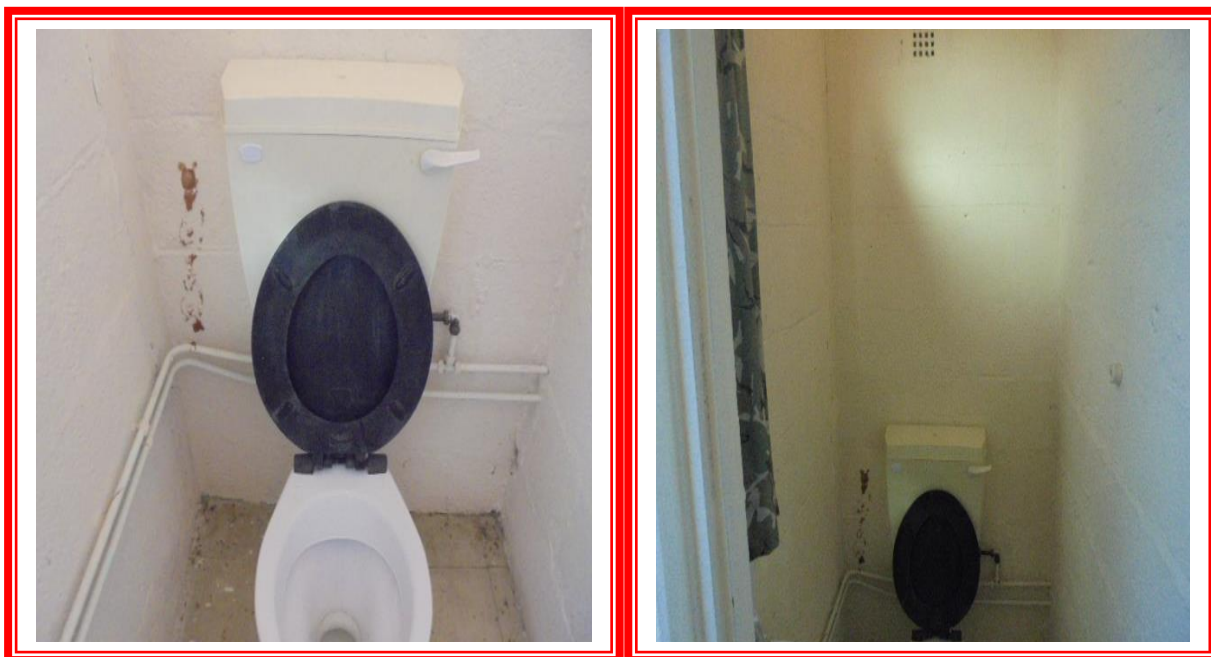
Item No: 3

Item 3 – Ground Floor - Men’s WC – Toilet Seat -- Not Possible to Sample as May Damage Integrity of Seat

Location: Ground Floor - Men's WC

| Material Description: | Toilet Seat | |
| Identification: | Presumed to Contain Asbestos | |
| Extent of Damage: | Minor | 1 |
| Material Assessment Score: | | 3 |
| Priority Assessment Score: | | Negligible |
| Comments: | Not Possible to Sample as may Damage Integrity of The Seat | |

| Action: | Manage | |

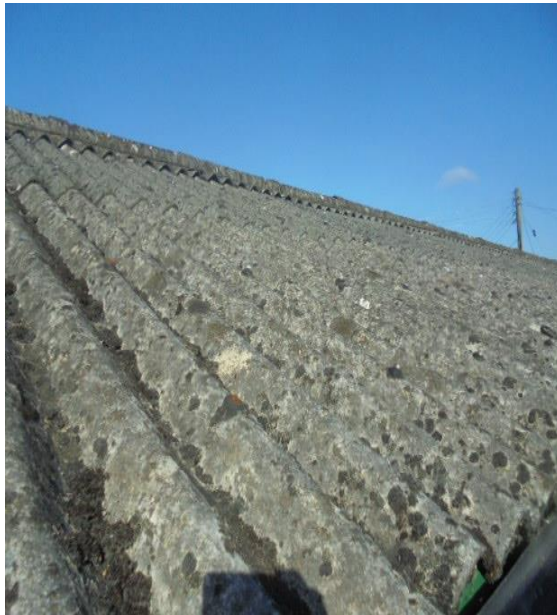
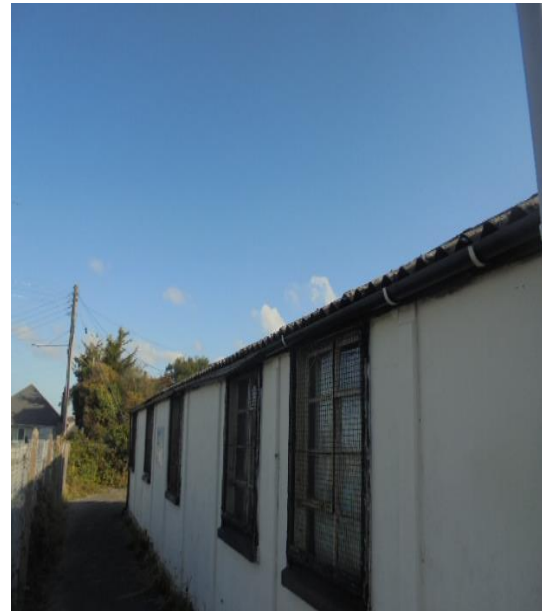
Item No: 11

| Sample Number | Sample Type | Location | Analysis |
|---|---|---|---|
| 4 | Profiled Cement Roof | External | Chrysotile |

Location: External - Roof

| Material Description: | Profiled Cement Roof | |
| Identification: | Sampled – Asbestos Detected | |
| Approx. quantity: | 46M2 | |
| Extent of Damage: | Minor | 1 |
| Material Assessment Score: | | 4 |
| Priority Assessment Score: | | Negligible |

| Sample No. | Sample Ref. | Location | Asbestos Detected | Asbestos Type |
|---|---|---|---|---|
| 4 | BS576305 | External - Profiled Cement Roof | Yes | Chrysotile |

| Action: | Manage | |

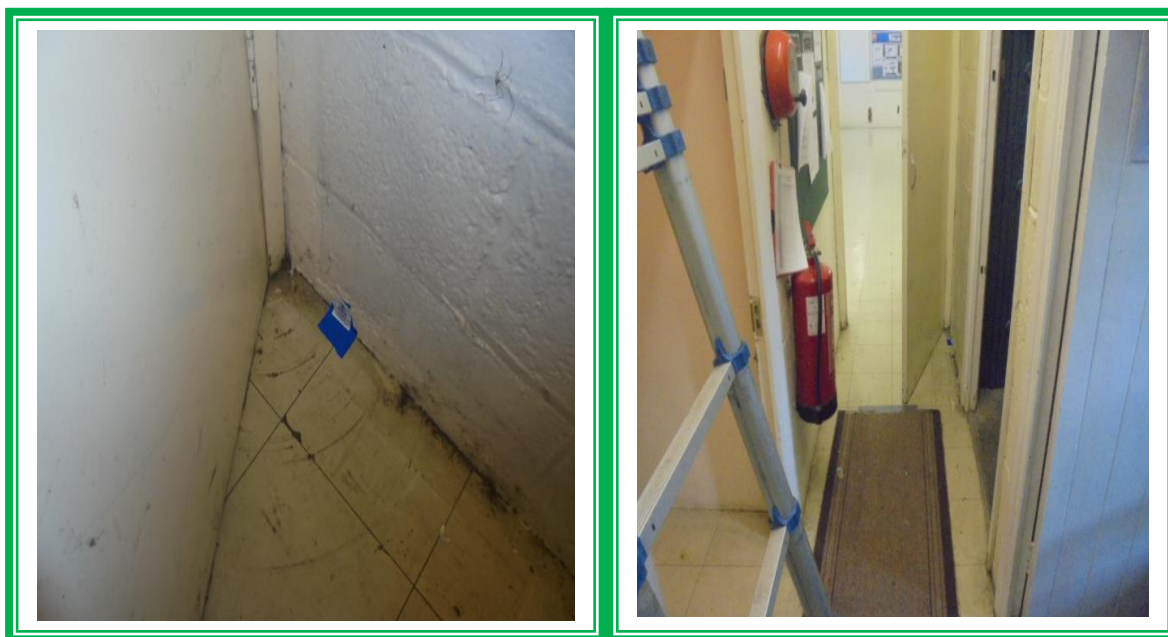
Item No: 1
Sample No: 1
Location: Ground Floor - Lobby

| Sample Number | Sample Type | Location | Analysis |
|---|---|---|---|
| 1 | Floor Tiles | Lobby | N.A.D.I.S. |

| Material Description: | Floor Tiles | |
| Identification: | Sampled – No Asbestos Detected | |

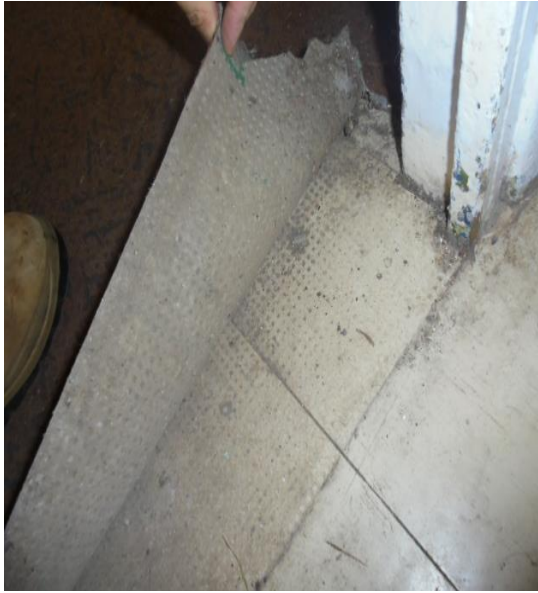
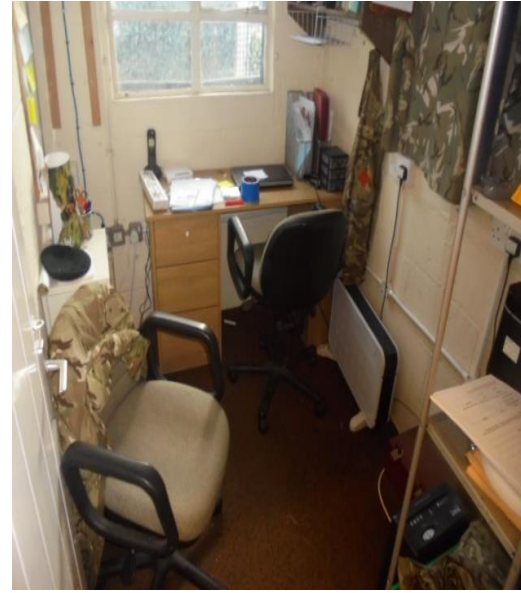
Item No: 2

Location: Ground Floor - Office

| Material Description: | Floor Tiles Under Carpet | |
| Identification: | As Per Sample 1 – No Asbestos Detected | |

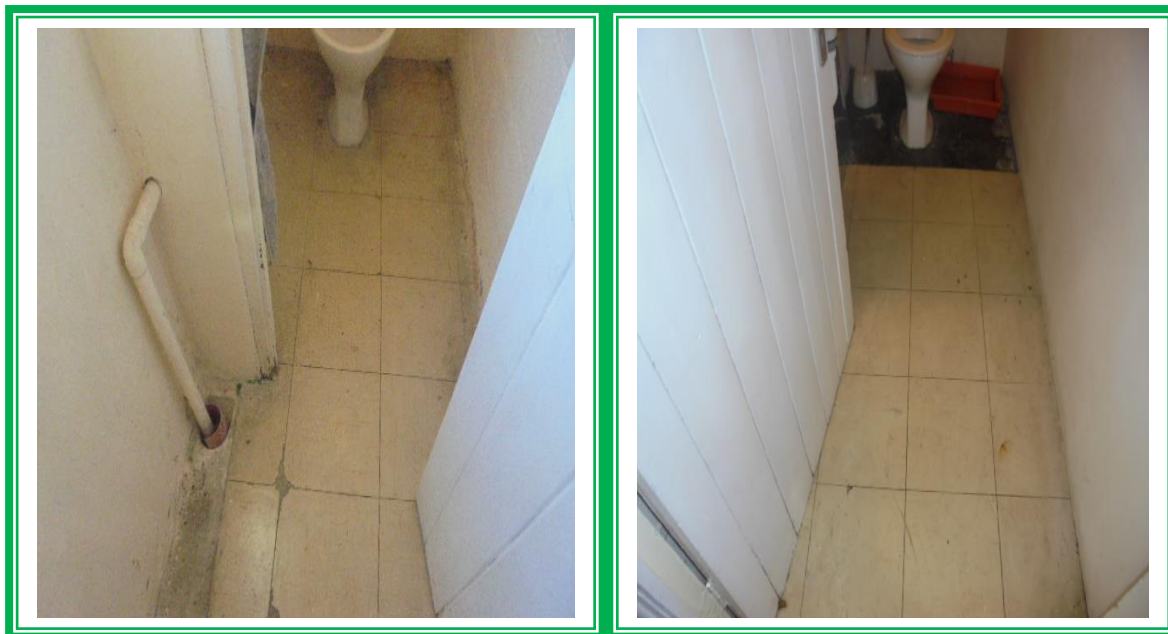
Item No: 4

Location: Ground Floor - Men's WC and Ladies WC

| Material Description: | Floor Tiles | |
| Identification: | As Per Sample 1 – No Asbestos Detected | |

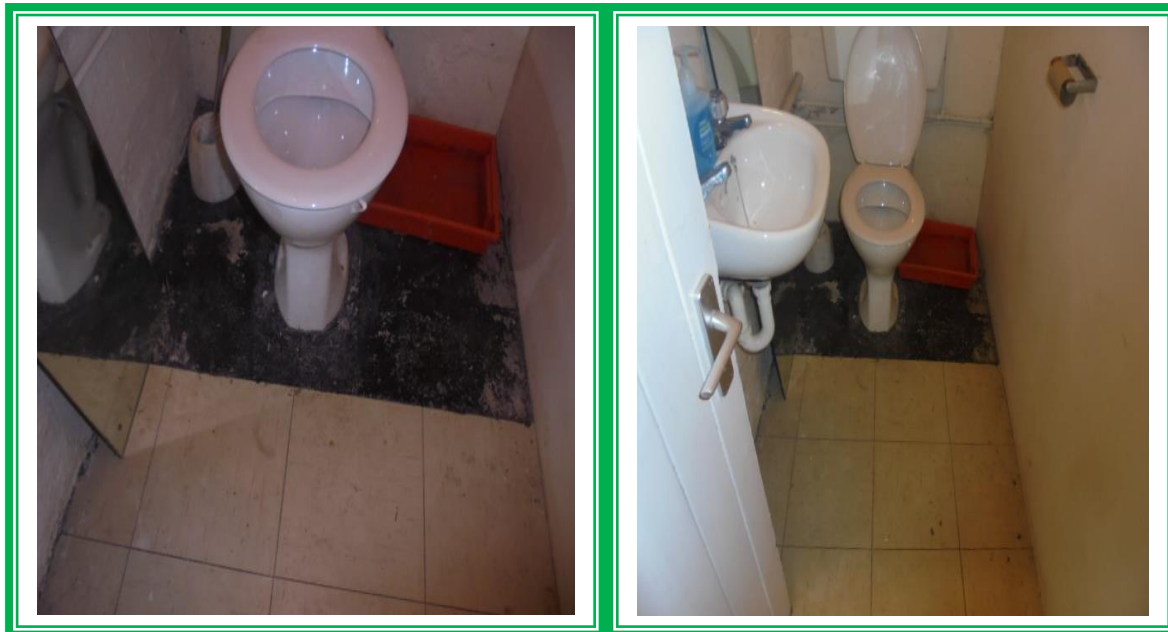
Item No: 5

Location: Ground Floor - Ladies WC

| Material Description: | Adhesive to Floor | |
| Identification: | Sampled – No Asbestos Detected | |
| Comments: | May Be Found Under Floor Tiles Throughout – Apply Caution. | |

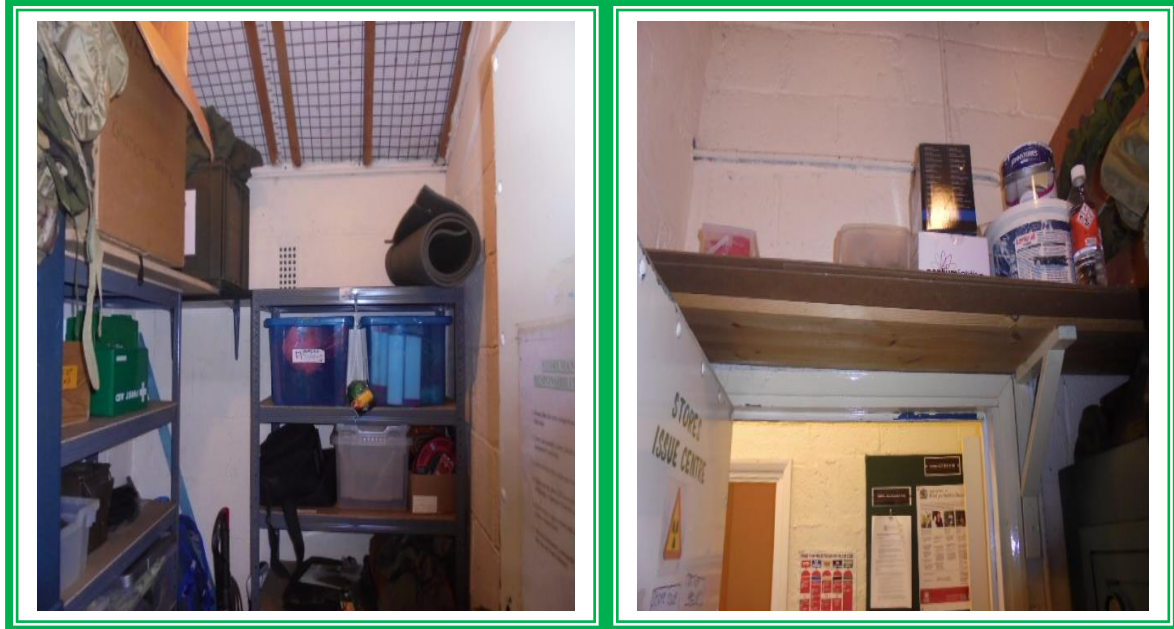
Item No: 6

Location: Ground Floor - Stores

| Material Description: | Visual Inspection – No Suspect Materials Found | |

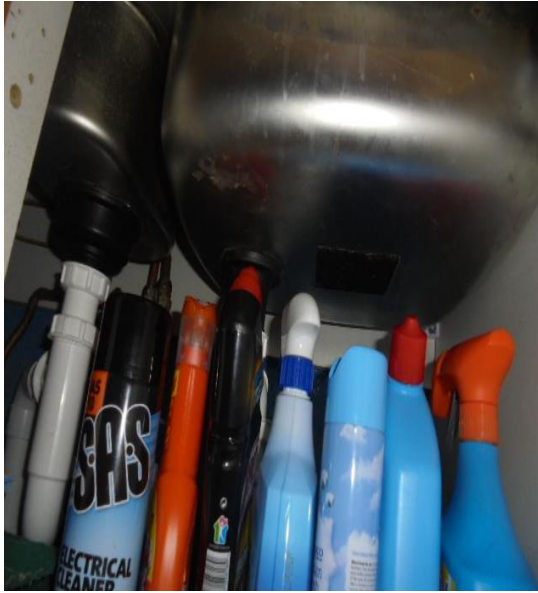
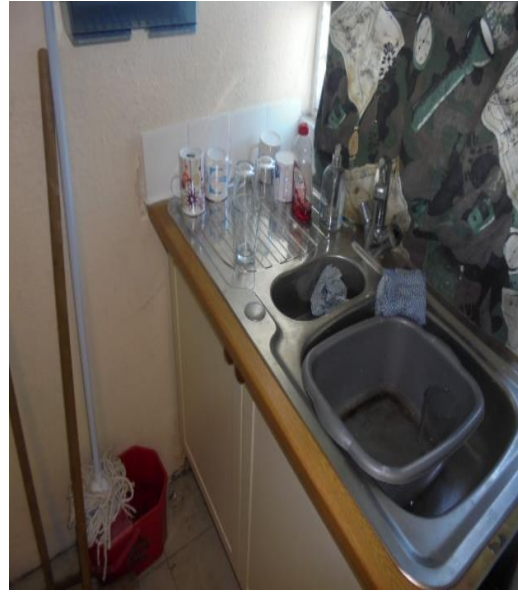
Item No: 7

Location: Ground Floor - Kitchen

| Material Description: | Sink Pad | |
| Identification: | Sampled – No Asbestos Detected | |

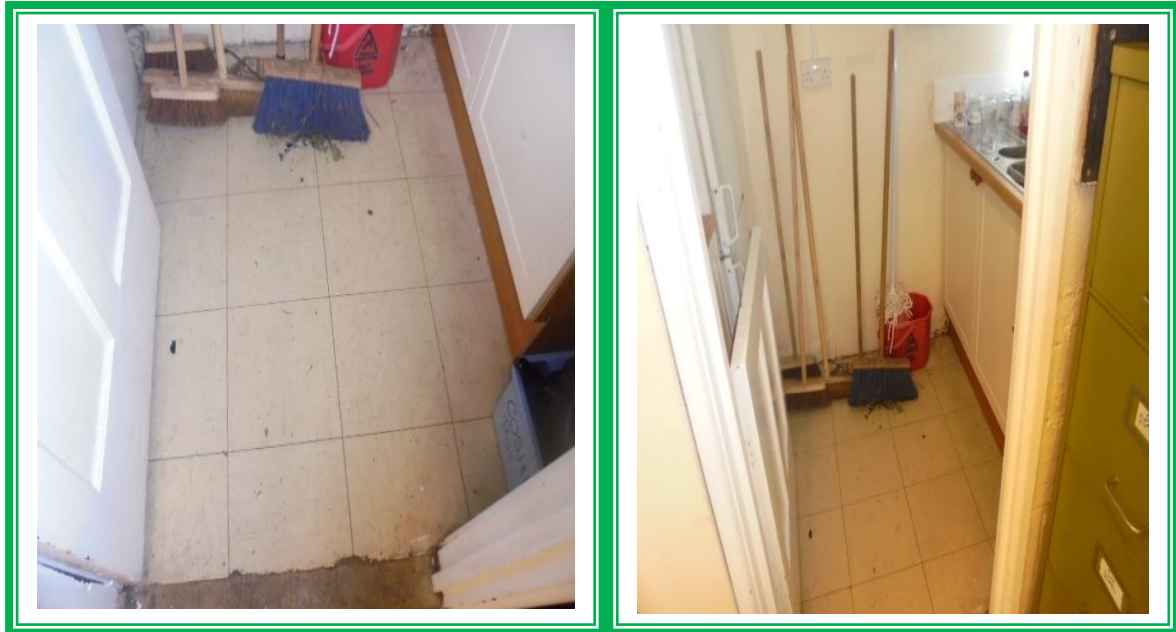
Item No: 8

Location: Ground Floor - Kitchen

| Material Description: | Floor Tiles | |
| Identification: | As Per Sample 1 – No Asbestos detected | |

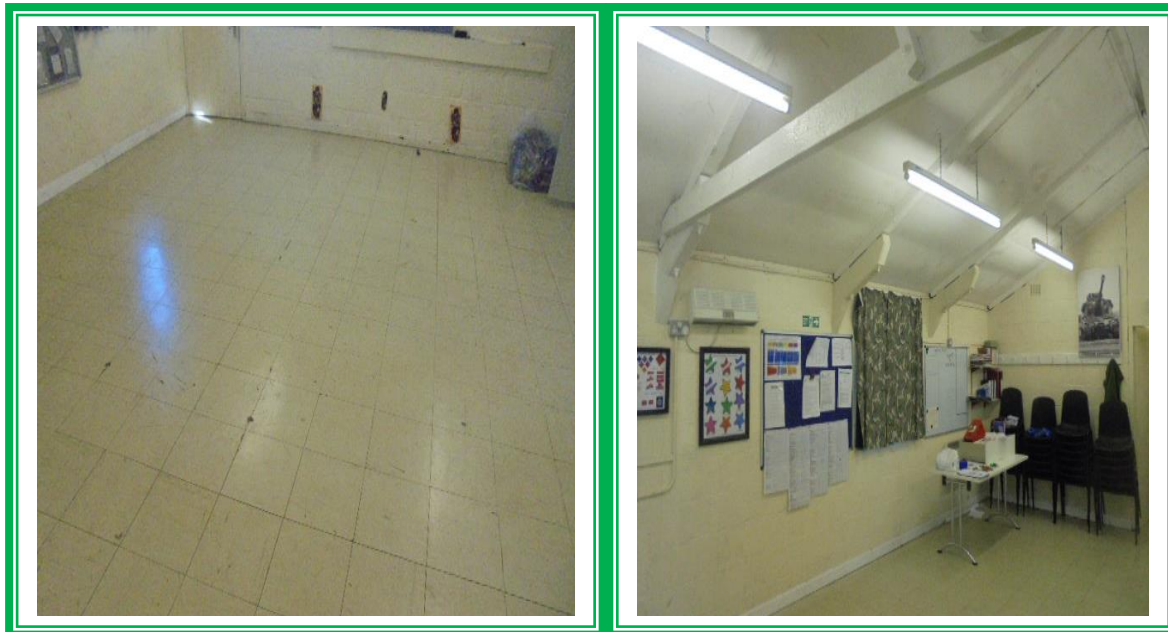
Item No: 9

Location: Ground Floor - Drill Hall

| Material Description: | Floor Tiles | |
| Identification: | As Per Sample 1 – No Asbestos Detected | |

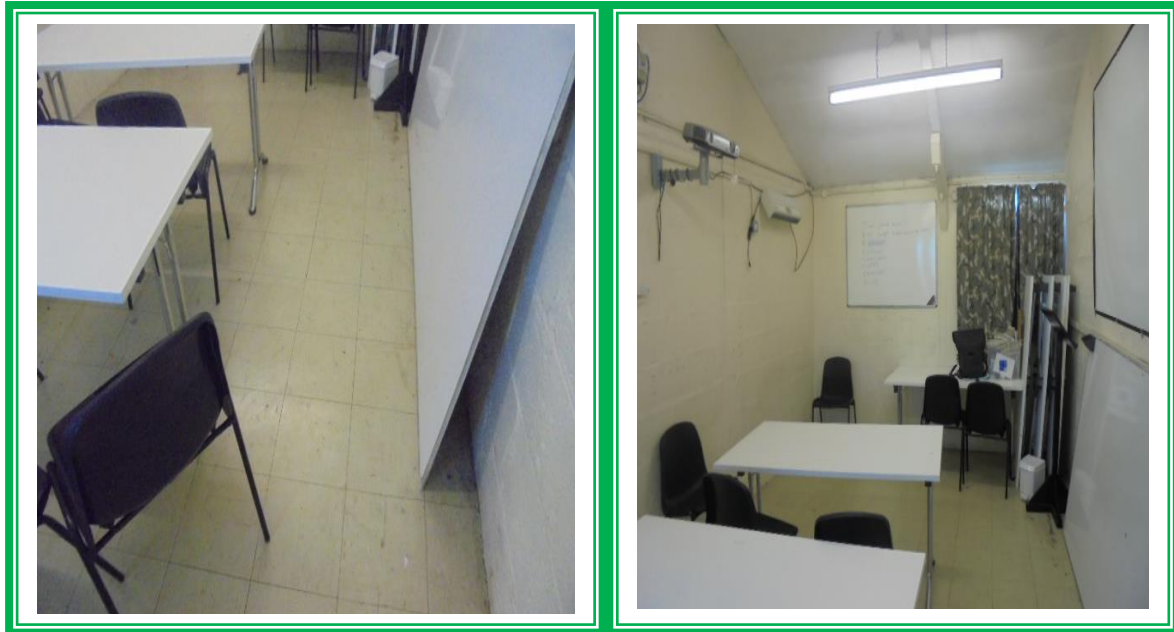
Item No: 10

Location: Ground Floor - Lecture Room

| Material Description: | Floor Tiles | |
| Identification: | As Per Sample 1 – No Asbestos Detected | |
