Project Number A-00402 (3700)

**Re-Inspection
Asbestos Survey Report - Revised**

**Wyvern Barracks
Barrack Road
Exeter
Devon
EX2 6AE**

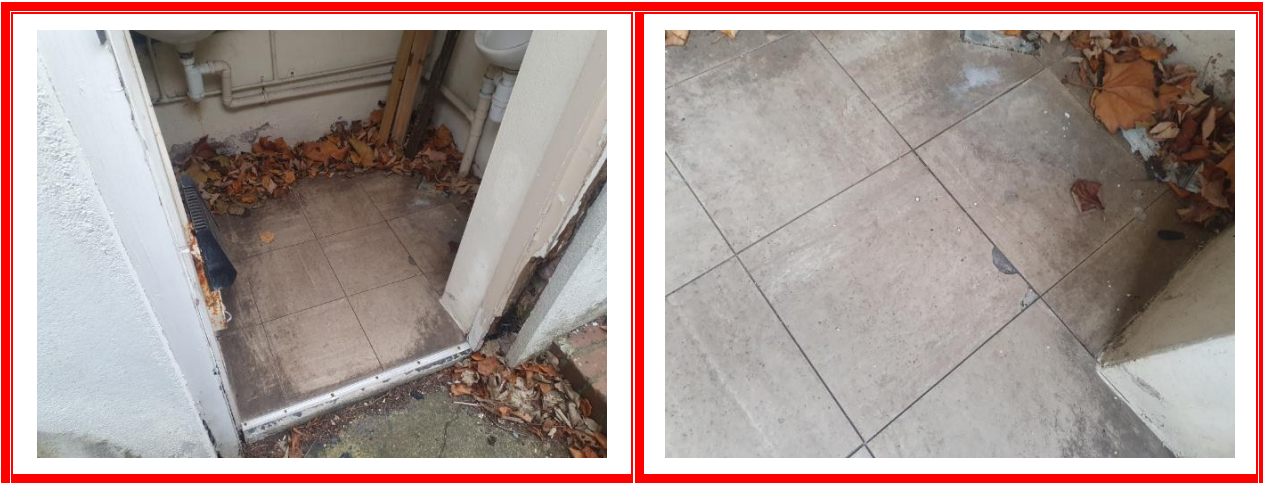
Item No:	1	Sample No:	N/A
Location:	Building 1, Ground Floor - External WC's x 2

Material Description:	Floor Tiles and Adhesive - Vinyl Products	
Identification:	Previously Sampled - Asbestos Detected	
Approx. quantity:	4 m ²	
Accessibility	Easy	Assessment Score
Product type:	Vinyl	1
Extent of Damage:	Slight / minor damage	1
Surface Treatment:	Floor Tiles	0
Asbestos type:	Chrysotile	1
Material Assessment Score:		3
Priority Assessment Score:		Negligible
Action:	Manage	
Comments:	Previously sampled ref: Armour 3/7/19 Sample 1 (Building 1)

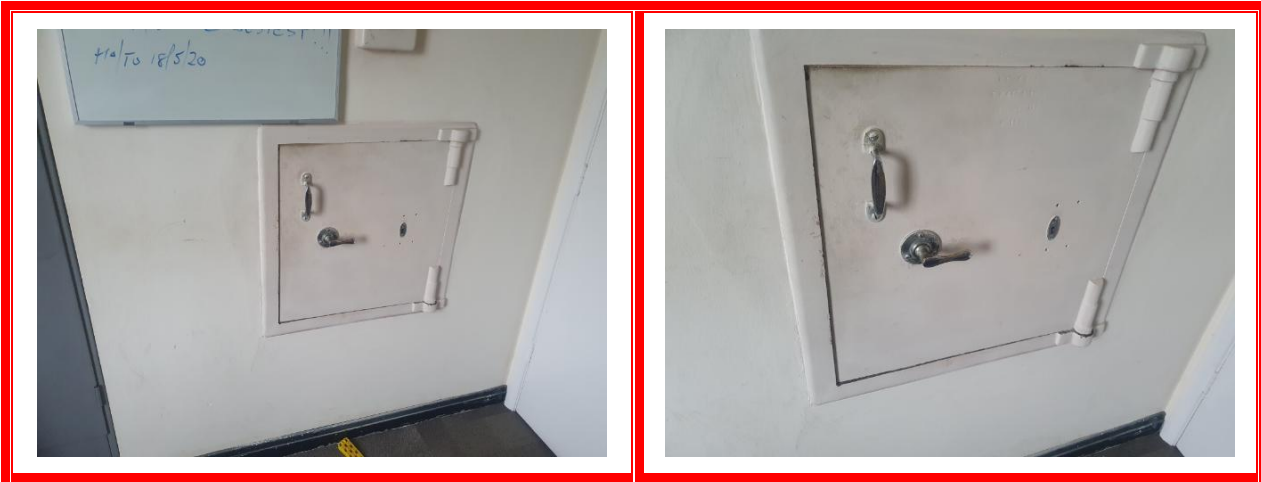
Item No:	2	Sample No:	N/A
Location:	Building 1, First Floor - Office

Material Description:	Safe - No Access Gained	
Identification:	Presumed to Contain Asbestos	
Approx. quantity:	1 no	
Accessibility	Difficult	<i>Assessment Score</i>
Product type:	Asbestos insulating board	2
Extent of Damage:	Major damage	3
Surface Treatment:	Unsealed AIB	2
Asbestos type:	Amosite, Chrysotile	2
Material Assessment Score:		9
Priority Assessment Score:		Medium
Action:	Manage	
Comments:	No access within safe casings without damaging safe

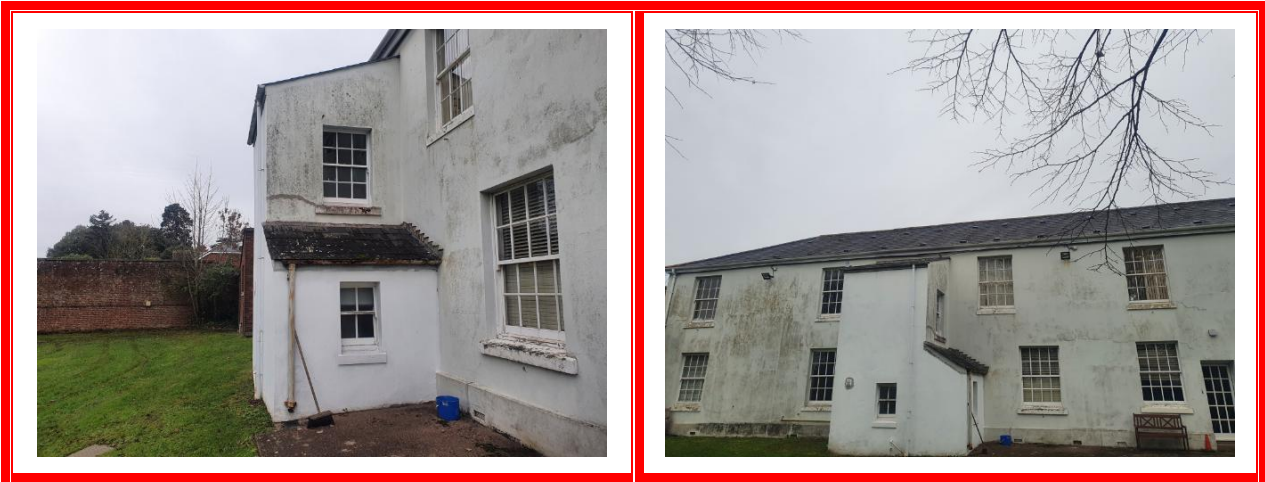
Item No:	3	Sample No:	N/A
Location:	Building 1, External - Roof

Material Description:	Roof Tiles - Cement Product	
Identification:	Previously Sampled - Asbestos Detected	
Approx. quantity:	168 m ²	
Accessibility	Difficult	<i>Assessment Score</i>
Product type:	Cement	1
Extent of Damage:	Slight / minor damage	1
Surface Treatment:	Unsealed Cement	1
Asbestos type:	Chrysotile	1
Material Assessment Score:		4
Priority Assessment Score:		Negligible
Action:	Manage	
Comments:	Previously sampled ref: Armour 3/7/19 Sample 3 (Building 1)

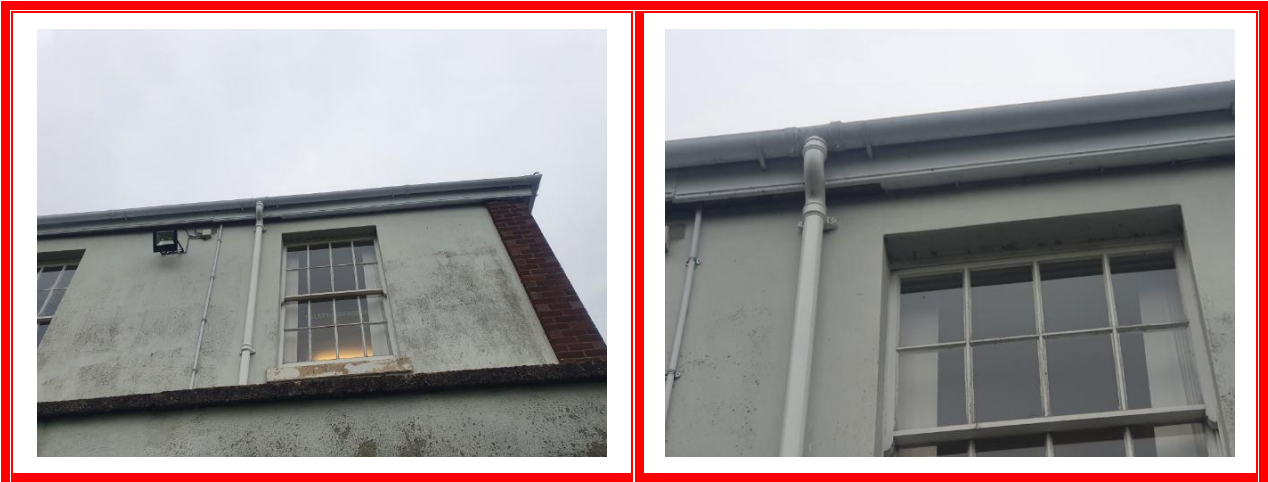
Item No:	4	Sample No:	N/A
Location:	Building 1, External - Roof

Material Description:	Soffits - Insulating Board	
Identification:	Presumed to Contain Asbestos	
Approx. quantity:	100 m ²	
Accessibility	Difficult	<i>Assessment Score</i>
Product type:	Asbestos insulating board	2
Extent of Damage:	Minor damage	1
Surface Treatment:	Sealed AIB	1
Asbestos type:	Amosite, Chrysotile	2
Material Assessment Score:		6
Priority Assessment Score:		Medium
Action:	Manage	
Comments:	No safe access to sample soffits due to height restrictions.

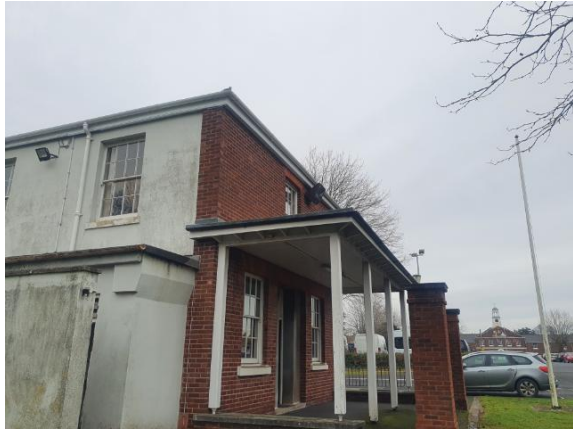
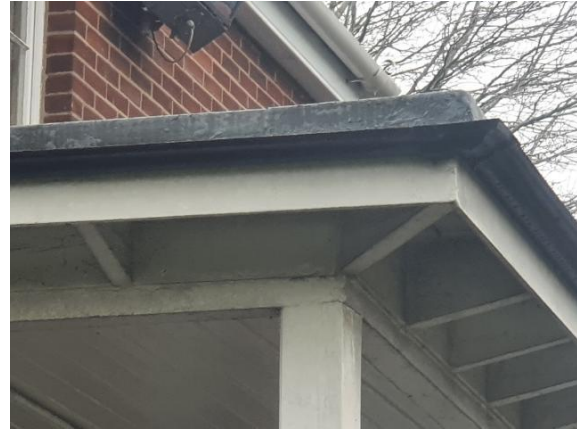
Material Description:	Roof Felt under Modern Roof Covering - Bituminous Product	
Identification:	Presumed to Contain Asbestos	
Approx. quantity:	15 m ²	
Accessibility	Difficult	Assessment Score
Product type:	Bitumen	1
Extent of Damage:	Good	0
Surface Treatment:	Non-friable	0
Asbestos type:	Chrysotile	1
Material Assessment Score:		2
Priority Assessment Score:		Negligible
Action:	Manage	
Comments:	<p>Felt under modern roof covering was previously identified as containing asbestos.</p> <p>No access to check under covering due to height restrictions</p>

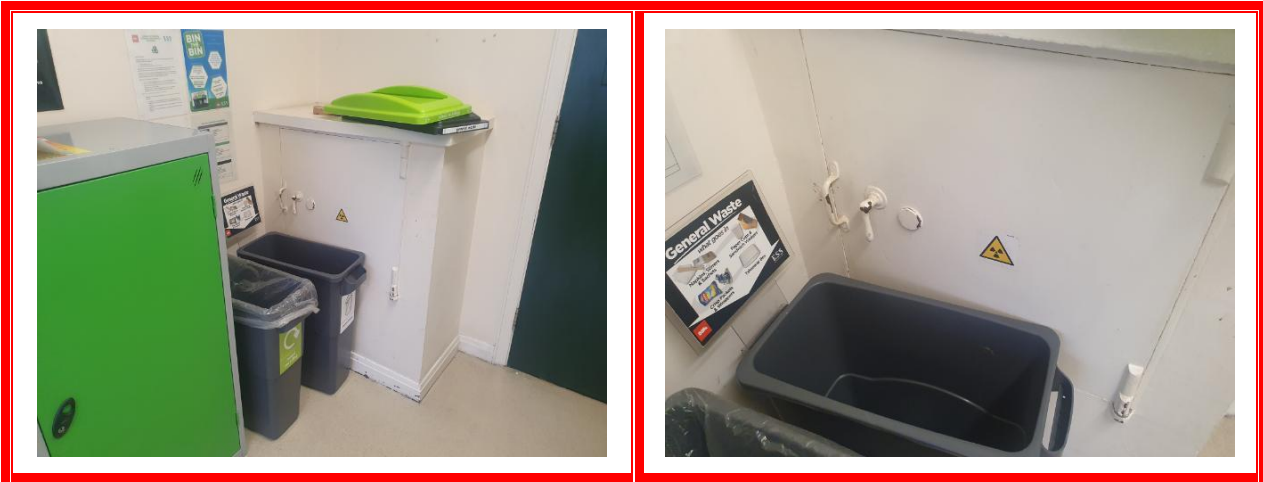
Material Description:	Safe - No Access Gained	
Identification:	Presumed to Contain Asbestos	
Approx. quantity:	1 no	
Accessibility	Difficult	<i>Assessment Score</i>
Product type:	Asbestos insulating board	2
Extent of Damage:	Major damage	3
Surface Treatment:	Unsealed AIB	2
Asbestos type:	Amosite, Chrysotile	2
Material Assessment Score:		9
Priority Assessment Score:		Medium
Action:	Manage	
Comments:	No access within safe casings without damaging safe

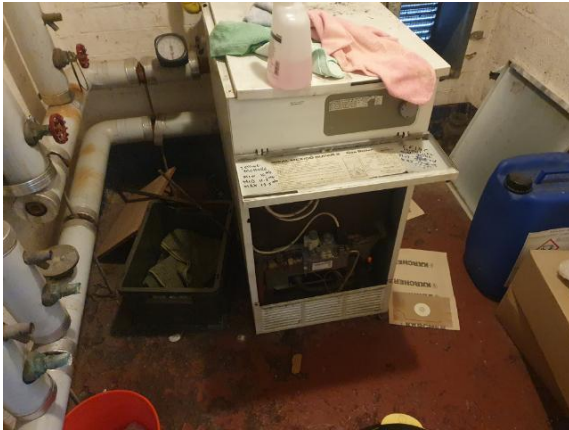
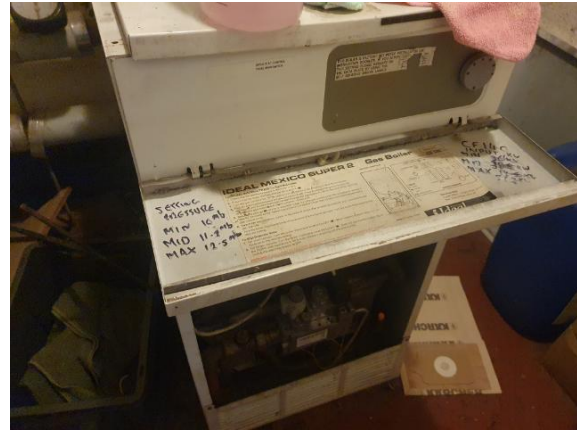
Material Description:	Boiler - No Access Gained	
Identification:	Presumed to Contain Asbestos	
Approx. quantity:	1 no	
Accessibility	Difficult	<i>Assessment Score</i>
Product type:	Asbestos insulating board	2
Extent of Damage:	Major damage	3
Surface Treatment:	Unsealed AIB	2
Asbestos type:	Amosite, Chrysotile	2
Material Assessment Score:		9
Priority Assessment Score:		Medium
Action:	Manage	
Comments:	No access within live boiler

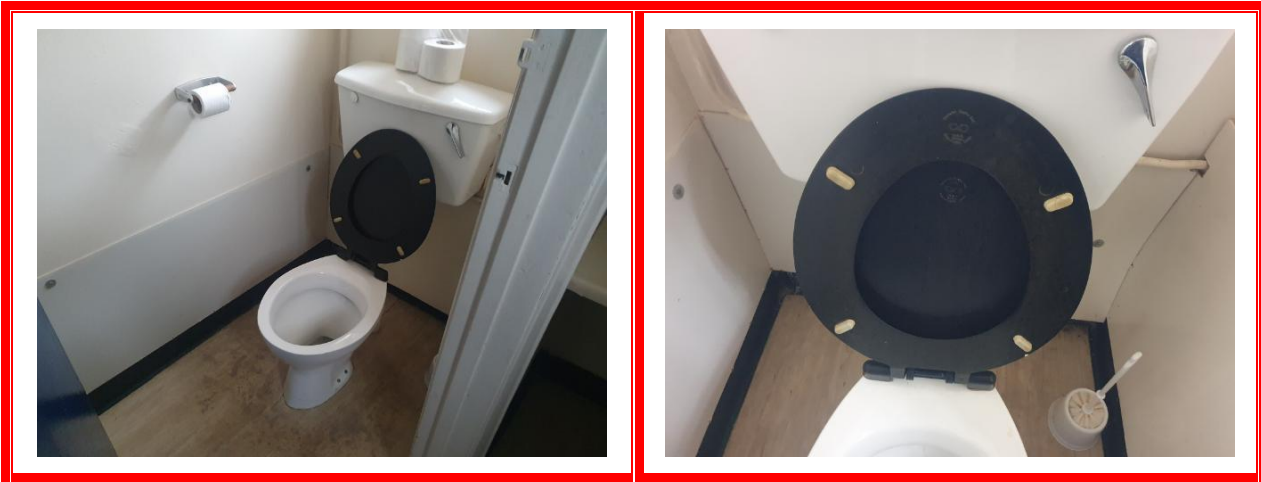
Material Description:	Toilet Seat - PVC / Reinforced Plastics	
Identification:	Presumed to Contain Asbestos	
Approx. quantity:	1 no	
Accessibility	Easy	<i>Assessment Score</i>
Product type:	Bakelite	1
Extent of Damage:	Minor damage	1
Surface Treatment:	Non-friable	0
Asbestos type:	Chrysotile	1
Material Assessment Score:		3
Priority Assessment Score:		Negligible
Action:	Manage	
Comments:	Not possible to sample as would damage integrity of seat

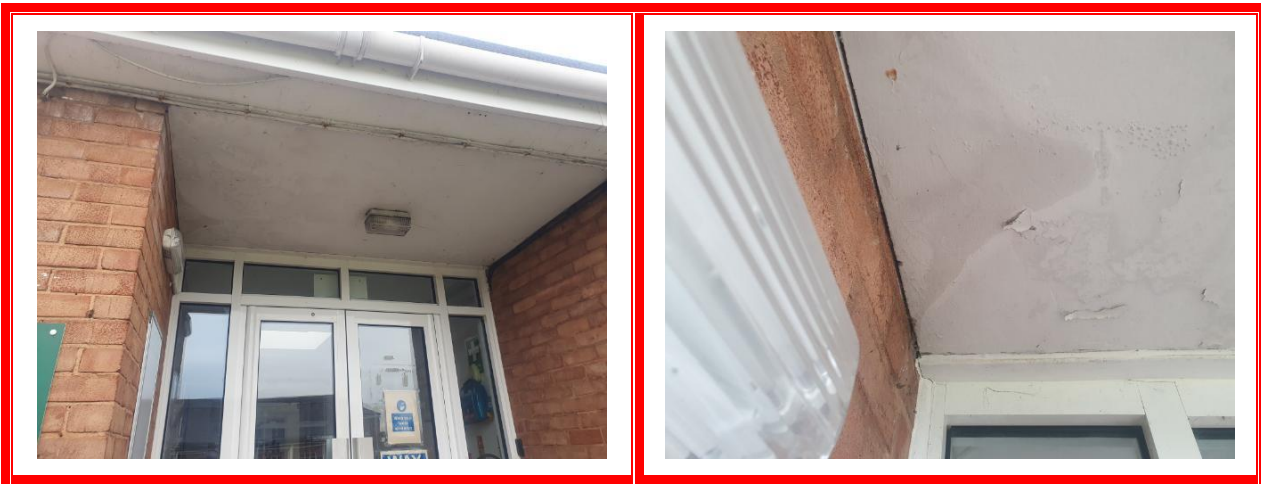
Material Description:	Ceiling - Insulating Board	
Identification:	Previously Sampled - Asbestos Detected	
Approx. quantity:	4 m ²	
Accessibility	Difficult	<i>Assessment Score</i>
Product type:	Asbestos insulating board	2
Extent of Damage:	Slight / minor damage	1
Surface Treatment:	Unsealed AIB	2
Asbestos type:	Amosite, Chrysotile	2
Material Assessment Score:		7
Priority Assessment Score:		Medium
Action:	Encapsulate	
Comments:	Previously sampled ref: Armour 3/7/19 Sample 1 (Building 18). Few small areas of damage require encapsulation

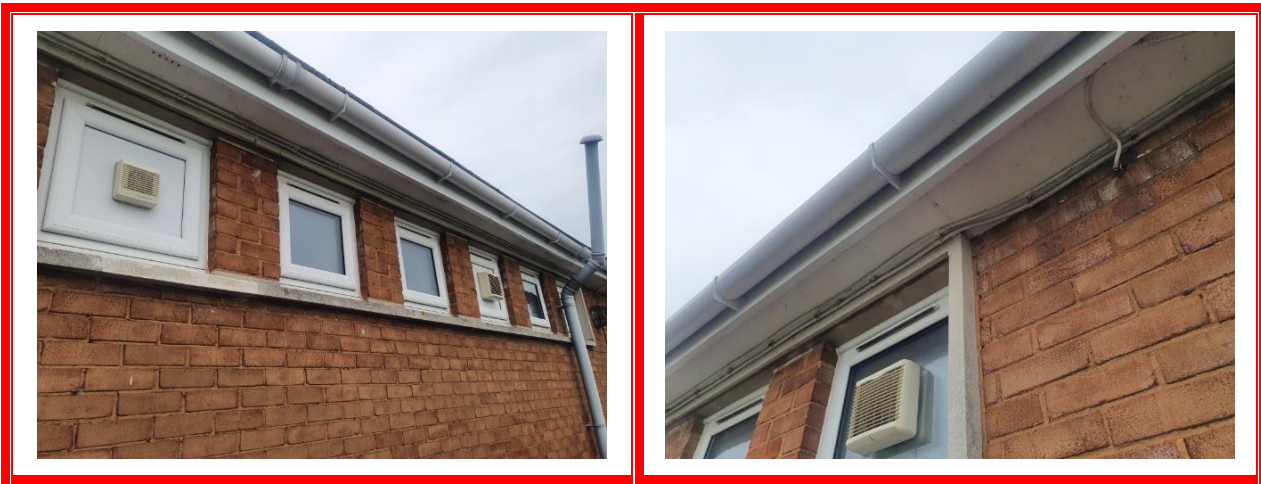
Material Description:	Soffit Boards - Cement Product	
Identification:	Previously Sampled - Asbestos Detected	
Approx. quantity:	50 LM	
Accessibility	Difficult	<i>Assessment Score</i>
Product type:	Cement	1
Extent of Damage:	Slight / minor damage	1
Surface Treatment:	Unsealed Cement,	1
Asbestos type:	Chrysotile	1
Material Assessment Score:		4
Priority Assessment Score:		Negligible
Action:	Manage	
Comments:	Previously sampled ref: Armour 3/7/19 Sample 2 (Building 18). Low level soffits

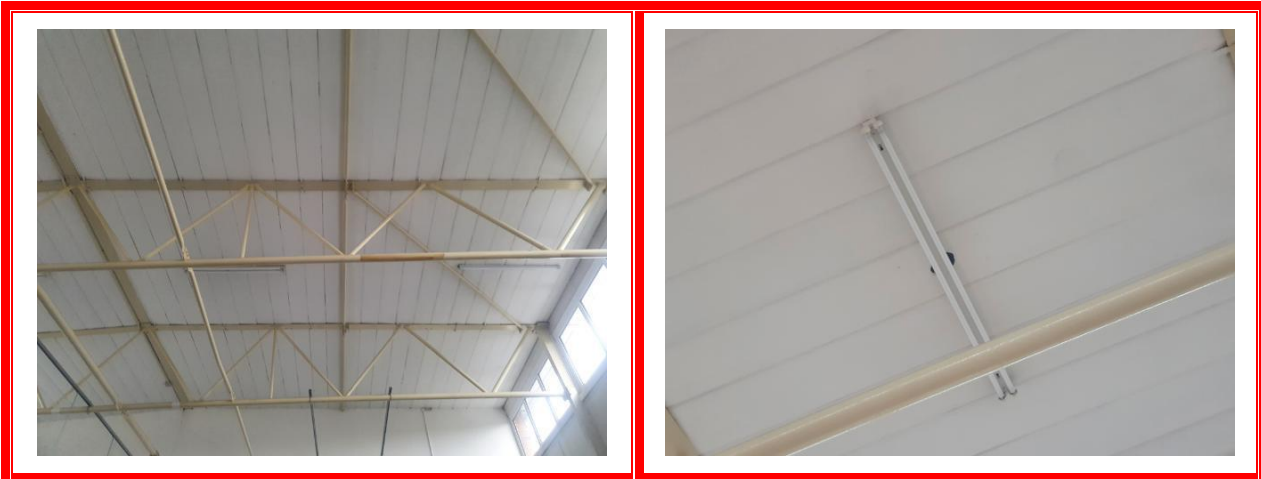
Material Description:	Ceiling Panels - Cement Product	
Identification:	Previously Sampled - Asbestos Detected	
Approx. quantity:	430 m ²	
Accessibility	Difficult	<i>Assessment Score</i>
Product type:	Cement	1
Extent of Damage:	Slight / minor damage	1
Surface Treatment:	Unsealed Cement	1
Asbestos type:	Chrysotile	1
Material Assessment Score:		4
Priority Assessment Score:		Negligible
Action:	Manage	
Comments:	Previously sampled ref: Sample 3-27739 (Building 18). To entire ceiling including high level soffits. Damage around light fittings

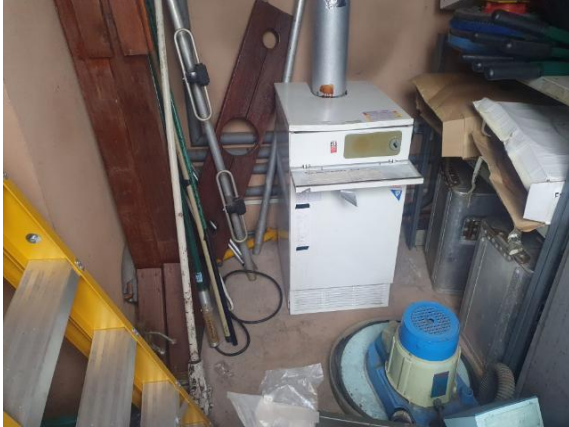
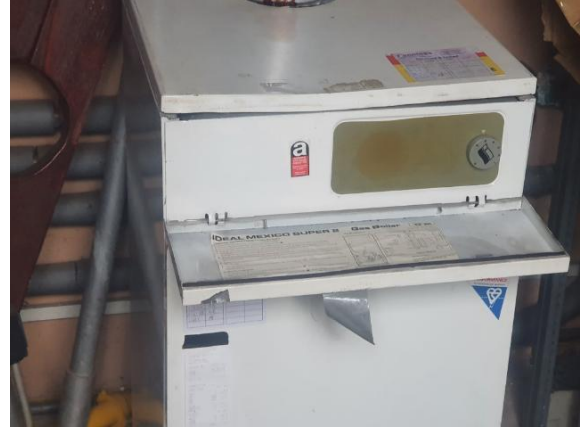
Material Description:	Boiler - No Access Gained	
Identification:	Presumed to Contain Asbestos	
Approx. quantity:	1 no	
Accessibility	Difficult	<i>Assessment Score</i>
Product type:	Asbestos insulating board	2
Extent of Damage:	Major damage	3
Surface Treatment:	Unsealed AIB	2
Asbestos type:	Amosite, Chrysotile	2
Material Assessment Score:		9
Priority Assessment Score:		Medium
Action:	Manage	
Comments:	No access within live boiler

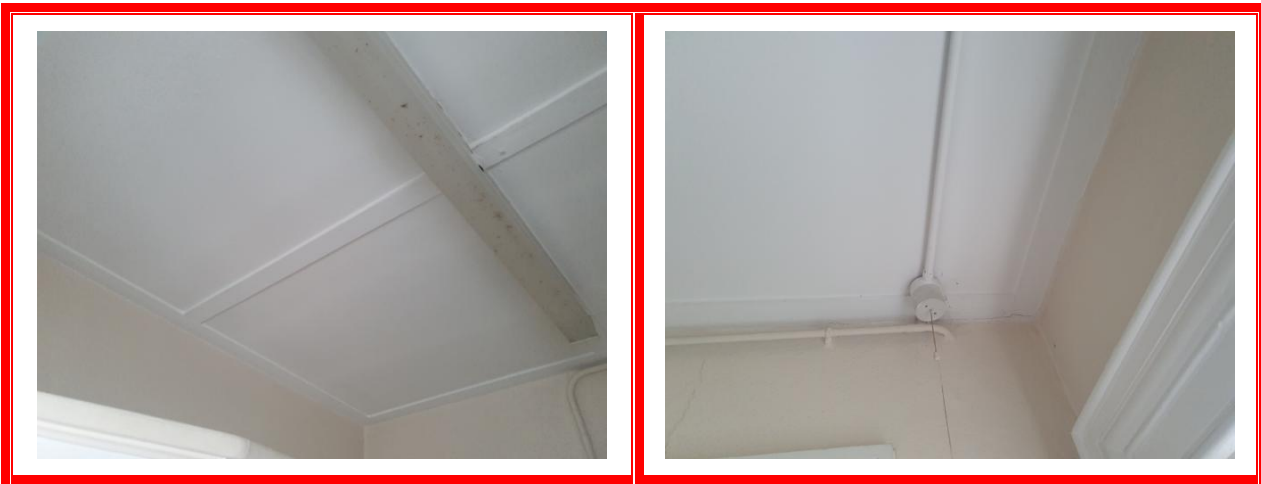
Material Description:	Ceiling Panels - Cement Product	
Identification:	Previously Sampled - Asbestos Detected	
Approx. quantity:	4 m ²	
Accessibility	Difficult	<i>Assessment Score</i>
Product type:	Cement	1
Extent of Damage:	Slight / minor damage	1
Surface Treatment:	Sealed Cement	0
Asbestos type:	Chrysotile	1
Material Assessment Score:		3
Priority Assessment Score:		Negligible
Action:	Manage	
Comments:	Previously sampled ref: Armour 11/7/19 Sample 3 (Building 11)

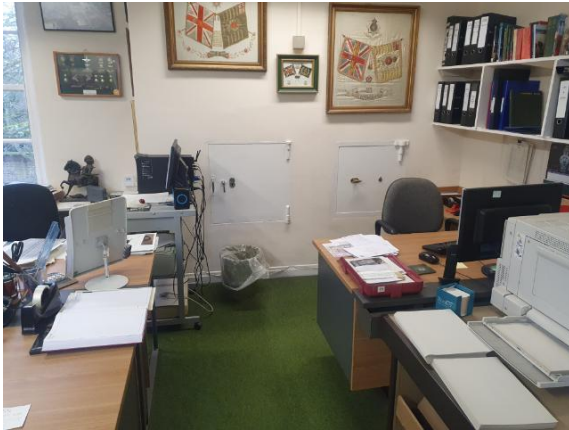
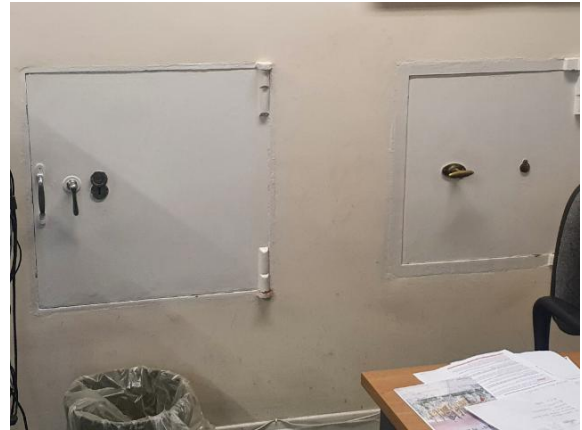
Item No: 17

Material Description:	Safe - No Access Gained	
Identification:	Presumed to Contain Asbestos	
Approx. quantity:	2 no	
Accessibility	Difficult	<i>Assessment Score</i>
Product type:	Asbestos insulating board	2
Extent of Damage:	Major damage	3
Surface Treatment:	Unsealed AIB	2
Asbestos type:	Amosite, Chrysotile	2
Material Assessment Score:		9
Priority Assessment Score:		Medium
Action:	Manage	
Comments:	No access without damaging safe

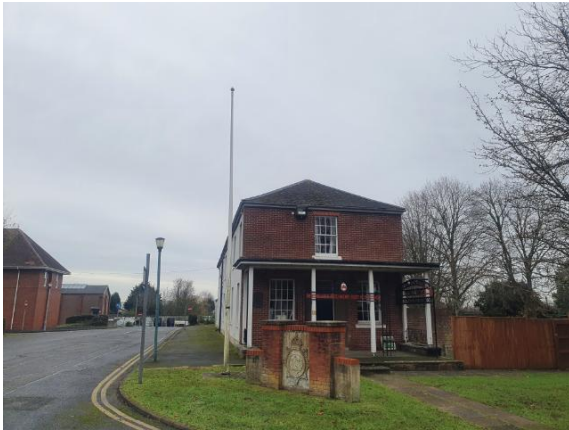
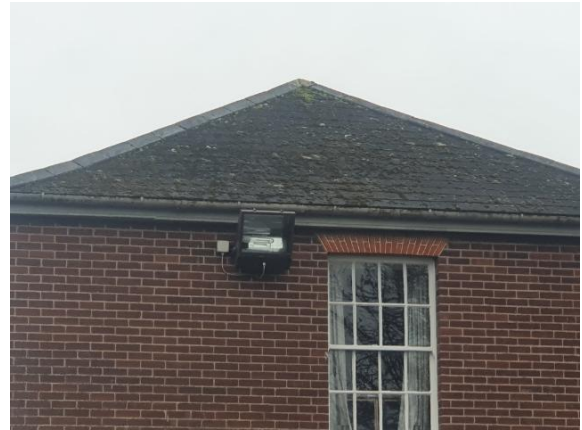
Material Description:	Roof Tiles - Cement Product	
Identification:	Previously Sampled - Asbestos Detected	
Approx. quantity:	230 m ²	
Accessibility	Difficult	<i>Assessment Score</i>
Product type:	Cement	1
Extent of Damage:	Slight / minor damage	1
Surface Treatment:	Unsealed Cement	1
Asbestos type:	Chrysotile	1
Material Assessment Score:		4
Priority Assessment Score:		Negligible
Action:	Manage	
Comments:	Previously sampled ref: Armour 11/7/19 Sample 4 (Building 11)

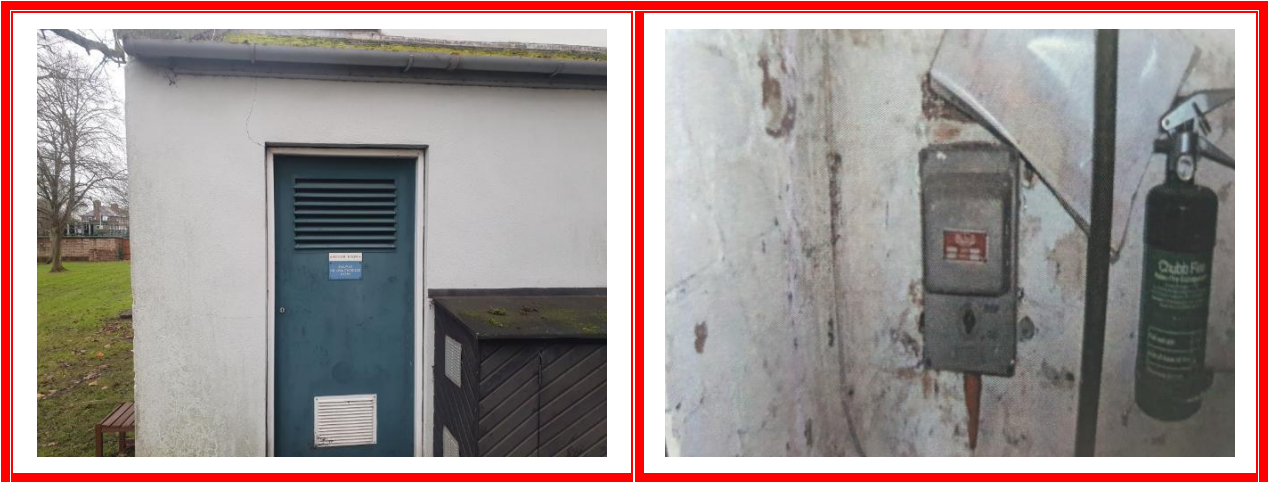
Material Description:	Electrical Panel - No Access Gained	
Identification:	Presumed to Contain Asbestos	
Approx. quantity:	1 no	
Accessibility	Difficult	<i>Assessment Score</i>
Product type:	Flashguards	2
Extent of Damage:	Minor damage	1
Surface Treatment:	Woven	1
Asbestos type:	Chrysotile	1
Material Assessment Score:		5
Priority Assessment Score:		Low
Action:	Manage	
Comments:	No access within live electrics

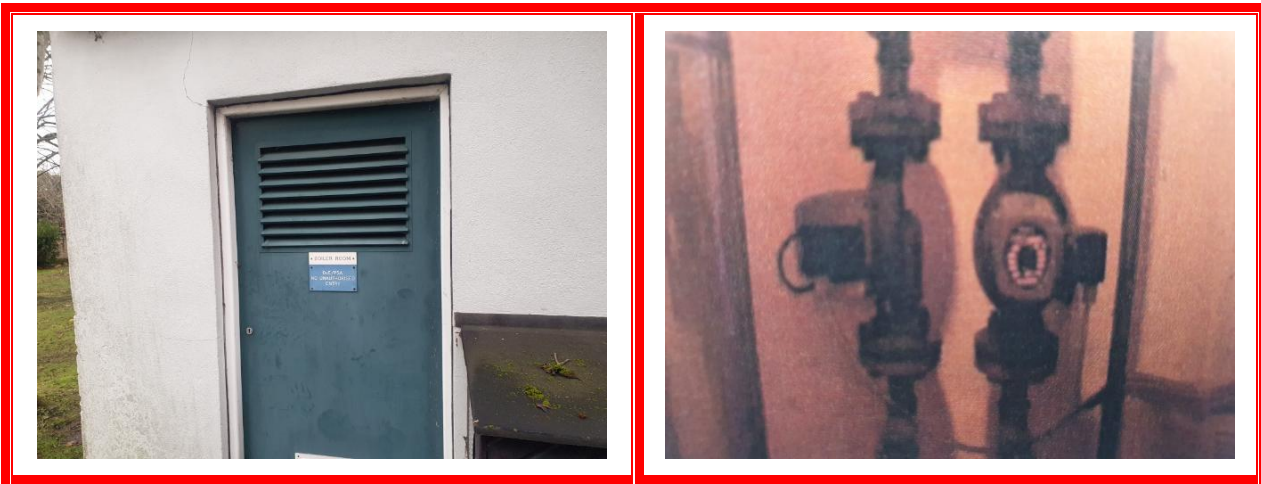
Material Description:	Gaskets - Gaskets (compressed)	
Identification:	Presumed to Contain Asbestos	
Approx. quantity:	4 no	
Accessibility	Difficult	<i>Assessment Score</i>
Product type:	Gaskets	2
Extent of Damage:	Minor damage	1
Surface Treatment:	Gasket	1
Asbestos type:	Chrysotile	1
Material Assessment Score:		5
Priority Assessment Score:		Low
Action:	Manage	
Comments:	Not possible to sample as gaskets are too inset within flanges

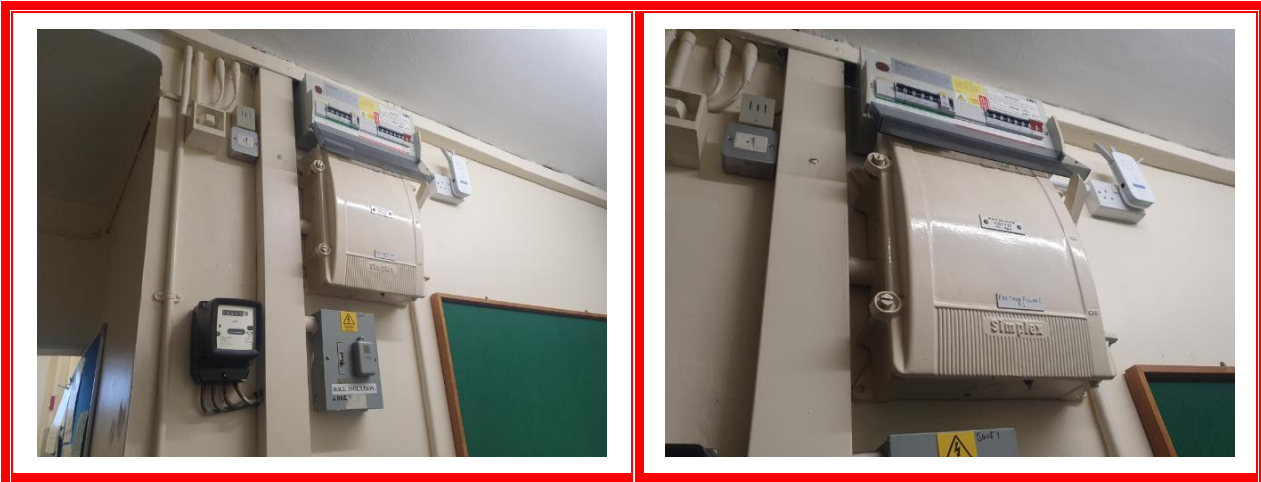
Material Description:	Electrical Panel - No Access Gained	
Identification:	Presumed to Contain Asbestos	
Approx. quantity:	1 no	
Accessibility	Difficult	<i>Assessment Score</i>
Product type:	Flashguards	2
Extent of Damage:	Minor damage	1
Surface Treatment:	Woven	1
Asbestos type:	Chrysotile	1
Material Assessment Score:		5
Priority Assessment Score:		Low
Action:	Manage	
Comments:	No access within live electrics

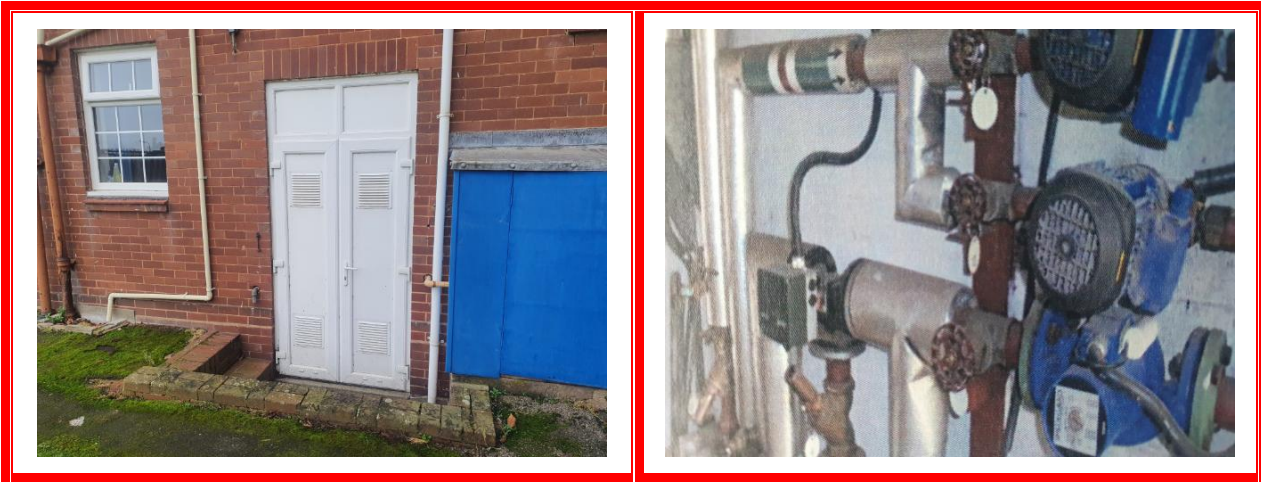
Material Description:	Gaskets - Gaskets (compressed)	
Identification:	Previously Sampled - Asbestos Detected	
Approx. quantity:	7 no	
Accessibility	Difficult	Assessment Score
Product type:	Gaskets	2
Extent of Damage:	Minor damage	1
Surface Treatment:	Gasket	1
Asbestos type:	Chrysotile	1
Material Assessment Score:		5
Priority Assessment Score:		Low
Action:	Manage	
Comments:	Previously sampled ref: Armour 11/7/19 Sample 2 (Building 9)

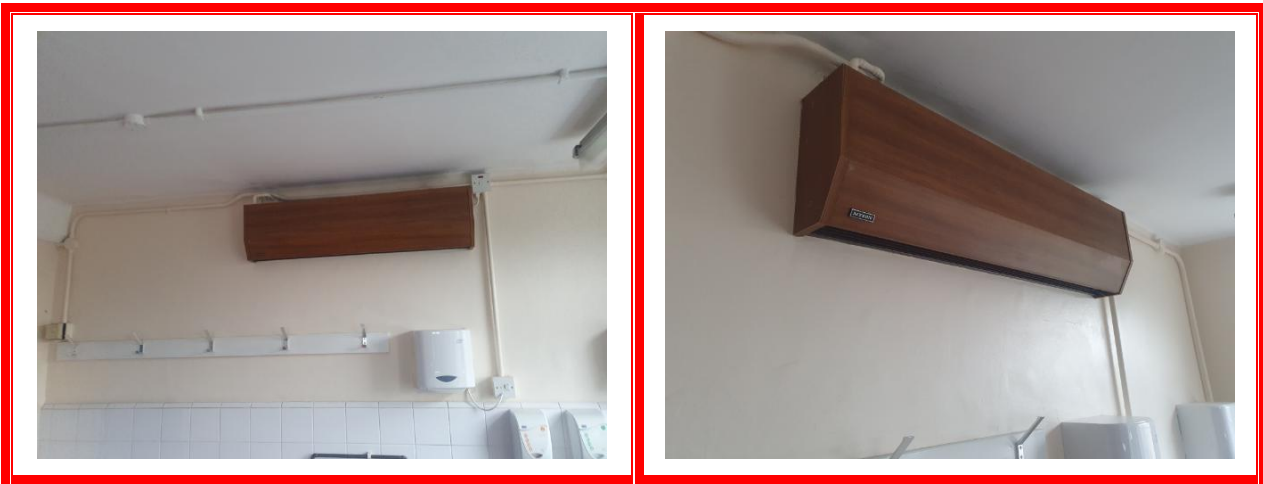
Material Description:	Heater - No Access Gained	
Identification:	Presumed to Contain Asbestos	
Approx. quantity:	1 no	
Accessibility	Difficult	<i>Assessment Score</i>
Product type:	Asbestos insulating board	2
Extent of Damage:	Slight / minor damage	1
Surface Treatment:	Unsealed AIB	2
Asbestos type:	Amosite, Chrysotile	2
Material Assessment Score:		7
Priority Assessment Score:		Low
Action:	Manage	
Comments:	No access within live heater

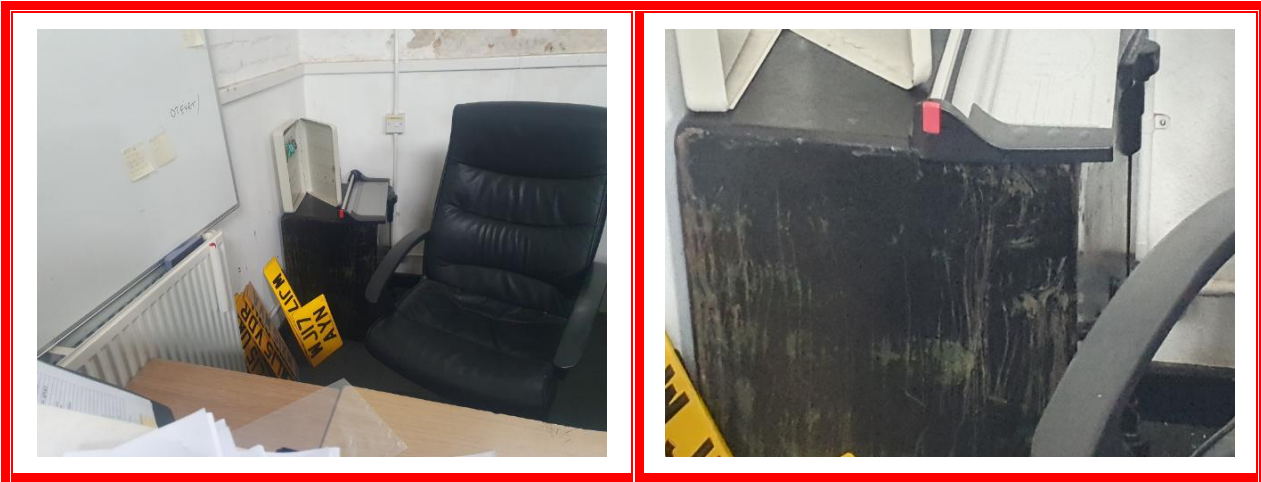
Material Description:	Safe - No Access Gained	
Identification:	Presumed to Contain Asbestos	
Approx. quantity:	1 no	
Accessibility	Difficult	<i>Assessment Score</i>
Product type:	Asbestos insulating board	2
Extent of Damage:	Major damage	3
Surface Treatment:	Unsealed AIB	2
Asbestos type:	Amosite, Chrysotile	2
Material Assessment Score:		9
Priority Assessment Score:		Medium
Action:	Manage	
Comments:	No access within safe within damaging it. Safe has been moved into a different room

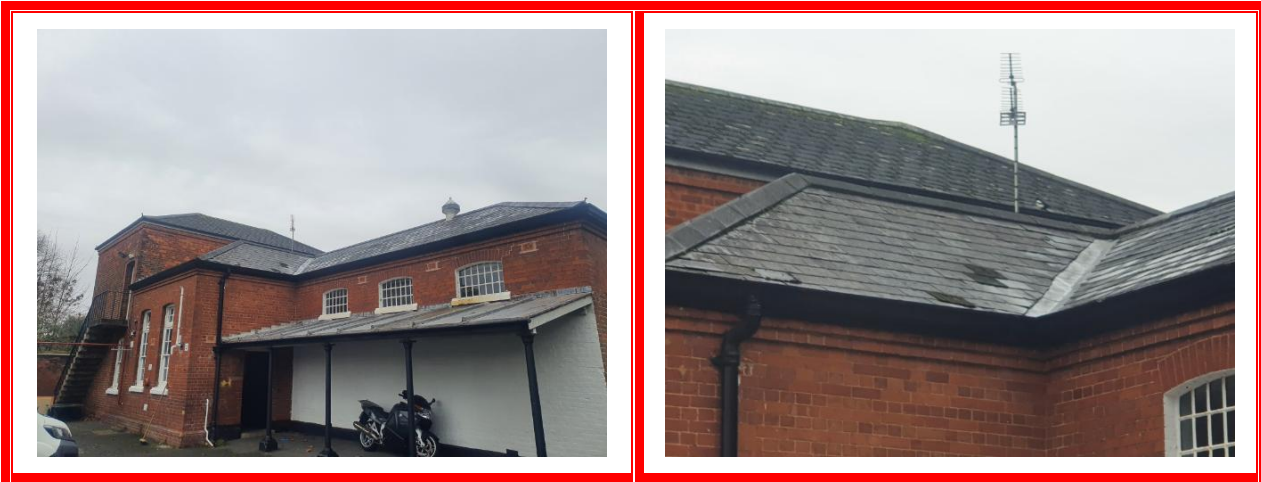
Material Description:	Roof Tiles - Cement Product	
Identification:	Presumed to Contain Asbestos	
Approx. quantity:	150 m ²	
Accessibility	Difficult	<i>Assessment Score</i>
Product type:	Cement	1
Extent of Damage:	Minor damage	1
Surface Treatment:	Unsealed Cement	1
Asbestos type:	Chrysotile	1
Material Assessment Score:		4
Priority Assessment Score:		Negligible
Action:	Manage	
Comments:	No access to sample due to height restrictions

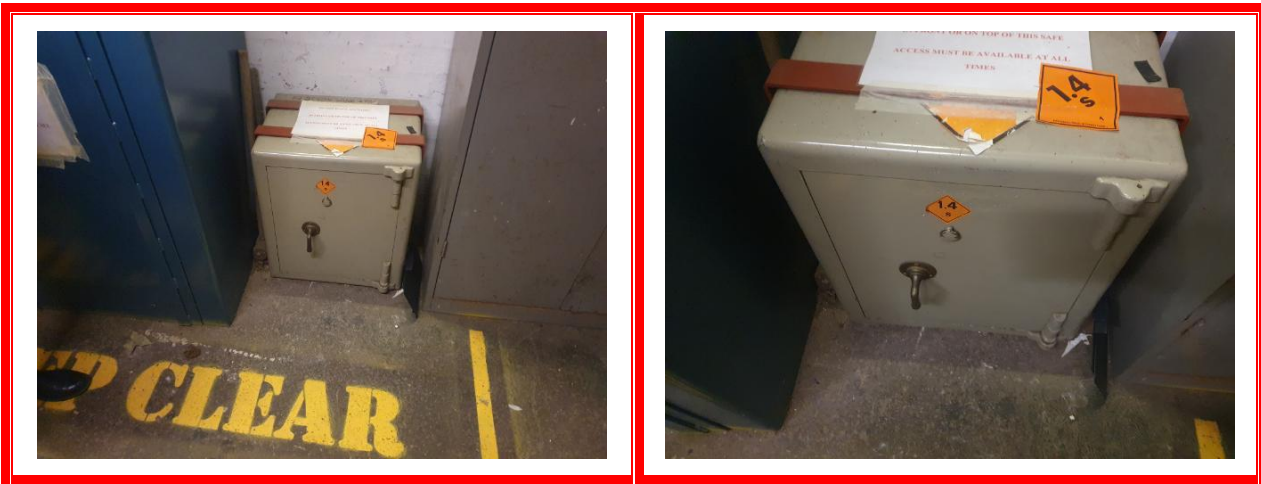
Material Description:	Safe - No Access Gained	
Identification:	Presumed to Contain Asbestos	
Approx. quantity:	1 no	
Accessibility	Difficult	<i>Assessment Score</i>
Product type:	Asbestos insulating board	2
Extent of Damage:	Major damage	3
Surface Treatment:	Unsealed AIB	2
Asbestos type:	Amosite, Chrysotile	2
Material Assessment Score:		9
Priority Assessment Score:		Medium
Action:	Manage	
Comments:	No access within without damaging safe

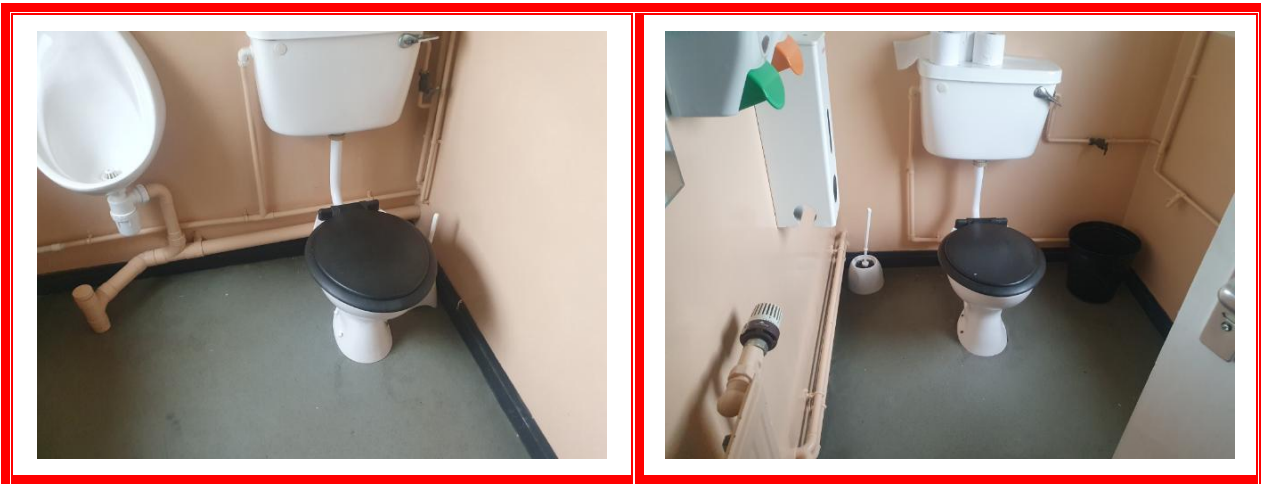
Material Description:	Toilet Seats - PVC / Reinforced Plastics	
Identification:	Presumed to Contain Asbestos	
Approx. quantity:	2 no	
Accessibility	Easy	<i>Assessment Score</i>
Product type:	Bakelite	1
Extent of Damage:	Minor damage	1
Surface Treatment:	Non-friable	0
Asbestos type:	Chrysotile	1
Material Assessment Score:		3
Priority Assessment Score:		Negligible
Action:	Manage	
Comments:	Not possible to sample as may damage integrity of the seats

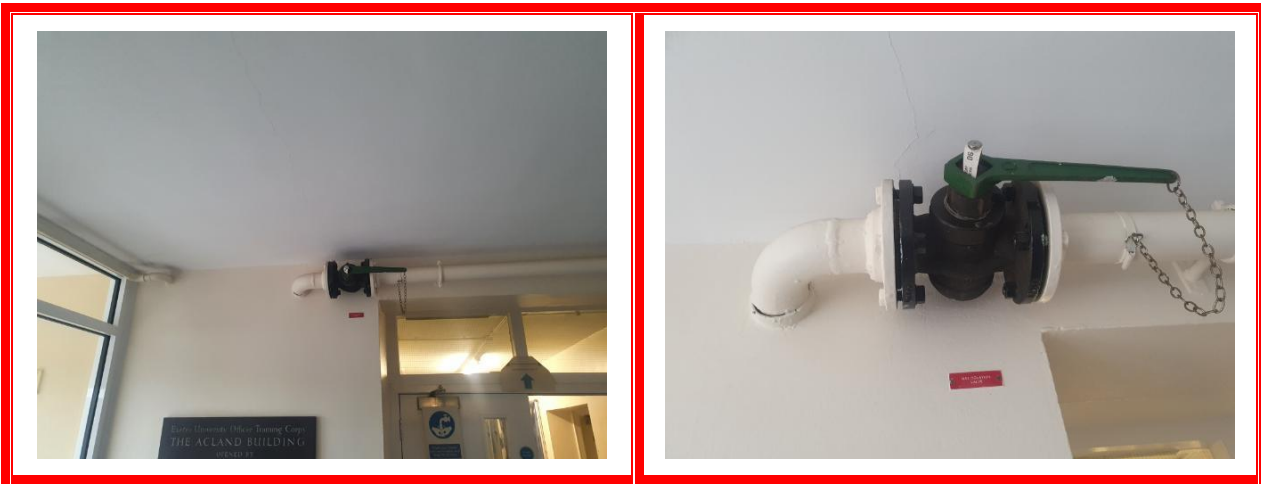
Material Description:	Gaskets - Gaskets (compressed)	
Identification:	Previously Sampled - Asbestos Detected	
Approx. quantity:	2 no	
Accessibility	Difficult	<i>Assessment Score</i>
Product type:	Gaskets	2
Extent of Damage:	Minor damage	1
Surface Treatment:	Gasket	1
Asbestos type:	Chrysotile	1
Material Assessment Score:		5
Priority Assessment Score:		Low
Action:	Manage	
Comments:	Previously sampled ref: Armour 3/7/19 Sample 1 (Building 3)

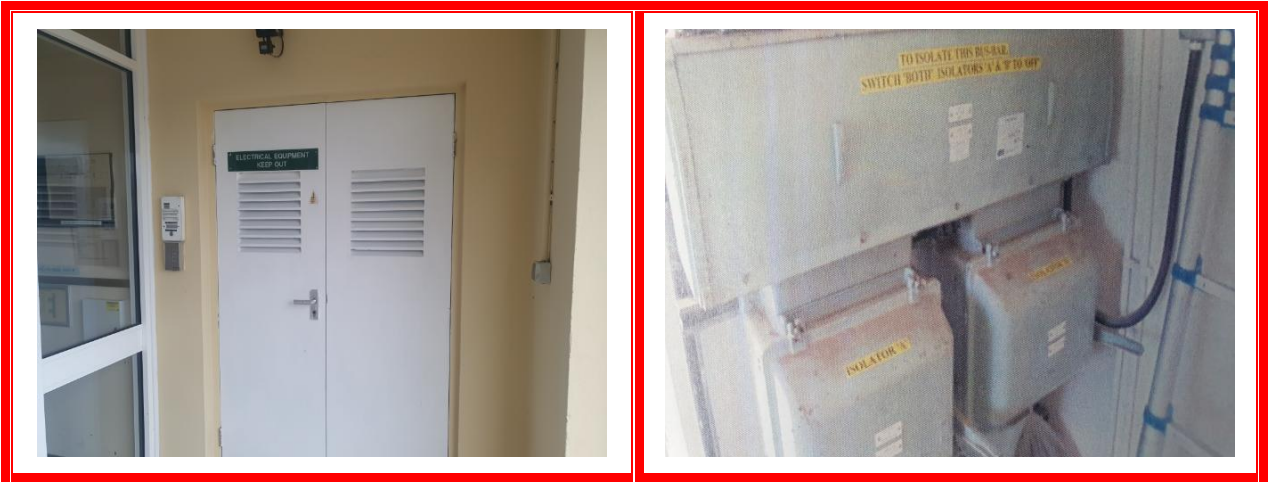
Material Description:	Electrical Panels - No Access Gained	
Identification:	Presumed to Contain Asbestos	
Approx. quantity:	3 no	
Accessibility	Difficult	<i>Assessment Score</i>
Product type:	Flashguards	2
Extent of Damage:	Minor damage	1
Surface Treatment:	Woven	1
Asbestos type:	Chrysotile	1
Material Assessment Score:		5
Priority Assessment Score:		Low
Action:	Manage	
Comments:	No access within live boxes

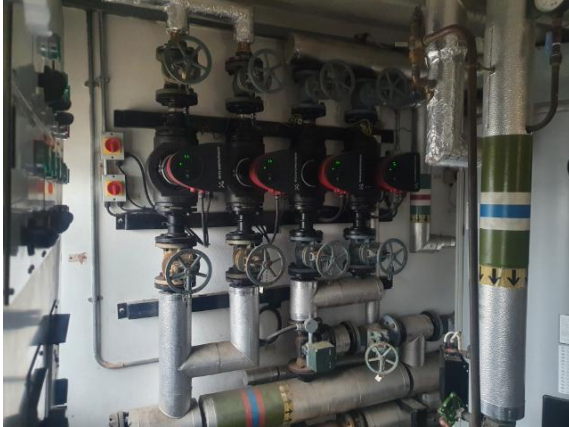
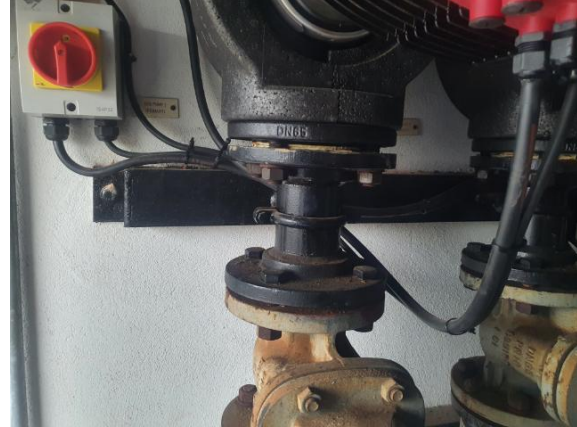
Material Description:	Gaskets - Gaskets (compressed)	
Identification:	Previously Sampled - Asbestos Detected	
Approx. quantity:	50 no	
Accessibility	Difficult	<i>Assessment Score</i>
Product type:	Gaskets	2
Extent of Damage:	Minor damage	1
Surface Treatment:	Gasket	1
Asbestos type:	Chrysotile	1
Material Assessment Score:		5
Priority Assessment Score:		Low
Action:	Manage	
Comments:	Previously sampled ref: Armour 3/7/19 Sample 2 (Building 3)

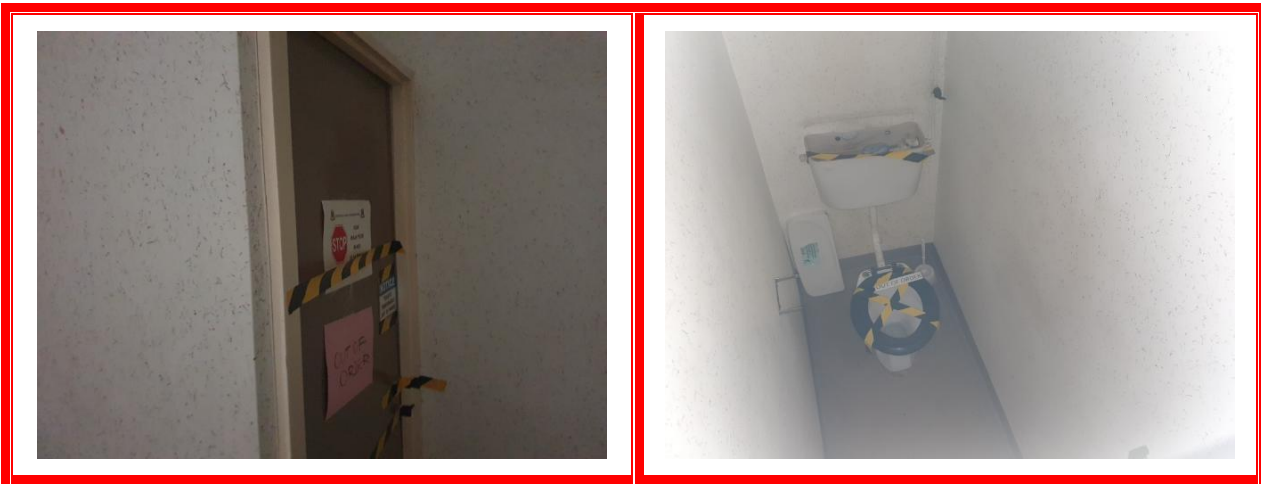
Material Description:	Toilet Seat - PVC / Reinforced Plastics	
Identification:	Presumed to Contain Asbestos	
Approx. quantity:	1 no	
Accessibility	Easy	<i>Assessment Score</i>
Product type:	Bakelite	1
Extent of Damage:	Minor damage	1
Surface Treatment:	Non-friable	0
Asbestos type:	Chrysotile	1
Material Assessment Score:		3
Priority Assessment Score:		Negligible
Action:	Manage	
Comments:	Not possible to sample as may damage integrity of the seat. Toilet currently out of bounds due to covid.

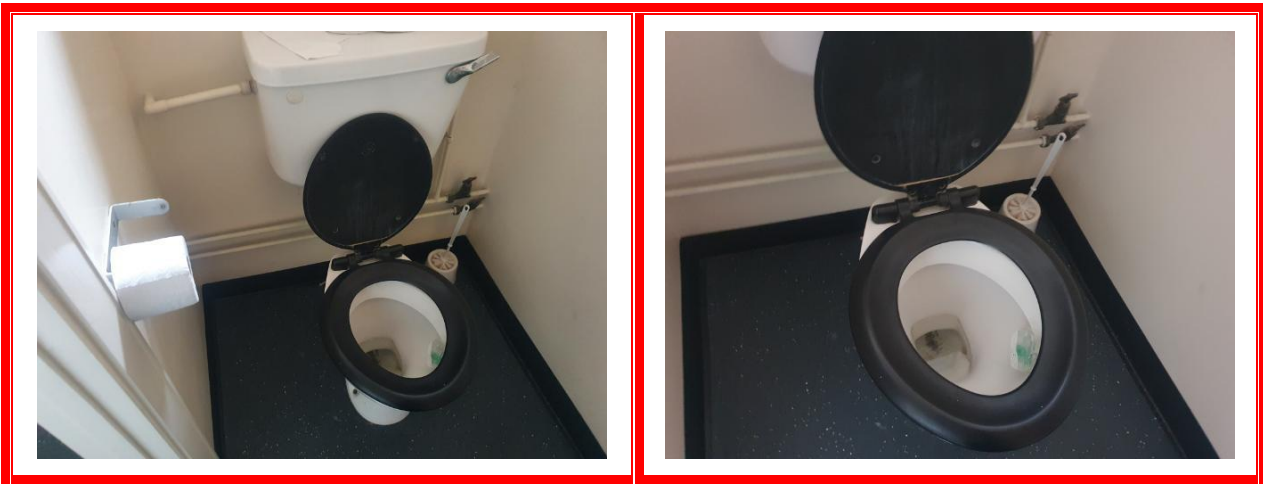
Material Description:	Toilet Seat - PVC / Reinforced Plastics	
Identification:	Presumed to Contain Asbestos	
Approx. quantity:	1 no	
Accessibility	Easy	<i>Assessment Score</i>
Product type:	Bakelite	1
Extent of Damage:	Minor damage	1
Surface Treatment:	Non-friable	0
Asbestos type:	Chrysotile	1
Material Assessment Score:		3
Priority Assessment Score:		Negligible
Action:	Manage	
Comments:	Not possible to sample as may damage integrity of the seat

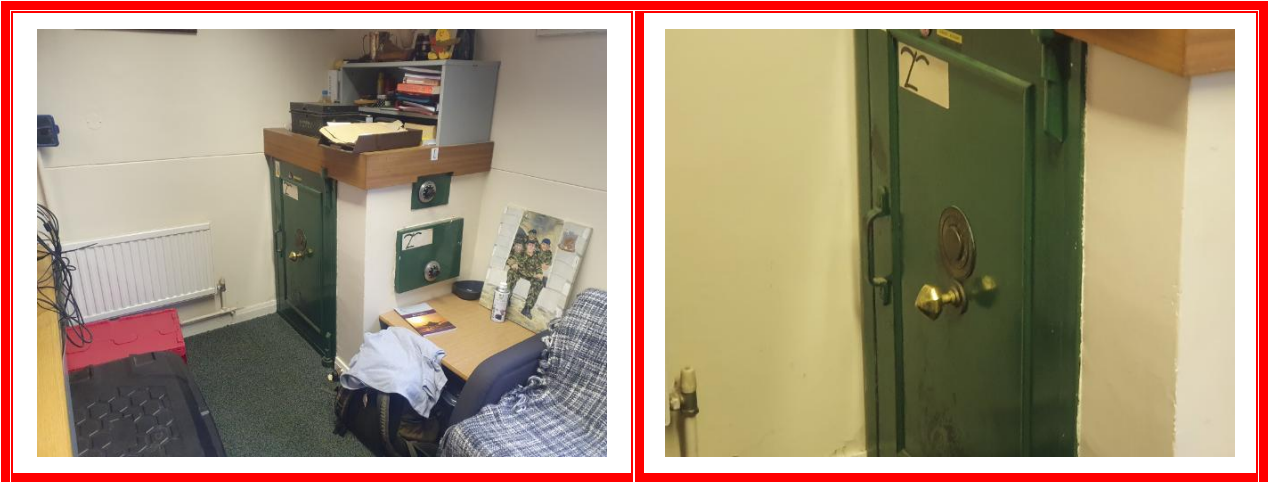
Material Description:	Safe - No Access Gained	
Identification:	Presumed to Contain Asbestos	
Approx. quantity:	1 no	
Accessibility	Difficult	<i>Assessment Score</i>
Product type:	Asbestos insulating board	2
Extent of Damage:	Major damage	3
Surface Treatment:	Unsealed AIB	2
Asbestos type:	Amosite, Chrysotile	2
Material Assessment Score:		9
Priority Assessment Score:		Medium
Action:	Manage	
Comments:	No access within safe casings without damaging safe

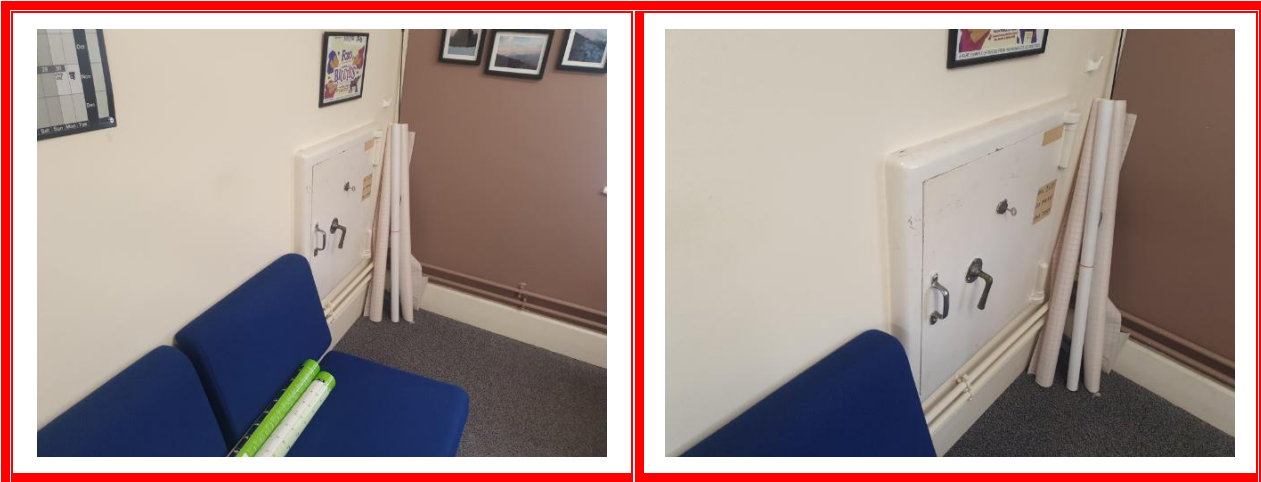
Material Description:	Safe - No Access Gained	
Identification:	Presumed to Contain Asbestos	
Approx. quantity:	1 no	
Accessibility	Difficult	<i>Assessment Score</i>
Product type:	Asbestos insulating board	2
Extent of Damage:	Major damage	3
Surface Treatment:	Unsealed AIB	2
Asbestos type:	Amosite, Chrysotile	2
Material Assessment Score:		9
Priority Assessment Score:		Medium
Action:	Manage	
Comments:	No access within safe casings without damaging safe
