Project Number A-00402 (3700)

**Re-Inspection
Asbestos Survey Report - Revised**

**Wyvern Barracks
Barrack Road
Exeter
Devon
EX2 6AE**

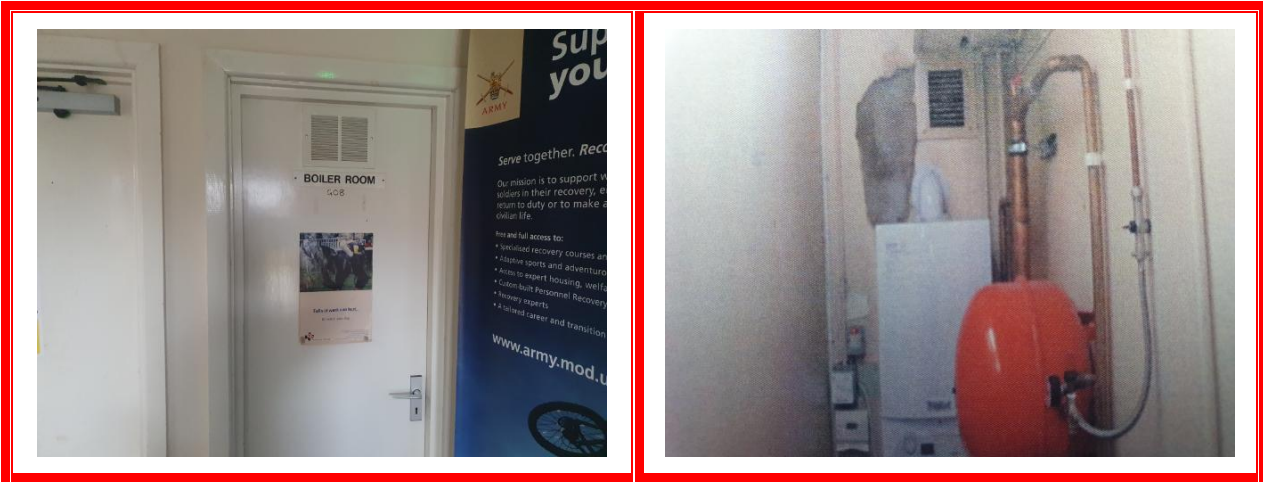
Material Description:	Gaskets - Gaskets (compressed)	
Identification:	Presumed to Contain Asbestos	
Approx. quantity:	2 no	
Accessibility	Difficult	<i>Assessment Score</i>
Product type:	Gaskets	2
Extent of Damage:	Minor damage	1
Surface Treatment:	Gasket	1
Asbestos type:	Chrysotile	1
Material Assessment Score:		5
Priority Assessment Score:		Low
Action:	Manage	
Comments:	Not possible to sample as gaskets were too inset within flanges

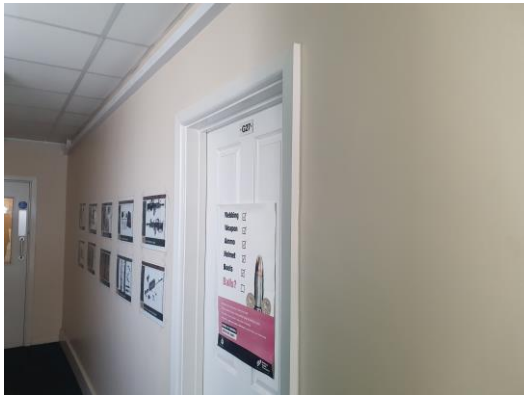
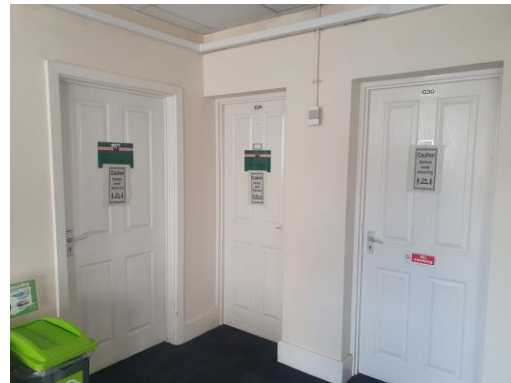
Material Description:	All - No Access Gained	
Identification:	Presumed to Contain Asbestos	
Approx. quantity:	Unknown	
Accessibility	Difficult	Assessment Score
Product type:	Pipe insulation, spray coating, friable debris	3
Extent of Damage:	Major damage	3
Surface Treatment:	Unsealed Pipe Insulation or Spray Coating	3
Asbestos type:	Amosite, Chrysotile, Crocidolite	3
Material Assessment Score:		12
Priority Assessment Score:		High
Action:	Further Investigation Needed	
Comments:	No Access into 5no offices on revisit survey 14/10/2021. Kelvin Walker to arrange access.

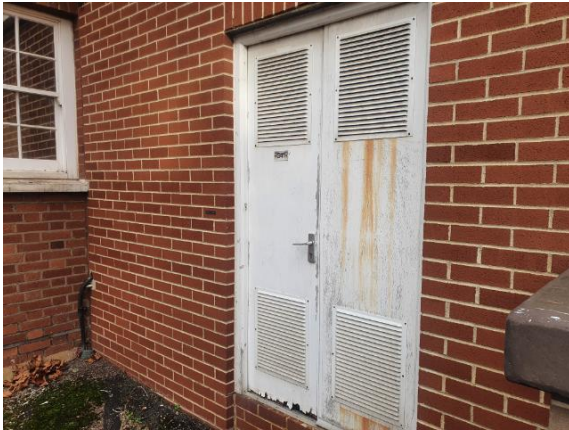
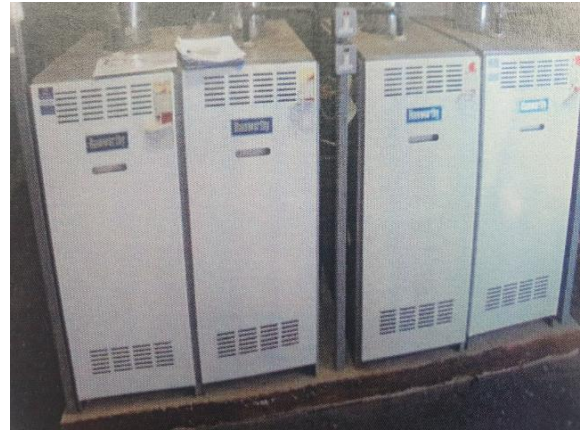
Item No: 47

Material Description:	Boilers - No Access Gained	
Identification:	Presumed to Contain Asbestos	
Approx. quantity:	4 no	
Accessibility	Difficult	<i>Assessment Score</i>
Product type:	Asbestos insulating board	2
Extent of Damage:	Major damage	3
Surface Treatment:	Unsealed AIB	2
Asbestos type:	Amosite, Chrysotile	2
Material Assessment Score:		9
Priority Assessment Score:		Medium
Action:	Manage	
Comments:	No access within live boilers

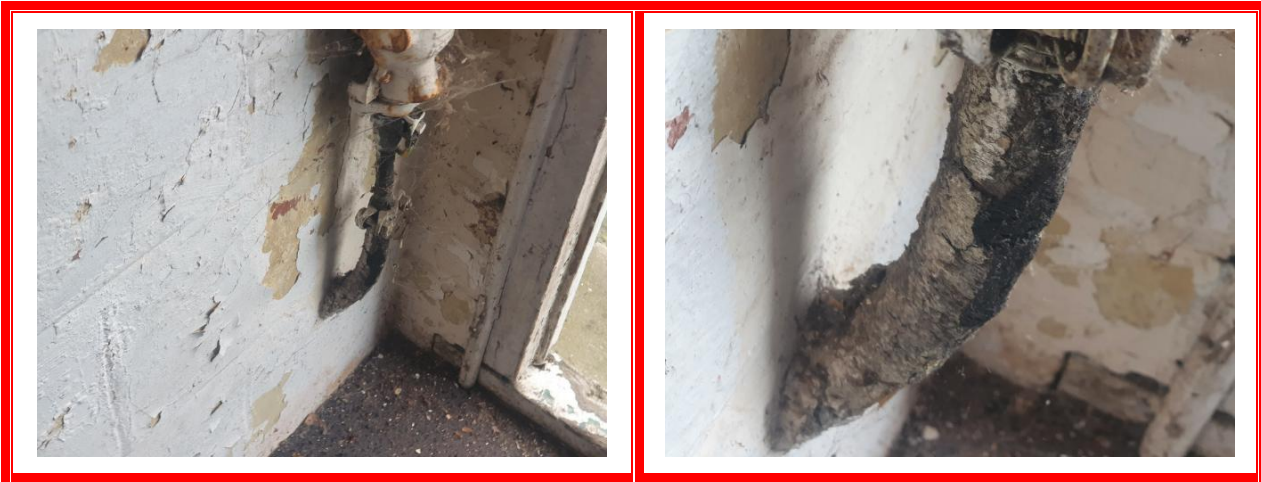
Material Description:	Wrap to Mains Cable - Bituminous Product	
Identification:	Presumed to Contain Asbestos	
Approx. quantity:	1 LM	
Accessibility	Difficult	<i>Assessment Score</i>
Product type:	Bitumen	1
Extent of Damage:	Minor damage	1
Surface Treatment:	Non Friable	0
Asbestos type:	Chrysotile	1
Material Assessment Score:		3
Priority Assessment Score:		Negligible
Action:	Manage	
Comments:	No access to sample live cable. Keys to building held by the Yeomanry (Room G14)

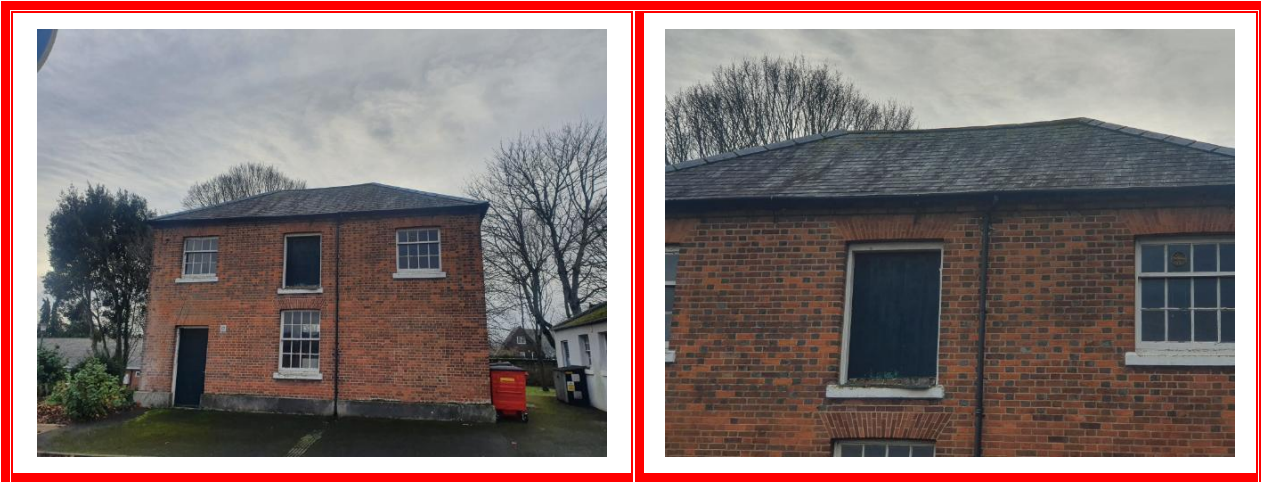
Material Description:	Roof Tiles - Cement Product	
Identification:	Presumed to Contain Asbestos	
Approx. quantity:	80 m ²	
Accessibility	Difficult	<i>Assessment Score</i>
Product type:	Cement	1
Extent of Damage:	Minor damage	1
Surface Treatment:	Unsealed Cement	1
Asbestos type:	Chrysotile	1
Material Assessment Score:		4
Priority Assessment Score:		Negligible
Action:	Manage	
Comments:	No access to sample tiles due to height restrictions. Keys to building held by the Yeomanry (Room G14)

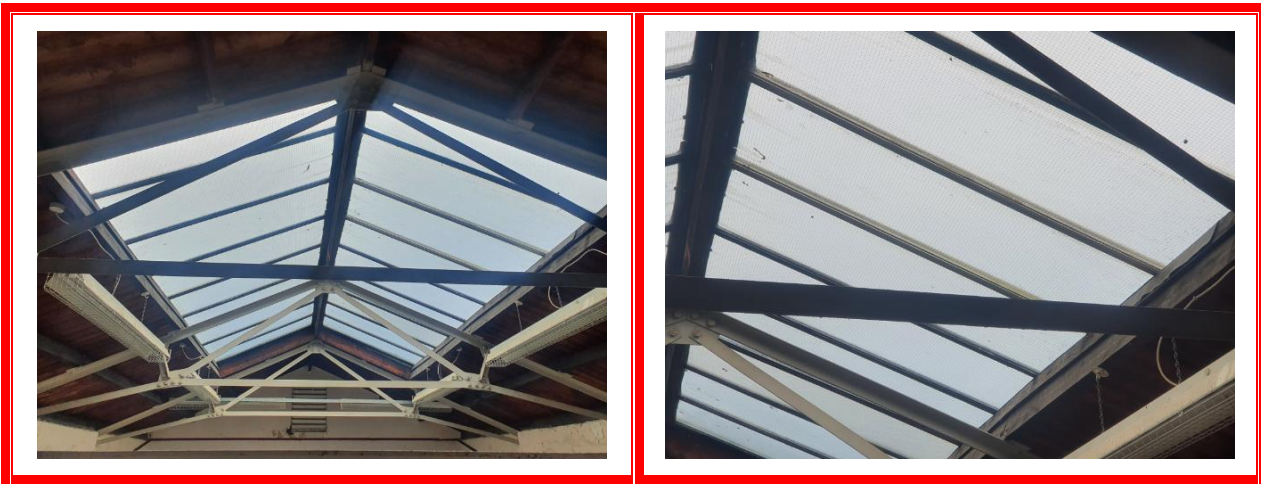
Material Description:	Rope Seals to Aluminium Skylights - Gaskets (rope/woven)	
Identification:	Presumed to Contain Asbestos	
Approx. quantity:	20 m ²	
Accessibility	Difficult	<i>Assessment Score</i>
Product type:	Rope	2
Extent of Damage:	Minor damage	1
Surface Treatment:	Woven	1
Asbestos type:	Chrysotile	1
Material Assessment Score:		5
Priority Assessment Score:		Negligible
Action:	Manage	
Comments:	No access to sample due to height restrictions
