Project Number 2481

**Management
Asbestos Survey Report**

**Thornbury Platoon, Gloucester Road,
Thornbury, BS35 1JH**

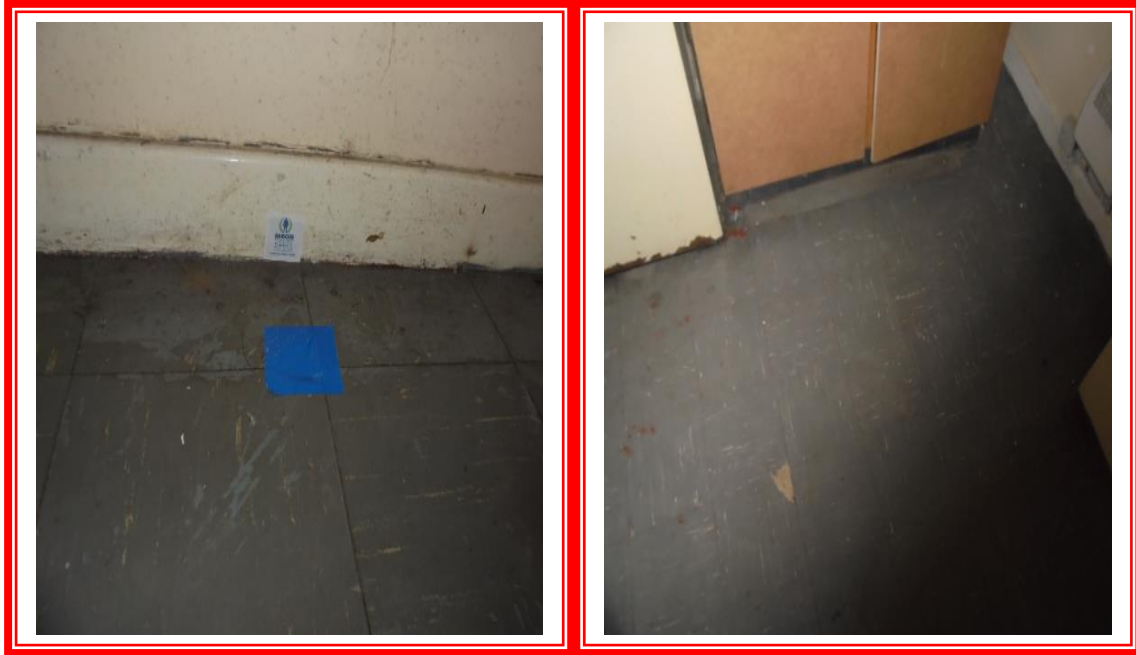
Item No: 3

Material Description:	Floor Tiles and Adhesive	
Identification:	Sampled – Asbestos Detected	
Approx. quantity:	6M2	
Accessibility	High	<i>Assessment Score</i>
Product type:	Composite	1
Extent of Damage:	Moderate	2
Surface Treatment:	Non-Friable	0
Asbestos type:	Chrysotile	1
Material Assessment Score:		4
Priority Assessment Score:		Negligible
Action:	Manage	
Comments:	N/A

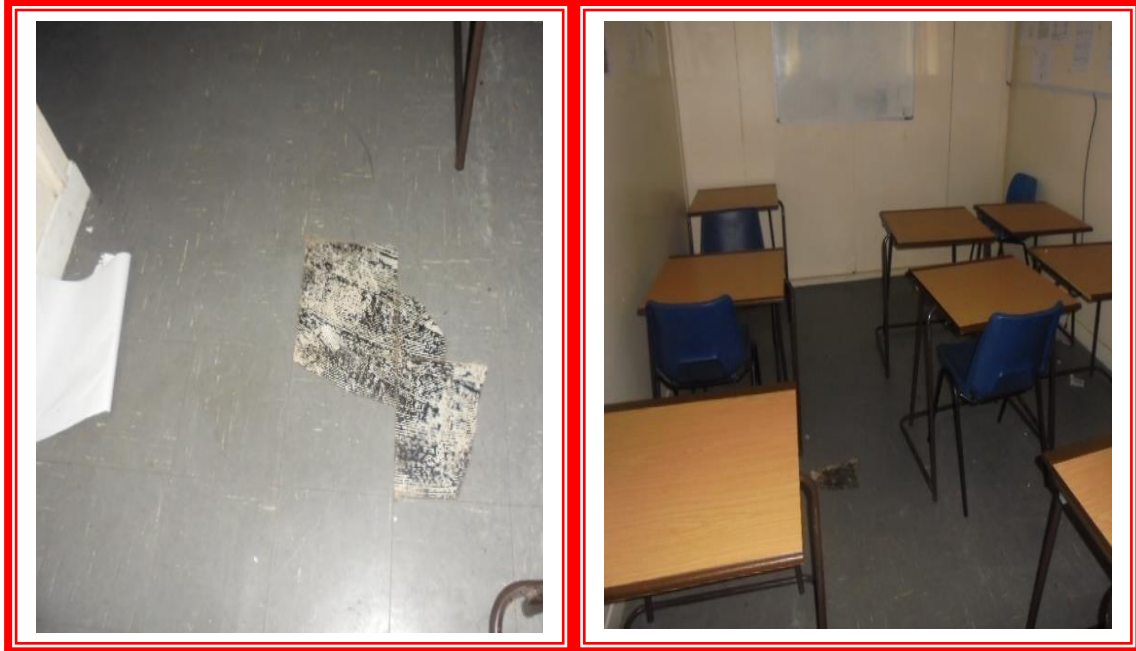
Item No: 4

Material Description:	Floor Tiles and Adhesive	
Identification:	As Per Sample DK/2 – Asbestos Detected	
Approx. quantity:	20M2	
Accessibility	High	<i>Assessment Score</i>
Product type:	Composite	1
Extent of Damage:	Moderate	2
Surface Treatment:	Non-Friable	0
Asbestos type:	Chrysotile	1
Material Assessment Score:		4
Priority Assessment Score:		Negligible
Action:	Manage	
Comments:	N/A

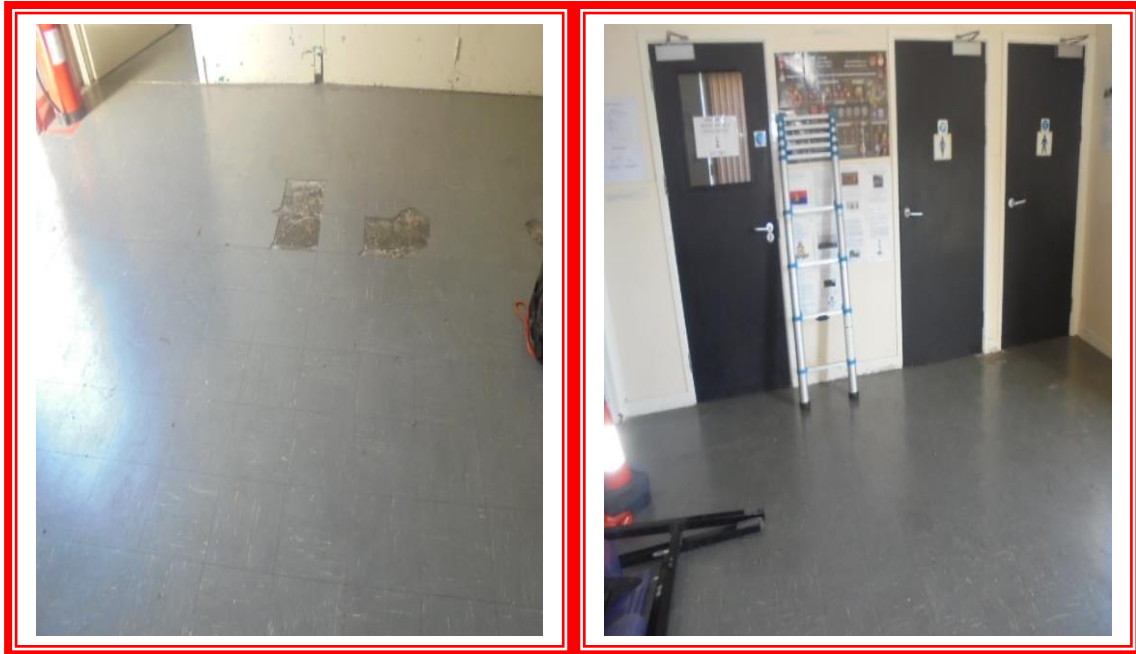
Item No: 5

Material Description:	Floor Tiles and Adhesive	
Identification:	As Per Sample DK/2 – Asbestos Detected	
Approx. quantity:	20M2	
Accessibility	High	<i>Assessment Score</i>
Product type:	Composite	1
Extent of Damage:	Moderate	2
Surface Treatment:	Non-Friable	0
Asbestos type:	Chrysotile	1
Material Assessment Score:		4
Priority Assessment Score:		Negligible
Action:	Manage	
Comments:	N/A

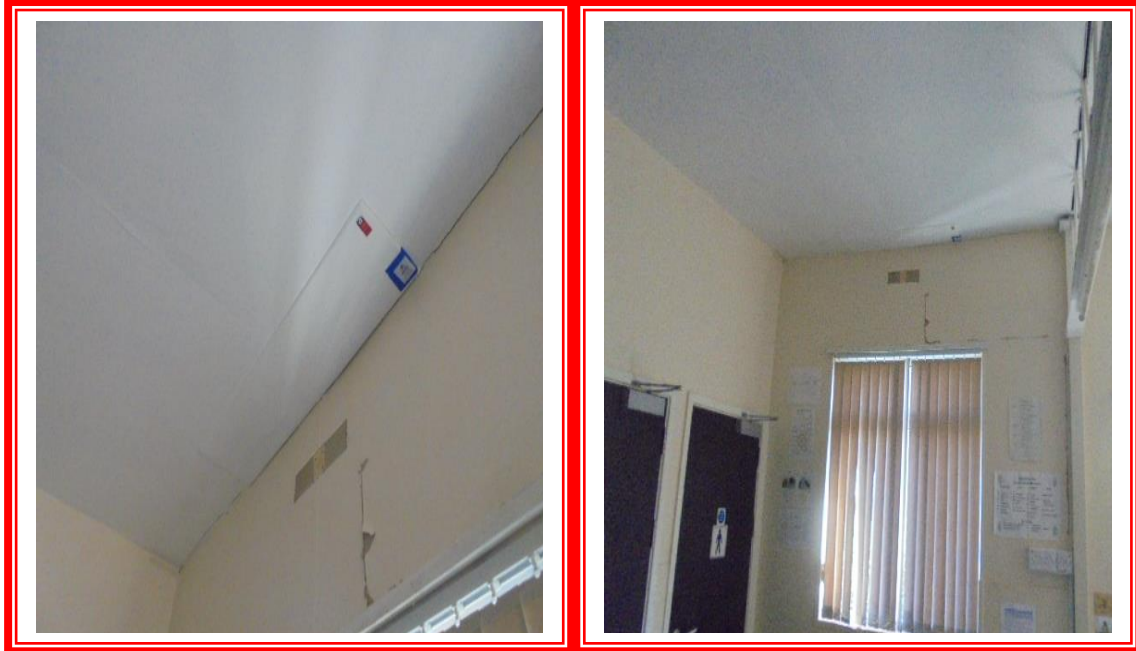
Item No: 6

Material Description:	Insulation Board Panel on Ceiling	
Identification:	Sampled – Asbestos Detected	
Approx. quantity:	1 x Panel (<1M2)	
Accessibility	Low	<i>Assessment Score</i>
Product type:	Insulation Board	2
Extent of Damage:	Minor	1
Surface Treatment:	Sealed	1
Asbestos type:	Amosite	2
Material Assessment Score:		6
Priority Assessment Score:		Low
Action:	Manage	
Comments:	N/A

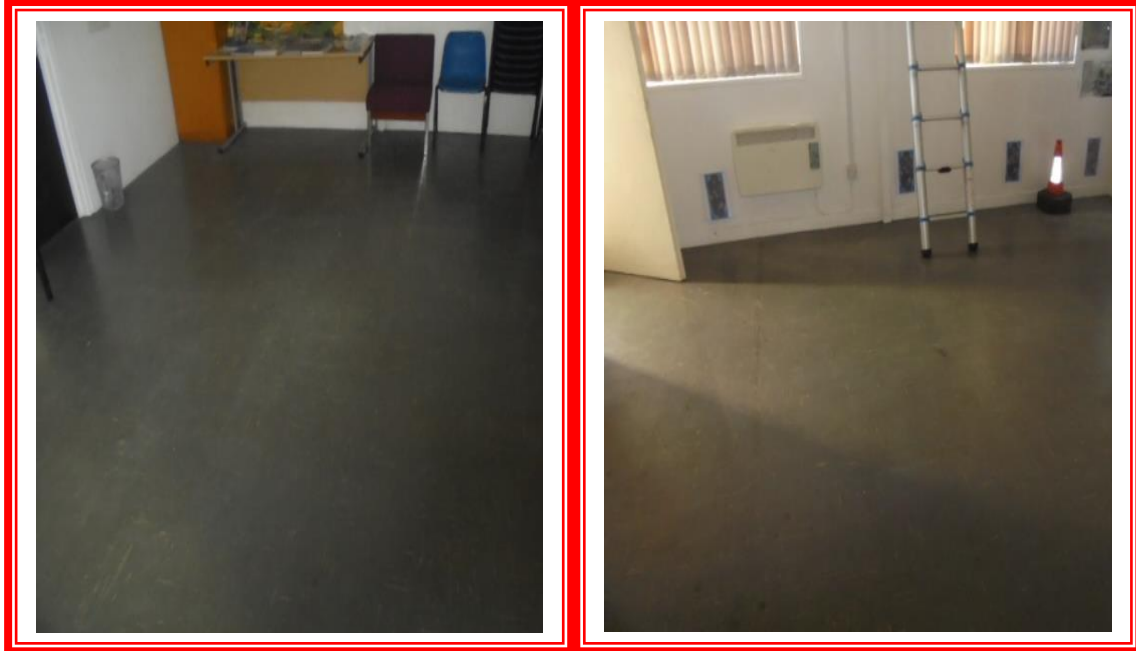
Item No: 7

Material Description:	Floor Tiles and Adhesive	
Identification:	As per Sample DK/2 – Asbestos Detected	
Approx. quantity:	30M2	
Accessibility	High	<i>Assessment Score</i>
Product type:	Composite	1
Extent of Damage:	Moderate	2
Surface Treatment:	Non-Friable	0
Asbestos type:	Chrysotile	1
Material Assessment Score:		4
Priority Assessment Score:		Negligible
Action:	Manage	
Comments:	N/A

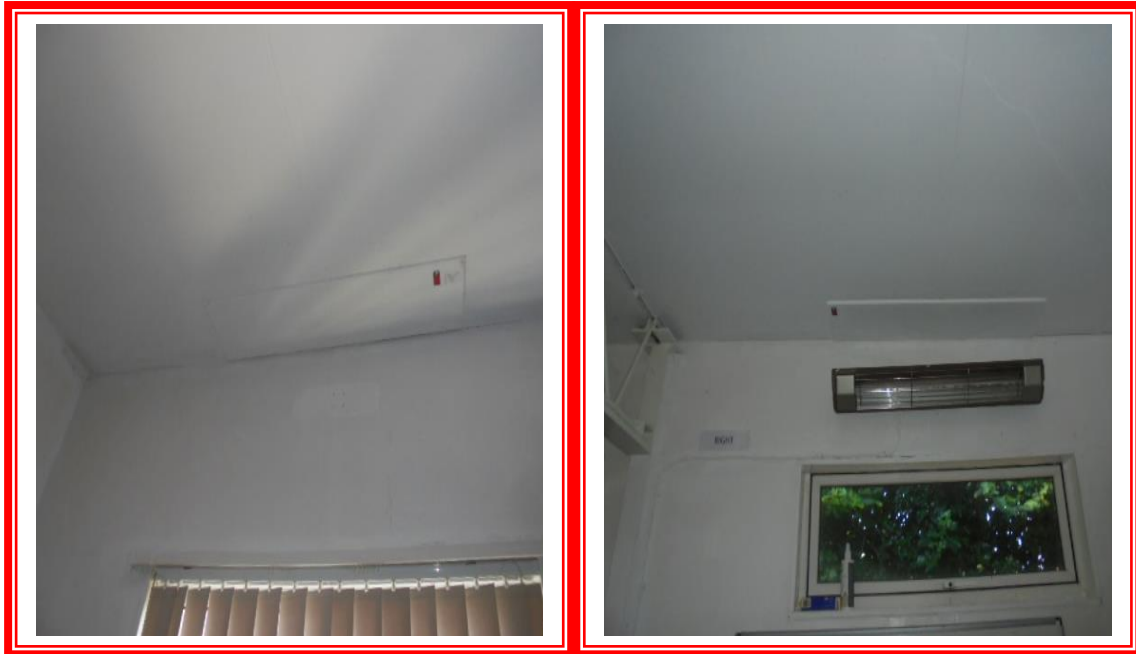
Item No: 8

Material Description:	Insulation Board Panels on Ceiling	
Identification:	As Per Sample DK/3 – Asbestos Detected	
Approx. quantity:	2 x Panels (1M2 Total)	
Accessibility	Low	<i>Assessment Score</i>
Product type:	Insulation Board	2
Extent of Damage:	Minor	1
Surface Treatment:	Sealed	1
Asbestos type:	Amosite	2
Material Assessment Score:		6
Priority Assessment Score:		Low
Action:	Manage	
Comments:	N/A

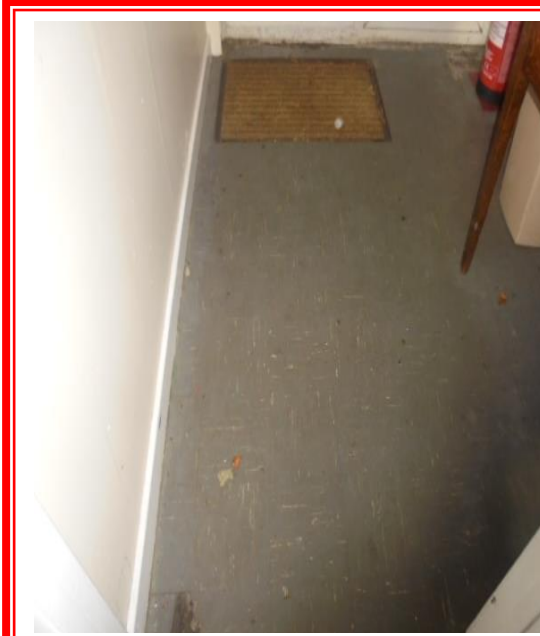
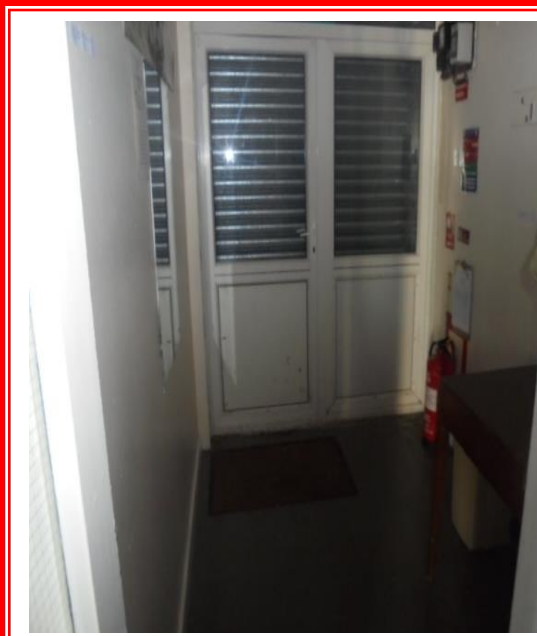
Item No: 9

Material Description:	Floor Tiles and Adhesive	
Identification:	As Per Sample DK/2 – Asbestos Detected	
Approx. quantity:	4M2	
Accessibility	High	<i>Assessment Score</i>
Product type:	Composite	1
Extent of Damage:	Moderate	2
Surface Treatment:	Non-Friable	0
Asbestos type:	Chrysotile	1
Material Assessment Score:		4
Priority Assessment Score:		Negligible
Action:	Manage	
Comments:	Modern electrics

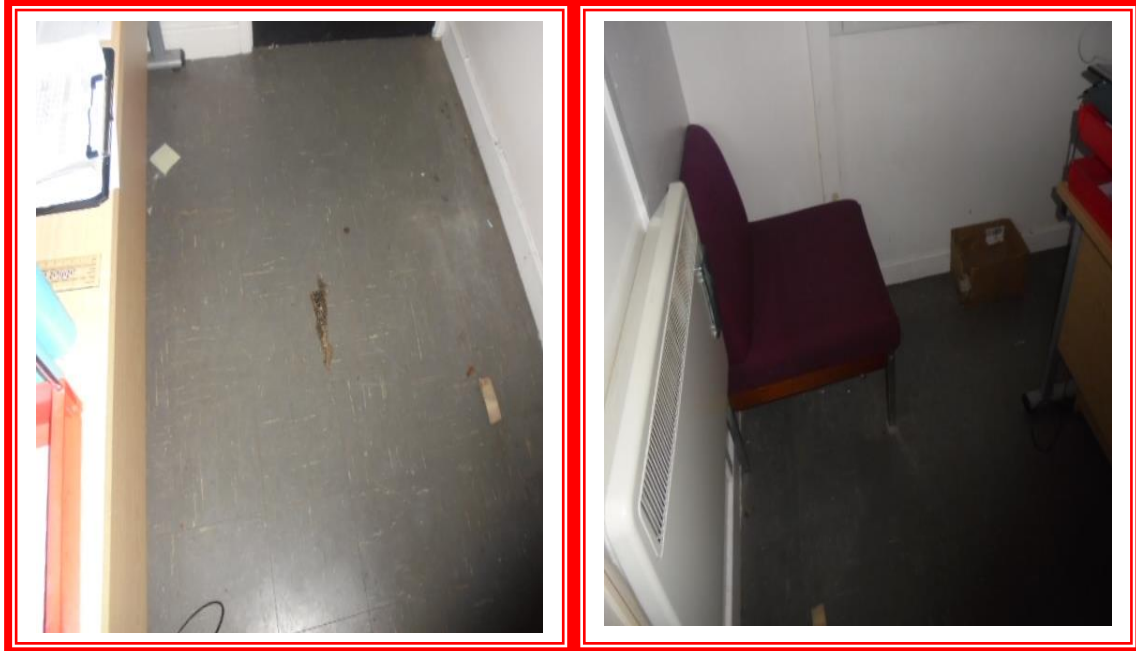
Item No: 10

Material Description:	Floor Tiles and Adhesive	
Identification:	As Per Sample DK/2 – Asbestos Detected	
Approx. quantity:	8M2	
Accessibility	High	<i>Assessment Score</i>
Product type:	Composite	1
Extent of Damage:	Moderate	2
Surface Treatment:	Non-Friable	0
Asbestos type:	Chrysotile	1
Material Assessment Score:		4
Priority Assessment Score:		Negligible
Action:	Manage	
Comments:	N/A

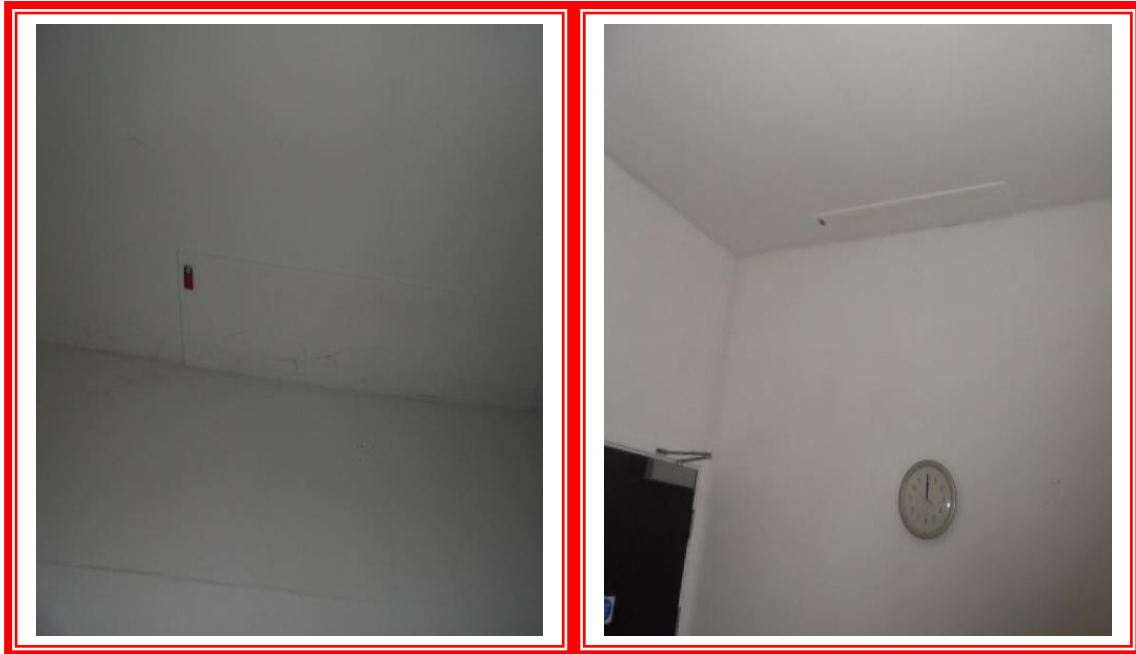
Item No: 11

Material Description:	Insulation Board Panel on Ceiling	
Identification:	As Per Sample DK/3 – Asbestos Detected	
Approx. quantity:	1 x Panels (<1M2)	
Accessibility	Low	<i>Assessment Score</i>
Product type:	Insulation Board	2
Extent of Damage:	Minor	1
Surface Treatment:	Sealed	1
Asbestos type:	Amosite	2
Material Assessment Score:		6
Priority Assessment Score:		Low
Action:	Manage	
Comments:	N/A

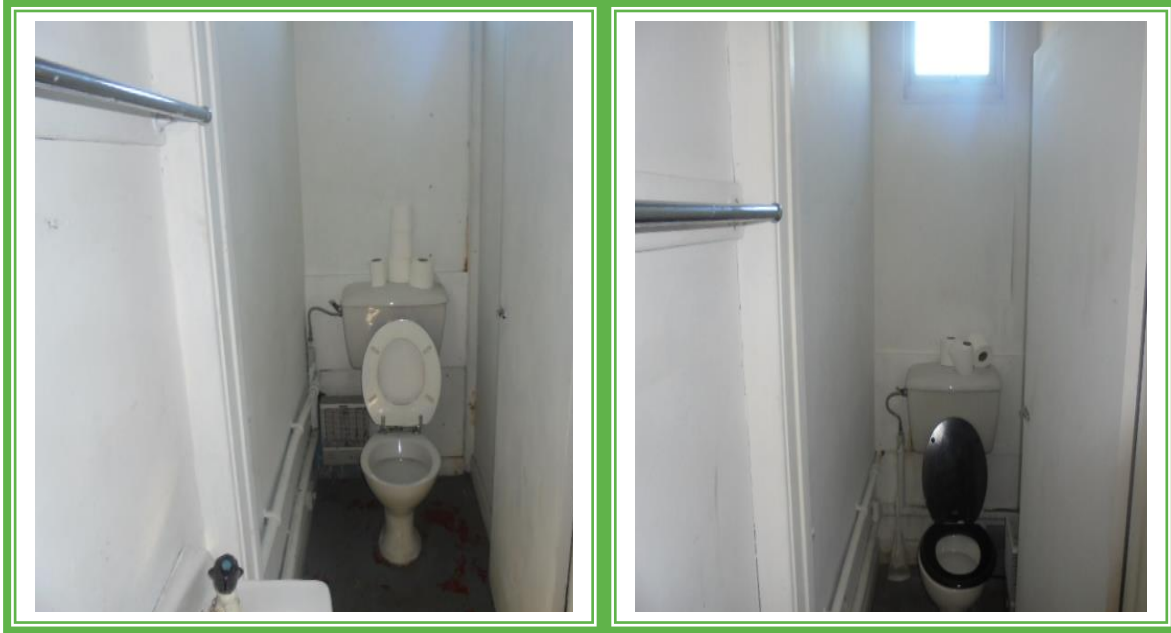
Item No: 1

Material Description:	Visual Inspection – No Suspect Materials Found	
Identification:	N/A	
Approx. quantity:	N/A	
Accessibility	N/A	<i>Assessment Score</i>
Product type:	N/A	
Extent of Damage:	N/A	
Surface Treatment:	N/A	
Asbestos type:	N/A	
Material Assessment Score:		N/A
Priority Assessment Score:		N/A
Action:	N/A	
Comments:	N/A

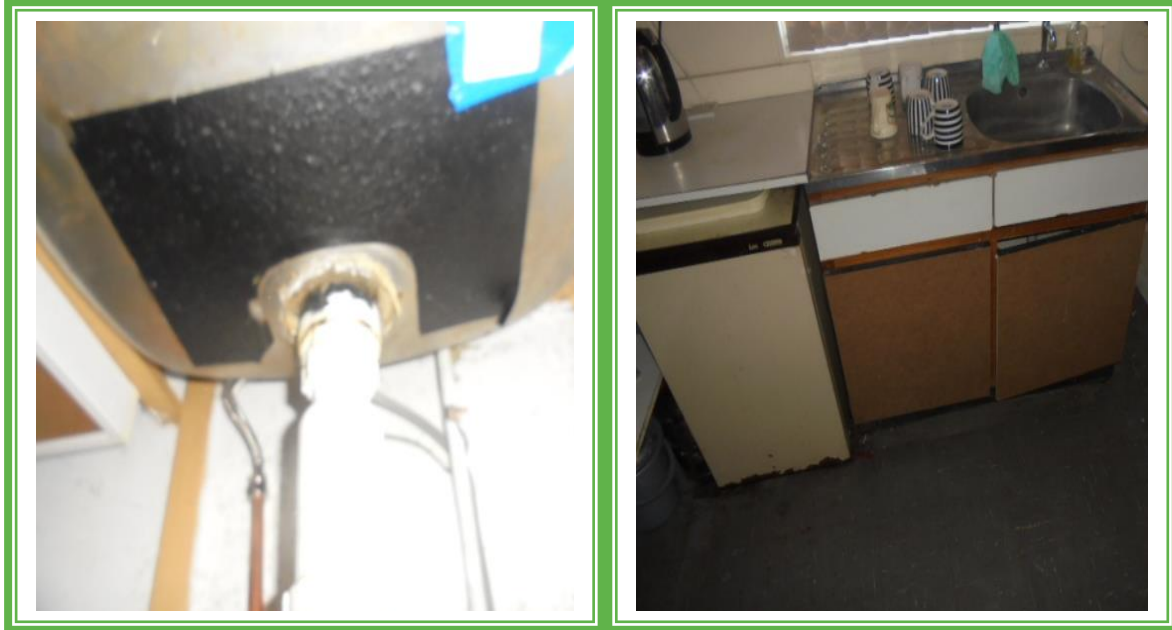
Item No: 2

Material Description:	Sink Pad	
Identification:	Sampled – No Asbestos Detected	
Approx. quantity:	1 x Sink	
Accessibility	N/A	<i>Assessment Score</i>
Product type:		N/A
Extent of Damage:		N/A
Surface Treatment:		N/A
Asbestos type:		N/A
Material Assessment Score:		N/A
Priority Assessment Score:		N/A
Action:	N/A	
Comments:	N/A

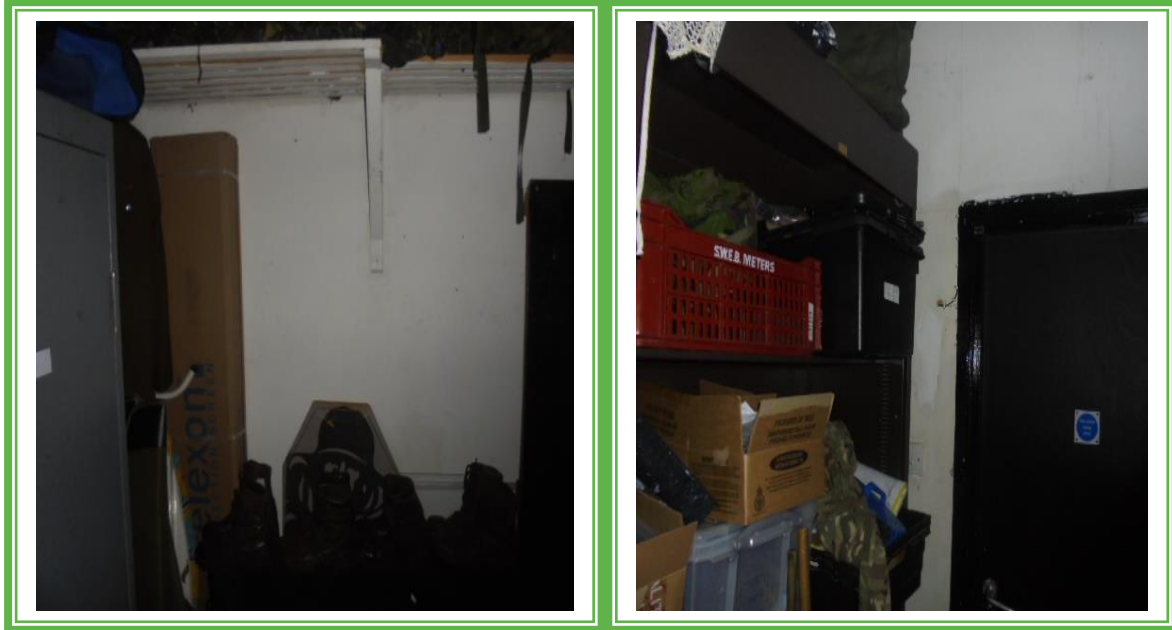
Item No: 12

Material Description:	Visual Inspection – No Suspect Materials Found	
Identification:	N/A	
Approx. quantity:	N/A	
Accessibility	N/A	<i>Assessment Score</i>
Product type:	N/A	
Extent of Damage:	N/A	
Surface Treatment:	N/A	
Asbestos type:	N/A	
Material Assessment Score:		N/A
Priority Assessment Score:		N/A
Action:	N/A	
Comments:	N/A
