Project Number 2481

**Management
Asbestos Survey Report**

**Wyvern Barracks, Barrack Road, Exeter, Devon,
EX2 6AE (Building 10)**

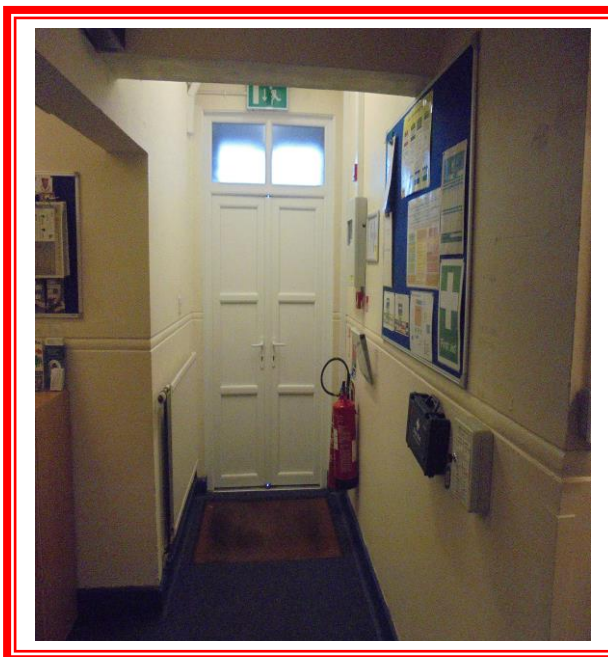
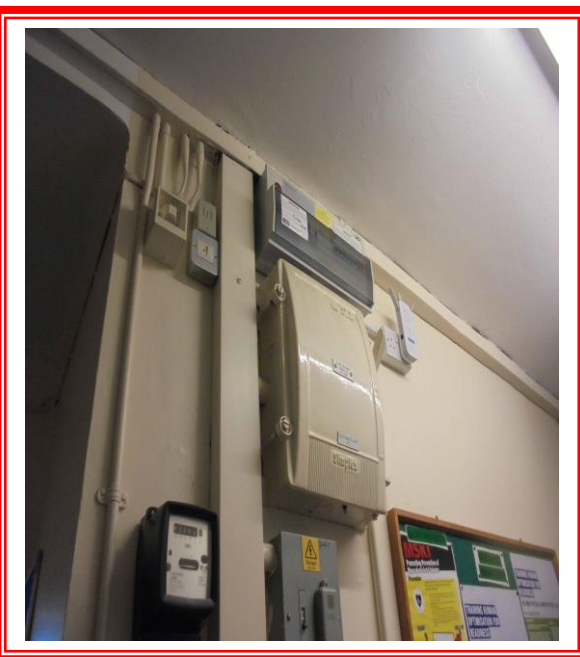
Item No: 5

Item 5 – Corridor – Electrical Box – No access to sample as live

| Material Description: | No access within electrical box | |
| Identification: | Presumed to Contain Asbestos | |
| Accessibility | Low | <i>Assessment Score</i> |
| Material Assessment Score: | | 8 |
| Priority Assessment Score: | | Medium |
| Comments: | No access as live | |

The presence of asbestos in these areas cannot be ascertained at this time. If any works are to be carried out in these areas in the future, then these works should be approached cautiously.

| Action: | Manage | |

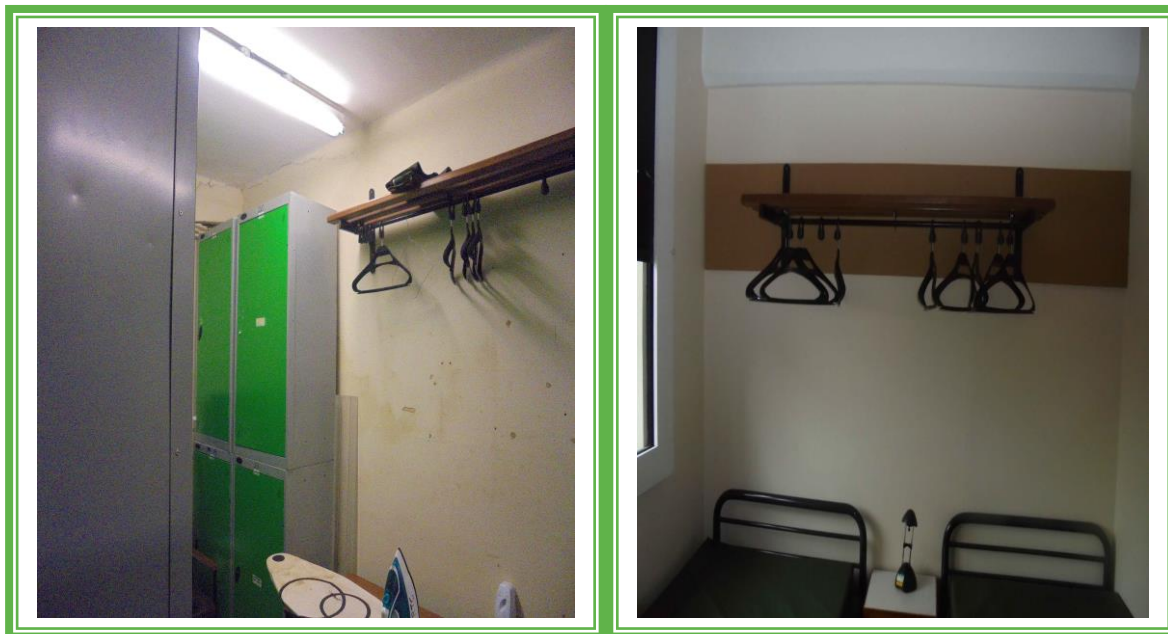
Item No: 1

| Material Description: | Visual Inspection – No Suspect Materials Found | |

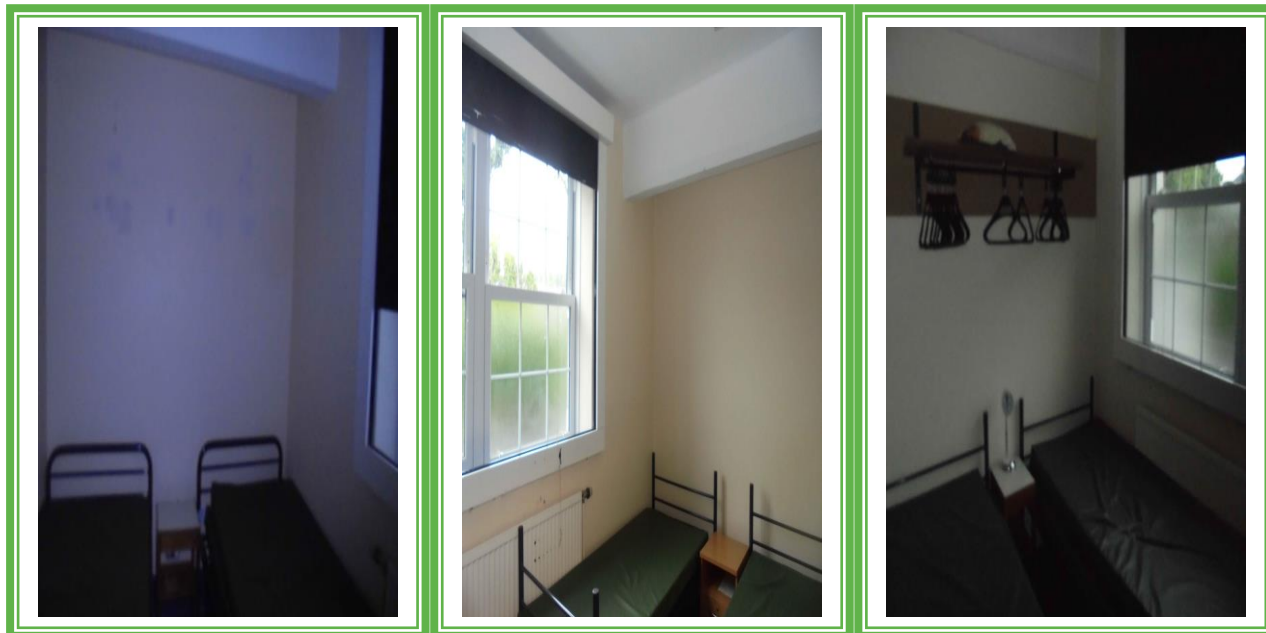
Item No: 2

| Material Description: | Visual Inspection – No Suspect Materials Found | |

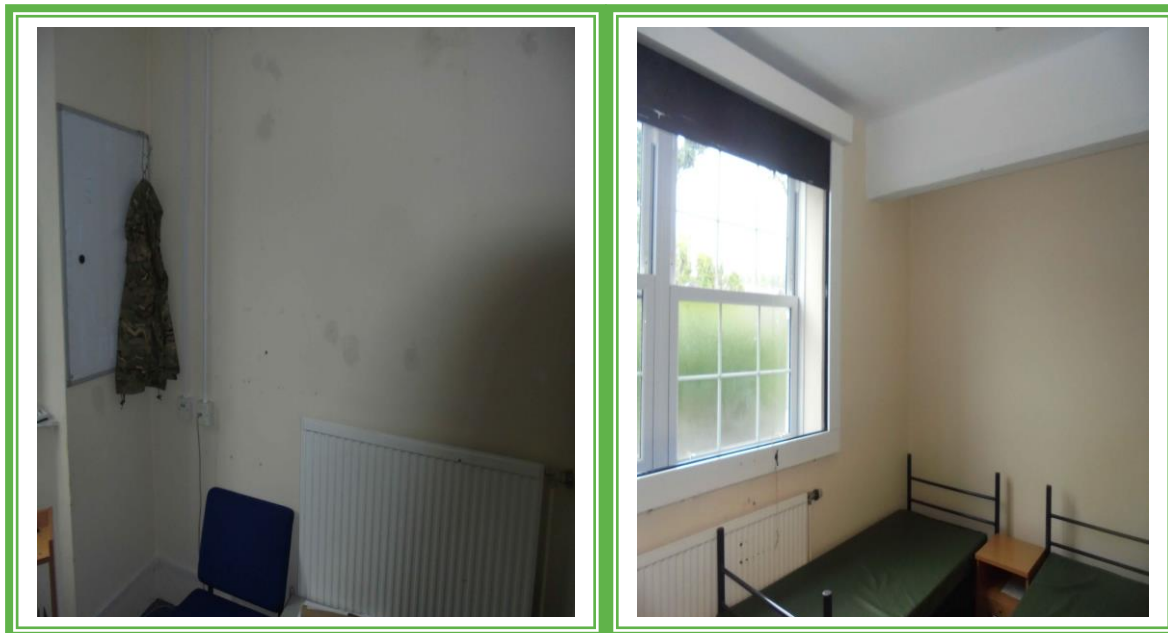
Item No: 3

| Material Description: | Visual Inspection – No Suspect Materials Found | |

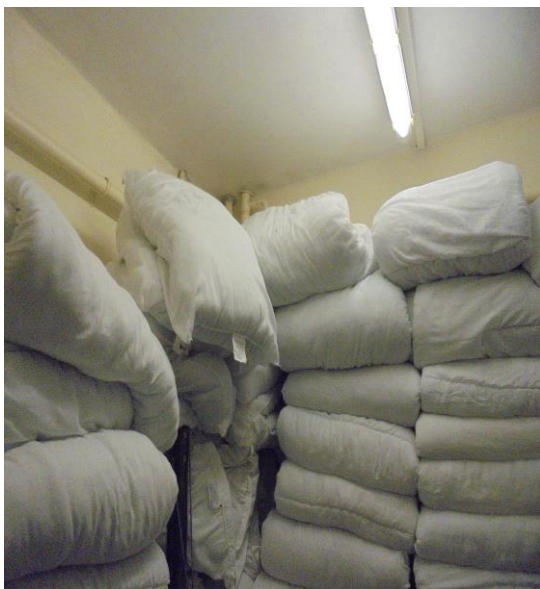
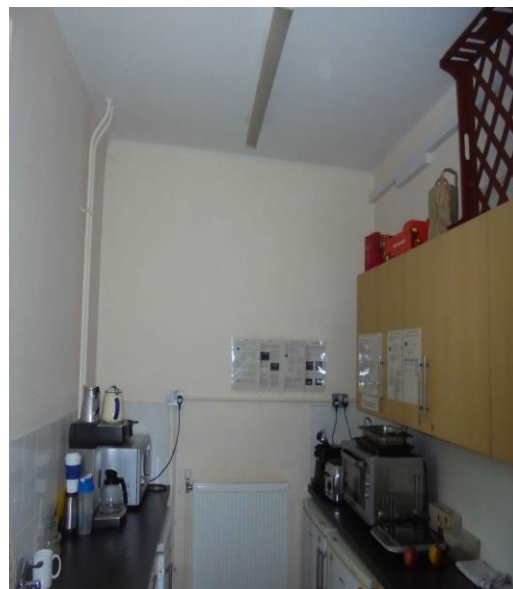
**Item No: 4****Sample No: N/A****Location: Kitchen and Store – Ground Floor**

| Material Description: | Visual Inspection – No Suspect Materials Found | |
| Comments: | Modern sink pad. Limited access into store due to stored items | |

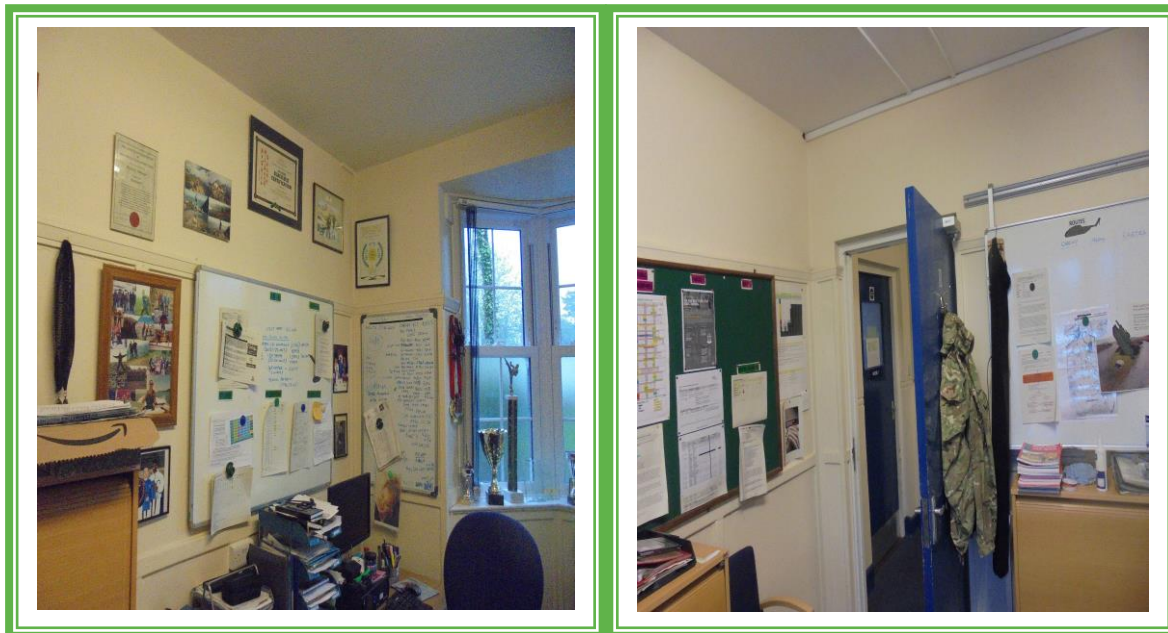
Item No: 6

| Material Description: | Visual Inspection – No Suspect Materials Found | |
| Comments: | Non-asbestos fiberboard wall panels | |

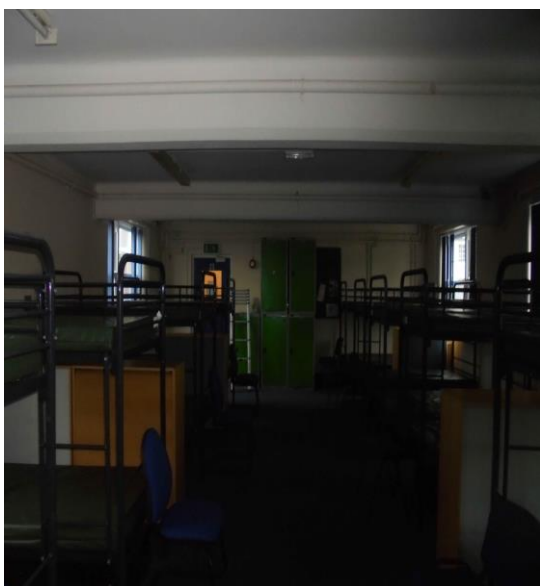
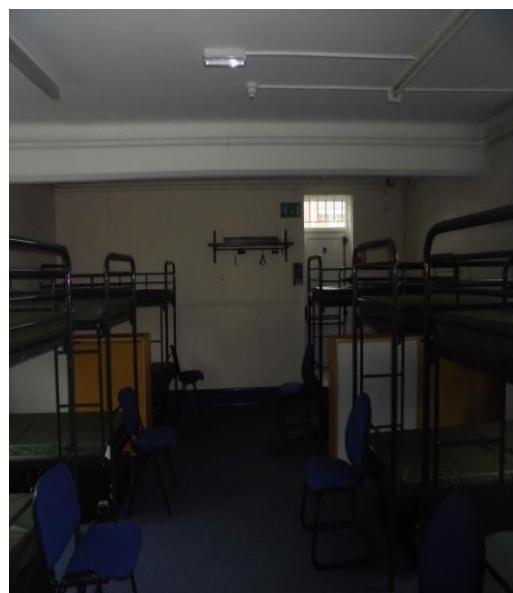
**Item No: 7****Sample No: N/A****Location: Bedroom 7 – Ground Floor**

| Material Description: | Visual Inspection – No Suspect Materials Found | |

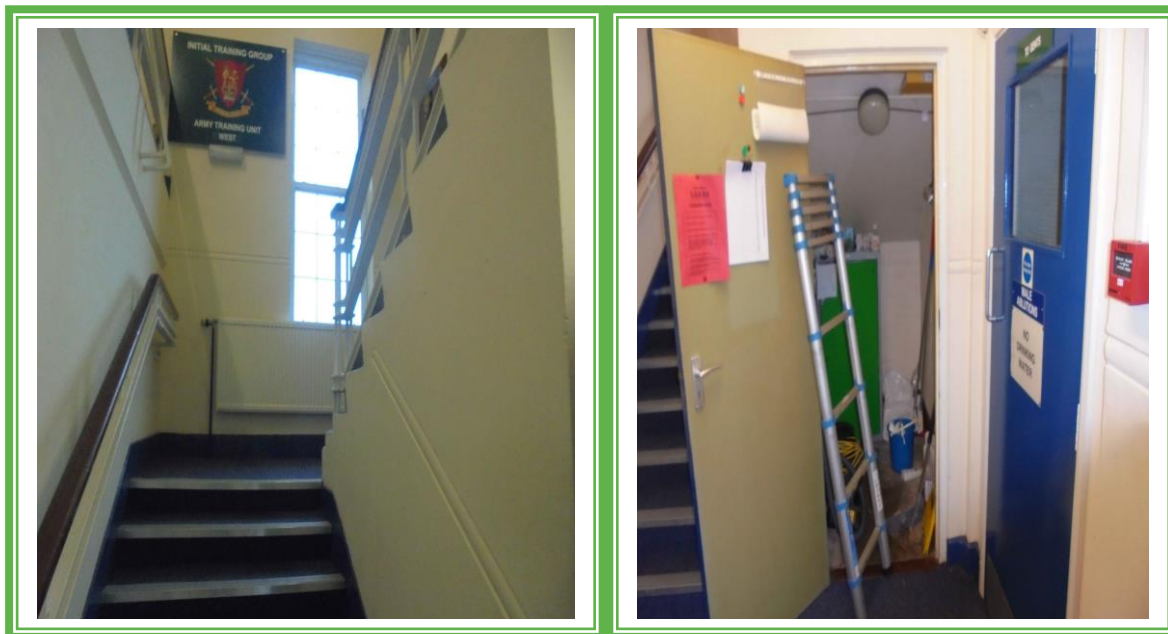
**Item No: 8****Sample No: N/A****Location: Lobby, Cupboard and Stairwell – Ground Floor**

| Material Description: | Visual Inspection – No Suspect Materials Found | |
| Comments: | Plasterboard infill panels to sides of blue door | |

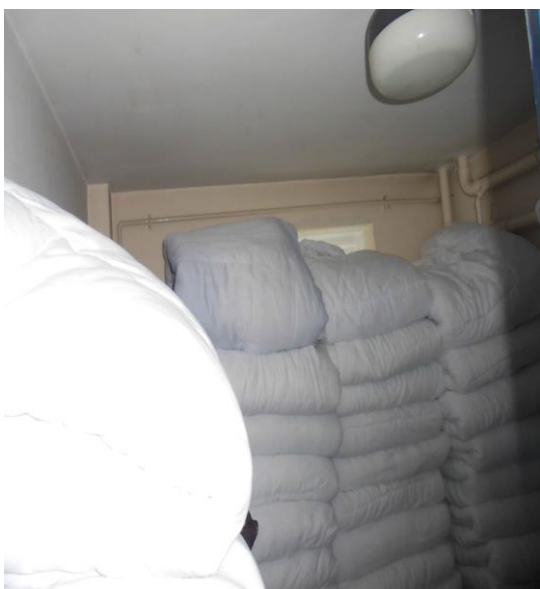
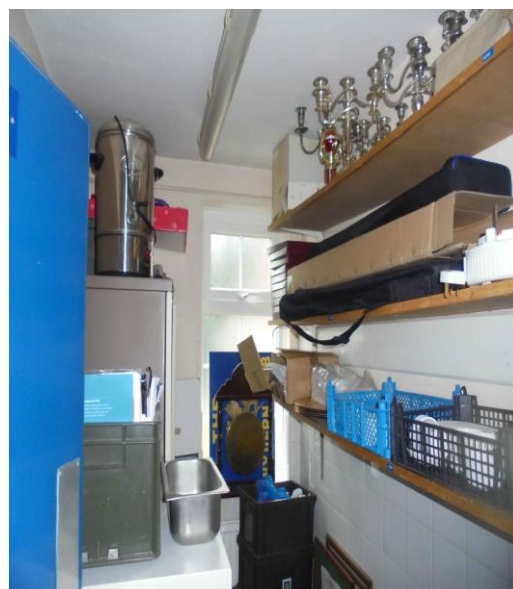
Item No: 9

| Material Description: | Visual Inspection – No Suspect Materials Found | |
| Comments: | Limited access into cupboards due to stored items | |

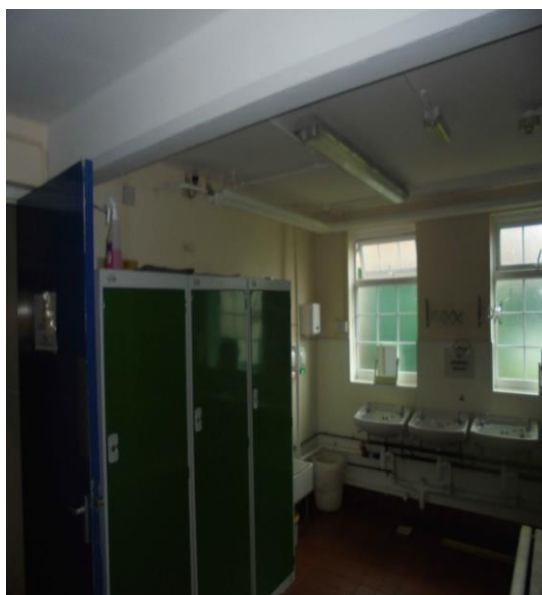
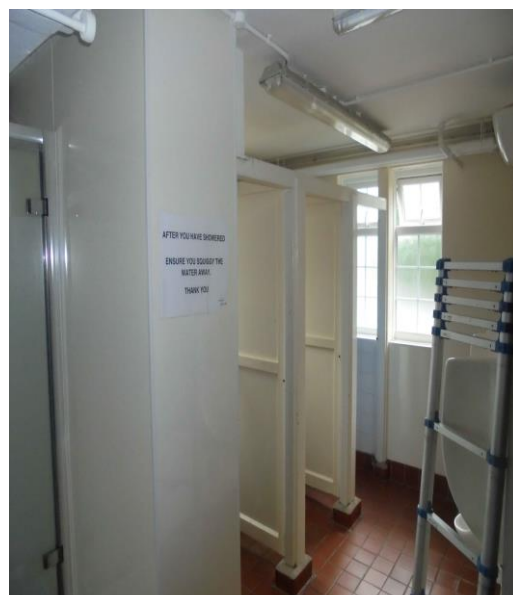
**Item No: 10****Sample No: N/A****Location: Men's WC and Shower Area – First Floor**

| Material Description: | Visual Inspection – No Suspect Materials Found | |
| Comments: | Metal panels in between toilets | |

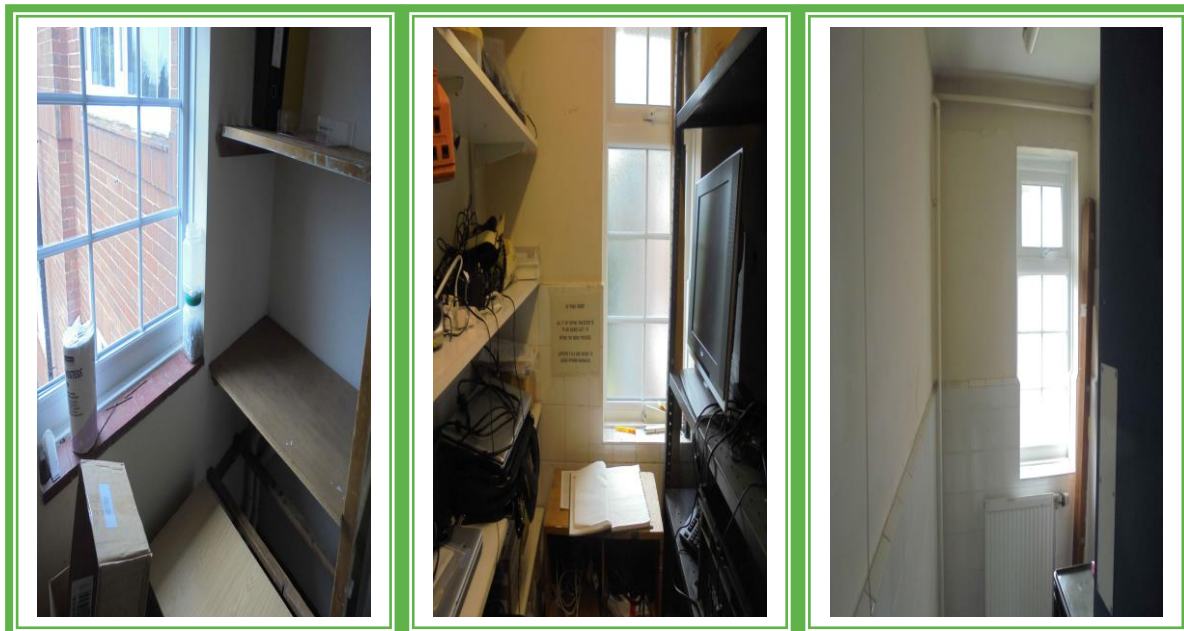
**Item No: 11****Sample No: N/A****Location: Cupboards x 3 – First Floor**

| Material Description: | Visual Inspection – No Suspect Materials Found | |

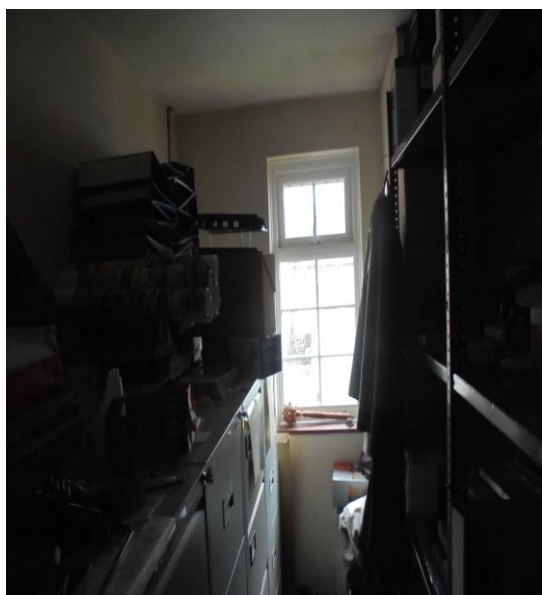
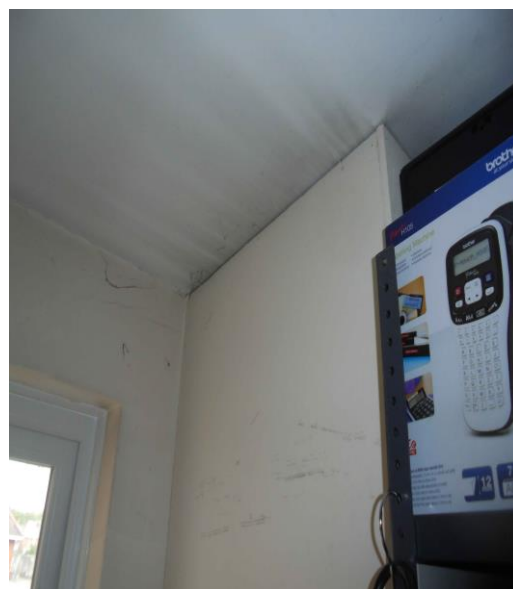
**Item No: 12****Sample No: 1****Location: Store Cupboard – First Floor**

| Sample Number | Sample Type | Location | Analysis |
|---|---|---|---|
| 1 | Insulation Board Boxing | Store Cupboard - First Floor | N.A.D.I.S |

| Material Description: | Insulation Board boxing | |
| Identification: | Sampled – No Asbestos Detected | |
| Approx. quantity: | 3M2 | |

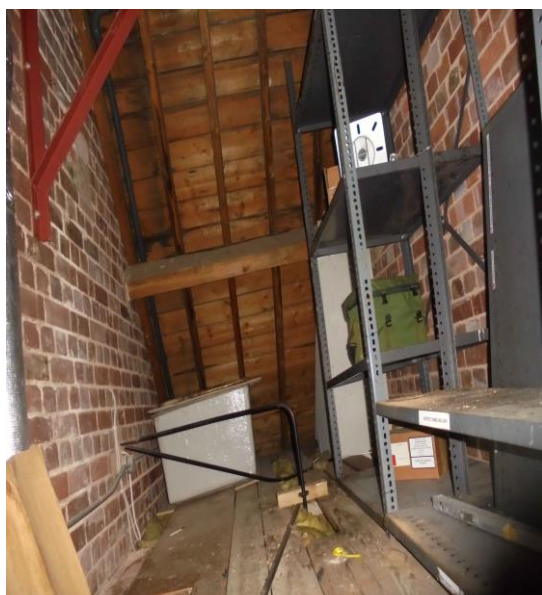
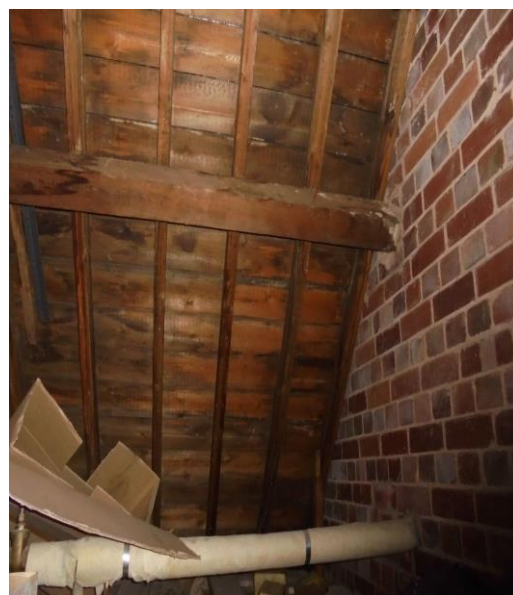
Item No: 13

| Material Description: | Visual Inspection – No Suspect Materials Found | |

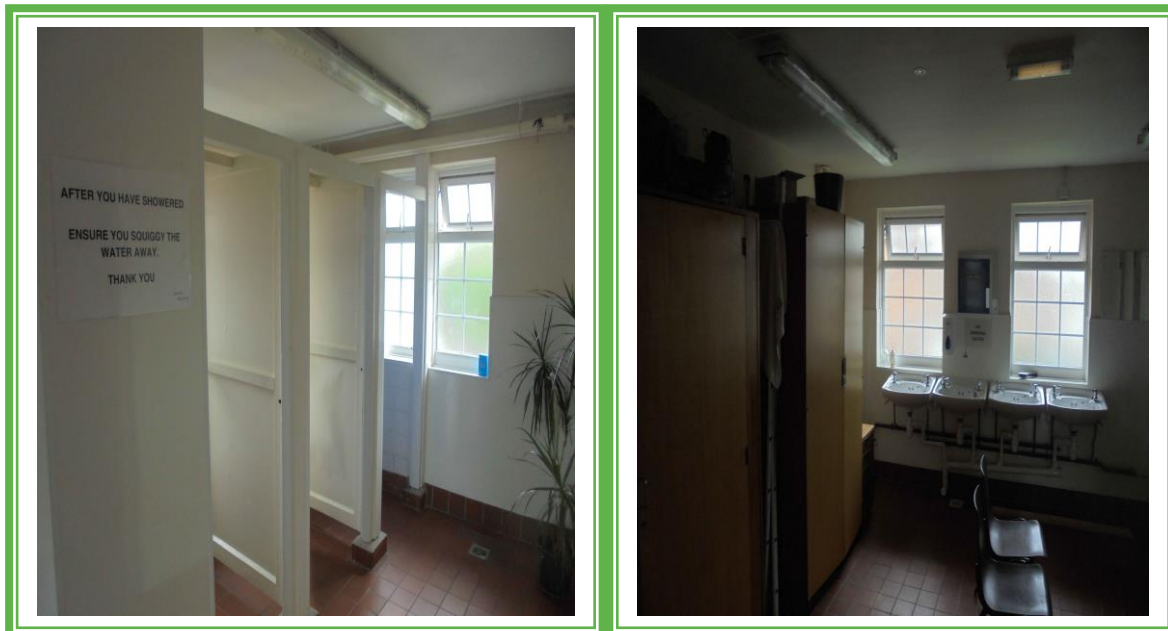
**Item No: 14****Sample No: N/A****Location: Ladies WC, Shower Area – First Floor**

| Material Description: | Visual Inspection – No Suspect Materials Found | |
| Comments: | Metal panels between toilets | |

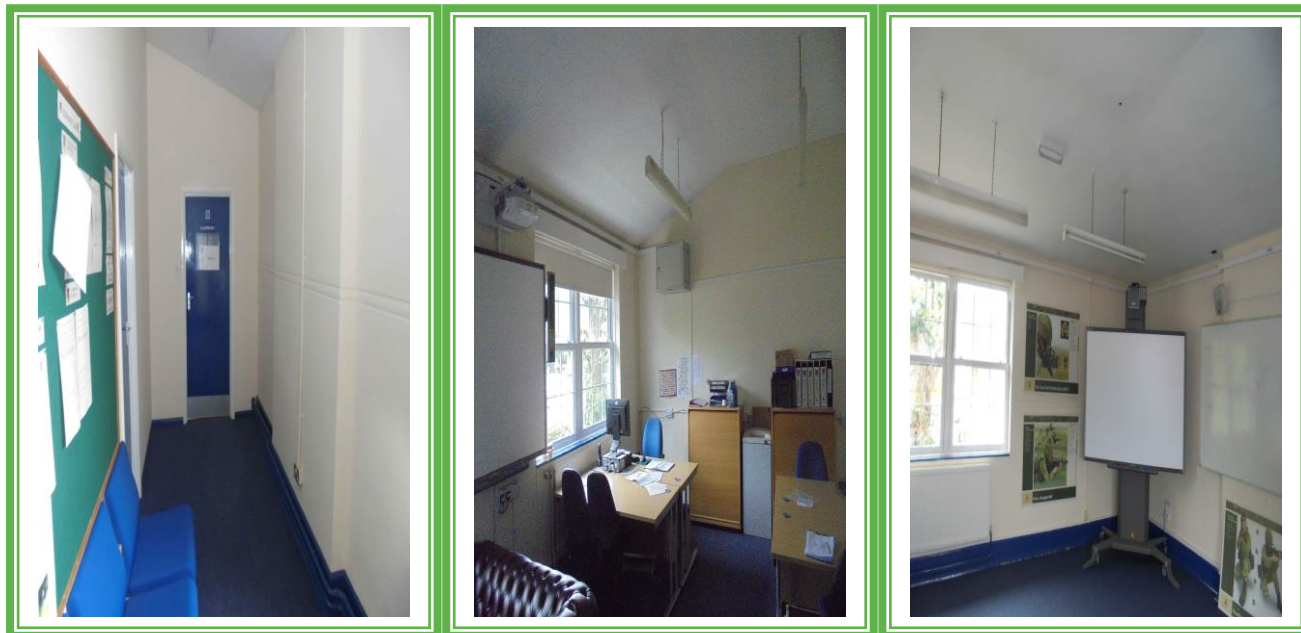
Item No: 15

| Material Description: | Visual Inspection – No Suspect Materials Found | |
| Comments: | No access within high level loft space due to height | |

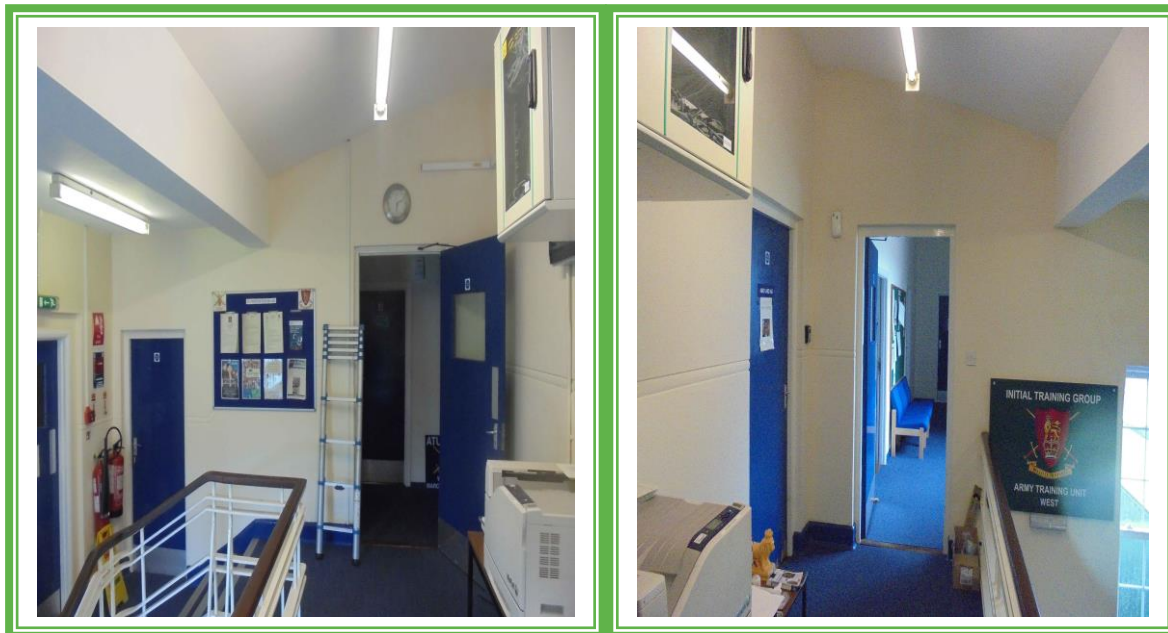
Item No: 16

| Material Description: | Visual Inspection – No Suspect Materials Found | |
| Comments: | No access within high level loft space due to height | |

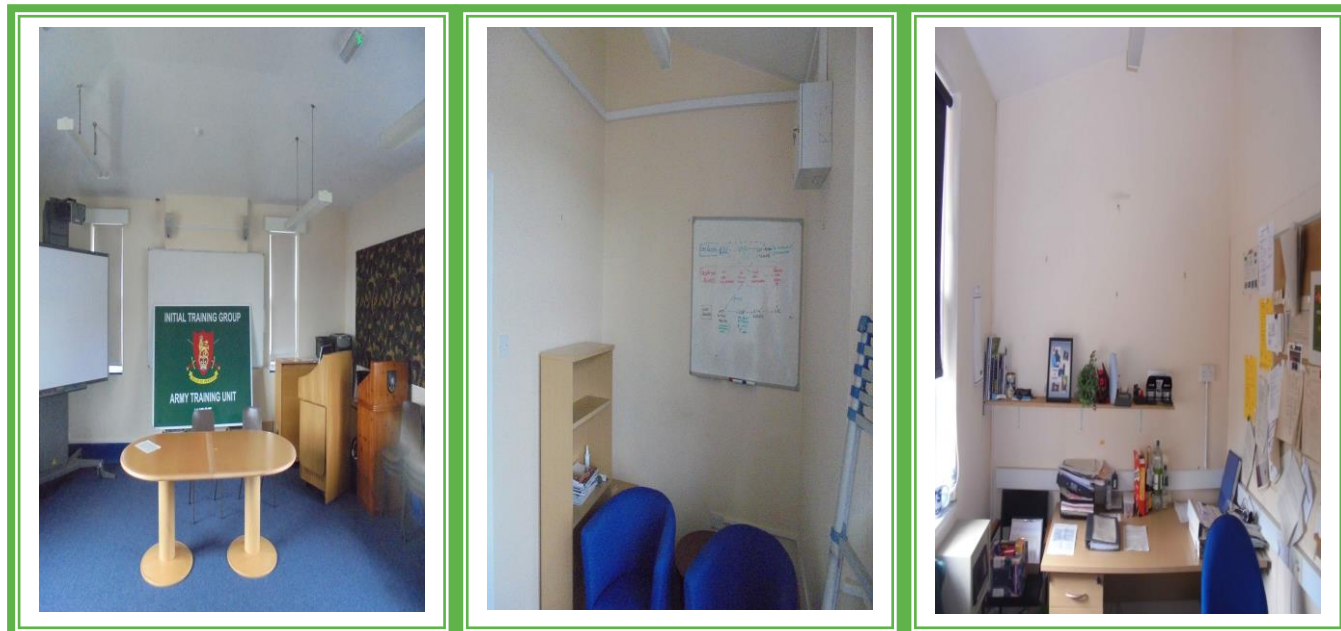
Item No: 17

| Material Description: | Visual Inspection – No Suspect Materials Found | |

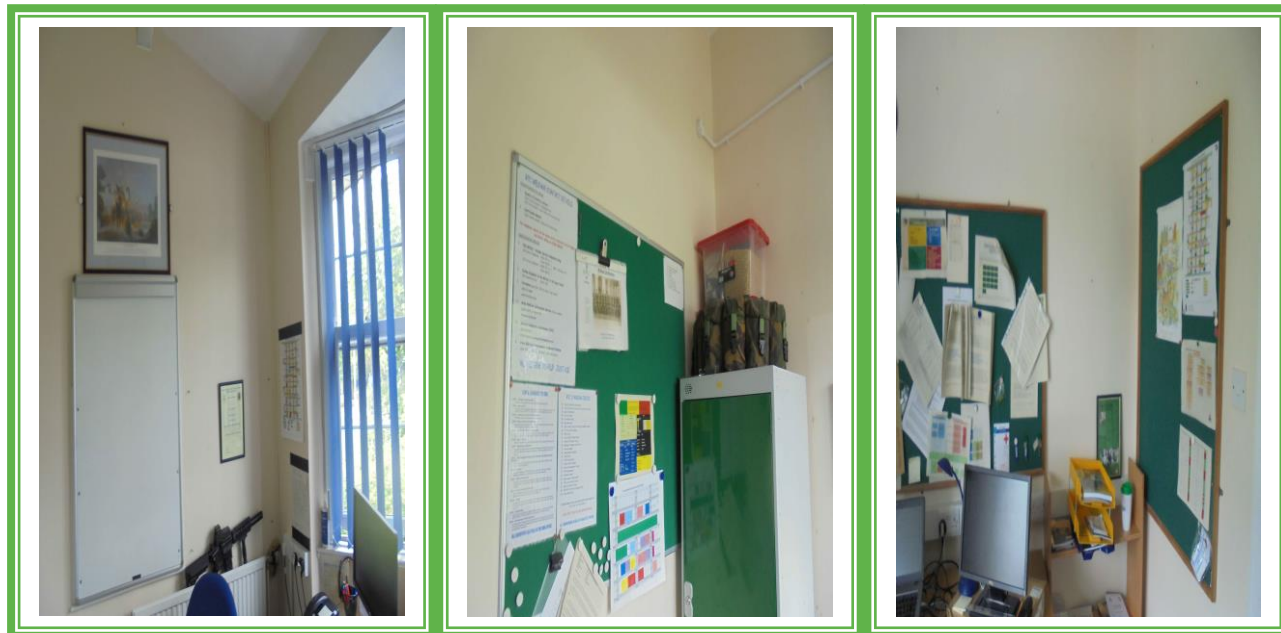
Item No: 18

| Material Description: | Visual Inspection – No Suspect Materials Found | |

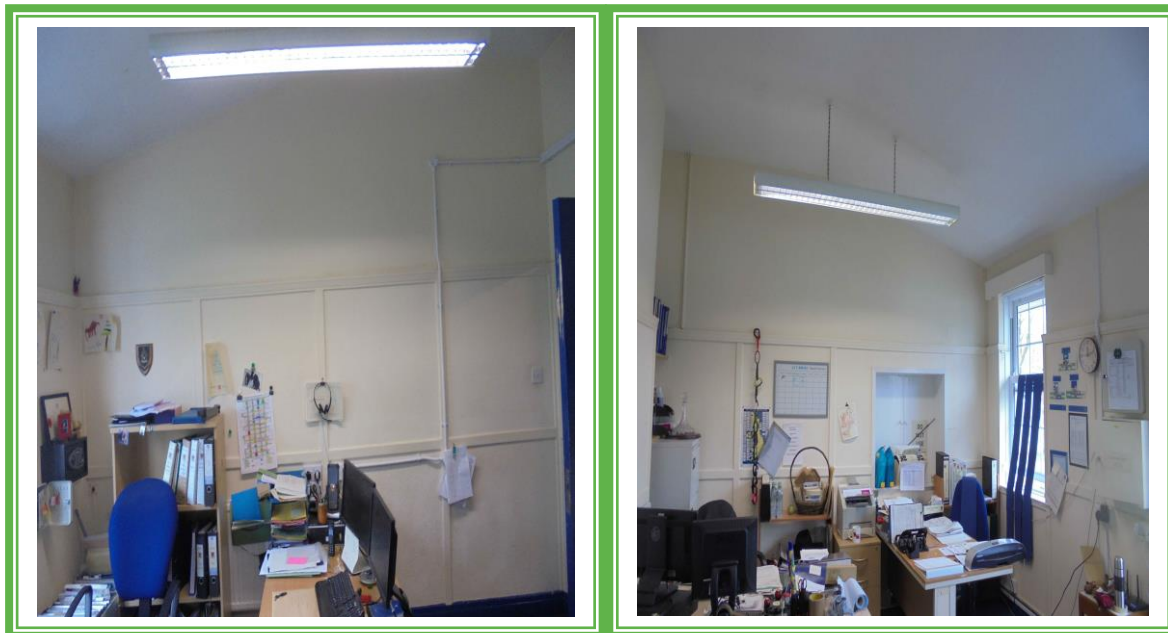
Item No: 19

| Material Description: | Visual Inspection – No Suspect Materials Found | |
| Comments: | Non-asbestos fiberboard wall panels | |

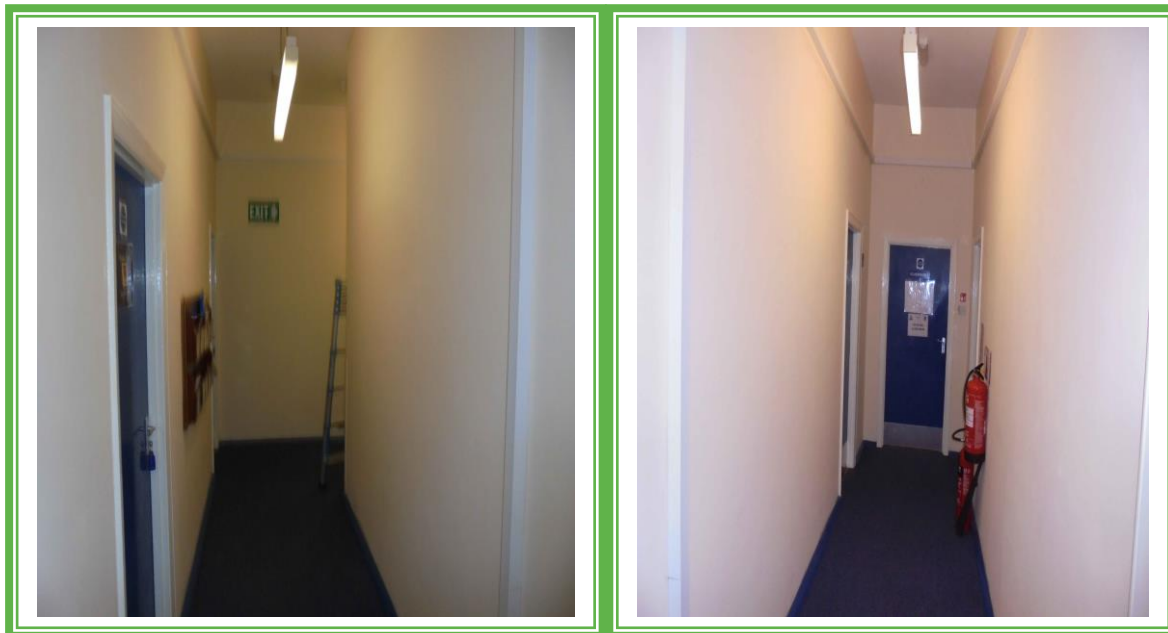
Item No: 20

| Material Description: | Visual Inspection – No Suspect Materials Found | |

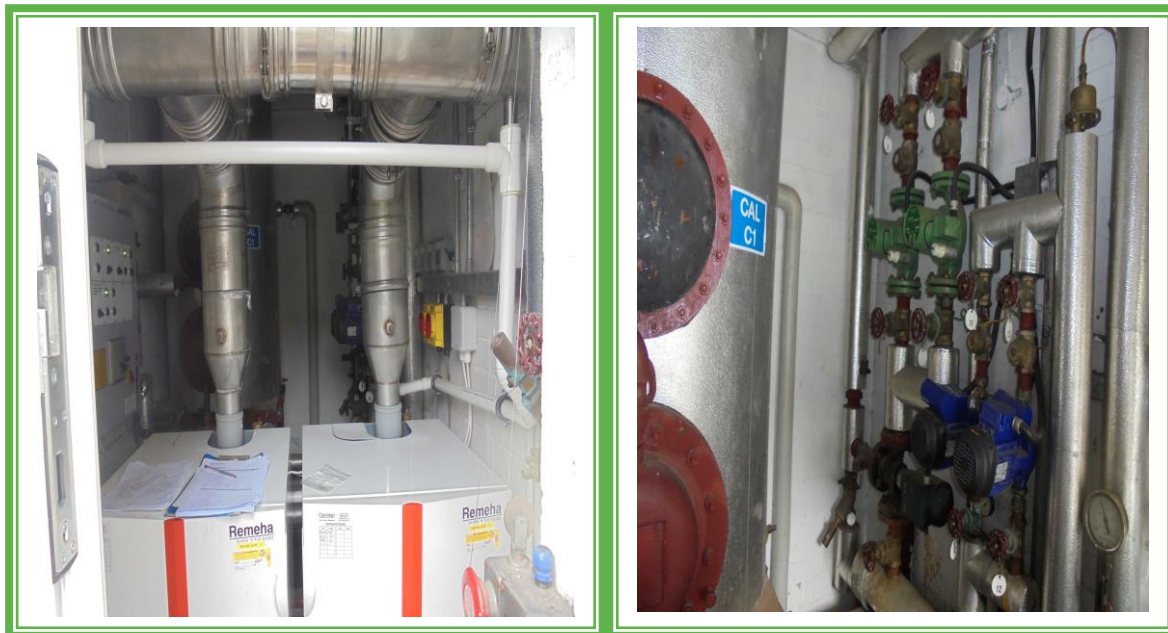
**Item No: 21****Sample No: 2****Location: Boiler Room – Ground Floor**

| Sample Number | Sample Type | Location | Analysis |
|---|---|---|---|
| 2 | Gaskets | Boiler Room | N.A.D.I.S |

| Material Description: | Gaskets | |
| Identification: | Sampled – No Asbestos Detected | |
| Approx. quantity: | X 8 | |
| Comments: | Modern Remeha boilers and Electrics | |

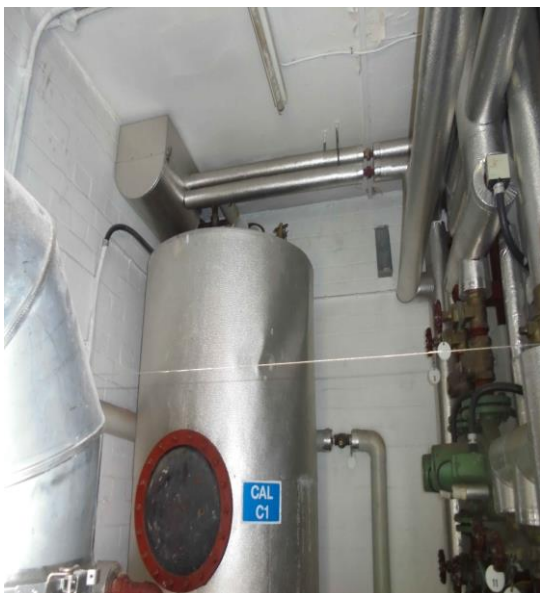
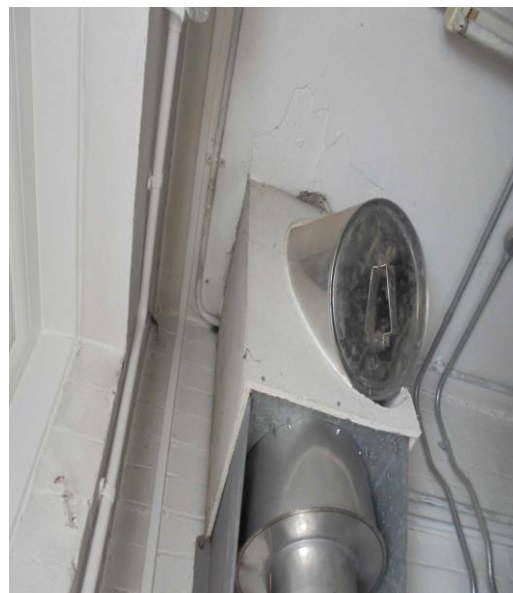
Item No: 22

| Material Description: | Insulation board boxing | |
| Identification: | As Sample 1 – No Asbestos Detected | |
| Approx. quantity: | 2M2 | |

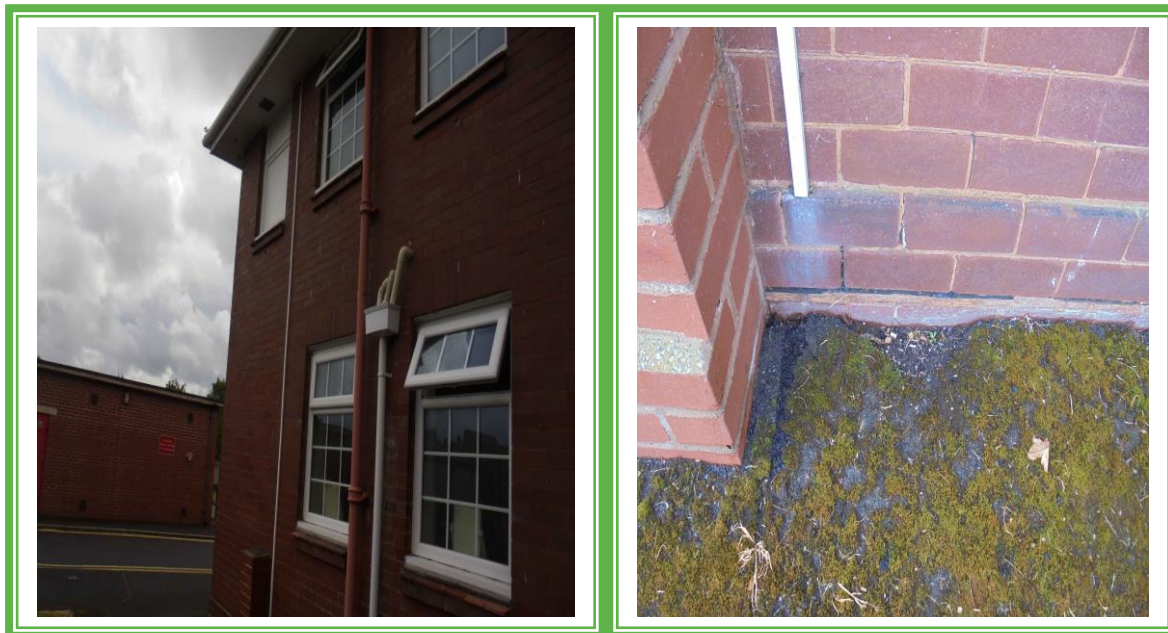
Item No: 23

| Sample Number | Sample Type | Location | Analysis |
|---|---|---|---|
| 3 | Damp Proof Course | External | N.A.D.I.S |

| Material Description: | Damp proof course | |
| Identification: | Sampled – No Asbestos Detected | |
| Approx. quantity: | To entire perimeter of the building | |
