Project Number A-00525 (3700)

**Re-Inspection
Asbestos Survey Report**

**39 Skinners
Horfield Common
Bristol
BS7 0XL**

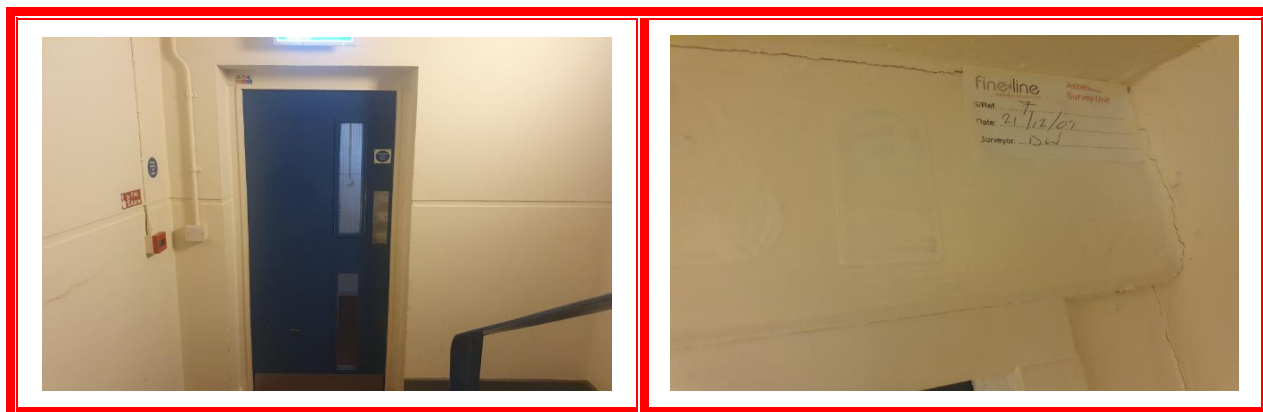
Item No:	3	Sample No:	N/A
Location:	First Floor - Door next to Range 003

Material Description:	Door Panel - Insulating Board	
Identification:	Previously Sampled - Asbestos Detected	
Approx. quantity:	1 LM	
Accessibility	Easy	Assessment Score
Product type:	Asbestos Insulating Board	2
Extent of Damage:	Good	0
Surface Treatment:	Encapsulated AIB	1
Asbestos type:	Amosite, Chrysotile	2
Material Assessment Score:		5
Priority Assessment Score:		Low
Action:	Manage	
Comments:	N/A

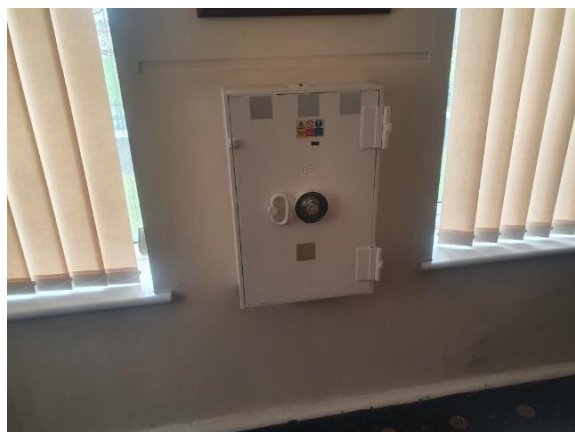
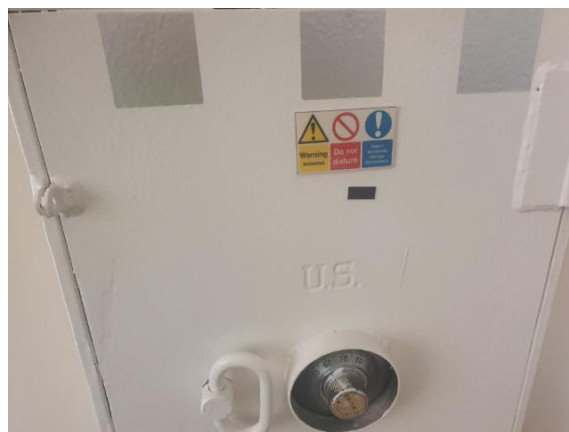
Location: First Floor - Co's Office 004

Material Description:	Safe - No Access Gained	
Identification:	Strongly Presumed to Contain Asbestos	
Approx. quantity:	1 no	
Accessibility	Difficult	<i>Assessment Score</i>
Product type:	Friable Debris	3
Extent of Damage:	Good	0
Surface Treatment:	Unsealed AIB	2
Asbestos type:	Presumed	3
Material Assessment Score:		8
Priority Assessment Score:		Medium
Action:	Manage	
Comments:	No access into safe no codes or keys

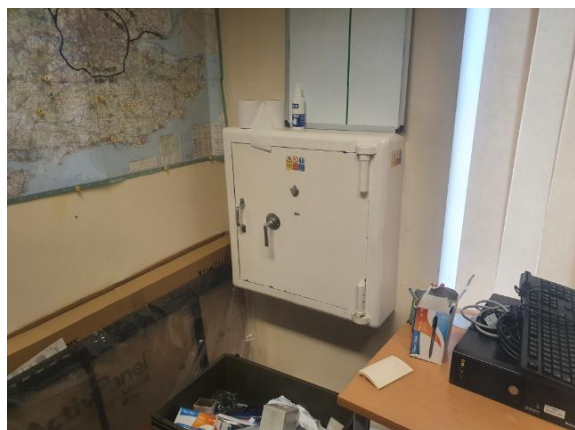
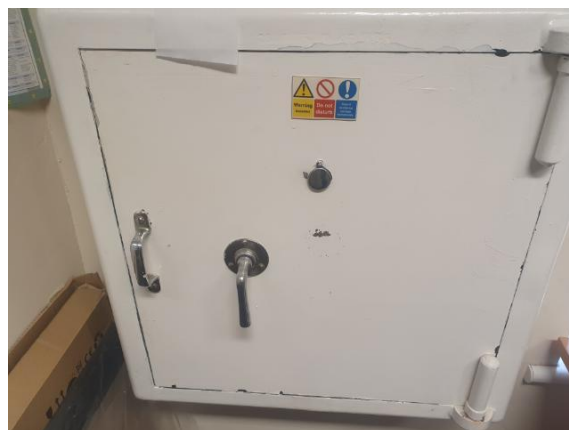
Location: First Floor - ISOC Office 005

Material Description:	Safe - No Access Gained	
Identification:	Strongly Presumed to Contain Asbestos	
Approx. quantity:	1 no	
Accessibility	Difficult	<i>Assessment Score</i>
Product type:	Friable Debris	3
Extent of Damage:	Good	0
Surface Treatment:	Unsealed AIB	2
Asbestos type:	Presumed	3
Material Assessment Score:		8
Priority Assessment Score:		Medium
Action:	Manage	
Comments:	No access into safe no codes or keys

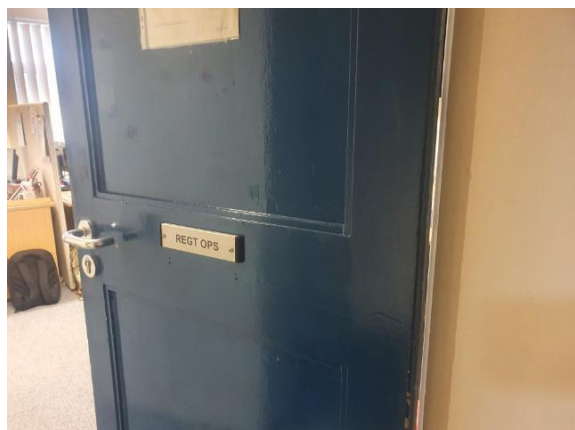
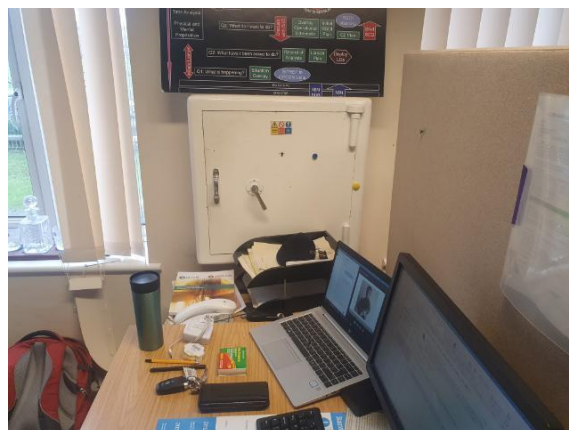
Location: First Floor - Regt Ops Office 006

Material Description:	Safe - No Access Gained	
Identification:	Strongly Presumed to Contain Asbestos	
Approx. quantity:	1 no	
Accessibility	Difficult	<i>Assessment Score</i>
Product type:	Friable Debris	3
Extent of Damage:	Good	0
Surface Treatment:	Unsealed AIB	2
Asbestos type:	Presumed	3
Material Assessment Score:		8
Priority Assessment Score:		Medium
Action:	Manage	
Comments:	No access into safe no codes or keys

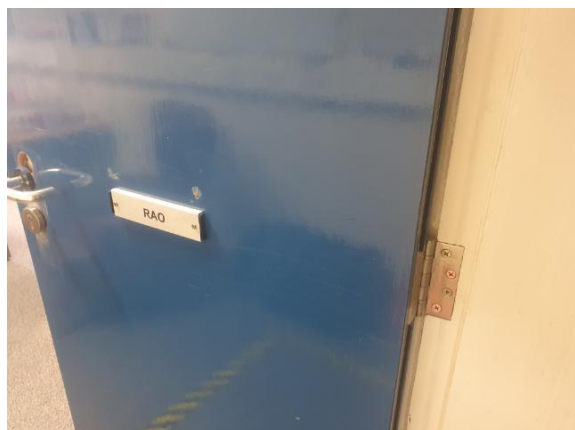
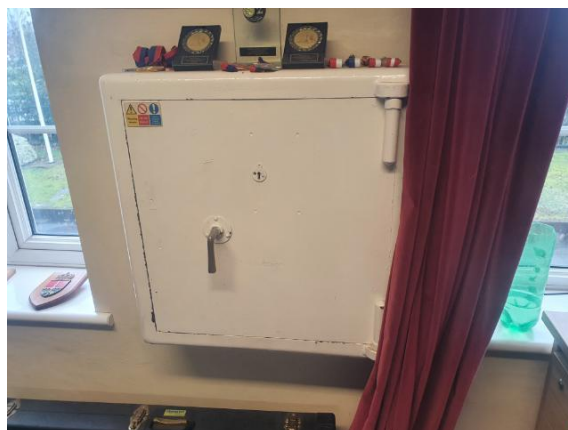
Location: First Floor - RAO Office 007

Material Description:	Safe - No Access Gained	
Identification:	Strongly Presumed to Contain Asbestos	
Approx. quantity:	1 no	
Accessibility	Difficult	<i>Assessment Score</i>
Product type:	Friable Debris	3
Extent of Damage:	Good	0
Surface Treatment:	Unsealed AIB	2
Asbestos type:	Presumed	3
Material Assessment Score:		8
Priority Assessment Score:		Medium
Action:	Manage	
Comments:	No access into safe no codes or keys

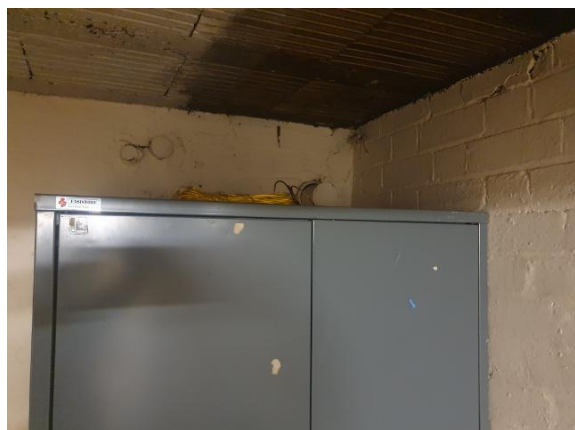
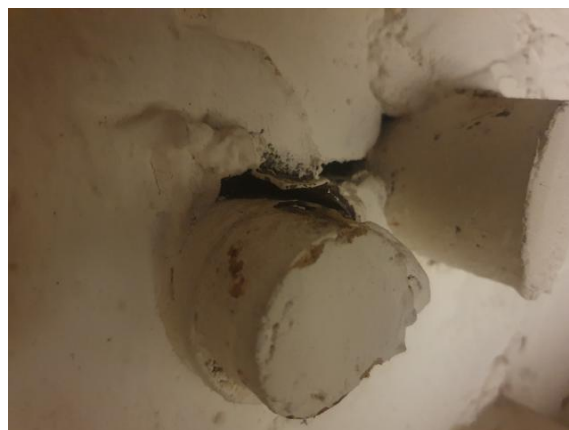
Location: First Floor - Basement Boiler Room 008

Material Description:	Pipework - Limited Access Gained	
Identification:	Strongly Presumed to Contain Asbestos	
Approx. quantity:	4 LM	
Accessibility	Difficult	<i>Assessment Score</i>
Product type:	Pipe Insulation	3
Extent of Damage:	Good	0
Surface Treatment:	Encapsulated Insulation	2
Asbestos type:	Presumed	3
Material Assessment Score:		8
Priority Assessment Score:		Medium
Action:	Manage	
Comments:	limited access due to equipment

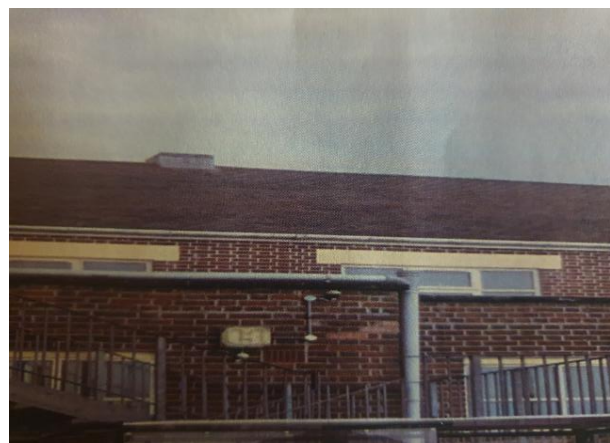
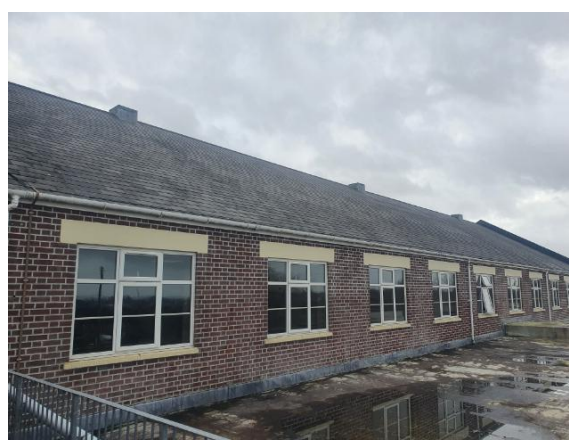
Location: External - Outside 009

Material Description:	Roof tiles - No Access Gained	
Identification:	Strongly Presumed to Contain Asbestos	
Approx. quantity:	250 m ²	
Accessibility	Difficult	<i>Assessment Score</i>
Product type:	Cement	1
Extent of Damage:	Good	0
Surface Treatment:	Non-friable	0
Asbestos type:	Presumed	3
Material Assessment Score:		4
Priority Assessment Score:		Negligible
Action:	Manage	
Comments:	Cement Roof tiles too high to sample

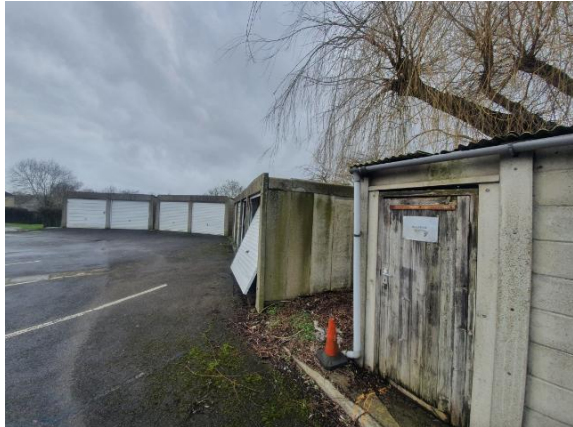
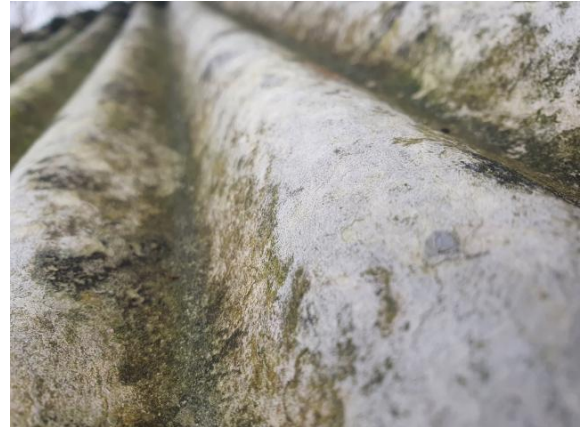
Location: External - Outside 011

Material Description:	Garages - Cement Product	
Identification:	Sampled - Asbestos Detected	
Approx. quantity:	45 m ²	
Accessibility	Easy	<i>Assessment Score</i>
Product type:	Cement	1
Extent of Damage:	Moderate damage	2
Surface Treatment:	Unsealed Cement	1
Asbestos type:	Chrysotile	1
Material Assessment Score:		5
Priority Assessment Score:		Low
Action:	Remove	
Comments:	Cement product to roof areas of small garages

Sample No.	Sample Ref.	Location	Asbestos Detected	Asbestos Type
JR/1	BS654197	Garage Roof	Yes	Chrysotile

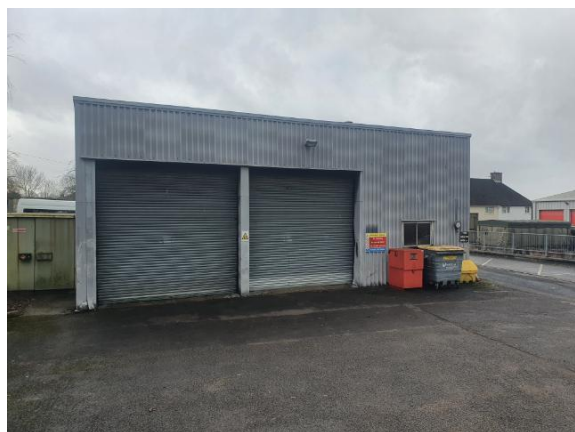
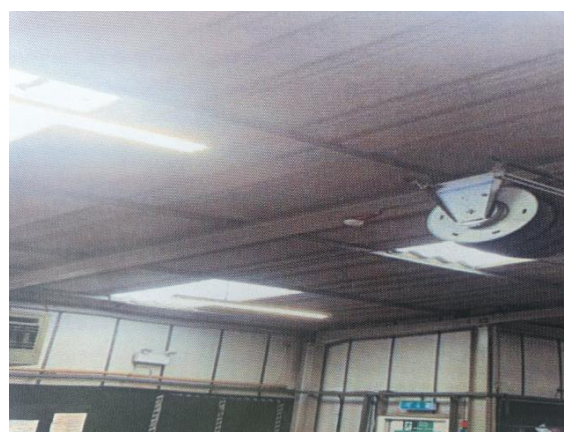
Location: External - Workshop 012

Material Description:	Roof - Limited Access Gained	
Identification:	Strongly Presumed to Contain Asbestos	
Approx. quantity:	50 m ²	
Accessibility	Difficult	<i>Assessment Score</i>
Product type:	Cement	1
Extent of Damage:	Good	0
Surface Treatment:	Unsealed Cement	1
Asbestos type:	Chrysotile	1
Material Assessment Score:		3
Priority Assessment Score:		Negligible
Action:	Manage	
Comments:	No access into workshop

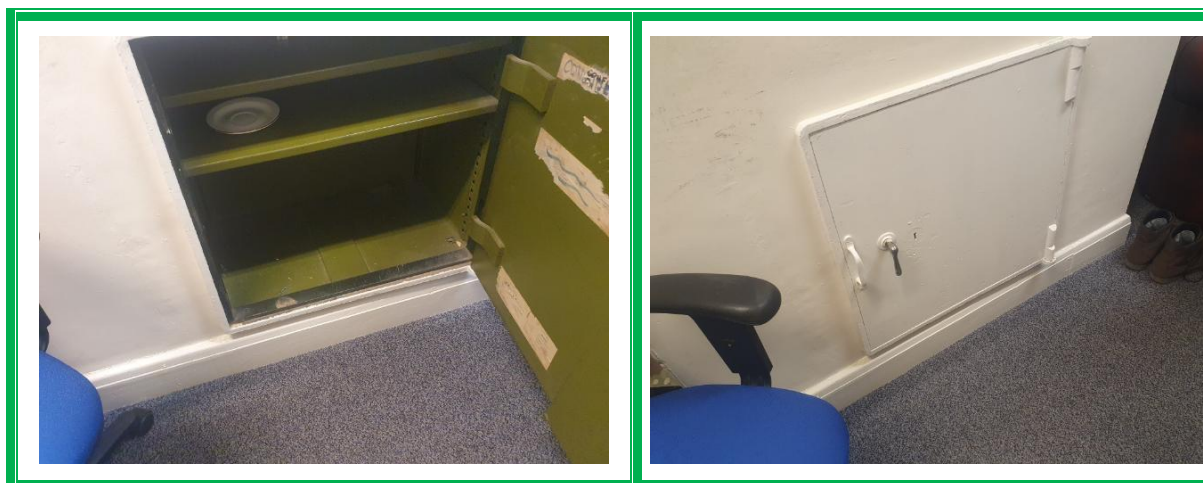
Item No:	1	Sample No:	N/A
Location:	Ground Floor - Room G46 001

Material Description:	No Suspect Materials Found	
Identification:	N/A	
Approx. quantity:	N/A	
Accessibility	N/A	<i>Assessment Score</i>
Product type:	N/A	N/A
Extent of Damage:	N/A	N/A
Surface Treatment:	N/A	N/A
Asbestos type:	N/A	N/A
Material Assessment Score:		N/A
Priority Assessment Score:		N/A
Action:	N/A	
Comments:	N/A

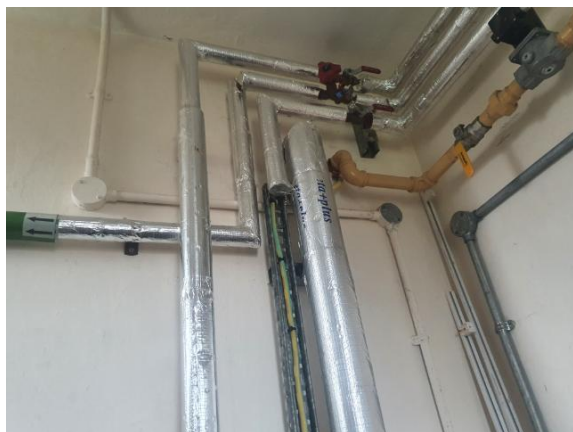
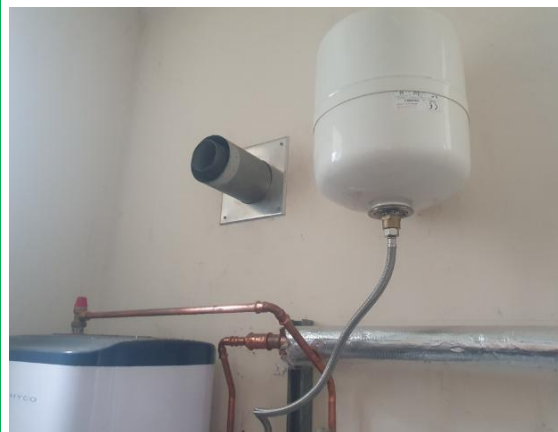
Location: Ground Floor - Boiler Store 002

Material Description:	No Suspect Materials Found	
Identification:	N/A	
Approx. quantity:	N/A	
Accessibility	N/A	<i>Assessment Score</i>
Product type:	N/A	N/A
Extent of Damage:	N/A	N/A
Surface Treatment:	N/A	N/A
Asbestos type:	N/A	N/A
Material Assessment Score:		N/A
Priority Assessment Score:		N/A
Action:	N/A	
Comments:	Been renewed and renovated

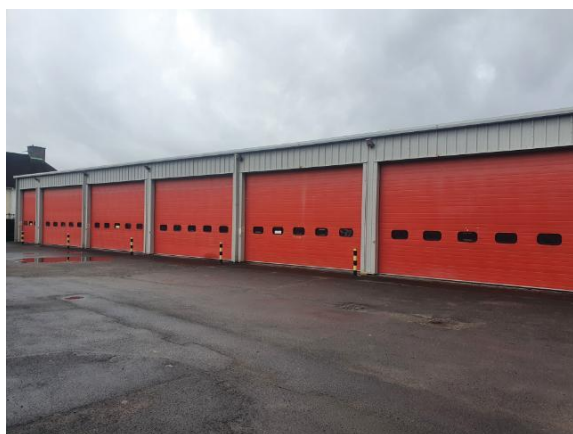
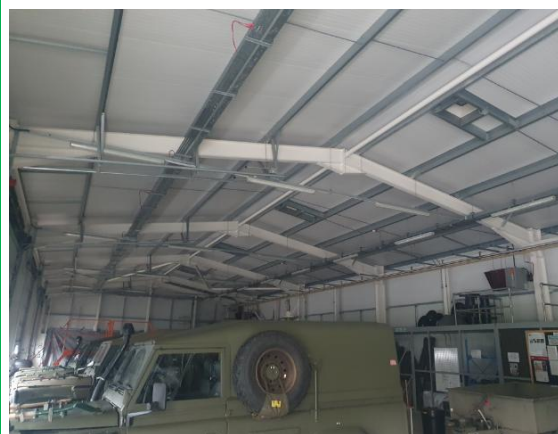
Location: External - Main Garages 010

Material Description:	No Suspect Materials Found	
Identification:	N/A	
Approx. quantity:	N/A	
Accessibility	N/A	<i>Assessment Score</i>
Product type:	N/A	N/A
Extent of Damage:	N/A	N/A
Surface Treatment:	N/A	N/A
Asbestos type:	N/A	N/A
Material Assessment Score:		N/A
Priority Assessment Score:		N/A
Action:	N/A	
Comments:	N/A
