Project Number 2481

**Management
Asbestos Survey Report**

**7th Battalion, The Rifles C, Dorset,
BH12 5AD**

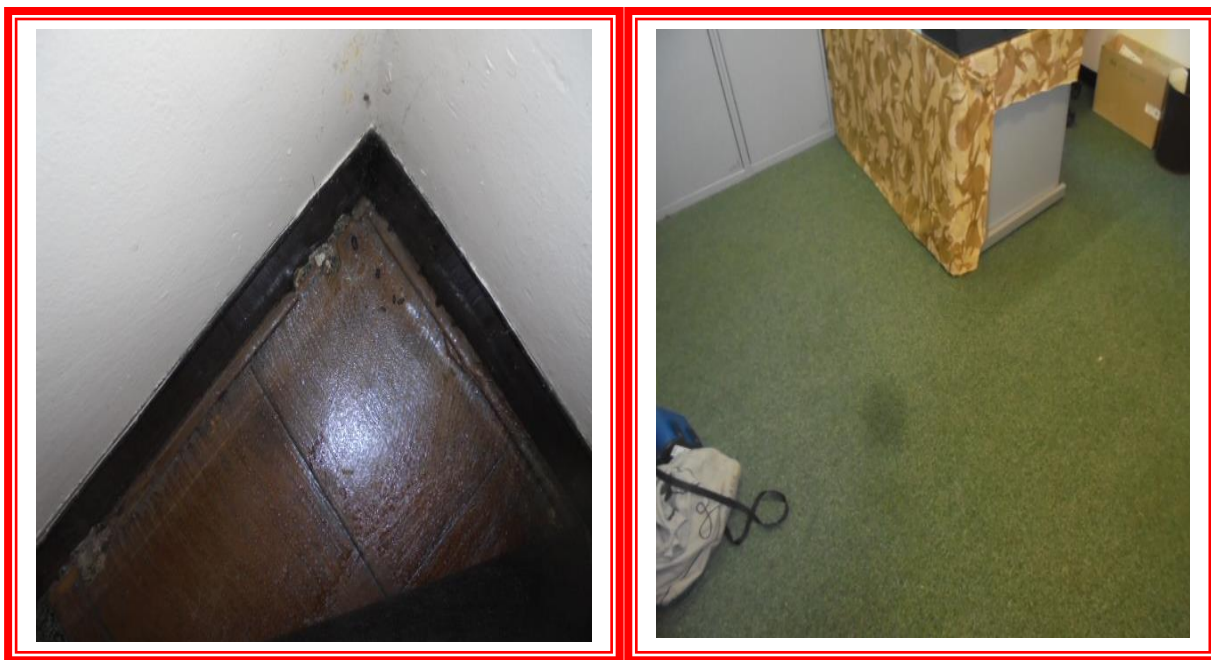
Location: Main Block - Ground Floor – Offices 0.02 and 0.03

Material Description:	Floor Tiles and Adhesive	
Identification:	Sampled – Asbestos Detected	
Approx. quantity:	32M2	
Accessibility	Low	<i>Assessment Score</i>
Product type:	Composite	1
Extent of Damage:	Minor	1
Surface Treatment:	Non-Friable	0
Asbestos type:	Chrysotile	1
Material Assessment Score:		3
Priority Assessment Score:		Negligible
Action:	Manage	
Comments:	Under Carpet

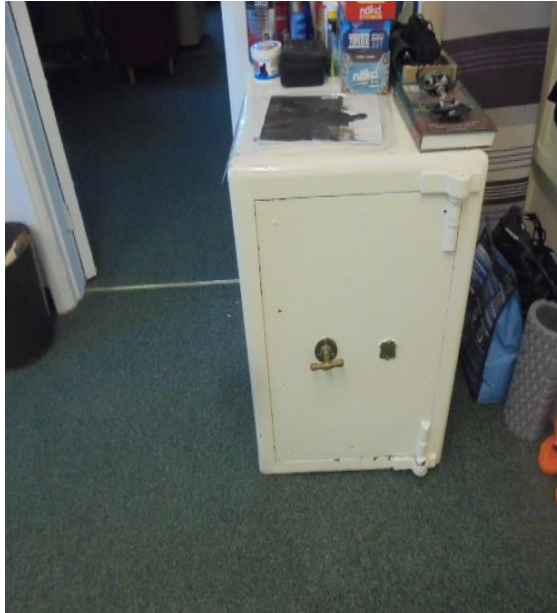
Location: Main Block – Ground Floor – Office 0.02

Material Description:	No Access within Safe Casings	
Identification:	Presumed to Contain Asbestos	
Approx. quantity:	1X Safe	
Accessibility	Low	Assessment Score
Product type:	No Access	2
Extent of Damage:	No Access	2
Surface Treatment:	No Access	2
Asbestos type:	No Access	2
Material Assessment Score:		8
Priority Assessment Score:		Medium
Action:	Manage	
Comments:	No access without damaging safe

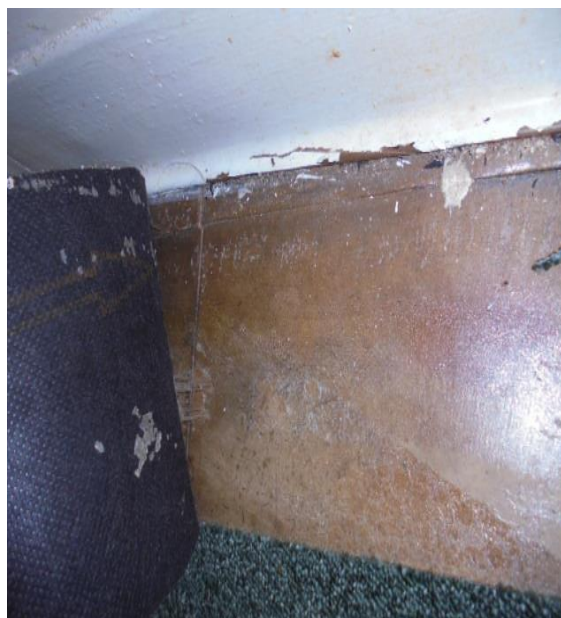
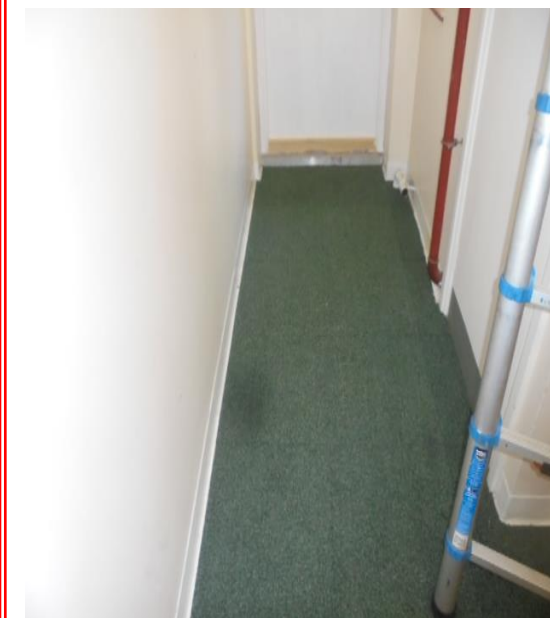
Location: Main Block – Ground Floor – Lobby 0.06

Material Description:	Floor Tiles and Adhesive	
Identification:	As Per Sample DK/2 – Asbestos Detected	
Approx. quantity:	5M2	
Accessibility	Low	Assessment Score
Product type:	Composite	1
Extent of Damage:	Minor	1
Surface Treatment:	Non-Friable	0
Asbestos type:	Chrysotile	1
Material Assessment Score:		3
Priority Assessment Score:		Negligible
Action:	Manage	
Comments:	Under Carpet

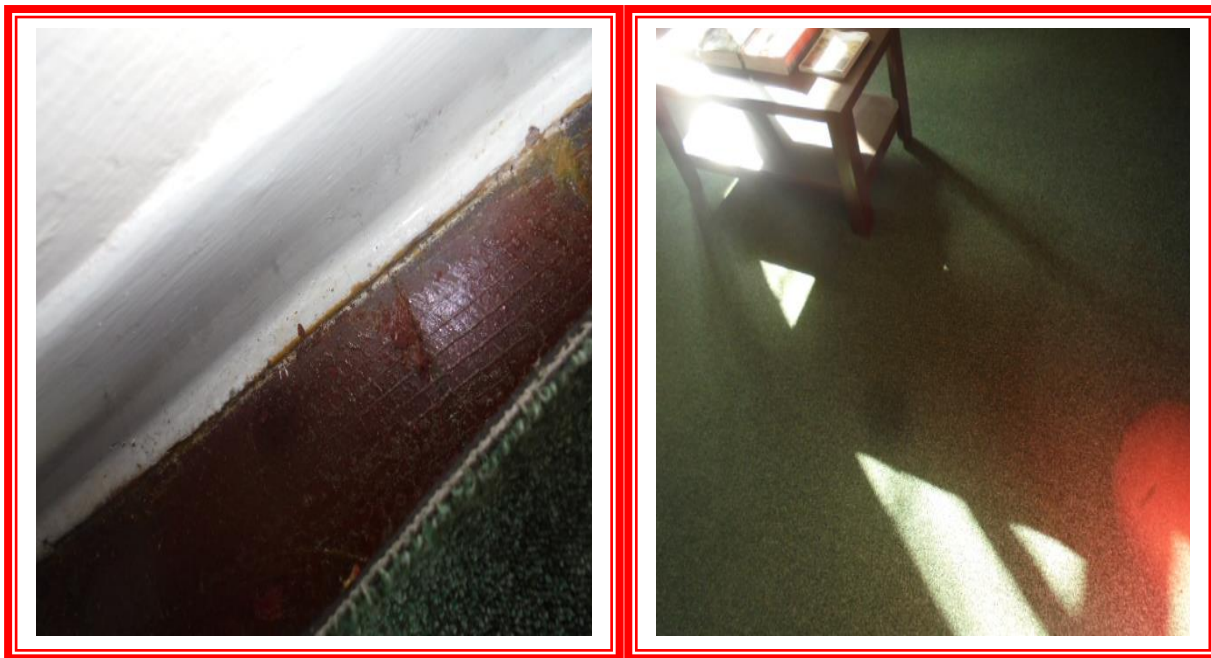
Material Description:	Floor Tiles and Adhesive	
Identification:	As Per Sample DK/2 – Asbestos Detected	
Approx. quantity:	25M2	
Accessibility	Low	Assessment Score
Product type:	Composite	1
Extent of Damage:	Minor	1
Surface Treatment:	Non-Friable	0
Asbestos type:	Chrysotile	1
Material Assessment Score:		3
Priority Assessment Score:		Negligible
Action:	Manage	
Comments:	Under Carpet

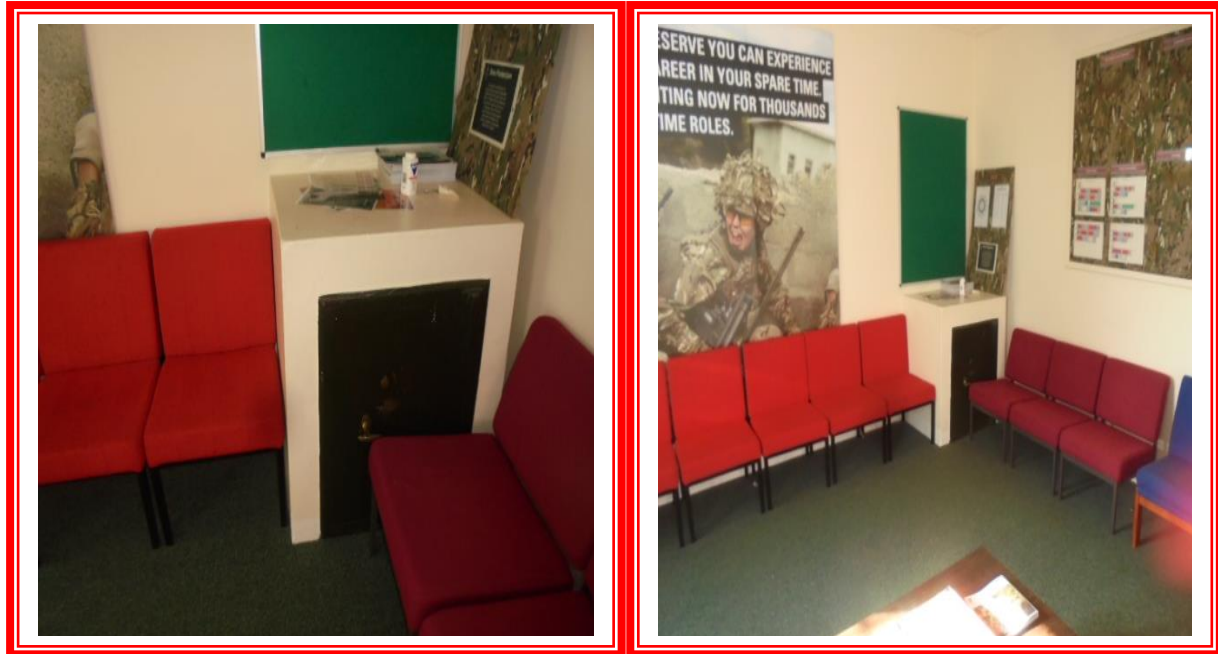
Material Description:	No Access within Safe Casings	
Identification:	Presumed to Contain Asbestos	
Approx. quantity:	1X Safe	
Accessibility	Low	Assessment Score
Product type:	No Access	2
Extent of Damage:	No Access	2
Surface Treatment:	No Access	2
Asbestos type:	No Access	2
Material Assessment Score:		8
Priority Assessment Score:		Medium
Action:	Manage	
Comments:	No access without damaging safe

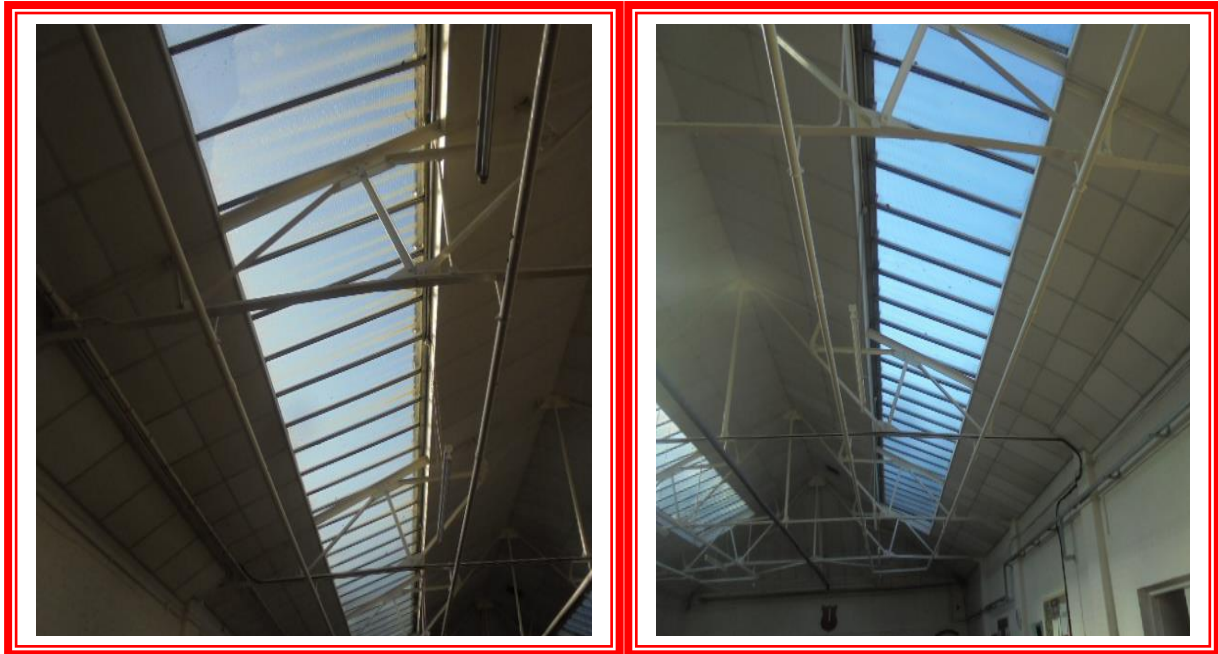
Material Description:	Rope Seals to Skylights	
Identification:	Presumed to Contain Asbestos	
Approx. quantity:	30M2 of Glazing	
Accessibility	Low	<i>Assessment Score</i>
Product type:	Rope	2
Extent of Damage:	Minor	1
Surface Treatment:	Unsealed	1
Asbestos type:	Chrysotile	1
Material Assessment Score:		5
Priority Assessment Score:		Low
Action:	Manage	
Comments:	No Access to Sample due to Height

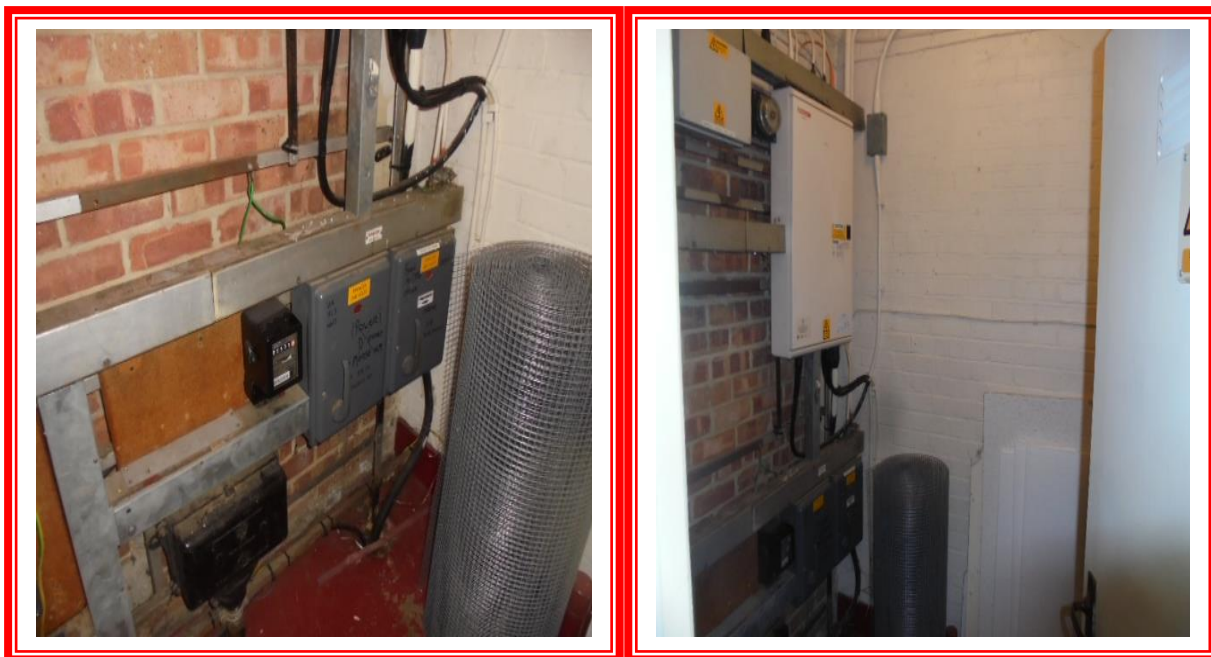
Material Description:	No Access within Electrical Panels	
Identification:	Presumed to Contain Asbestos	
Approx. quantity:	2X Panels	
Accessibility	Low	<i>Assessment Score</i>
Product type:	No Access	2
Extent of Damage:	No Access	1
Surface Treatment:	No Access	1
Asbestos type:	No Access	1
Material Assessment Score:		5
Priority Assessment Score:		Low
Action:	Manage	
Comments:	N/A

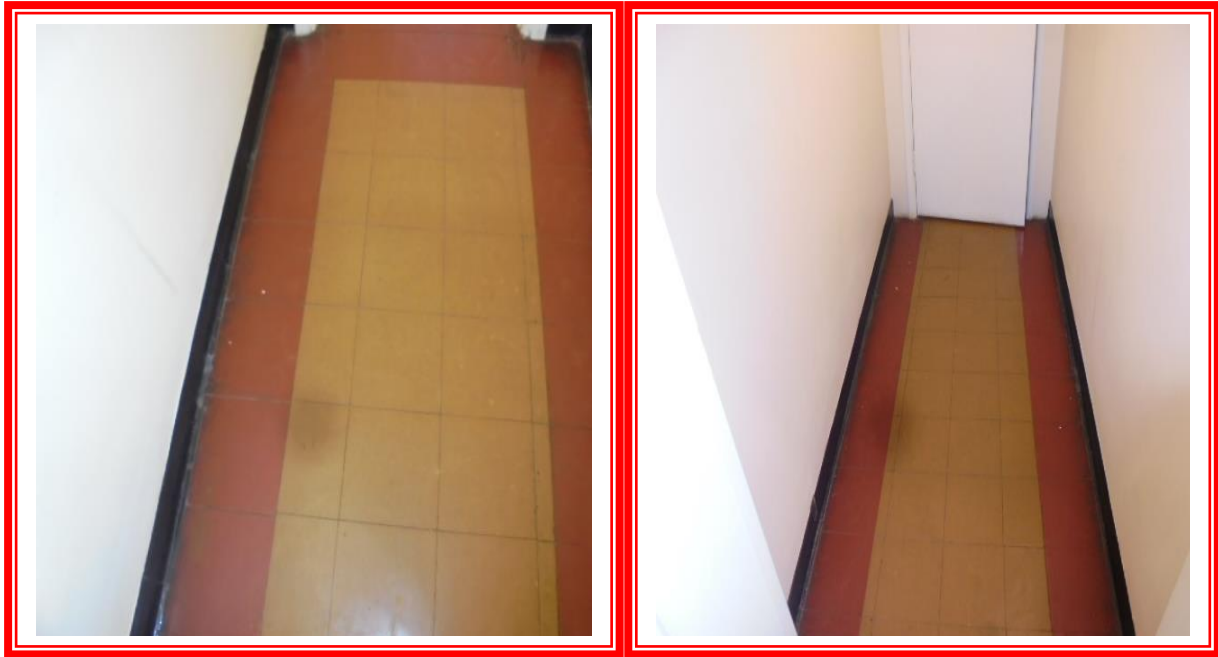
Material Description:	Floor Tiles and Adhesive	
Identification:	As Per Sample DK/2 – No Asbestos Detected	
Approx. quantity:	3M2	
Accessibility	High	<i>Assessment Score</i>
Product type:	Composite	1
Extent of Damage:	Minor	1
Surface Treatment:	Non-Friable	0
Asbestos type:	Chrysotile	1
Material Assessment Score:		3
Priority Assessment Score:		Negligible
Action:	Manage	
Comments:	N/A

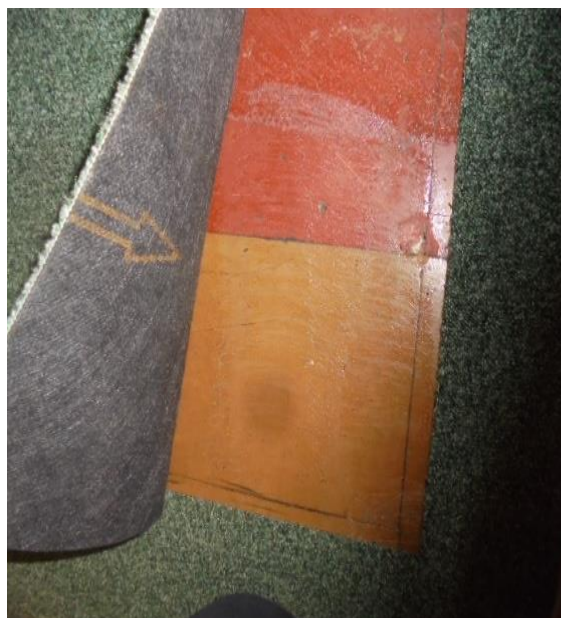
Material Description:	Floor Tiles and Adhesive	
Identification:	Sampled – Asbestos Detected	
Approx. quantity:	20M2	
Accessibility	Low	Assessment Score
Product type:	Composite	1
Extent of Damage:	Minor	1
Surface Treatment:	Non-Friable	0
Asbestos type:	Chrysotile	1
Material Assessment Score:		3
Priority Assessment Score:		Negligible
Action:	Manage	
Comments:	Under Carpet

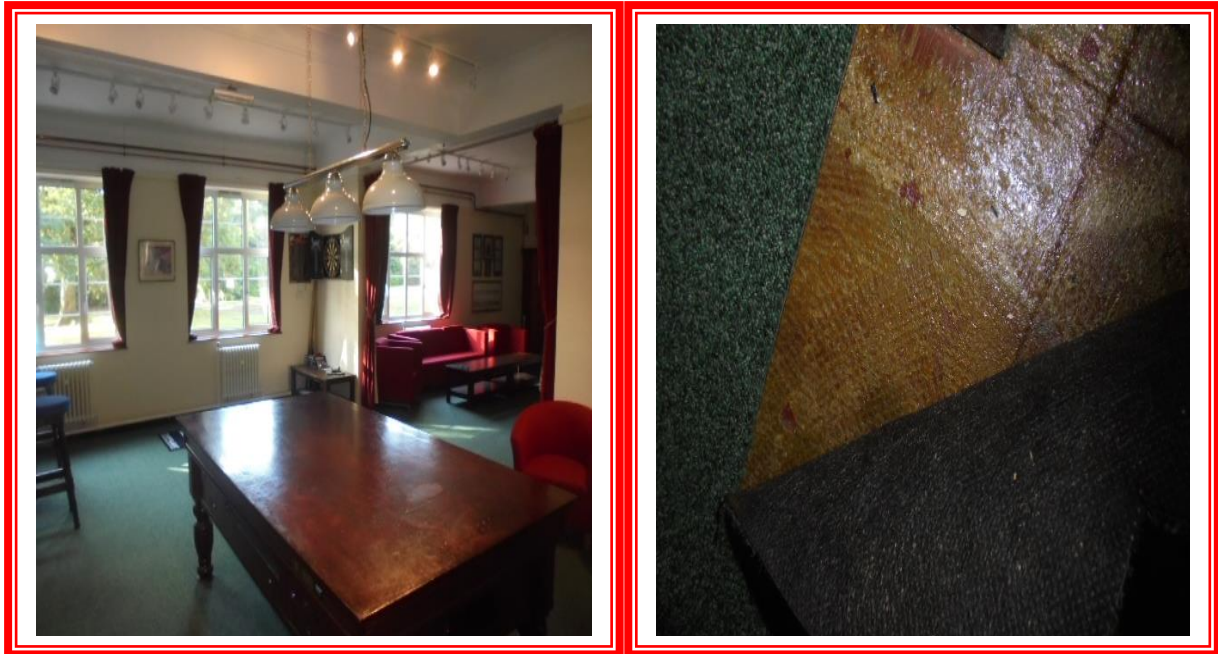
Material Description:	Floor Tiles Under Carpet	
Identification:	As Per Sample DK/2 and DK/5 – Asbestos Detected	
Approx. quantity:	60M2	
Accessibility	Low	<i>Assessment Score</i>
Product type:	Cement	1
Extent of Damage:	Minor	1
Surface Treatment:	Non-Friable	0
Asbestos type:	Chrysotile	1
Material Assessment Score:		3
Priority Assessment Score:		Negligible
Action:	Manage	
Comments:	N/A

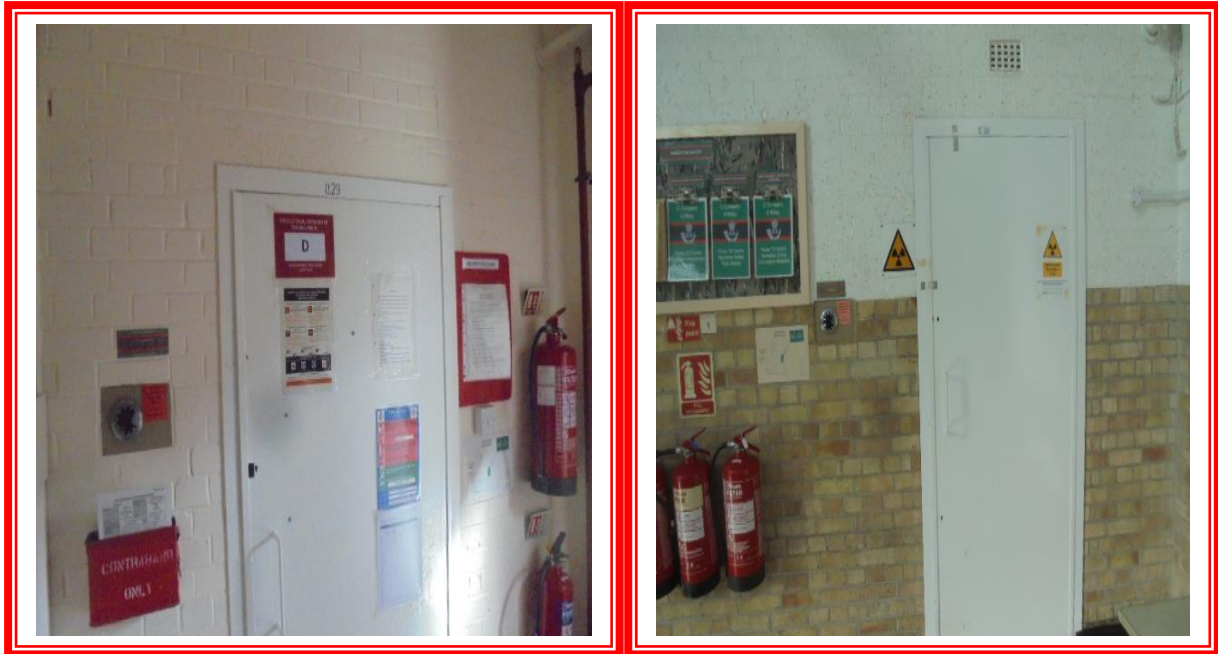
Material Description:	No Access within Locked Rooms	
Identification:	Presumed to Contain Asbestos	
Approx. quantity:	3X Rooms	
Accessibility	Low	Assessment Score
Product type:	No Access	3
Extent of Damage:	No Access	3
Surface Treatment:	No Access	3
Asbestos type:	No Access	3
Material Assessment Score:		12
Priority Assessment Score:		High
Action:	Further Investigation Required	
Comments:	No Access Possible as Advised by Site Contact

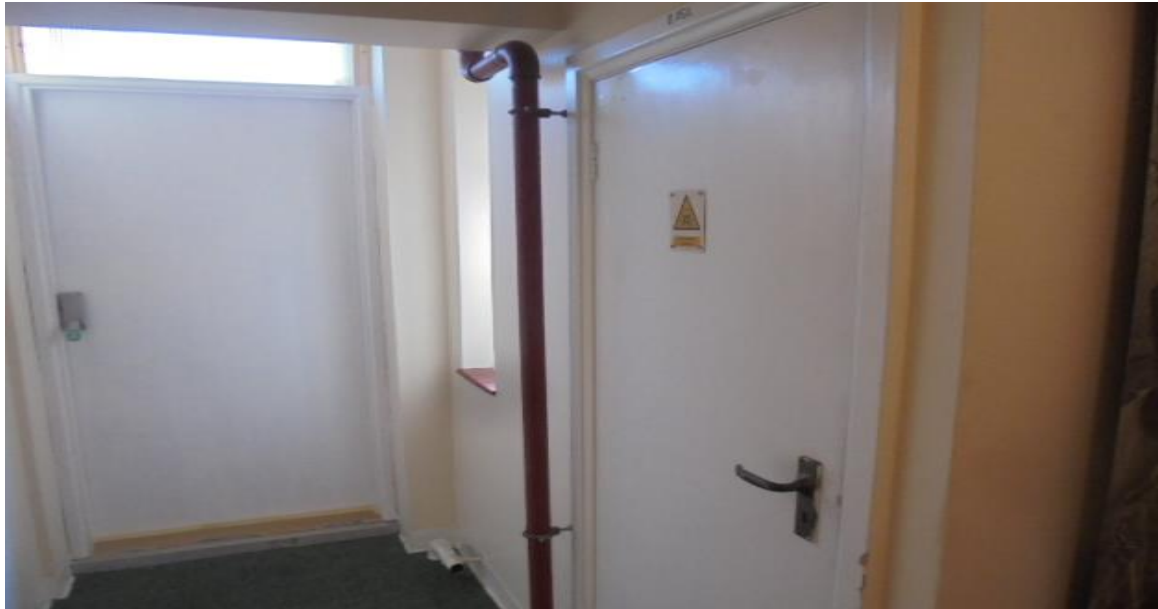
Material Description:	No Access within Locked Room	
Identification:	Presumed to Contain Asbestos	
Approx. quantity:	1X Room	
Accessibility	Low	<i>Assessment Score</i>
Product type:	No Access	3
Extent of Damage:	No Access	3
Surface Treatment:	No Access	3
Asbestos type:	No Access	3
Material Assessment Score:		12
Priority Assessment Score:		High
Action:	Further Investigation Required	
Comments:	Key Has Been Lost

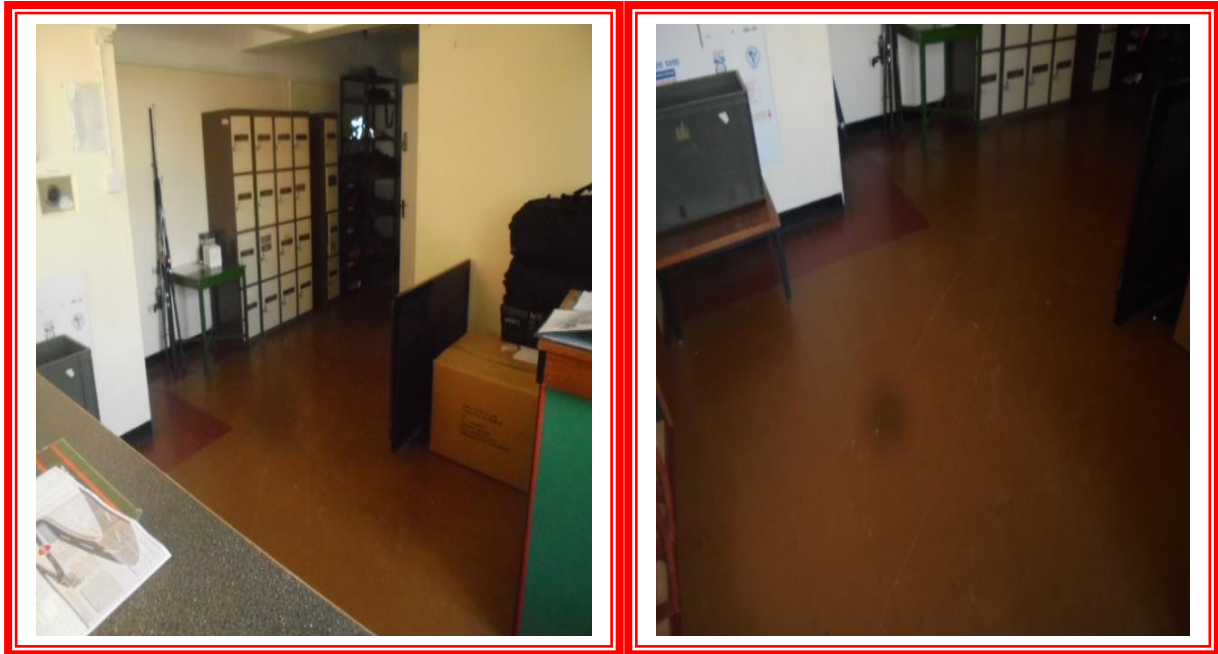
Material Description:	Floor Tiles and Adhesive	
Identification:	As Per Sample DK/2 and DK/5 – Asbestos Detected	
Approx. quantity:	32M2	
Accessibility	High	Assessment Score
Product type:	Composite	1
Extent of Damage:	Minor	1
Surface Treatment:	Non-Friable	0
Asbestos type:	Chrysotile	1
Material Assessment Score:		3
Priority Assessment Score:		Negligible
Action:	Manage	
Comments:	N/A

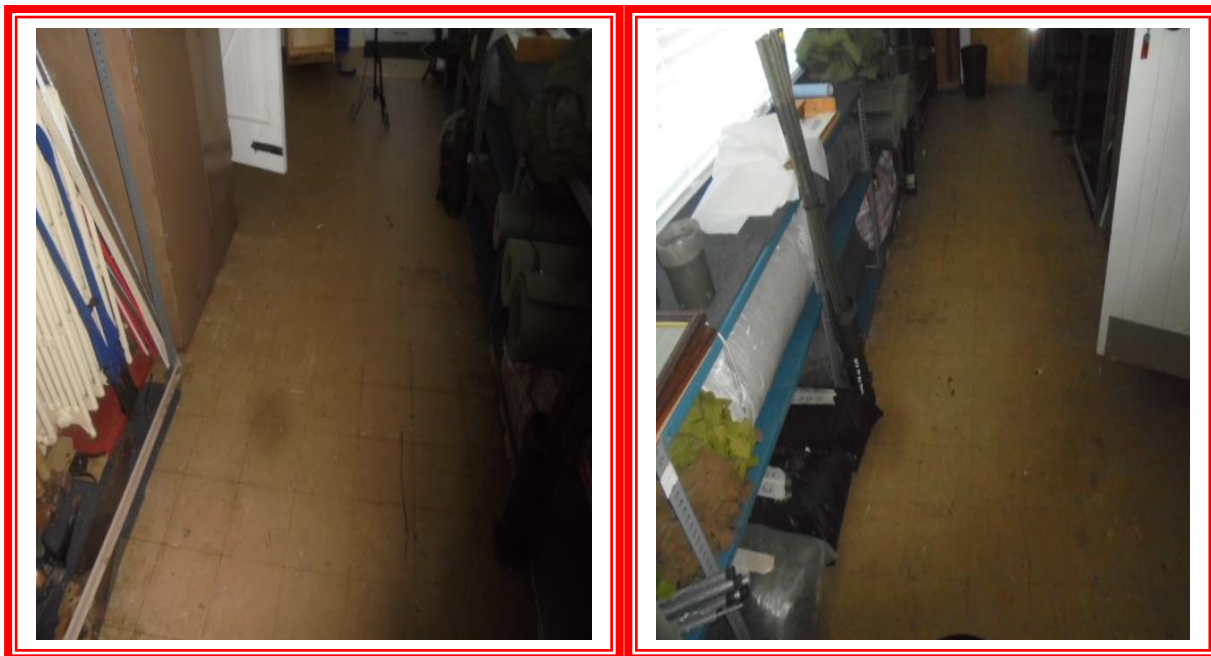
Material Description:	Floor Tiles and Adhesive	
Identification:	Sampled – Asbestos Detected	
Approx. quantity:	14M2	
Accessibility	High	Assessment Score
Product type:	Composite	1
Extent of Damage:	Moderate	2
Surface Treatment:	Non-Friable	0
Asbestos type:	Chrysotile	1
Material Assessment Score:		4
Priority Assessment Score:		Negligible
Action:	Manage	
Comments:	N/A

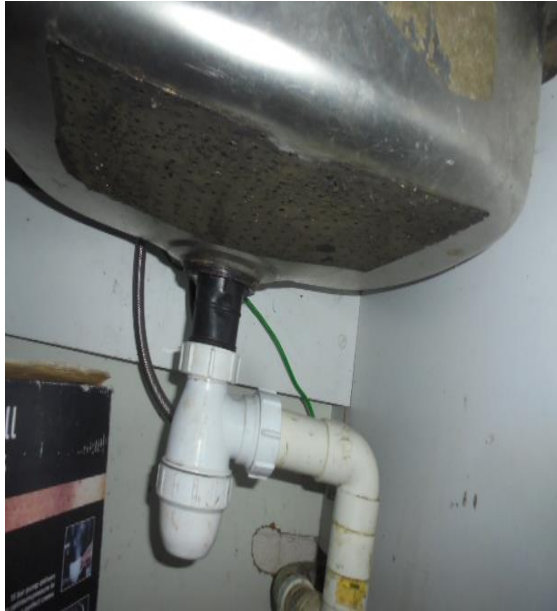
Material Description:	Sink Pad	
Identification:	Sampled – Asbestos Detected	
Approx. quantity:	1X Sink	
Accessibility	Low	Assessment Score
Product type:	Bitumen	1
Extent of Damage:	Minor	1
Surface Treatment:	Non-Friable	0
Asbestos type:	Chrysotile	1
Material Assessment Score:		3
Priority Assessment Score:		Negligible
Action:	Manage	
Comments:	N/A

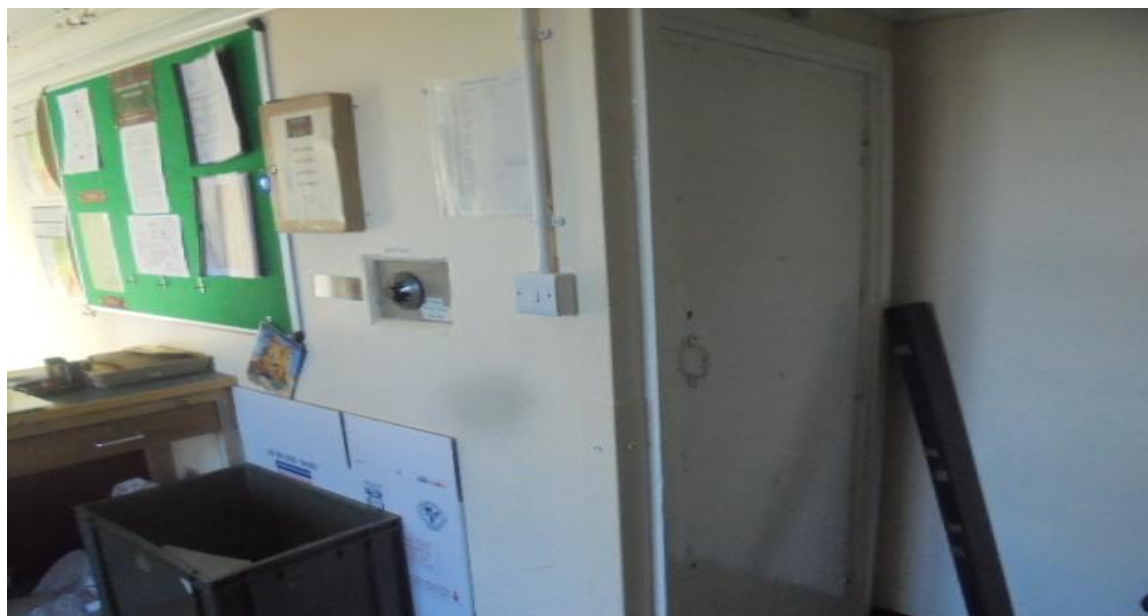
Material Description:	No Access within Locked Room	
Identification:	Presumed to Contain Asbestos	
Approx. quantity:	1X Room	
Accessibility	Low	Assessment Score
Product type:	No Access	3
Extent of Damage:	No Access	3
Surface Treatment:	No Access	3
Asbestos type:	No Access	3
Material Assessment Score:		12
Priority Assessment Score:		High
Action:	Further Investigation Required	
Comments:	No Access Possible as Advised by Site Contact

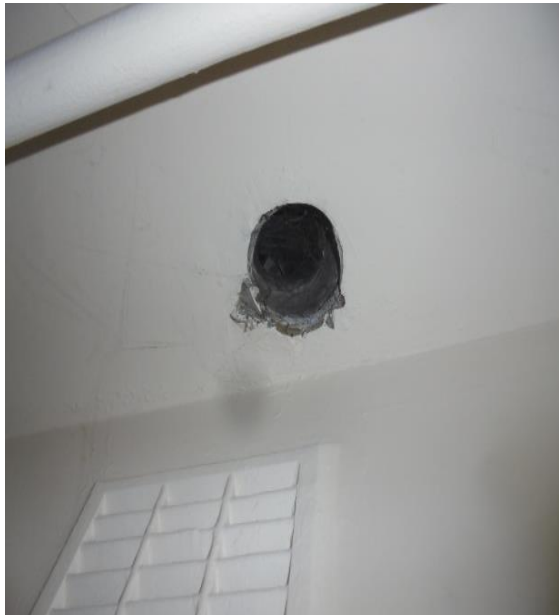
Material Description:	Cement Pipe Running Through Ceiling	
Identification:	Strongly Presumed to Contain Asbestos	
Approx. quantity:	<1LM Visible	
Accessibility	Low	Assessment Score
Product type:	Cement	1
Extent of Damage:	Minor	1
Surface Treatment:	Unsealed	1
Asbestos type:	Chrysotile	1
Material Assessment Score:		4
Priority Assessment Score:		Negligible
Action:	Manage	
Comments:	No Access to Sample due to Stored Items Blocking Access

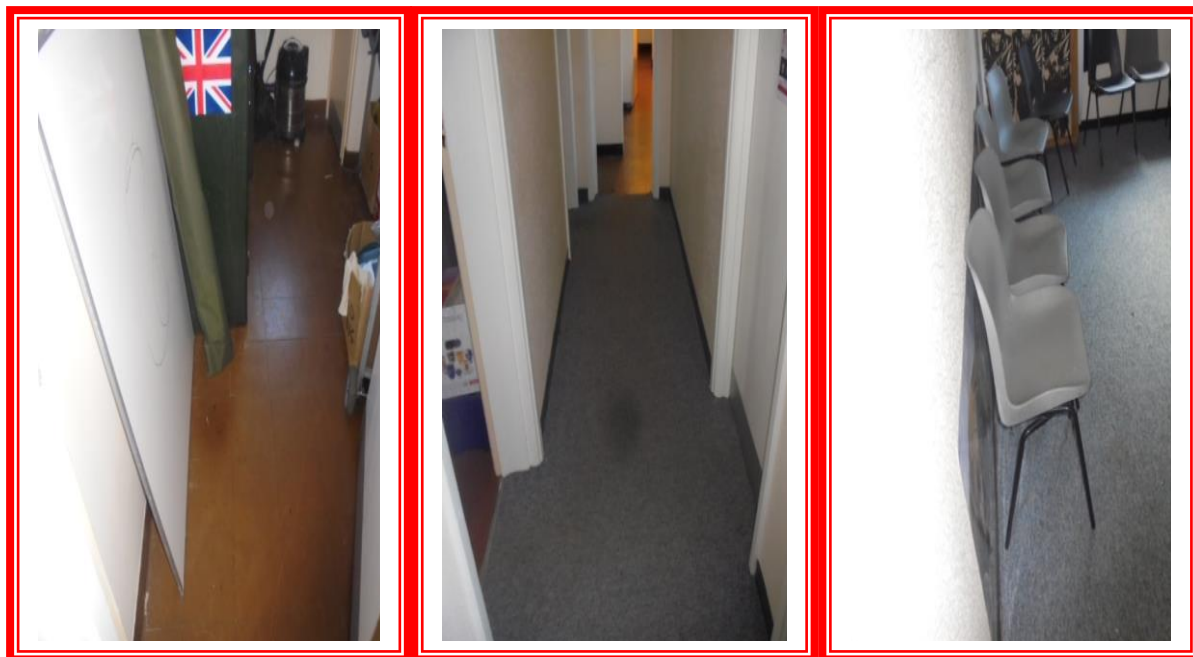
Material Description:	Floor Tiles and Adhesive	
Identification:	Sampled – Asbestos Detected	
Approx. quantity:	32M2	
Accessibility	High	Assessment Score
Product type:	Composite	1
Extent of Damage:	Minor	1
Surface Treatment:	Non-Friable	0
Asbestos type:	Chrysotile	1
Material Assessment Score:		3
Priority Assessment Score:		Negligible
Action:	Manage	
Comments:	Under Carpet in 3no. Rooms

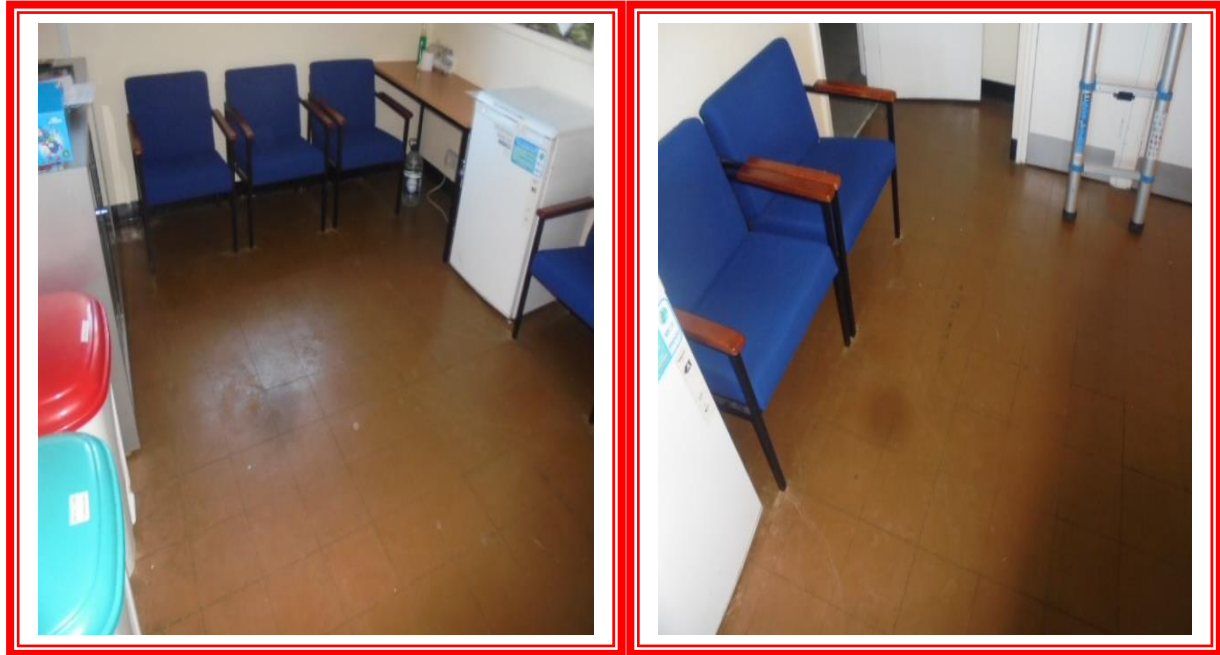
Material Description:	Floor Tiles and Adhesive	
Identification:	As Per Sample DK/12 – Asbestos Detected	
Approx. quantity:	15M2	
Accessibility	High	<i>Assessment Score</i>
Product type:	Composite	1
Extent of Damage:	Minor	1
Surface Treatment:	Non-Friable	0
Asbestos type:	Chrysotile	1
Material Assessment Score:		3
Priority Assessment Score:		Negligible
Action:	Manage	
Comments:	N/A

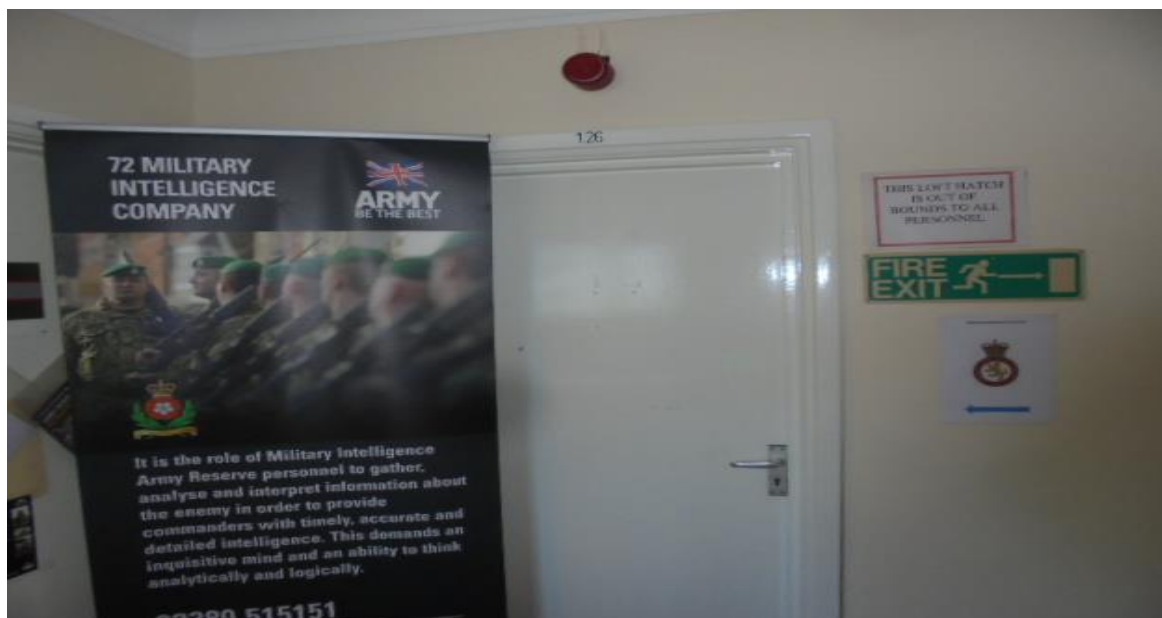
Material Description:	No Access within Locked Room	
Identification:	Presumed to Contain Asbestos	
Approx. quantity:	1X Room	
Accessibility	Low	<i>Assessment Score</i>
Product type:	No Access	3
Extent of Damage:	No Access	3
Surface Treatment:	No Access	3
Asbestos type:	No Access	3
Material Assessment Score:		12
Priority Assessment Score:		High
Action:	Further Investigation Required	
Comments:	No Key Available

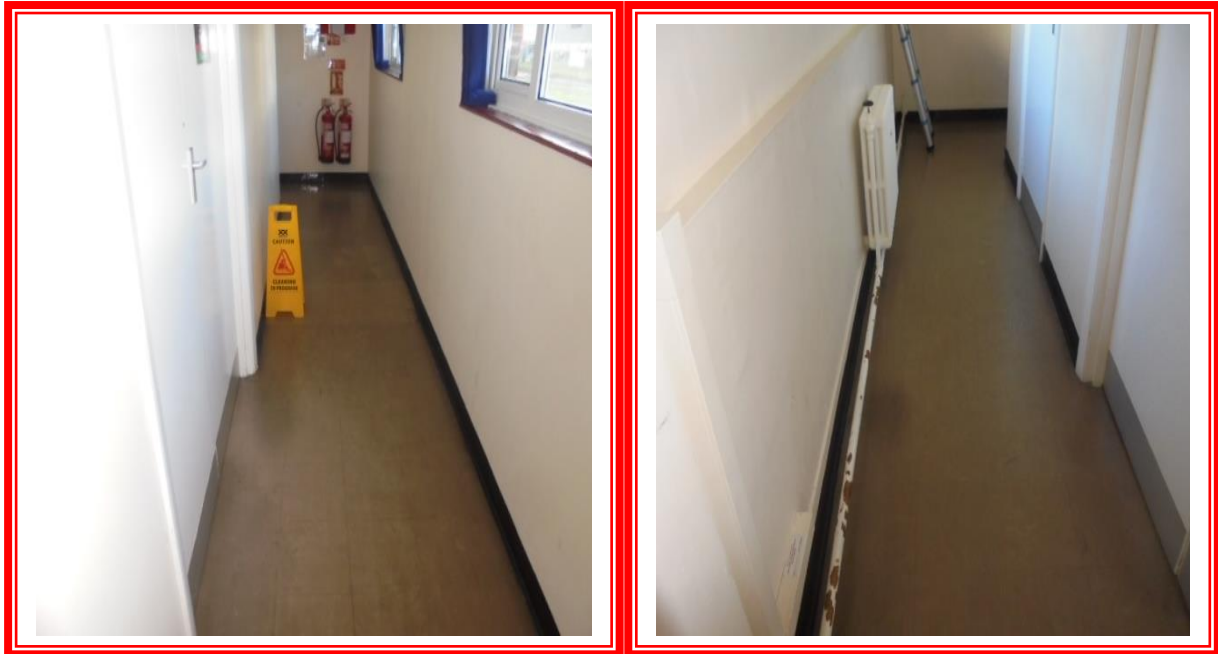
Material Description:	Floor Tiles and Adhesive	
Identification:	Sampled – Asbestos Detected	
Approx. quantity:	17M2	
Accessibility	High	Assessment Score
Product type:	Composite	1
Extent of Damage:	Minor	1
Surface Treatment:	Non-Friable	0
Asbestos type:	Chrysotile	1
Material Assessment Score:		3
Priority Assessment Score:		Negligible
Action:	Manage	
Comments:	N/A

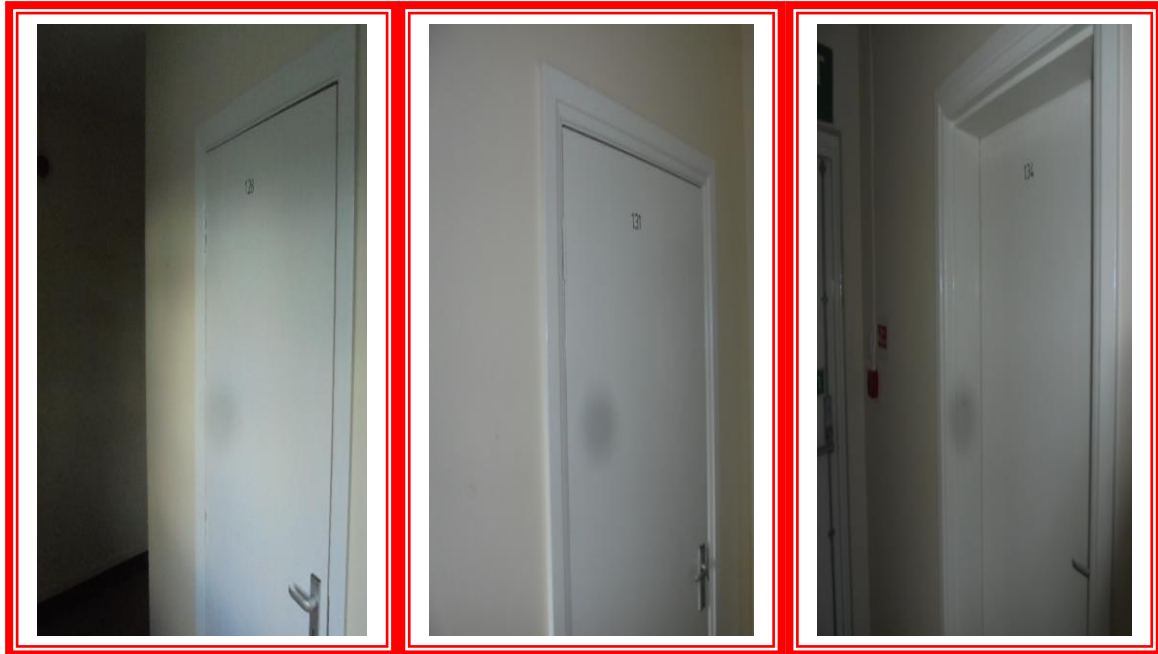
Material Description:	No Access within Locked Rooms	
Identification:	Presumed to Contain Asbestos	
Approx. quantity:	3 X Rooms	
Accessibility	Low	<i>Assessment Score</i>
Product type:	No Access	3
Extent of Damage:	No Access	3
Surface Treatment:	No Access	3
Asbestos type:	No Access	3
Material Assessment Score:		12
Priority Assessment Score:		High
Action:	Further Investigation Required	
Comments:	No Keys Available

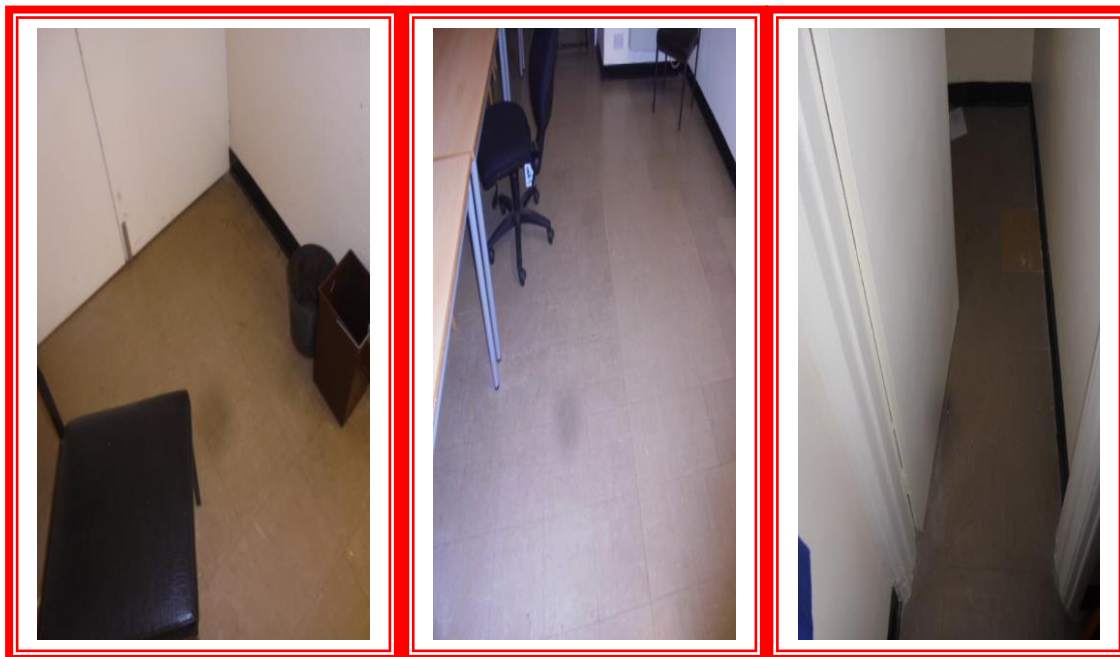
Material Description:	Floor Tiles and Adhesive	
Identification:	As Per Sample DK/16 – Asbestos Detected	
Approx. quantity:	54M2	
Accessibility	High	Assessment Score
Product type:	Composite	1
Extent of Damage:	Minor	1
Surface Treatment:	Non-Friable	0
Asbestos type:	Chrysotile	1
Material Assessment Score:		3
Priority Assessment Score:		Negligible
Action:	Manage	
Comments:	N/A

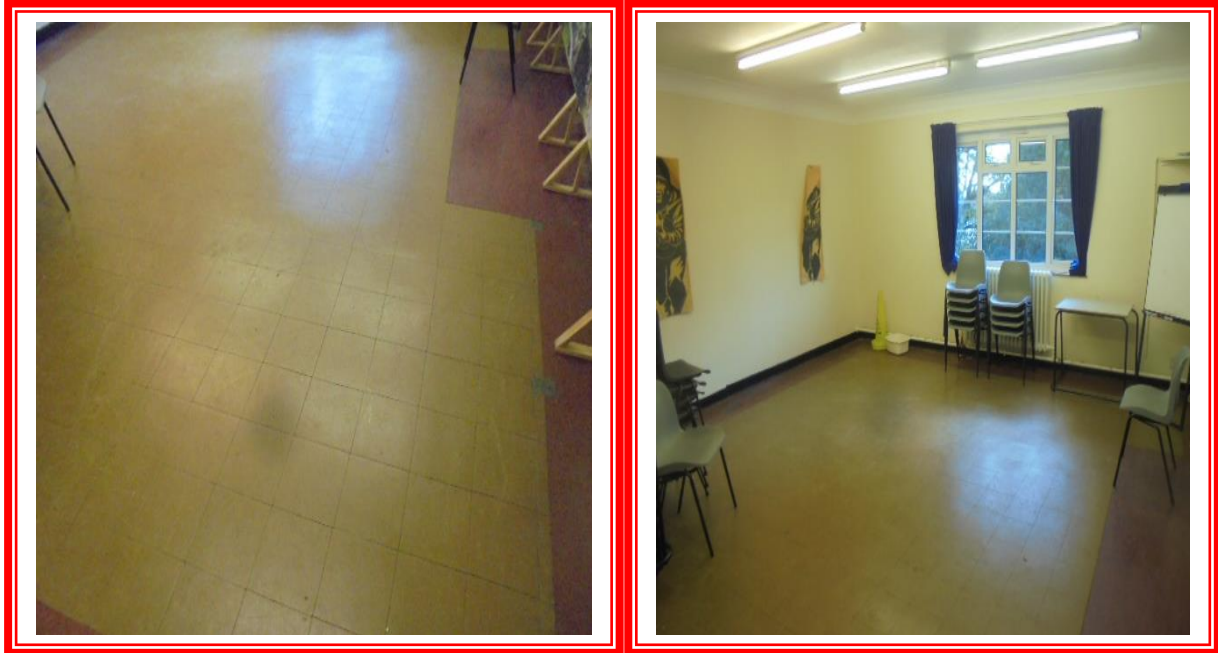
Material Description:	Floor Tiles and Adhesive	
Identification:	As Per Sample DK/12 – Asbestos Detected	
Approx. quantity:	25M2	
Accessibility	High	<i>Assessment Score</i>
Product type:	Composite	1
Extent of Damage:	Moderate	2
Surface Treatment:	Non-Friable	0
Asbestos type:	Chrysotile	1
Material Assessment Score:		4
Priority Assessment Score:		Negligible
Action:	Manage	
Comments:	N/A

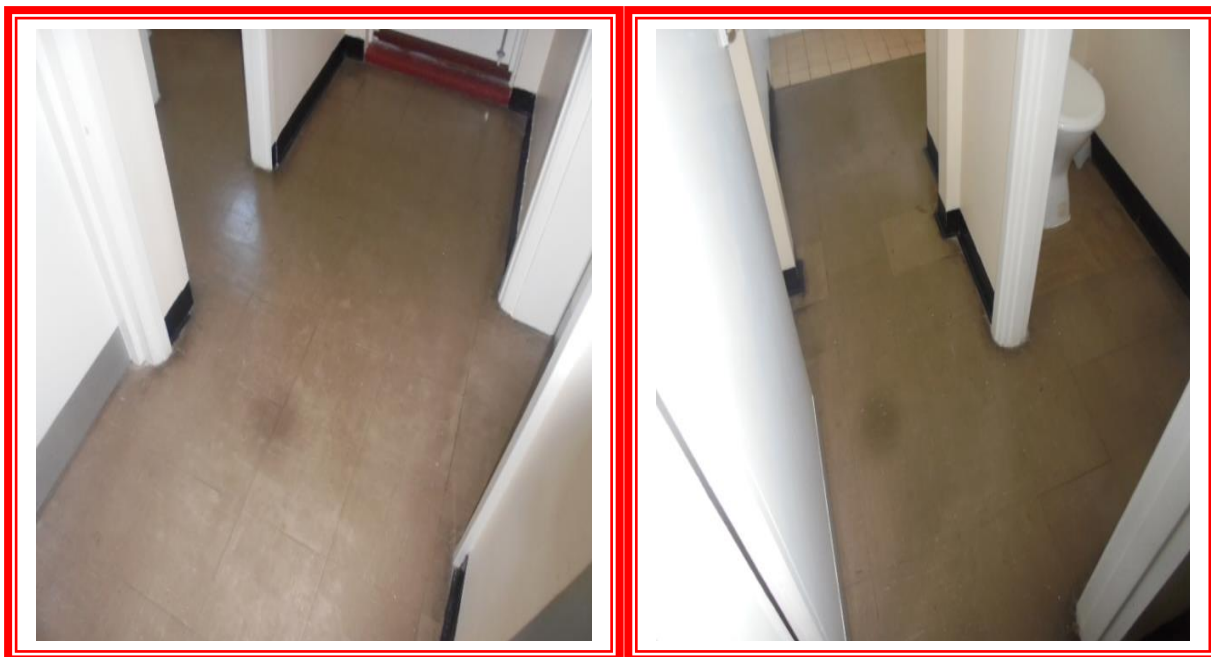
Material Description:	Floor Tiles and Adhesive	
Identification:	As Per Sample DK/16 – No Asbestos Detected	
Approx. quantity:	8M2	
Accessibility	High	Assessment Score
Product type:	Composite	1
Extent of Damage:	Minor	1
Surface Treatment:	Non-Friable	0
Asbestos type:	Chrysotile	1
Material Assessment Score:		3
Priority Assessment Score:		Negligible
Action:	Manage	
Comments:	Plastic Black Toilet Cistern

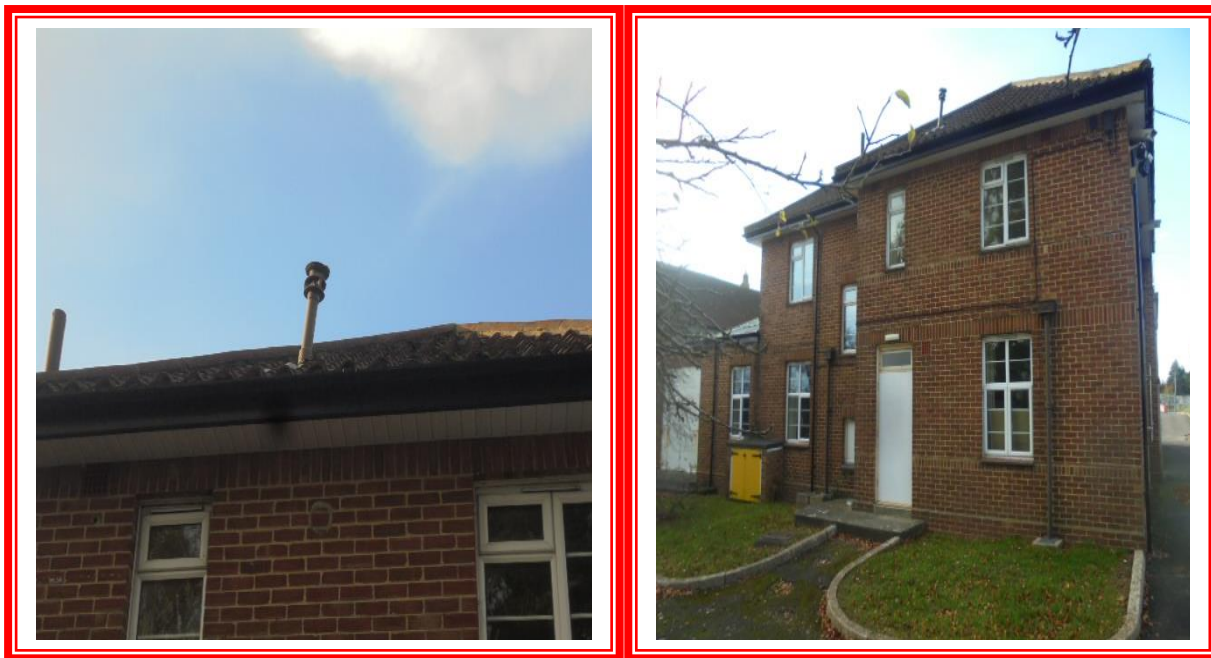
Material Description:	Cement Flue Pipes	
Identification:	Strongly Presumed to Contain Asbestos	
Approx. quantity:	(2No. Pipes 1-2LM)	
Accessibility	Low	Assessment Score
Product type:	Cement	1
Extent of Damage:	Minor	1
Surface Treatment:	Unsealed	1
Asbestos type:	Chrysotile	1
Material Assessment Score:		4
Priority Assessment Score:		Negligible
Action:	Manage	
Comments:	No Access to Sample due to Height

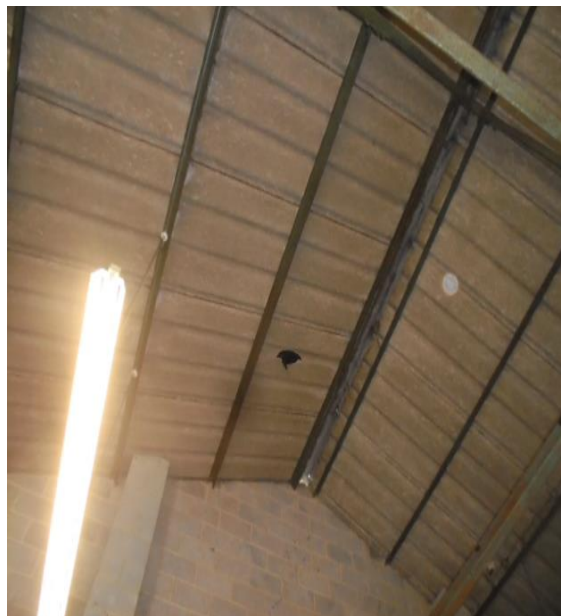
Material Description:	Profiled Cement Roof	
Identification:	Strongly Presumed to Contain Asbestos	
Approx. quantity:	800M2	
Accessibility	Low	<i>Assessment Score</i>
Product type:	Cement	1
Extent of Damage:	Moderate	2
Surface Treatment:	Unsealed	1
Asbestos type:	Chrysotile	1
Material Assessment Score:		5
Priority Assessment Score:		Low
Action:	Manage	
Comments:	Several Holes in Roof

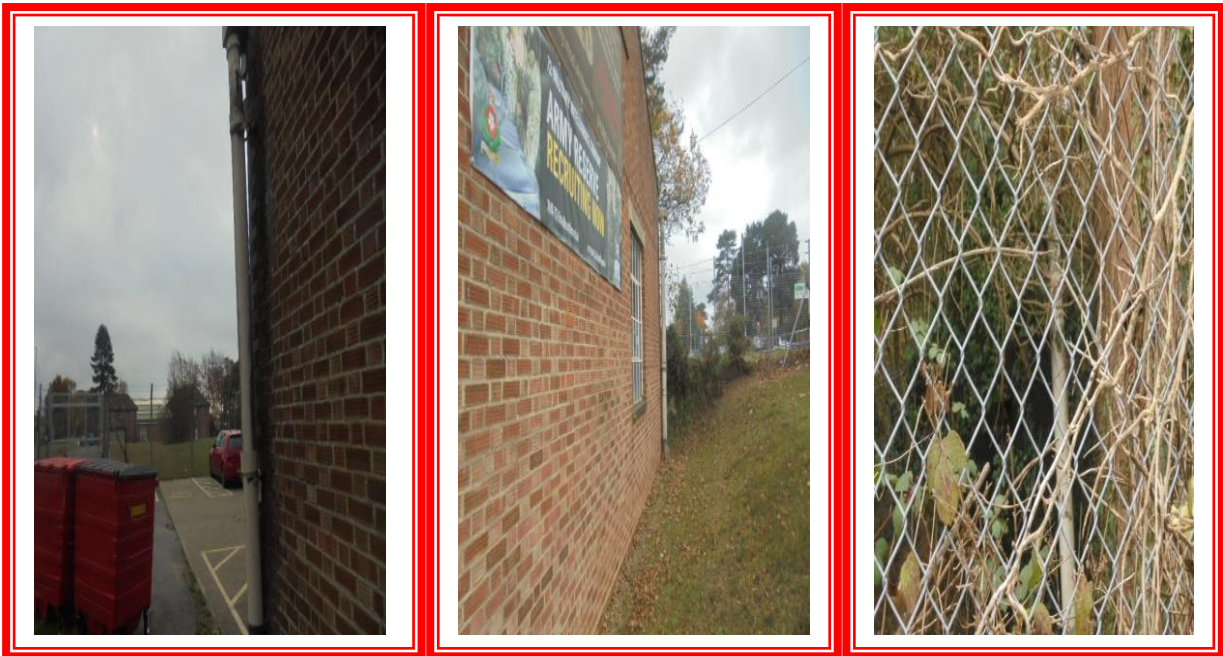
Material Description:	Cement Downpipes	
Identification:	Sampled – Asbestos Detected	
Approx. quantity:	X3 (15LM Total)	
Accessibility	Low	Assessment Score
Product type:	Cement	1
Extent of Damage:	Moderate	2
Surface Treatment:	Unsealed	1
Asbestos type:	Chrysotile	1
Material Assessment Score:		5
Priority Assessment Score:		Low
Action:	Remove	
Comments:	One downpipe has fallen off, and the other two Pipes appear to be loose
