Project Number 2481

**Management
Asbestos Survey Report**

**7th Battalion, The Rifles C, Dorset,
BH12 5AD**

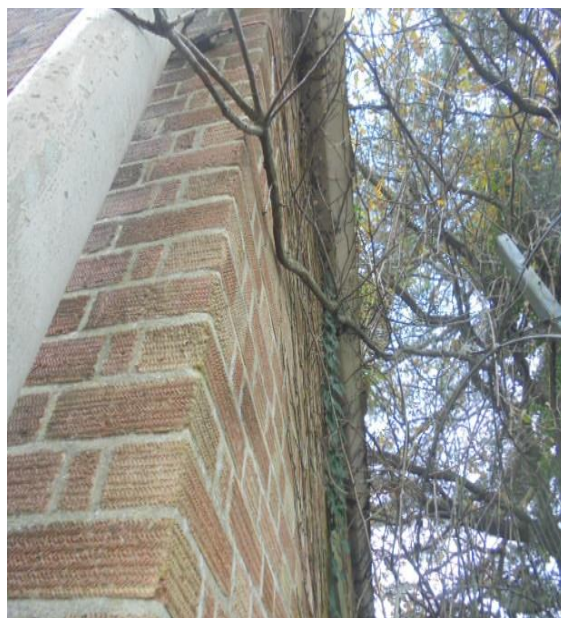
Material Description:	Cement Guttering	
Identification:	As Per Sample DK/17 – Asbestos Detected	
Approx. quantity:	55LM	
Accessibility	Low	Assessment Score
Product type:	Cement	1
Extent of Damage:	Minor	1
Surface Treatment:	Unsealed	1
Asbestos type:	Chrysotile	1
Material Assessment Score:		4
Priority Assessment Score:		Negligible
Action:	Manage	
Comments:	N/A

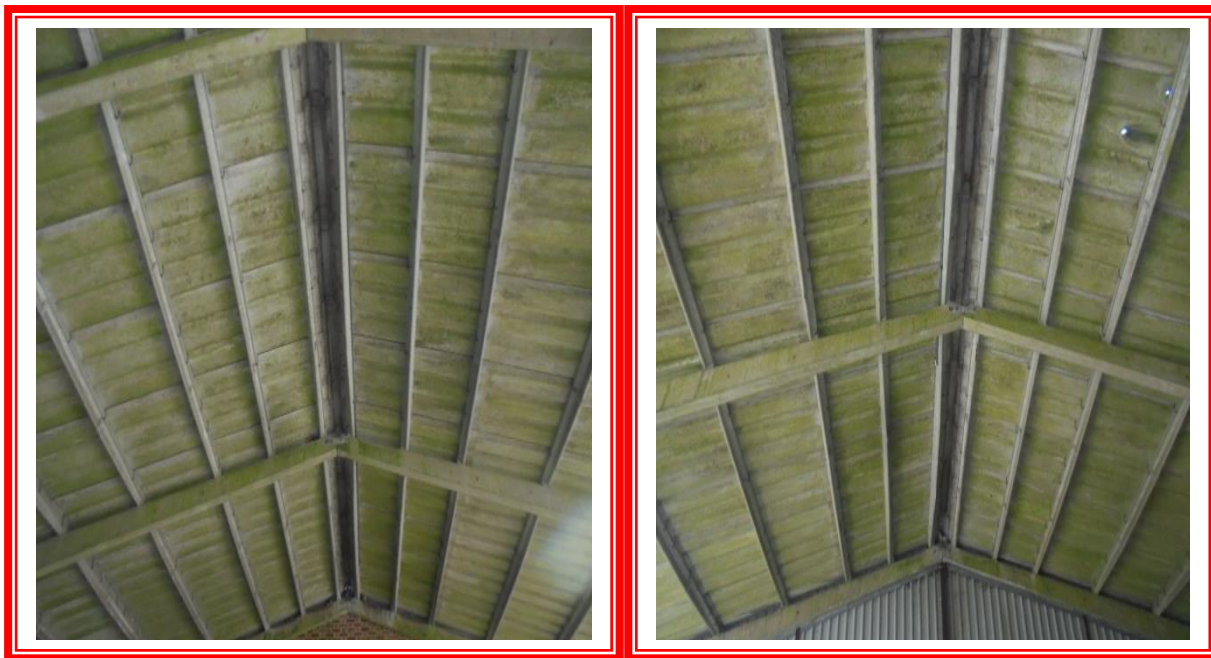
Material Description:	Profiled Cement Roof	
Identification:	Strongly Presumed to Contain Asbestos	
Approx. quantity:	510M2	
Accessibility	Low	Assessment Score
Product type:	Cement	1
Extent of Damage:	Moderate	2
Surface Treatment:	Unsealed	1
Asbestos type:	Chrysotile	1
Material Assessment Score:		5
Priority Assessment Score:		Low
Action:	Manage	
Comments:	Several Holes in Roof and Possible Debris – Floor Must Only Be Cleaned/swept by an Asbestos Trained Contractor

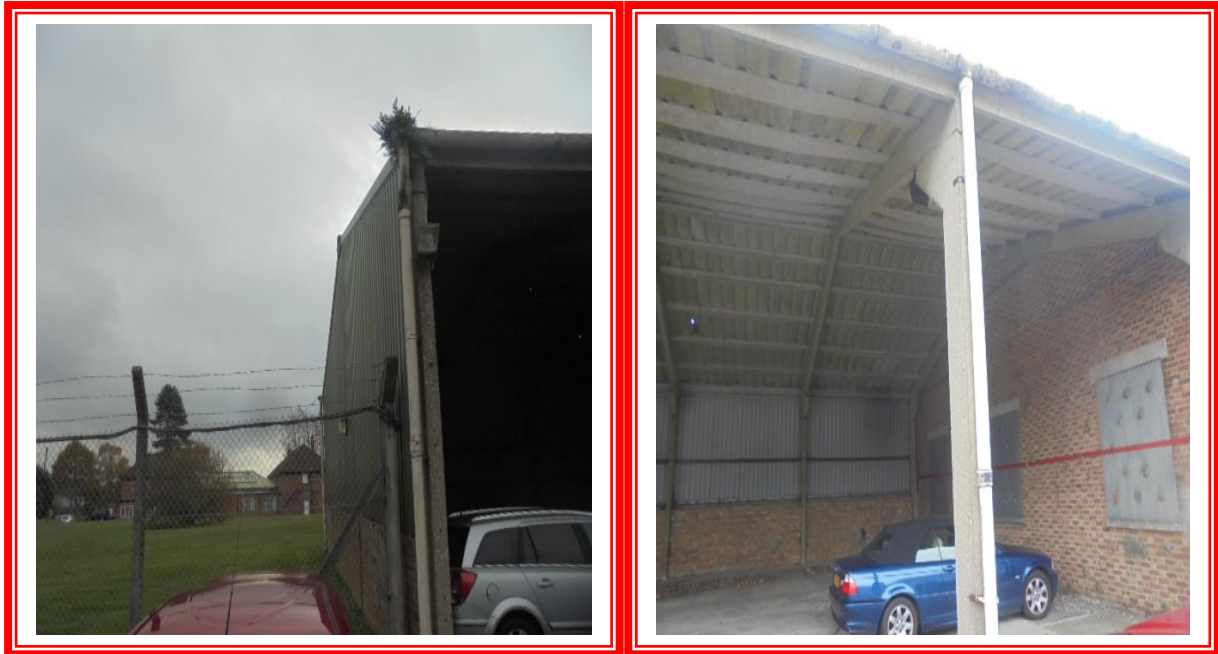
Material Description:	Cement Downpipes	
Identification:	As Per Sample DK/17 – Asbestos Detected	
Approx. quantity:	6X Pipes (30LM Total)	
Accessibility	Low	Assessment Score
Product type:	Cement	1
Extent of Damage:	Minor	1
Surface Treatment:	Unsealed	1
Asbestos type:	Chrysotile	1
Material Assessment Score:		4
Priority Assessment Score:		Negligible
Action:	Manage/Encapsulate	
Comments:	One Pipe Appears to be Loose and Should be Replaced

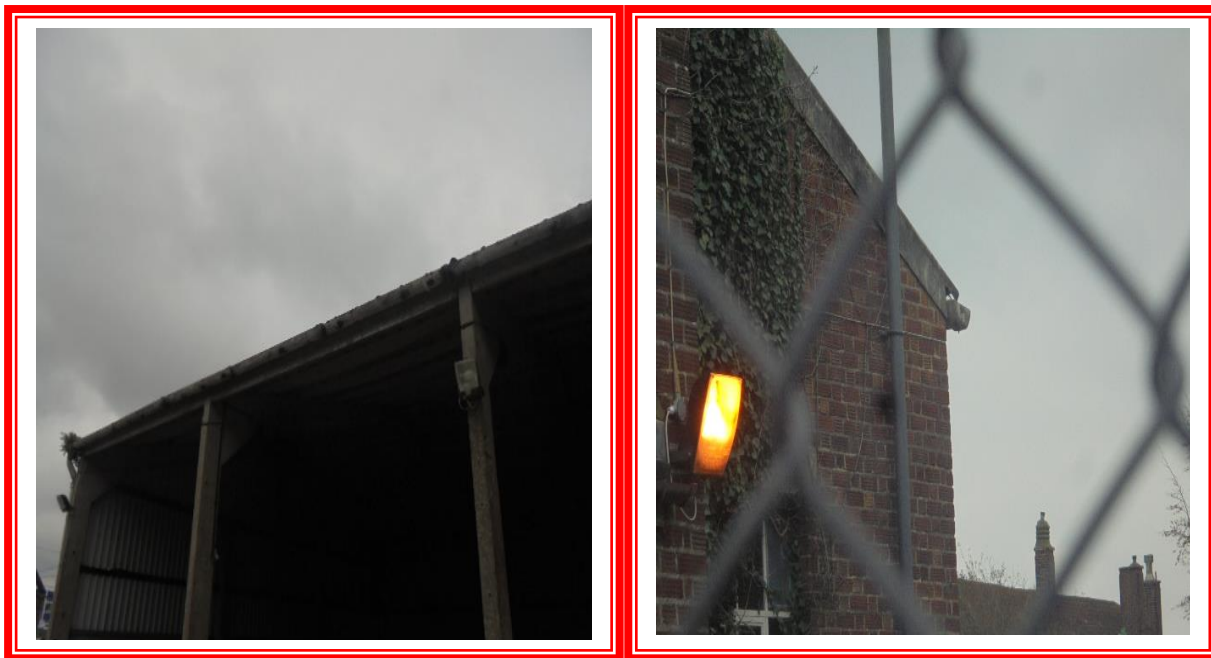
Material Description:	Cement Guttering	
Identification:	As Per Sample DK/17 – Asbestos Detected	
Approx. quantity:	55LM	
Accessibility	Low	Assessment Score
Product type:	Cement	1
Extent of Damage:	Minor	1
Surface Treatment:	Unsealed	1
Asbestos type:	Chrysotile	1
Material Assessment Score:		4
Priority Assessment Score:		Negligible
Action:	Manage	
Comments:	N/A

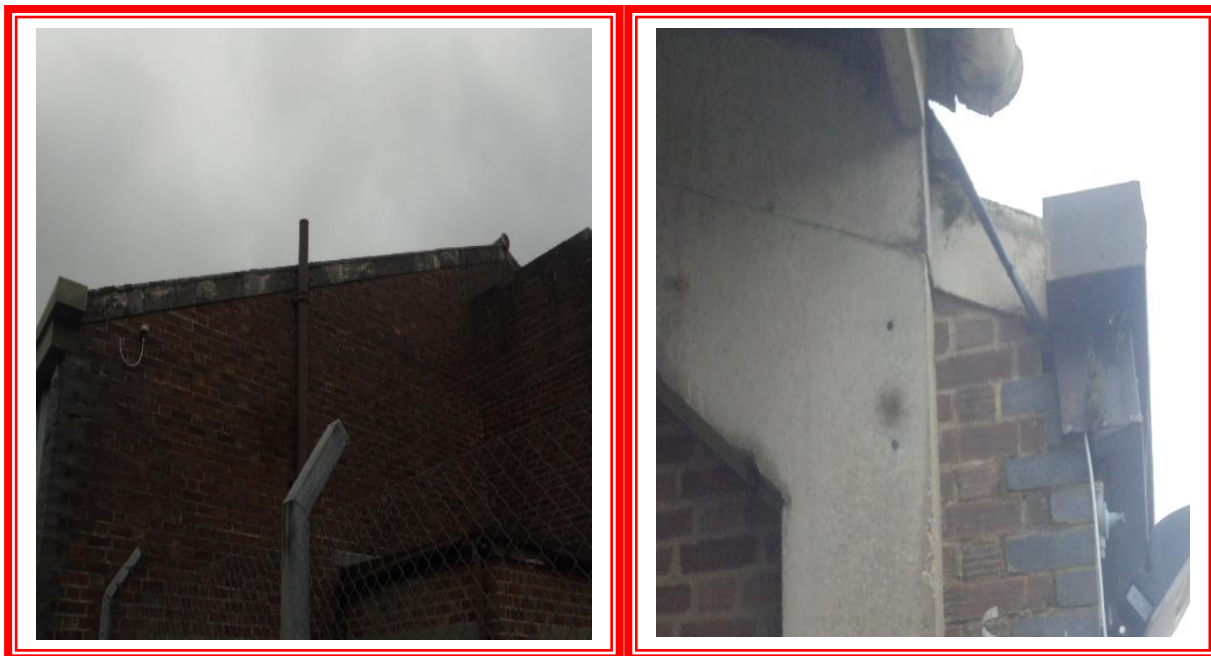
Material Description:	Cement Roof Edging	
Identification:	Strongly Presumed to Contain Asbestos	
Approx. quantity:	42LM	
Accessibility	Low	Assessment Score
Product type:	Cement	1
Extent of Damage:	Minor	1
Surface Treatment:	Unsealed	1
Asbestos type:	Chrysotile	1
Material Assessment Score:		4
Priority Assessment Score:		Negligible
Action:	Manage	
Comments:	No Access to Sample due to Height

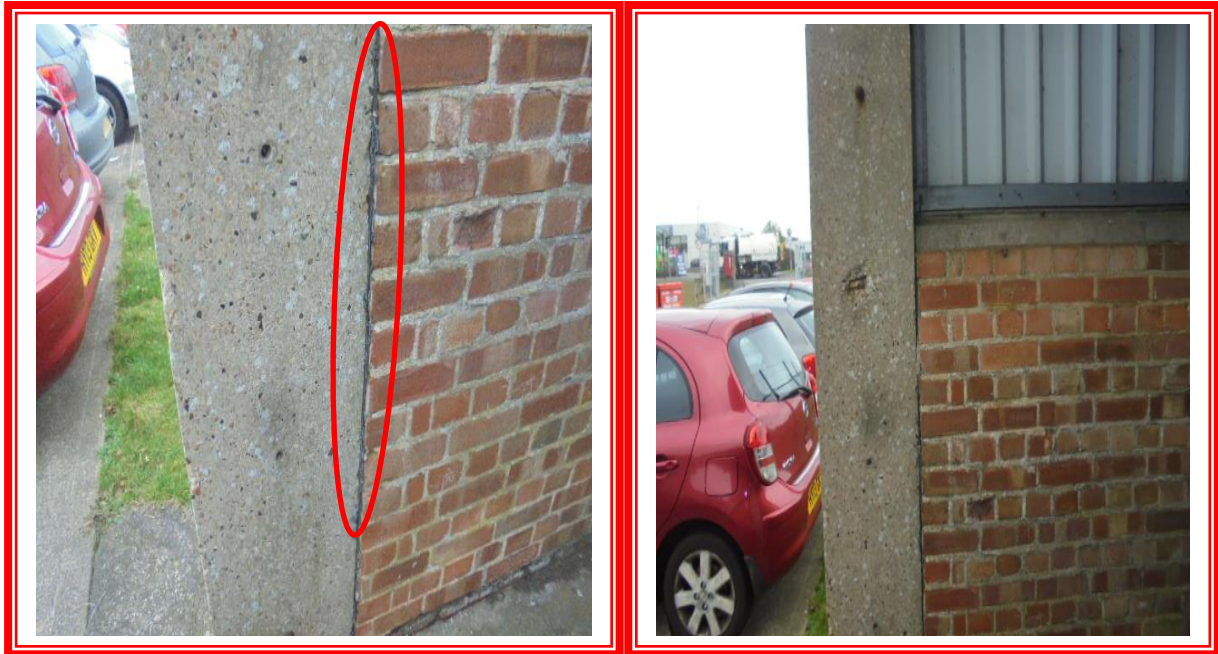
Material Description:	Damp Proof Course	
Identification:	Sampled – Asbestos Detected	
Approx. quantity:	To Entire Perimeter of Building and Walls	
Accessibility	Low	Assessment Score
Product type:	Bitumen	1
Extent of Damage:	Minor	1
Surface Treatment:	Non-Friable	0
Asbestos type:	Chrysotile	1
Material Assessment Score:		3
Priority Assessment Score:		Negligible
Action:	Manage	
Comments:	N/A

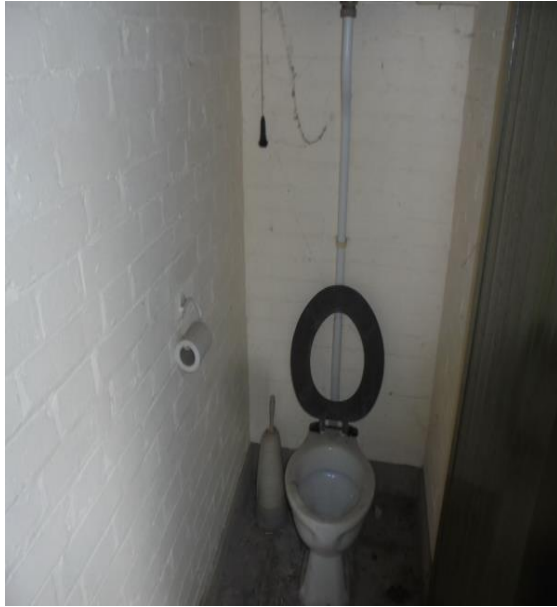
Material Description:	Toilet Seats	
Identification:	Presumed to Contain Asbestos	
Approx. quantity:	X2 Seats	
Accessibility	Low	Assessment Score
Product type:	Composite	1
Extent of Damage:	Minor	1
Surface Treatment:	Non-Friable	0
Asbestos type:	Chrysotile	1
Material Assessment Score:		3
Priority Assessment Score:		Negligible
Action:	Manage	
Comments:	No Access to Sample as May Damage integrity of Seats

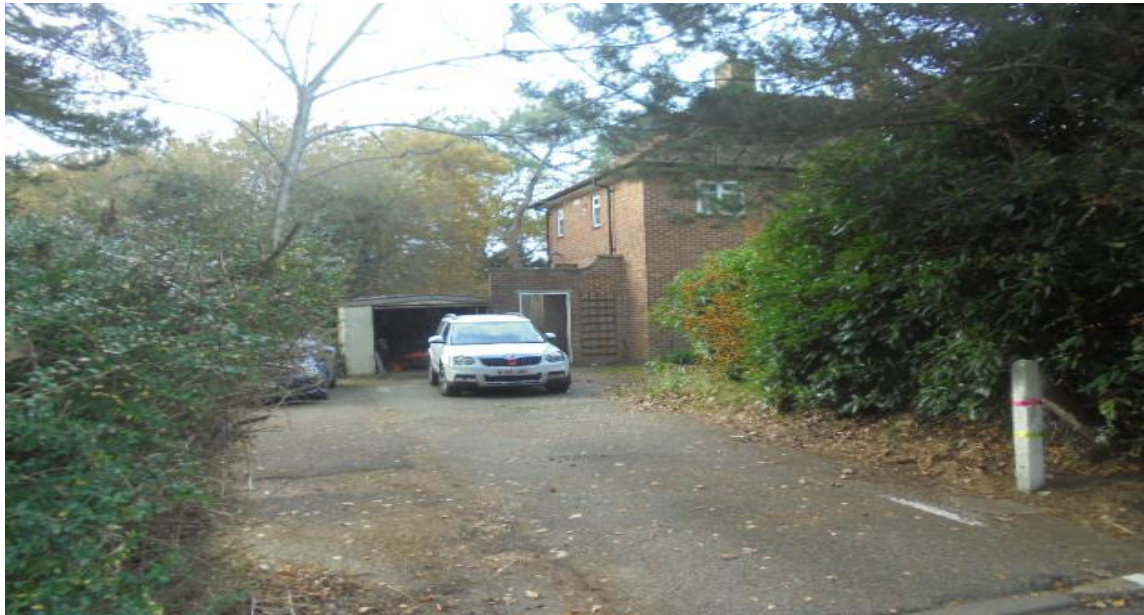
Material Description:	No Access within House	
Identification:	Presumed to Contain Asbestos	
Approx. quantity:	Unknown	
Accessibility	Low	Assessment Score
Product type:	No Access	3
Extent of Damage:	No Access	3
Surface Treatment:	No Access	3
Asbestos type:	No Access	3
Material Assessment Score:		12
Priority Assessment Score:		High
Action:	Further Investigation Required	
Comments:	No Access to Inspect House on Request of the Caretaker

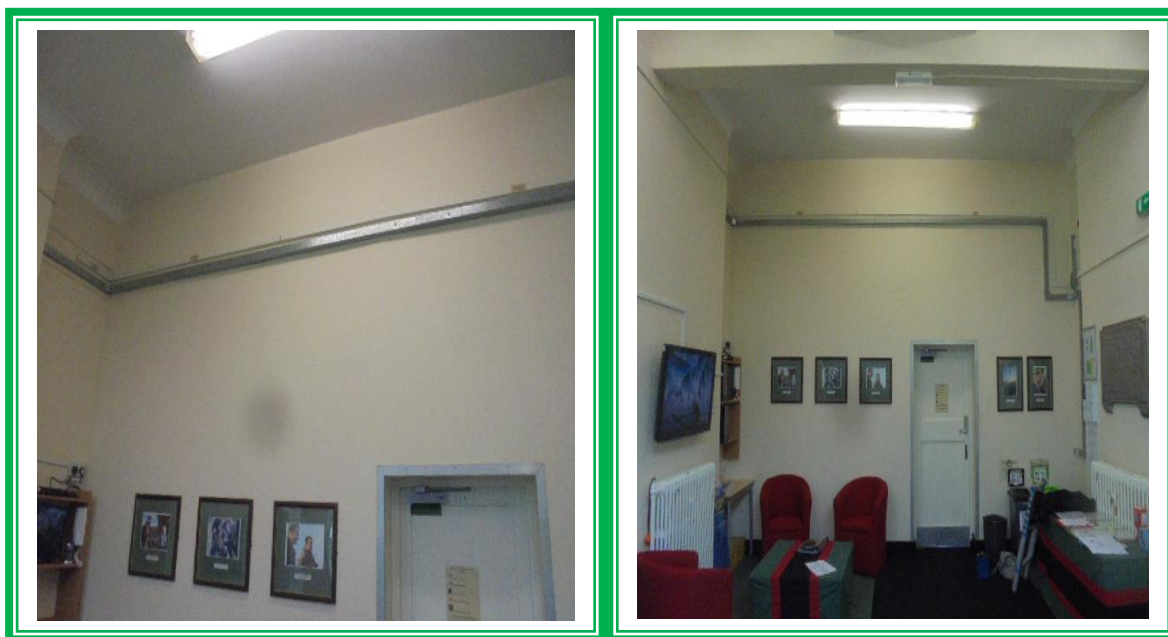
Material Description:	Insulation Board Wall Panels	
Identification:	Sampled – No Asbestos Detected	
Approx. quantity:	Medium	
Accessibility	High	<i>Assessment Score</i>
Product type:	N/A	N/A
Extent of Damage:	N/A	N/A
Surface Treatment:	N/A	N/A
Asbestos type:	N/A	N/A
Material Assessment Score:		N/A
Priority Assessment Score:		N/A
Action:	N/A	
Comments:	N/A

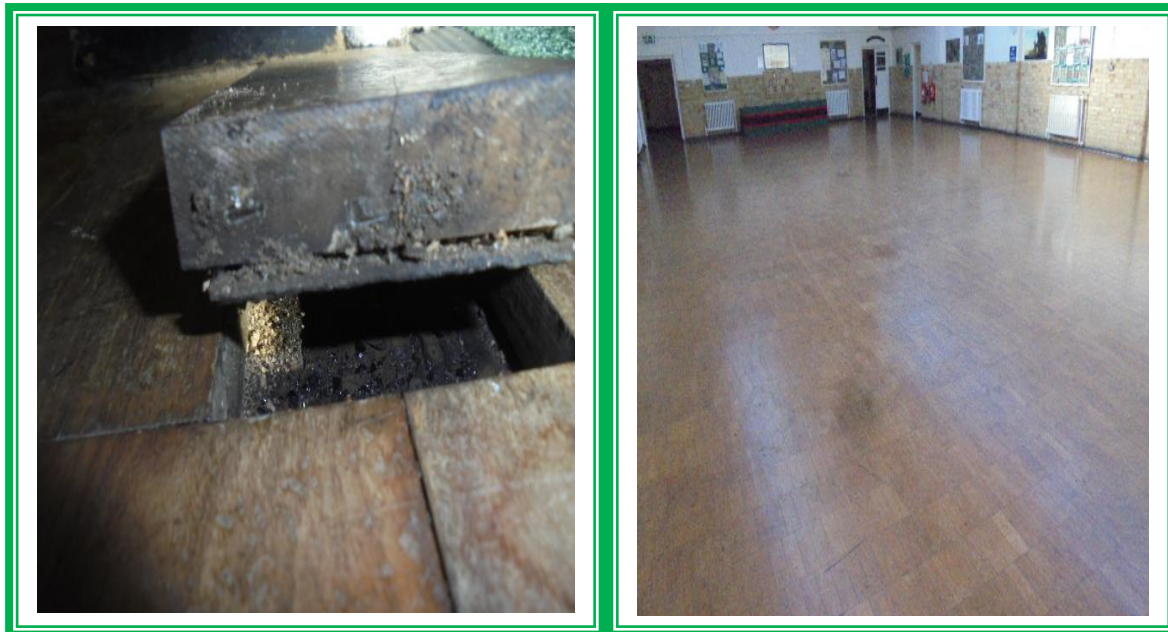
Material Description:	Bitumen Under Parquet Flooring	
Identification:	Sampled – No Asbestos Detected	
Approx. quantity:	190M2	
Accessibility	N/A	<i>Assessment Score</i>
Product type:	N/A	N/A
Extent of Damage:	N/A	N/A
Surface Treatment:	N/A	N/A
Asbestos type:	N/A	N/A
Material Assessment Score:		N/A
Priority Assessment Score:		N/A
Action:	N/A	
Comments:	Limited Access above Suspended Ceiling Tiles due to Height

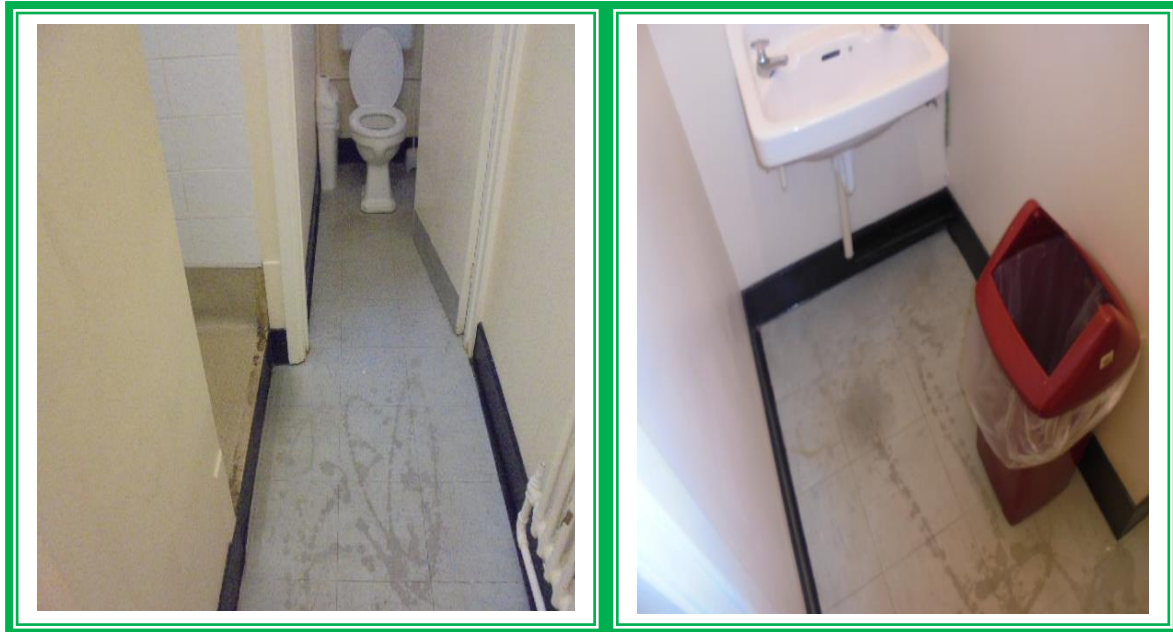
Material Description:	Floor Tiles and Adhesive	
Identification:	Sampled – No Asbestos Detected	
Approx. quantity:	5M2	
Accessibility	N/A	<i>Assessment Score</i>
Product type:	N/A	N/A
Extent of Damage:	N/A	N/A
Surface Treatment:	N/A	N/A
Asbestos type:	N/A	N/A
Material Assessment Score:		N/A
Priority Assessment Score:		N/A
Action:	N/A	
Comments:	N/A

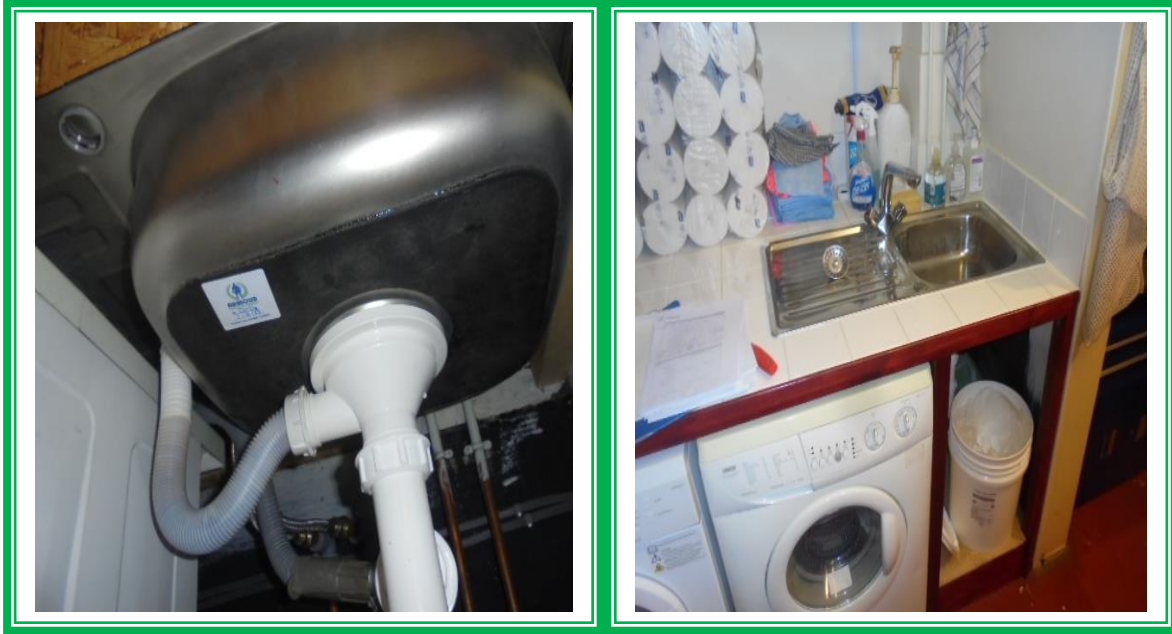
Material Description:	Sink Pad	
Identification:	Sampled – No Asbestos Detected	
Approx. quantity:	1X Sink	
Accessibility	N/A	<i>Assessment Score</i>
Product type:	N/A	N/A
Extent of Damage:	N/A	N/A
Surface Treatment:	N/A	N/A
Asbestos type:	N/A	N/A
Material Assessment Score:		N/A
Priority Assessment Score:		N/A
Action:	N/A	
Comments:	N/A

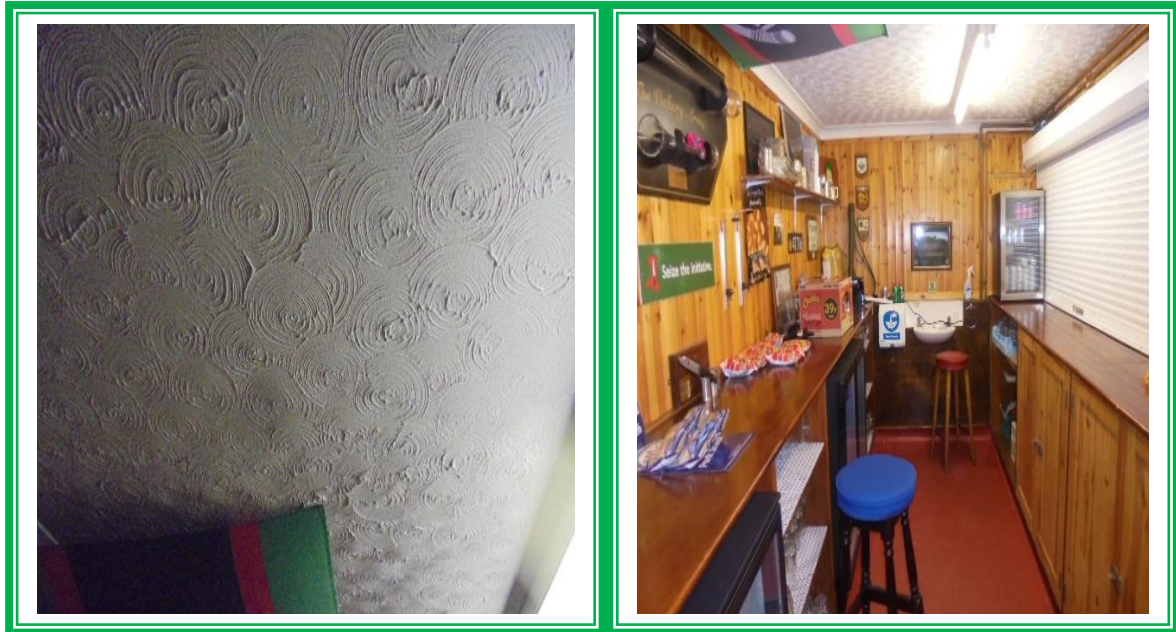
Material Description:	Textured Coating to Ceiling	
Identification:	Sampled – No Asbestos Detected	
Approx. quantity:	10M2	
Accessibility	N/A	<i>Assessment Score</i>
Product type:	N/A	N/A
Extent of Damage:	N/A	N/A
Surface Treatment:	N/A	N/A
Asbestos type:	N/A	N/A
Material Assessment Score:		N/A
Priority Assessment Score:		N/A
Action:	N/A	
Comments:	N/A

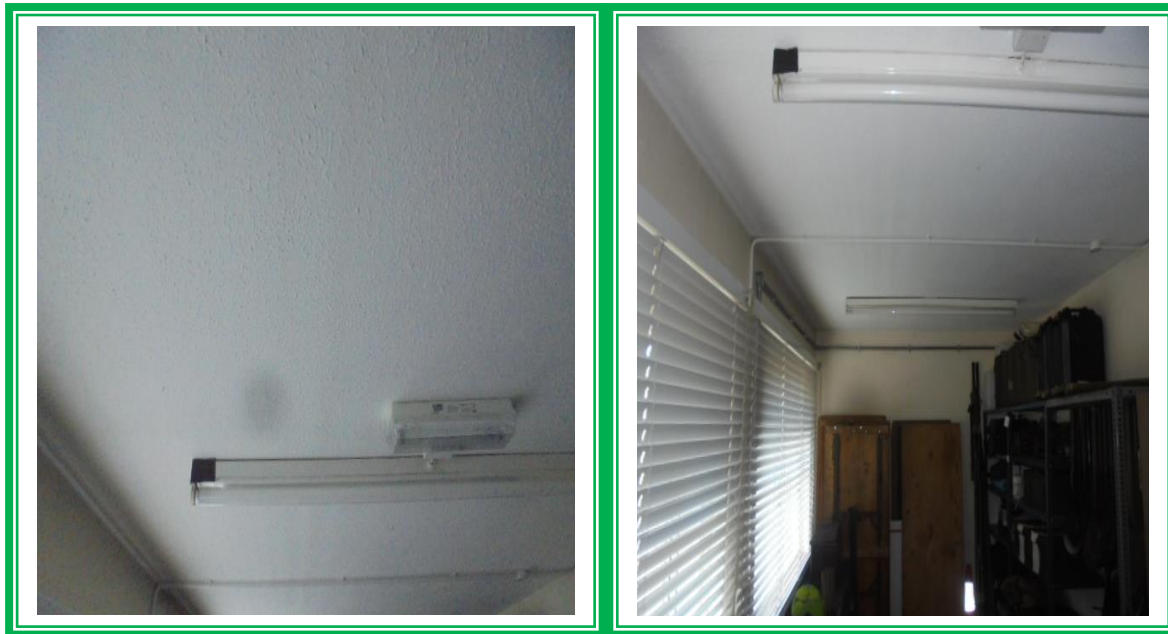
Material Description:	Textured Coating to Ceiling	
Identification:	Sampled – No Asbestos Detected	
Approx. quantity:	14M2	
Accessibility	N/A	<i>Assessment Score</i>
Product type:	N/A	N/A
Extent of Damage:	N/A	N/A
Surface Treatment:	N/A	N/A
Asbestos type:	N/A	N/A
Material Assessment Score:		N/A
Priority Assessment Score:		N/A
Action:	N/A	
Comments:	N/A

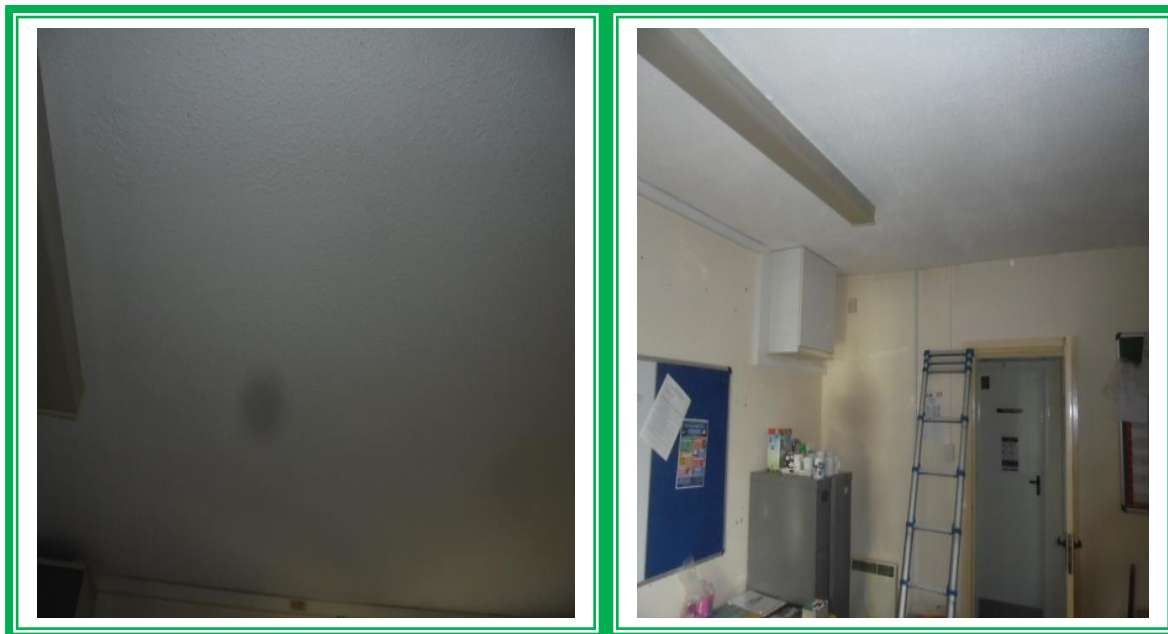
Material Description:	Textured Coating to Ceiling	
Identification:	Sampled – No Asbestos Detected	
Approx. quantity:	20M2	
Accessibility	N/A	<i>Assessment Score</i>
Product type:	N/A	N/A
Extent of Damage:	N/A	N/A
Surface Treatment:	N/A	N/A
Asbestos type:	N/A	N/A
Material Assessment Score:		N/A
Priority Assessment Score:		N/A
Action:	N/A	
Comments:	N/A

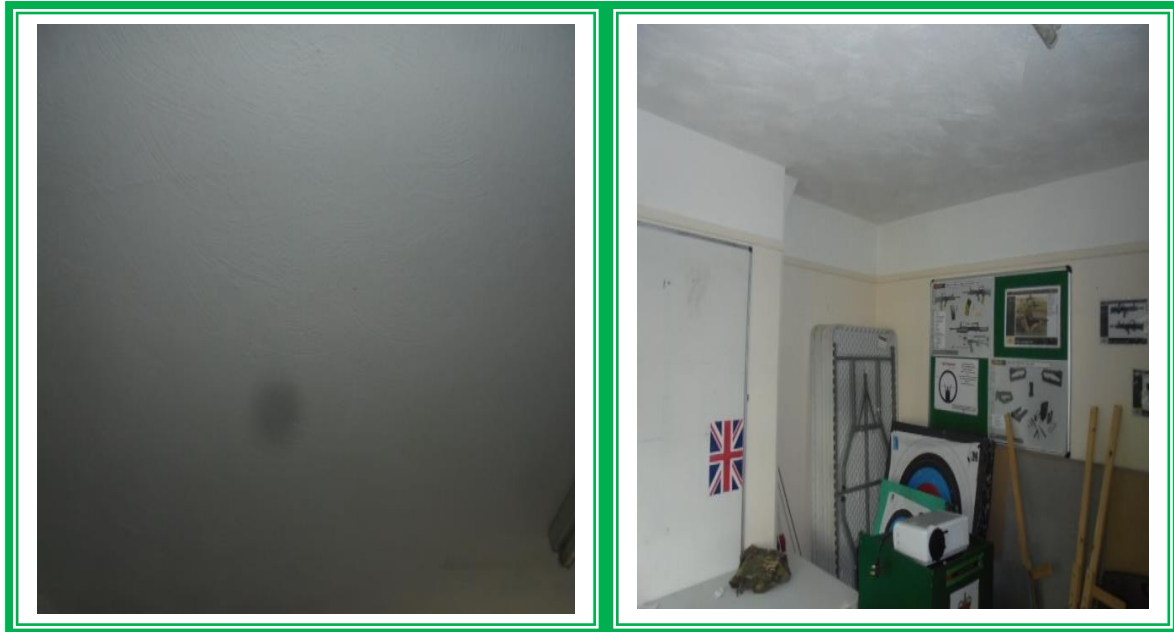
Material Description:	Textured Coating to Ceiling	
Identification:	Sampled – No Asbestos Detected	
Approx. quantity:	16M2	
Accessibility	N/A	<i>Assessment Score</i>
Product type:	N/A	N/A
Extent of Damage:	N/A	N/A
Surface Treatment:	N/A	N/A
Asbestos type:	N/A	N/A
Material Assessment Score:		N/A
Priority Assessment Score:		N/A
Action:	N/A	
Comments:	N/A

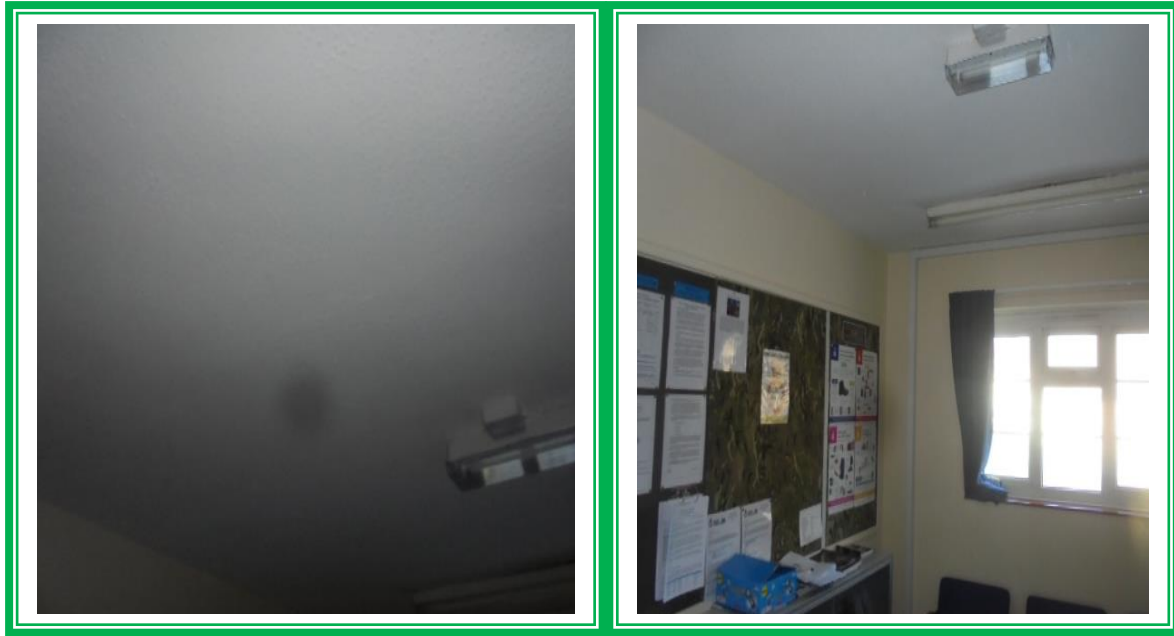
Material Description:	Textured Coating to Ceilings	
Identification:	As Per Sample DK/13 – No Asbestos Detected	
Approx. quantity:	15M2	
Accessibility	N/A	Assessment Score
Product type:	N/A	N/A
Extent of Damage:	N/A	N/A
Surface Treatment:	N/A	N/A
Asbestos type:	N/A	N/A
Material Assessment Score:		N/A
Priority Assessment Score:		N/A
Action:	N/A	
Comments:	N/A

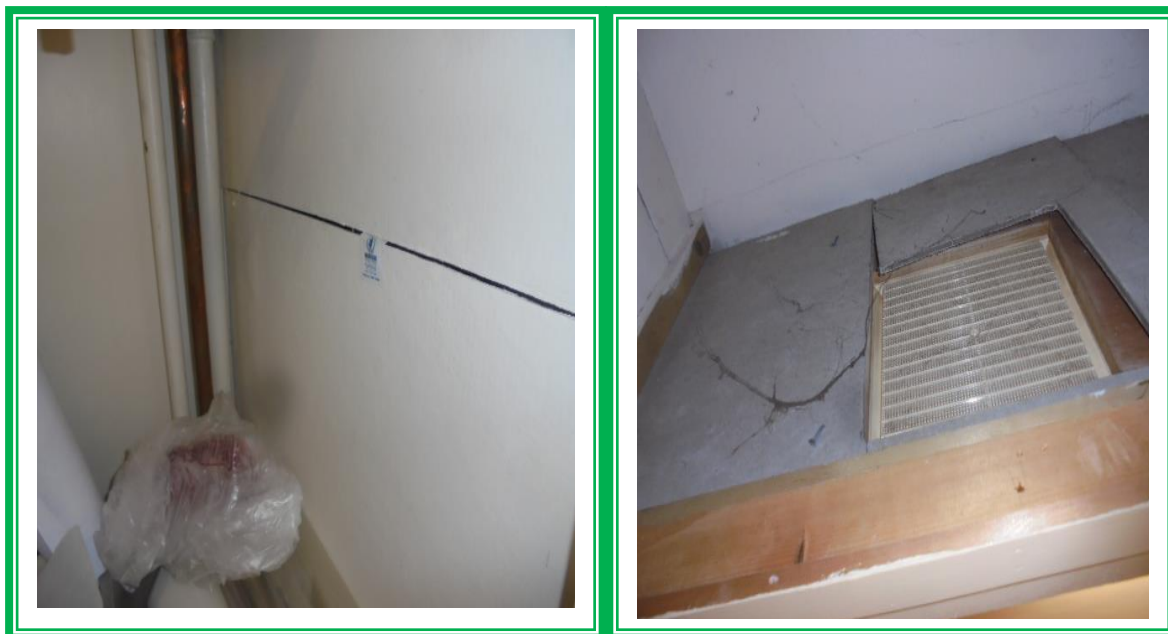
Material Description:	Cement Wall and Door Header Panels	
Identification:	Sampled – No Asbestos Detected	
Approx. quantity:	5M2	
Accessibility	N/A	<i>Assessment Score</i>
Product type:	N/A	N/A
Extent of Damage:	N/A	N/A
Surface Treatment:	N/A	N/A
Asbestos type:	N/A	N/A
Material Assessment Score:		N/A
Priority Assessment Score:		N/A
Action:	N/A	
Comments:	Located to Cupboard
