Project Number A-00712 (3700)

**Re-Inspection
Asbestos Survey Report**

**HMS Flying Fox
Winter stokes Road.
Bristol
BS3 2NS**

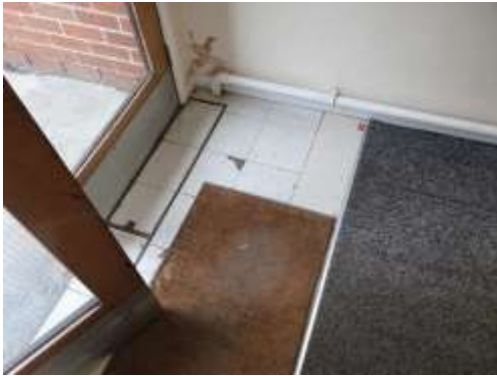
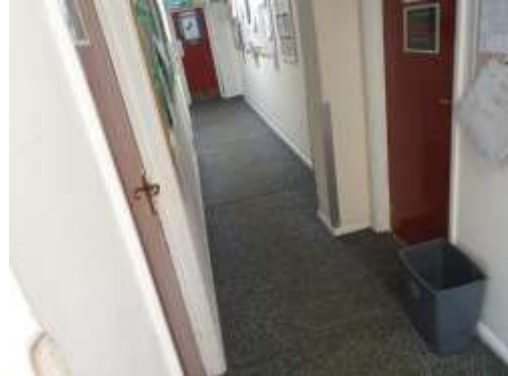
Item No:	2	Sample No:	N/A
Location:	Ground Floor - 6 Rifles Offices, Lobby & Corridor 002

Material Description:	Floor - Vinyl Products	
Identification:	Previously Sampled - Asbestos Detected	
Approx. quantity:	200 m ²	
Accessibility	Medium	Assessment Score
Product type:	Vinyl	1
Extent of Damage:	Moderate damage	2
Surface Treatment:	Non-friable	0
Asbestos type:	Chrysotile	1
Material Assessment Score:		4
Priority Assessment Score:		Negligible
Action:	Manage	
Comments:	Previously sampled as per samples 1 & 7 Under all carpets in 6 rifles offices & bar. White & Brown tiles throughout area of building.

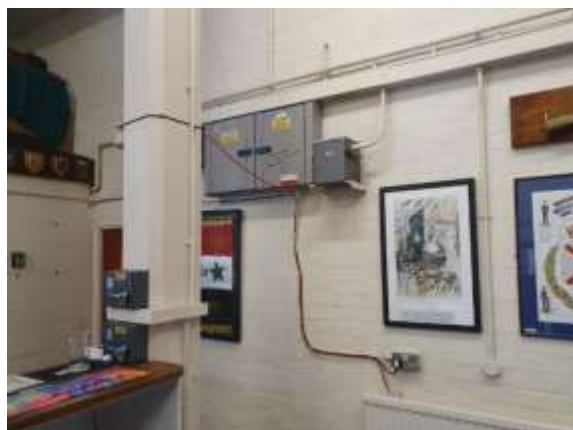
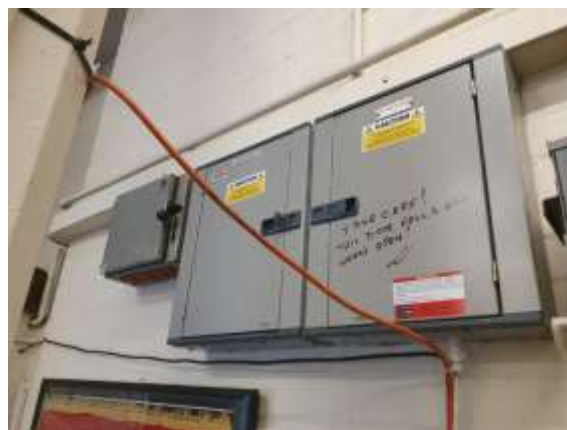
Location: Ground Floor - 6 Rifles Bar Area 003

Material Description:	Electric Box - Gaskets (rope/woven)	
Identification:	Presumed to Contain Asbestos	
Approx. quantity:	2 no	
Accessibility	Difficult	<i>Assessment Score</i>
Product type:	Rope	2
Extent of Damage:	Major damage	3
Surface Treatment:	Unsealed Insulation	3
Asbestos type:	Presumed	3
Material Assessment Score:		11
Priority Assessment Score:		High
Action:	Manage	
Comments:	Presumed Flashguards within live electrics. Unable to sample as Live

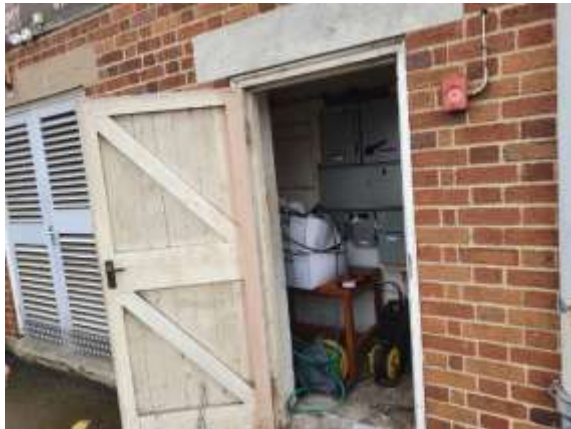
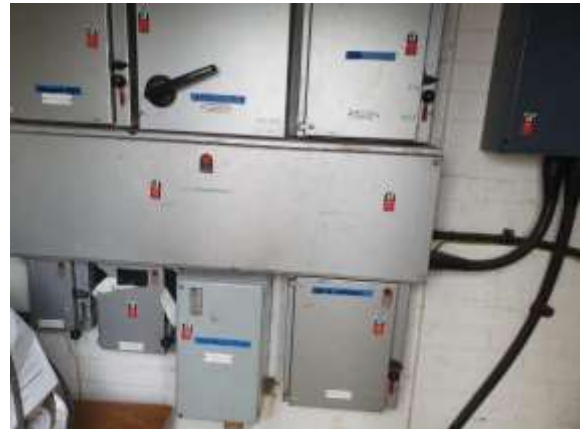
Location: Ground Floor - 6 Rifles Boiler Room (Small) 004

Material Description:	Electric Box - Gaskets (rope/woven)	
Identification:	Presumed to Contain Asbestos	
Approx. quantity:	8 no	
Accessibility	Difficult	<i>Assessment Score</i>
Product type:	Rope	2
Extent of Damage:	Major damage	3
Surface Treatment:	Unsealed Insulation	3
Asbestos type:	Presumed	3
Material Assessment Score:		11
Priority Assessment Score:		High
Action:	Manage	
Comments:	Presumed Flashguards within live electrics. Unable to sample as Live

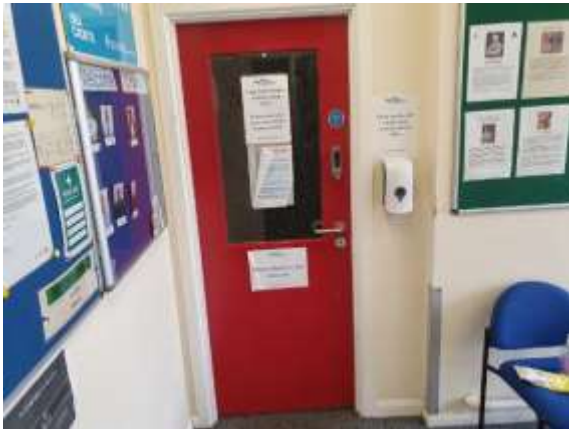
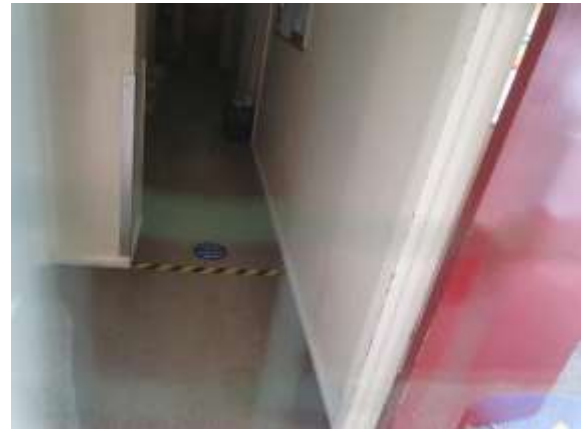
Location: Ground Floor - Sea Cadets Offices & Corridor 005

Material Description:	Floor - Vinyl Products	
Identification:	Previously Sampled - Asbestos Detected	
Approx. quantity:	200 m ²	
Accessibility	Difficult	<i>Assessment Score</i>
Product type:	Vinyl	1
Extent of Damage:	Moderate damage	2
Surface Treatment:	Non-friable	0
Asbestos type:	Chrysotile	1
Material Assessment Score:		4
Priority Assessment Score:		Negligible
Action:	Manage	
Comments:	No access to this area as designated person was not on site but it is Previously sampled as per sample 1 & 7 by David Kelly and is under all carpets. Would suggest this remains same.

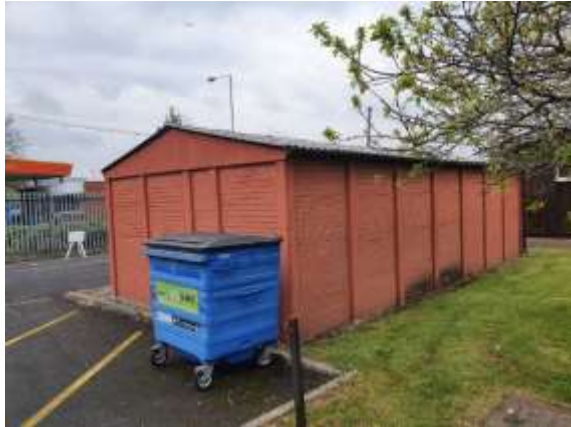
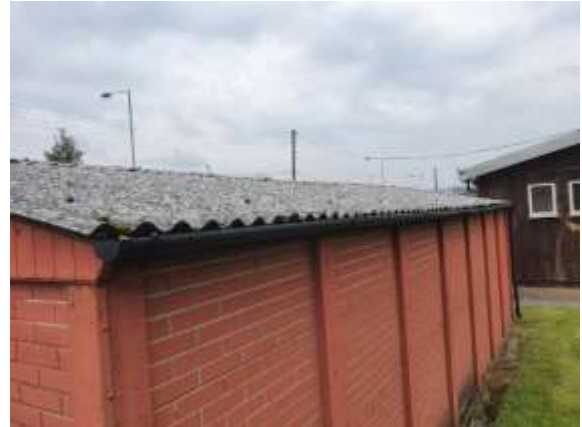
Location: External - RNR Storage 006

Material Description:	Roof Sheets - Cement Product	
Identification:	Presumed to Contain Asbestos	
Approx. quantity:	20 m ²	
Accessibility	Medium	<i>Assessment Score</i>
Product type:	Cement	1
Extent of Damage:	Major damage	3
Surface Treatment:	Unsealed Insulation	3
Asbestos type:	Presumed	3
Material Assessment Score:		10
Priority Assessment Score:		High
Action:	Manage	
Comments:	Presumed to contain Asbestos

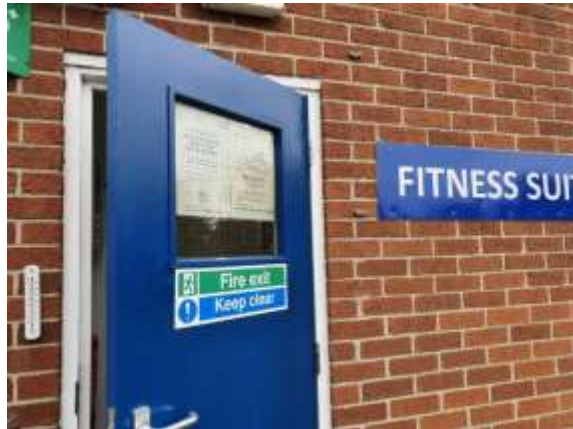
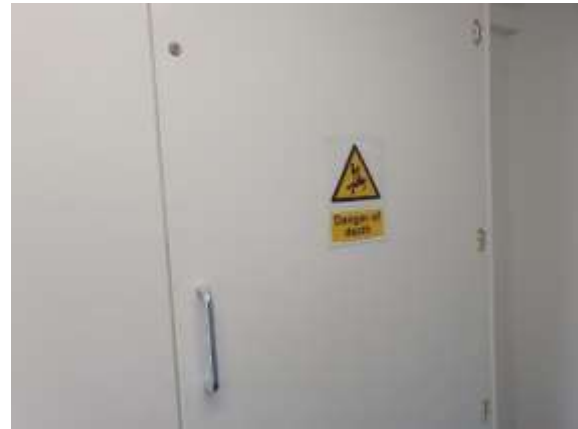
Location: Ground Floor - Fitness Suite 007

Material Description:	Electric Box - Gaskets (rope/woven)	
Identification:	Presumed to Contain Asbestos	
Approx. quantity:	2 no	
Accessibility	Difficult	<i>Assessment Score</i>
Product type:	Rope	2
Extent of Damage:	Major damage	3
Surface Treatment:	Unsealed Insulation	3
Asbestos type:	Presumed	3
Material Assessment Score:		11
Priority Assessment Score:		High
Action:	Manage	
Comments:	Presumed to contain Asbestos. Rest of suite modernised. Unable to sample as Live

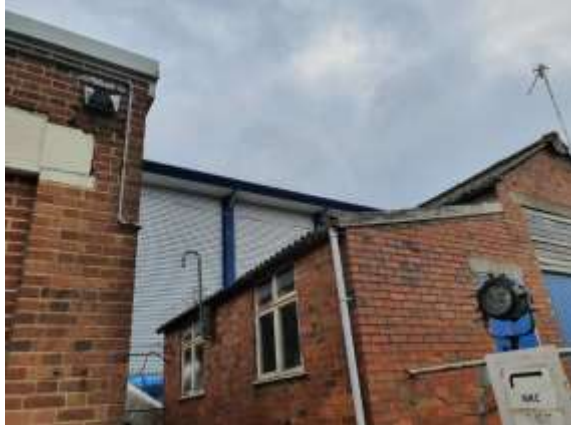
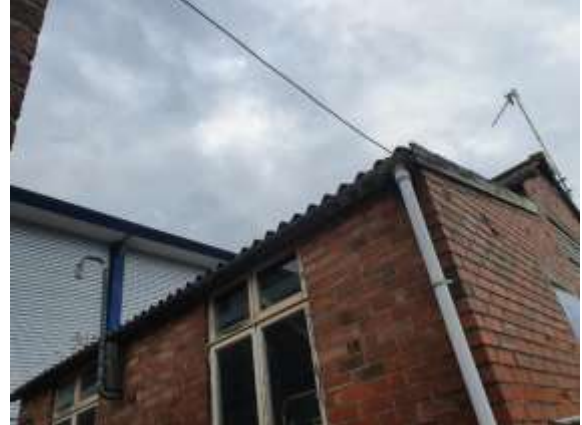
Location: External - Lay apart Store 008

Material Description:	Roof Sheets - Cement Product	
Identification:	Strongly Presumed to Contain Asbestos	
Approx. quantity:	20 m ²	
Accessibility	Difficult	<i>Assessment Score</i>
Product type:	Cement	1
Extent of Damage:	Moderate damage	2
Surface Treatment:	Non-friable	0
Asbestos type:	Presumed	3
Material Assessment Score:		6
Priority Assessment Score:		Low
Action:	Manage	
Comments:	Strongly Presume to contain Asbestos. No access due to height

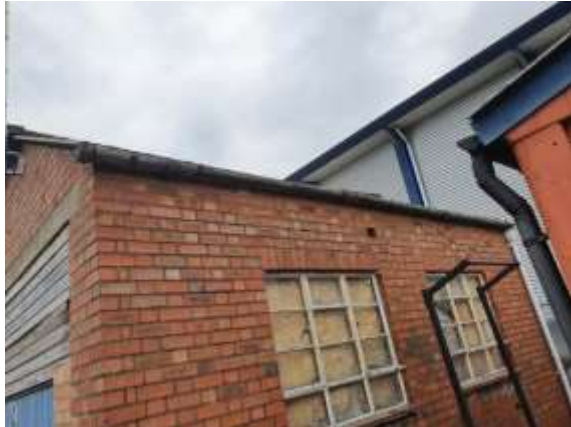
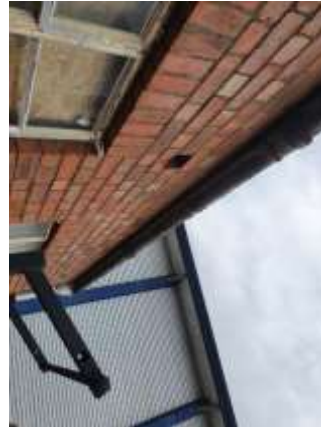
Location: External - Lay apart Store 009

Material Description:	Guttering - Cement Product	
Identification:	Strongly Presumed to Contain Asbestos	
Approx. quantity:	20 LM	
Accessibility	Difficult	<i>Assessment Score</i>
Product type:	Cement	1
Extent of Damage:	Moderate damage	2
Surface Treatment:	Non-friable	0
Asbestos type:	Presumed	3
Material Assessment Score:		6
Priority Assessment Score:		Low
Action:	Encapsulate	
Comments:	Strongly presume to contain Asbestos. Encapsulate or Remove

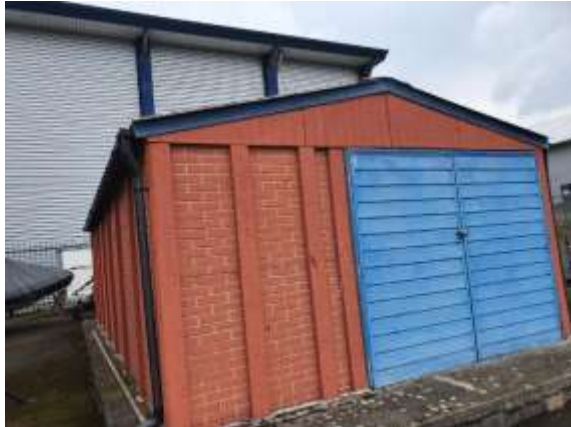
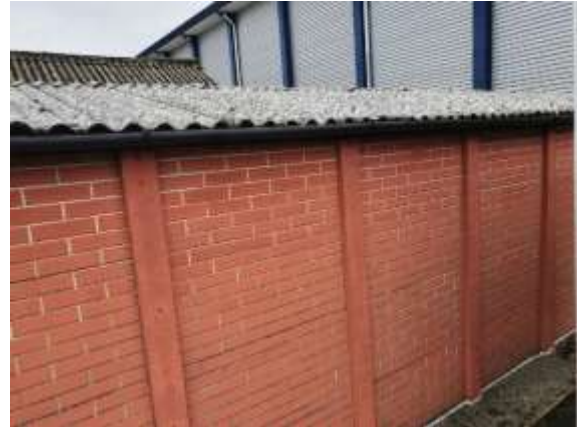
Location: External - Garage 010

Material Description:	Roof Sheets - Cement Product	
Identification:	Strongly Presumed to Contain Asbestos	
Approx. quantity:	20 m ²	
Accessibility	Difficult	<i>Assessment Score</i>
Product type:	Cement	1
Extent of Damage:	Moderate damage	2
Surface Treatment:	Non-friable	0
Asbestos type:	Presumed	3
Material Assessment Score:		6
Priority Assessment Score:		Low
Action:	Manage	
Comments:	Strongly presume to contain Asbestos

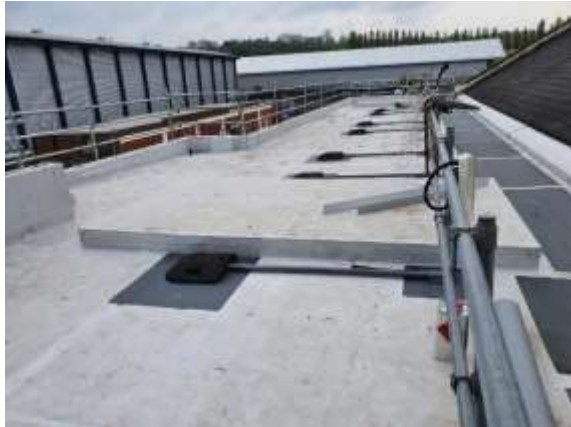
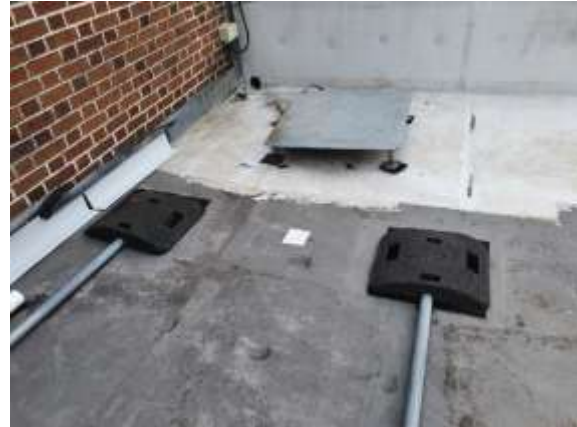
Location: External - Main Building Flat Roof 012

Material Description:	Roof Panels - Cement Product	
Identification:	Previously Sampled - Asbestos Detected	
Approx. quantity:	600 m ²	
Accessibility	Difficult	<i>Assessment Score</i>
Product type:	Cement	1
Extent of Damage:	Moderate damage	2
Surface Treatment:	Non-friable	0
Asbestos type:	Chrysotile	1
Material Assessment Score:		4
Priority Assessment Score:		Negligible
Action:	Manage	
Comments:	Previously identified in 2018 survey by Fineline Environmental. The roof panels have now been sealed over but Asbestos still present.

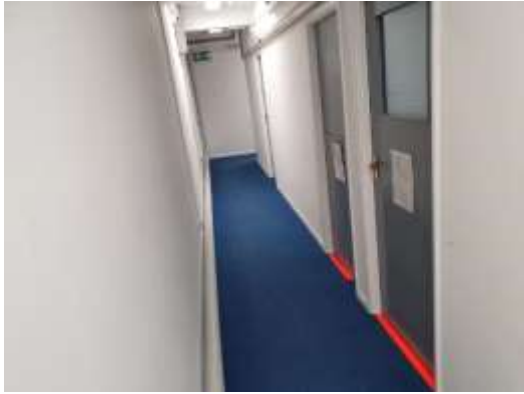
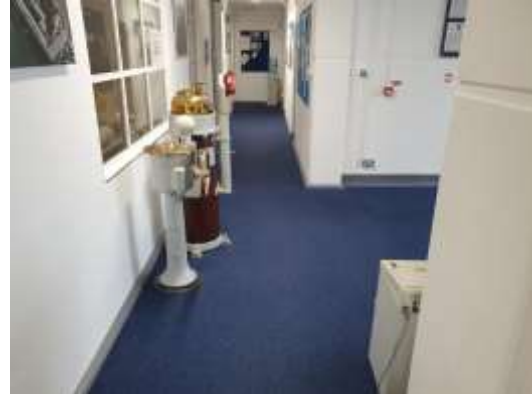
Location: First Floor - Main Building Corridors & Offices 013

Material Description:	Floor - Vinyl Products	
Identification:	Previously Sampled - Asbestos Detected	
Approx. quantity:	100 m ²	
Accessibility	Medium	<i>Assessment Score</i>
Product type:	Vinyl	1
Extent of Damage:	Moderate damage	2
Surface Treatment:	Non-friable	0
Asbestos type:	Chrysotile	1
Material Assessment Score:		4
Priority Assessment Score:		Negligible
Action:	Manage	
Comments:	<p>Previously sampled as per sample 1 + 7</p> <p>Under all carpets, white & brown tiles.</p> <p>INT instructor's office not carpeted will be in near future, no access to that room as door is locked</p>

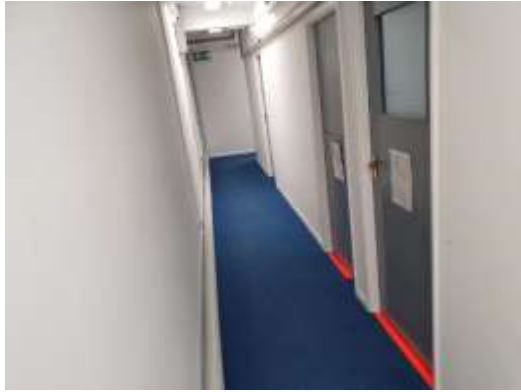
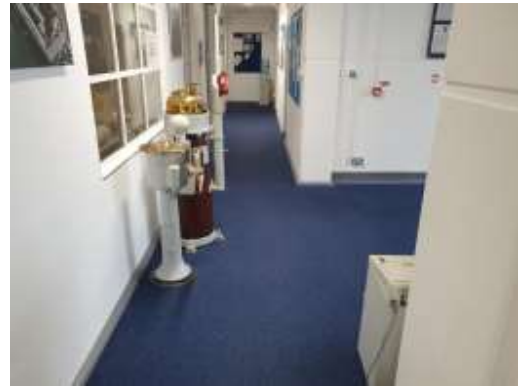
Location: First Floor - Main Building Corridors & Offices 014

Material Description:	Floor - Vinyl Products	
Identification:	Previously Sampled - Asbestos Detected	
Approx. quantity:	300 m ²	
Accessibility	Medium	Assessment Score
Product type:	Vinyl	1
Extent of Damage:	Moderate damage	2
Surface Treatment:	Non-friable	0
Asbestos type:	Chrysotile	1
Material Assessment Score:		4
Priority Assessment Score:		Negligible
Action:	Manage	
Comments:	<p>Previously sampled as per sample 1</p> <p>Under all carpets, white & brown tiles.</p> <p>INT instructor's office not carpeted will be in near future, no access to that room as door is locked</p>

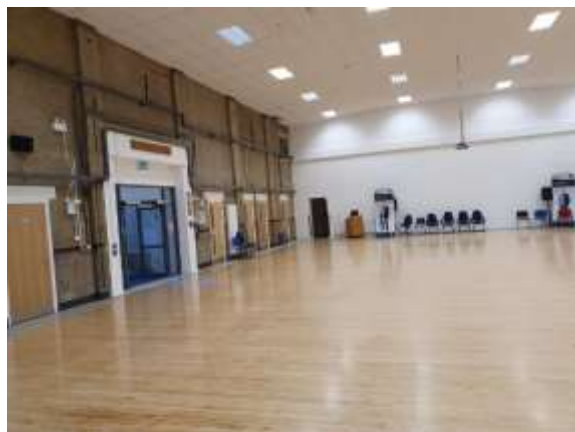
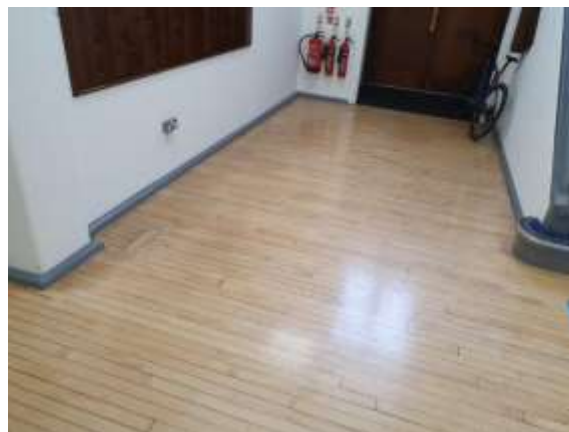
Location: Ground Floor - Main Building Corridors & Hall 015

Material Description:	Bitumen/Adhesive - Bituminous Product	
Identification:	Strongly Presumed to Contain Asbestos	
Approx. quantity:	420 m ²	
Accessibility	Difficult	Assessment Score
Product type:		
Extent of Damage:	Good	0
Surface Treatment:	Non-friable	0
Asbestos type:	Presumed	3
Material Assessment Score:		3
Priority Assessment Score:		Negligible
Action:	Manage	
Comments:	Strongly presumed to contain Asbestos beneath Parquet flooring. Unable to sample without damaging flooring

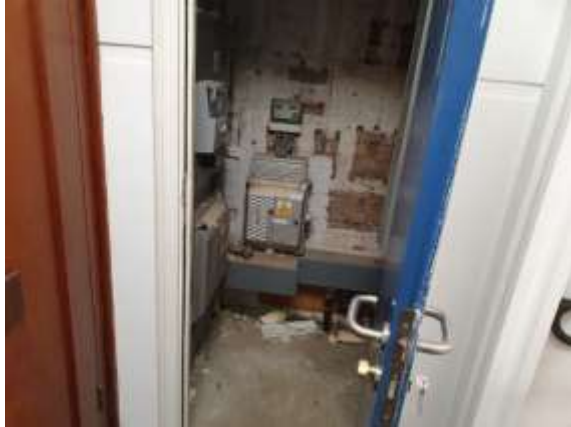
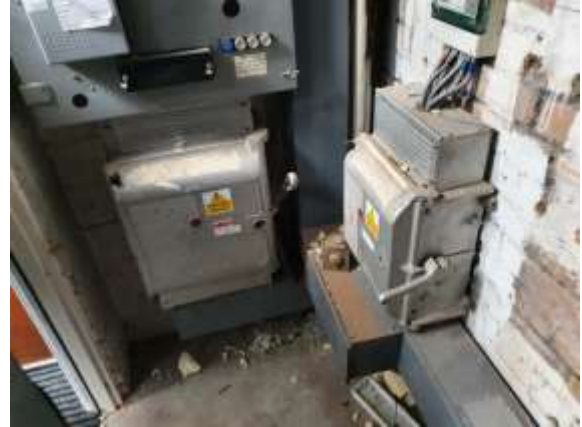
Location: Ground Floor - Main Building Main Entrance Electrical Cupboard 016

Material Description:	Electric Box - Gaskets (rope/woven)	
Identification:	Strongly Presumed to Contain Asbestos	
Approx. quantity:	2 no	
Accessibility	Difficult	Assessment Score
Product type:	Rope	2
Extent of Damage:	Good	0
Surface Treatment:	Woven Material	1
Asbestos type:	Presumed	3
Material Assessment Score:		6
Priority Assessment Score:		Low
Action:	Manage	
Comments:	Strongly presume to contain Asbestos. Unable to sample as Live

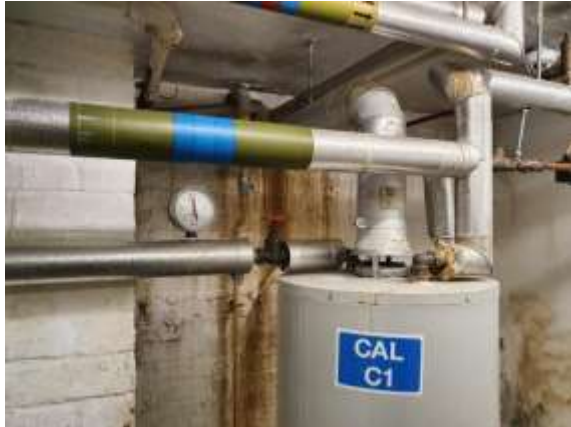
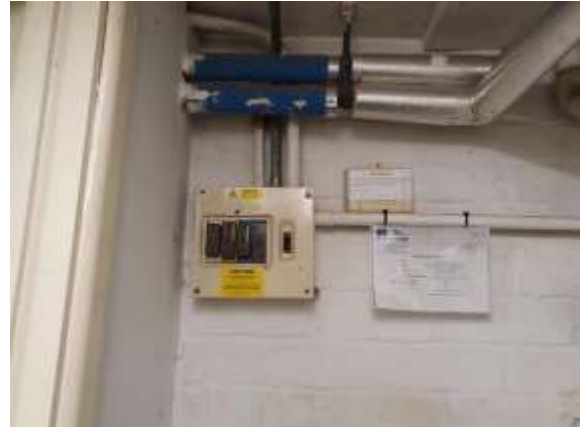
Location: Basement - Main Building Basement Boiler Room 017

Material Description:	Electric Box - Gaskets (rope/woven)	
Identification:	Presumed to Contain Asbestos	
Approx. quantity:	4 no	
Accessibility	Difficult	<i>Assessment Score</i>
Product type:	Rope	2
Extent of Damage:	Major damage	3
Surface Treatment:	Unsealed Insulation	3
Asbestos type:	Presumed	3
Material Assessment Score:		11
Priority Assessment Score:		High
Action:	Manage	
Comments:	Presumed to contain Asbestos. Unable to sample as live.

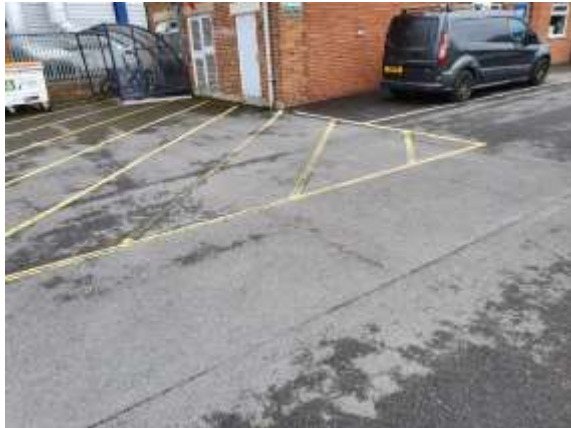
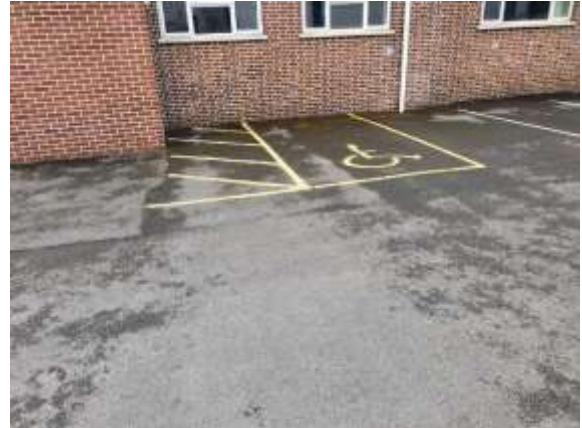
Location: External - Main Building Car Park 018

Material Description:	Pipework - Insulation	
Identification:	Strongly Presumed to Contain Asbestos	
Approx. quantity:	20 LM	
Accessibility	Difficult	<i>Assessment Score</i>
Product type:	Pipe Insulation	3
Extent of Damage:	Major damage	3
Surface Treatment:	Unsealed Pipe Lagging	3
Asbestos type:	Presumed	3
Material Assessment Score:		12
Priority Assessment Score:		High
Action:	Manage	
Comments:	<p>Strongly presume to contain Asbestos as identified in previous survey.</p> <p>Runs into 1st LT and COM Office on ground floor. Now under Tarmac so no access.</p>

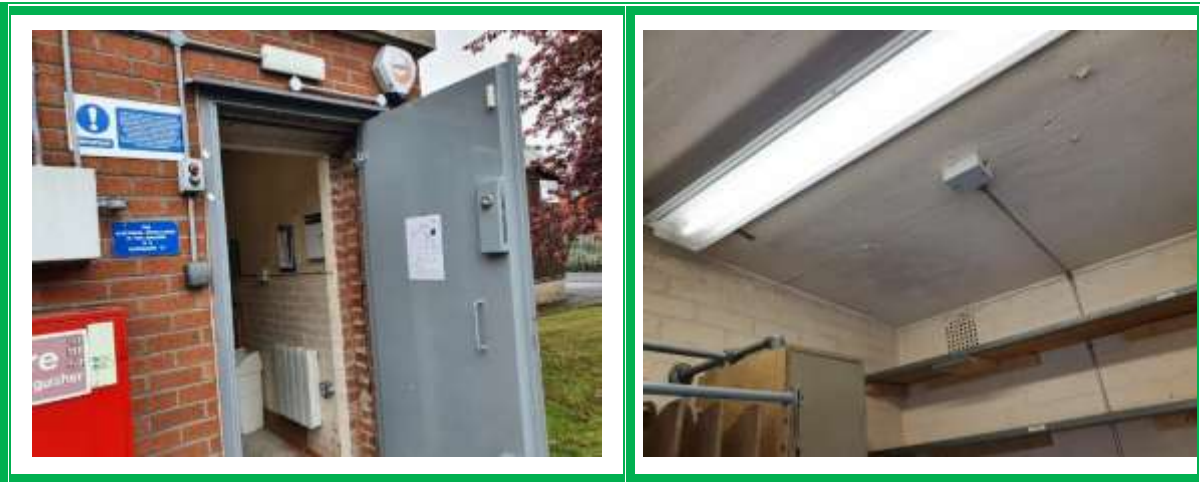
Item No:	1	Sample No:	N/A
Location:	Ground Floor - 6 Rifles Armoury 001

Material Description:	No Suspect Materials Found	
Identification:	N/A	
Approx. quantity:	N/A	
Accessibility	N/A	<i>Assessment Score</i>
Product type:	N/A	N/A
Extent of Damage:	N/A	N/A
Surface Treatment:	N/A	N/A
Asbestos type:	N/A	N/A
Material Assessment Score:		N/A
Priority Assessment Score:		N/A
Action:	N/A	
Comments:	Previously no accessed Armory, now accessed no ACM's present

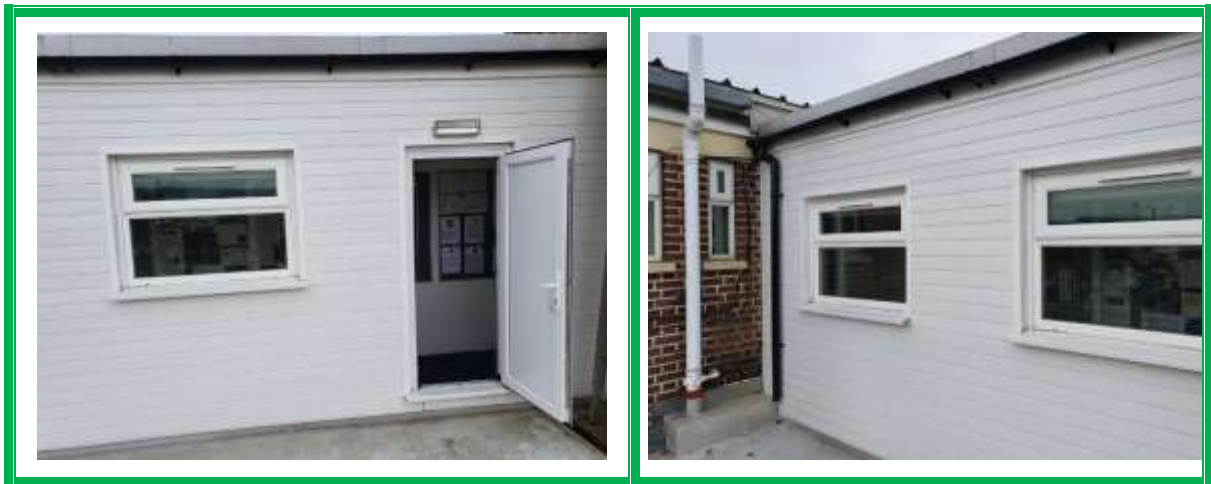
Location: Second Floor - Main Building 2nd Floor 011

Material Description:	No Suspect Materials Found	
Identification:	N/A	
Approx. quantity:	N/A	
Accessibility	N/A	<i>Assessment Score</i>
Product type:	N/A	N/A
Extent of Damage:	N/A	N/A
Surface Treatment:	N/A	N/A
Asbestos type:	N/A	N/A
Material Assessment Score:		N/A
Priority Assessment Score:		N/A
Action:	N/A	
Comments:	This item has been removed since previous survey.

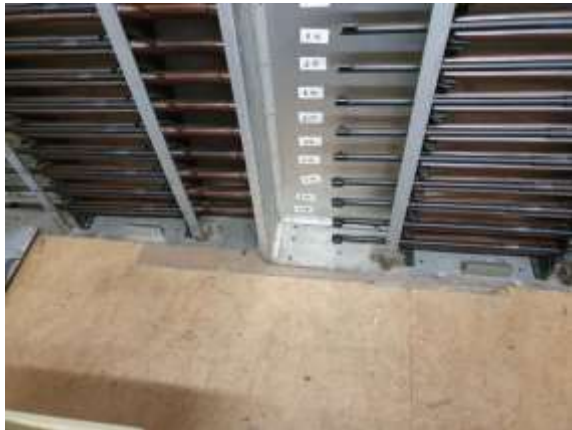
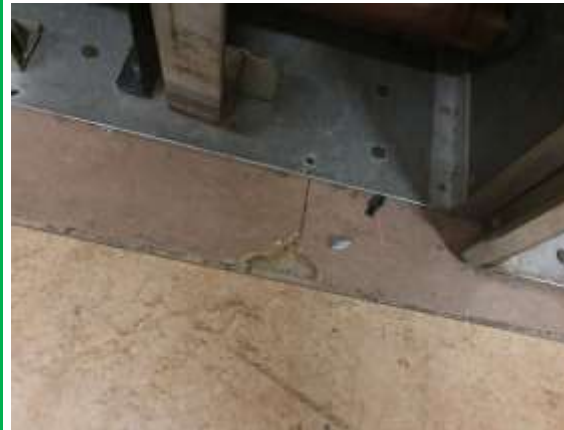
Location: Ground Floor - Main Building Armoury 019

Material Description:	Floor - Vinyl Products	
Identification:	Sampled - No Asbestos Found	
Approx. quantity:	N/A	
Accessibility	N/A	<i>Assessment Score</i>
Product type:	N/A	N/A
Extent of Damage:	N/A	N/A
Surface Treatment:	N/A	N/A
Asbestos type:	N/A	N/A
Material Assessment Score:		N/A
Priority Assessment Score:		N/A
Action:	N/A	
Comments:	Sample taken of the red floor covering

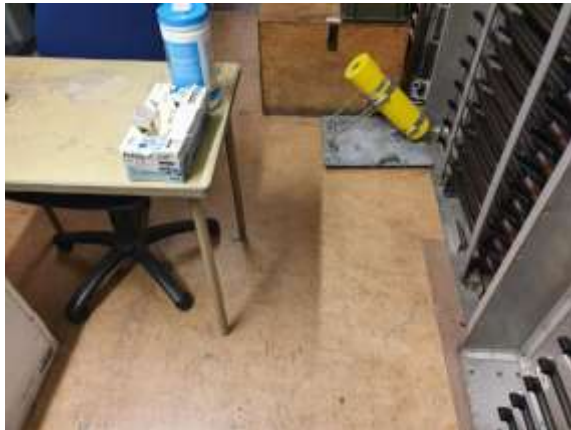
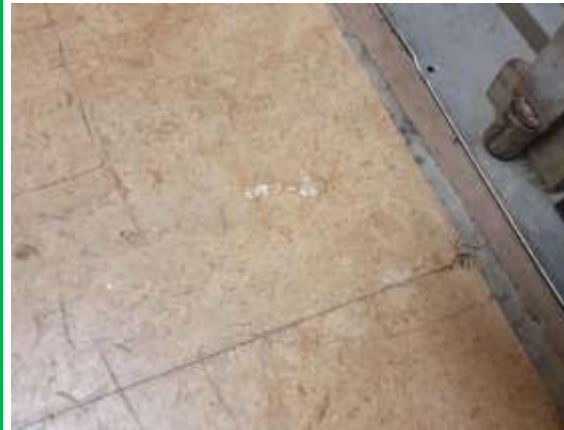
Location: Ground Floor - Main Building Armoury 020

Material Description:	Floor - Vinyl Products	
Identification:	Sampled - No Asbestos Found	
Approx. quantity:	N/A	
Accessibility	N/A	<i>Assessment Score</i>
Product type:	N/A	N/A
Extent of Damage:	N/A	N/A
Surface Treatment:	N/A	N/A
Asbestos type:	N/A	N/A
Material Assessment Score:		N/A
Priority Assessment Score:		N/A
Action:	N/A	
Comments:	Sample taken of the Beige floor covering
