Project Number A-00523 (3700)

**Re-Inspection
Asbestos Survey Report - Revised**

**Truro ARC
6th Battalion the Rifles D Company
Cornwall
TR1 1DF**

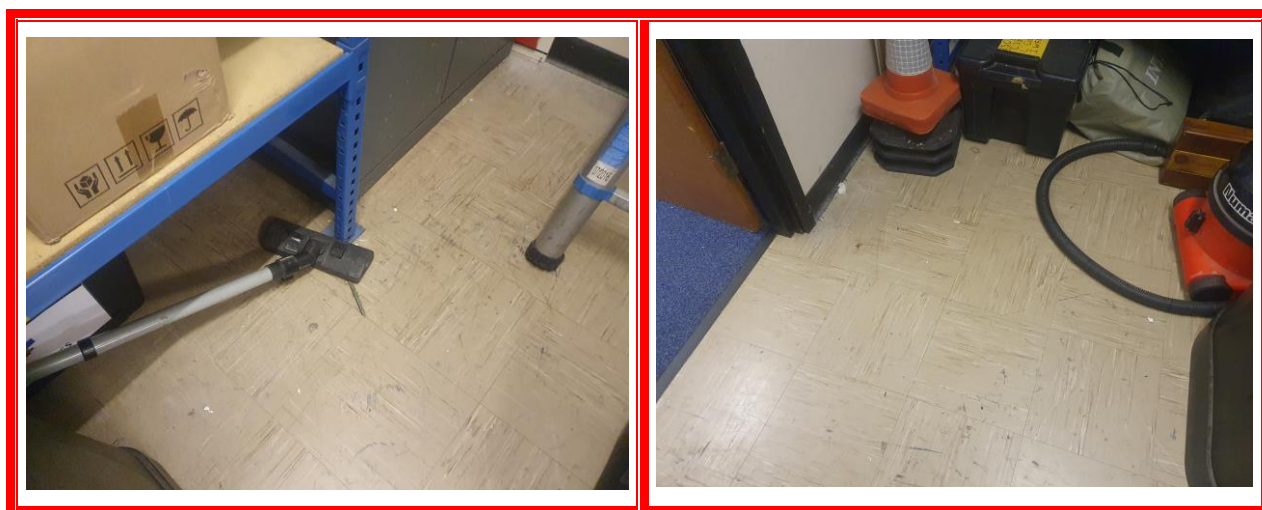
Item No:	1	Sample No:	N/A
Location:	Ground Floor - Mattress Store 001

Material Description:	Floor Tiles and Adhesive	
Identification:	As per Sample S/003	
Approx. quantity:	8m2	
Accessibility	Easy	Assessment Score
Product type:	Vinyl	1
Extent of Damage:	Slight / minor damage	1
Surface Treatment:	Non-friable	0
Asbestos type:	Chrysotile	1
Material Assessment Score:		3
Priority Assessment Score:		Negligible
Action:	Manage	
Comments:	Previously a no access area. Floor tiles visually similar to sampled floor tiles within the building.

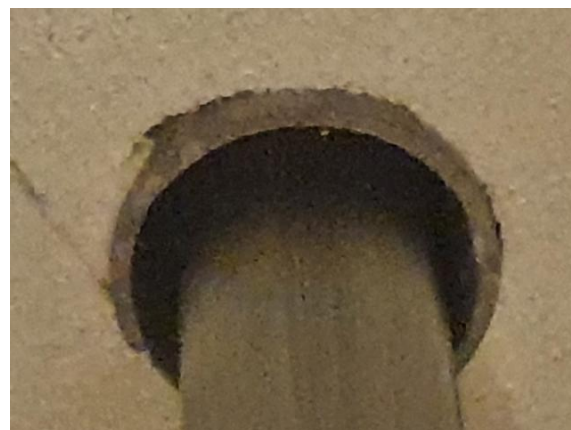
Location: Ground Floor - Boiler Room 002

Material Description:	Flue Pipes - Cement Product	
Identification:	Strongly Presumed to Contain Asbestos	
Approx. quantity:	3 no	
Accessibility	Difficult	<i>Assessment Score</i>
Product type:	Cement	1
Extent of Damage:	Slight / minor damage	1
Surface Treatment:	Unsealed Cement	1
Asbestos type:	Chrysotile	1
Material Assessment Score:		4
Priority Assessment Score:		Negligible
Action:	Manage	
Comments:	Located to the ceiling

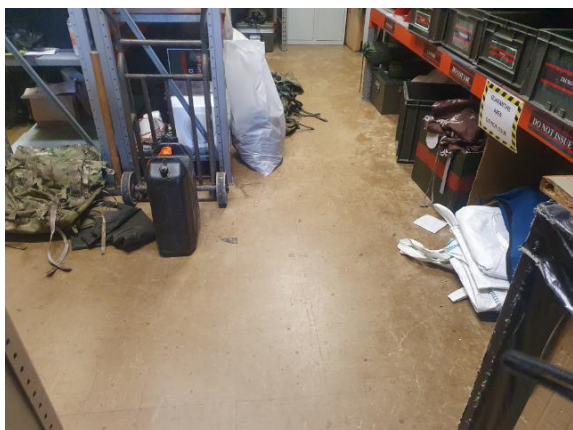
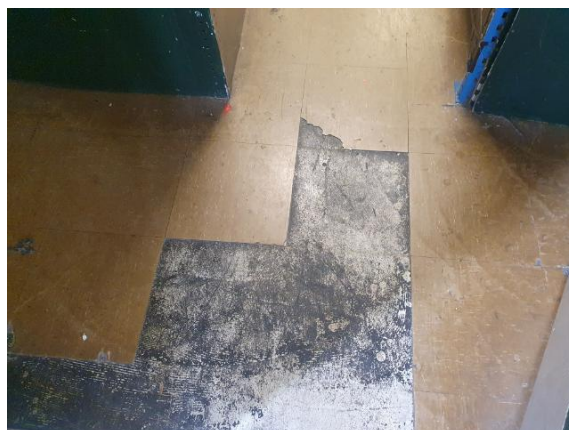
Location: Ground Floor - Equipment Store 007

Material Description:	Floor Tiles and Adhesive - Vinyl Products	
Identification:	Sampled - Asbestos Detected	
Approx. quantity:	40 m ²	
Accessibility	Easy	<i>Assessment Score</i>
Product type:	Vinyl	1
Extent of Damage:	Moderate damage	2
Surface Treatment:	Non-friable	0
Asbestos type:	Chrysotile	1
Material Assessment Score:		4
Priority Assessment Score:		Negligible
Action:	Manage	
Comments:	N/A

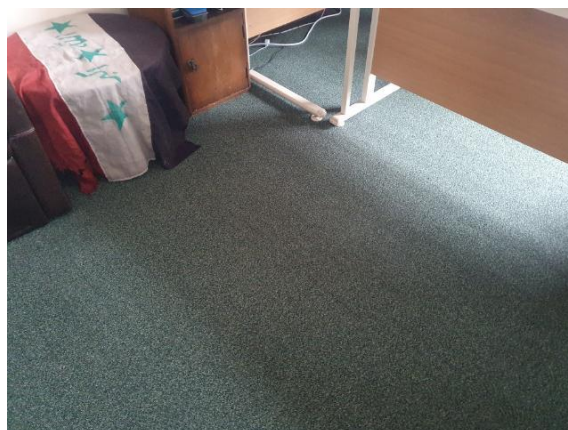
Location: First Floor - PSAO Office 008

Material Description:	Floor Tiles and Adhesive - Vinyl Products	
Identification:	Previously Sampled - Asbestos Detected	
Approx. quantity:	16 m ²	
Accessibility	Difficult	<i>Assessment Score</i>
Product type:	Vinyl	1
Extent of Damage:	Major damage	3
Surface Treatment:	Non-friable	0
Asbestos type:	Chrysotile	1
Material Assessment Score:		5
Priority Assessment Score:		Low
Action:	Manage	
Comments:	Previously sampled ref: Armour 28/1/20 Sample GR003. Now under carpet

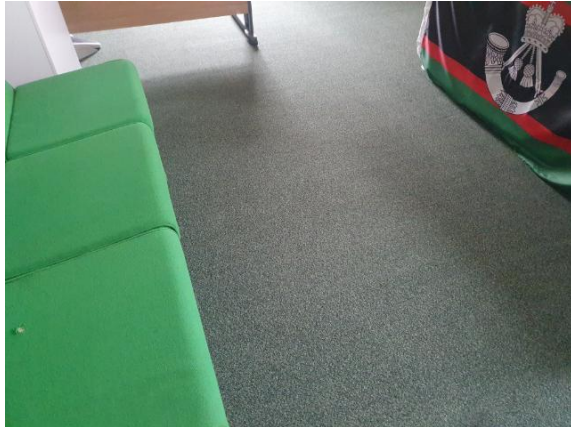
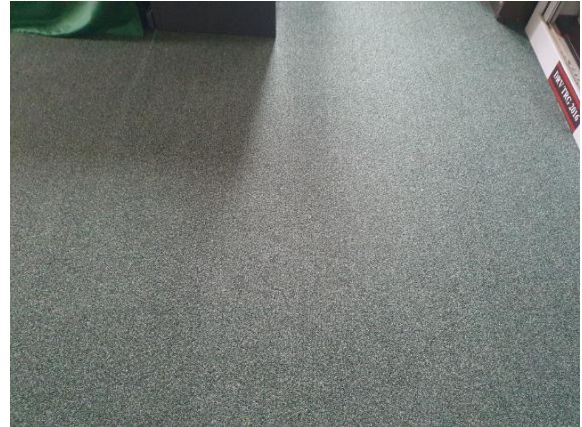
Location: First Floor - SPSI Office 011

Material Description:	Floor Tiles and Adhesive - Vinyl Products	
Identification:	Previously Sampled - Asbestos Detected	
Approx. quantity:	12 m ²	
Accessibility	Difficult	<i>Assessment Score</i>
Product type:	Vinyl	1
Extent of Damage:	Moderate damage	2
Surface Treatment:	Non-friable	0
Asbestos type:	Chrysotile	1
Material Assessment Score:		4
Priority Assessment Score:		Negligible
Action:	Manage	
Comments:	Previously sampled ref: Armour 28/1/20 Sample GR003. Now under carpet

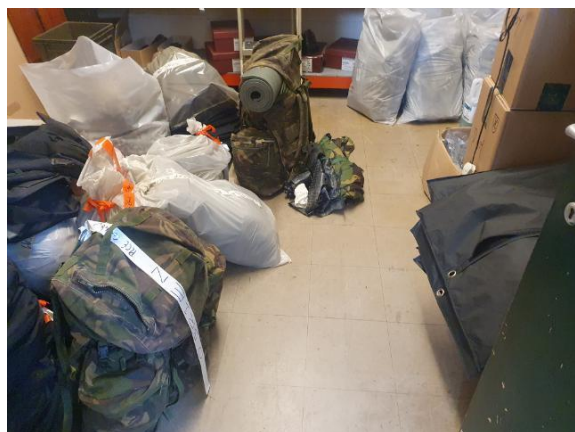
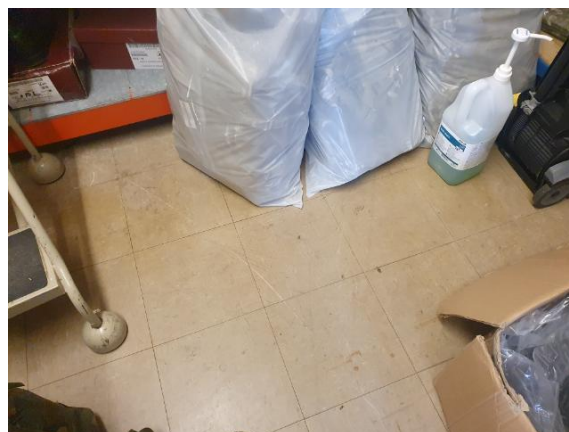
Location: Ground Floor - MSA Store 013

Material Description:	Floor Tiles and Adhesive - Vinyl Products	
Identification:	As Per Sample S003 - Asbestos Detected	
Approx. quantity:	20 m ²	
Accessibility	Easy	Assessment Score
Product type:	Vinyl	1
Extent of Damage:	Slight / minor damage	1
Surface Treatment:	Non-friable	0
Asbestos type:	Chrysotile	1
Material Assessment Score:		3
Priority Assessment Score:		Negligible
Action:	Manage	
Comments:	N/A

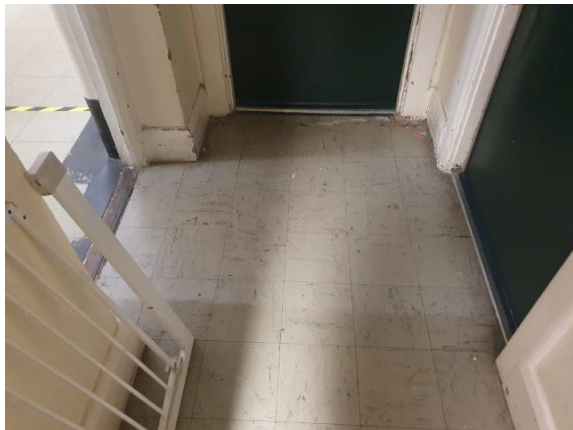
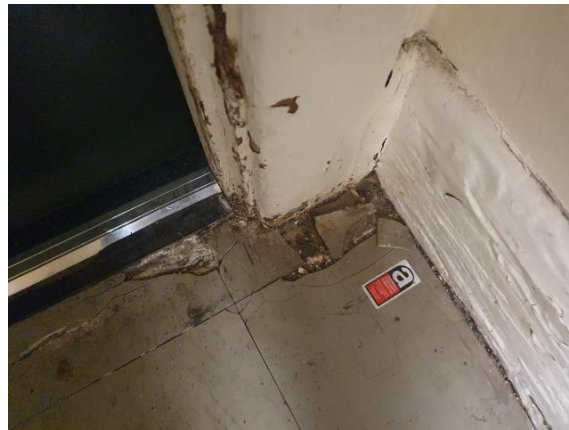
Location: Ground Floor - Admin Office Lobby 014

Material Description:	Floor Tiles and Adhesive - Vinyl Products	
Identification:	Previously Sampled - Asbestos Detected	
Approx. quantity:	2 m ²	
Accessibility	Easy	<i>Assessment Score</i>
Product type:	Vinyl	1
Extent of Damage:	Major damage	3
Surface Treatment:	Non-friable	0
Asbestos type:	Chrysotile	1
Material Assessment Score:		5
Priority Assessment Score:		Low
Action:	Remove	
Comments:	Previously sampled ref: Armour 28/1/20 Sample GR004. Several loose pieces of floor tile. Remove loose pieces and manage the rest of tiles

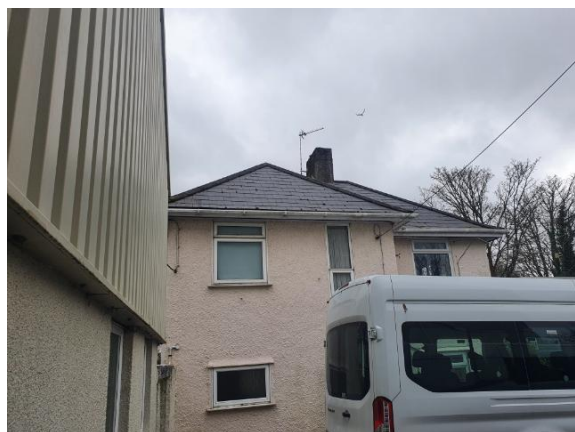
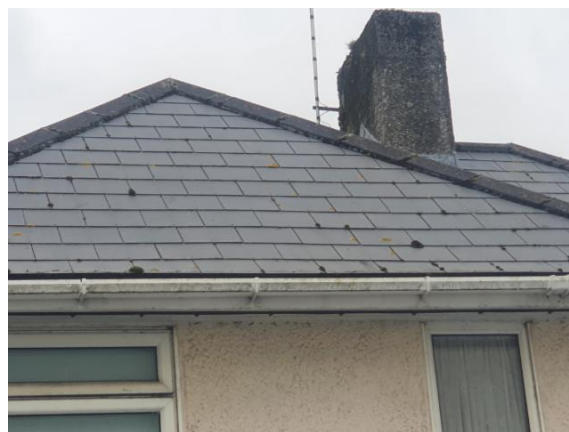
Location: External - Caretakers House 016

Material Description:	Roof Tiles - Cement Product	
Identification:	Presumed to Contain Asbestos	
Approx. quantity:	60 m ²	
Accessibility	Difficult	<i>Assessment Score</i>
Product type:	Cement	1
Extent of Damage:	Major damage	3
Surface Treatment:	Unsealed Insulation	3
Asbestos type:	Chrysotile	1
Material Assessment Score:		8
Priority Assessment Score:		Medium
Action:	Manage	
Comments:	N/A

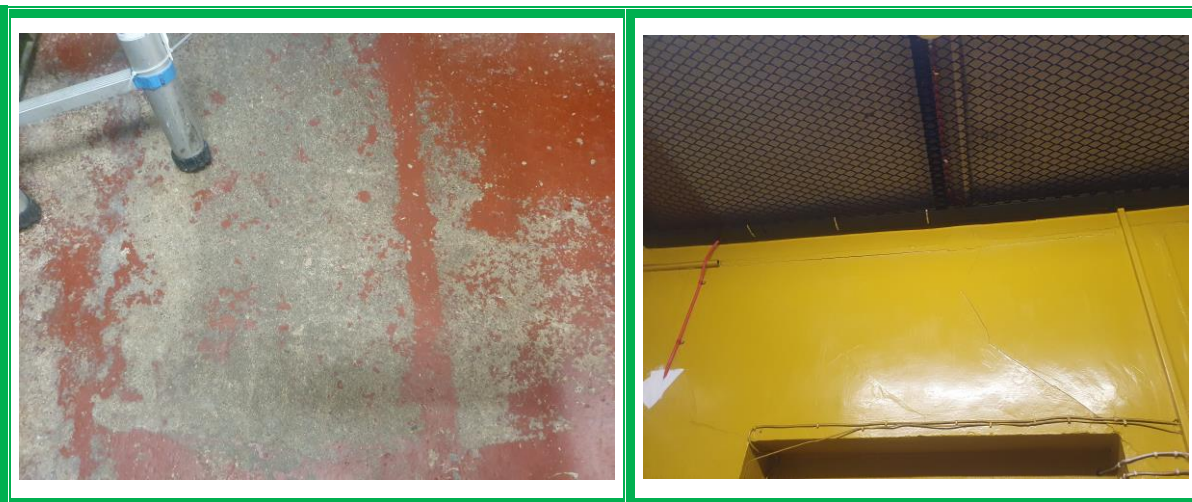
Item No:	12	Sample No:	N/A
Location:	Ground Floor - Armoury 012

Material Description:	No Suspect Materials Found	
Identification:	N/A	
Approx. quantity:	N/A	
Accessibility	N/A	<i>Assessment Score</i>
Product type:	N/A	N/A
Extent of Damage:	N/A	N/A
Surface Treatment:	N/A	N/A
Asbestos type:	N/A	N/A
Material Assessment Score:		N/A
Priority Assessment Score:		N/A
Action:	N/A	
Comments:	<p>Previously a no access area.</p> <p>Now accessed and no asbestos found</p>

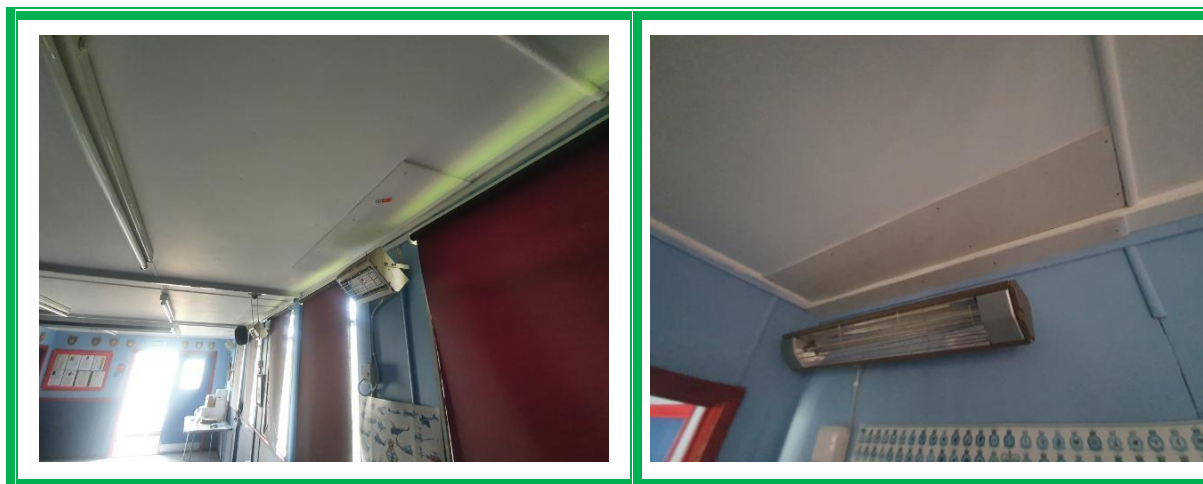
Item No:	17	Sample No:	DK/04
Location:	Ground Floor - 730 Squadron Hut - Drill Hall and Classrooms 017

Material Description:	Panels on Ceilings - Insulating Board	
Identification:	Sampled - No Asbestos Found	
Approx. quantity:	N/A	
Accessibility	N/A	<i>Assessment Score</i>
Product type:	N/A	N/A
Extent of Damage:	N/A	N/A
Surface Treatment:	N/A	N/A
Asbestos type:	N/A	N/A
Material Assessment Score:		N/A
Priority Assessment Score:		N/A
Action:	N/A	
Comments:	Panels are non-asbestos Supalux but have been sampled as there are asbestos stickers on the panels. 8no panels

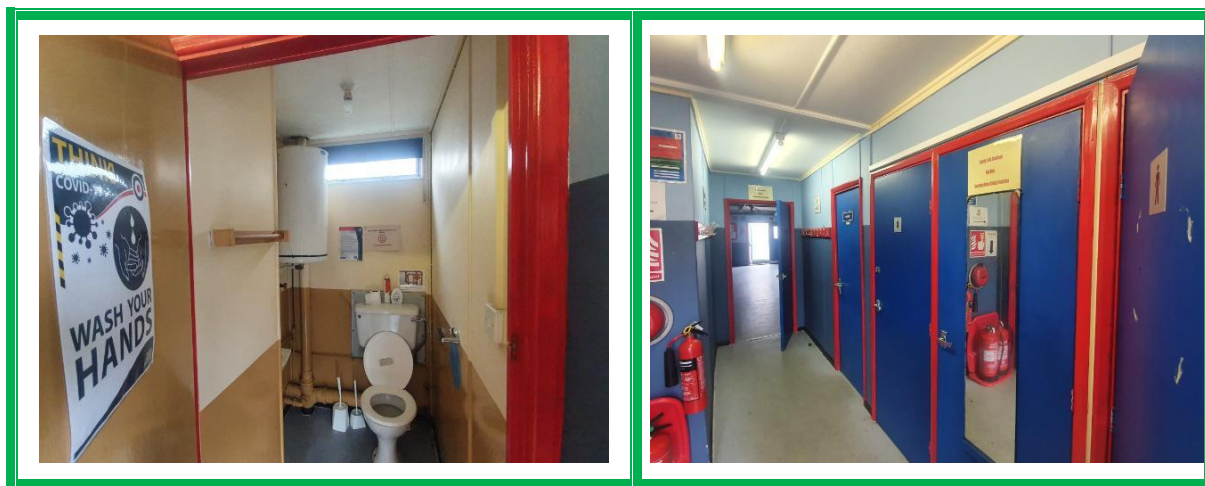
Location: Ground Floor - 730 Squadron Hut - WC's, Cupboard and Kitchen 018

Material Description:	No Suspect Materials Found	
Identification:	N/A	
Approx. quantity:	N/A	
Accessibility	N/A	<i>Assessment Score</i>
Product type:	N/A	N/A
Extent of Damage:	N/A	N/A
Surface Treatment:	N/A	N/A
Asbestos type:	N/A	N/A
Material Assessment Score:		N/A
Priority Assessment Score:		N/A
Action:	N/A	
Comments:	Previously a no access area. Now accessed and no asbestos found. Modern sink pad in kitchen

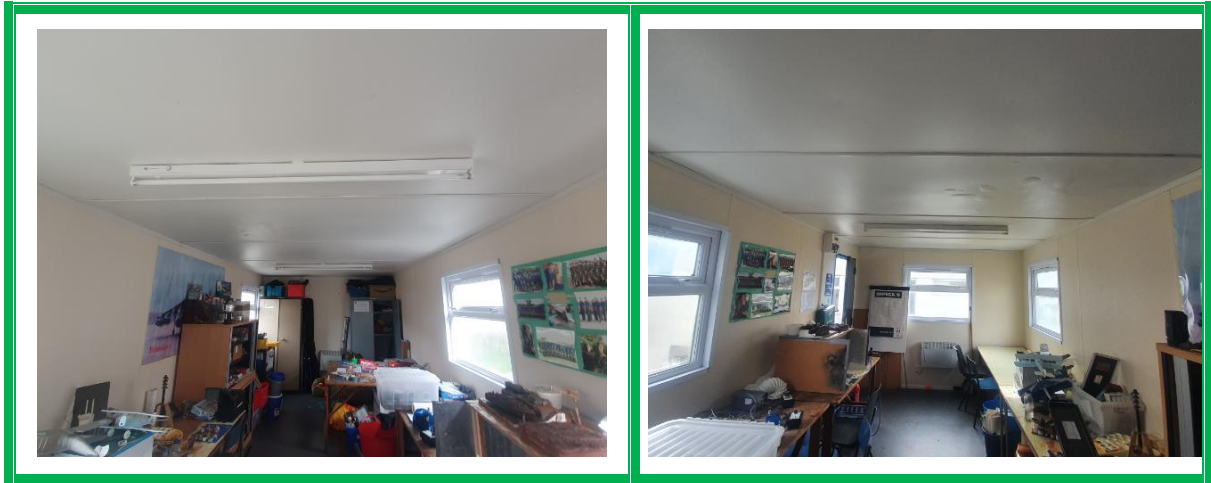
Item No:	20	Sample No:	N/A
Location:	Ground Floor - Modelling Hut - Classroom 3 020

Material Description:	No Suspect Materials Found	
Identification:	N/A	
Approx. quantity:	N/A	
Accessibility	N/A	<i>Assessment Score</i>
Product type:	N/A	N/A
Extent of Damage:	N/A	N/A
Surface Treatment:	N/A	N/A
Asbestos type:	N/A	N/A
Material Assessment Score:		N/A
Priority Assessment Score:		N/A
Action:	N/A	
Comments:	Previously a no access area. Now accessed and no asbestos found
