Project Number 2481

**Management
Asbestos Survey Report**

Kingswood Platoon, Bristol, BS15 4RF

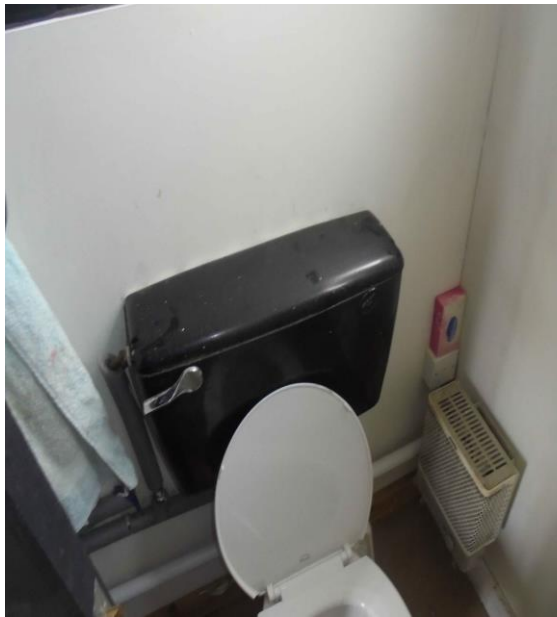
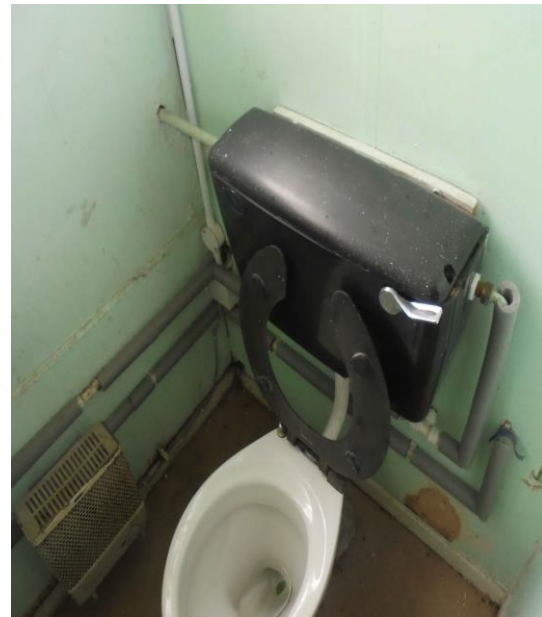
Item No: 1

Sample Number	Sample Type	Location	Analysis
DK/1	Toilet Cisterns	WC's X 2	Amosite
DK/2	Sink Pad	Kitchen	Chrysotile
DK/3	Insulation Board Panels	Offices X 2	Chrysotile Amosite
DK/4	Damp Proof Course	External	N.A.D.I.S

Material Description:	Toilet Cisterns & Seat	
Identification:	Sampled – Asbestos Detected	
Approx. quantity:	2 x Cisterns, 1 x Seat	
Accessibility	High	<i>Assessment Score</i>
Product type:	Composite	1
Extent of Damage:	Minor	1
Surface Treatment:	Non-Friable	0
Asbestos type:	Amosite	2
Material Assessment Score:		4
Priority Assessment Score:		Negligible
Action:	Manage	
Comments:	N/A

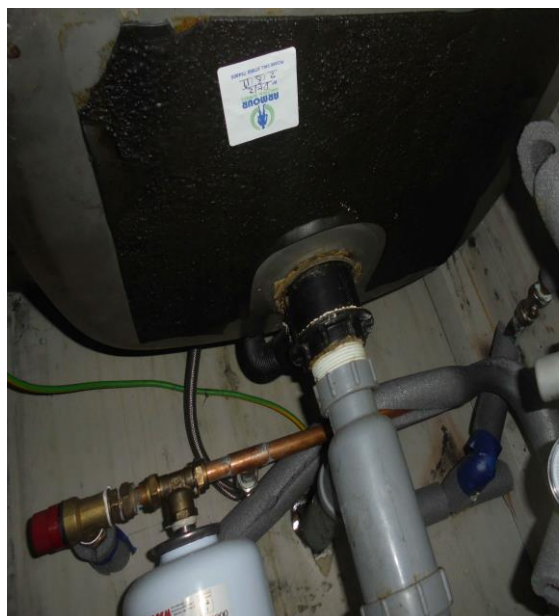
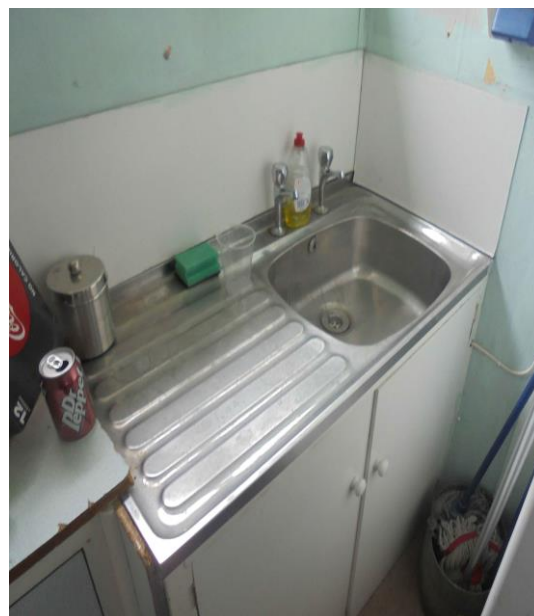
Item No: 2

Material Description:	Sink Pad	
Identification:	Sampled – Asbestos Detected	
Approx. quantity:	1 x Sink	
Accessibility	Low	<i>Assessment Score</i>
Product type:	Bitumen	1
Extent of Damage:	Minor	1
Surface Treatment:	Non-Friable	0
Asbestos type:	Chrysotile	1
Material Assessment Score:		3
Priority Assessment Score:		Negligible
Action:	Manage	
Comments:	N/A

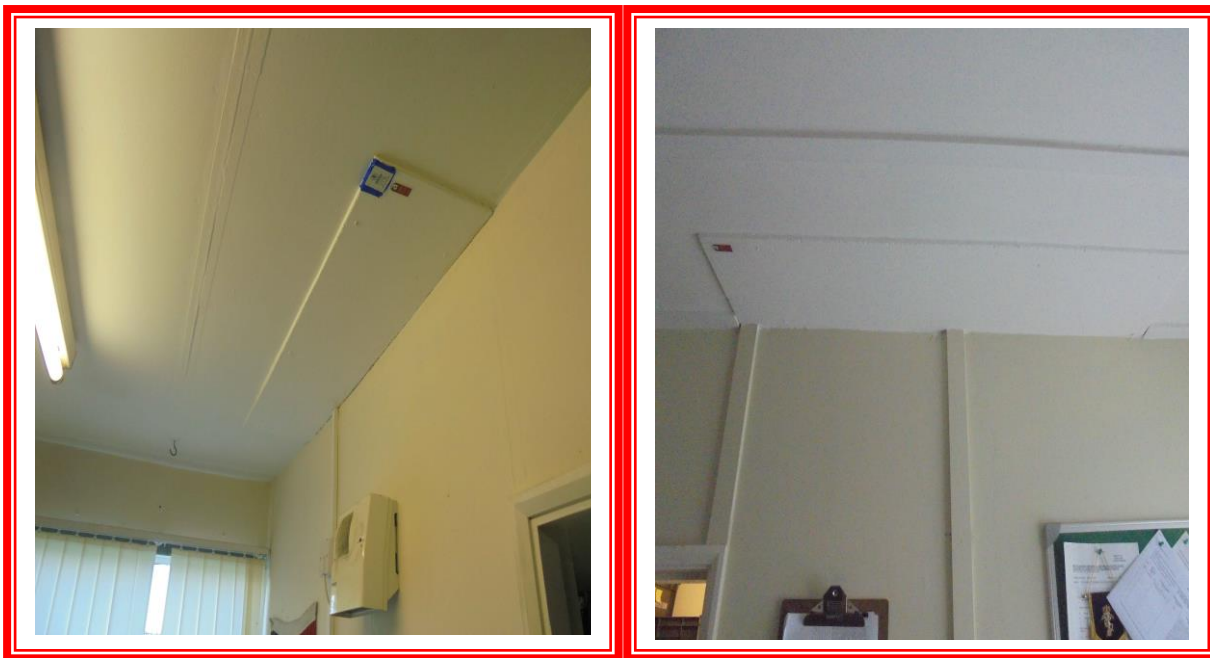
Item No: 4

Material Description:	Insulation Board Panels on Ceiling	
Identification:	Sampled – Asbestos Detected	
Approx. quantity:	2 x Panels (2M2 Total)	
Accessibility	Low	Assessment Score
Product type:	Insulation Board	2
Extent of Damage:	Minor	1
Surface Treatment:	Sealed	1
Asbestos type:	Chrysotile/Amosite	2
Material Assessment Score:		6
Priority Assessment Score:		Low
Action:	Manage	
Comments:	N/A

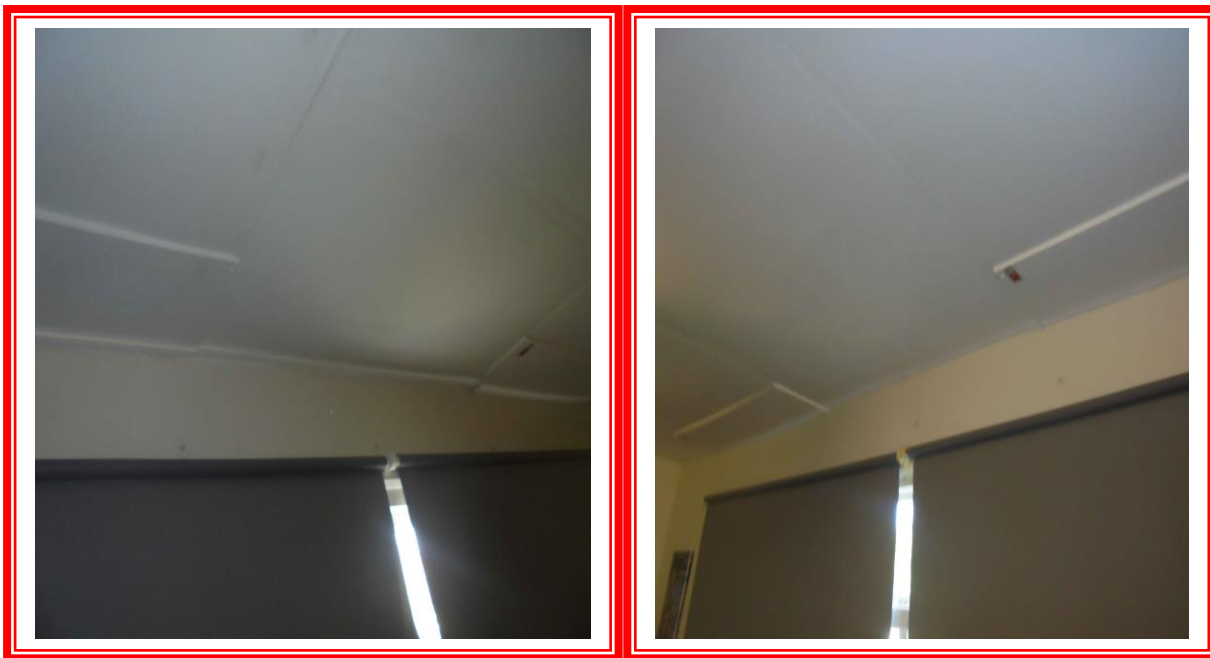
**Item No: 7****Sample No: N/A****Location: Ground Floor – Parade Hall**

Material Description:	Insulation Board Panels on Ceiling	
Identification:	As per Sample DK/3 – Asbestos Detected	
Approx. quantity:	4 x Panels (3M2 Total)	
Accessibility	Low	<i>Assessment Score</i>
Product type:	Insulation Board	2
Extent of Damage:	Moderate	2
Surface Treatment:	Sealed	1
Asbestos type:	Chrysotile/Amosite	2
Material Assessment Score:		7
Priority Assessment Score:		Medium
Action:	Encapsulate	
Comments:	Damage to corner of panel nearest the server hatch.

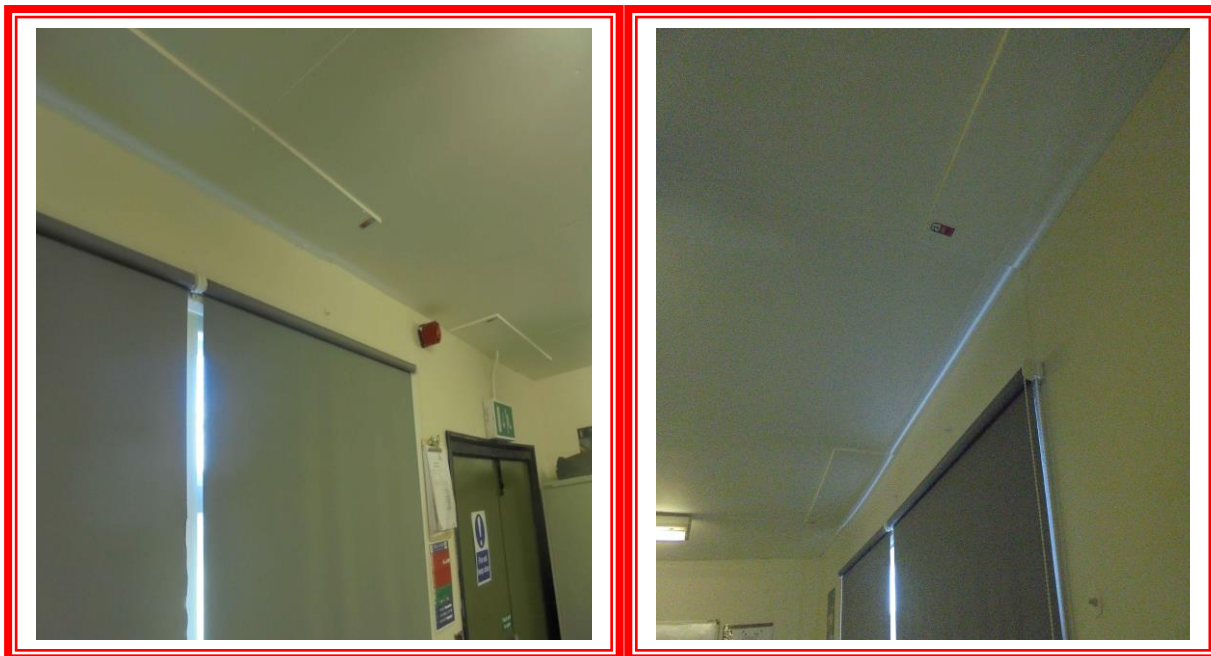
Item No: 8

Material Description:	Insulation Board Panels on Ceiling	
Identification:	As per Sample DK/3 – Asbestos Detected	
Approx. quantity:	4 x Panels (3M2 Total)	
Accessibility	Low	Assessment Score
Product type:	Insulation Board	2
Extent of Damage:	Minor	1
Surface Treatment:	Sealed	1
Asbestos type:	Chrysotile/Amosite	2
Material Assessment Score:		6
Priority Assessment Score:		Low
Action:	Manage	
Comments:	N/A

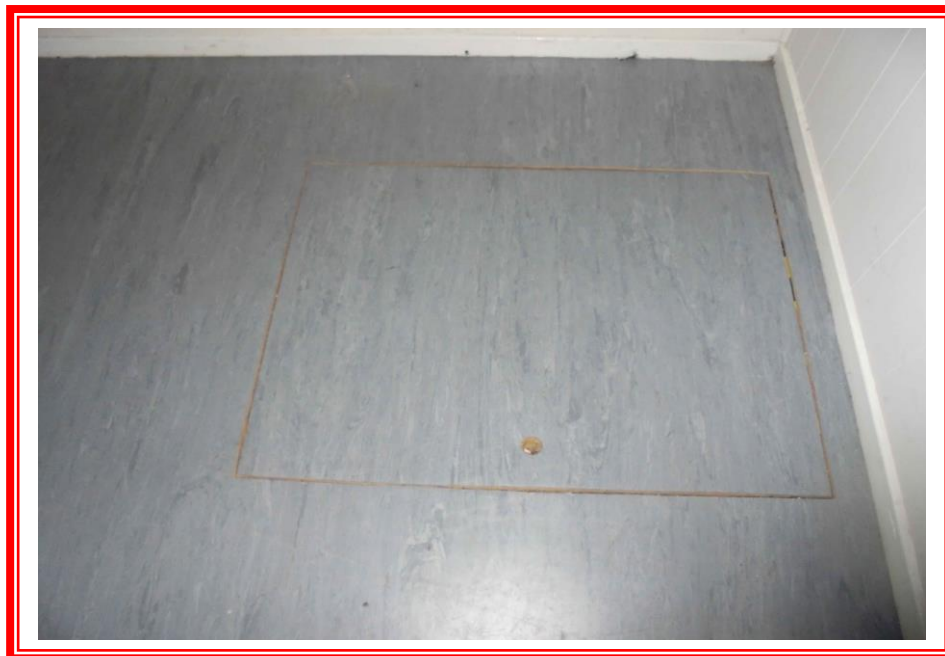
**Item No: 9****Sample No: N/A****Location: Ground Floor – Range**

Item 9 – Range – No Access

Material Description:	No Access within Range	
Identification:	Presumed to Contain Asbestos	
Approx. quantity:	Unknown	
Accessibility	Low	<i>Assessment Score</i>
Product type:	No Access	3
Extent of Damage:	No Access	3
Surface Treatment:	No Access	3
Asbestos type:	No Access	3
Material Assessment Score:		12
Priority Assessment Score:		High
Action:	Further Investigation Required/Restrict Access	
Comments:	No access within range as hatch screwed shut. Site contact stated that asbestos cement was once stored within the range and although it has been removed, it is likely that debris remains

The presence of asbestos in these areas cannot be ascertained at this time. If any works are to be carried out in these areas in the future, then these works should be approached cautiously.

In accordance with current legislation, any suspect materials encountered in these areas are to be assumed to contain asbestos until proven otherwise. This will normally involve cessation of works in the affected area.

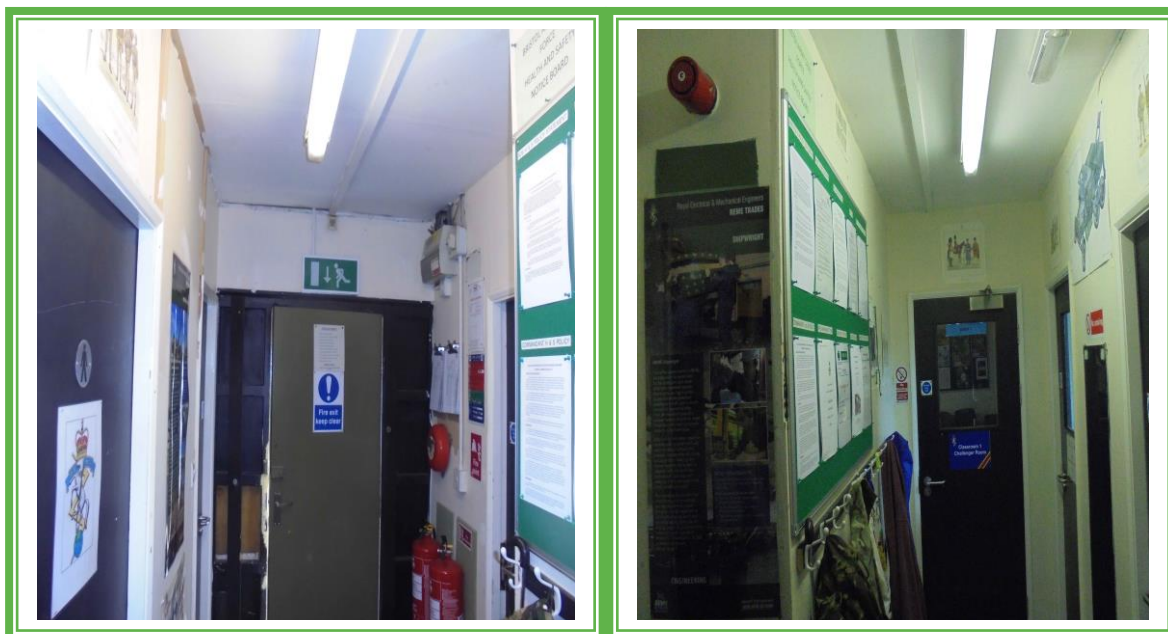
Item No: 3

Material Description:	Visual Inspection – No Suspect Materials Found	
Identification:	N/A	
Approx. quantity:	N/A	
Accessibility	N/A	<i>Assessment Score</i>
Product type:		N/A
Extent of Damage:		N/A
Surface Treatment:		N/A
Asbestos type:		N/A
Material Assessment Score:		N/A
Priority Assessment Score:		N/A
Action:	N/A	
Comments:	Modern Electrics

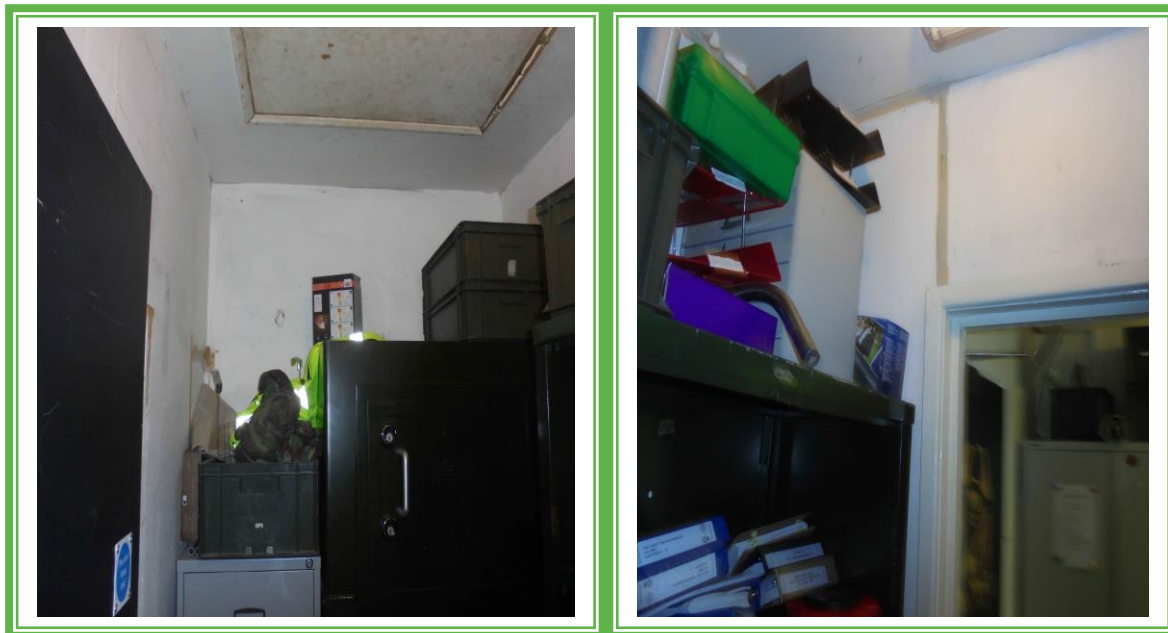
Item No: 5

Material Description:	Visual Inspection – No Suspect Materials Found	
Identification:	N/A	
Approx. quantity:	N/A	
Accessibility	N/A	<i>Assessment Score</i>
Product type:		N/A
Extent of Damage:		N/A
Surface Treatment:		N/A
Asbestos type:		N/A
Material Assessment Score:		N/A
Priority Assessment Score:		N/A
Action:	N/A	
Comments:	N/A

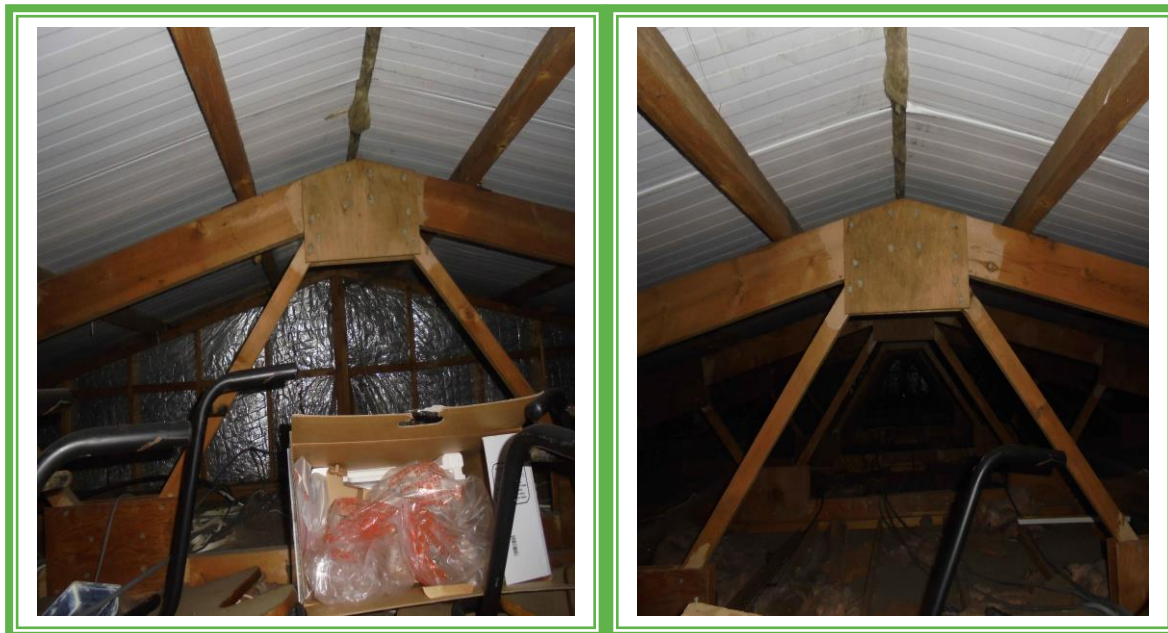
Item No: 6

Material Description:	Visual Inspection – No Suspect Materials Found	
Identification:	N/A	
Approx. quantity:	N/A	
Accessibility	N/A	<i>Assessment Score</i>
Product type:		N/A
Extent of Damage:		N/A
Surface Treatment:		N/A
Asbestos type:		N/A
Material Assessment Score:		N/A
Priority Assessment Score:		N/A
Action:	N/A	
Comments:	N/A

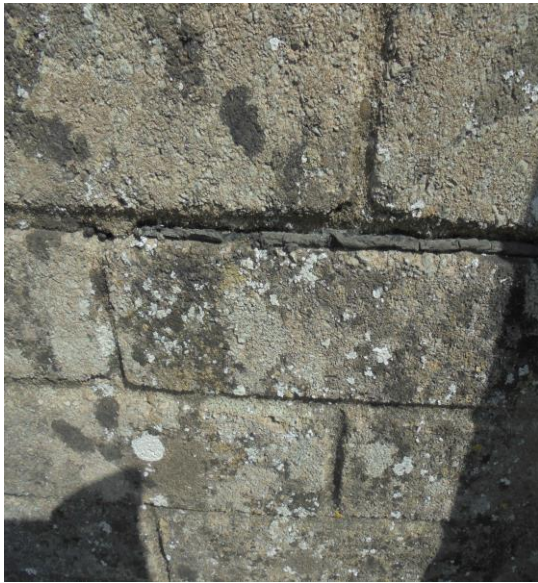
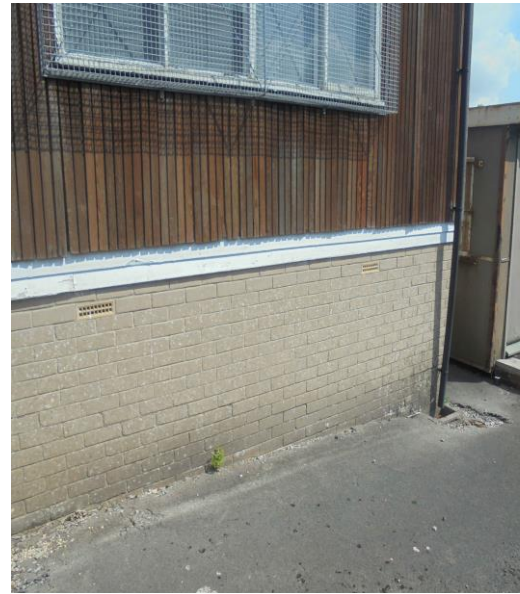
Item No: 10

Material Description:	Damp Proof Course	
Identification:	Sampled – No Asbestos Detected	
Approx. quantity:	To Entire Perimeter of Building	
Accessibility	N/A	<i>Assessment Score</i>
Product type:		N/A
Extent of Damage:		N/A
Surface Treatment:		N/A
Asbestos type:		N/A
Material Assessment Score:		N/A
Priority Assessment Score:		N/A
Action:	N/A	
Comments:	N/A
