**Project Number A-00415 (3700)**

**Re-Inspection  
Asbestos Survey Report**

**Lytchett Maltravers  
Dorset  
BH16 6BH**

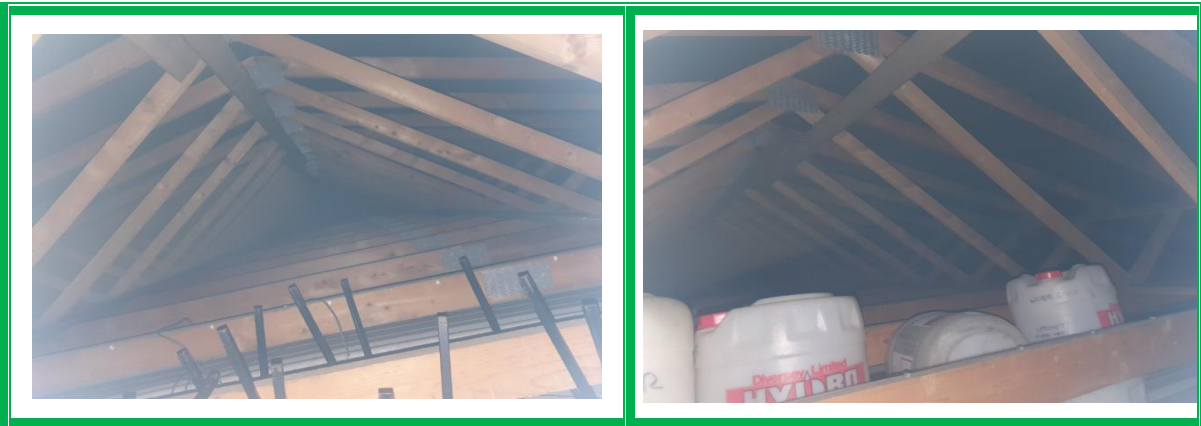
<b>Item No:</b>	<b>1</b>	<b>Sample No:</b>	<b>N/A</b>
<b>Location:</b>	Ground Floor - Loft Space 001

<b>Material Description:</b>	No Suspect Materials Found	
<b>Identification:</b>	N/A	
<b>Approx. quantity:</b>	N/A	
<b>Accessibility</b>	N/A	<i>Assessment Score</i>
<b>Product type:</b>	N/A	N/A
<b>Extent of Damage:</b>	N/A	N/A
<b>Surface Treatment:</b>	N/A	N/A
<b>Asbestos type:</b>	N/A	N/A
<b>Material Assessment Score:</b>		
<b>Priority Assessment Score:</b>		
<b>Action:</b>	N/A	
<b>Comments:</b>	Loft space previously not accessed. Now accessed and no asbestos found
