LEGIONELLA RISK ASSESSMENT

Client:	Wessex RFCA		
Site:	Wyvern Barracks Building 3		
Address:	Wyvern Barracks, Barrack Road, Exeter, EX2 6AR		
Risk Rating:	Medium		
Report Ref:	AQST/LRA/331		
Surveyed By:	Jon Barton		
Survey Date:	11 th -13 th March 2024		
Report Date:	15 th March 2024		
Recommended Review Date:	March 2026

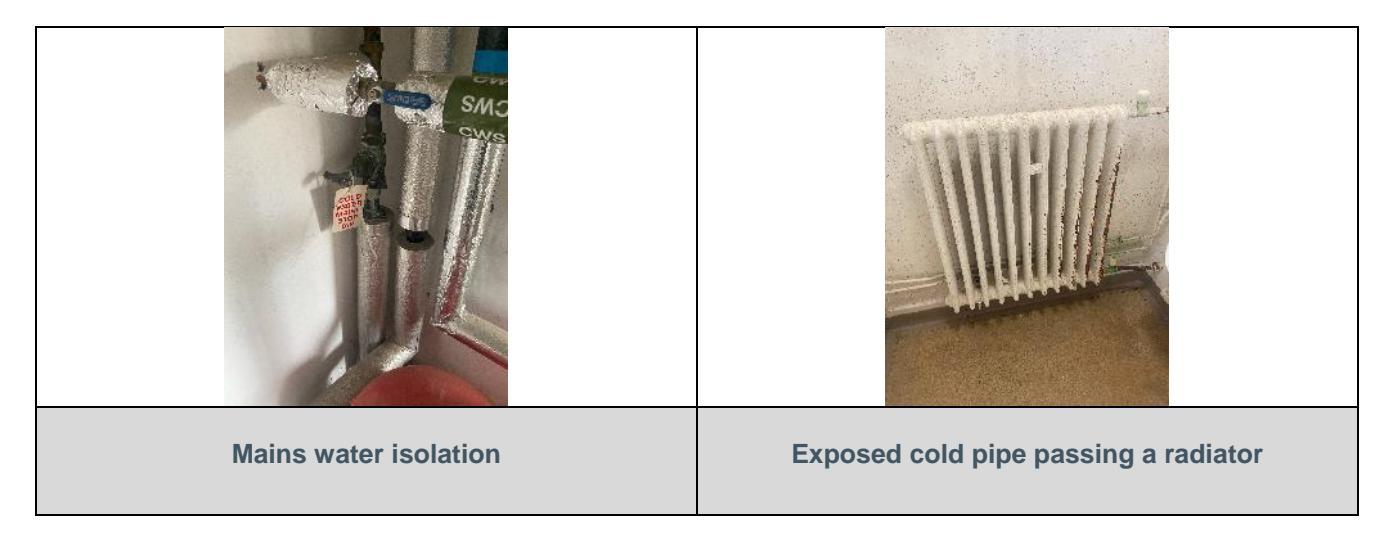
6.1 MAINS WATER SUPPLY REPORT (continued)

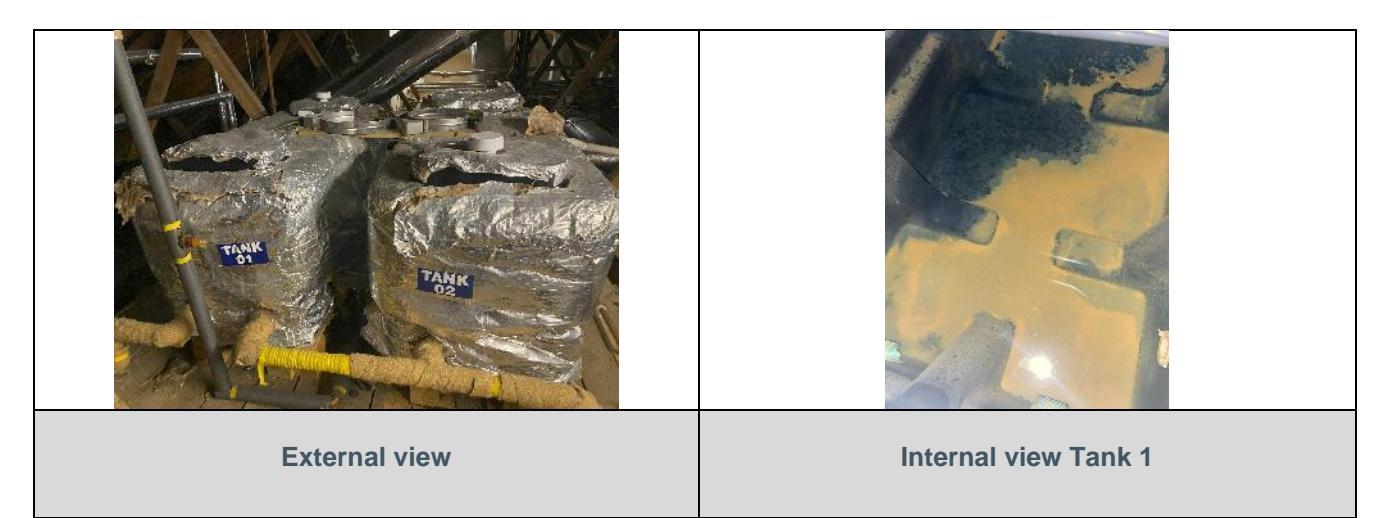
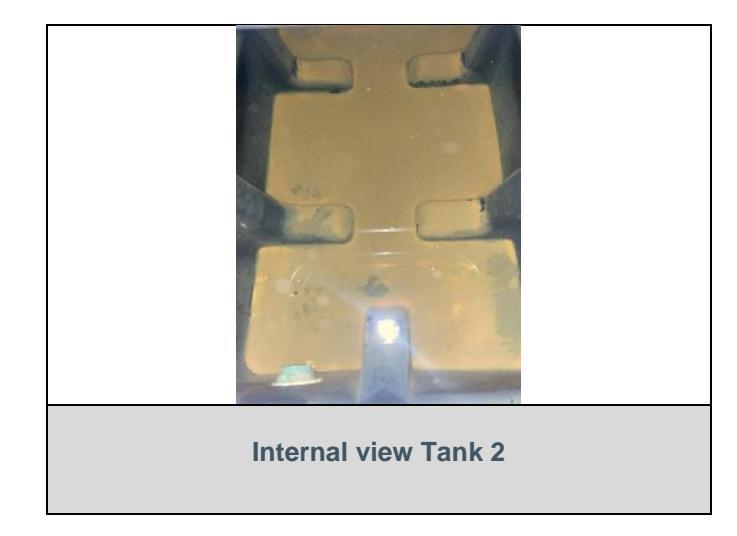
Water in Tank	Temperature C	T1: 12.C		T2: 12. C.	
	Degree of sediment		Неаvy		
	Biological slime severe/mediu	ım/light	Light		
	Extent of corrosion		Nil		
	Is there adequate crossflow w	vithin the	Yes		
	Is the stored water over capa	citv??	No		
Labels	Is the tank labelled	,	Yes		
	Supply pipe labelled or coded		Yes		
	Outlets labelled or coded		Yes		
Operation	How far to adequate drain		20m		
	Power supply – volts/distance	2	20m		
	Is lighting adequate		Yes		
	Access limit ht x w		870 x 670		
CWST Risk Score			High

Comments/Recommendations:

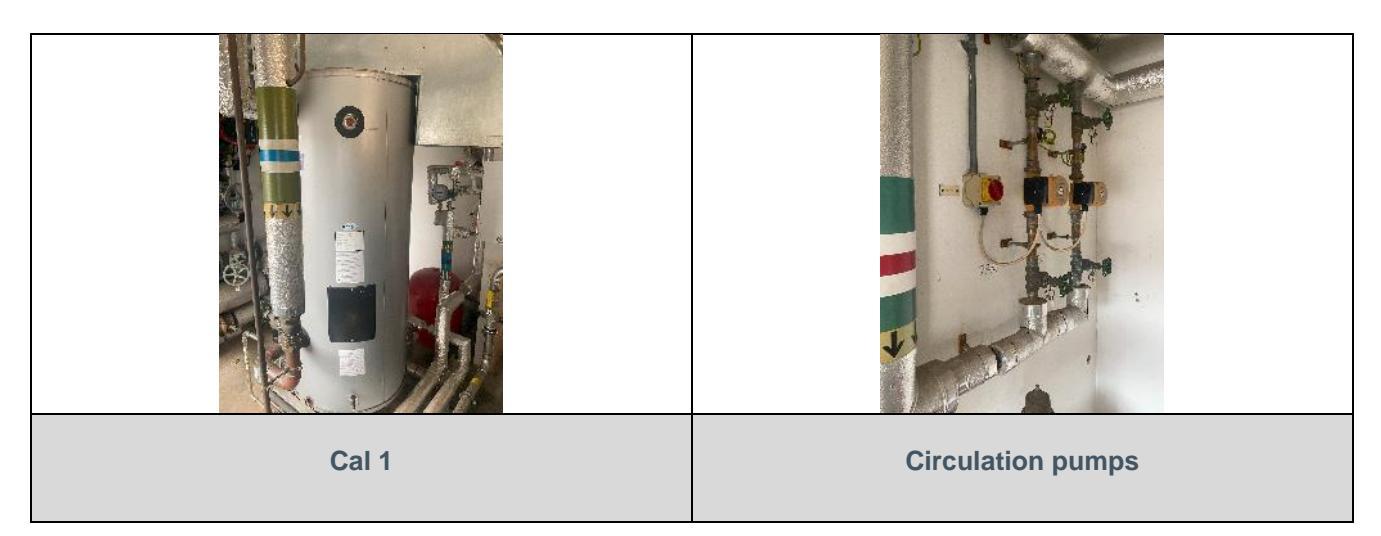
Location of hot water storage vessel	Boiler room
Construction	Stainless steel
Size of hot water storage vessel	253 litres
Horizontal/vertical	Vertical
Storage/non-storage	Storage
Main heat source	Gas
Supplementary heating	No
Insulation type	Pre insulated
Is there an open vent	No
Is there an Expansion Vessel	No
Size of Expansion Vessel	-
IS there a flow through Valve fitted?	-
Is there a drain fitted & what size?	-
What size is access hatch	220 mm
Is there a drain valve – if yes give size	Yes ¾ "
Does drain valve work	Not attempted
Condition of water from drain valve	-
Size and materials cold feed pipe	54 mm copper
Is cold feed valved	Yes
Fed from mains, tank or softened	Tank 1-2
Pressure gauge reading	-
Temp from main gauge on hot water flow	60.C
Temp from gauge on sec return flow	57.C
Safety valve size	3⁄4 "
Is system circulated by sec return (yes/no)	Yes
Is calorifier circulated	Yes
Anti-stratification Pump (yes/no)	No

Comments/Recommendations:

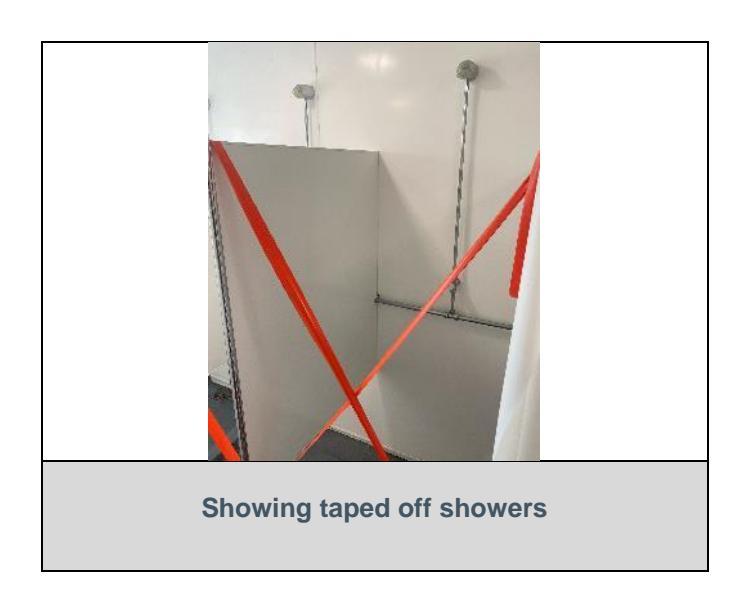
Location	Nos of showers	Dismantled/ cleaned and disinfected YES/NO	Overall condition	Any repairs replacements	Regularity of Use		
Male ablutions	6	No	Good	2 x out of order	Unknown		
Female ablutions	8	No	Good No Unknown		Unknown		
COMMENTS:							
 Two male showers have been placed out of order, reinstate flow to all showers. Infrequently used showers should be flushed weekly.

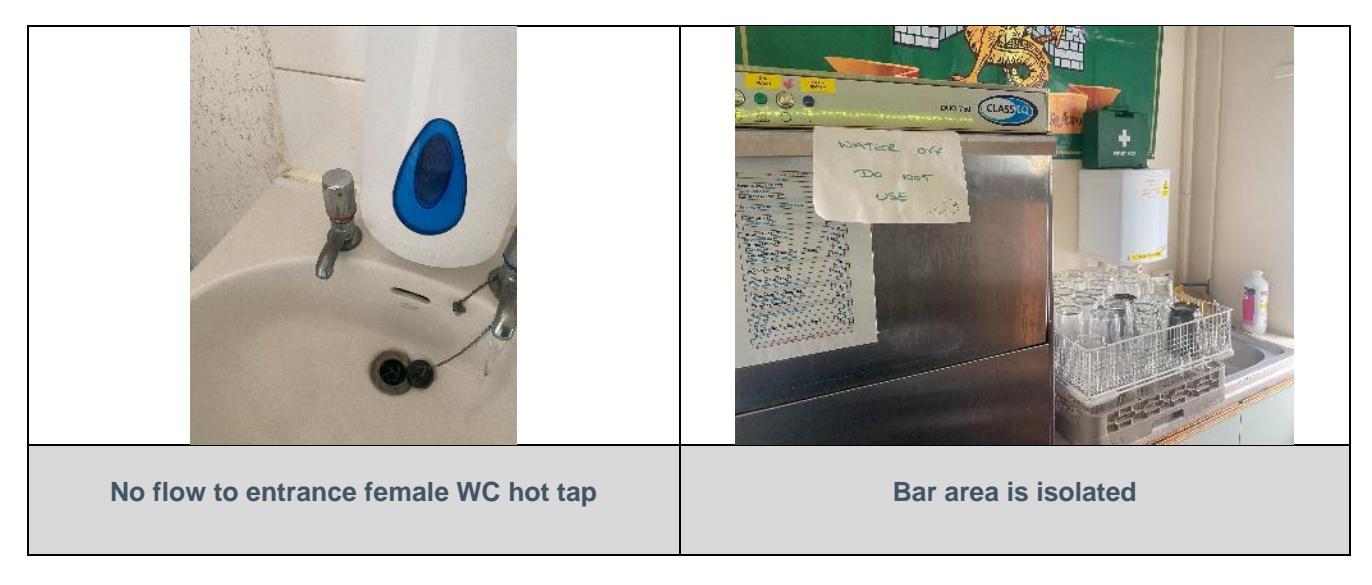
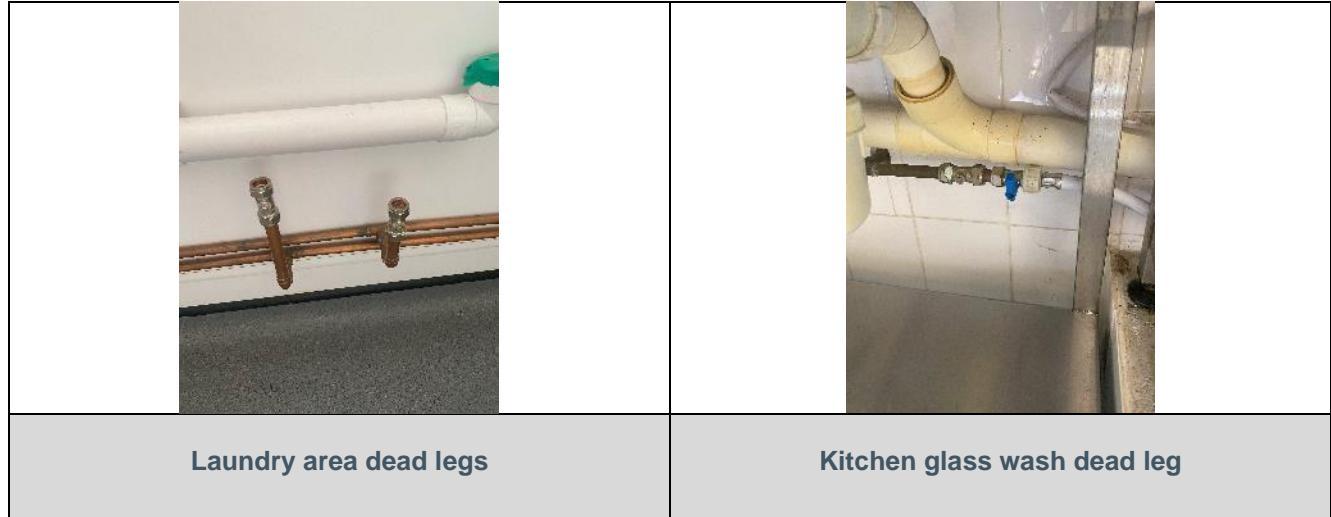
LOCATIONS	SYSTEM	ACTION
FF kitchen	Mains	Double check valve required at 'T off' to quick fill
Male showers	-	Reinstate flow to showers
Ground floor laundry	Hot and cold	Remove dead legs at source
Ground floor bar	Hot and cold	Isolated area. Reinstate flow or remove at source
Right side male WC	Mains	No flow to cold tap, reinstate flow to tap
Entrance female WC	Hot water	Reinstate flow to tap
Kitchen glass wash	Mains	Glass wash isolated. Remove or reinstate flow
