**Project Number 2481**

**Management  
Asbestos Survey Report**

**Wyvern Barracks, Barrack Road, Exeter, Devon,  
EX2 6AE (Building 18)**

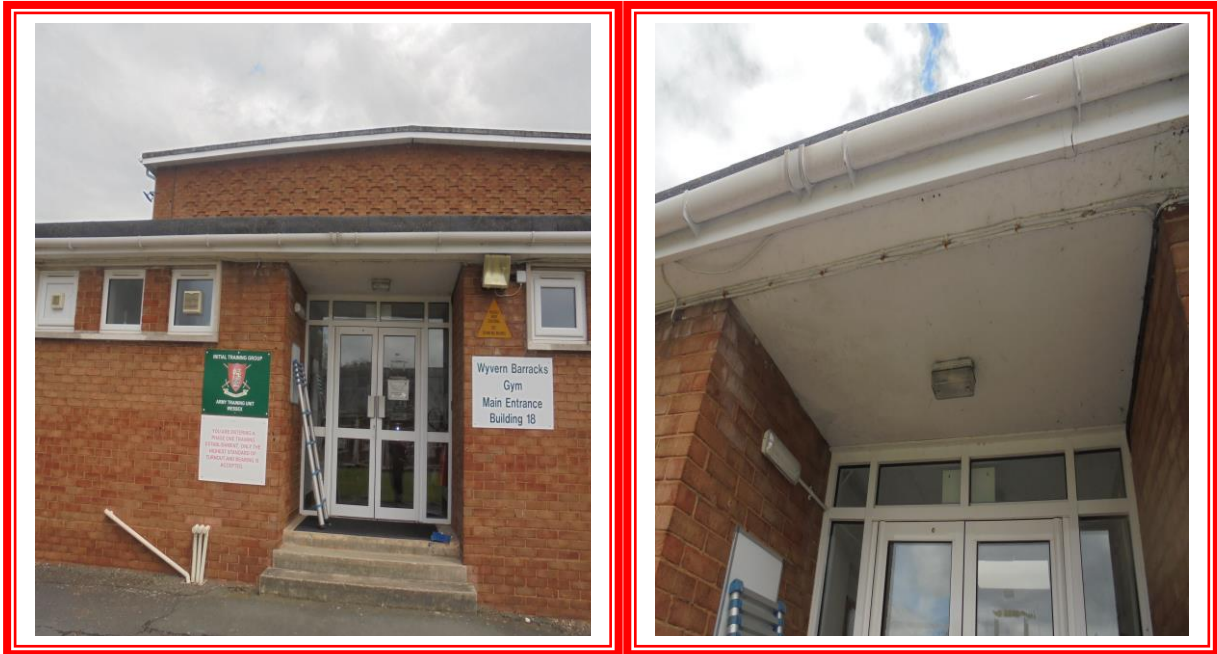
**Item No: 1**

**Location: Porch**

<b>Material Description:</b>	Insulation board ceiling	
<b>Identification:</b>	Sampled – Asbestos Detected	
<b>Approx. quantity:</b>	4M2	
<b>Accessibility</b>	Low	<i>Assessment Score</i>
<b>Product type:</b>	Asbestos Insulation Board	2
<b>Extent of Damage:</b>	Slight	1
<b>Surface Treatment:</b>	Unsealed	2
<b>Asbestos type:</b>	Chrysotile/ Amosite	2
<b>Material Assessment Score:</b>		7
<b>Priority Assessment Score:</b>		Medium
<b>Action:</b>	Encapsulate/Manage	
<b>Comments:</b>	Minor encapsulation required

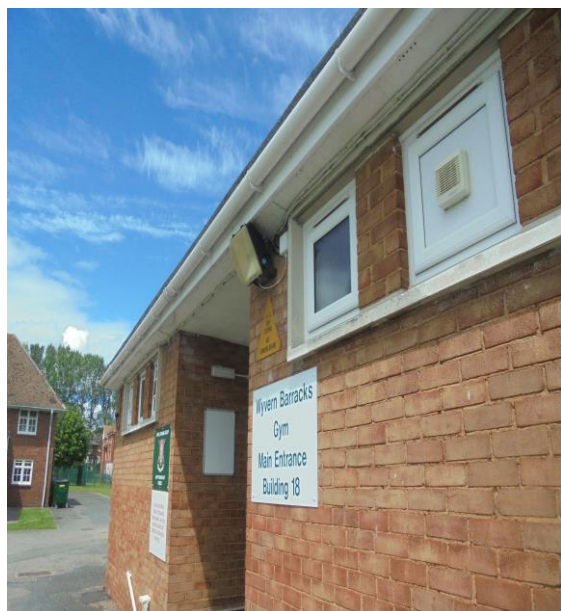
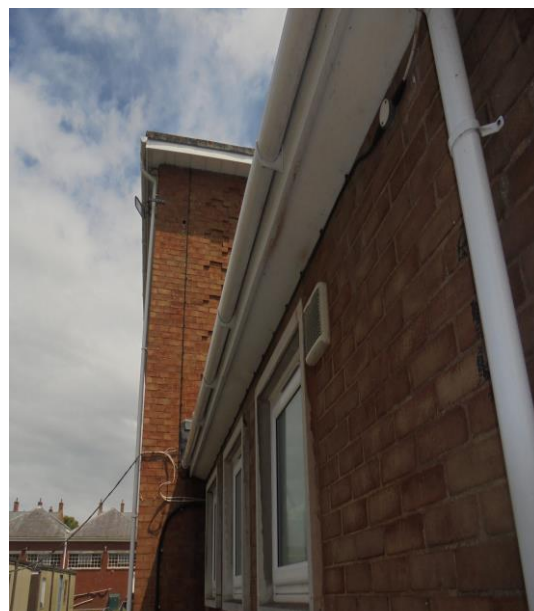
**Item No: 2****Sample No: 2****Location: External**

<b>Material Description:</b>	Soffit Boards	
<b>Identification:</b>	Sampled – Asbestos Detected	
<b>Approx. quantity:</b>	50LM	
<b>Accessibility</b>	Low	Assessment Score
<b>Product type:</b>	Cement	1
<b>Extent of Damage:</b>	Minor	1
<b>Surface Treatment:</b>	Unsealed	1
<b>Asbestos type:</b>	Chrysotile	1
<b>Material Assessment Score:</b>		4
<b>Priority Assessment Score:</b>		Negligible
<b>Action:</b>	Manage	
<b>Comments:</b>	Located to low level soffits

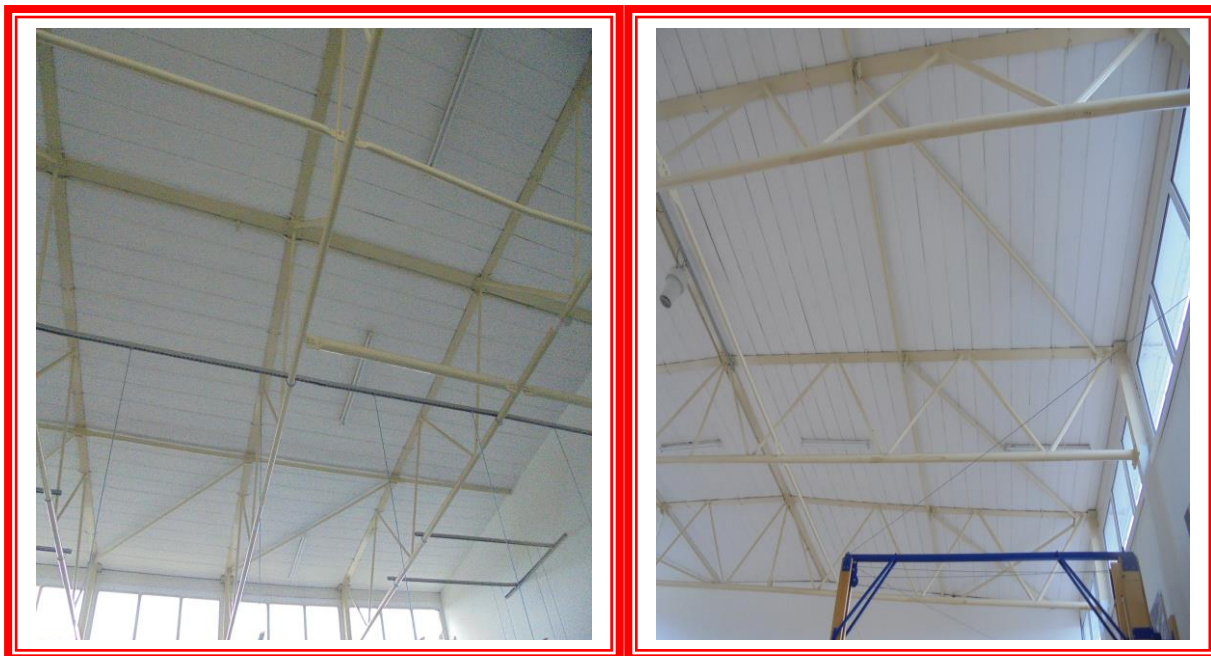
**Item No: 6****Sample No: N/A****Location: Gym 1 and 2 and Store**

<b>Material Description:</b>	Ceiling panels	
<b>Identification:</b>	As Per Previous Sample – 3-27739	
<b>Approx. quantity:</b>	Entire roof including external soffit – 430M2	
<b>Accessibility</b>	Low	<i>Assessment Score</i>
<b>Product type:</b>	Cement	1
<b>Extent of Damage:</b>	Minor	1
<b>Surface Treatment:</b>	Unsealed	1
<b>Asbestos type:</b>	Chrysotile	1
<b>Material Assessment Score:</b>		4
<b>Priority Assessment Score:</b>		Negligible
<b>Action:</b>	Manage	
<b>Comments:</b>	Ceiling panels were sampled on a previous survey. No access to sampled during this survey due to height

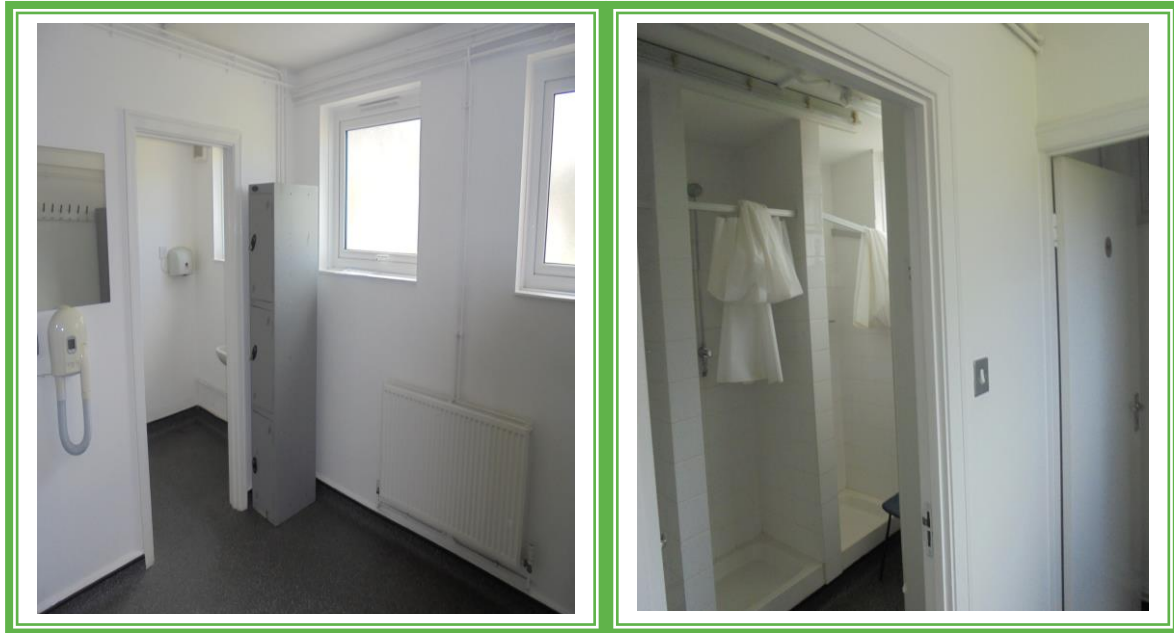
**Item No: 3**

**Location: Ladies Changing Room and WC**

<b>Material Description:</b>	Visual Inspection – No Suspect Materials Found	
<b>Identification:</b>	N/A	
<b>Approx. quantity:</b>	N/A	
<b>Accessibility</b>	N/A	<i>Assessment Score</i>
<b>Product type:</b>		N/A
<b>Extent of Damage:</b>		N/A
<b>Surface Treatment:</b>		N/A
<b>Asbestos type:</b>		N/A
<b>Material Assessment Score:</b>		N/A
<b>Priority Assessment Score:</b>		N/A
<b>Action:</b>	N/A	
<b>Comments:</b>	No access within timber boxing

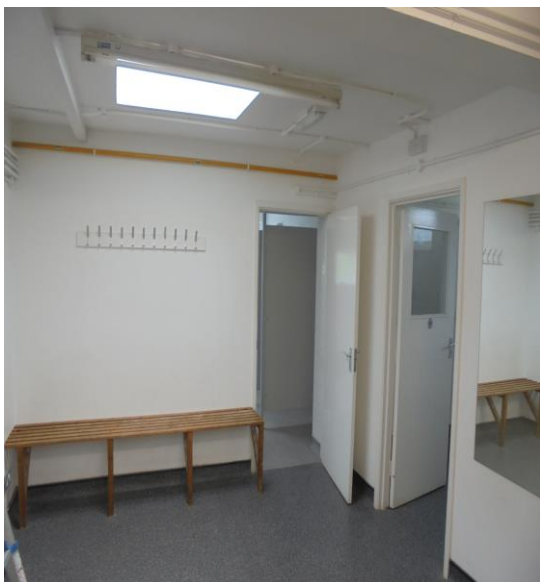
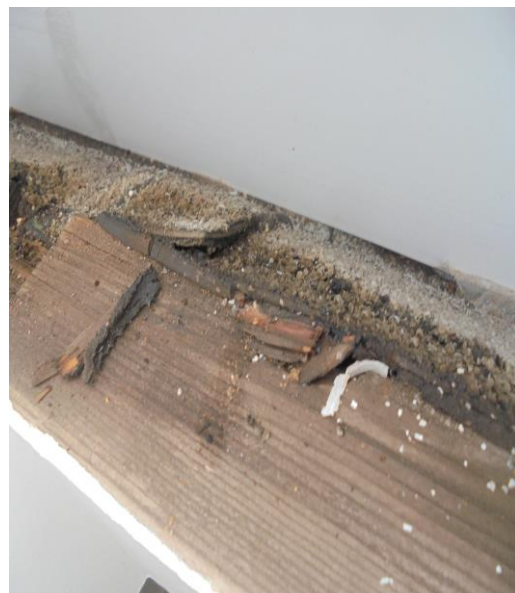
**Item No: 4****Sample No: 3****Location: Men's Changing room, WC and Disabled WC**

<b>Material Description:</b>	Bitumen seal to skylight	
<b>Identification:</b>	Sampled – No Asbestos Detected	
<b>Approx. quantity:</b>	X 4 Skylights	
<b>Accessibility</b>	N/A	<i>Assessment Score</i>
<b>Product type:</b>		N/A
<b>Extent of Damage:</b>		N/A
<b>Surface Treatment:</b>		N/A
<b>Asbestos type:</b>		N/A
<b>Material Assessment Score:</b>		N/A
<b>Priority Assessment Score:</b>		N/A
<b>Action:</b>	N/A	
<b>Comments:</b>	Plasterboard skylight cheeks

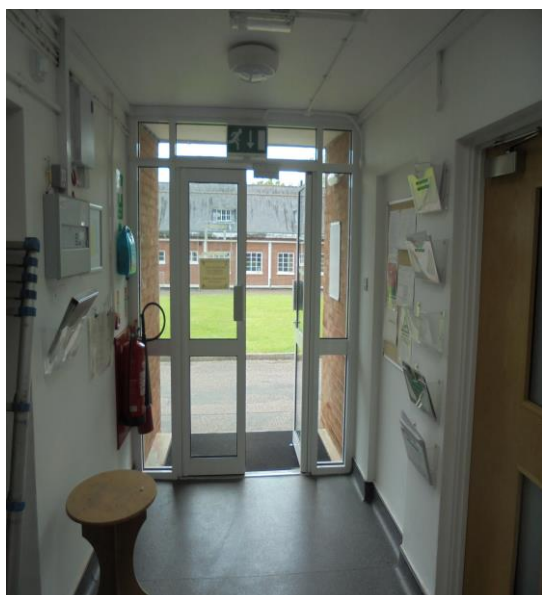
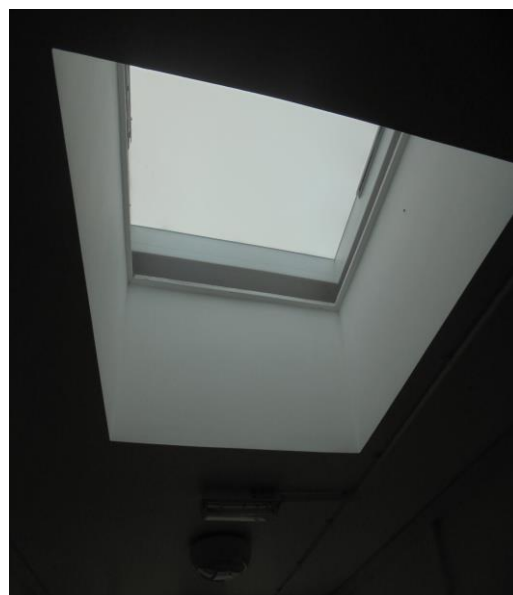
**Item No: 5**

**Location: Lobby**

<b>Material Description:</b>	Bitumen seal to skylight	
<b>Identification:</b>	As Per Sample DK/3 – No Asbestos Detected	
<b>Approx. quantity:</b>	X 1 Skylight	
<b>Accessibility</b>	N/A	<i>Assessment Score</i>
<b>Product type:</b>		N/A
<b>Extent of Damage:</b>		N/A
<b>Surface Treatment:</b>		N/A
<b>Asbestos type:</b>		N/A
<b>Material Assessment Score:</b>		N/A
<b>Priority Assessment Score:</b>		N/A
<b>Action:</b>	N/A	
<b>Comments:</b>	Modern Electrics. No access within boxing
