Project Number 2481

**Management
Asbestos Survey Report**

**Wyvern Barracks, Barrack Road, Exeter, Devon,
EX2 6AE (Building 13)**

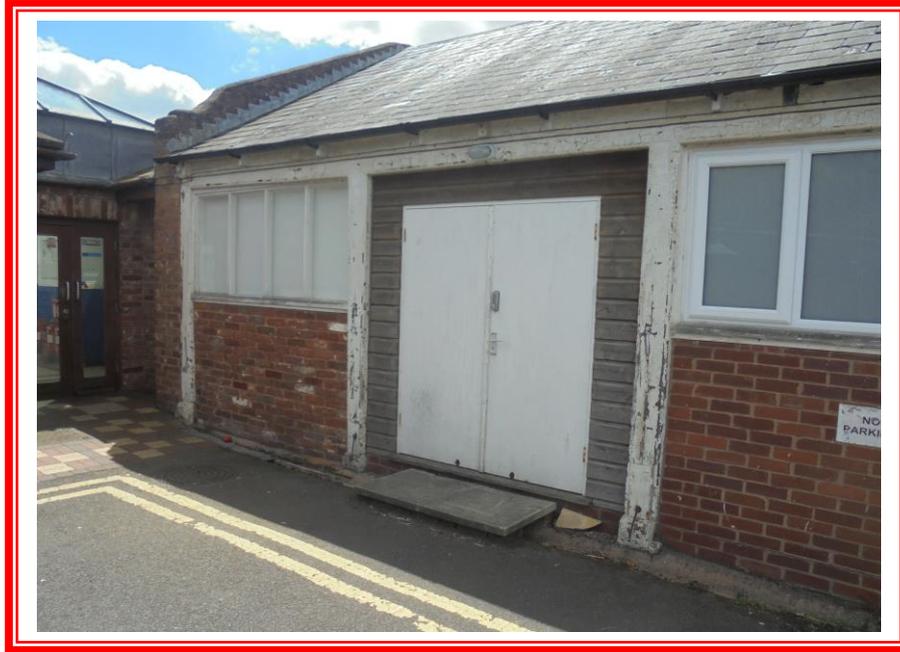
Item No: 4

Location: Building 13B - Store

Material Description:	No access as locked	
Identification:	Presumed to Contain Asbestos	
Approx. quantity:	X 1 Room	
Accessibility	Low	<i>Assessment Score</i>
Product type:	No Access	3
Extent of Damage:	No Access	3
Surface Treatment:	No Access	3
Asbestos type:	No Access	3
Material Assessment Score:		12
Priority Assessment Score:		High
Action:	Further Investigation Required	
Comments:	Tried in several buildings to acquire keys but they could not be located.

Item 4 – Building 13B – Store – No access as no keys were available and no one who has access to a key was available during the survey.

The presence of asbestos in these areas cannot be ascertained at this time. If any works are to be carried out in these areas in the future, then these works should be approached cautiously.

In accordance with current legislation, any suspect materials encountered in these areas are to be assumed to contain asbestos until proven otherwise. This will normally involve cessation of works in the affected area.

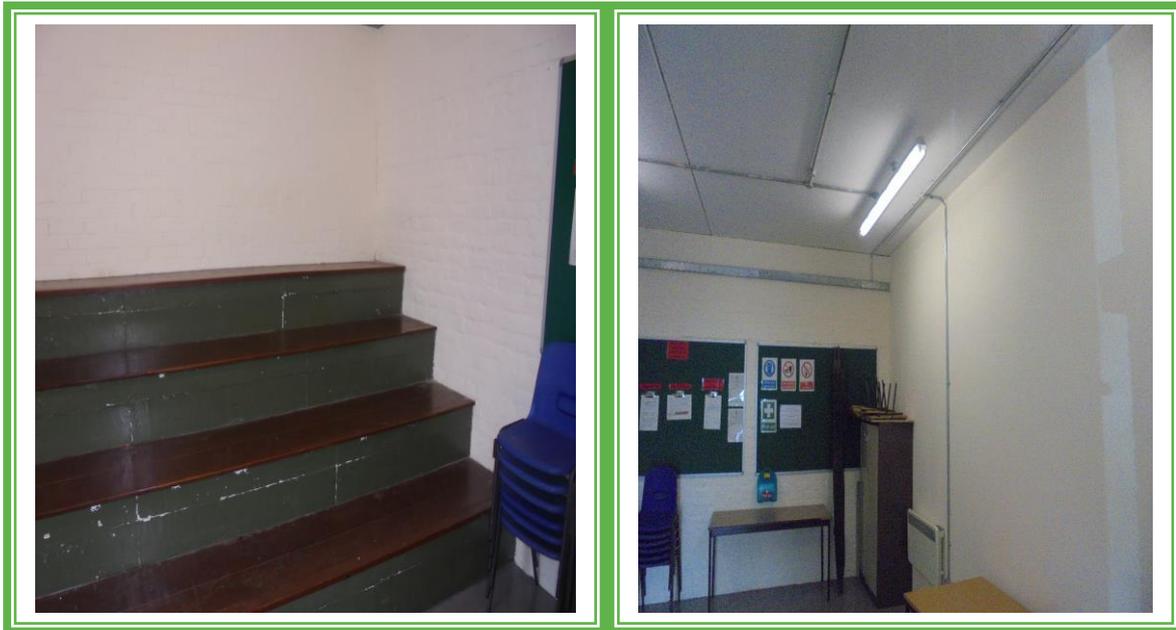
Item No: 1

Location: Building 13A – Conference Room and Cupboard

Material Description:	Visual Inspection – No Suspect Materials Found	
Identification:	N/A	
Approx. quantity:	N/A	
Accessibility	N/A	<i>Assessment Score</i>
Product type:		N/A
Extent of Damage:		N/A
Surface Treatment:		N/A
Asbestos type:		N/A
	Material Assessment Score:	N/A
	Priority Assessment Score:	N/A
Action:	N/A	
Comments:	Modern Electrics

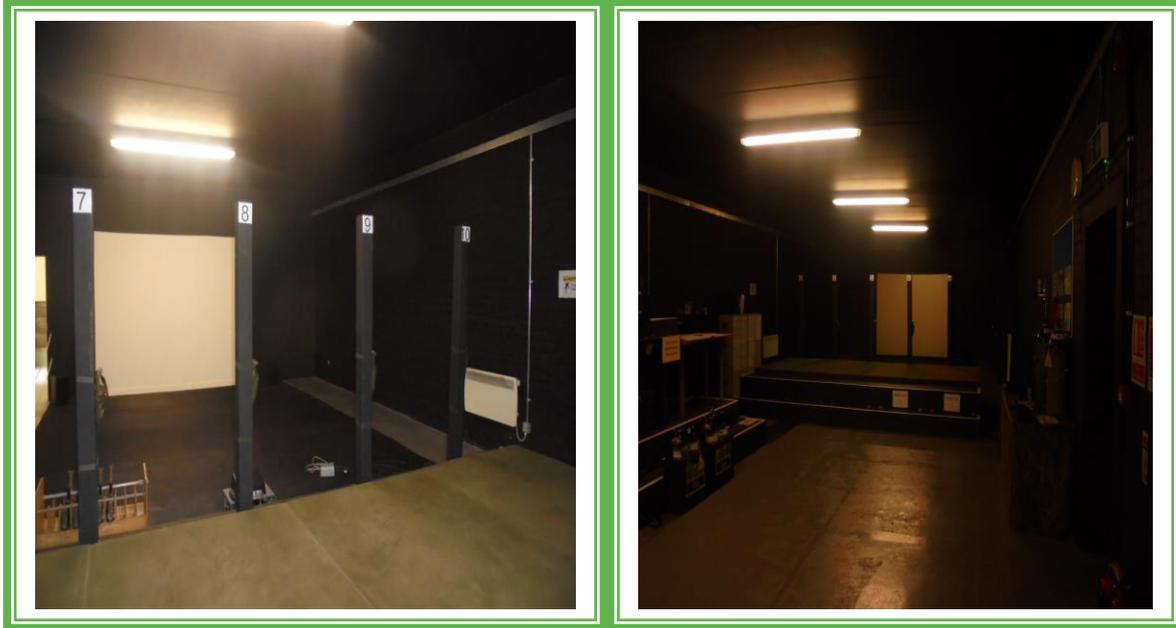
Item No: 2

Location: Building 13A – Firing Range

Material Description:	Visual Inspection – No Suspect Materials Found	
Identification:	N/A	
Approx. quantity:	N/A	
Accessibility	N/A	<i>Assessment Score</i>
Product type:	N/A	
Extent of Damage:	N/A	
Surface Treatment:	N/A	
Asbestos type:	N/A	
Material Assessment Score:		N/A
Priority Assessment Score:		N/A
Action:	N/A	
Comments:	N/A

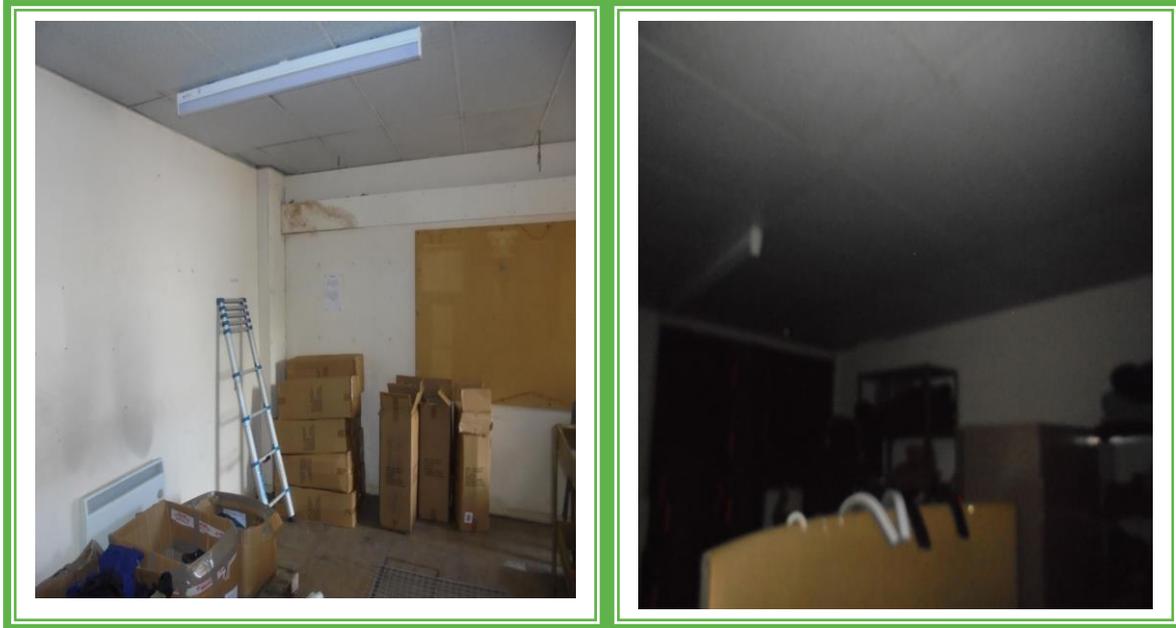
Item No: 3

Location: Building 13B – Band Store

Material Description:	Visual Inspection – No Suspect Materials Found	
Identification:	N/A	
Approx. quantity:	N/A	
Accessibility	N/A	<i>Assessment Score</i>
Product type:	N/A	
Extent of Damage:	N/A	
Surface Treatment:	N/A	
Asbestos type:	N/A	
Material Assessment Score:		N/A
Priority Assessment Score:		N/A
Action:	N/A	
Comments:	N/A

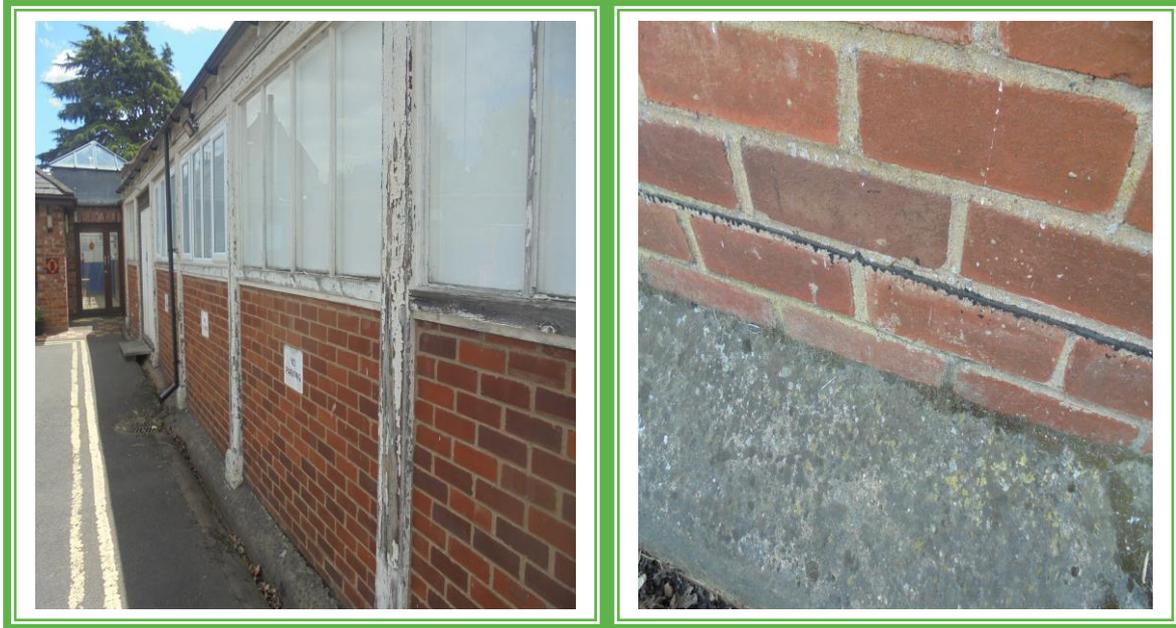
Item No: 5

Location: Building 13 - External

Material Description:	Damp proof course	
Identification:	Sampled – No Asbestos Detected	
Approx. quantity:	To the entire perimeter of the building	
Accessibility	N/A	<i>Assessment Score</i>
Product type:		N/A
Extent of Damage:		N/A
Surface Treatment:		N/A
Asbestos type:		N/A
Material Assessment Score:		N/A
Priority Assessment Score:		N/A
Action:	N/A	
Comments:	N/A

Sample No.	Sample Ref.	Location	Asbestos Detected	Asbestos Type
1	BS559454	External. Damp proof course	No

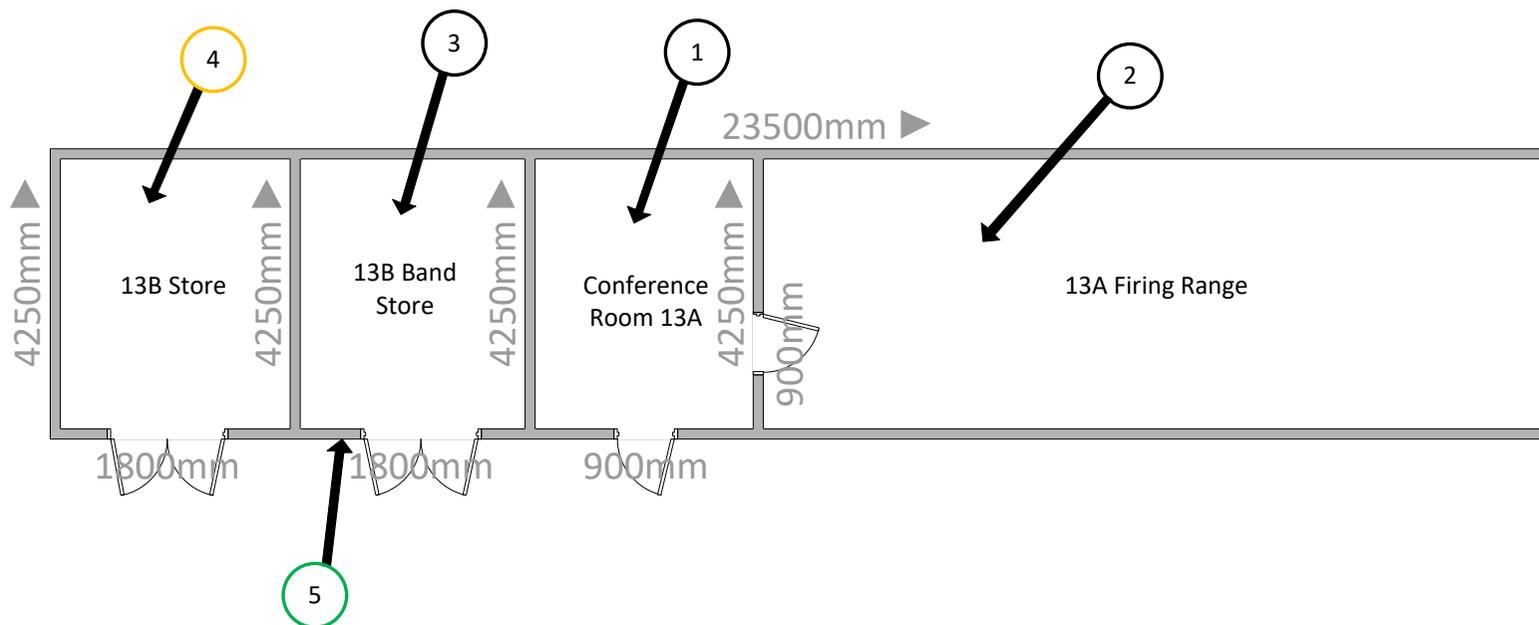
Section 12: Site Plan

The drawings in the report are not to scale and are illustrative only to indicate approximate locations. The descriptions used are for location identification purposes.
