Project Number A-01571 (6461)

**Targeted Refurbishment and
Demolition**

Asbestos Survey Report

**165 Port and Maritime
Brest Road
Devon
PL6 5EW**

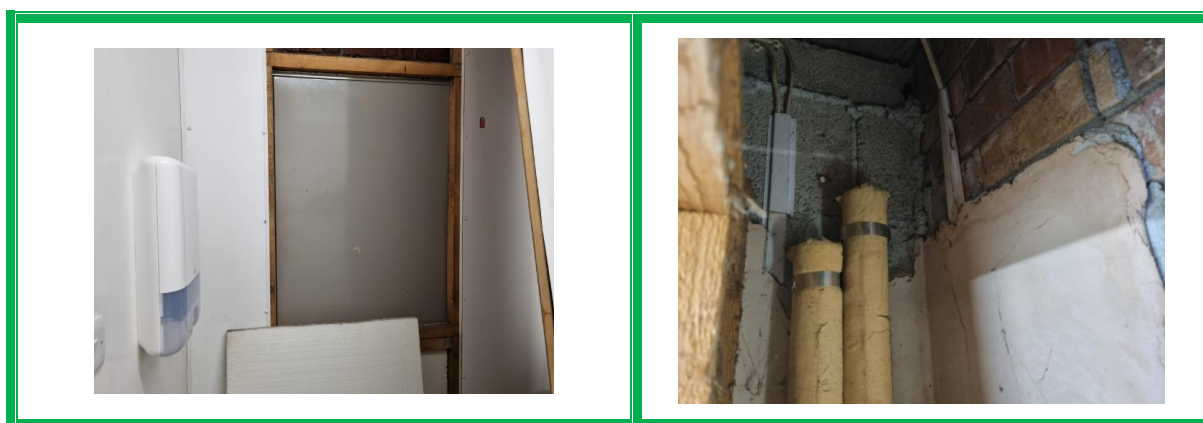
Item No:	1	Sample No:	PT/01
Location:	Ground Floor - Kitchen 001

Material Description:	Pipe Insulation - Insulation	
Identification:	Sampled - No Asbestos Found	
Approx. quantity:	N/A	
Accessibility	N/A	<i>Assessment Score</i>
Product type:	N/A	N/A
Extent of Damage:	N/A	N/A
Surface Treatment:	N/A	N/A
Asbestos type:	N/A	N/A
Material Assessment Score:		N/A
Risk Assessment Score:		N/A
Action:	N/A	
Comments:	<p>Concrete ceiling above Plasterboard ceiling, block, plastic and brick walls, vinyl and grey floor tiles or another vinyl underneath, timber door and frame, timber boxing with clean pipework running through, metal radiator and clean pipework, electric unit in timber cupboard.</p> <p>Pipework insulation in ceiling and wall void connected to air conditioning system</p>

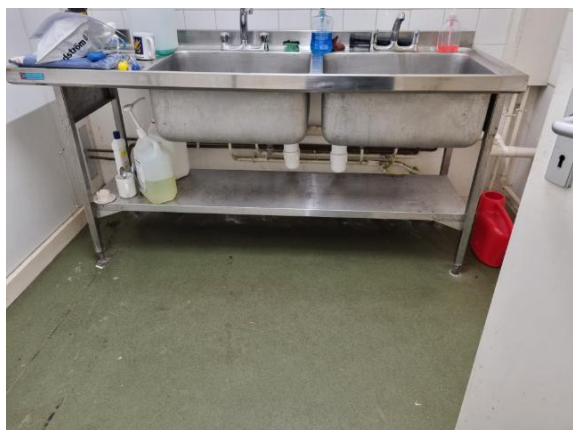
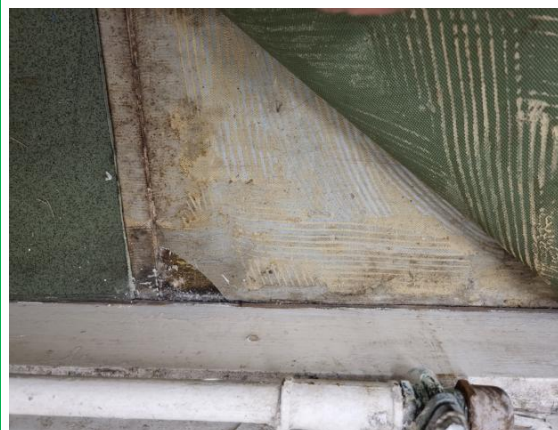
Item No: 2

Material Description:	Floor tiles - Bituminous Product	
Identification:	Sampled - No Asbestos Found	
Approx. quantity:	N/A	
Accessibility	N/A	<i>Assessment Score</i>
Product type:	N/A	N/A
Extent of Damage:	N/A	N/A
Surface Treatment:	N/A	N/A
Asbestos type:	N/A	N/A
Material Assessment Score:		N/A
Risk Assessment Score:		N/A
Action:	N/A	
Comments:	Grey floor tiles or vinyl underneath modern vinyl flooring.

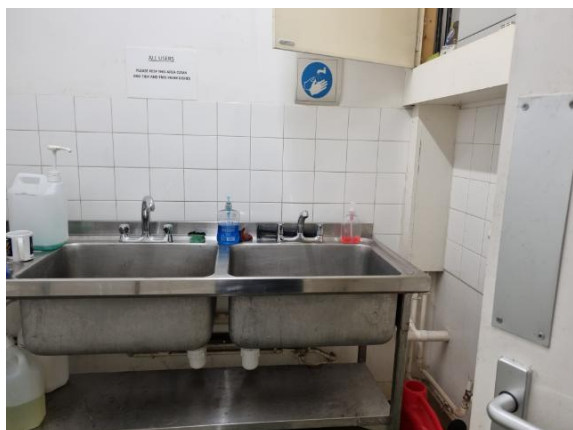
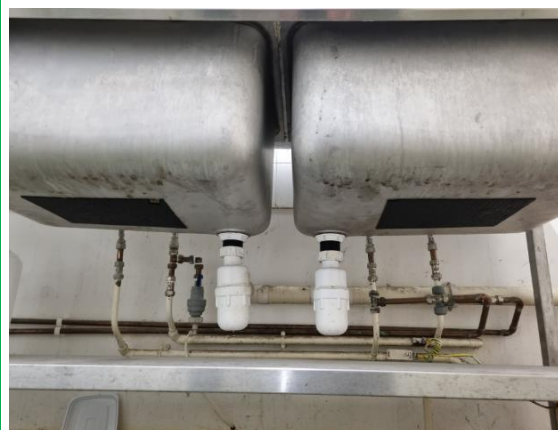
Item No: 3

Material Description:	Sink pads - Bituminous Product	
Identification:	Sampled - No Asbestos Found	
Approx. quantity:	N/A	
Accessibility	N/A	<i>Assessment Score</i>
Product type:	N/A	N/A
Extent of Damage:	N/A	N/A
Surface Treatment:	N/A	N/A
Asbestos type:	N/A	N/A
Material Assessment Score:		N/A
Risk Assessment Score:		N/A
Action:	N/A	
Comments:	3 x sink pads

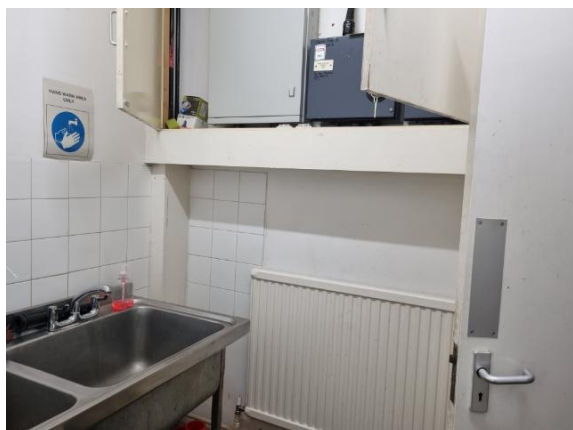
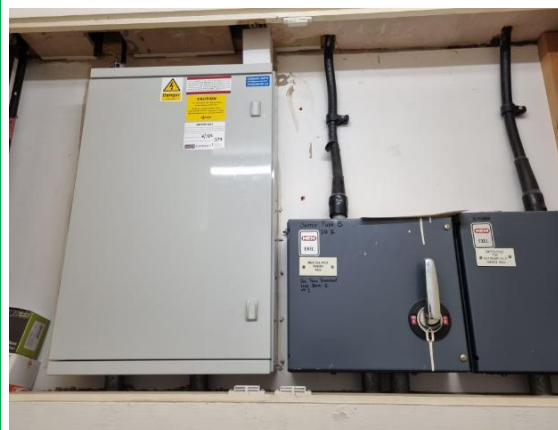
Item No: 4

Material Description:	No Suspect Materials Found	
Identification:	N/A	
Approx. quantity:	N/A	
Accessibility	N/A	<i>Assessment Score</i>
Product type:	N/A	N/A
Extent of Damage:	N/A	N/A
Surface Treatment:	N/A	N/A
Asbestos type:	N/A	N/A
Material Assessment Score:		N/A
Risk Assessment Score:		N/A
Action:	N/A	
Comments:	Plasterboard ceiling, block and timber walls, timber floor, timber doors.
