LEGIONELLA RISK ASSESSMENT

Client:	Wessex RF & CA
Site:	Keynsham ARC
Address:	Ashmead Road, Keynsham BS31 1SX
Risk Rating:	Low
Report Ref:	AQST/LRA/264
Surveyed By:	David Fletcher
Survey Date:	10th & 20th November 2023
Report Date:	24th November 2023
Recommended Review Date:	November 2025

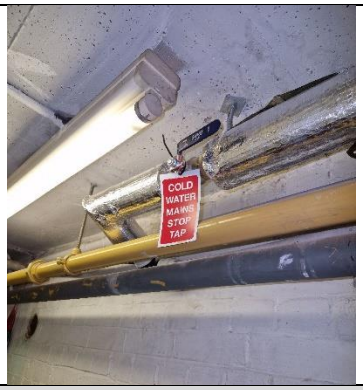
Main Building CWM stop tap	New side CWM stop tap

Source of supply	Towns mains
Number of mains cold water supply?	2
Location of main isolation valve?	Main Building in Basement boiler room high level by door New side in boiler room
Is there a water meter installed?	No
Is the pipework labelled?	Yes
Materials of construction	Main Building – 35mm copper New side – 22mm copper
Are there any materials or fittings visibly present on the mains water system, that do not conform to the Water Regulations Advisory Scheme (WRAS) directory?	No
Mains water temperature ˚C (sentinel outlets)	As per outlet sheet
Are all other distribution temperatures that were tested within the correct temperature range? i.e. Below 20 ˚C?	Yes
Are there any none flow through expansion vessels to any services on this system?	Yes
Is the pipework suitably insulated?	Yes
Does the cold-water supply have any inline filters including scale inhibitors/softeners?	No
COMMENTS	
Mains Water Supply Risk Score	**Low**

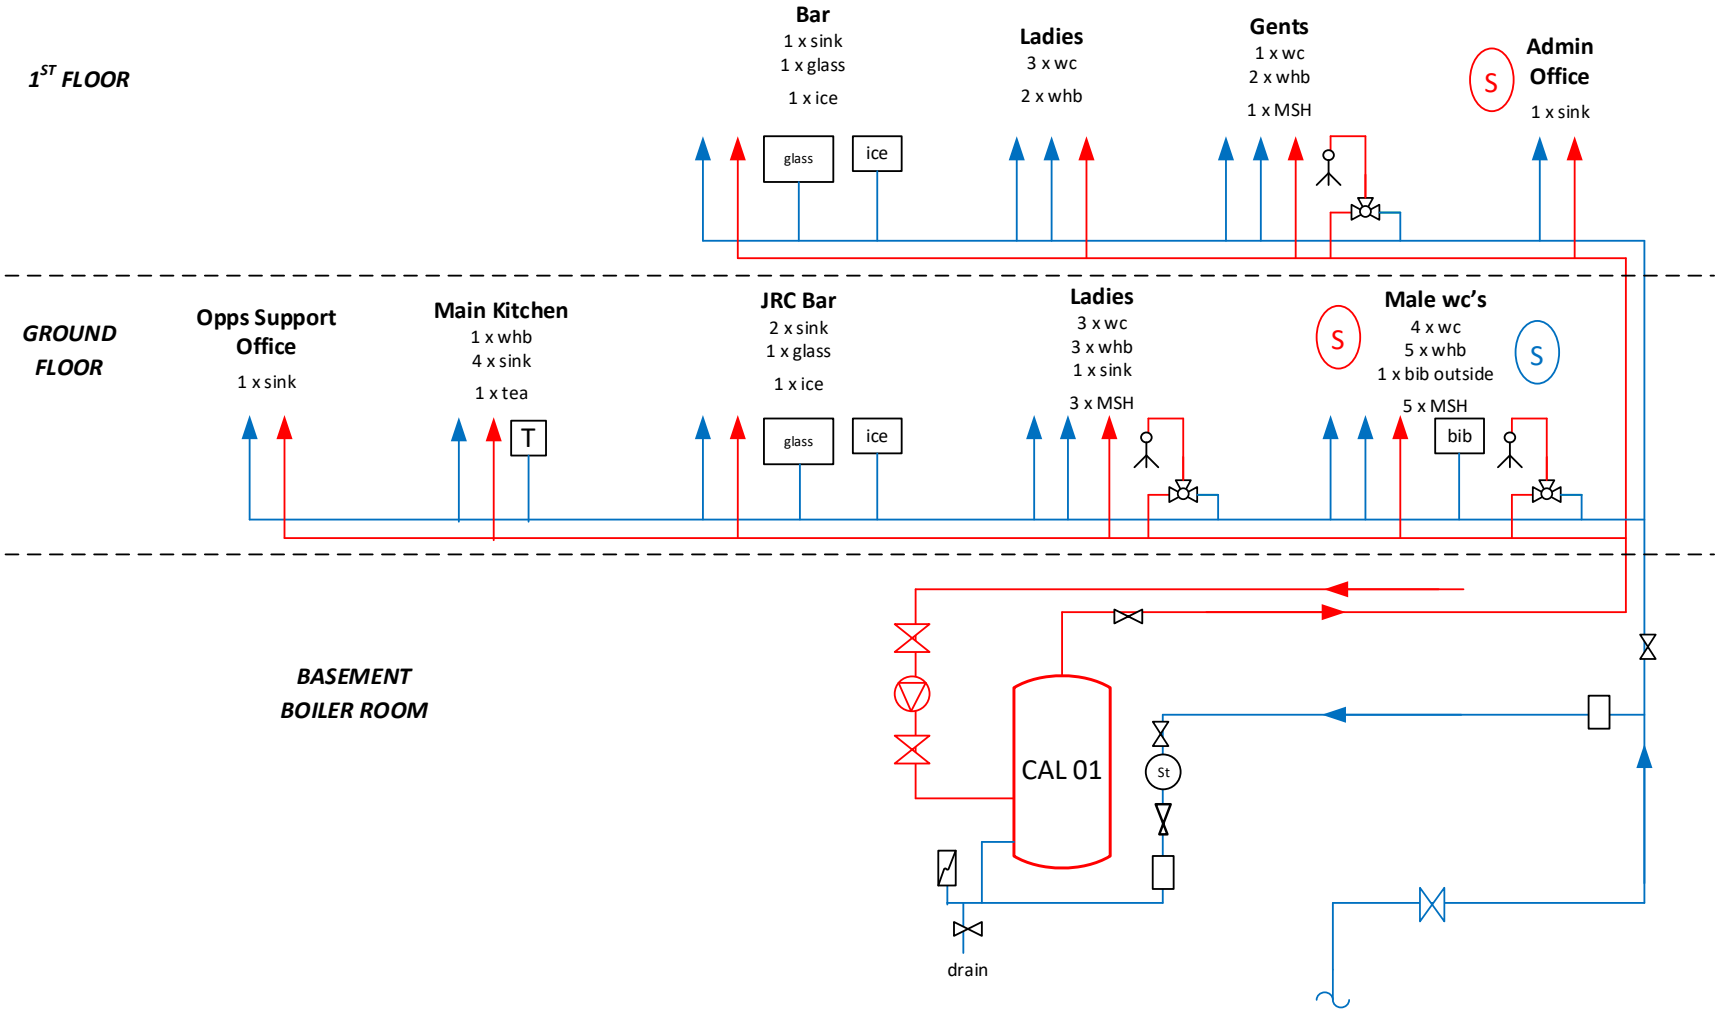
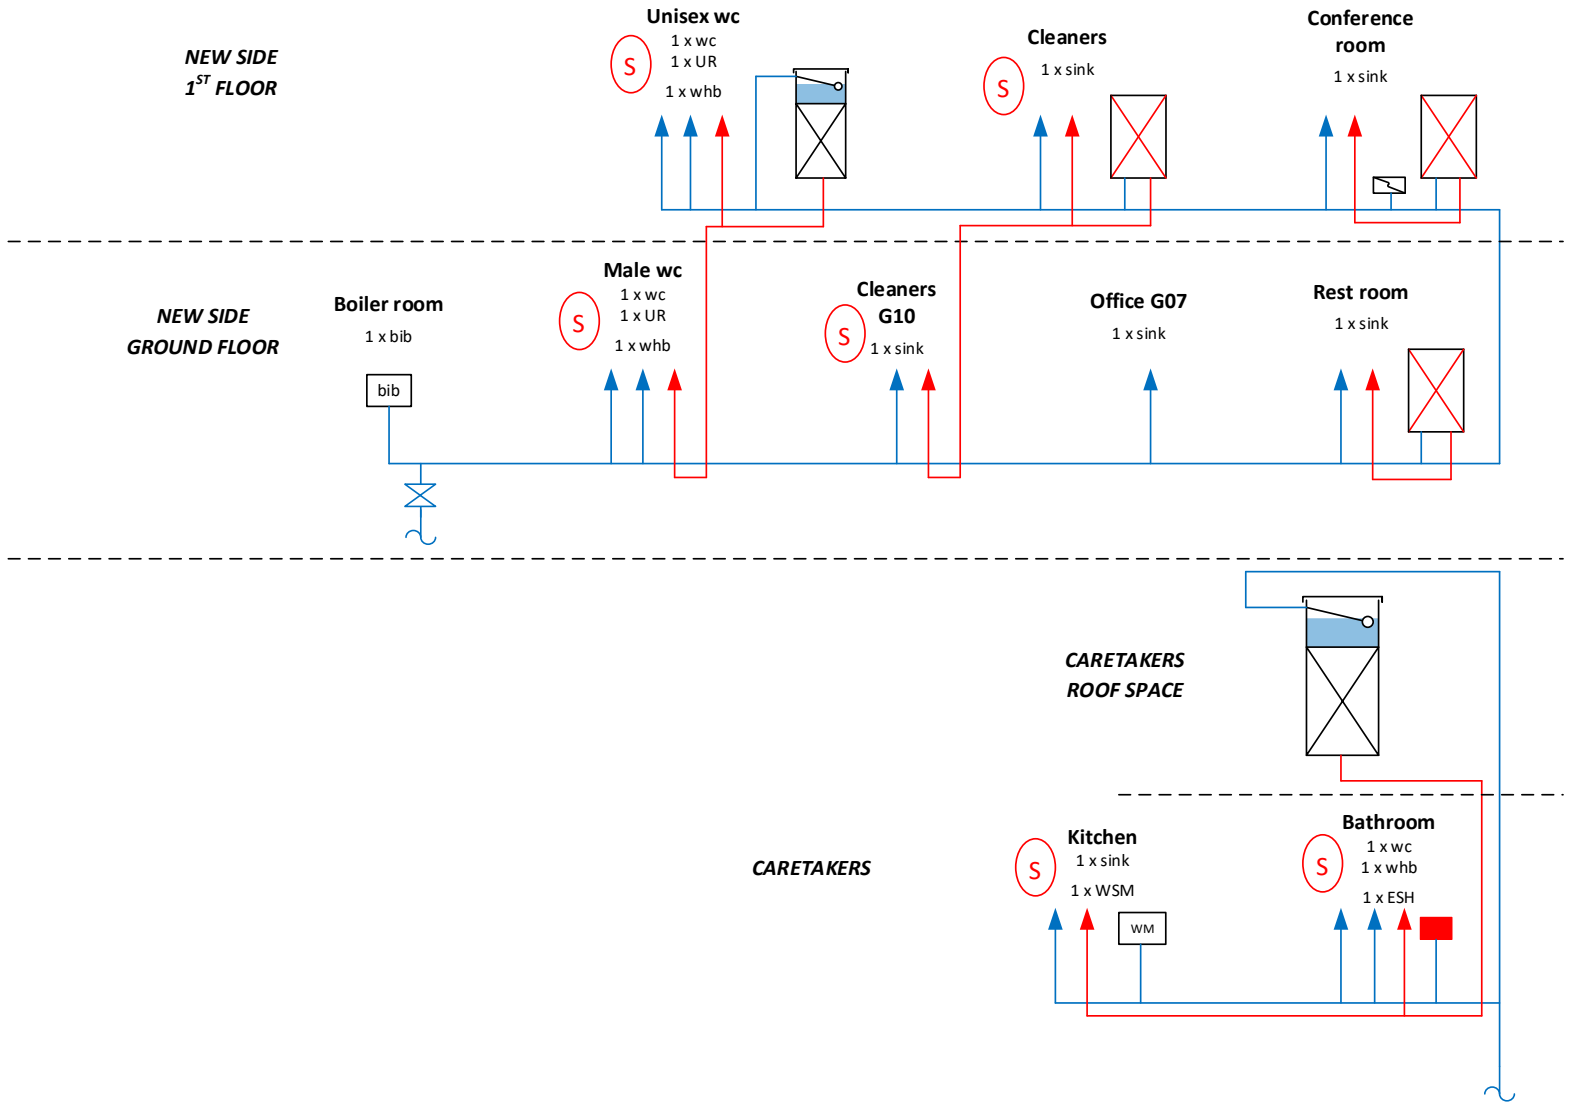
8. LINE DRAWINGS OF WATER SYSTEMS SITE: ARC Keynsham November 2023

NB: Due to the complexity of the pipe work at this site it is not possible to ensure the total accuracy of these line drawings. They may require revision.

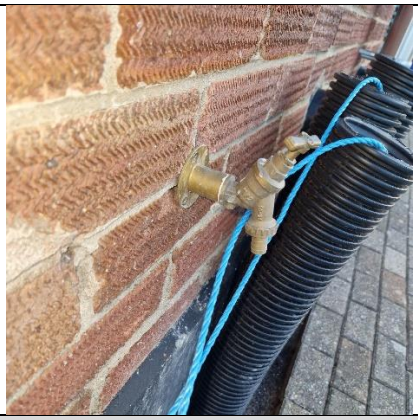
New side Building

Outside bib
