UPDATED
RISK ASSESSMENT

THE PREVENTION AND CONTROL OF LEGIONNAIRES' DISEASE

WESSEX RF & CA

6th Battalion The Rifles C Company
ARC Dorchester
Poundbury Road
Dorchester
DT1 1SL

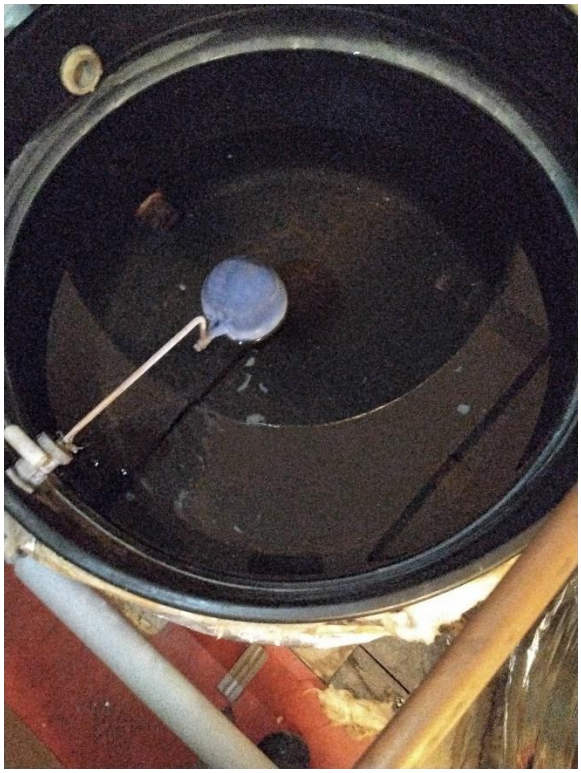
Inside CWST 01

1. Tank 01 outlet requires 1m of 1 ½"pipe insulation.
2. CWST 02 temperature is slightly high possibly due to lack of use. All little used outlets should be flushed thoroughly on a weekly basis and recorded in the log book. Requires careful monitor.
3. Supply pipe and outlets should be labelled or coded.
