Project Number 3700

**Re-Inspection
Asbestos Survey Report**

**232 Port Squadron
Bodmin
Cornwall
PL31 1DX**

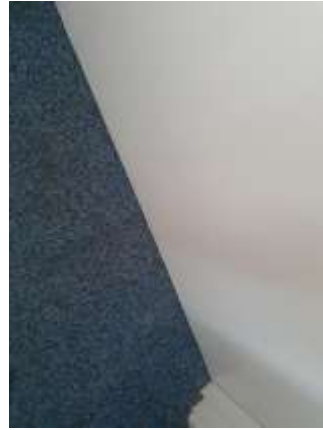
Location: Ground Floor - Stationary Office 034

Material Description:	Floor Tiles - Vinyl Products	
Identification:	Presumed to Contain Asbestos	
Approx. quantity:	15 m ²	
Accessibility	Difficult	<i>Assessment Score</i>
Product type:	Vinyl	1
Extent of Damage:	Slight / minor damage	1
Surface Treatment:	Non-friable	0
Asbestos type:	Chrysotile	1
Material Assessment Score:		3
Priority Assessment Score:		Negligible
Action:	Manage	
Comments:	Under carpet

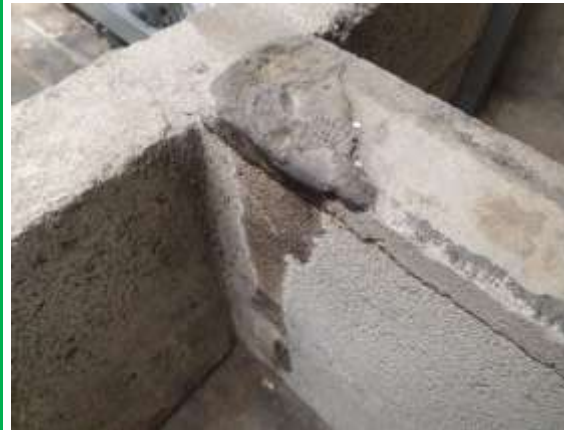
Location: Basement - Boiler Room 022

Material Description:	Remains of Bitumen where Tank used to sit - Bituminous Product	
Identification:	Sampled - No Asbestos Found	
Approx. quantity:	N/A	
Accessibility	N/A	<i>Assessment Score</i>
Product type:	N/A	N/A
Extent of Damage:	N/A	N/A
Surface Treatment:	N/A	N/A
Asbestos type:	N/A	N/A
Material Assessment Score:		N/A
Priority Assessment Score:		N/A
Action:	N/A	
Comments:	Modern boilers and pipework. Non asbestos slate packers visible within hole in wall
