ARMOUR
ANALYTICAL SERVICES

Project Number 2481

**Management
Asbestos Survey Report**

**2152 North Bristol Squadron, Filton, Bristol,
BS7 0SL**

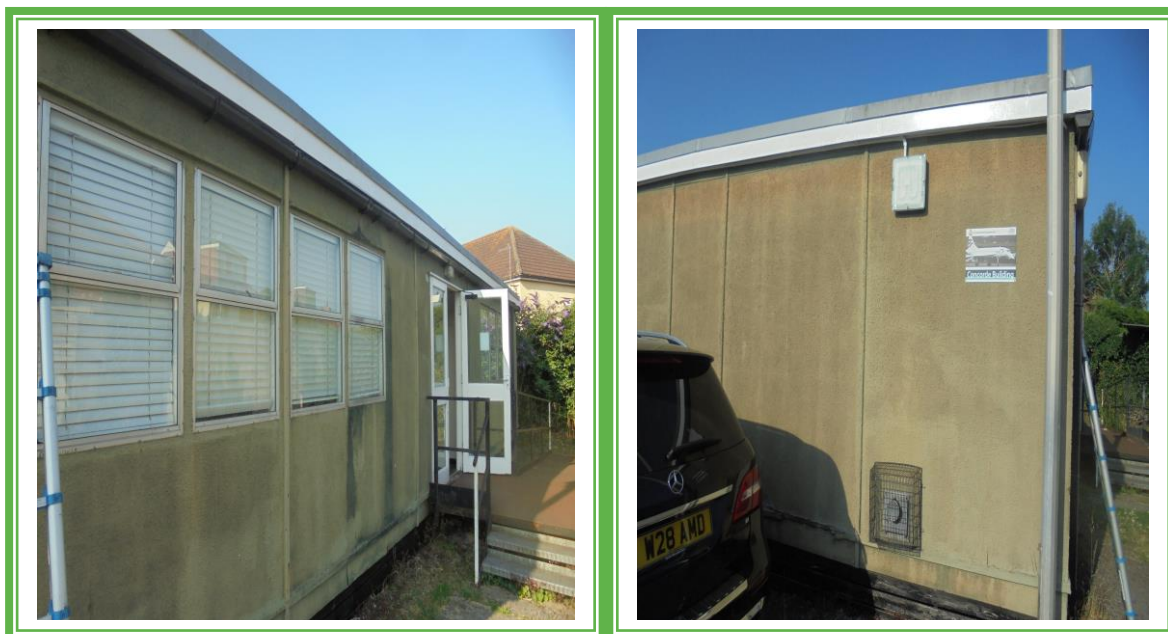
Location: External – Concorde Building

Material Description:	Visual Inspection – No Suspect Materials Found	
Identification:	N/A	
Approx. quantity:	N/A	
Accessibility	N/A	<i>Assessment Score</i>
Product type:		N/A
Extent of Damage:		N/A
Surface Treatment:		N/A
Asbestos type:		N/A
Material Assessment Score:		N/A
Priority Assessment Score:		N/A
Action:	N/A	
Comments:	N/A

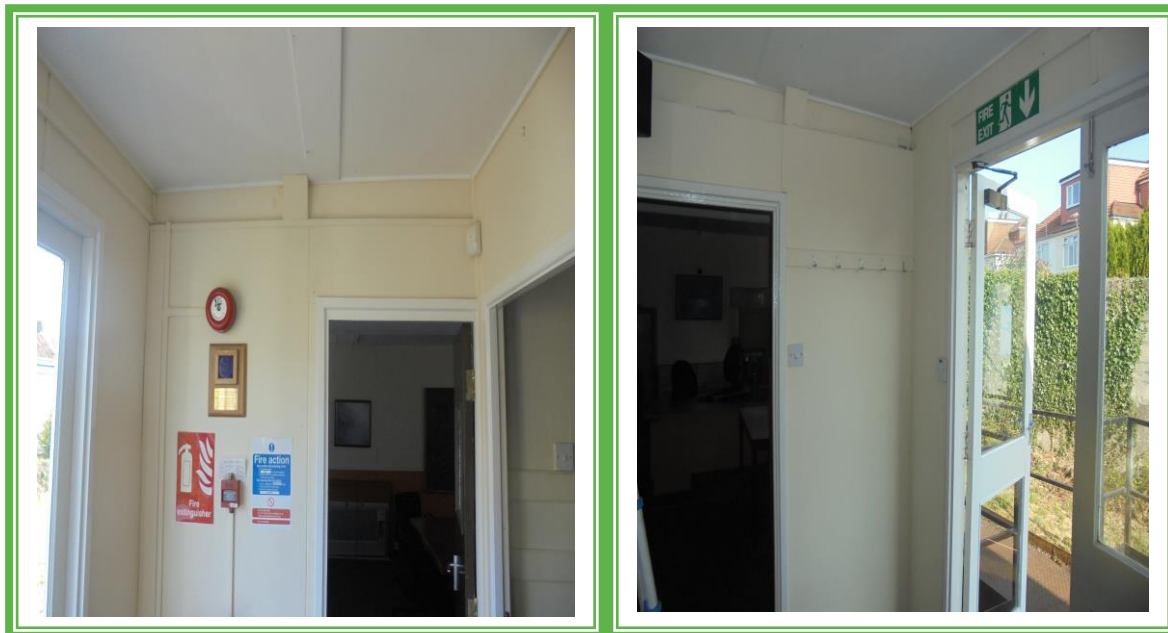
**Item No: 2****Sample No: N/A****Location: Concorde Building - Lobby**

Material Description:	Visual Inspection – No Suspect Materials Found	
Identification:	N/A	
Approx. quantity:	N/A	
Accessibility	N/A	<i>Assessment Score</i>
Product type:		N/A
Extent of Damage:		N/A
Surface Treatment:		N/A
Asbestos type:		N/A
Material Assessment Score:		N/A
Priority Assessment Score:		N/A
Action:	N/A	
Comments:	N/A

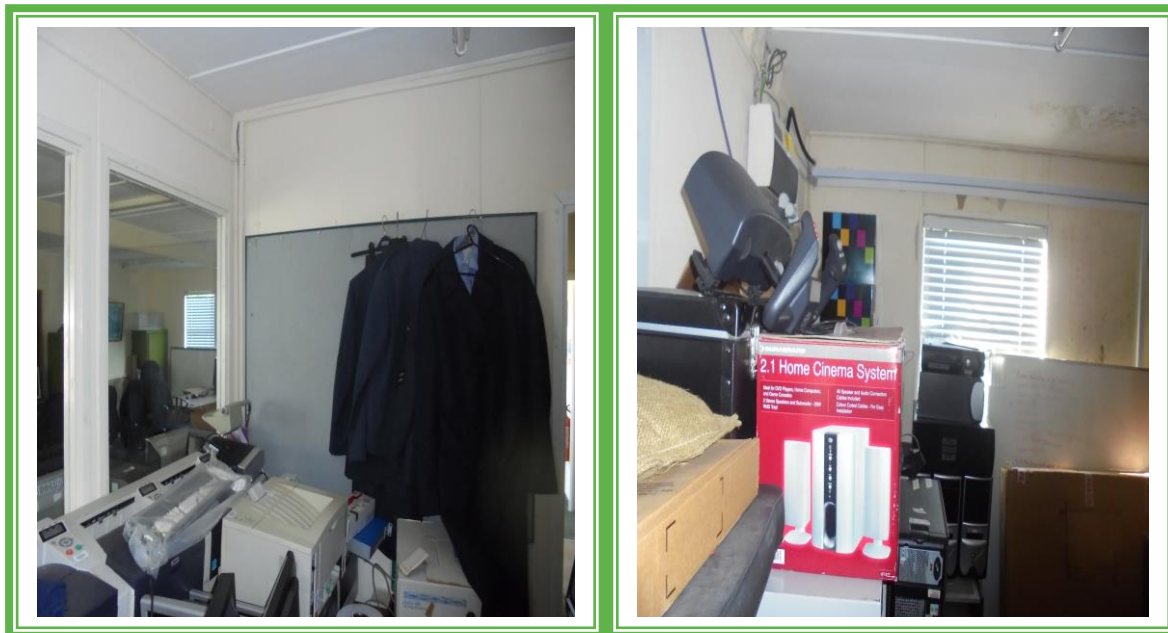
Location: Concorde Building – Store

Material Description:	Visual Inspection – No Suspect Materials Found	
Identification:	N/A	
Approx. quantity:	N/A	
Accessibility	N/A	<i>Assessment Score</i>
Product type:		N/A
Extent of Damage:		N/A
Surface Treatment:		N/A
Asbestos type:		N/A
Material Assessment Score:		N/A
Priority Assessment Score:		N/A
Action:	N/A	
Comments:	Modern Electrics in room

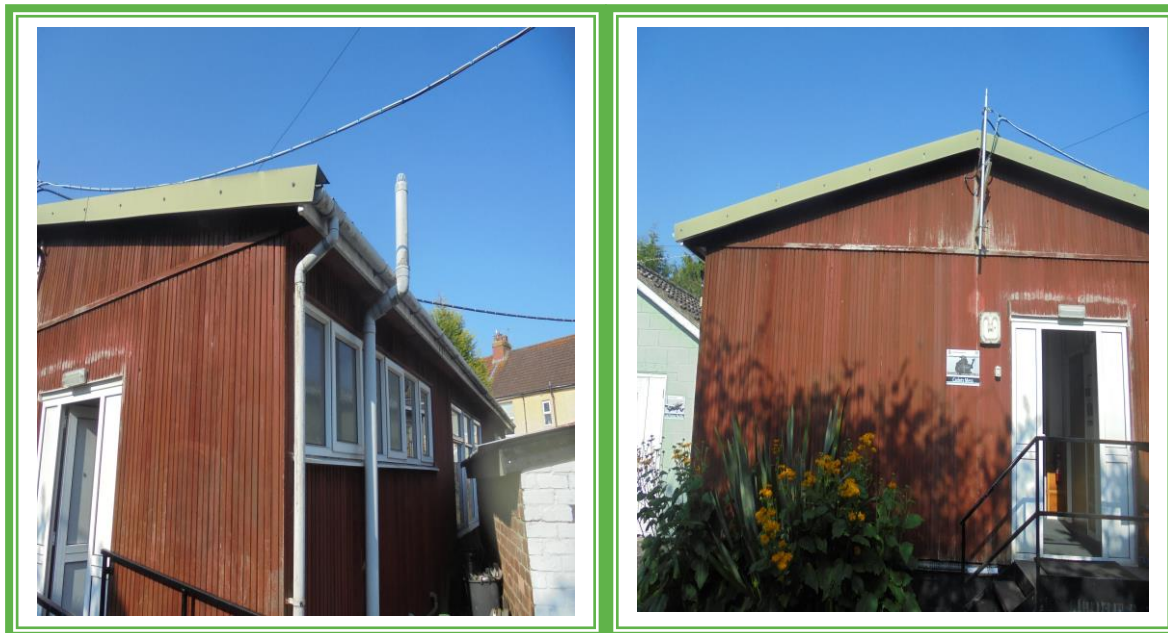
Location: External – Cadets Mess

Material Description:	Visual Inspection – No Suspect Materials Found	
Identification:	N/A	
Approx. quantity:	N/A	
Accessibility	N/A	<i>Assessment Score</i>
Product type:		N/A
Extent of Damage:		N/A
Surface Treatment:		N/A
Asbestos type:		N/A
Material Assessment Score:		N/A
Priority Assessment Score:		N/A
Action:	N/A	
Comments:	N/A

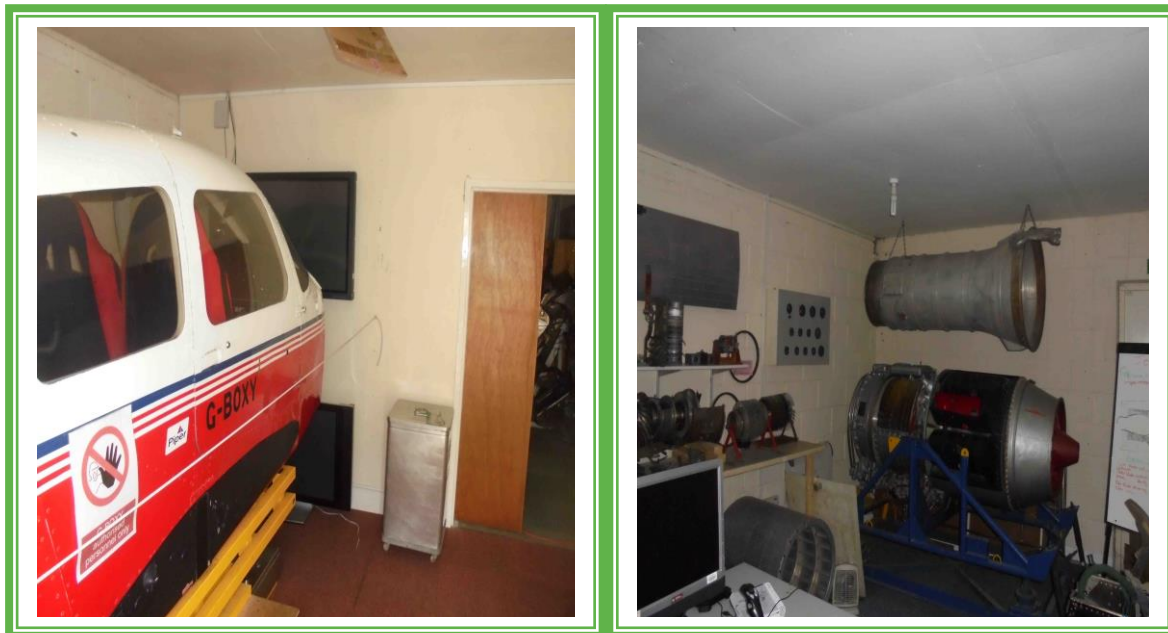
Location: Link Trainer Facility – Rooms 1 and 2

Material Description:	Visual Inspection – No Suspect Materials Found	
Identification:	N/A	
Approx. quantity:	N/A	
Accessibility	N/A	<i>Assessment Score</i>
Product type:		N/A
Extent of Damage:		N/A
Surface Treatment:		N/A
Asbestos type:		N/A
Material Assessment Score:		N/A
Priority Assessment Score:		N/A
Action:	N/A	
Comments:	Non-Asbestos felt to underside or roof

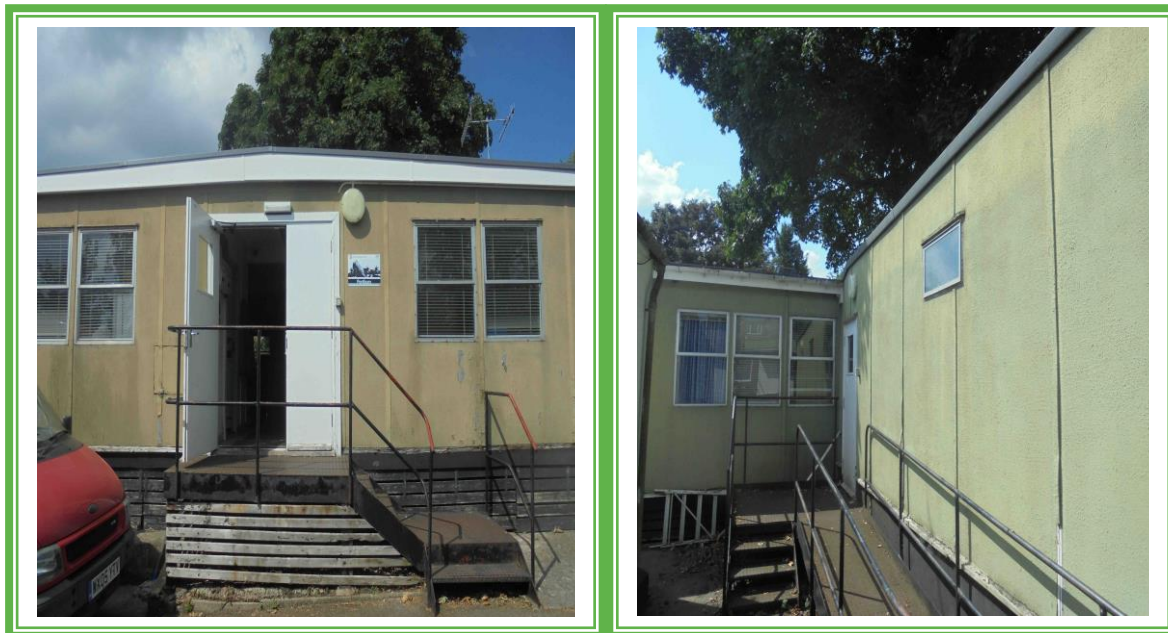
Location: External - Portbury Building

Material Description:	Visual Inspection – No Suspect Materials Found	
Identification:	N/A	
Approx. quantity:	N/A	
Accessibility	N/A	<i>Assessment Score</i>
Product type:		N/A
Extent of Damage:		N/A
Surface Treatment:		N/A
Asbestos type:		N/A
Material Assessment Score:		N/A
Priority Assessment Score:		N/A
Action:	N/A	
Comments:	N/A

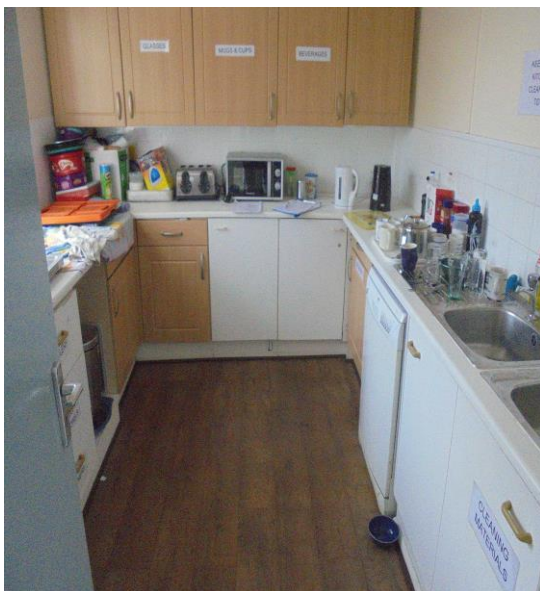
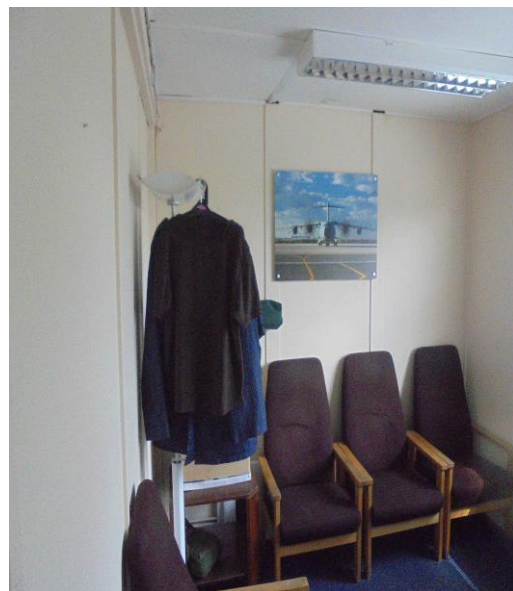
**Item No: 27****Sample No: N/A****Location: Portbury Building – Kitchen and Lounge**

Material Description:	Visual Inspection – No Suspect Materials Found	
Identification:	N/A	
Approx. quantity:	N/A	
Accessibility	N/A	<i>Assessment Score</i>
Product type:		N/A
Extent of Damage:		N/A
Surface Treatment:		N/A
Asbestos type:		N/A
Material Assessment Score:		N/A
Priority Assessment Score:		N/A
Action:	N/A	
Comments:	Modern Sink Pads

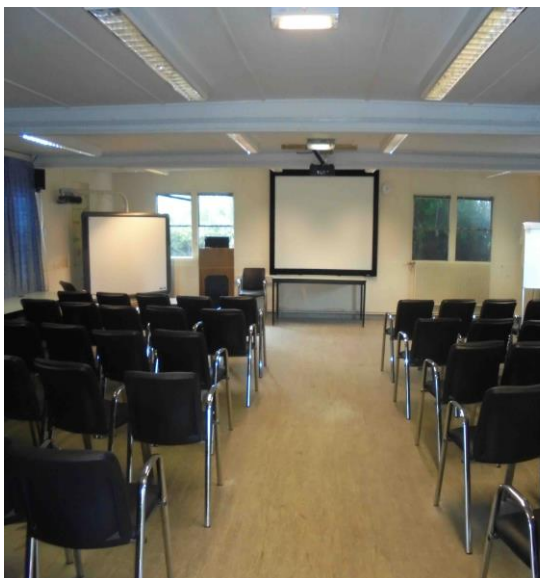
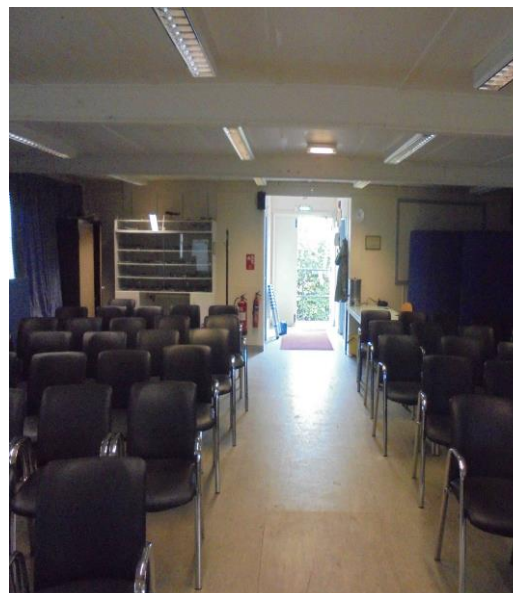
**Item No: 28****Sample No: N/A****Location: Portbury Building – Conference Room**

Material Description:	Visual Inspection – No Suspect Materials Found	
Identification:	N/A	
Approx. quantity:	N/A	
Accessibility	N/A	<i>Assessment Score</i>
Product type:		N/A
Extent of Damage:		N/A
Surface Treatment:		N/A
Asbestos type:		N/A
Material Assessment Score:		N/A
Priority Assessment Score:		N/A
Action:	N/A	
Comments:	N/A

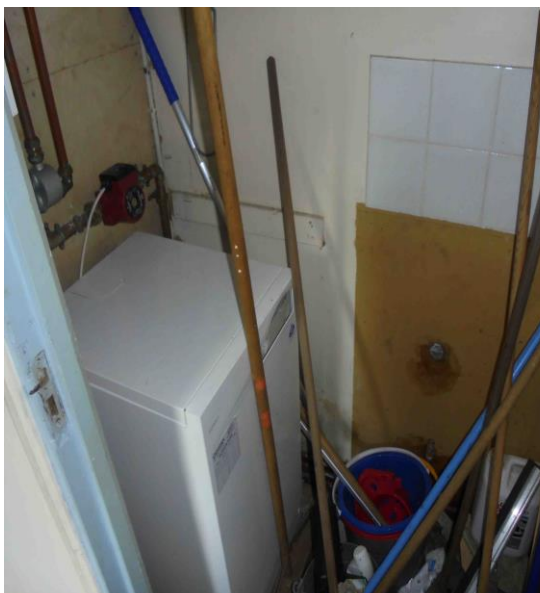
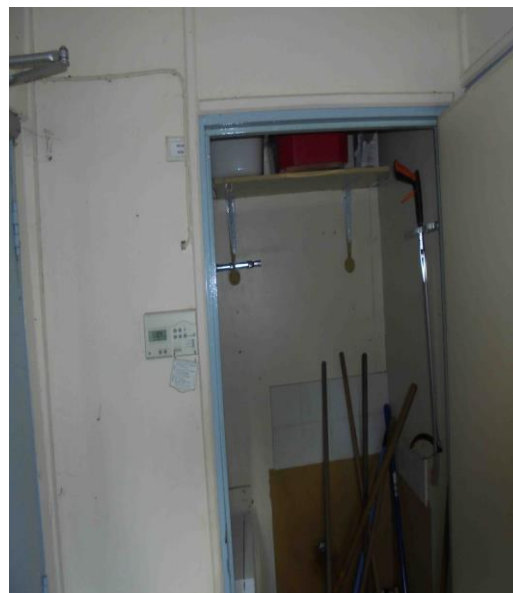
Location: Portbury Building – Lobby and Cupboard

Material Description:	Visual Inspection – No Suspect Materials Found	
Identification:	N/A	
Approx. quantity:	N/A	
Accessibility	N/A	<i>Assessment Score</i>
Product type:		N/A
Extent of Damage:		N/A
Surface Treatment:		N/A
Asbestos type:		N/A
Material Assessment Score:		N/A
Priority Assessment Score:		N/A
Action:	N/A	
Comments:	Modern Ideal Boiler in Cupboard

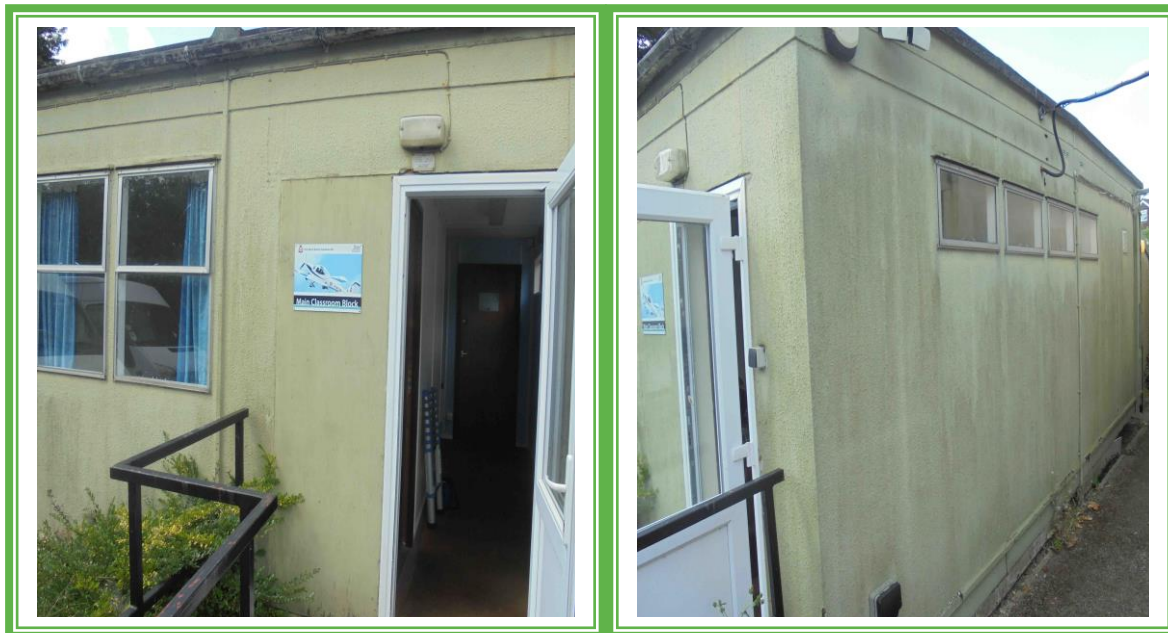
Location: External - Main Classroom Block

Material Description:	Visual Inspection – No Suspect Materials Found	
Identification:	N/A	
Approx. quantity:	N/A	
Accessibility	N/A	<i>Assessment Score</i>
Product type:		N/A
Extent of Damage:		N/A
Surface Treatment:		N/A
Asbestos type:		N/A
Material Assessment Score:		N/A
Priority Assessment Score:		N/A
Action:	N/A	
Comments:	N/A

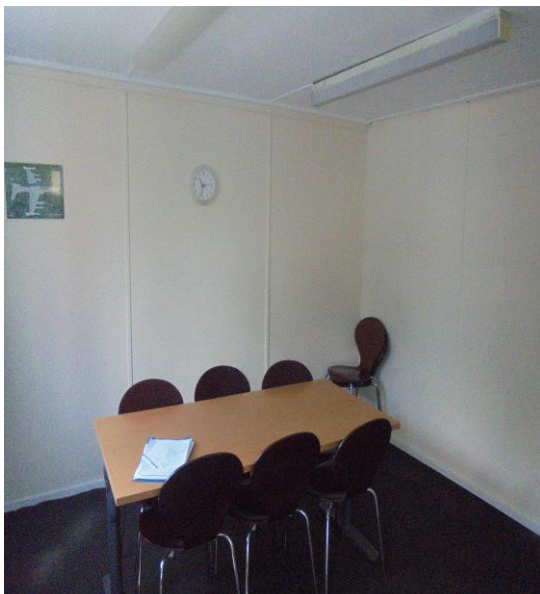
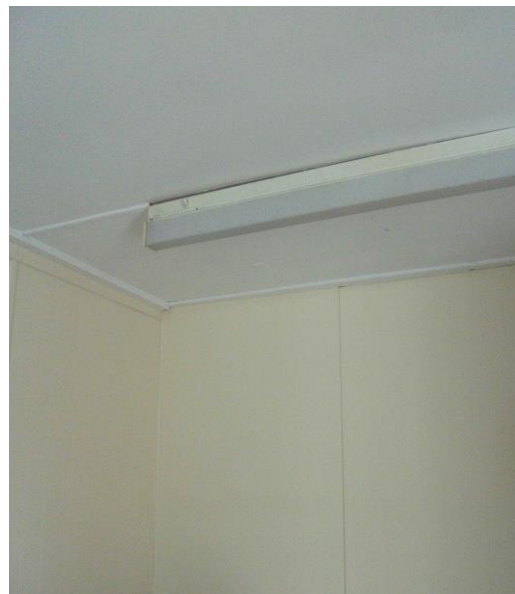
Location: Main Classroom Block – Hawk and Typhoon rooms

Material Description:	Visual Inspection – No Suspect Materials Found	
Identification:	N/A	
Approx. quantity:	N/A	
Accessibility	N/A	<i>Assessment Score</i>
Product type:		N/A
Extent of Damage:		N/A
Surface Treatment:		N/A
Asbestos type:		N/A
Material Assessment Score:		N/A
Priority Assessment Score:		N/A
Action:	N/A	
Comments:	N/A

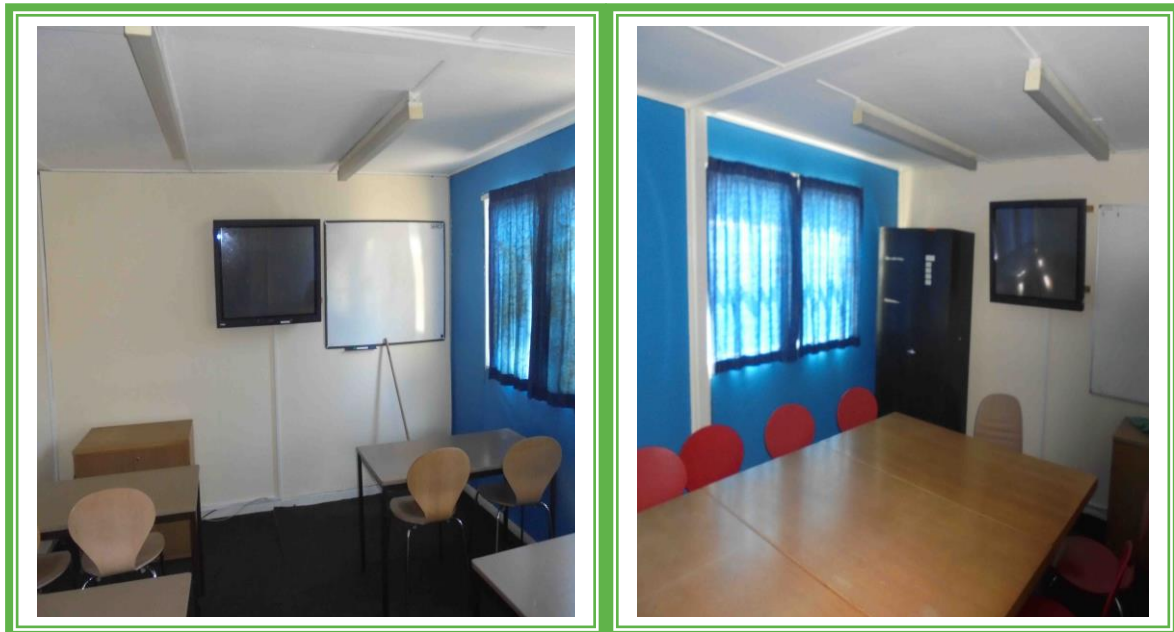
Location: Main Classroom Block – Harrier and Training Rooms

Material Description:	Visual Inspection – No Suspect Materials Found	
Identification:	N/A	
Approx. quantity:	N/A	
Accessibility	N/A	<i>Assessment Score</i>
Product type:		N/A
Extent of Damage:		N/A
Surface Treatment:		N/A
Asbestos type:		N/A
Material Assessment Score:		N/A
Priority Assessment Score:		N/A
Action:	N/A	
Comments:	N/A

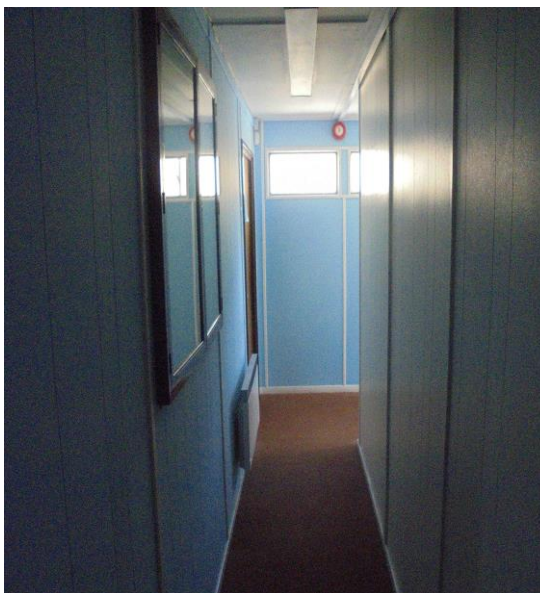
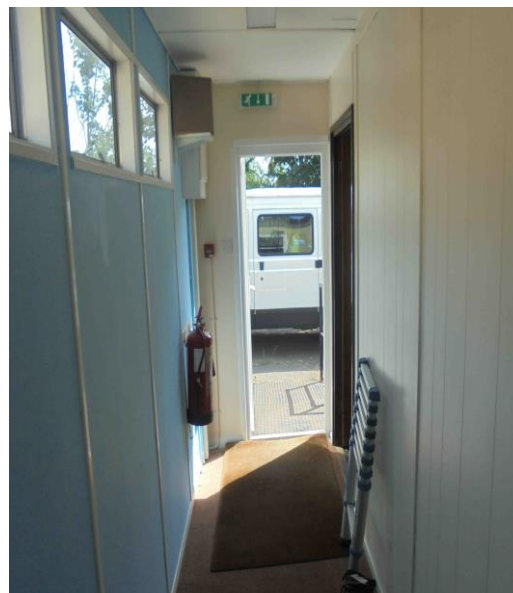
Location: Main Classroom Block - Corridor

Material Description:	Visual Inspection – No Suspect Materials Found	
Identification:	N/A	
Approx. quantity:	N/A	
Accessibility	N/A	<i>Assessment Score</i>
Product type:		N/A
Extent of Damage:		N/A
Surface Treatment:		N/A
Asbestos type:		N/A
Material Assessment Score:		N/A
Priority Assessment Score:		N/A
Action:	N/A	
Comments:	Modern Electrical Box

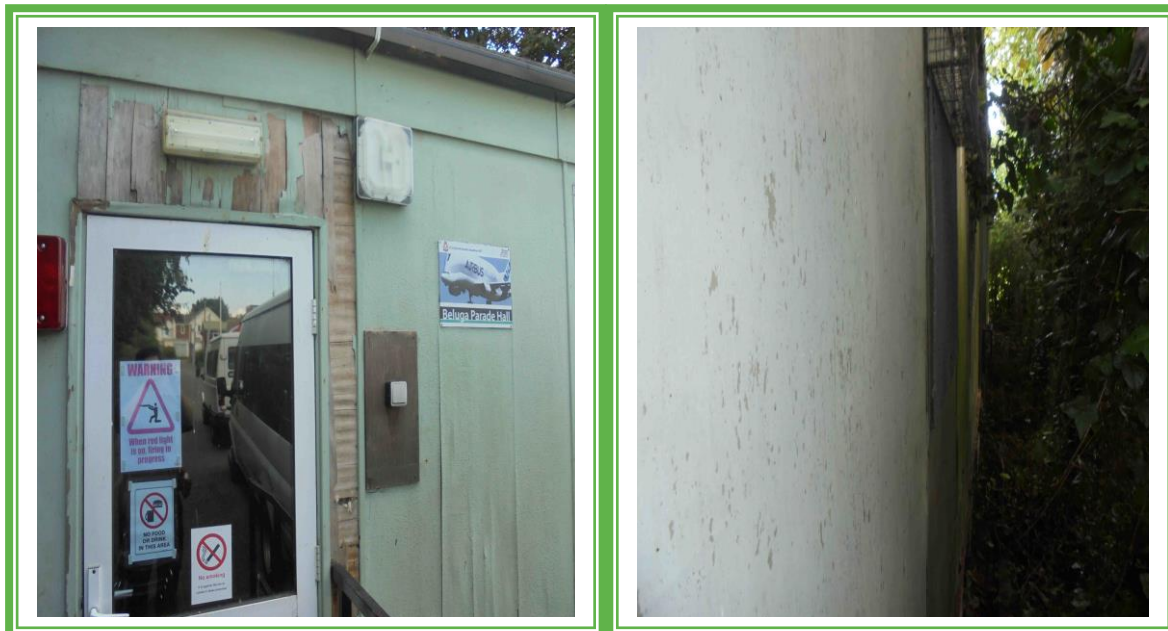
Location: External - Beluga Parade Hall

Material Description:	Visual Inspection – No Suspect Materials Found	
Identification:	N/A	
Approx. quantity:	N/A	
Accessibility	N/A	<i>Assessment Score</i>
Product type:		N/A
Extent of Damage:		N/A
Surface Treatment:		N/A
Asbestos type:		N/A
Material Assessment Score:		N/A
Priority Assessment Score:		N/A
Action:	N/A	
Comments:	N/A

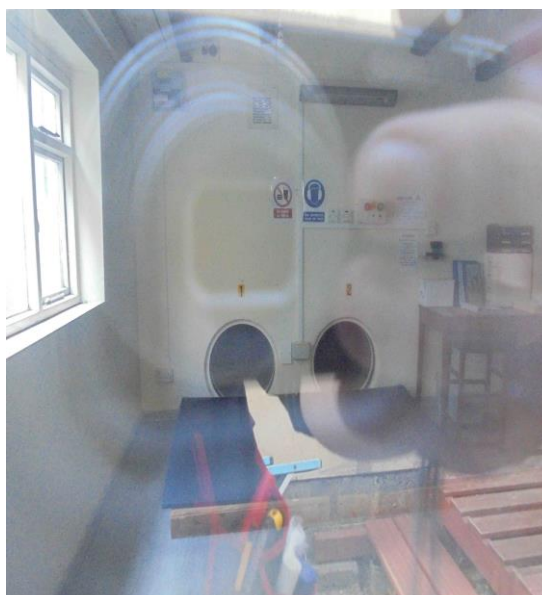
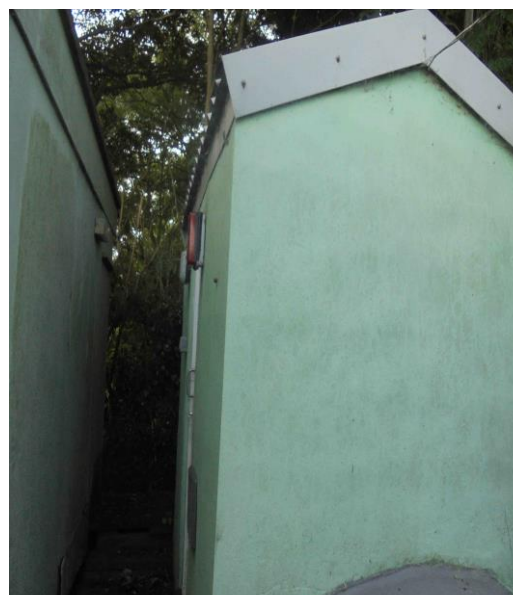
Location: Firing Range 1 and 2

Material Description:	Visual Inspection – No Suspect Materials Found	
Identification:	N/A	
Approx. quantity:	N/A	
Accessibility	N/A	<i>Assessment Score</i>
Product type:		N/A
Extent of Damage:		N/A
Surface Treatment:		N/A
Asbestos type:		N/A
Material Assessment Score:		N/A
Priority Assessment Score:		N/A
Action:	N/A	
Comments:	N/A

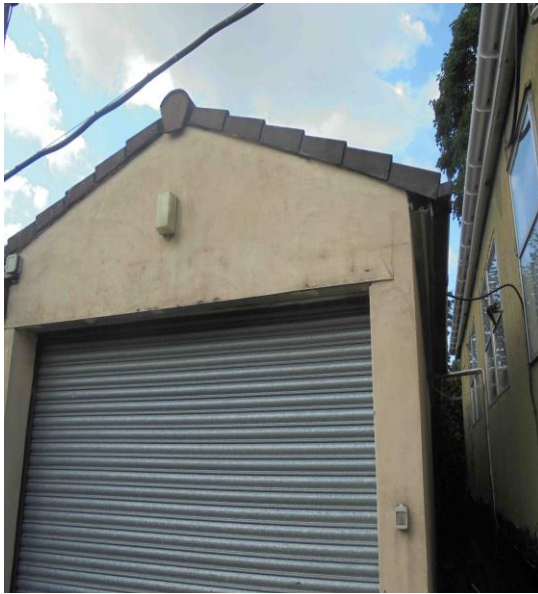
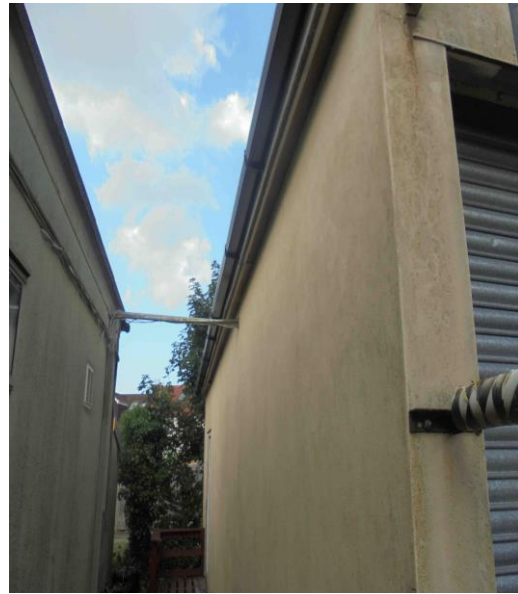
**Item No: 39****Sample No: N/A****Location: Garage**

Material Description:	Visual Inspection – No Suspect Materials Found	
Identification:	N/A	
Approx. quantity:	N/A	
Accessibility	N/A	<i>Assessment Score</i>
Product type:		N/A
Extent of Damage:		N/A
Surface Treatment:		N/A
Asbestos type:		N/A
Material Assessment Score:		N/A
Priority Assessment Score:		N/A
Action:	N/A	
Comments:	N/A

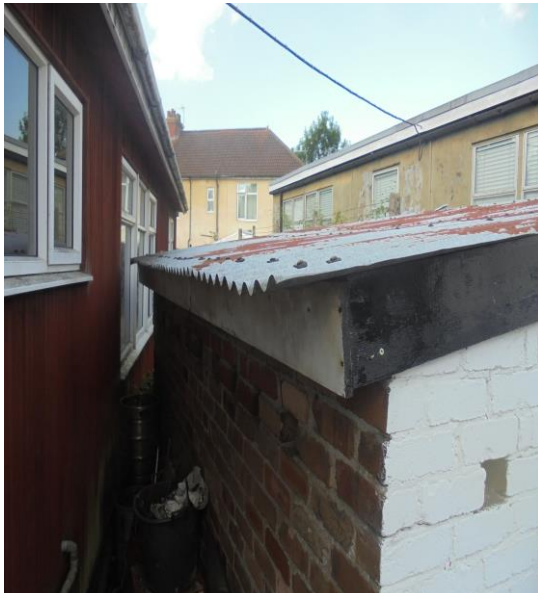
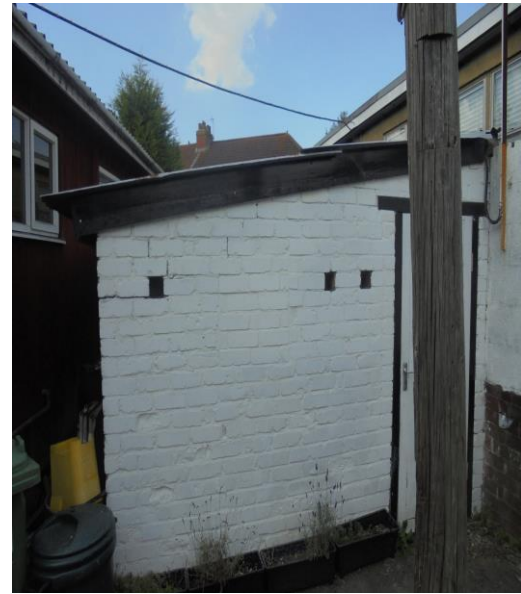
Location: Shed

Material Description:	Visual Inspection – No Suspect Materials Found	
Identification:	N/A	
Approx. quantity:	N/A	
Accessibility	N/A	<i>Assessment Score</i>
Product type:		N/A
Extent of Damage:		N/A
Surface Treatment:		N/A
Asbestos type:		N/A
Material Assessment Score:		N/A
Priority Assessment Score:		N/A
Action:	N/A	
Comments:	N/A
