ARMOUR
ANALYTICAL SERVICES

Project Number 2481

**Management
Asbestos Survey Report**

Wellington Platoon, Somerset, TA21 8AX

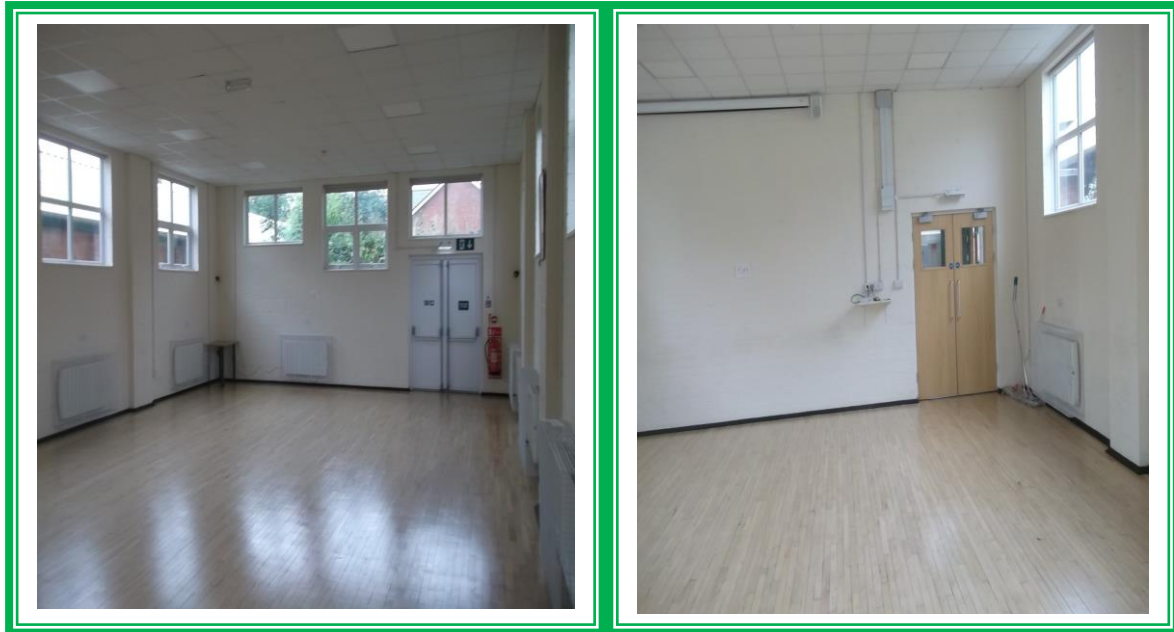
Location: Ground Floor - Drill Hall

Material Description:	Visual Inspection – No Suspect Materials Found	
Identification:	N/A	
Approx. quantity:	N/A	
Accessibility	N/A	<i>Assessment Score</i>
Product type:	N/A	N/A
Extent of Damage:	N/A	N/A
Surface Treatment:	N/A	N/A
Asbestos type:	N/A	N/A
Material Assessment Score:		N/A
Priority Assessment Score:		N/A
Action:	N/A	
Comments:	N/A

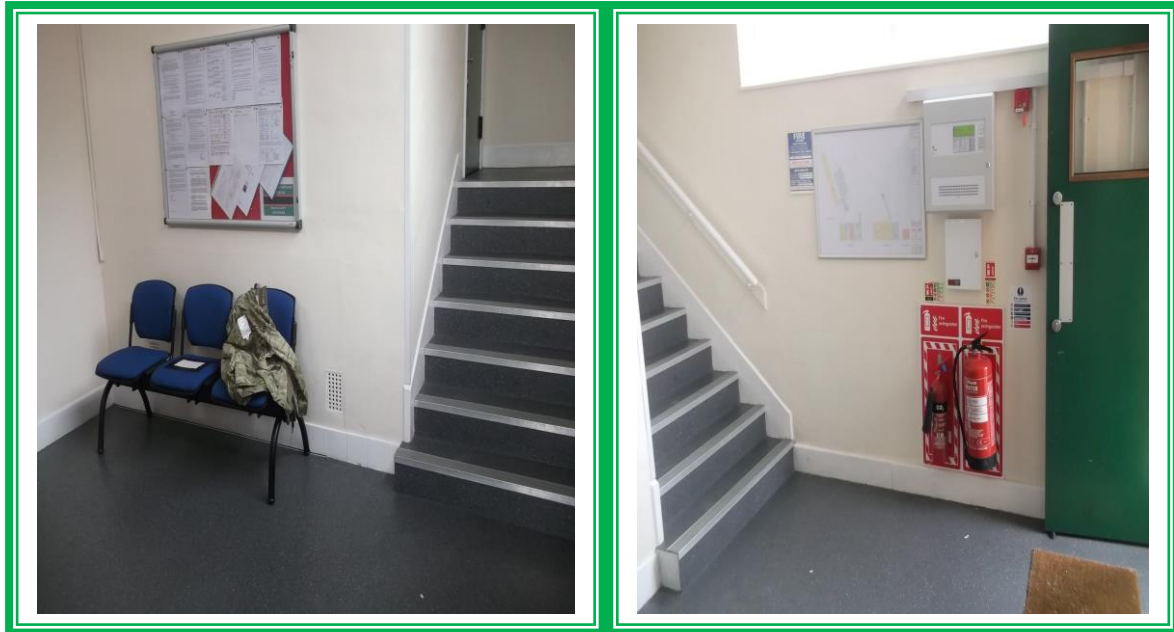
Location: Ground Floor - Lobby Near Drill Hall

Material Description:	Visual Inspection – No Suspect Materials Found	
Identification:	N/A	
Approx. quantity:	N/A	
Accessibility	N/A	<i>Assessment Score</i>
Product type:	N/A	N/A
Extent of Damage:	N/A	N/A
Surface Treatment:	N/A	N/A
Asbestos type:	N/A	N/A
Material Assessment Score:		N/A
Priority Assessment Score:		N/A
Action:	N/A	
Comments:	N/A

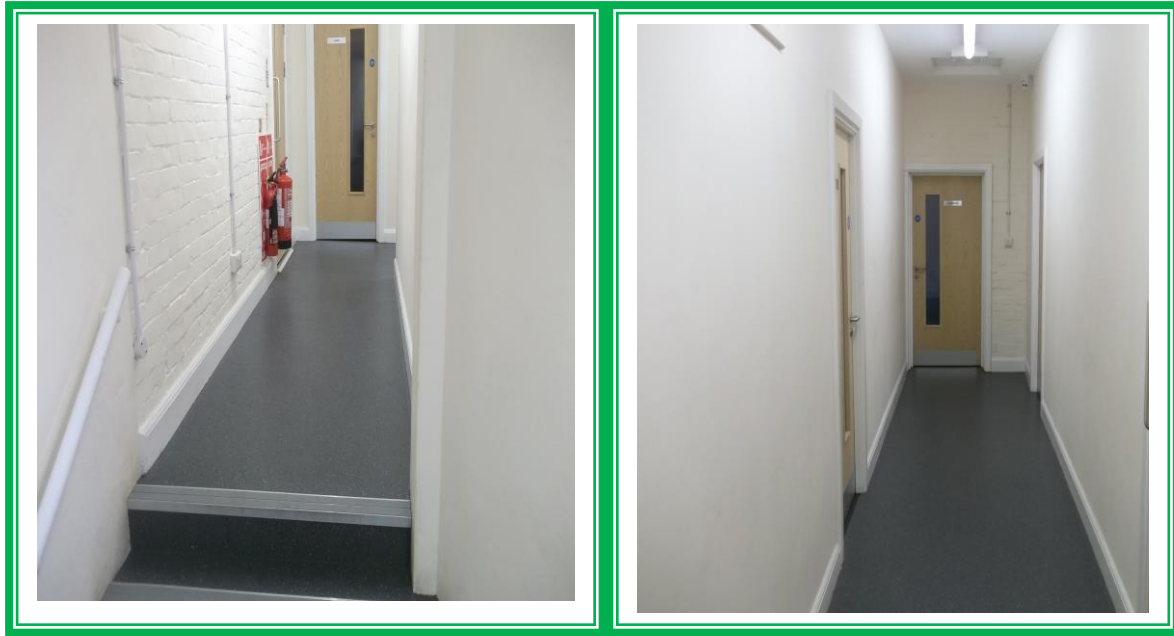
Location: First Floor - Corridor Near Armoury and Classroom

Material Description:	Visual Inspection – No Suspect Materials Found	
Identification:	N/A	
Approx. quantity:	N/A	
Accessibility	N/A	<i>Assessment Score</i>
Product type:	N/A	N/A
Extent of Damage:	N/A	N/A
Surface Treatment:	N/A	N/A
Asbestos type:	N/A	N/A
Material Assessment Score:		N/A
Priority Assessment Score:		N/A
Action:	N/A	
Comments:	N/A

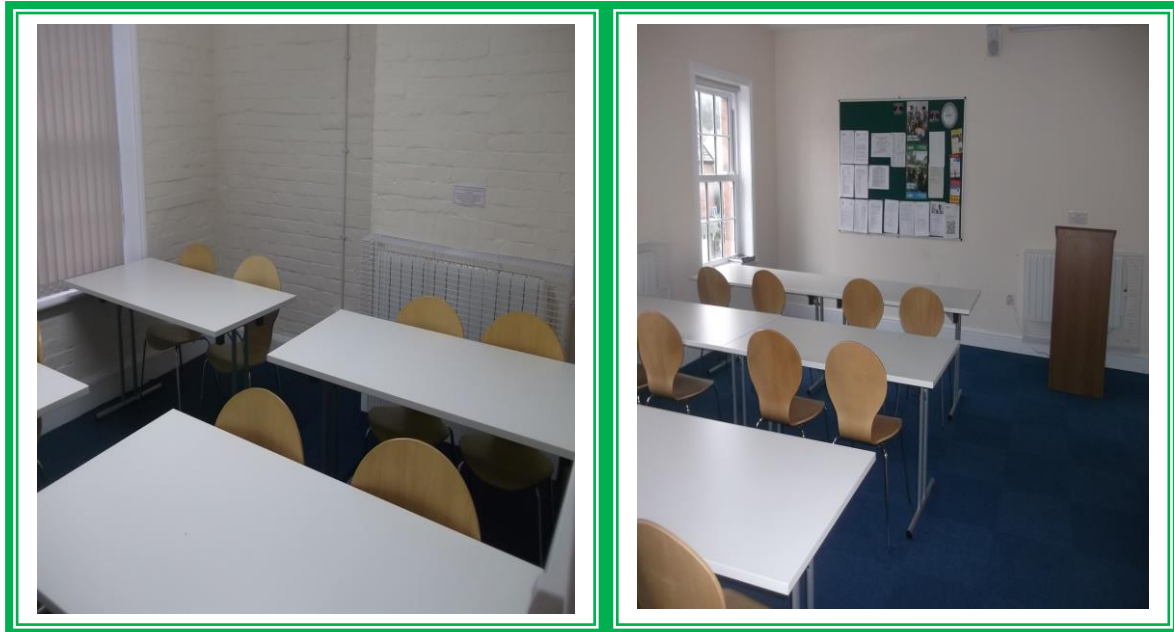
Location: First Floor - Classrooms 1 and 2

Material Description:	Visual Inspection – No Suspect Materials Found	
Identification:	N/A	
Approx. quantity:	N/A	
Accessibility	N/A	<i>Assessment Score</i>
Product type:	N/A	N/A
Extent of Damage:	N/A	N/A
Surface Treatment:	N/A	N/A
Asbestos type:	N/A	N/A
Material Assessment Score:		N/A
Priority Assessment Score:		N/A
Action:	N/A	
Comments:	N/A

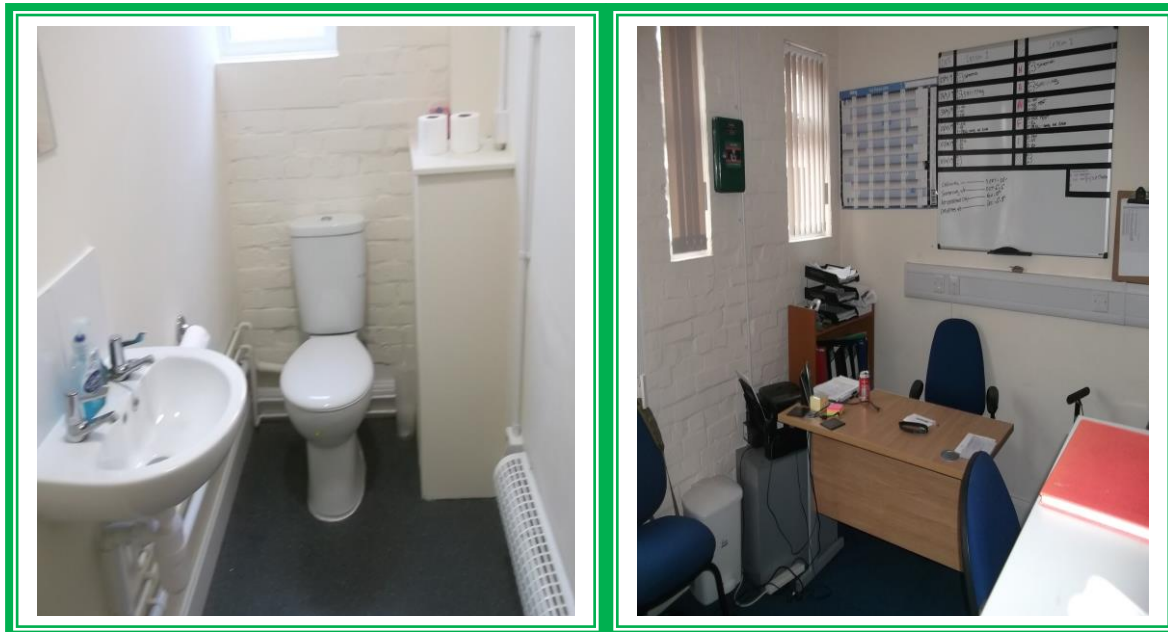
Location: First Floor – Toilets (Male and Female)

Material Description:	Visual Inspection – No Suspect Materials Found	
Identification:	N/A	
Approx. quantity:	N/A	
Accessibility	N/A	<i>Assessment Score</i>
Product type:	N/A	N/A
Extent of Damage:	N/A	N/A
Surface Treatment:	N/A	N/A
Asbestos type:	N/A	N/A
Material Assessment Score:		N/A
Priority Assessment Score:		N/A
Action:	N/A	
Comments:	N/A

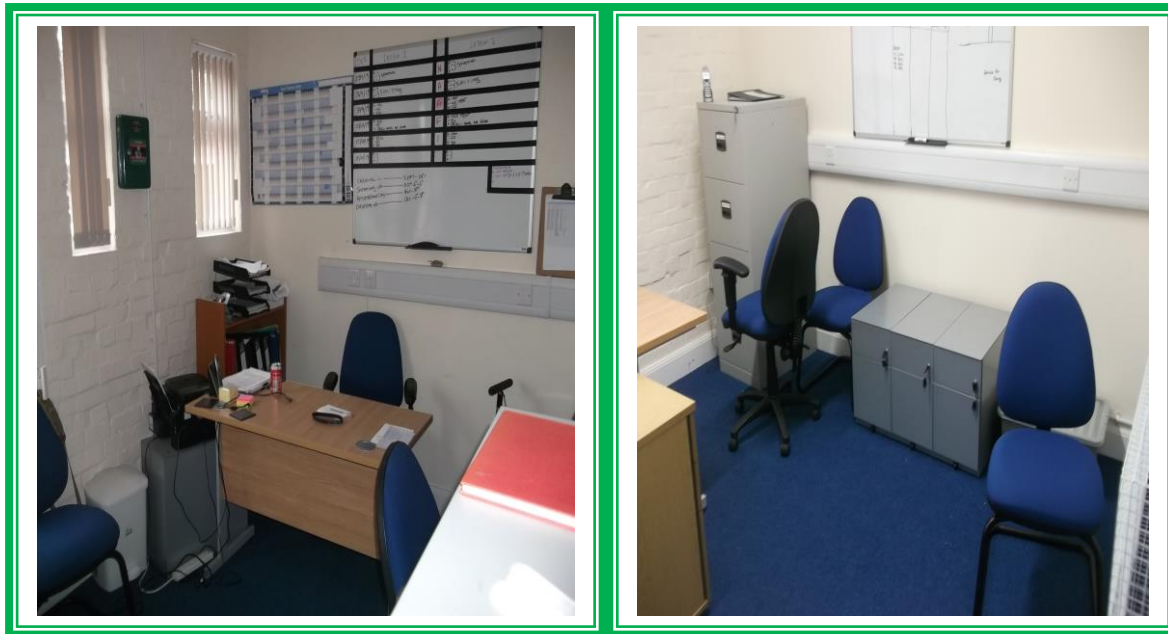
Location: First Floor – Admin Office and CO's Office

Material Description:	Visual Inspection – No Suspect Materials Found	
Identification:	N/A	
Approx. quantity:	N/A	
Accessibility	N/A	<i>Assessment Score</i>
Product type:	N/A	N/A
Extent of Damage:	N/A	N/A
Surface Treatment:	N/A	N/A
Asbestos type:	N/A	N/A
Material Assessment Score:		N/A
Priority Assessment Score:		N/A
Action:	N/A	
Comments:	N/A

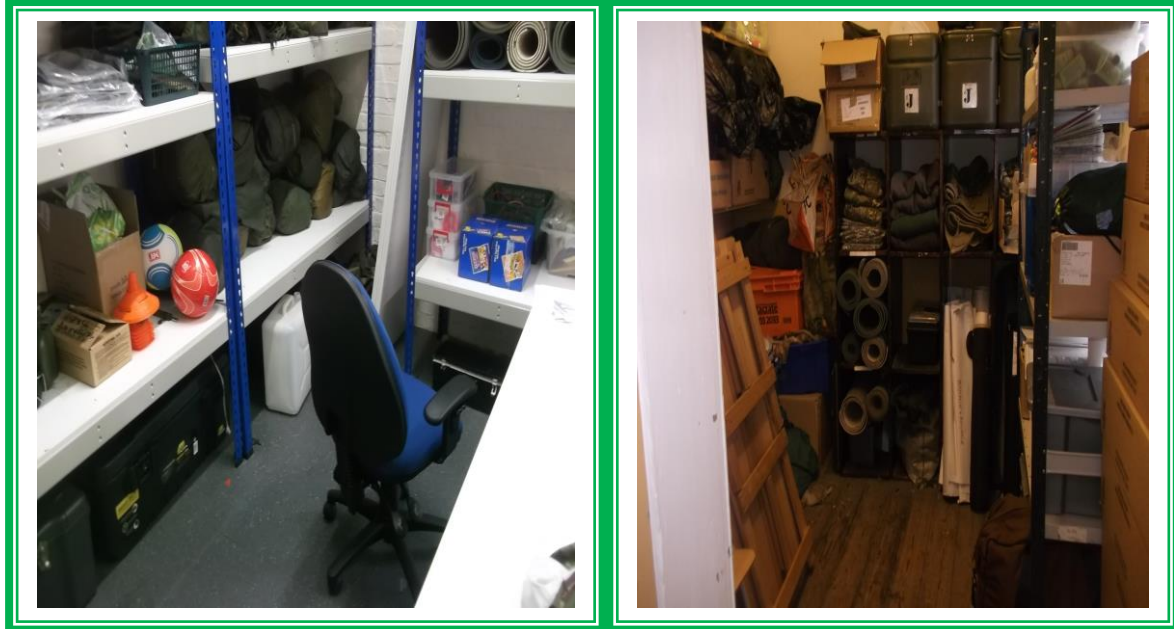
Location: Ground Floor - Platoon Stores and HQ Stores 2

Material Description:	Visual Inspection – No Suspect Materials Found	
Identification:	N/A	
Approx. quantity:	N/A	
Accessibility	N/A	<i>Assessment Score</i>
Product type:	N/A	N/A
Extent of Damage:	N/A	N/A
Surface Treatment:	N/A	N/A
Asbestos type:	N/A	N/A
Material Assessment Score:		N/A
Priority Assessment Score:		N/A
Action:	N/A	
Comments:	N/A

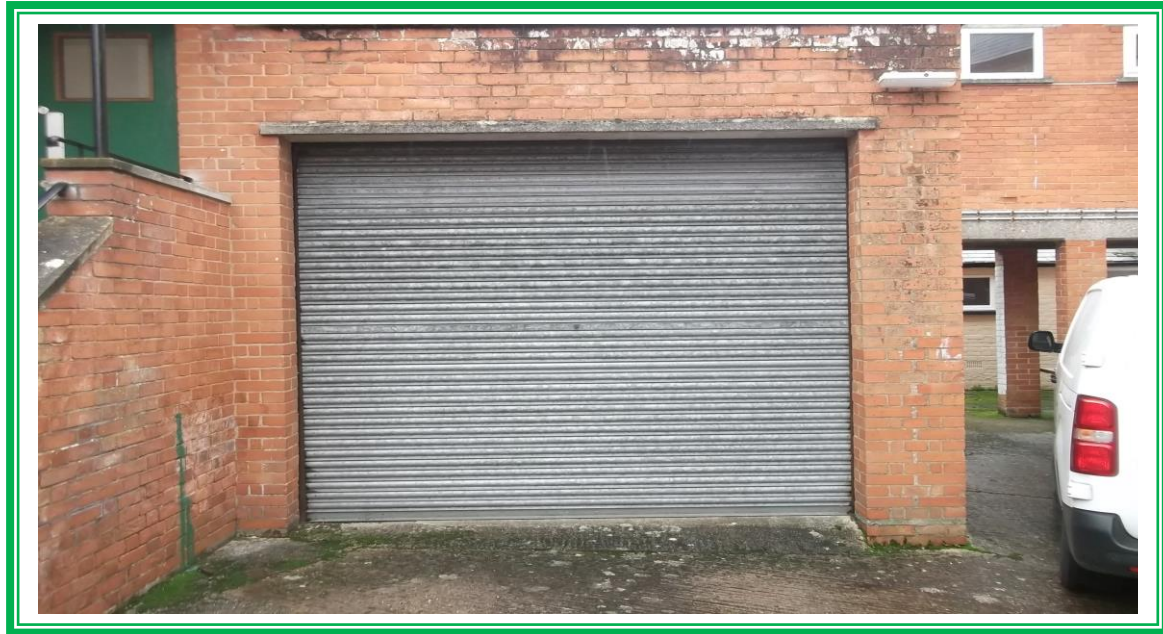
Location: External – Garage

Material Description:	Visual Inspection – No Suspect Materials Found	
Identification:	N/A	
Approx. quantity:	N/A	
Accessibility	N/A	<i>Assessment Score</i>
Product type:	N/A	N/A
Extent of Damage:	N/A	N/A
Surface Treatment:	N/A	N/A
Asbestos type:	N/A	N/A
Material Assessment Score:		N/A
Priority Assessment Score:		N/A
Action:	N/A	
Comments:	N/A
