Project Number 2481

**Management
Asbestos Survey Report**

**Wyvern Barracks, Barrack Road, Exeter, Devon,
EX2 6AE (Building 7)**

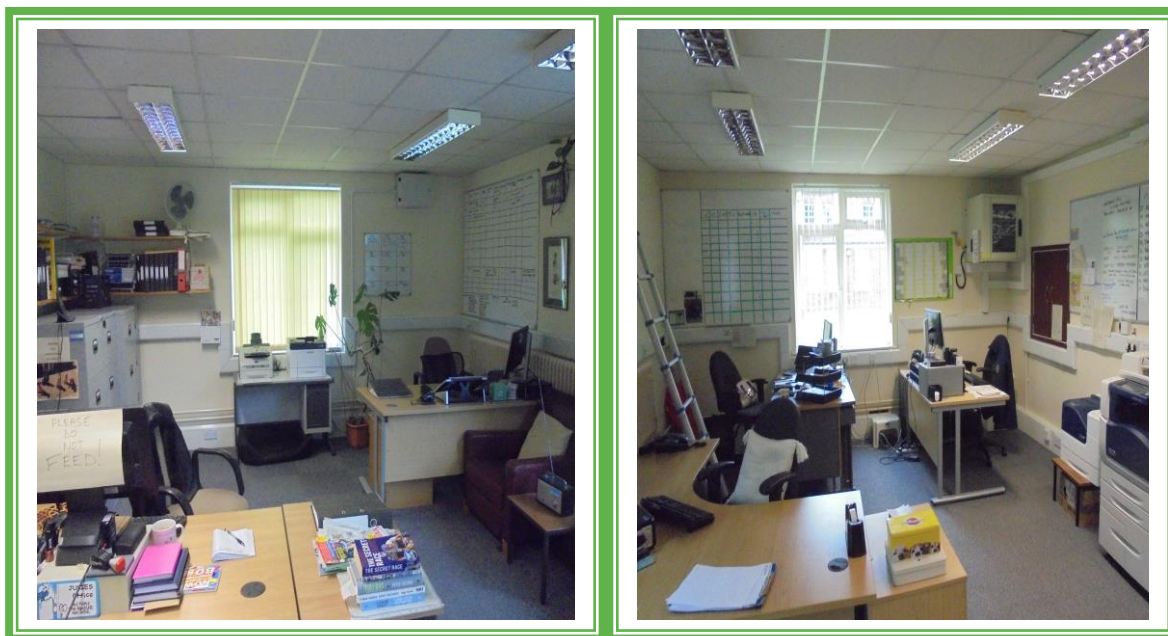
Item No: 1
Sample No: N/A
Location: Office – G01

Material Description:	Visual Inspection – No Suspect Materials Found	
Identification:	N/A	
Approx. quantity:	N/A	
Accessibility	N/A	<i>Assessment Score</i>
Product type:		N/A
Extent of Damage:		N/A
Surface Treatment:		N/A
Asbestos type:		N/A
Material Assessment Score:		N/A
Priority Assessment Score:		N/A
Action:	N/A	
Comments:	N/A

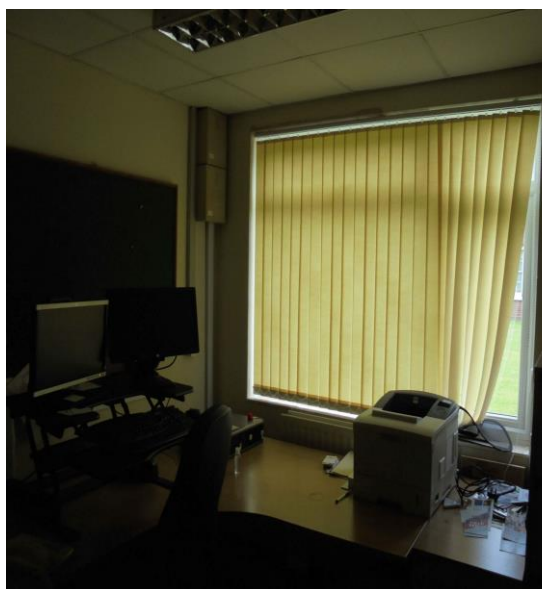
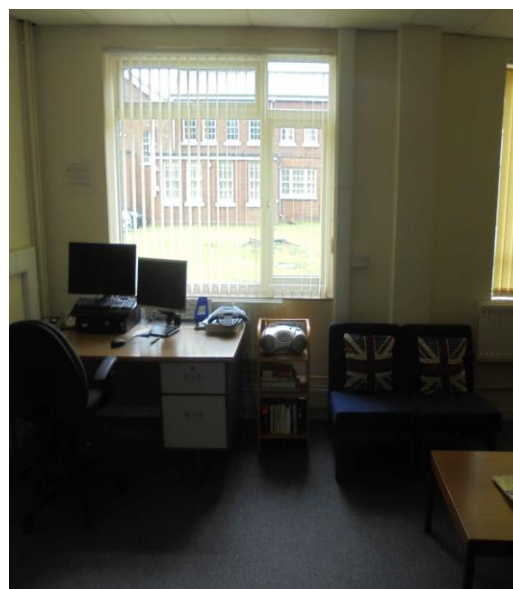
Location: Offices – G05 and G05A

Material Description:	Visual Inspection – No Suspect Materials Found	
Identification:	N/A	
Approx. quantity:	N/A	
Accessibility	N/A	<i>Assessment Score</i>
Product type:		N/A
Extent of Damage:		N/A
Surface Treatment:		N/A
Asbestos type:		N/A
Material Assessment Score:		N/A
Priority Assessment Score:		N/A
Action:	N/A	
Comments:	No access within timber boxing

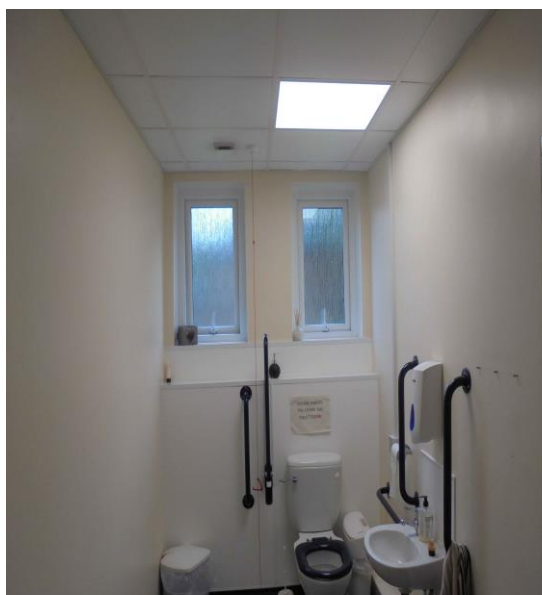
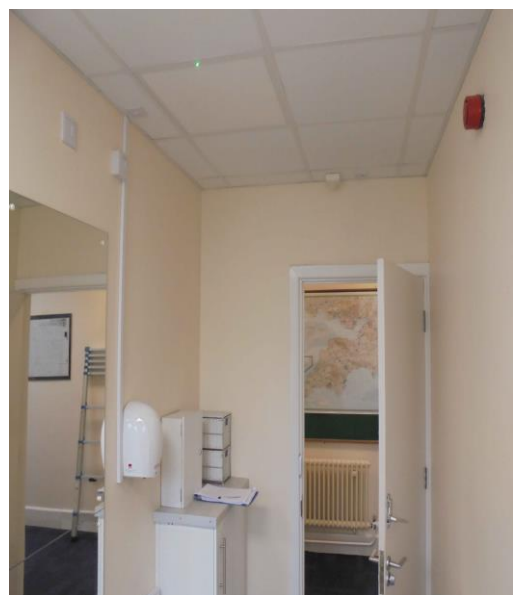
Location: WC

Material Description:	Visual Inspection – No Suspect Materials Found	
Identification:	N/A	
Approx. quantity:	N/A	
Accessibility	N/A	<i>Assessment Score</i>
Product type:		N/A
Extent of Damage:		N/A
Surface Treatment:		N/A
Asbestos type:		N/A
Material Assessment Score:		N/A
Priority Assessment Score:		N/A
Action:	N/A	
Comments:	N/A

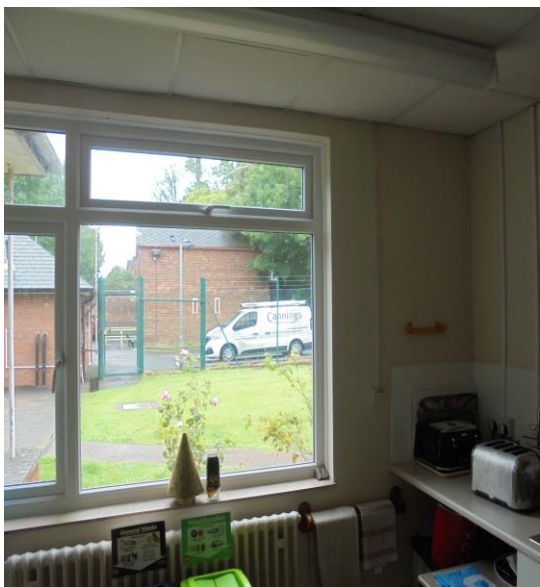
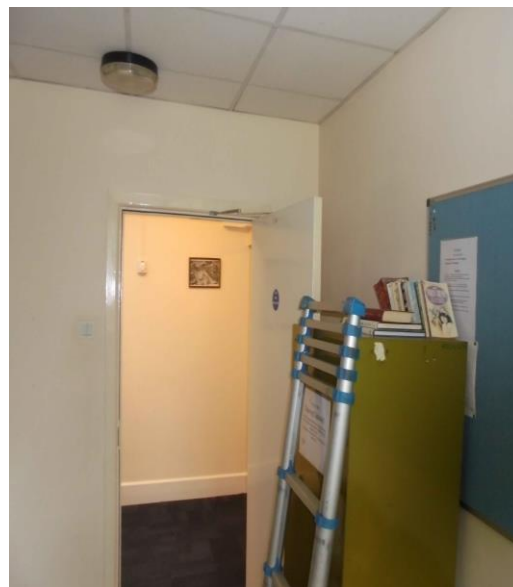
Location: Kitchen – G04

Material Description:	Visual Inspection – No Suspect Materials Found	
Identification:	N/A	
Approx. quantity:	N/A	
Accessibility	N/A	<i>Assessment Score</i>
Product type:		N/A
Extent of Damage:		N/A
Surface Treatment:		N/A
Asbestos type:		N/A
Material Assessment Score:		N/A
Priority Assessment Score:		N/A
Action:	N/A	
Comments:	N/A

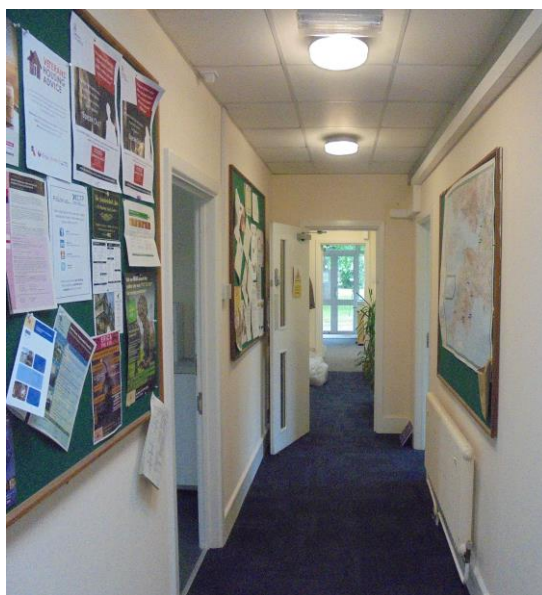
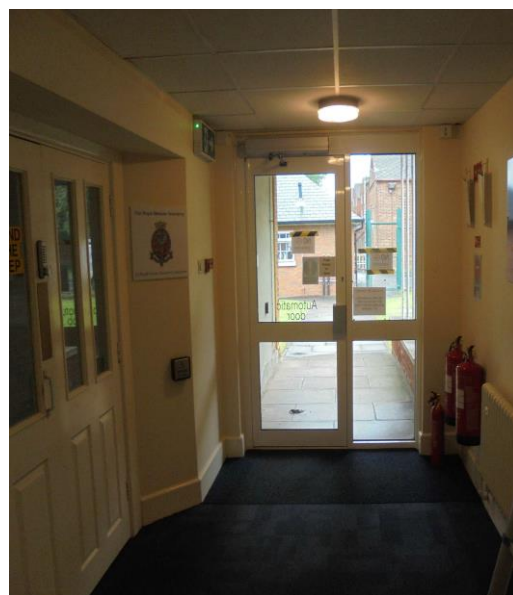
Location: Corridor & Lobby – Ground Floor

Material Description:	Visual Inspection – No Suspect Materials Found	
Identification:	N/A	
Approx. quantity:	N/A	
Accessibility	N/A	<i>Assessment Score</i>
Product type:		N/A
Extent of Damage:		N/A
Surface Treatment:		N/A
Asbestos type:		N/A
Material Assessment Score:		N/A
Priority Assessment Score:		N/A
Action:	N/A	
Comments:	Limited access into ceiling voids due to services and insulation blocking access

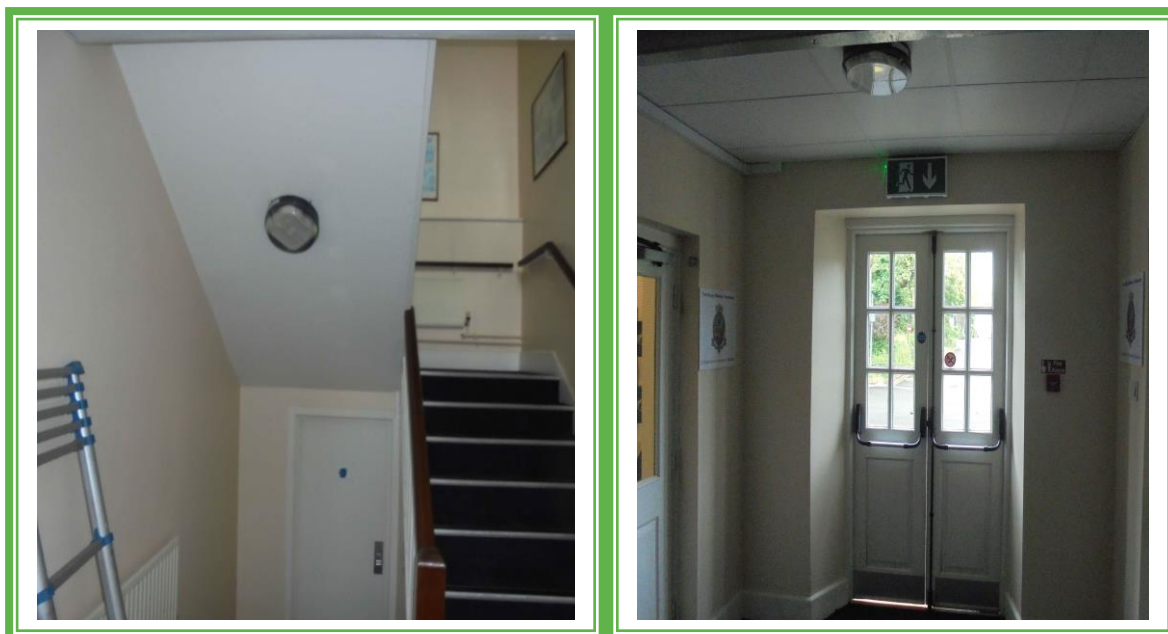
Location: Lobby – Ground Floor

Material Description:	Visual Inspection – No Suspect Materials Found	
Identification:	N/A	
Approx. quantity:	N/A	
Accessibility	N/A	<i>Assessment Score</i>
Product type:		N/A
Extent of Damage:		N/A
Surface Treatment:		N/A
Asbestos type:		N/A
Material Assessment Score:		N/A
Priority Assessment Score:		N/A
Action:	N/A	
Comments:	Modern Stair Nosing

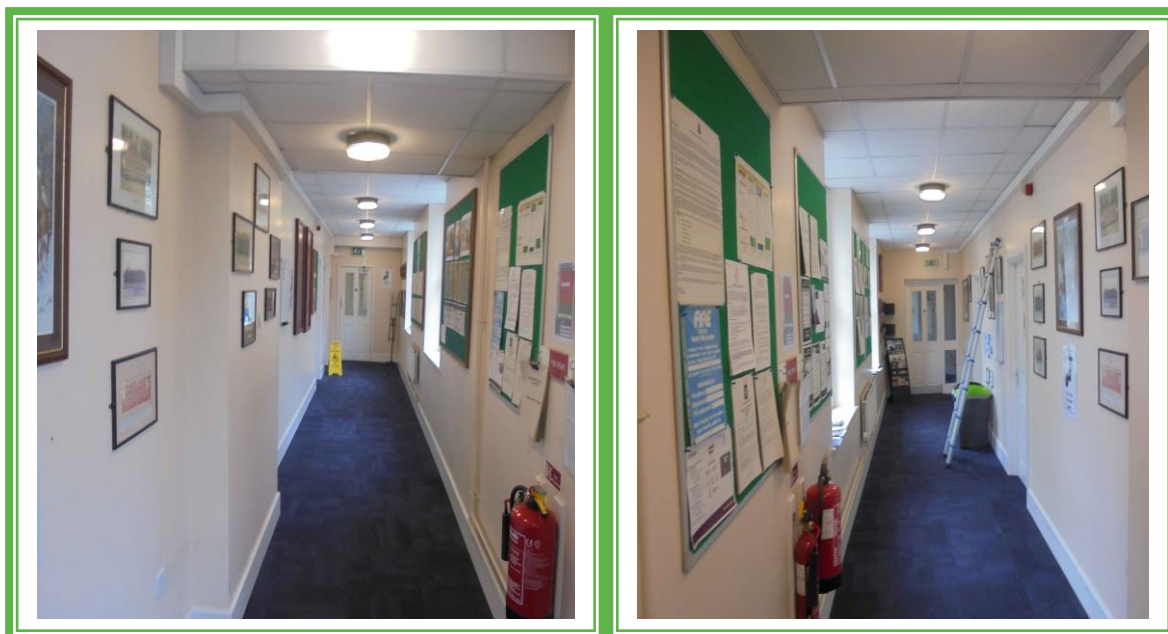
Location: Yeomanry Corridor – Ground Floor

Material Description:	Visual Inspection – No Suspect Materials Found	
Identification:	N/A	
Approx. quantity:	N/A	
Accessibility	N/A	<i>Assessment Score</i>
Product type:		N/A
Extent of Damage:		N/A
Surface Treatment:		N/A
Asbestos type:		N/A
Material Assessment Score:		N/A
Priority Assessment Score:		N/A
Action:	N/A	
Comments:	Non asbestos slate tiles packers under ceiling joists

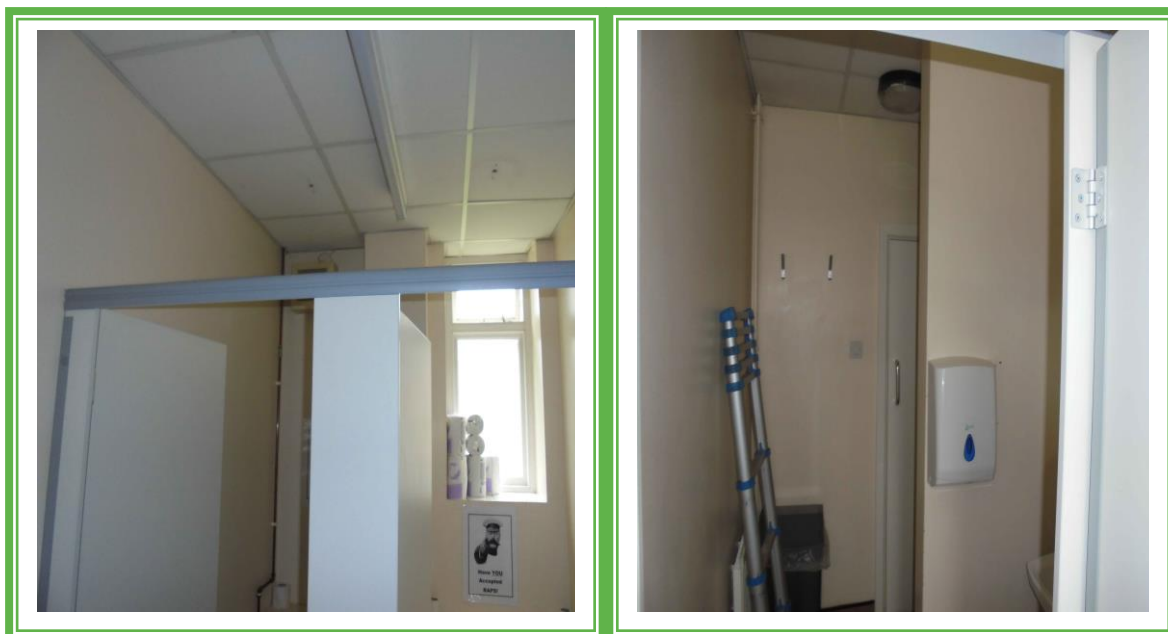
Location: WC – Ground Floor

Material Description:	Visual Inspection – No Suspect Materials Found	
Identification:	N/A	
Approx. quantity:	N/A	
Accessibility	N/A	<i>Assessment Score</i>
Product type:		N/A
Extent of Damage:		N/A
Surface Treatment:		N/A
Asbestos type:		N/A
Material Assessment Score:		N/A
Priority Assessment Score:		N/A
Action:	N/A	
Comments:	No access within timber boxings

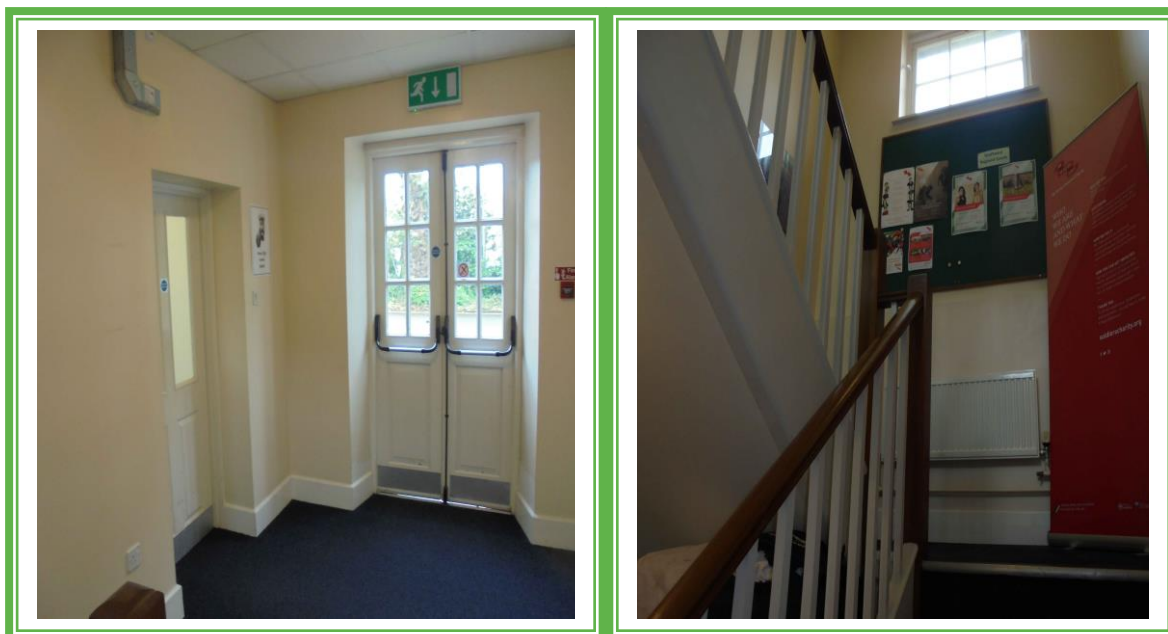
Location: Lobby and Stairwell – Ground Floor

Material Description:	Visual Inspection – No Suspect Materials Found	
Identification:	N/A	
Approx. quantity:	N/A	
Accessibility	N/A	<i>Assessment Score</i>
Product type:		N/A
Extent of Damage:		N/A
Surface Treatment:		N/A
Asbestos type:		N/A
Material Assessment Score:		N/A
Priority Assessment Score:		N/A
Action:	N/A	
Comments:	Modern Stair Nosing

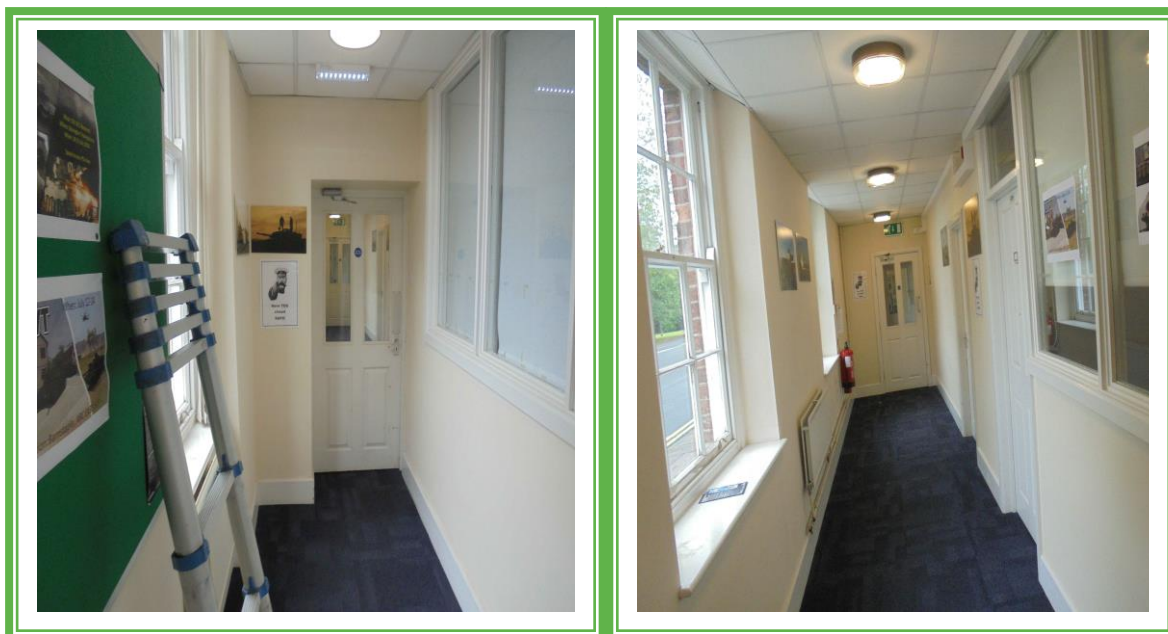
Location: Corridor x 2 – Ground Floor

Material Description:	Visual Inspection – No Suspect Materials Found	
Identification:	N/A	
Approx. quantity:	N/A	
Accessibility	N/A	<i>Assessment Score</i>
Product type:		N/A
Extent of Damage:		N/A
Surface Treatment:		N/A
Asbestos type:		N/A
Material Assessment Score:		N/A
Priority Assessment Score:		N/A
Action:	N/A	
Comments:	N/A

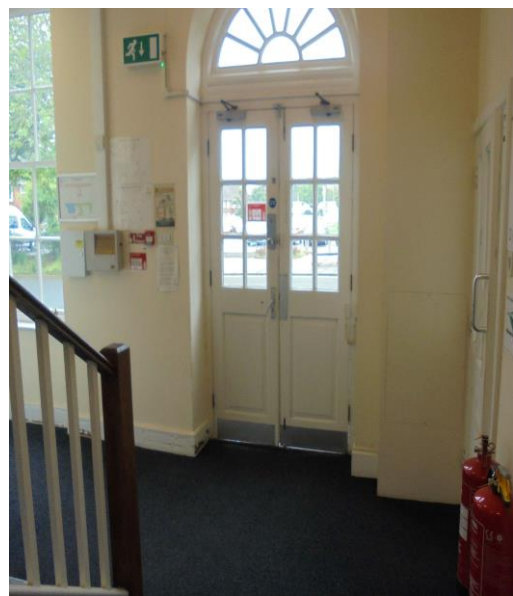
Location: Main Lobby & Stairwell – Ground Floor

Material Description:	Gaskets	
Identification:	Sampled – No Asbestos Detected	
Approx. quantity:	X 2	
Accessibility	N/A	<i>Assessment Score</i>
Product type:		N/A
Extent of Damage:		N/A
Surface Treatment:		N/A
Asbestos type:		N/A
Material Assessment Score:		N/A
Priority Assessment Score:		N/A
Action:	N/A	
Comments:	Located within boxing. Modern stair nosing to stairs

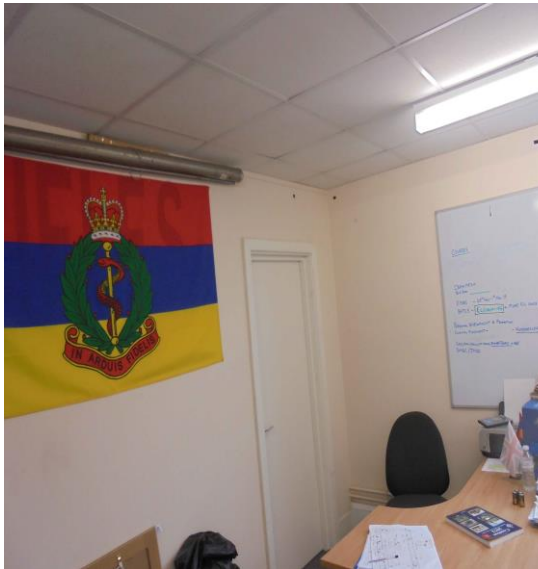
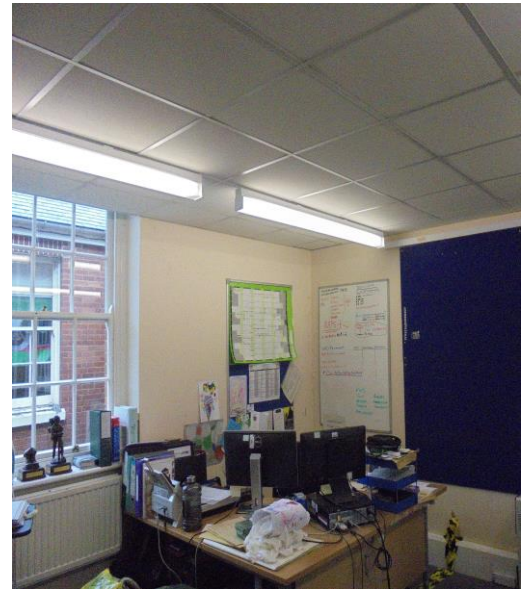
Location: Office – G43

Material Description:	Visual Inspection – No Suspect Materials Found	
Identification:	N/A	
Approx. quantity:	N/A	
Accessibility	N/A	<i>Assessment Score</i>
Product type:		N/A
Extent of Damage:		N/A
Surface Treatment:		N/A
Asbestos type:		N/A
Material Assessment Score:		N/A
Priority Assessment Score:		N/A
Action:	N/A	
Comments:	N/A

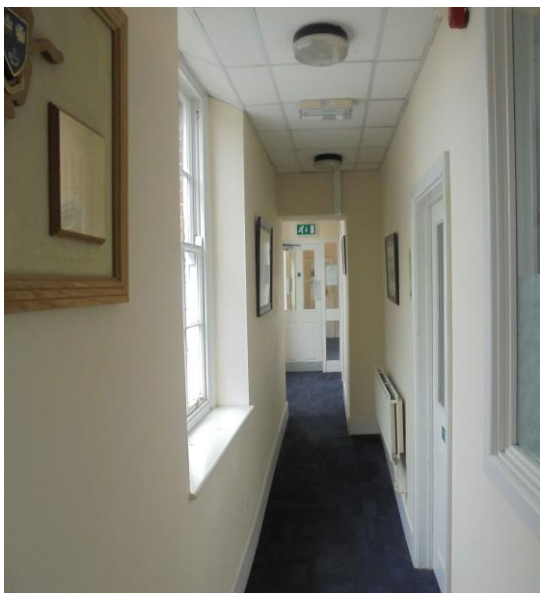
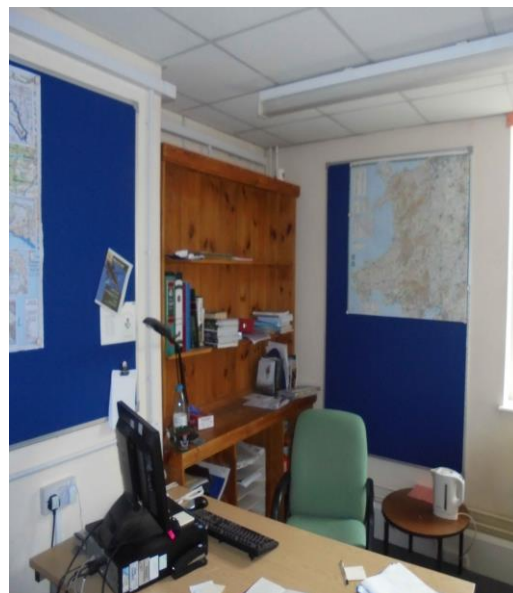
**Item No: 14****Sample No: N/A****Location: Corridor – Ground Floor**

Material Description:	Visual Inspection – No Suspect Materials Found	
Identification:	N/A	
Approx. quantity:	N/A	
Accessibility	N/A	<i>Assessment Score</i>
Product type:		N/A
Extent of Damage:		N/A
Surface Treatment:		N/A
Asbestos type:		N/A
Material Assessment Score:		N/A
Priority Assessment Score:		N/A
Action:	N/A	
Comments:	N/A

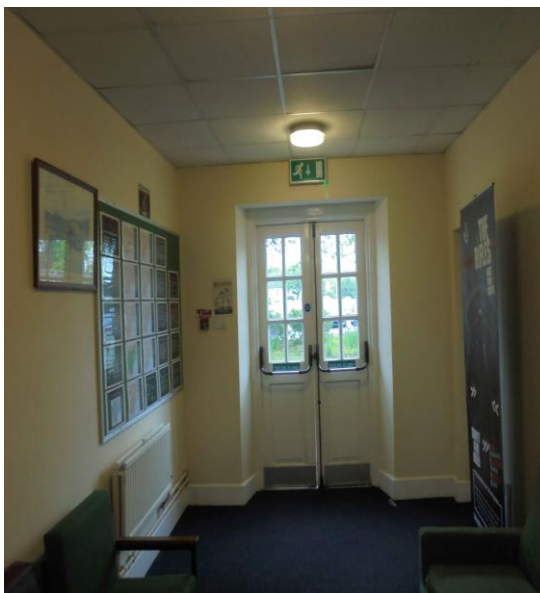
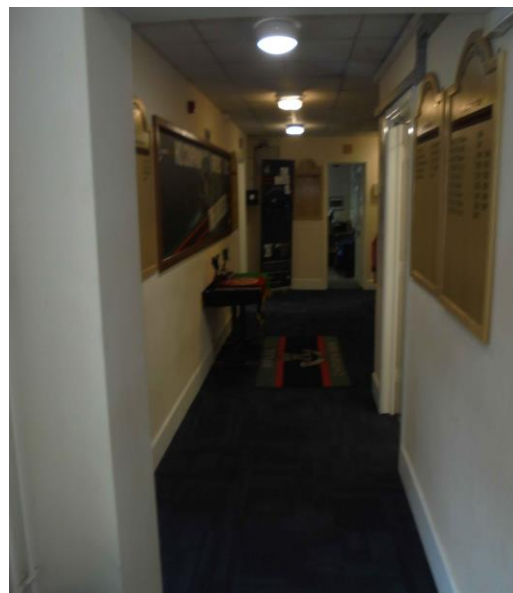
Location: Lobby and Corridor – Ground Floor

Material Description:	Visual Inspection – No Suspect Materials Found	
Identification:	N/A	
Approx. quantity:	N/A	
Accessibility	N/A	<i>Assessment Score</i>
Product type:		N/A
Extent of Damage:		N/A
Surface Treatment:		N/A
Asbestos type:		N/A
Material Assessment Score:		N/A
Priority Assessment Score:		N/A
Action:	N/A	
Comments:	N/A

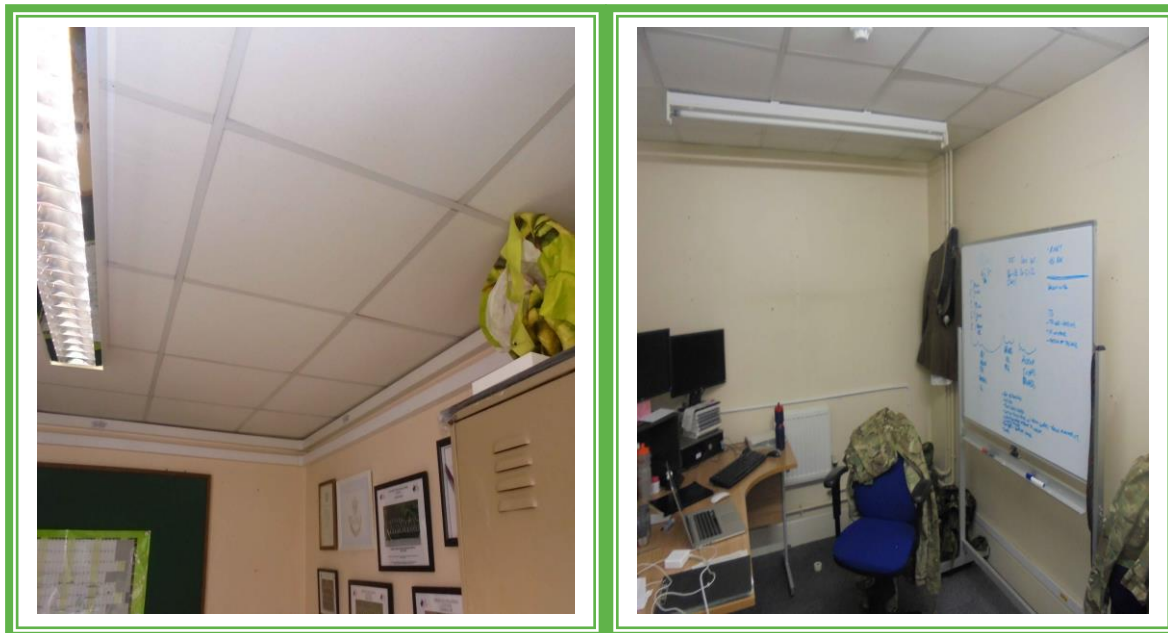
**Item No: 16****Sample No: N/A****Location: Offices G45 and G57**

Material Description:	Visual Inspection – No Suspect Materials Found	
Identification:	N/A	
Approx. quantity:	N/A	
Accessibility	N/A	<i>Assessment Score</i>
Product type:		N/A
Extent of Damage:		N/A
Surface Treatment:		N/A
Asbestos type:		N/A
Material Assessment Score:		N/A
Priority Assessment Score:		N/A
Action:	N/A	
Comments:	Limited access into ceiling voids due to services and insulation blocking access

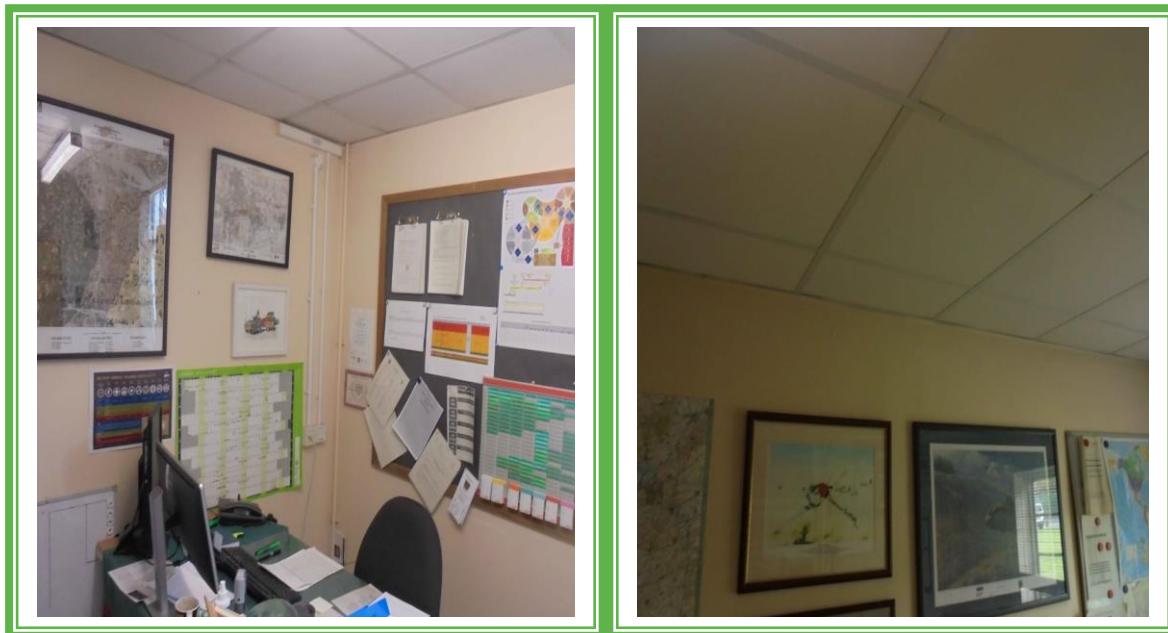
Location: Offices G46, G47 & G48

Material Description:	Visual Inspection – No Suspect Materials Found	
Identification:	N/A	
Approx. quantity:	N/A	
Accessibility	N/A	<i>Assessment Score</i>
Product type:		N/A
Extent of Damage:		N/A
Surface Treatment:		N/A
Asbestos type:		N/A
Material Assessment Score:		N/A
Priority Assessment Score:		N/A
Action:	N/A	
Comments:	Limited access into ceiling voids due to services and insulation blocking access

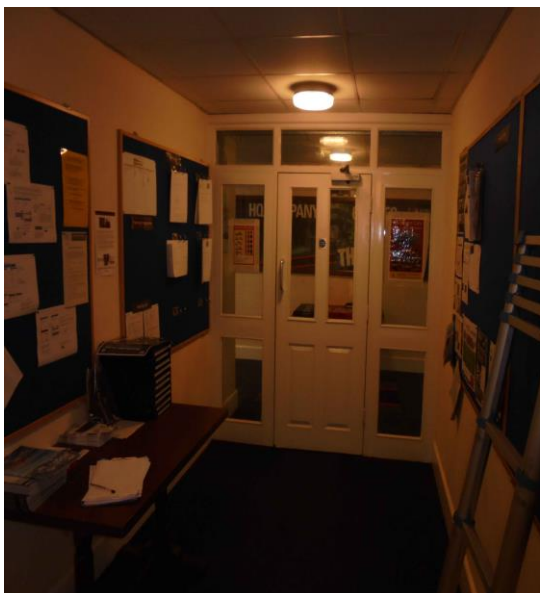
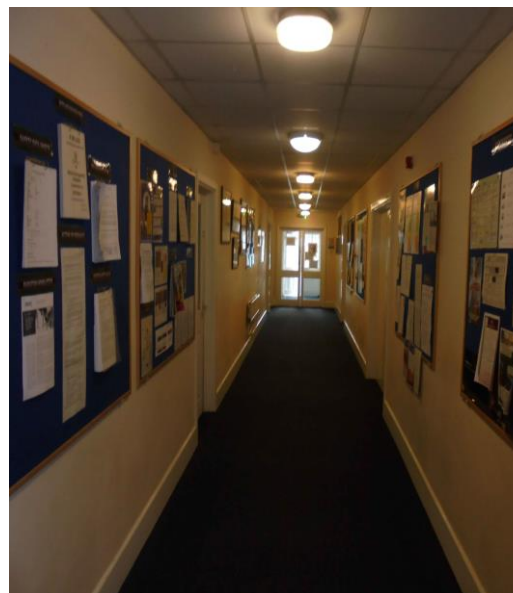
Location: Corridor & Lobby – Ground Floor

Material Description:	Visual Inspection – No Suspect Materials Found	
Identification:	N/A	
Approx. quantity:	N/A	
Accessibility	N/A	<i>Assessment Score</i>
Product type:		N/A
Extent of Damage:		N/A
Surface Treatment:		N/A
Asbestos type:		N/A
Material Assessment Score:		N/A
Priority Assessment Score:		N/A
Action:	N/A	
Comments:	N/A

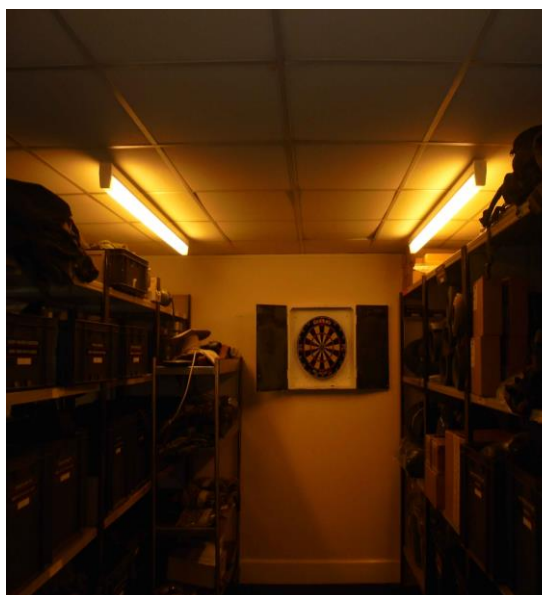
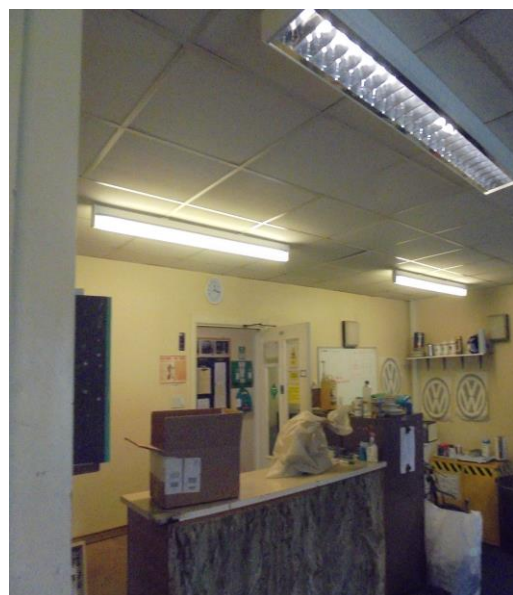
Location: Stores G50 and G51

Material Description:	Visual Inspection – No Suspect Materials Found	
Identification:	N/A	
Approx. quantity:	N/A	
Accessibility	N/A	<i>Assessment Score</i>
Product type:		N/A
Extent of Damage:		N/A
Surface Treatment:		N/A
Asbestos type:		N/A
Material Assessment Score:		N/A
Priority Assessment Score:		N/A
Action:	N/A	
Comments:	N/A

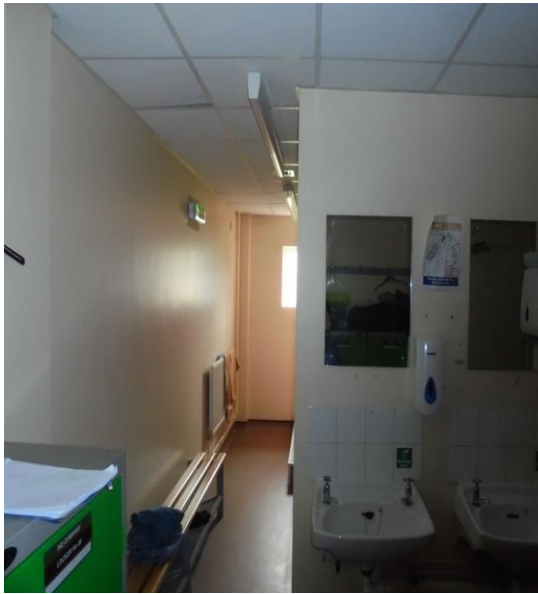
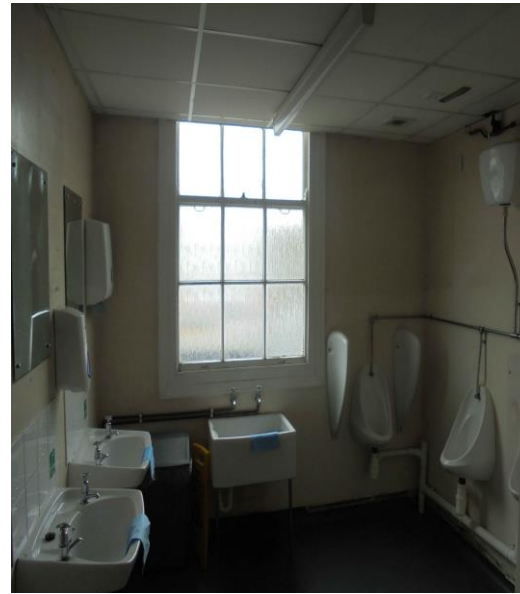
**Item No: 21****Sample No: N/A****Location: WC's x 2 – Ground Floor**

Material Description:	Visual Inspection – No Suspect Materials Found	
Identification:	N/A	
Approx. quantity:	N/A	
Accessibility	N/A	<i>Assessment Score</i>
Product type:		N/A
Extent of Damage:		N/A
Surface Treatment:		N/A
Asbestos type:		N/A
Material Assessment Score:		N/A
Priority Assessment Score:		N/A
Action:	N/A	
Comments:	Modern water heater. No access within timber boxings

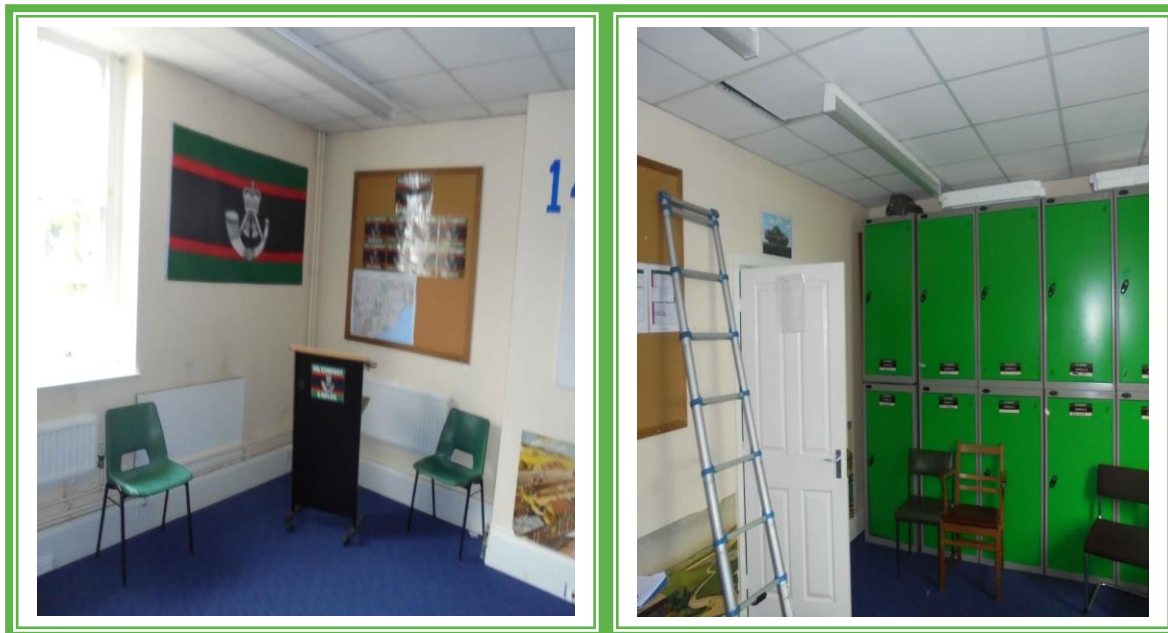
**Item No: 22****Sample No: N/A****Location: Locker Room – G65**

Material Description:	Visual Inspection – No Suspect Materials Found	
Identification:	N/A	
Approx. quantity:	N/A	
Accessibility	N/A	<i>Assessment Score</i>
Product type:		N/A
Extent of Damage:		N/A
Surface Treatment:		N/A
Asbestos type:		N/A
Material Assessment Score:		N/A
Priority Assessment Score:		N/A
Action:	N/A	
Comments:	N/A

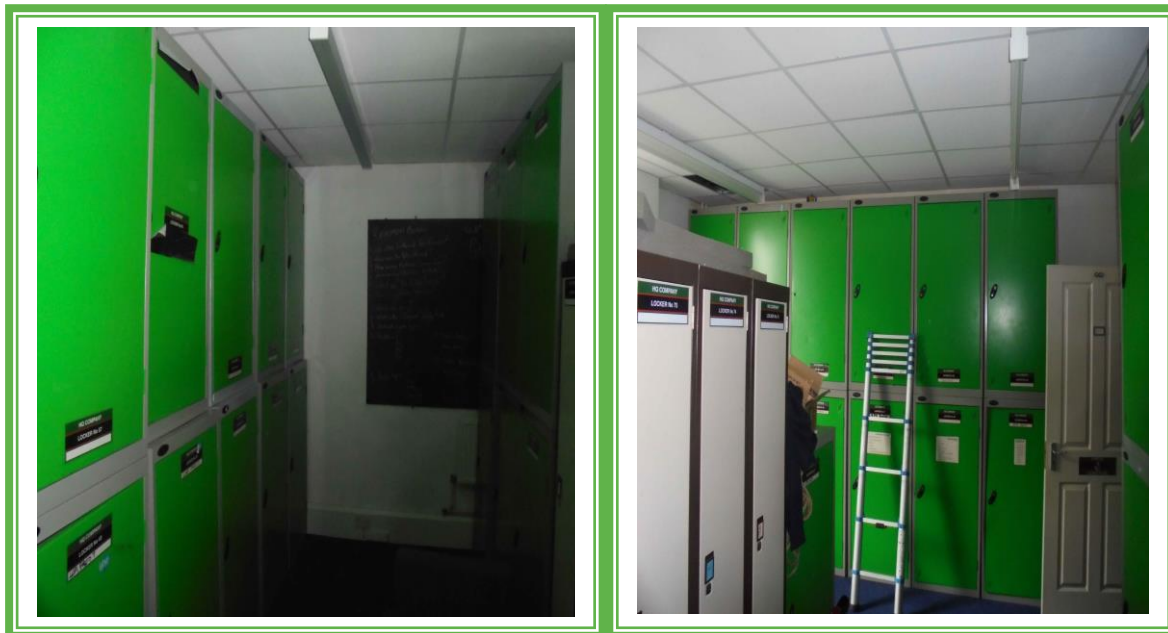
Location: Locker Room – G82

Material Description:	Visual Inspection – No Suspect Materials Found	
Identification:	N/A	
Approx. quantity:	N/A	
Accessibility	N/A	<i>Assessment Score</i>
Product type:		N/A
Extent of Damage:		N/A
Surface Treatment:		N/A
Asbestos type:		N/A
Material Assessment Score:		N/A
Priority Assessment Score:		N/A
Action:	N/A	
Comments:	N/A

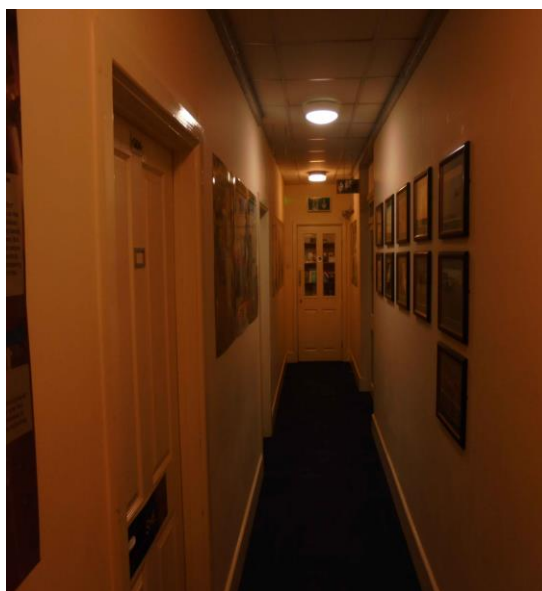
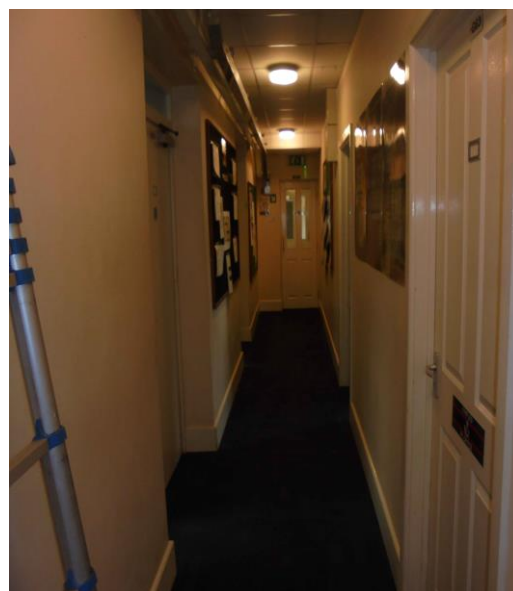
Location: Corridor – Ground Floor

Material Description:	Visual Inspection – No Suspect Materials Found	
Identification:	N/A	
Approx. quantity:	N/A	
Accessibility	N/A	<i>Assessment Score</i>
Product type:		N/A
Extent of Damage:		N/A
Surface Treatment:		N/A
Asbestos type:		N/A
Material Assessment Score:		N/A
Priority Assessment Score:		N/A
Action:	N/A	
Comments:	N/A

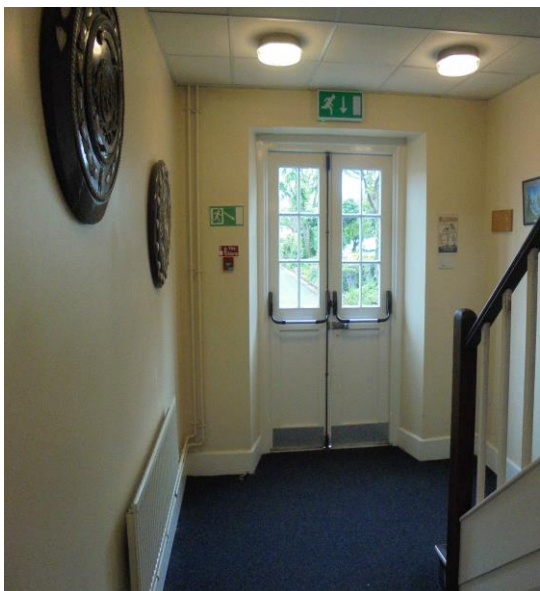
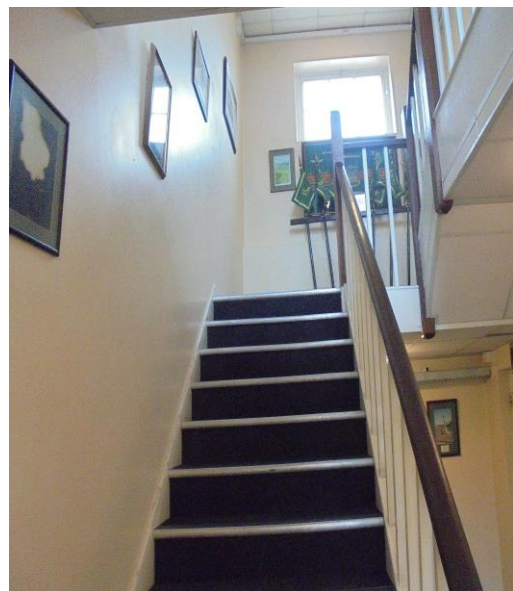
Location: Lobby & Stairwell – Ground Floor

Material Description:	Visual Inspection – No Suspect Materials Found	
Identification:	N/A	
Approx. quantity:	N/A	
Accessibility	N/A	<i>Assessment Score</i>
Product type:		N/A
Extent of Damage:		N/A
Surface Treatment:		N/A
Asbestos type:		N/A
Material Assessment Score:		N/A
Priority Assessment Score:		N/A
Action:	N/A	
Comments:	Modern Stair Nosing

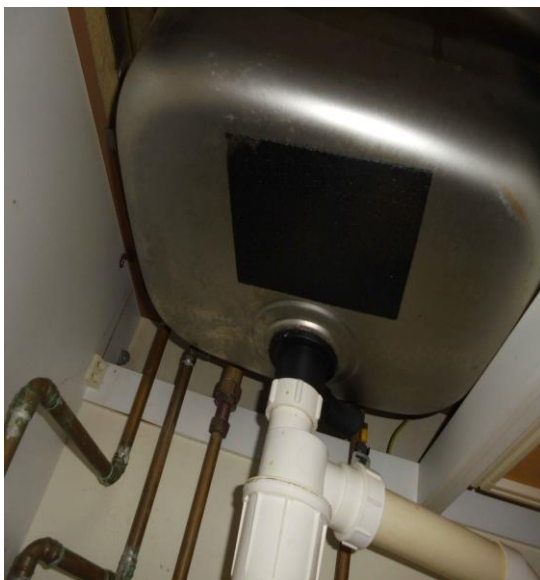
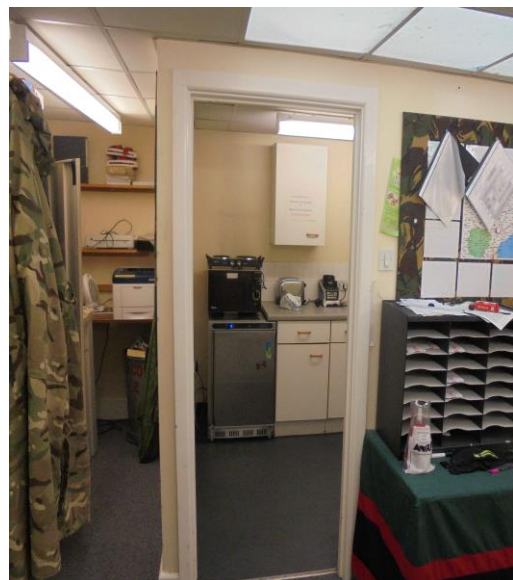
**Item No: 26****Sample No: DK/3****Location: Office & Kitchen – Ground Floor**

Material Description:	Sink Pad	
Identification:	Sampled – No Asbestos Detected	
Approx. quantity:	1 x Sink	
Accessibility	N/A	<i>Assessment Score</i>
Product type:		N/A
Extent of Damage:		N/A
Surface Treatment:		N/A
Asbestos type:		N/A
Material Assessment Score:		N/A
Priority Assessment Score:		N/A
Action:	N/A	
Comments:	N/A

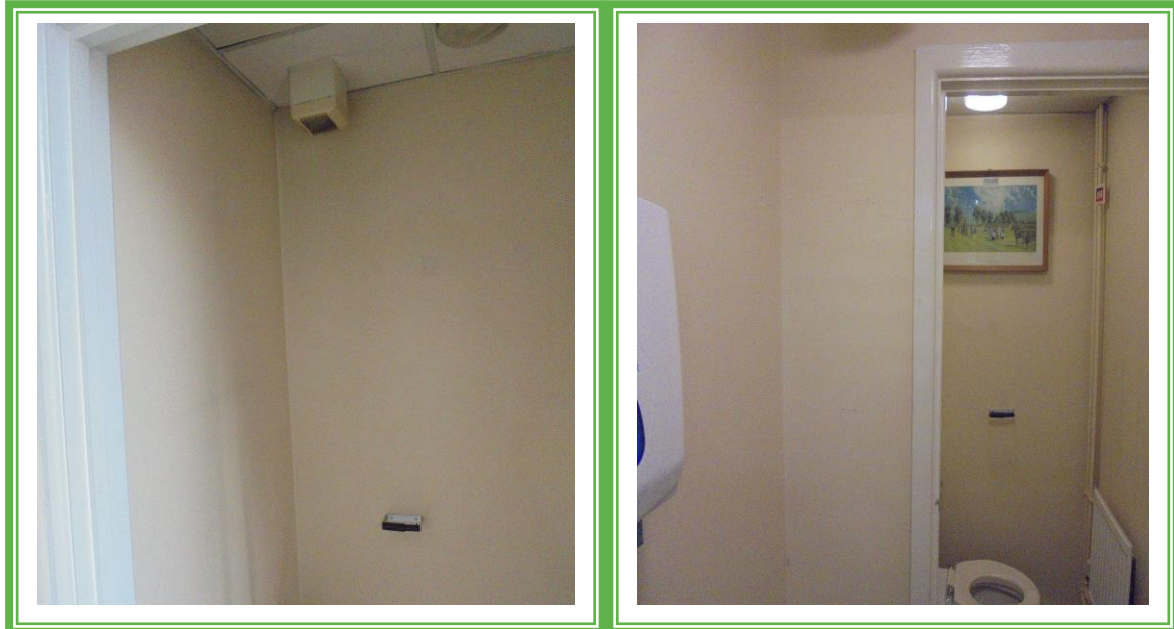
Location: WC's G88 & G89

Material Description:	Visual Inspection – No Suspect Materials Found	
Identification:	N/A	
Approx. quantity:	N/A	
Accessibility	N/A	<i>Assessment Score</i>
Product type:		N/A
Extent of Damage:		N/A
Surface Treatment:		N/A
Asbestos type:		N/A
Material Assessment Score:		N/A
Priority Assessment Score:		N/A
Action:	N/A	
Comments:	N/A

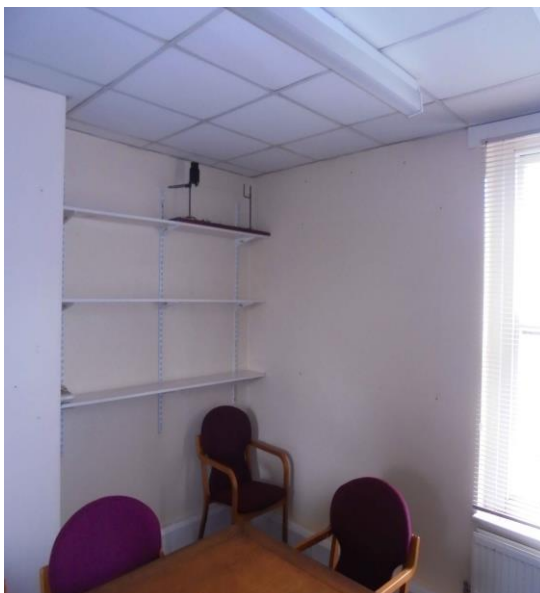
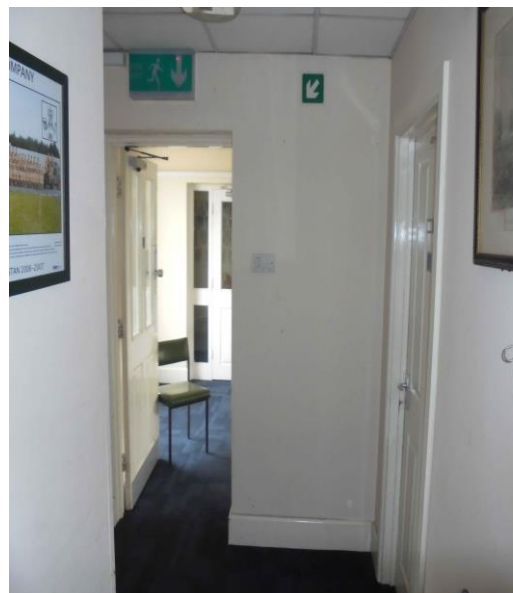
**Item No: 29****Sample No: N/A****Location: Rooms F31,F32, F33 & Circulation**

Material Description:	Visual Inspection – No Suspect Materials Found	
Identification:	N/A	
Approx. quantity:	N/A	
Accessibility	N/A	<i>Assessment Score</i>
Product type:		N/A
Extent of Damage:		N/A
Surface Treatment:		N/A
Asbestos type:		N/A
Material Assessment Score:		N/A
Priority Assessment Score:		N/A
Action:	N/A	
Comments:	N/A

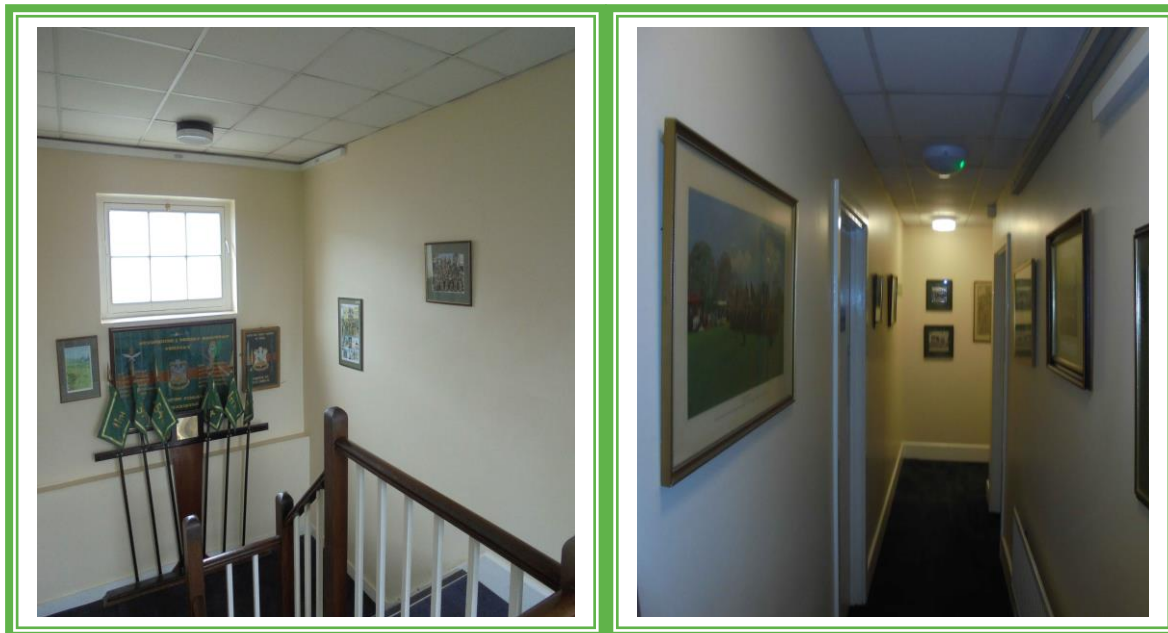
Location: Landing & Corridor – First Floor

Material Description:	Visual Inspection – No Suspect Materials Found	
Identification:	N/A	
Approx. quantity:	N/A	
Accessibility	N/A	<i>Assessment Score</i>
Product type:		N/A
Extent of Damage:		N/A
Surface Treatment:		N/A
Asbestos type:		N/A
Material Assessment Score:		N/A
Priority Assessment Score:		N/A
Action:	N/A	
Comments:	N/A

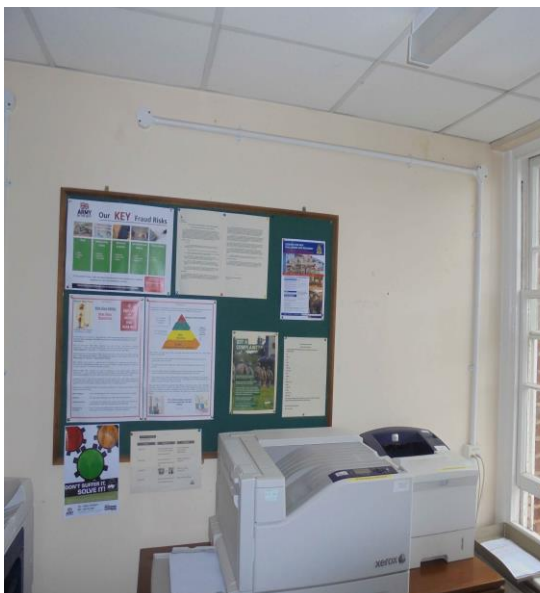
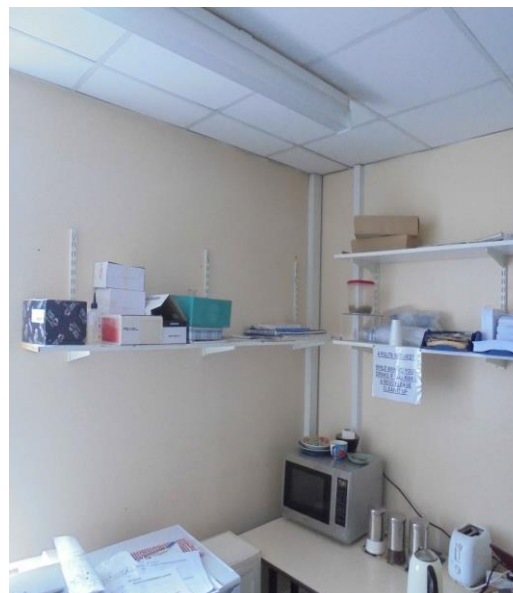
Location: Copy Room – F28 & F27

Material Description:	Visual Inspection – No Suspect Materials Found	
Identification:	N/A	
Approx. quantity:	N/A	
Accessibility	N/A	<i>Assessment Score</i>
Product type:		N/A
Extent of Damage:		N/A
Surface Treatment:		N/A
Asbestos type:		N/A
Material Assessment Score:		N/A
Priority Assessment Score:		N/A
Action:	N/A	
Comments:	Limited access above ceiling tiles due to insulation above tiles

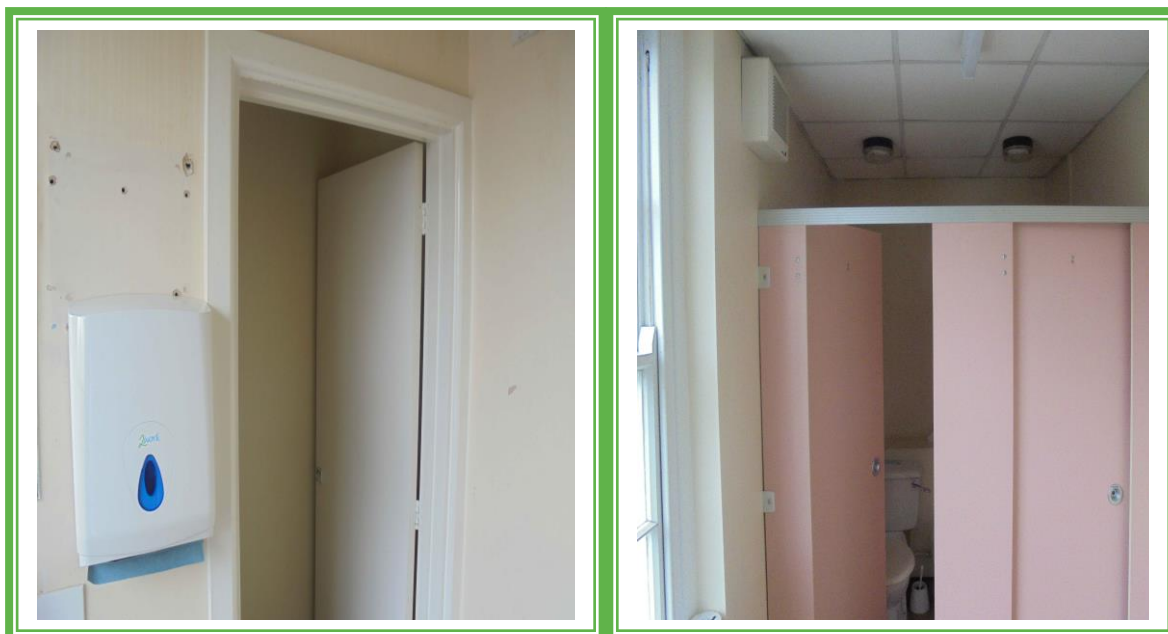
Location: WC's F29 & F30

Material Description:	Visual Inspection – No Suspect Materials Found	
Identification:	N/A	
Approx. quantity:	N/A	
Accessibility	N/A	<i>Assessment Score</i>
Product type:		N/A
Extent of Damage:		N/A
Surface Treatment:		N/A
Asbestos type:		N/A
Material Assessment Score:		N/A
Priority Assessment Score:		N/A
Action:	N/A	
Comments:	N/A
