Project Number 2481

**Management
Asbestos Survey Report**

**Wyvern Barracks, Barrack Road, Exeter, Devon,
EX2 6AE (Building 7)**

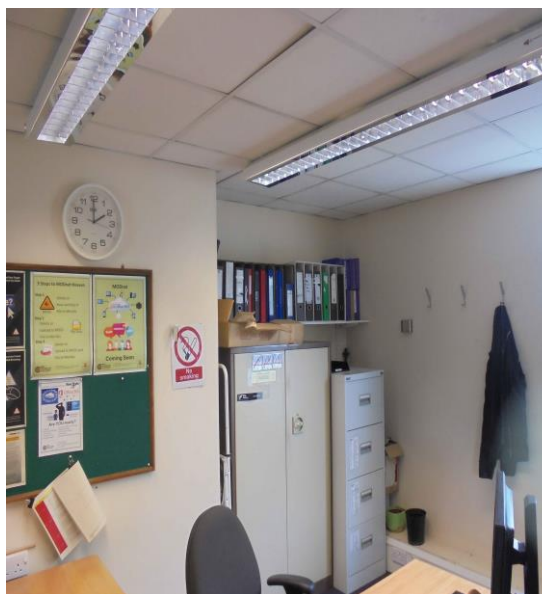
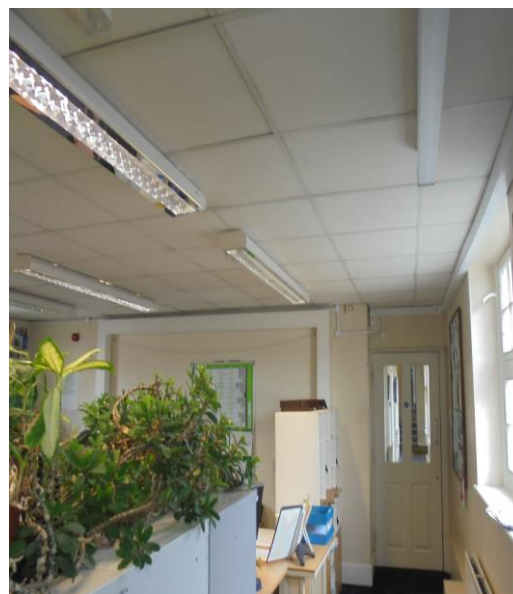
Location: Office – F26

Material Description:	Visual Inspection – No Suspect Materials Found	
Identification:	N/A	
Approx. quantity:	N/A	
Accessibility	N/A	<i>Assessment Score</i>
Product type:		N/A
Extent of Damage:		N/A
Surface Treatment:		N/A
Asbestos type:		N/A
Material Assessment Score:		N/A
Priority Assessment Score:		N/A
Action:	N/A	
Comments:	Limited access above ceiling tiles due to insulation above tiles. No access within timber boxing

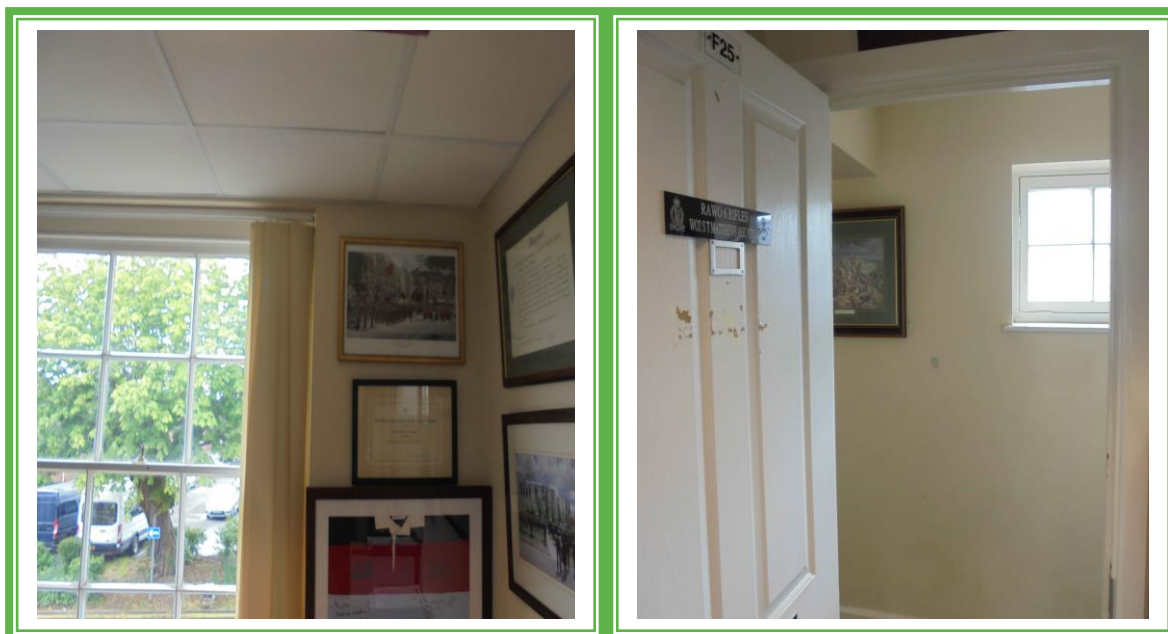
Location: Office – F25

Material Description:	Visual Inspection – No Suspect Materials Found	
Identification:	N/A	
Approx. quantity:	N/A	
Accessibility	N/A	<i>Assessment Score</i>
Product type:		N/A
Extent of Damage:		N/A
Surface Treatment:		N/A
Asbestos type:		N/A
Material Assessment Score:		N/A
Priority Assessment Score:		N/A
Action:	N/A	
Comments:	N/A

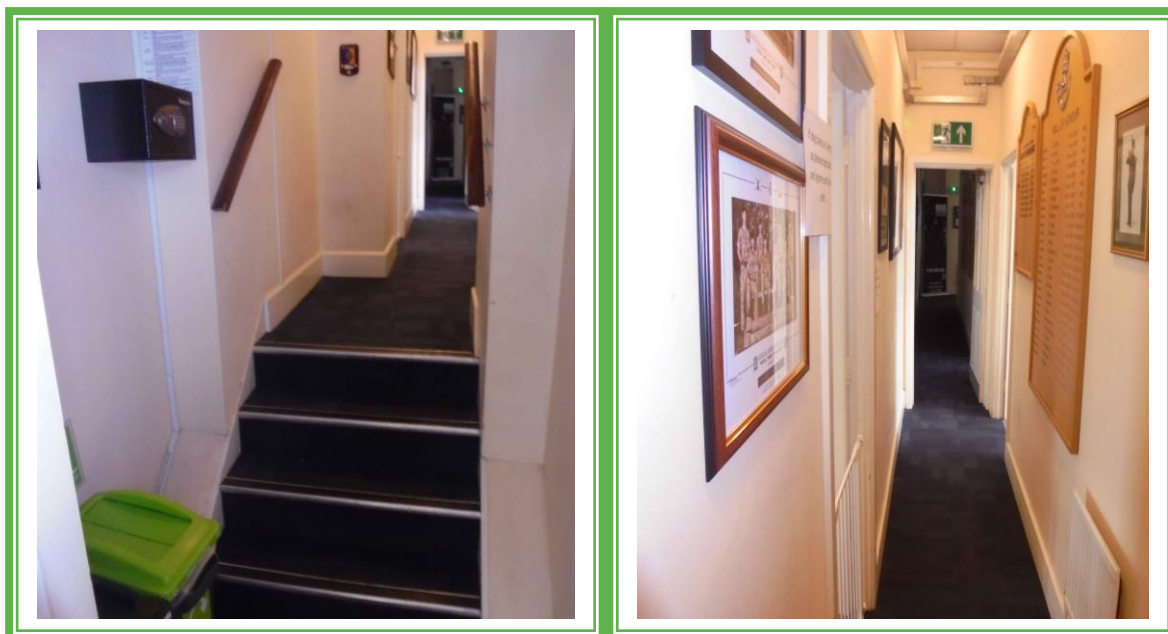
Location: Corridors x 2 – First Floor

Material Description:	Visual Inspection – No Suspect Materials Found	
Identification:	N/A	
Approx. quantity:	N/A	
Accessibility	N/A	<i>Assessment Score</i>
Product type:		N/A
Extent of Damage:		N/A
Surface Treatment:		N/A
Asbestos type:		N/A
Material Assessment Score:		N/A
Priority Assessment Score:		N/A
Action:	N/A	
Comments:	Modern stair nosing

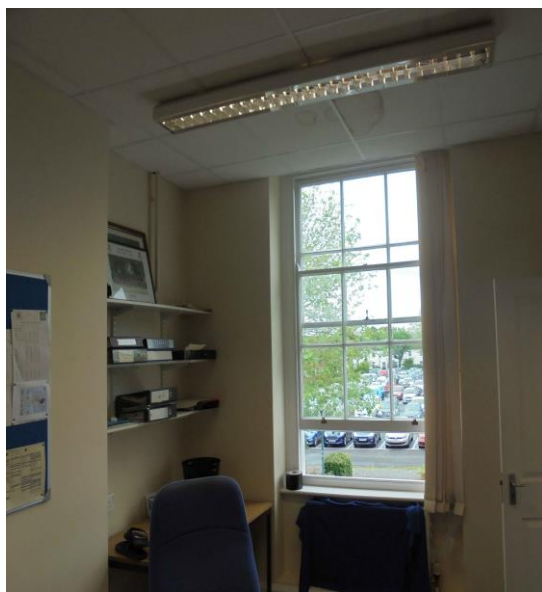
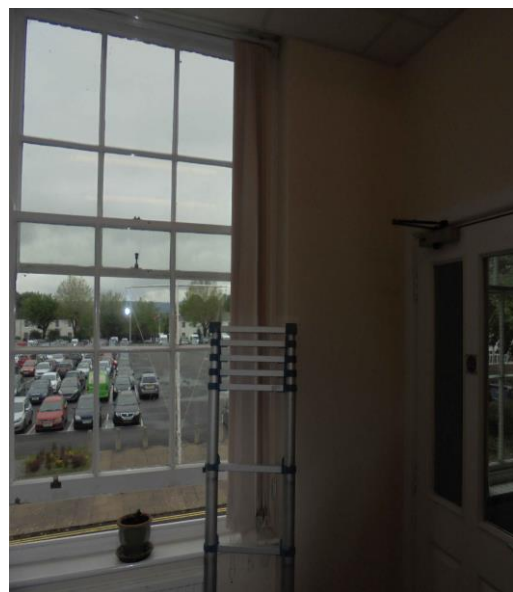
Location: Offices F22, F21 and F20

Material Description:	Visual Inspection – No Suspect Materials Found	
Identification:	N/A	
Approx. quantity:	N/A	
Accessibility	N/A	<i>Assessment Score</i>
Product type:		N/A
Extent of Damage:		N/A
Surface Treatment:		N/A
Asbestos type:		N/A
Material Assessment Score:		N/A
Priority Assessment Score:		N/A
Action:	N/A	
Comments:	Limited access above ceiling tiles due to insulation above tiles

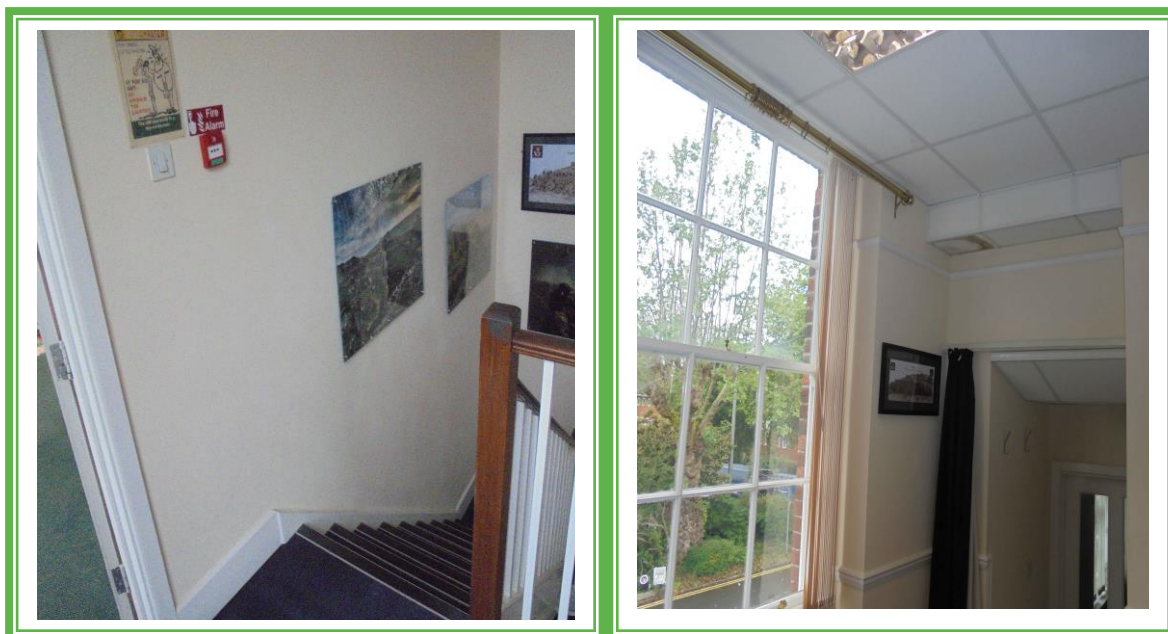
Location: Landing & Office F11

Material Description:	Visual Inspection – No Suspect Materials Found	
Identification:	N/A	
Approx. quantity:	N/A	
Accessibility	N/A	<i>Assessment Score</i>
Product type:		N/A
Extent of Damage:		N/A
Surface Treatment:		N/A
Asbestos type:		N/A
Material Assessment Score:		N/A
Priority Assessment Score:		N/A
Action:	N/A	
Comments:	Modern stair nosing in office. Limited access above ceiling tiles due to insulation above tiles

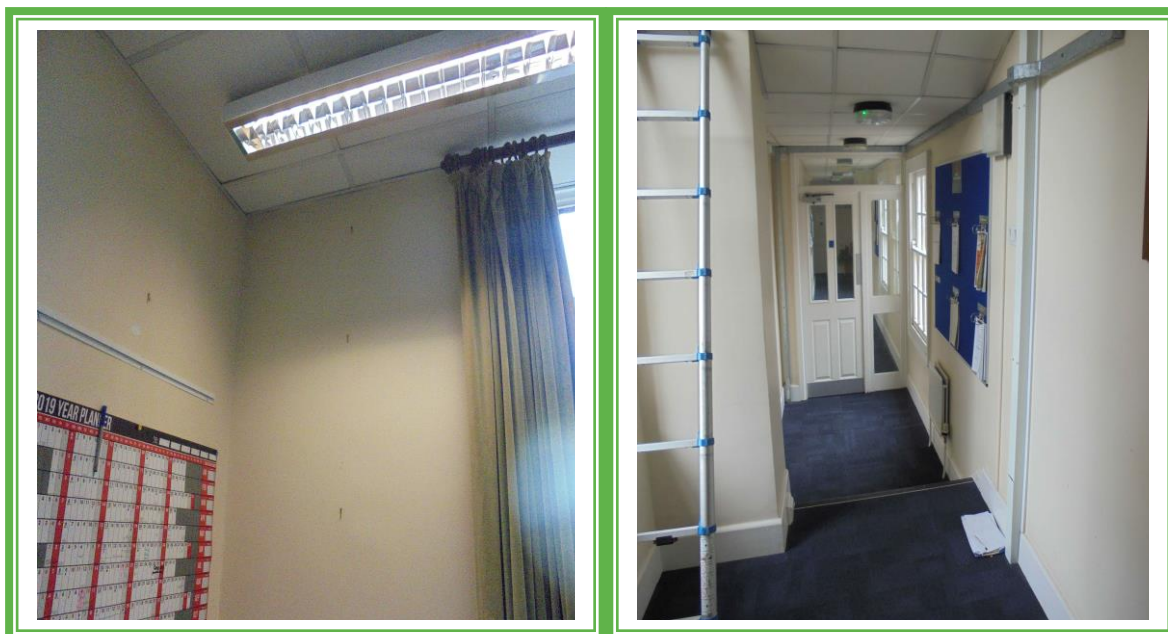
Location: Office F19 & Corridor

Material Description:	Visual Inspection – No Suspect Materials Found	
Identification:	N/A	
Approx. quantity:	N/A	
Accessibility	N/A	<i>Assessment Score</i>
Product type:		N/A
Extent of Damage:		N/A
Surface Treatment:		N/A
Asbestos type:		N/A
Material Assessment Score:		N/A
Priority Assessment Score:		N/A
Action:	N/A	
Comments:	Modern stair nosing in corridor

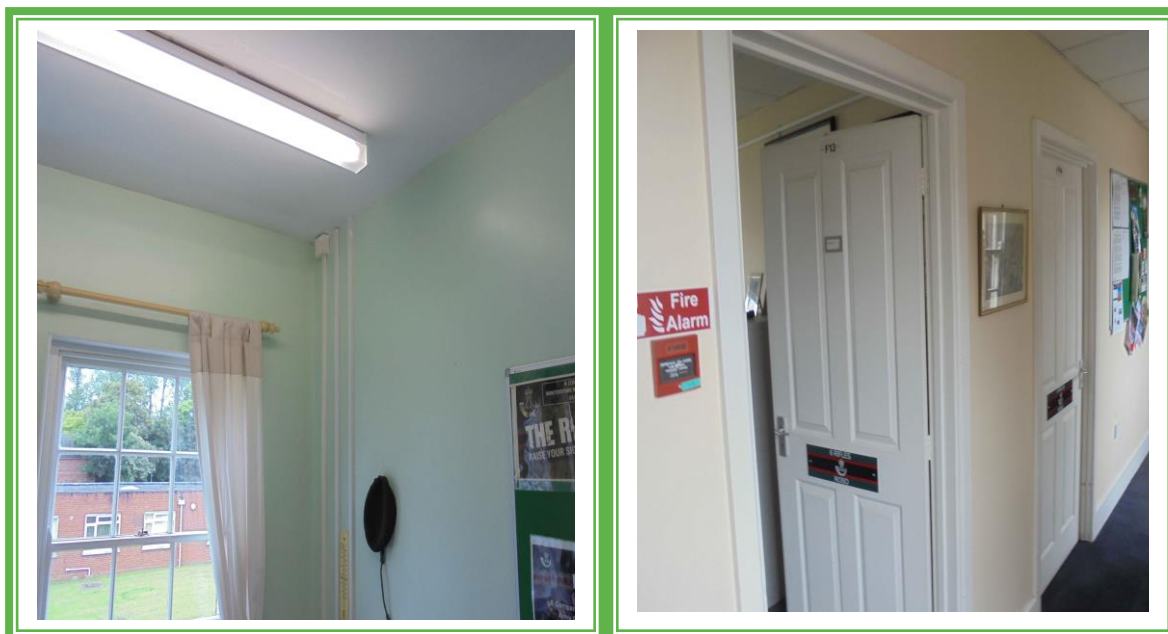
Location: Offices F12, F13 & F14

Material Description:	Visual Inspection – No Suspect Materials Found	
Identification:	N/A	
Approx. quantity:	N/A	
Accessibility	N/A	<i>Assessment Score</i>
Product type:		N/A
Extent of Damage:		N/A
Surface Treatment:		N/A
Asbestos type:		N/A
Material Assessment Score:		N/A
Priority Assessment Score:		N/A
Action:	N/A	
Comments:	N/A

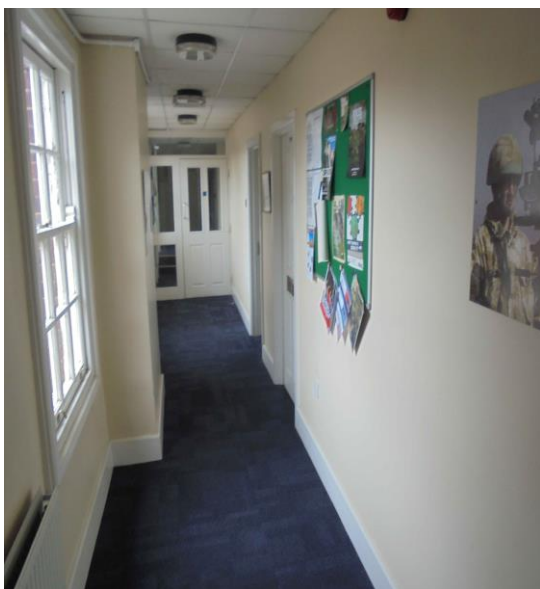
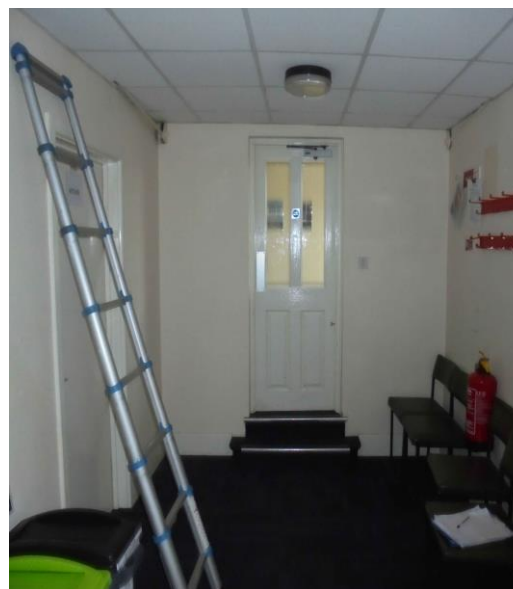
Location: Corridors x 2 – First Floor

Material Description:	Visual Inspection – No Suspect Materials Found	
Identification:	N/A	
Approx. quantity:	N/A	
Accessibility	N/A	<i>Assessment Score</i>
Product type:		N/A
Extent of Damage:		N/A
Surface Treatment:		N/A
Asbestos type:		N/A
Material Assessment Score:		N/A
Priority Assessment Score:		N/A
Action:	N/A	
Comments:	Modern stair nosing

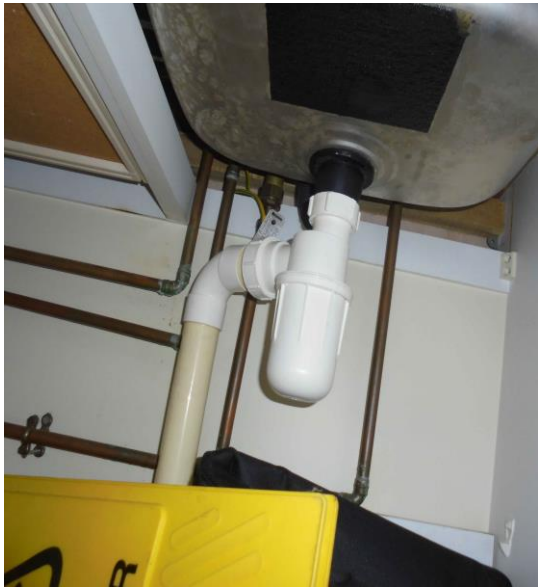
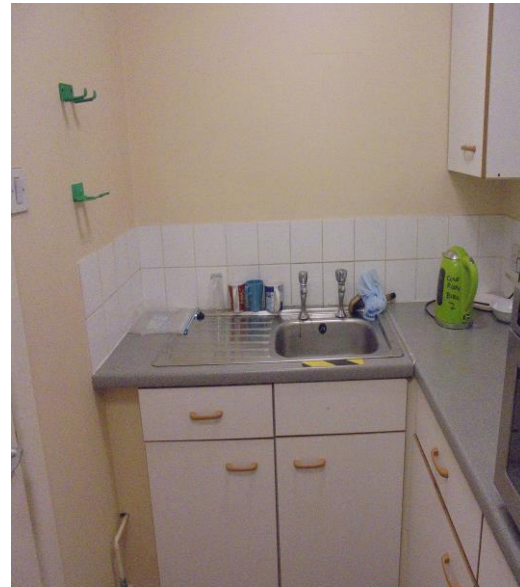
Location: Kitchen – F15

Material Description:	Sink Pad	
Identification:	Samples – No Asbestos Detected	
Approx. quantity:	1 x Sink	
Accessibility	N/A	<i>Assessment Score</i>
Product type:		N/A
Extent of Damage:		N/A
Surface Treatment:		N/A
Asbestos type:		N/A
Material Assessment Score:		N/A
Priority Assessment Score:		N/A
Action:	N/A	
Comments:	N/A

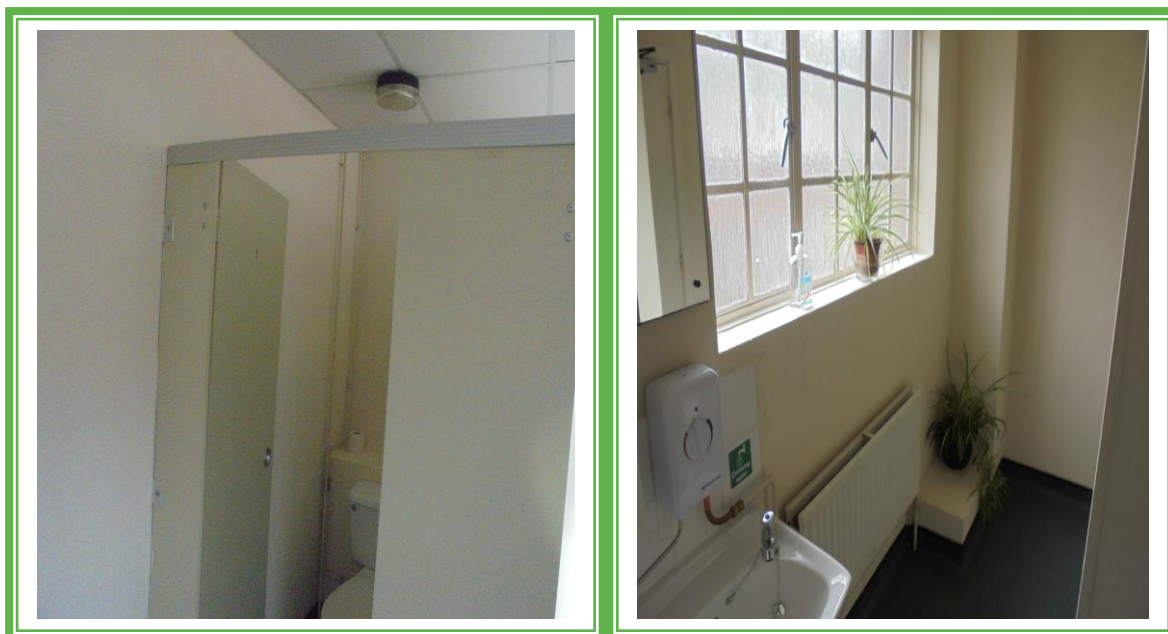
Location: WC – First Floor

Material Description:	Visual Inspection – No Suspect Materials Found	
Identification:	N/A	
Approx. quantity:	N/A	
Accessibility	N/A	<i>Assessment Score</i>
Product type:		N/A
Extent of Damage:		N/A
Surface Treatment:		N/A
Asbestos type:		N/A
Material Assessment Score:		N/A
Priority Assessment Score:		N/A
Action:	N/A	
Comments:	No access within timber boxings. Non-asbestos fibreboard ceiling above suspended ceiling

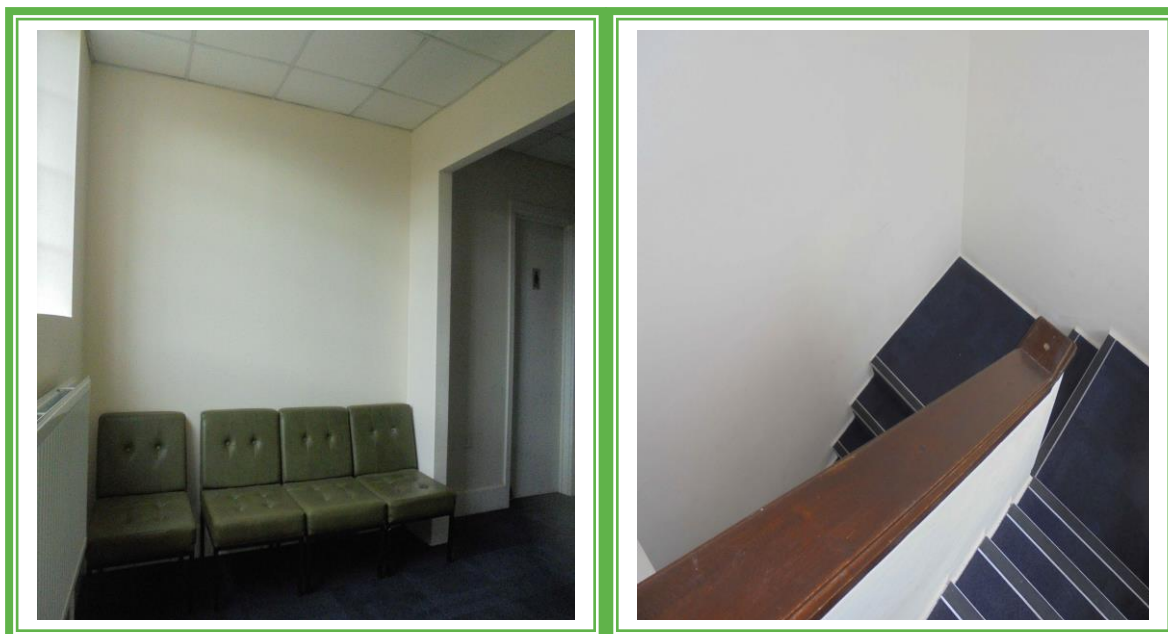
Location: Landing & Stairwell

Material Description:	Visual Inspection – No Suspect Materials Found	
Identification:	N/A	
Approx. quantity:	N/A	
Accessibility	N/A	<i>Assessment Score</i>
Product type:		N/A
Extent of Damage:		N/A
Surface Treatment:		N/A
Asbestos type:		N/A
Material Assessment Score:		N/A
Priority Assessment Score:		N/A
Action:	N/A	
Comments:	Modern Stair nosing.

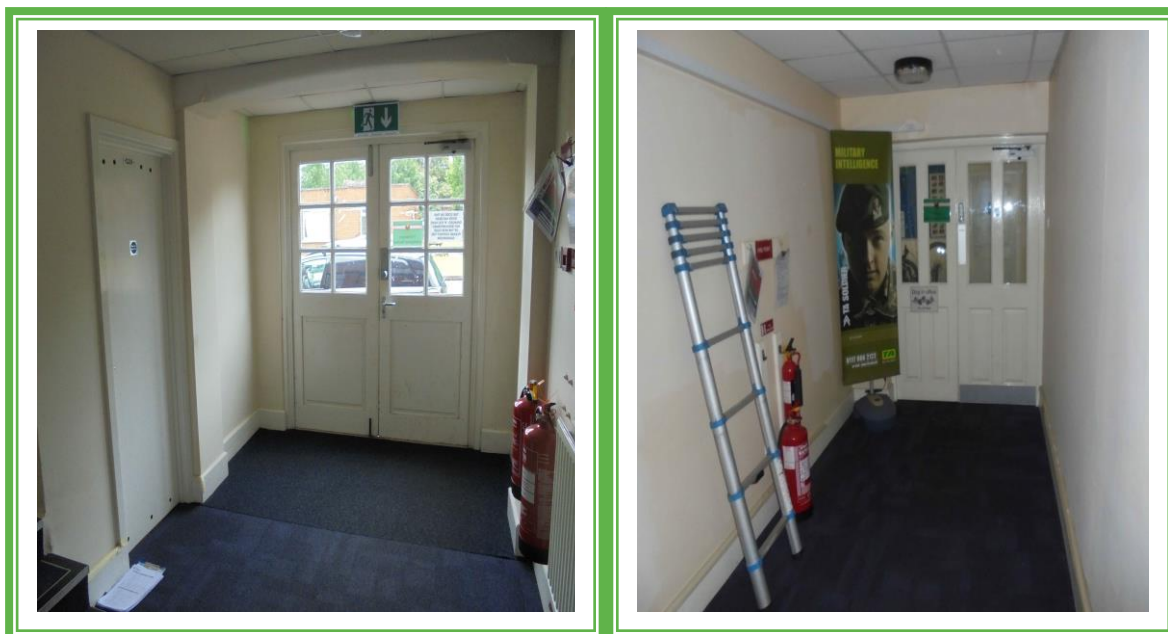
Location: Lobby – Ground Floor

Material Description:	Visual Inspection – No Suspect Materials Found	
Identification:	N/A	
Approx. quantity:	N/A	
Accessibility	N/A	<i>Assessment Score</i>
Product type:		N/A
Extent of Damage:		N/A
Surface Treatment:		N/A
Asbestos type:		N/A
Material Assessment Score:		N/A
Priority Assessment Score:		N/A
Action:	N/A	
Comments:	N/A

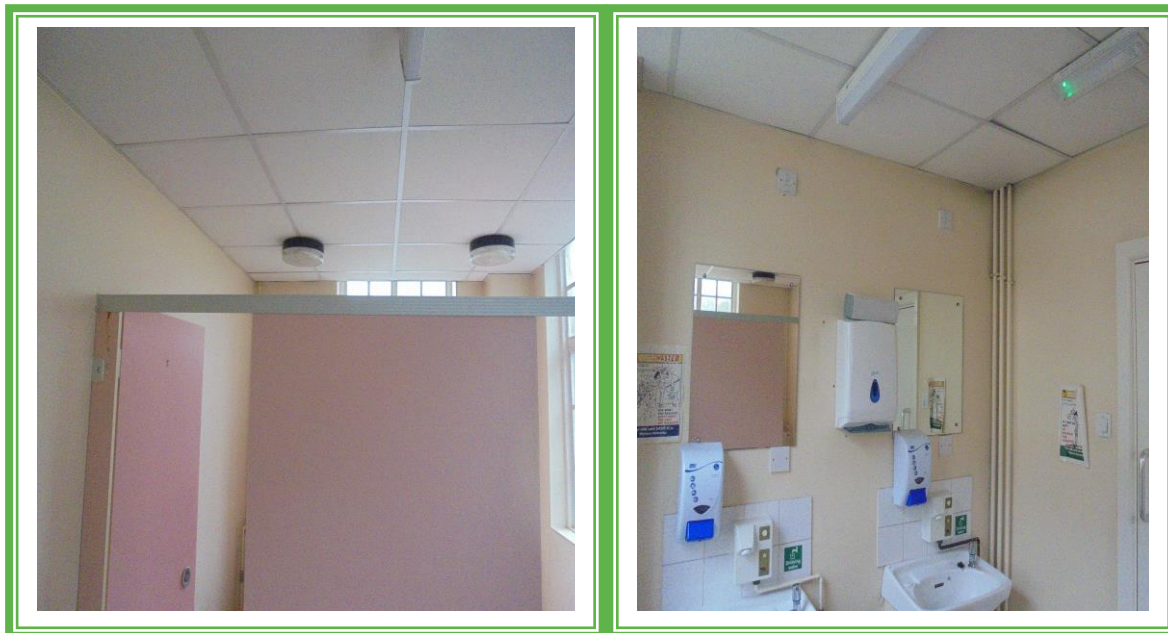
Location: WC – G32

Material Description:	Visual Inspection – No Suspect Materials Found	
Identification:	N/A	
Approx. quantity:	N/A	
Accessibility	N/A	<i>Assessment Score</i>
Product type:		N/A
Extent of Damage:		N/A
Surface Treatment:		N/A
Asbestos type:		N/A
Material Assessment Score:		N/A
Priority Assessment Score:		N/A
Action:	N/A	
Comments:	N/A

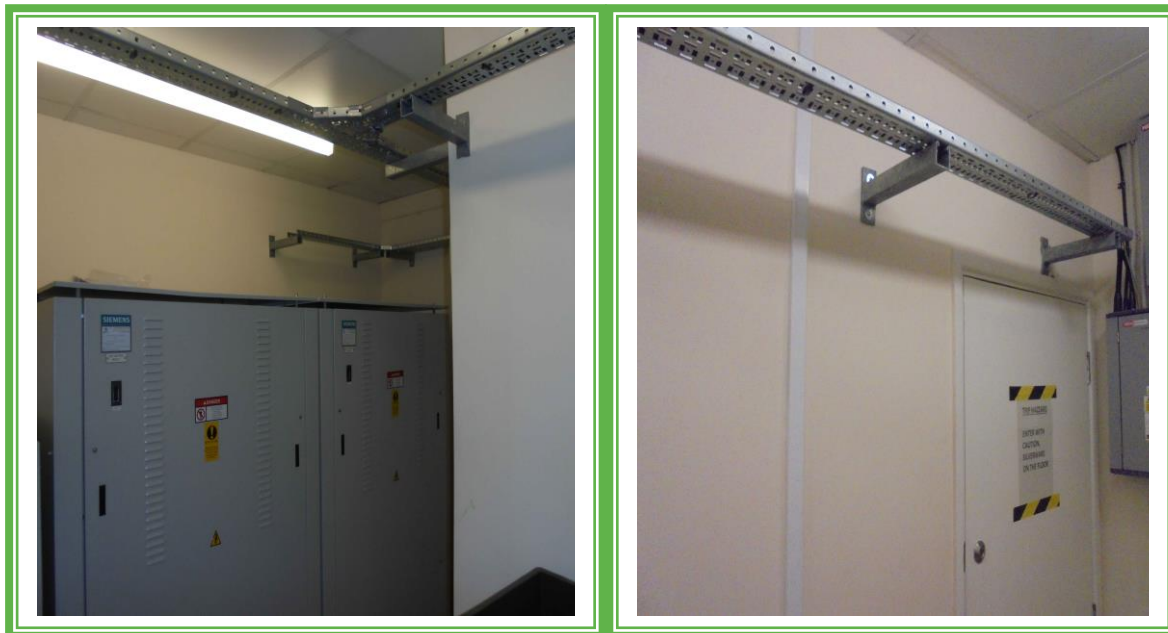
Location: Rooms G07 & G02

Material Description:	Visual Inspection – No Suspect Materials Found	
Identification:	N/A	
Approx. quantity:	N/A	
Accessibility	N/A	<i>Assessment Score</i>
Product type:		N/A
Extent of Damage:		N/A
Surface Treatment:		N/A
Asbestos type:		N/A
Material Assessment Score:		N/A
Priority Assessment Score:		N/A
Action:	N/A	
Comments:	Modern electrics

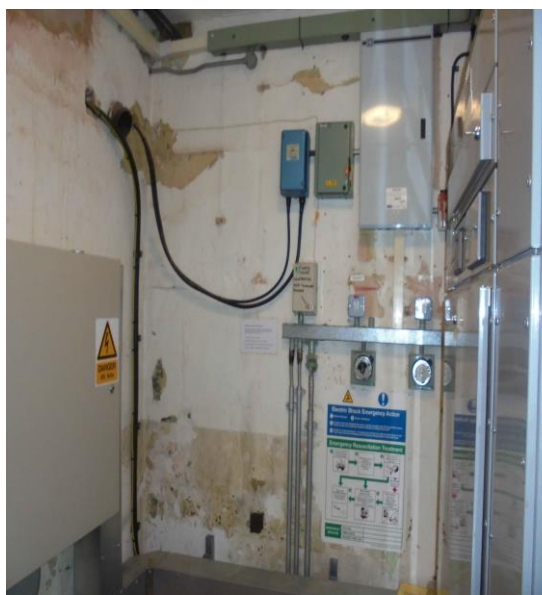
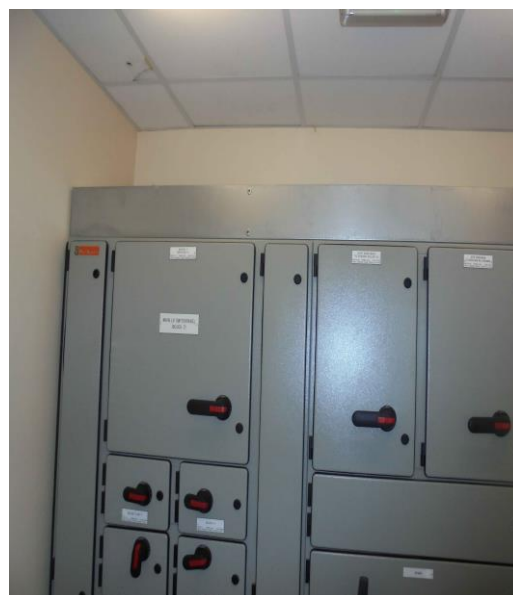
Location: Rooms G11 & G12

Material Description:	Visual Inspection – No Suspect Materials Found	
Identification:	N/A	
Approx. quantity:	N/A	
Accessibility	N/A	<i>Assessment Score</i>
Product type:		N/A
Extent of Damage:		N/A
Surface Treatment:		N/A
Asbestos type:		N/A
Material Assessment Score:		N/A
Priority Assessment Score:		N/A
Action:	N/A	
Comments:	Modern electrics

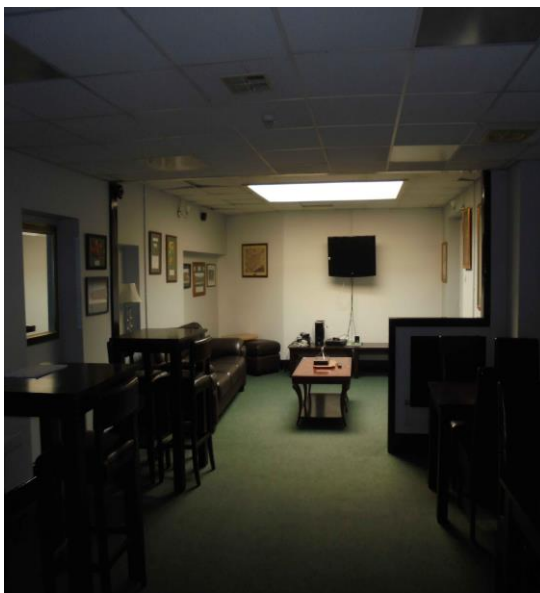
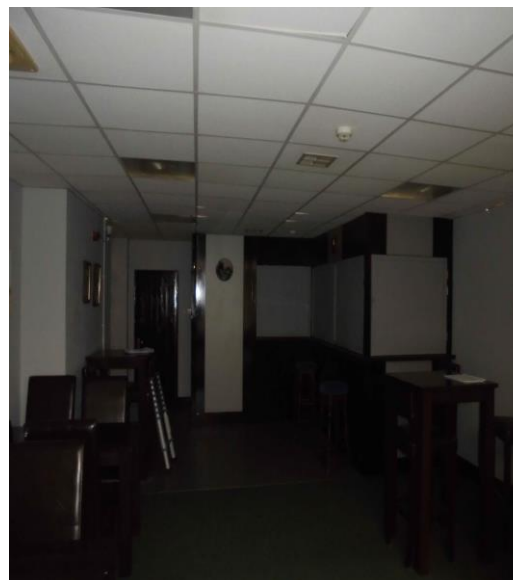
Location: Bar & Mess Room – G59 & G60

Material Description:	Visual Inspection – No Suspect Materials Found	
Identification:	N/A	
Approx. quantity:	N/A	
Accessibility	N/A	<i>Assessment Score</i>
Product type:		N/A
Extent of Damage:		N/A
Surface Treatment:		N/A
Asbestos type:		N/A
Material Assessment Score:		N/A
Priority Assessment Score:		N/A
Action:	N/A	
Comments:	N/A

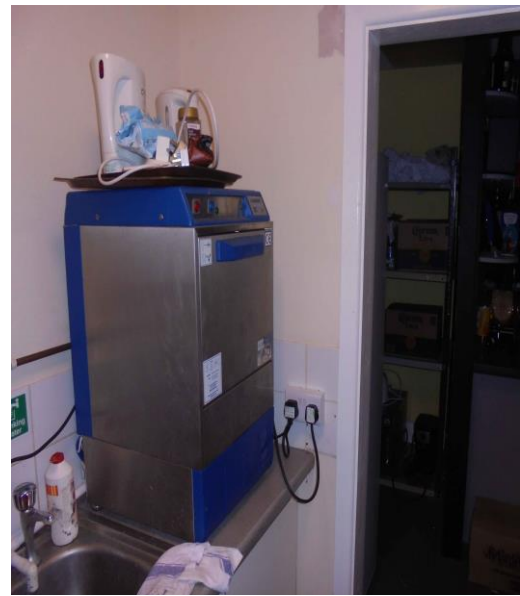
Location: Bar Kitchen – Ground Floor

Material Description:	Sink Pad	
Identification:	Sampled – No Asbestos Detected	
Approx. quantity:	1 x Sink	
Accessibility	N/A	<i>Assessment Score</i>
Product type:		N/A
Extent of Damage:		N/A
Surface Treatment:		N/A
Asbestos type:		N/A
Material Assessment Score:		N/A
Priority Assessment Score:		N/A
Action:	N/A	
Comments:	N/A

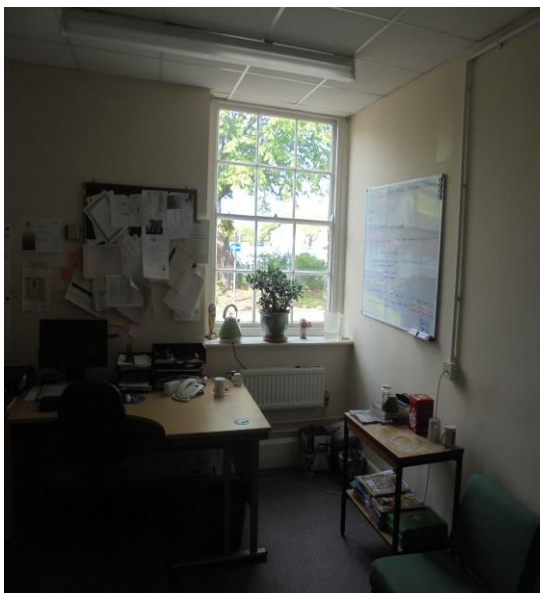
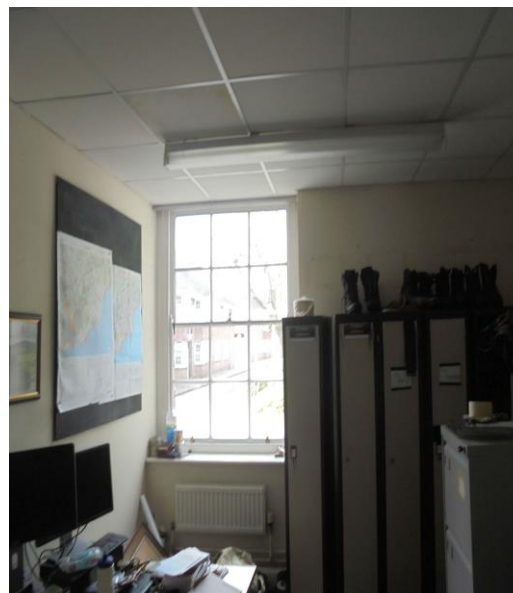
**Item No: 60****Sample No: N/A****Location: Offices G64, G63 & G61**

Material Description:	Visual Inspection – No Suspect Materials Found	
Identification:	N/A	
Approx. quantity:	N/A	
Accessibility	N/A	<i>Assessment Score</i>
Product type:		N/A
Extent of Damage:		N/A
Surface Treatment:		N/A
Asbestos type:		N/A
Material Assessment Score:		N/A
Priority Assessment Score:		N/A
Action:	N/A	
Comments:	N/A

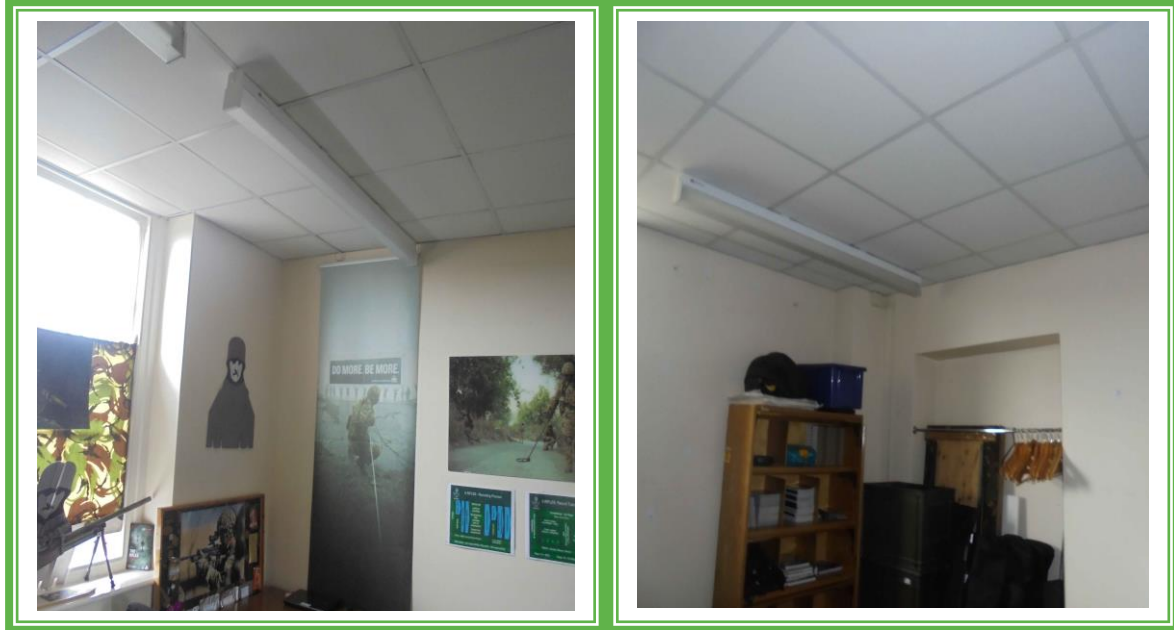
Location: Rooms G73, G72 & G71

Material Description:	Visual Inspection – No Suspect Materials Found	
Identification:	N/A	
Approx. quantity:	N/A	
Accessibility	N/A	<i>Assessment Score</i>
Product type:		N/A
Extent of Damage:		N/A
Surface Treatment:		N/A
Asbestos type:		N/A
Material Assessment Score:		N/A
Priority Assessment Score:		N/A
Action:	N/A	
Comments:	No access within timber boxings

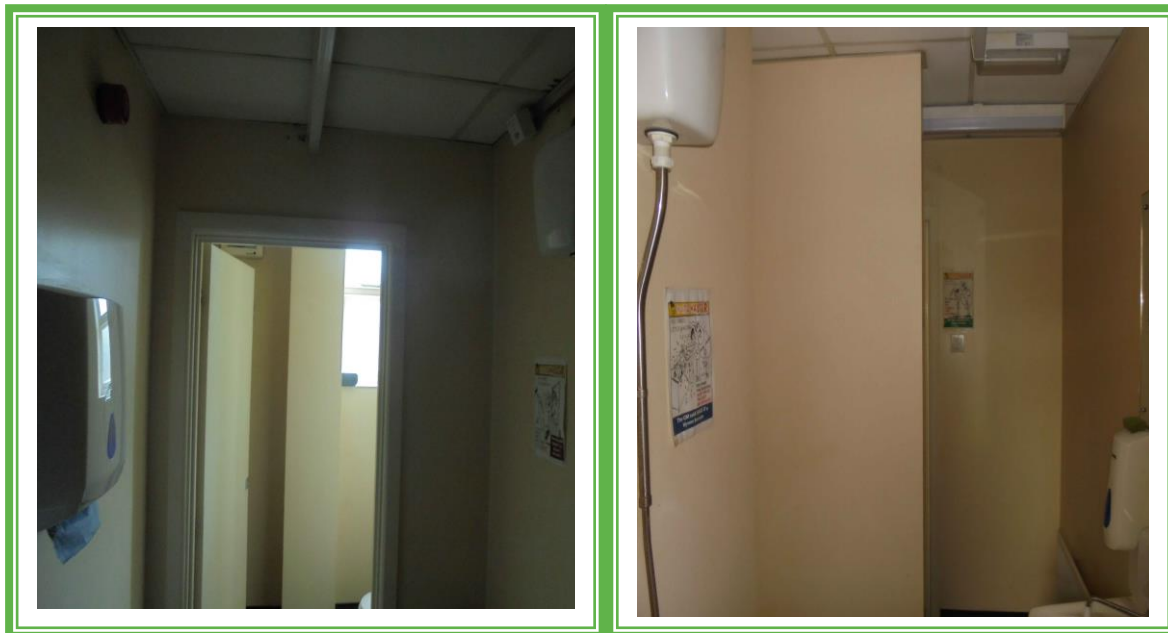
Location: WC – F07

Material Description:	Visual Inspection – No Suspect Materials Found	
Identification:	N/A	
Approx. quantity:	N/A	
Accessibility	N/A	<i>Assessment Score</i>
Product type:		N/A
Extent of Damage:		N/A
Surface Treatment:		N/A
Asbestos type:		N/A
Material Assessment Score:		N/A
Priority Assessment Score:		N/A
Action:	N/A	
Comments:	No access within timber boxings

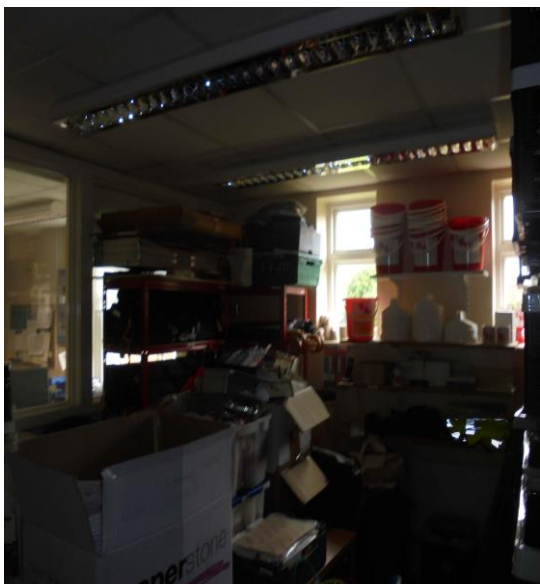
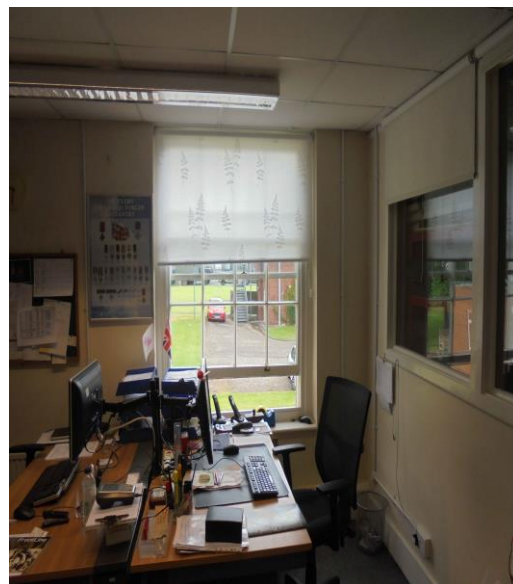
**Item No: 63****Sample No: N/A****Location: Rooms F06 & F06B**

Material Description:	Visual Inspection – No Suspect Materials Found	
Identification:	N/A	
Approx. quantity:	N/A	
Accessibility	N/A	<i>Assessment Score</i>
Product type:		N/A
Extent of Damage:		N/A
Surface Treatment:		N/A
Asbestos type:		N/A
Material Assessment Score:		N/A
Priority Assessment Score:		N/A
Action:	N/A	
Comments:	N/A

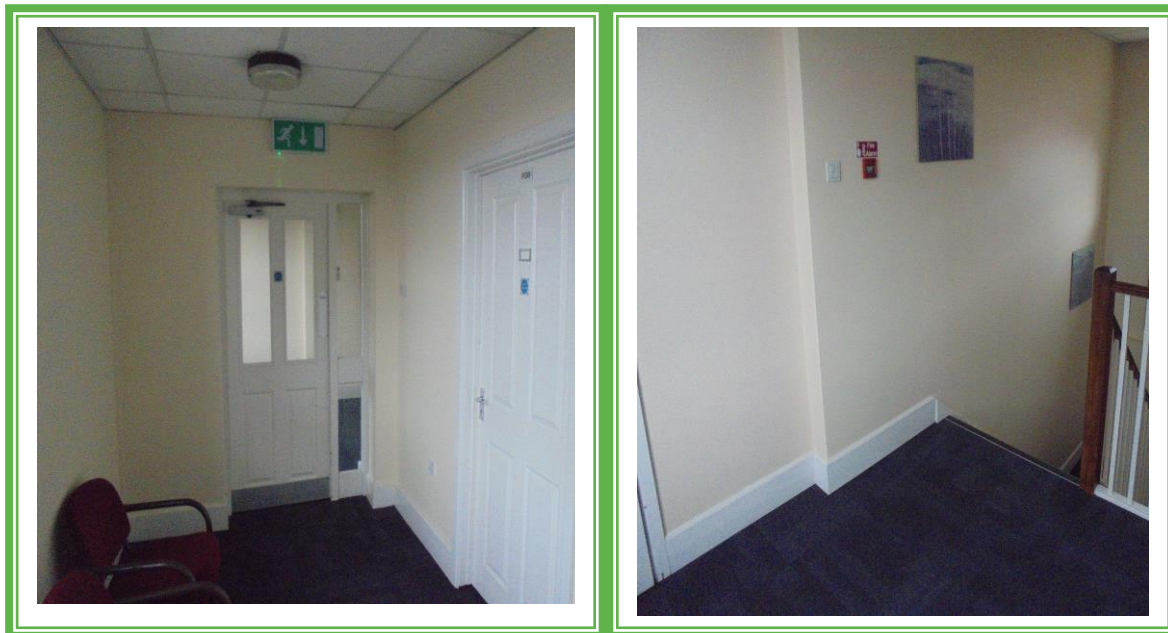
Location: Landing & Circulation – First Floor

Material Description:	Visual Inspection – No Suspect Materials Found	
Identification:	N/A	
Approx. quantity:	N/A	
Accessibility	N/A	<i>Assessment Score</i>
Product type:		N/A
Extent of Damage:		N/A
Surface Treatment:		N/A
Asbestos type:		N/A
Material Assessment Score:		N/A
Priority Assessment Score:		N/A
Action:	N/A	
Comments:	N/A

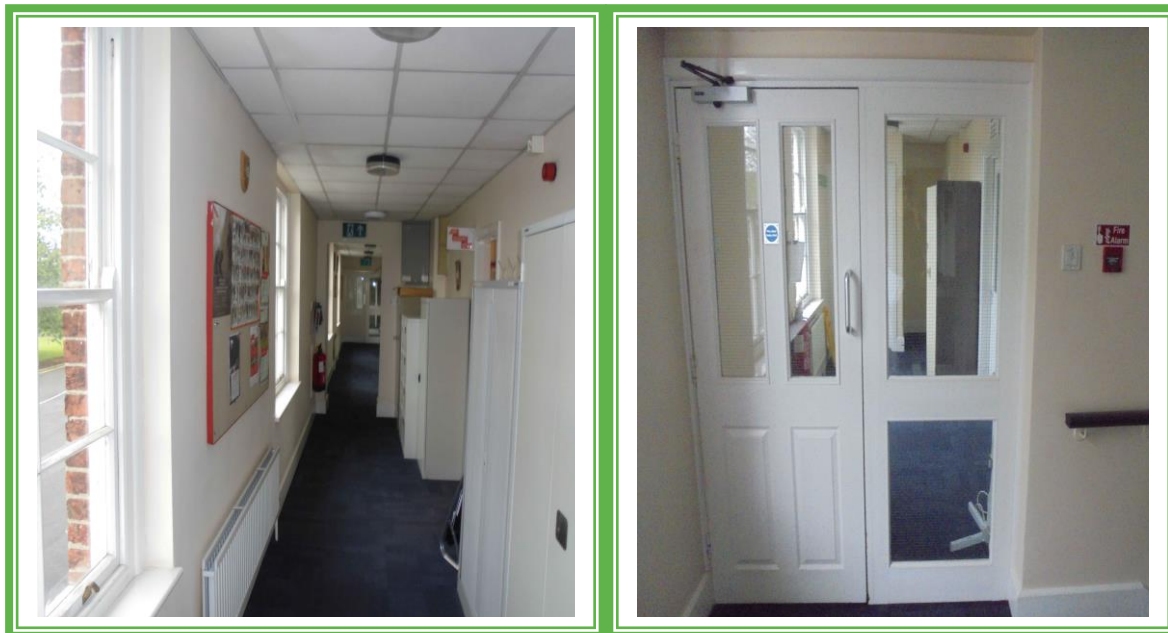
**Item No: 65****Sample No: N/A****Location: Circulations x 2 and Landing – First Floor**

Material Description:	Visual Inspection – No Suspect Materials Found	
Identification:	N/A	
Approx. quantity:	N/A	
Accessibility	N/A	<i>Assessment Score</i>
Product type:		N/A
Extent of Damage:		N/A
Surface Treatment:		N/A
Asbestos type:		N/A
Material Assessment Score:		N/A
Priority Assessment Score:		N/A
Action:	N/A	
Comments:	N/A

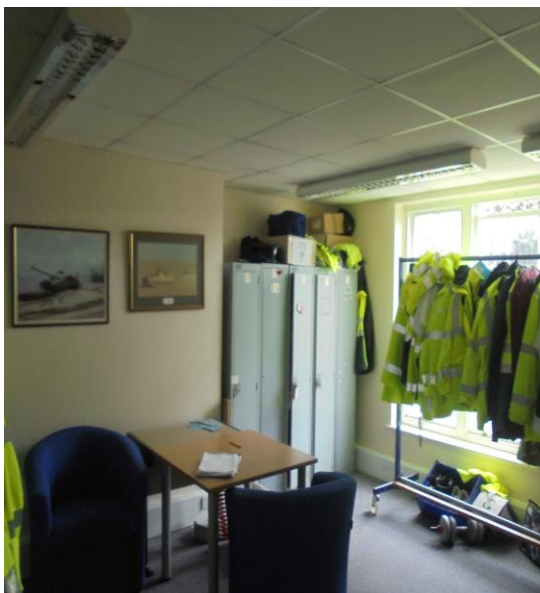
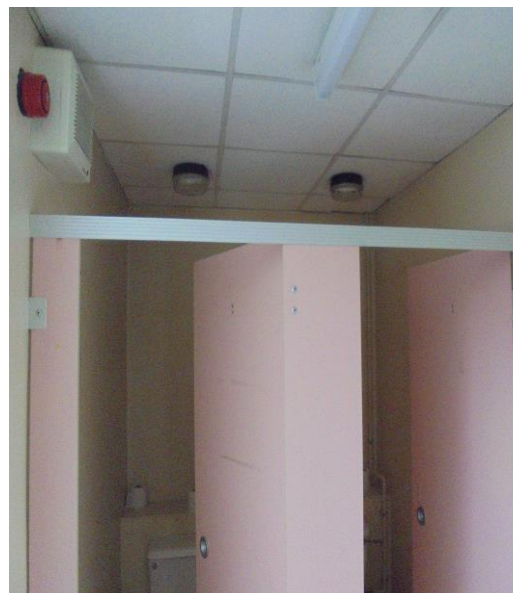
**Item No: 66****Sample No: N/A****Location: Locker Room F01 & WC**

Material Description:	Visual Inspection – No Suspect Materials Found	
Identification:	N/A	
Approx. quantity:	N/A	
Accessibility	N/A	<i>Assessment Score</i>
Product type:		N/A
Extent of Damage:		N/A
Surface Treatment:		N/A
Asbestos type:		N/A
Material Assessment Score:		N/A
Priority Assessment Score:		N/A
Action:	N/A	
Comments:	No access within timber boxings

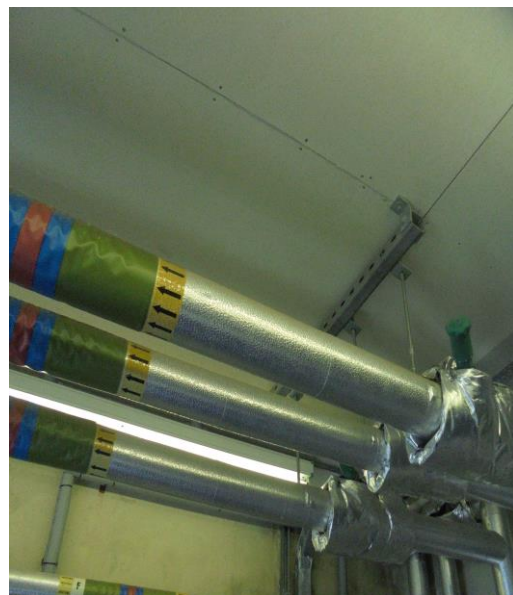
**Item No: 68****Sample No: DK/5****Location: Boiler Room**

Material Description:	Insulation Board Ceiling Tiles	
Identification:	Sampled – No Asbestos Detected	
Approx. quantity:	12M2	
Accessibility	N/A	<i>Assessment Score</i>
Product type:		N/A
Extent of Damage:		N/A
Surface Treatment:		N/A
Asbestos type:		N/A
Material Assessment Score:		N/A
Priority Assessment Score:		N/A
Action:	N/A	
Comments:	N/A

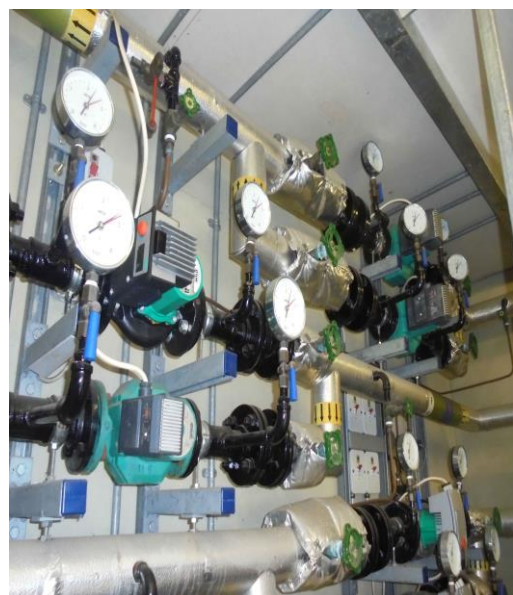
**Item No: 69****Sample No: DK/6****Location: Boiler Room**

Material Description:	Gaskets	
Identification:	Sampled – No Asbestos Detected	
Approx. quantity:	30+ Gaskets	
Accessibility	N/A	<i>Assessment Score</i>
Product type:		N/A
Extent of Damage:		N/A
Surface Treatment:		N/A
Asbestos type:		N/A
Material Assessment Score:		N/A
Priority Assessment Score:		N/A
Action:	N/A	
Comments:	N/A

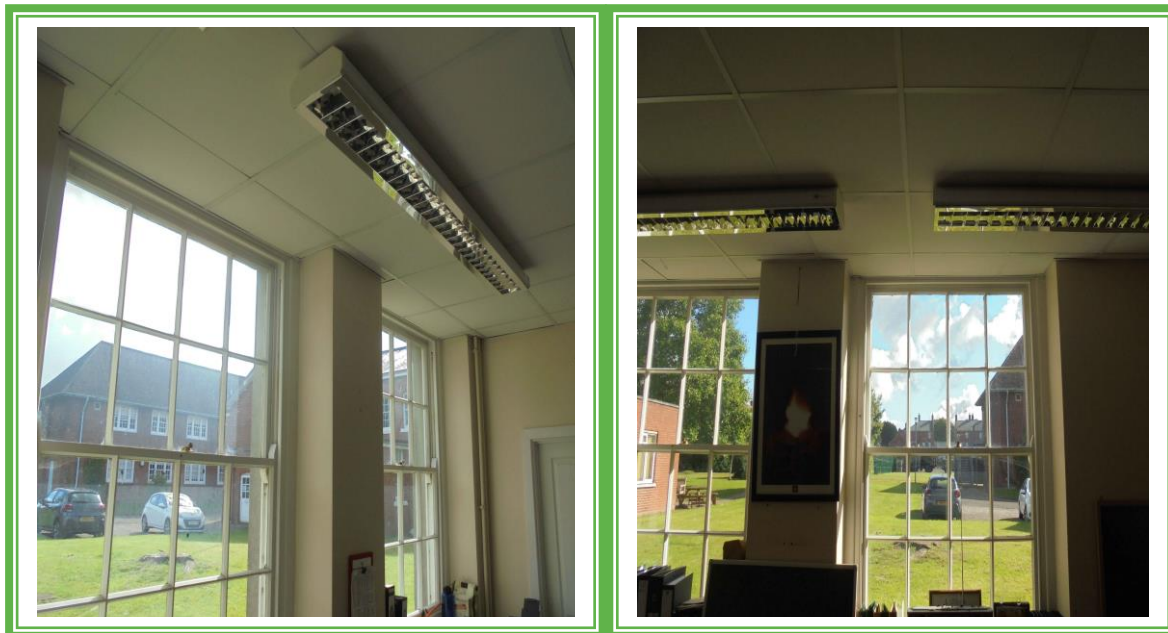
**Item No: 71****Sample No: N/A****Location: Rooms G14 & G15**

Material Description:	Visual Inspection – No Suspect Materials Found	
Identification:	N/A	
Approx. quantity:	N/A	
Accessibility	N/A	<i>Assessment Score</i>
Product type:		N/A
Extent of Damage:		N/A
Surface Treatment:		N/A
Asbestos type:		N/A
Material Assessment Score:		N/A
Priority Assessment Score:		N/A
Action:	N/A	
Comments:	N/A
