Project Number 2481

**Management
Asbestos Survey Report**

**Tiverton Platoon, King Street,
Devon, EX16 5JJ**

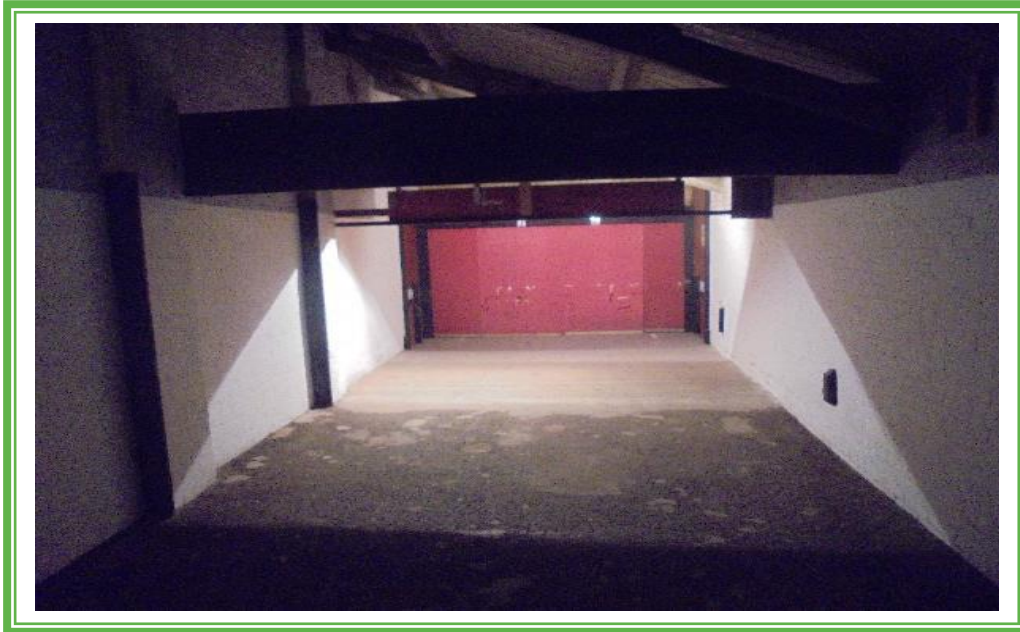
Location: Ground Floor - Firing Range

Material Description:	Visual Inspection – No Suspect Materials Found	
Identification:	N/A	
Approx. quantity:	N/A	
Accessibility	N/A	<i>Assessment Score</i>
Product type:		N/A
Extent of Damage:		N/A
Surface Treatment:		N/A
Asbestos type:		N/A
Material Assessment Score:		N/A
Priority Assessment Score:		N/A
Action:	N/A	
Comments:	N/A

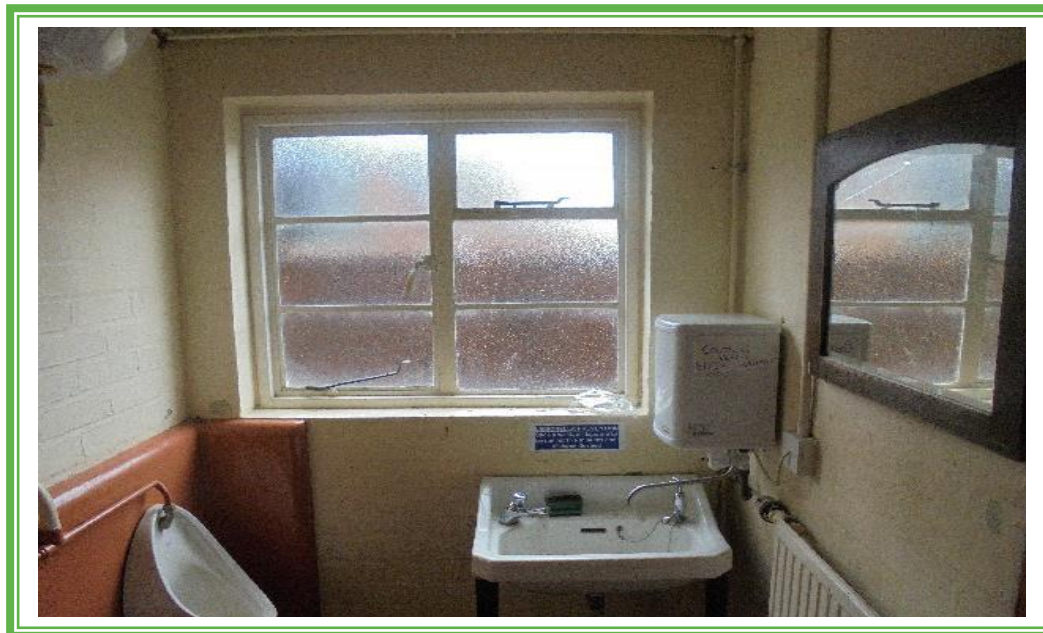
Location: Ground Floor – Washroom WC

Material Description:	Visual Inspection – No Suspect Materials Found	
Identification:	N/A	
Approx. quantity:	N/A	
Accessibility	N/A	<i>Assessment Score</i>
Product type:		N/A
Extent of Damage:		N/A
Surface Treatment:		N/A
Asbestos type:		N/A
Material Assessment Score:		N/A
Priority Assessment Score:		N/A
Action:	N/A	
Comments:	N/A

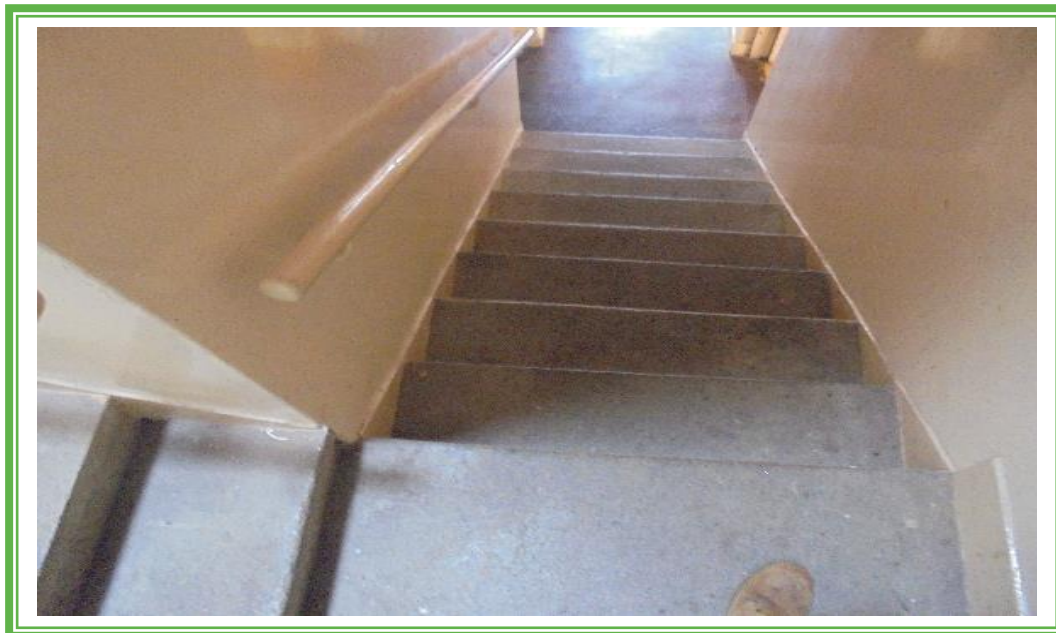
Location: First Floor - Stairwell

Material Description:	Visual Inspection – No Suspect Materials Found	
Identification:	N/A	
Approx. quantity:	N/A	
Accessibility	N/A	<i>Assessment Score</i>
Product type:		N/A
Extent of Damage:		N/A
Surface Treatment:		N/A
Asbestos type:		N/A
Material Assessment Score:		N/A
Priority Assessment Score:		N/A
Action:	N/A	
Comments:	N/A

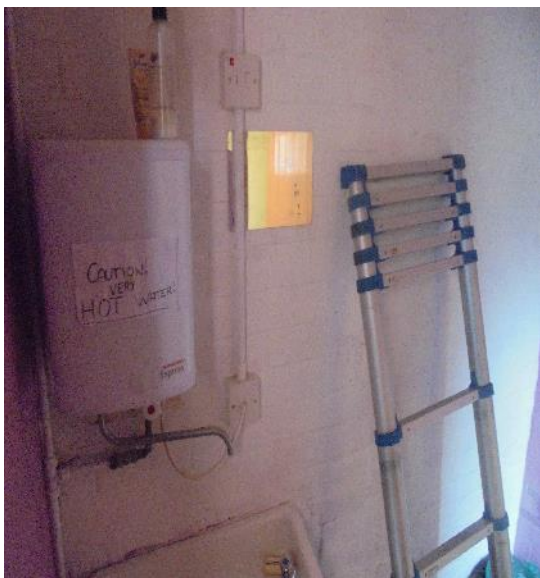
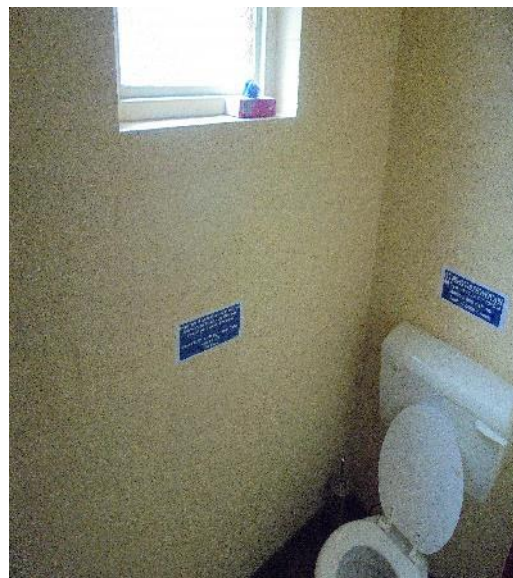
Location: Ground Floor – WC & Washroom

Material Description:	Visual Inspection – No Suspect Materials Found	
Identification:	N/A	
Approx. quantity:	N/A	
Accessibility	N/A	<i>Assessment Score</i>
Product type:		N/A
Extent of Damage:		N/A
Surface Treatment:		N/A
Asbestos type:		N/A
Material Assessment Score:		N/A
Priority Assessment Score:		N/A
Action:	N/A	
Comments:	N/A

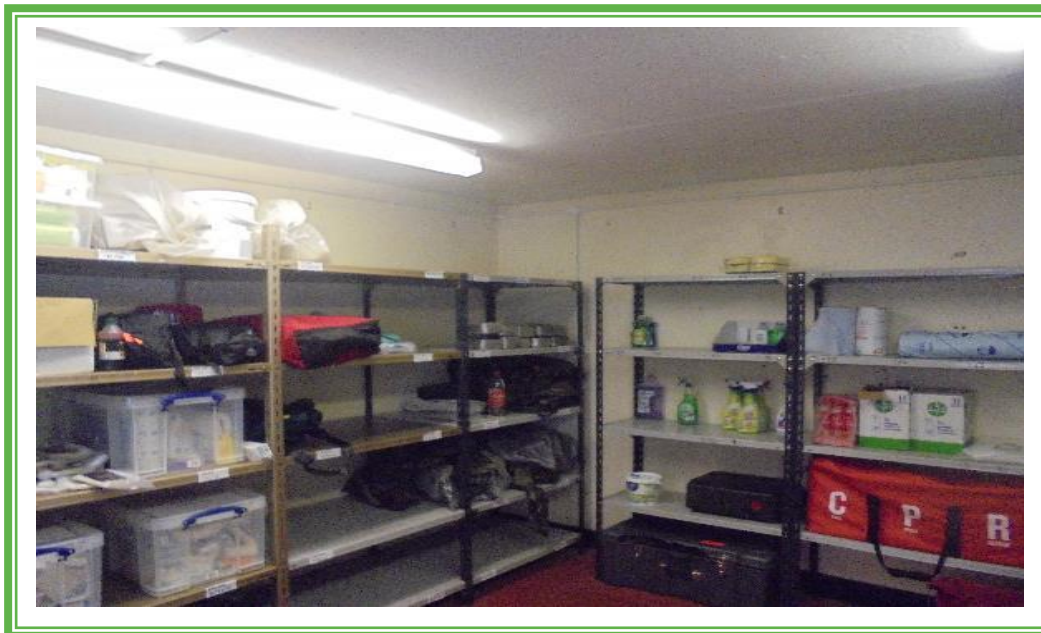
Location: Ground Floor - Store

Material Description:	Visual Inspection – No Suspect Materials Found	
Identification:	N/A	
Approx. quantity:	N/A	
Accessibility	N/A	<i>Assessment Score</i>
Product type:		N/A
Extent of Damage:		N/A
Surface Treatment:		N/A
Asbestos type:		N/A
Material Assessment Score:		N/A
Priority Assessment Score:		N/A
Action:	N/A	
Comments:	N/A

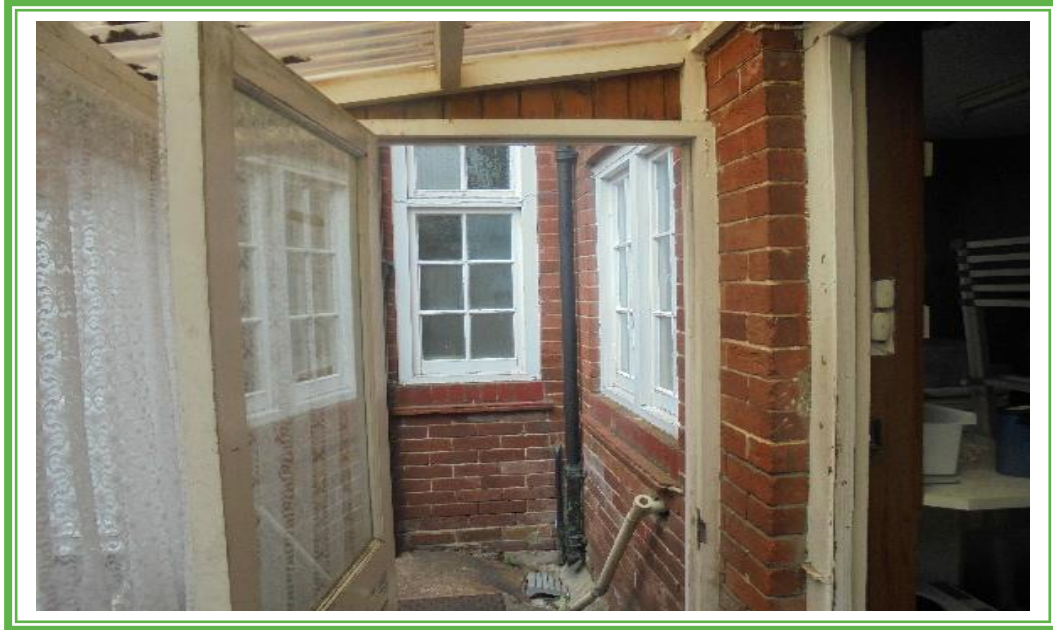
Location: Ground Floor - Lobby

Material Description:	Visual Inspection – No Suspect Materials Found	
Identification:	N/A	
Approx. quantity:	N/A	
Accessibility	N/A	<i>Assessment Score</i>
Product type:		N/A
Extent of Damage:		N/A
Surface Treatment:		N/A
Asbestos type:		N/A
Material Assessment Score:		N/A
Priority Assessment Score:		N/A
Action:	N/A	
Comments:	N/A

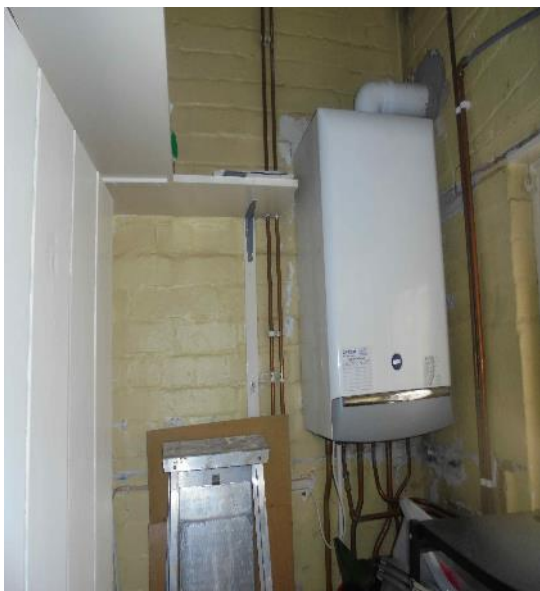
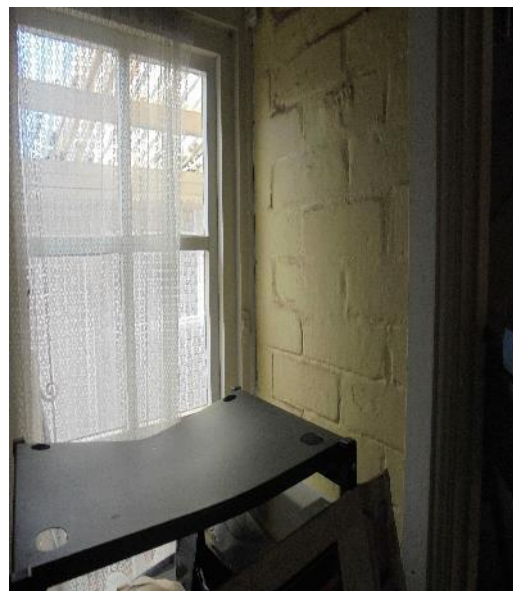
**Item No: 20****Sample No: N/A****Location: Ground Floor - Cupboard**

Material Description:	Visual Inspection – No Suspect Materials Found	
Identification:	N/A	
Approx. quantity:	N/A	
Accessibility	N/A	<i>Assessment Score</i>
Product type:		N/A
Extent of Damage:		N/A
Surface Treatment:		N/A
Asbestos type:		N/A
Material Assessment Score:		N/A
Priority Assessment Score:		N/A
Action:	N/A	
Comments:	Modern Baxi Boiler

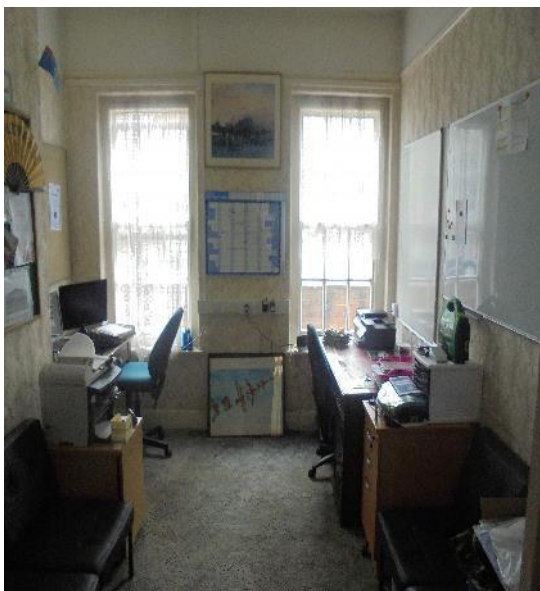
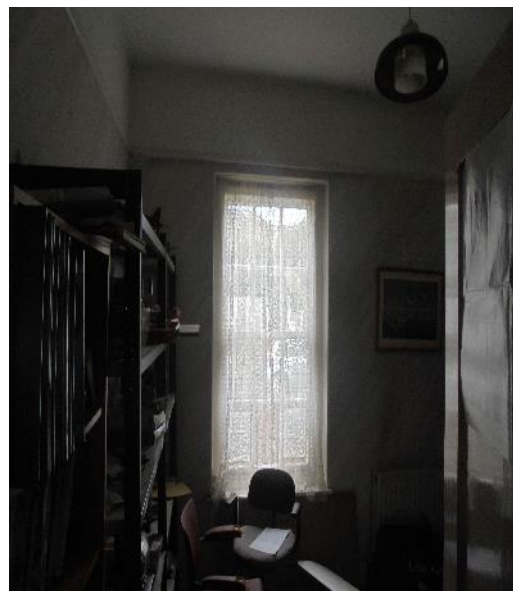
**Item No: 21****Sample No: N/A****Location: Ground Floor – Offices x2**

Material Description:	Visual Inspection – No Suspect Materials Found	
Identification:	N/A	
Approx. quantity:	N/A	
Accessibility	N/A	<i>Assessment Score</i>
Product type:		N/A
Extent of Damage:		N/A
Surface Treatment:		N/A
Asbestos type:		N/A
Material Assessment Score:		N/A
Priority Assessment Score:		N/A
Action:	N/A	
Comments:	N/A

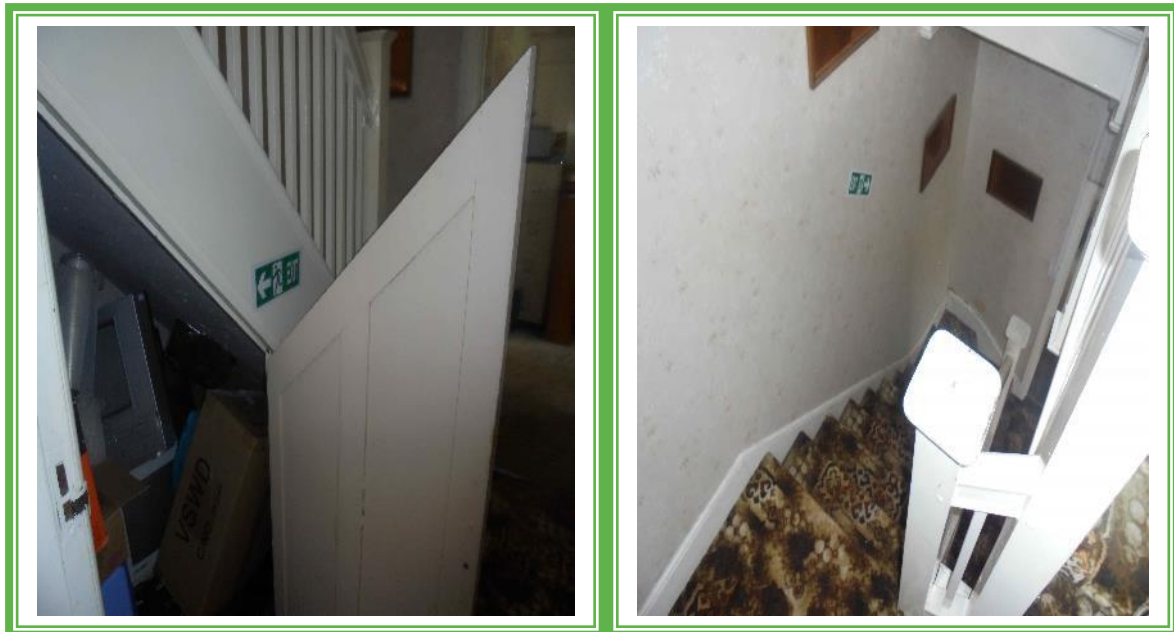
Location: Ground Floor – Circulation & Stairwell

Material Description:	Visual Inspection – No Suspect Materials Found	
Identification:	N/A	
Approx. quantity:	N/A	
Accessibility	N/A	<i>Assessment Score</i>
Product type:		N/A
Extent of Damage:		N/A
Surface Treatment:		N/A
Asbestos type:		N/A
Material Assessment Score:		N/A
Priority Assessment Score:		N/A
Action:	N/A	
Comments:	Limited access under stairs due to stored items

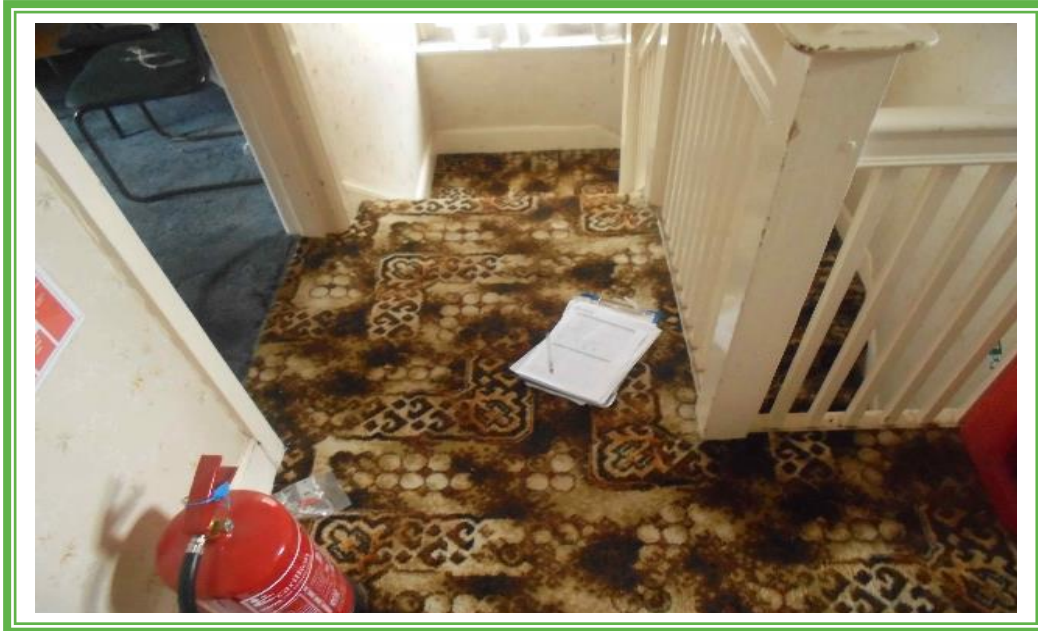
Location: First Floor - Landing

Material Description:	Visual Inspection – No Suspect Materials Found	
Identification:	N/A	
Approx. quantity:	N/A	
Accessibility	N/A	<i>Assessment Score</i>
Product type:		N/A
Extent of Damage:		N/A
Surface Treatment:		N/A
Asbestos type:		N/A
Material Assessment Score:		N/A
Priority Assessment Score:		N/A
Action:	N/A	
Comments:	N/A

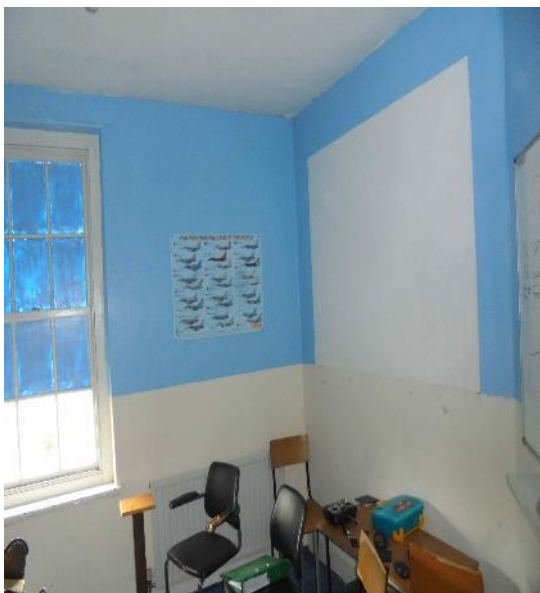
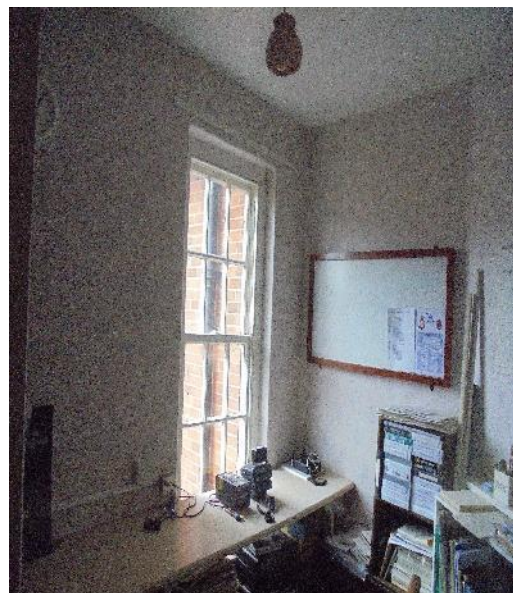
**Item No: 26****Sample No: N/A****Location: First Floor – Office x3**

Material Description:	Visual Inspection – No Suspect Materials Found	
Identification:	N/A	
Approx. quantity:	N/A	
Accessibility	N/A	<i>Assessment Score</i>
Product type:		N/A
Extent of Damage:		N/A
Surface Treatment:		N/A
Asbestos type:		N/A
Material Assessment Score:		N/A
Priority Assessment Score:		N/A
Action:	N/A	
Comments:	Non Asbestos lino under carpet to radio room

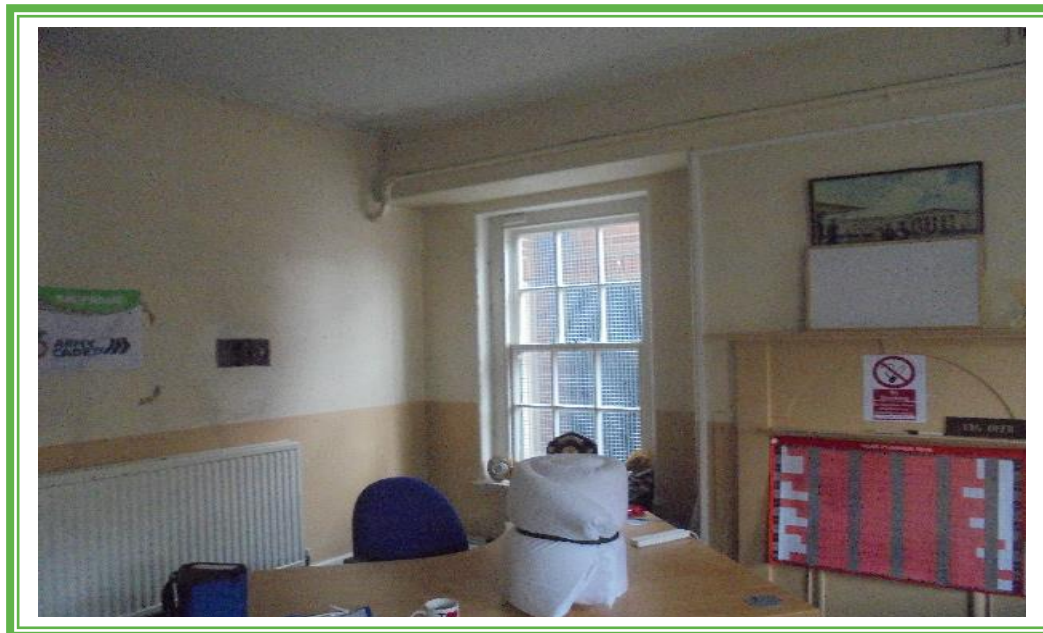
Location: Ground Floor - Office

Material Description:	Visual Inspection – No Suspect Materials Found	
Identification:	N/A	
Approx. quantity:	N/A	
Accessibility	N/A	<i>Assessment Score</i>
Product type:		N/A
Extent of Damage:		N/A
Surface Treatment:		N/A
Asbestos type:		N/A
Material Assessment Score:		N/A
Priority Assessment Score:		N/A
Action:	N/A	
Comments:	N/A

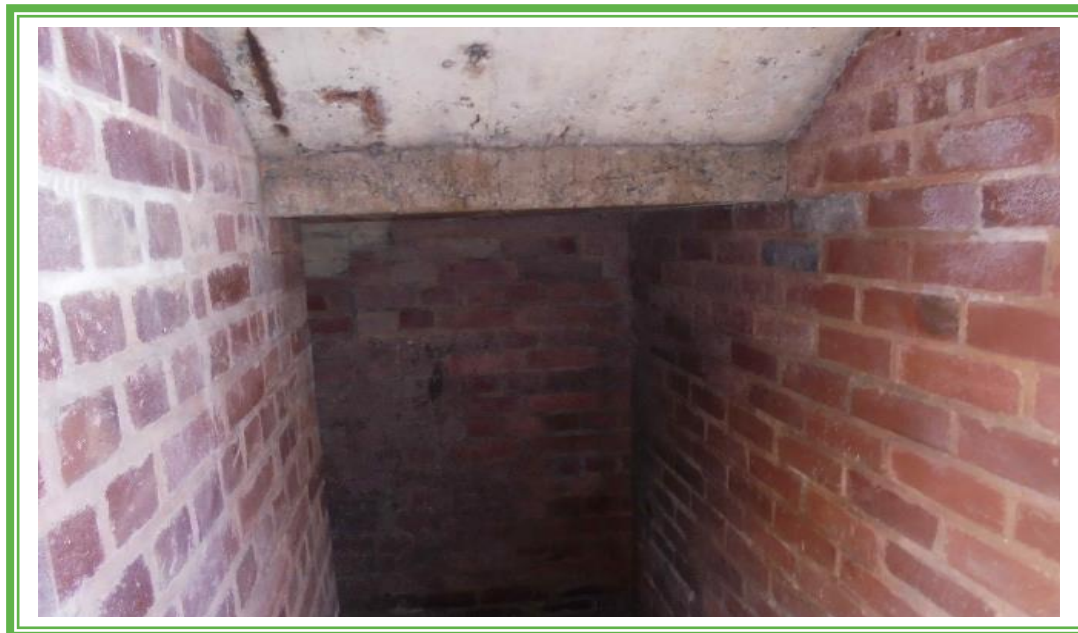
**Item No: 28****Sample No: N/A****Location: Ground Floor - Cupboard**

Material Description:	Visual Inspection – No Suspect Materials Found	
Identification:	N/A	
Approx. quantity:	N/A	
Accessibility	N/A	<i>Assessment Score</i>
Product type:		N/A
Extent of Damage:		N/A
Surface Treatment:		N/A
Asbestos type:		N/A
Material Assessment Score:		N/A
Priority Assessment Score:		N/A
Action:	N/A	
Comments:	N/A

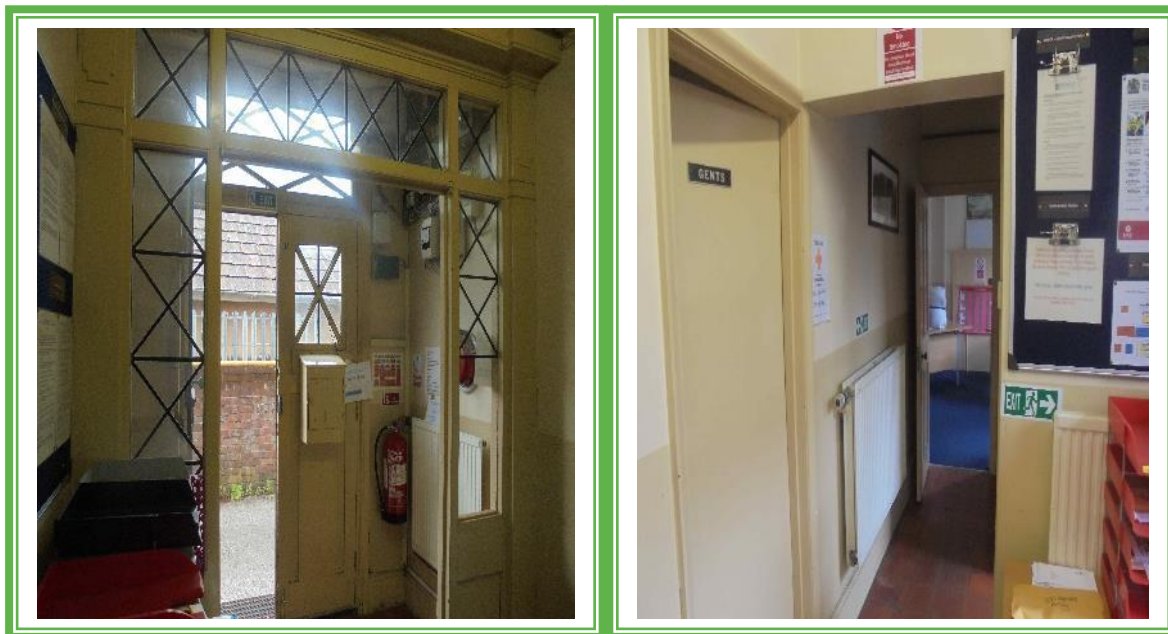
Location: Ground Floor – Lobby, Circulation & Cupboard

Material Description:	Visual Inspection – No Suspect Materials Found	
Identification:	N/A	
Approx. quantity:	N/A	
Accessibility	N/A	<i>Assessment Score</i>
Product type:		N/A
Extent of Damage:		N/A
Surface Treatment:		N/A
Asbestos type:		N/A
Material Assessment Score:		N/A
Priority Assessment Score:		N/A
Action:	N/A	
Comments:	Modern Electrics

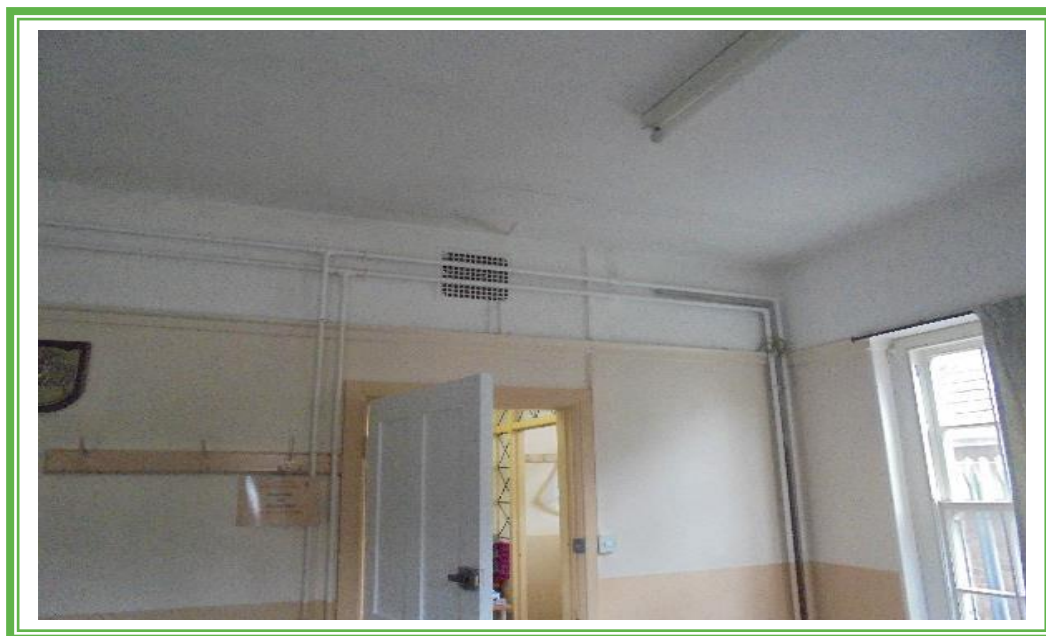
Location: Ground Floor - Office

Material Description:	Visual Inspection – No Suspect Materials Found	
Identification:	N/A	
Approx. quantity:	N/A	
Accessibility	N/A	<i>Assessment Score</i>
Product type:		N/A
Extent of Damage:		N/A
Surface Treatment:		N/A
Asbestos type:		N/A
Material Assessment Score:		N/A
Priority Assessment Score:		N/A
Action:	N/A	
Comments:	N/A

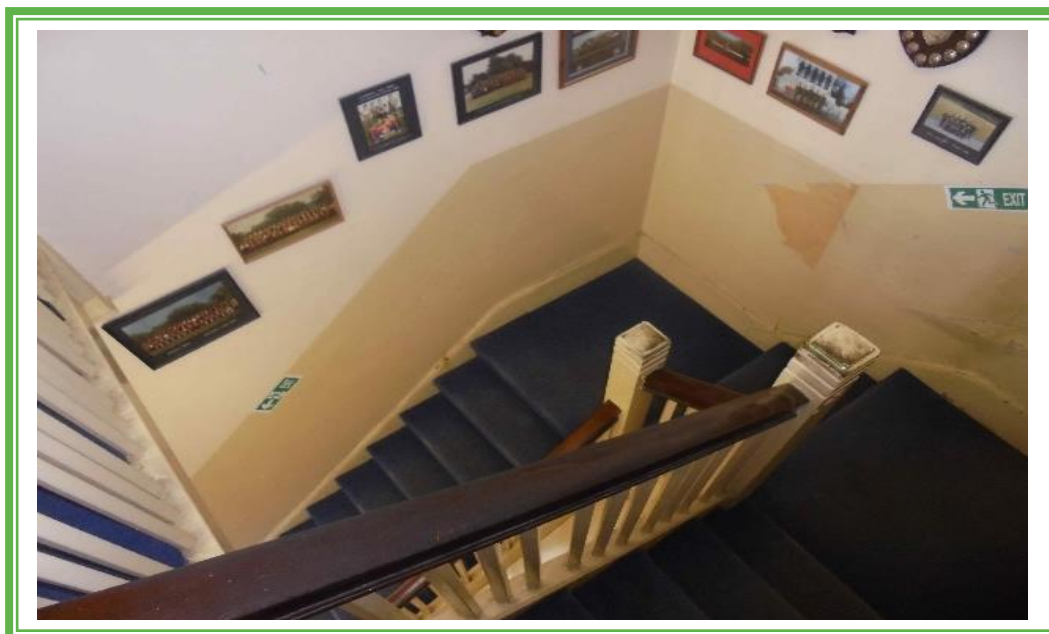
Location: First Floor – Stairwell & Lobby

Material Description:	Visual Inspection – No Suspect Materials Found	
Identification:	N/A	
Approx. quantity:	N/A	
Accessibility	N/A	<i>Assessment Score</i>
Product type:		N/A
Extent of Damage:		N/A
Surface Treatment:		N/A
Asbestos type:		N/A
Material Assessment Score:		N/A
Priority Assessment Score:		N/A
Action:	N/A	
Comments:	N/A

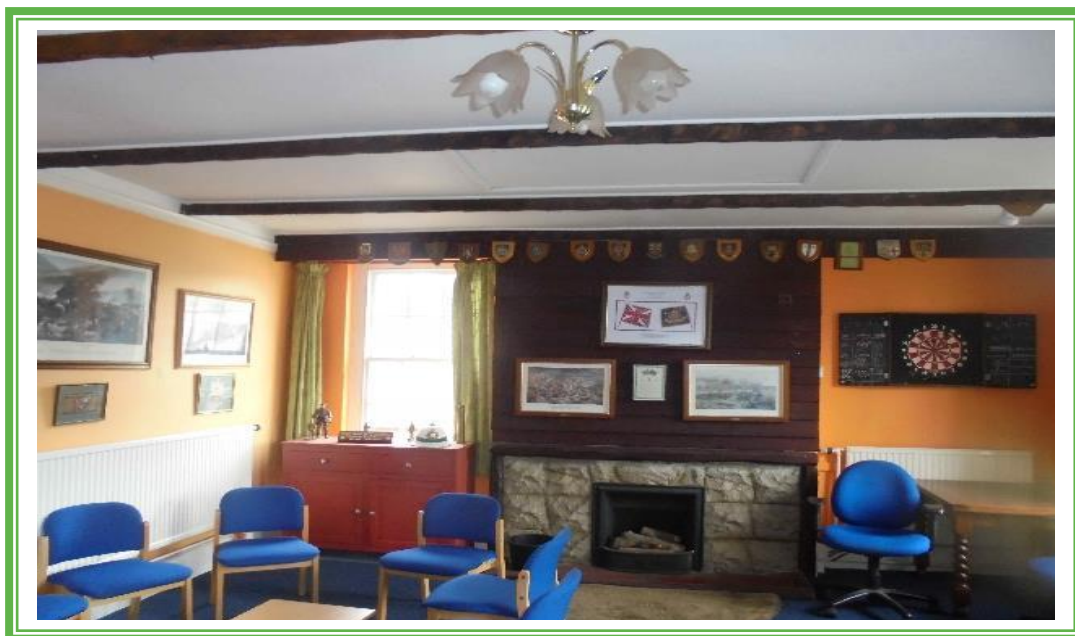
Location: First Floor – Mess Room

Material Description:	Visual Inspection – No Suspect Materials Found	
Identification:	N/A	
Approx. quantity:	N/A	
Accessibility	N/A	<i>Assessment Score</i>
Product type:		N/A
Extent of Damage:		N/A
Surface Treatment:		N/A
Asbestos type:		N/A
Material Assessment Score:		N/A
Priority Assessment Score:		N/A
Action:	N/A	
Comments:	Non-Asbestos Fiberboard ceiling panels

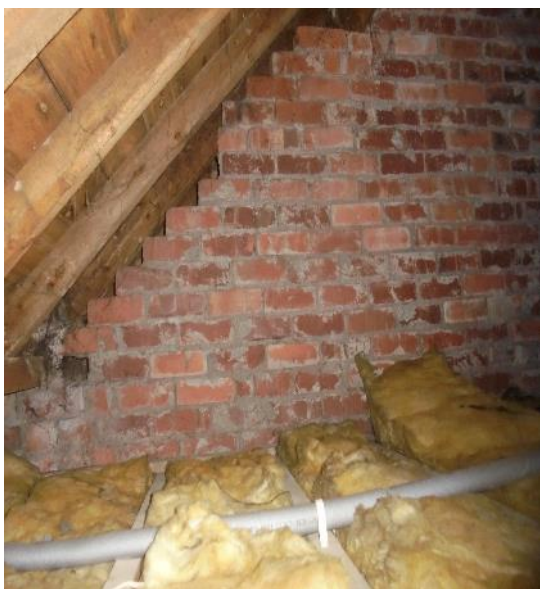
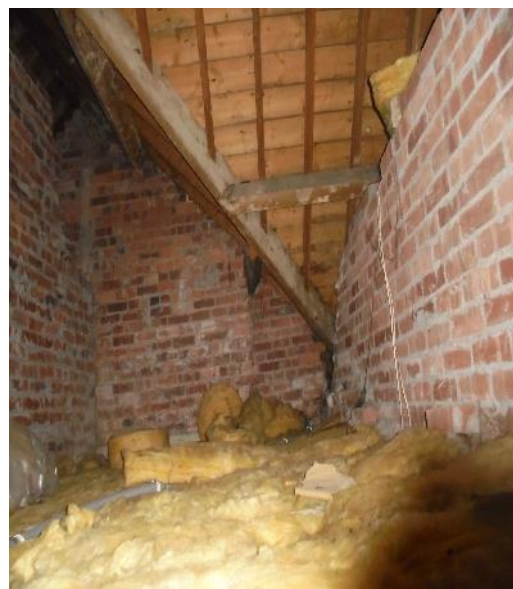
Location: Loft Space over Kitchen

Material Description:	Visual Inspection – No Suspect Materials Found	
Identification:	N/A	
Approx. quantity:	N/A	
Accessibility	N/A	<i>Assessment Score</i>
Product type:		N/A
Extent of Damage:		N/A
Surface Treatment:		N/A
Asbestos type:		N/A
Material Assessment Score:		N/A
Priority Assessment Score:		N/A
Action:	N/A	
Comments:	N/A

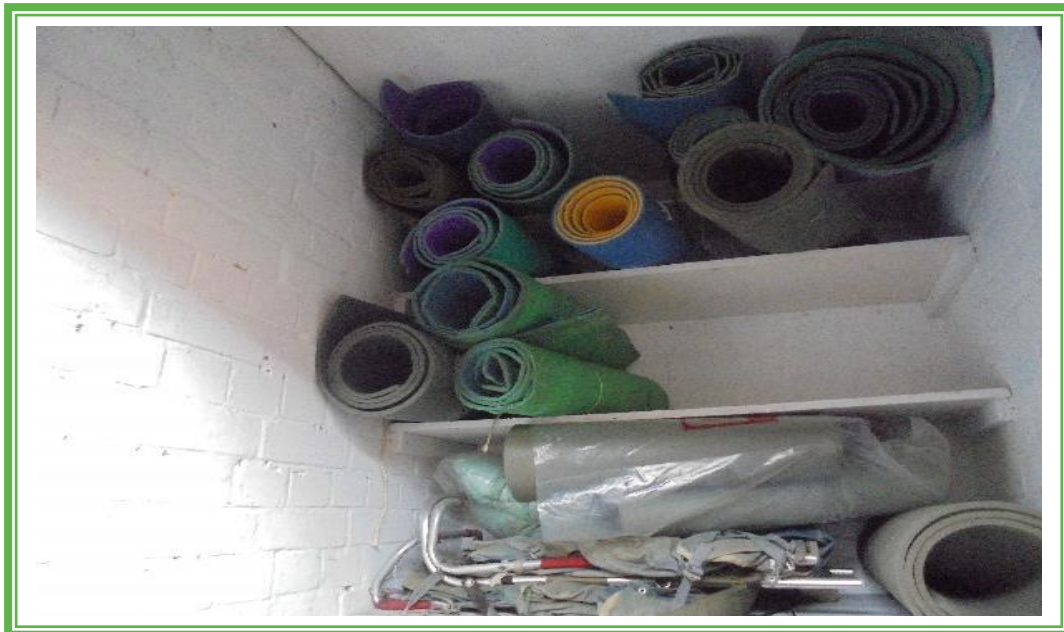
Location: Ground Floor - Cupboard

Material Description:	Visual Inspection – No Suspect Materials Found	
Identification:	N/A	
Approx. quantity:	N/A	
Accessibility	N/A	<i>Assessment Score</i>
Product type:		N/A
Extent of Damage:		N/A
Surface Treatment:		N/A
Asbestos type:		N/A
Material Assessment Score:		N/A
Priority Assessment Score:		N/A
Action:	N/A	
Comments:	Limited access into cupboard due to stored items
