Project Number A-00524 (5435)

**Re-Inspection
Asbestos Survey Report - Revised**

**6th Battalion the Rifles
C Company (Poole Detachment)
Dorset
BH12 5AD**

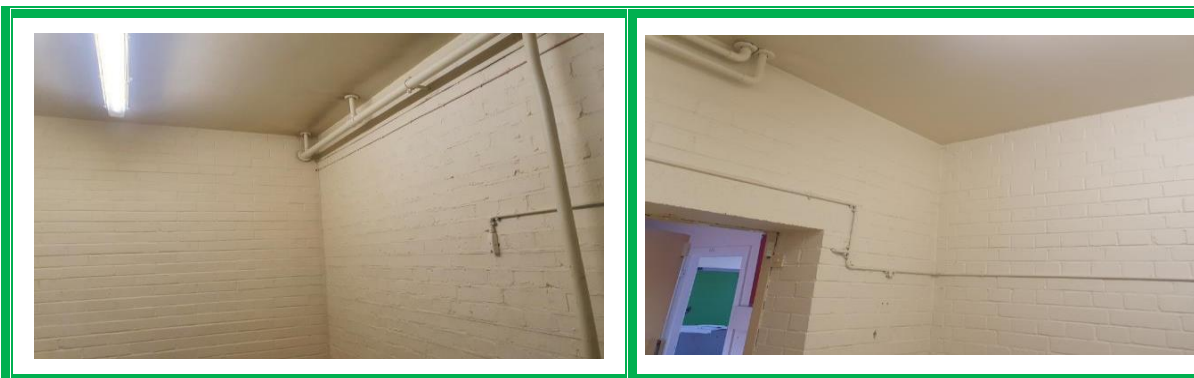
Item No:	11	Sample No:	N/A
Location:	Ground Floor - Main Building 1 - Armoury and Ammo Stores 0.29, 0.30 and 0.31 011

Material Description:	No Suspect Materials Found	
Identification:	N/A	
Approx. quantity:	N/A	
Accessibility	N/A	<i>Assessment Score</i>
Product type:	N/A	N/A
Extent of Damage:	N/A	N/A
Surface Treatment:	N/A	N/A
Asbestos type:	N/A	N/A
Material Assessment Score:		N/A
Priority Assessment Score:		N/A
Action:	N/A	
Comments:	Previously not accessed rooms. Now accessed and no asbestos found

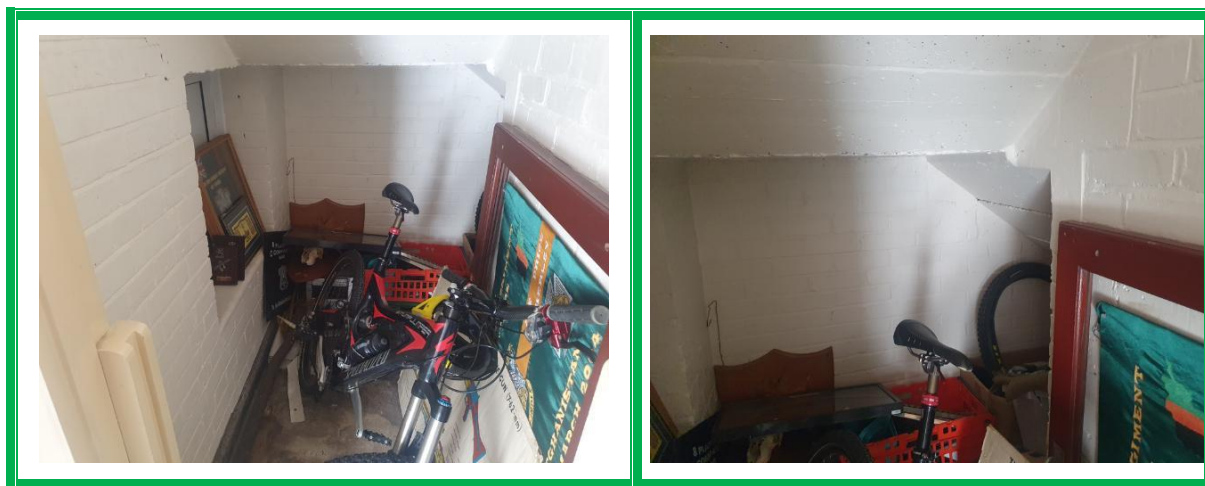
Location: Ground Floor - Main Building - Under Stairs
Cupboard 012

Material Description:	No Suspect Materials Found	
Identification:	N/A	
Approx. quantity:	N/A	
Accessibility	N/A	<i>Assessment Score</i>
Product type:	N/A	N/A
Extent of Damage:	N/A	N/A
Surface Treatment:	N/A	N/A
Asbestos type:	N/A	N/A
Material Assessment Score:		N/A
Priority Assessment Score:		N/A
Action:	N/A	
Comments:	Room previously not accessed. Now accessed and no asbestos found

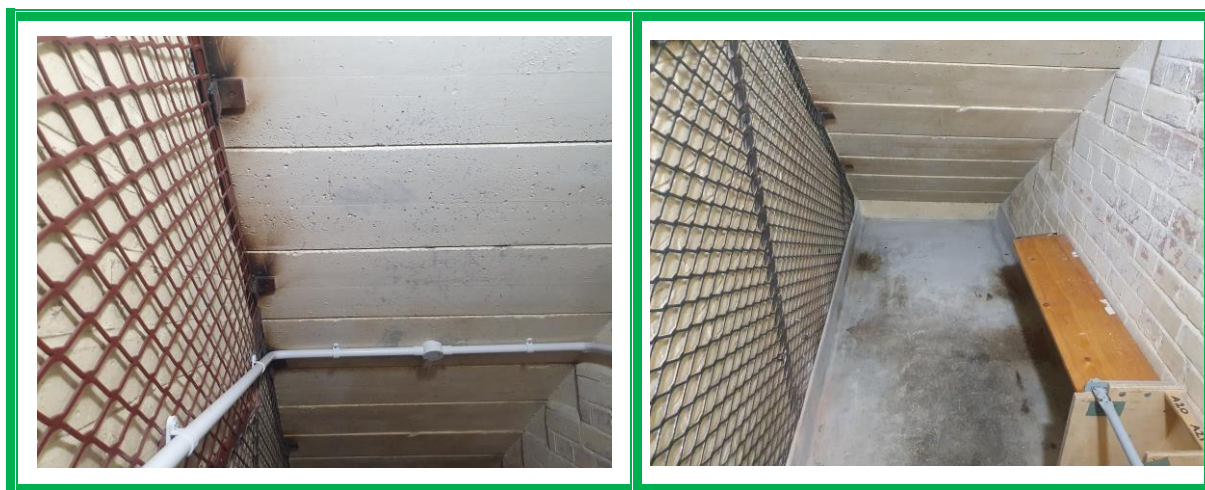
Location: Ground Floor – Armour Cupboard 016

Material Description:	No Suspect Materials Found	
Identification:	N/A	
Approx. quantity:	N/A	
Accessibility	N/A	<i>Assessment Score</i>
Product type:	N/A	N/A
Extent of Damage:	N/A	N/A
Surface Treatment:	N/A	N/A
Asbestos type:	N/A	N/A
Material Assessment Score:		N/A
Priority Assessment Score:		N/A
Action:	N/A	
Comments:	Room previously not accessed, now accessed. No asbestos found

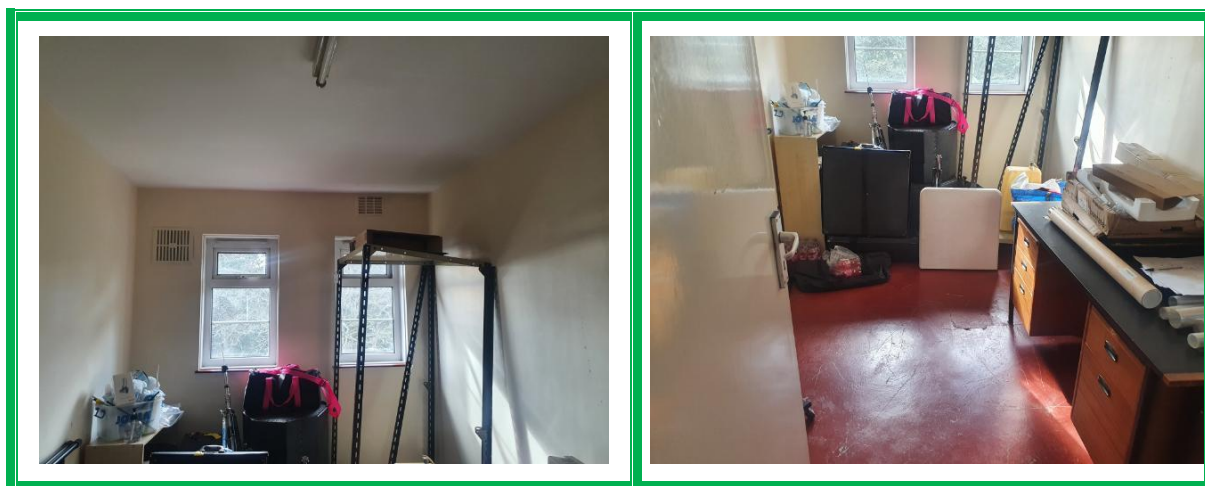
Location: First Floor - Main Building - Room 1.26 020

Material Description:	No Suspect Materials Found	
Identification:	N/A	
Approx. quantity:	N/A	
Accessibility	N/A	<i>Assessment Score</i>
Product type:	N/A	N/A
Extent of Damage:	N/A	N/A
Surface Treatment:	N/A	N/A
Asbestos type:	N/A	N/A
Material Assessment Score:		N/A
Priority Assessment Score:		N/A
Action:	N/A	
Comments:	Room previously not accessed. Now accessed and no asbestos found

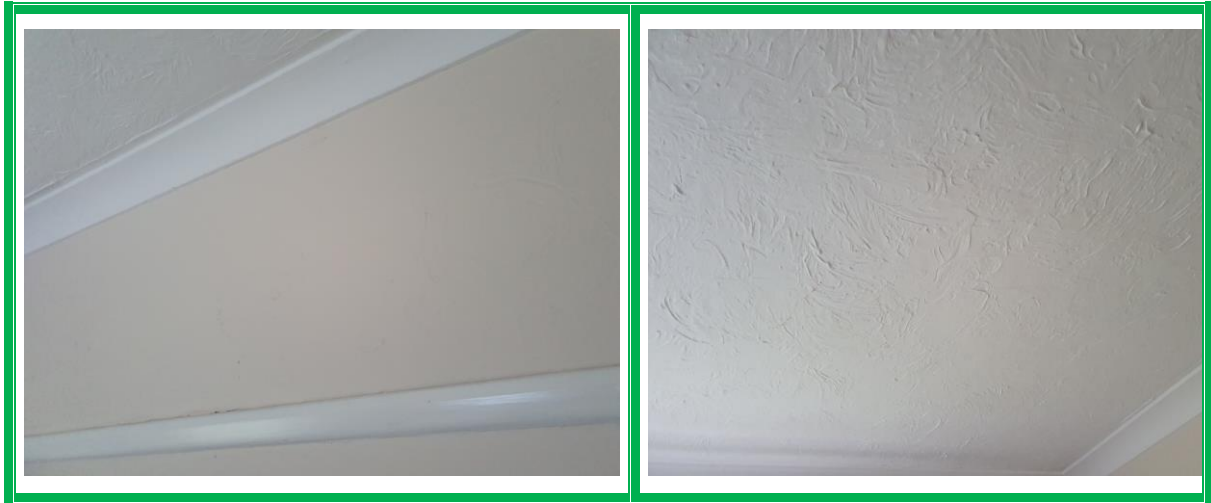
Location: Building 8 Living and Dining Room 039

Material Description:	Sampled – No Asbestos Detected	
Identification:	N/A	
Approx. quantity:	N/A	
Accessibility	N/A	<i>Assessment Score</i>
Product type:	N/A	N/A
Extent of Damage:	N/A	N/A
Surface Treatment:	N/A	N/A
Asbestos type:	N/A	N/A
Material Assessment Score:		N/A
Priority Assessment Score:		N/A
Action:	N/A	
Comments:	Previously a no access area, now accessed. No asbestos found.

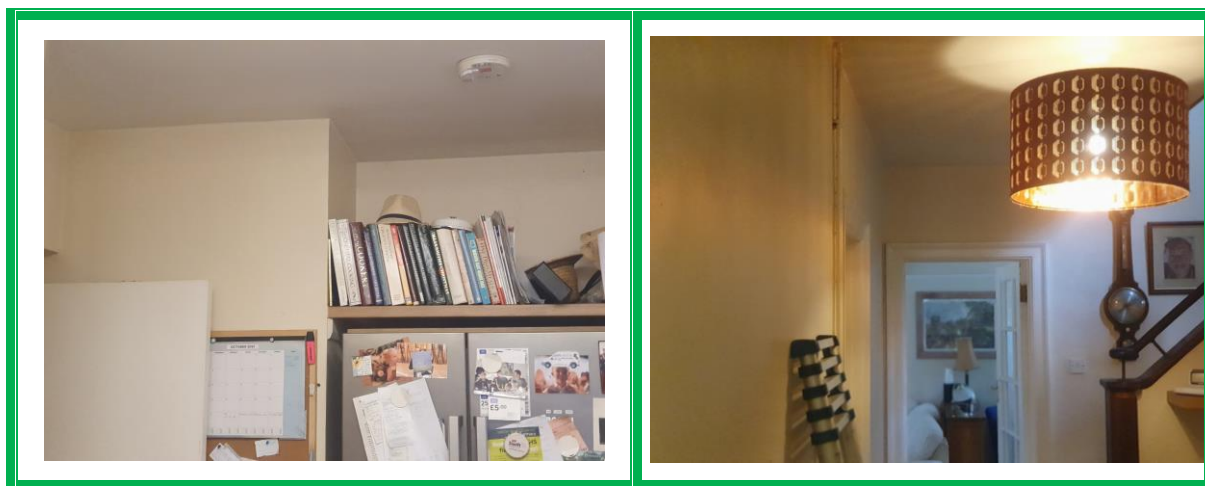
Location: Building 8 GF Kitchen, Hall, WC and Cupboards 040

Material Description:	No Asbestos Suspected	
Identification:	N/A	
Approx. quantity:	N/A	
Accessibility	N/A	<i>Assessment Score</i>
Product type:	N/A	N/A
Extent of Damage:	N/A	N/A
Surface Treatment:	N/A	N/A
Asbestos type:	N/A	N/A
Material Assessment Score:		N/A
Priority Assessment Score:		N/A
Action:	N/A	
Comments:	Previously a no access area, now accessed. No asbestos found.

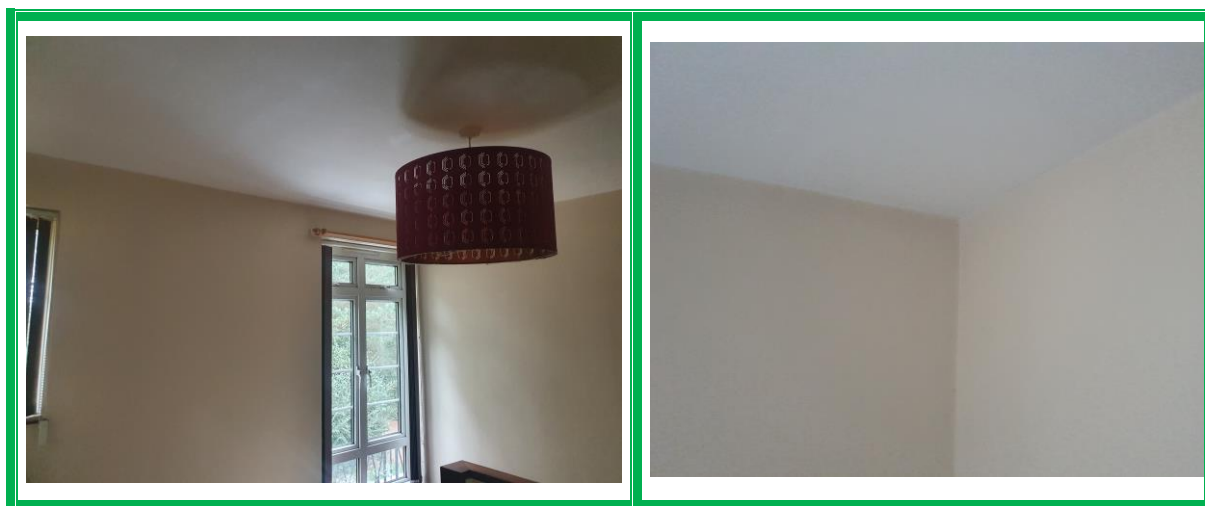
Location: Building 8 First Floor All Rooms 041

Material Description:	No Asbestos Suspected	
Identification:	N/A	
Approx. quantity:	N/A	
Accessibility	N/A	<i>Assessment Score</i>
Product type:	N/A	N/A
Extent of Damage:	N/A	N/A
Surface Treatment:	N/A	N/A
Asbestos type:	N/A	N/A
Material Assessment Score:		N/A
Priority Assessment Score:		N/A
Action:	N/A	
Comments:	Previously a no access area, now accessed. No asbestos found.
