## LEGIONELLA RISK ASSESSMENT

<b>Client:</b>	Wessex RFCA
<b>Site:</b>	ARC Dorchester
<b>Address:</b>	Poundbury Road, Dorchester, DT1 1SL
<b>Risk Rating:</b>	Medium
<b>Report Ref:</b>	AQRA/AQST/LRA/087
<b>Surveyed By:</b>	Jon Barton
<b>Survey Date:</b>	7 <sup>th</sup> August 2023
<b>Report Date:</b>	10 <sup>th</sup> August 2023
<b>Recommended Review Date:</b>	August 2025

### 6.1 MAINS WATER SUPPLY REPORT

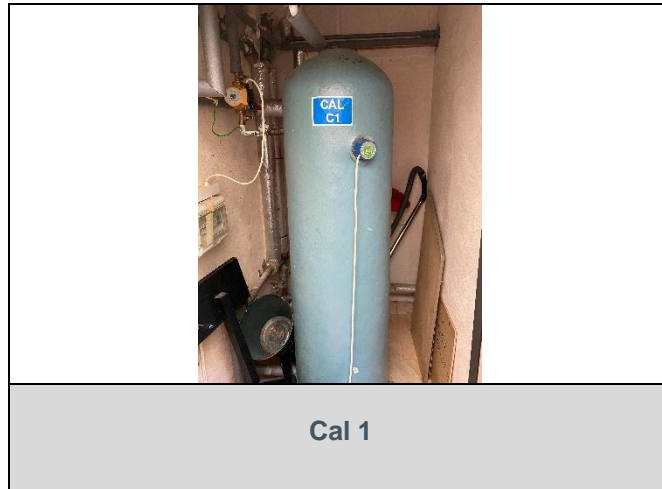
HWSV Ref : Cal 2

Actioned date:	Company/initials:	
<b>HOT WATER CALORIFIERS:</b>		
	Cal 2 (boiler room) was not on during the survey, resulting in no hot water at associated outlets. This is due to the boilers supplying the heat source not being operational. There is an immersion within the vessel which is not operational. Repair the boilers and/or replace the immersion heater to ensure water is stored at 60.C.	High
Actioned date:	Company/initials:	
	Cal 1 storage temperature slightly below 60.C (50.C). Increase to 60. C.	Medium
Actioned date:	Company/initials:	
<b>POINT OF USE WATER HEATERS:</b>		
	Satisfactory	
<b>SHOWERS AND SPRAY OUTLETS:</b>		
	Satisfactory	
<b>GENERAL: Control Schemes</b>		
	Ensure a responsible person is appointed, has received Legionella training, and audits the logbook annually	High
Actioned date:	Company/initials:	
	Replace flexible hoses with hard copper	Low
Actioned date:	Company/initials:

### Comments/Recommendations:

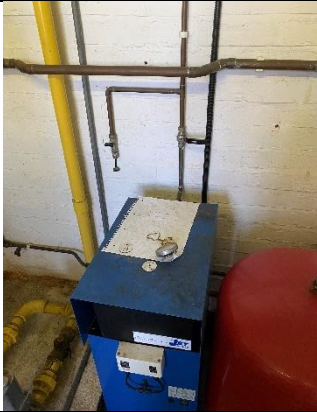
<p>Pressurisation unit and quick fill</p>	<p>Management chart within site logbook</p>
