LEGIONELLA RISK ASSESSMENT

Client:	Wessex RFCA		
Site:	Wyvern Barracks Building 3		
Address:	Wyvern Barracks, Barrack Road, Exeter, EX2 6AR		
Risk Rating:	Medium		
Report Ref:	AQST/LRA/331		
Surveyed By:	Jon Barton		
Survey Date:	11 th -13 th March 2024		
Report Date:	15 th March 2024		
Recommended Review Date:	March 2026

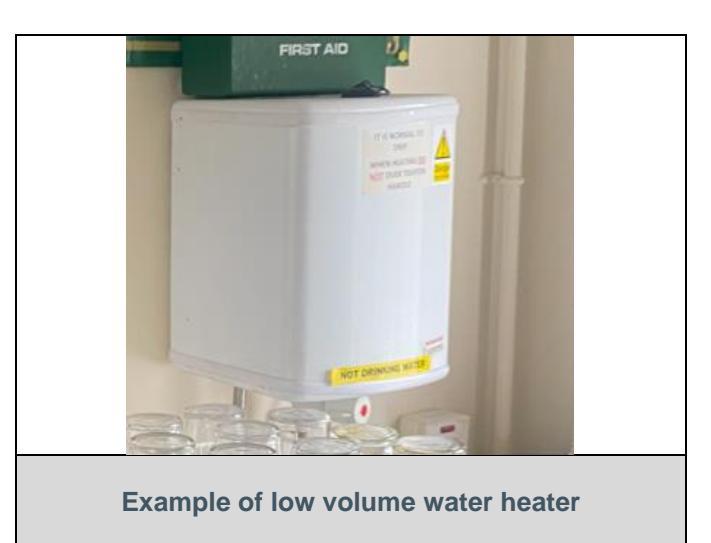
<u>6.7</u> **POINT OF USE WATER HEATERS**

EXPANSIO	N VESSEL INFO
Water	Location	Make/model and capacity	Mains or	Full clean	Is there a	If yes – make model
Heater		of each heater	tank fed	possible	pressure vessel	and size and
					– Yes/No	whether fitted
ID						horizontally or
Number						vertically
1	GF male WC	Sadia 7	Mains	No	No	-
2	GF female WC	Santon 7	Mains	No	No	-
3	GF bar	Santon 7	Mains	No	No	-
