**Project Number 3700**

**Re-Inspection  
Asbestos Survey Report - Revised**

**675 Army Air Corps  
Somerset  
TA1 5LJ**

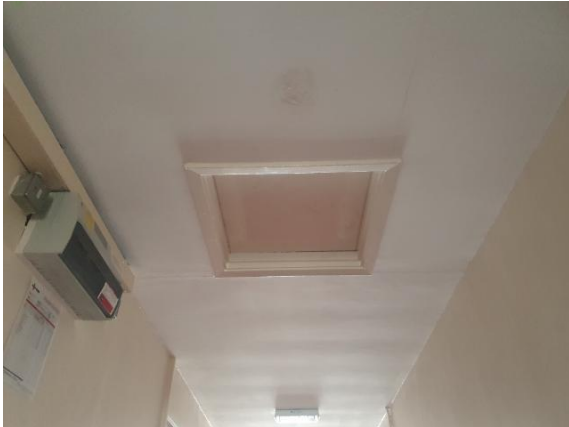
**Location:** First Floor - Loft Space above Corridor 007

<b>Material Description:</b>	Panel to Door - Insulating Board	
<b>Identification:</b>	Previously Sampled - Asbestos Detected	
<b>Approx. quantity:</b>	1 m <sup>2</sup>	
<b>Accessibility</b>	Difficult	<i>Assessment Score</i>
<b>Product type:</b>	Asbestos Insulating Board	2
<b>Extent of Damage:</b>	Slight / minor damage	1
<b>Surface Treatment:</b>	Unsealed AIB	2
<b>Asbestos type:</b>	Amosite	2
<b>Material Assessment Score:</b>		7
<b>Priority Assessment Score:</b>		Medium
<b>Action:</b>	Further Investigation Needed	
<b>Comments:</b>	No safe access to inspect. Panel is visible from the hatch

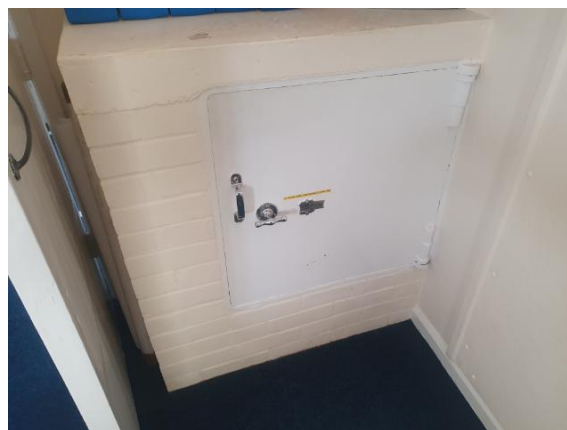
**Location:** First Floor - CEO Office 012

<b>Material Description:</b>	Safe - Insulating Board	
<b>Identification:</b>	Presumed to Contain Asbestos	
<b>Approx. quantity:</b>	1 no	
<b>Accessibility</b>	Difficult	<i>Assessment Score</i>
<b>Product type:</b>	Asbestos Insulating Board	2
<b>Extent of Damage:</b>	Major damage	3
<b>Surface Treatment:</b>	Unsealed Insulation	3
<b>Asbestos type:</b>	Amosite, Chrysotile	2
<b>Material Assessment Score:</b>		10
<b>Priority Assessment Score:</b>		High
<b>Action:</b>	Manage	
<b>Comments:</b>	No access within safe casings without damaging safe

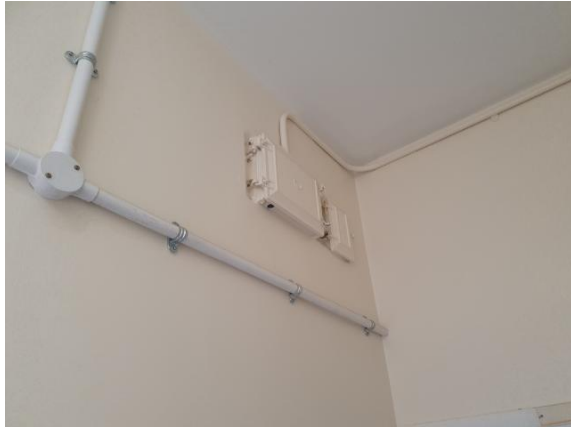
**Location:** First Floor - Landing/Corridor 014

<b>Material Description:</b>	Components within Electrical Boxes - Woven Product	
<b>Identification:</b>	Presumed to Contain Asbestos	
<b>Approx. quantity:</b>	2 no	
<b>Accessibility</b>	Difficult	<i>Assessment Score</i>
<b>Product type:</b>	Rope	2
<b>Extent of Damage:</b>	Major damage	3
<b>Surface Treatment:</b>	Unsealed Insulation	3
<b>Asbestos type:</b>	Chrysotile	1
<b>Material Assessment Score:</b>		9
<b>Priority Assessment Score:</b>		N/A
<b>Action:</b>	Manage	
<b>Comments:</b>	No access within live boxes

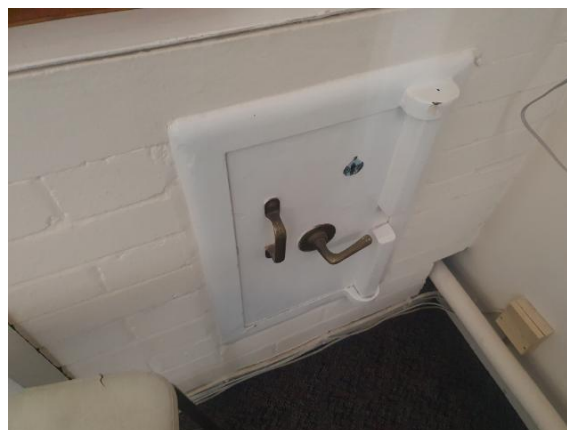
**Location:** Ground Floor - Office 019

<b>Material Description:</b>	Safe - Insulating Board	
<b>Identification:</b>	Presumed to Contain Asbestos	
<b>Approx. quantity:</b>	1 no	
<b>Accessibility</b>	Difficult	Assessment Score
<b>Product type:</b>	Asbestos Insulating Board	2
<b>Extent of Damage:</b>	Major damage	3
<b>Surface Treatment:</b>	Unsealed Insulation	3
<b>Asbestos type:</b>	Amosite, Chrysotile	2
<b>Material Assessment Score:</b>		10
<b>Priority Assessment Score:</b>		High
<b>Action:</b>	Manage	
<b>Comments:</b>	No access within safe casings without damaging safe

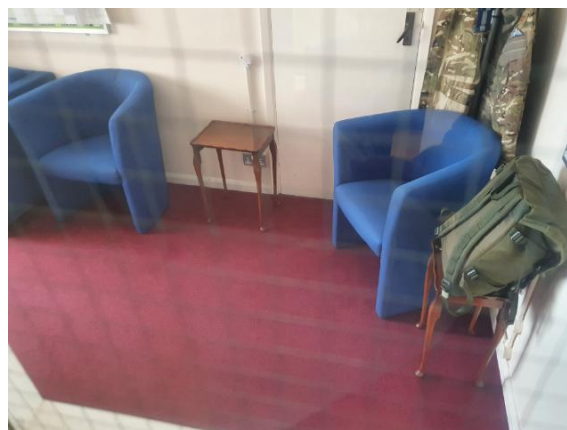
**Location:** Ground Floor - Offices x 3 023

<b>Material Description:</b>	Floor Tiles - Vinyl Products	
<b>Identification:</b>	Previously Sampled - Asbestos Detected	
<b>Approx. quantity:</b>	40 m <sup>2</sup>	
<b>Accessibility</b>	Difficult	<i>Assessment Score</i>
<b>Product type:</b>	Vinyl	1
<b>Extent of Damage:</b>	Slight / minor damage	1
<b>Surface Treatment:</b>	Non-friable	0
<b>Asbestos type:</b>	Chrysotile	1
<b>Material Assessment Score:</b>		3
<b>Priority Assessment Score:</b>		Negligible
<b>Action:</b>	Manage	
<b>Comments:</b>	Previously sampled ref: Armour 18/6/19 Sample DK/10. Under carpet

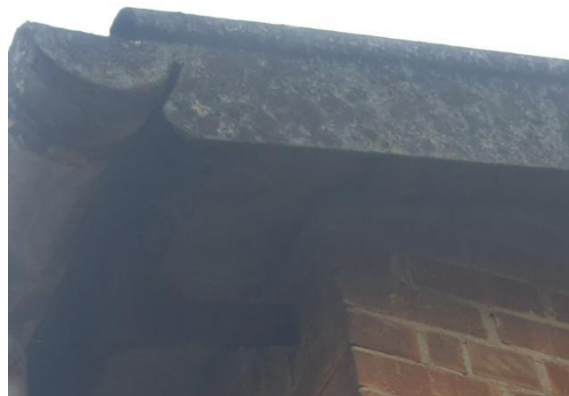
**Location:** External - Garages 032

<b>Material Description:</b>	Roof Edging - Cement Product	
<b>Identification:</b>	Previously Sampled - Asbestos Detected	
<b>Approx. quantity:</b>	8 LM	
<b>Accessibility</b>	Difficult	<i>Assessment Score</i>
<b>Product type:</b>	Cement	1
<b>Extent of Damage:</b>	Slight / minor damage	1
<b>Surface Treatment:</b>	Unsealed Cement	1
<b>Asbestos type:</b>	Chrysotile	1
<b>Material Assessment Score:</b>		4
<b>Priority Assessment Score:</b>		Negligible
<b>Action:</b>	Manage	
<b>Comments:</b>	No access to sample due to height restrictions
