**Project Number 2481**

**Management  
Asbestos Survey Report**

**675 Army Air Corps, Somerset, TA1 5LJ**

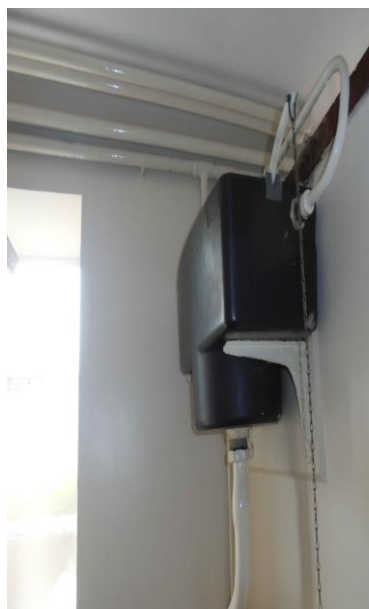
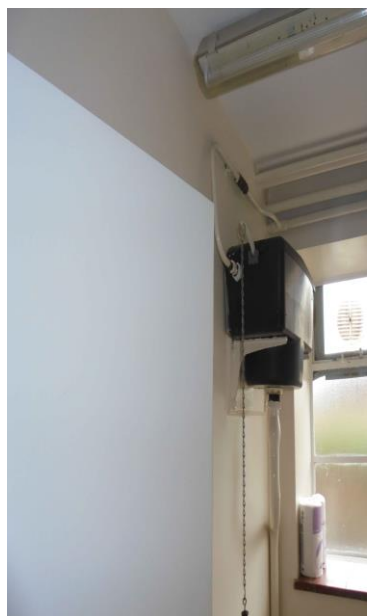
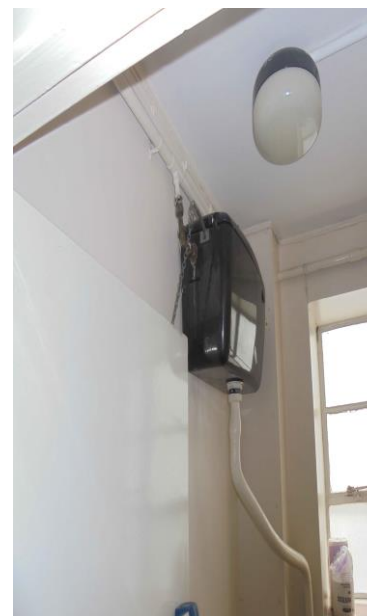
**Item No: 21****Sample No: DK/8****Location: WC, Store and Changing Room – Ground Floor**

<b>Material Description:</b>	Reinforced plastic cisterns	
<b>Identification:</b>	Sampled – Asbestos Detected	
<b>Approx. quantity:</b>	X 4	
<b>Accessibility</b>	Low	<i>Assessment Score</i>
<b>Product type:</b>	Composite	1
<b>Extent of Damage:</b>	Minor	1
<b>Surface Treatment:</b>	Non-Friable	0
<b>Asbestos type:</b>	Amosite	2
<b>Material Assessment Score:</b>		4
<b>Priority Assessment Score:</b>		Negligible
<b>Action:</b>	Manage	
<b>Comments:</b>	N/A

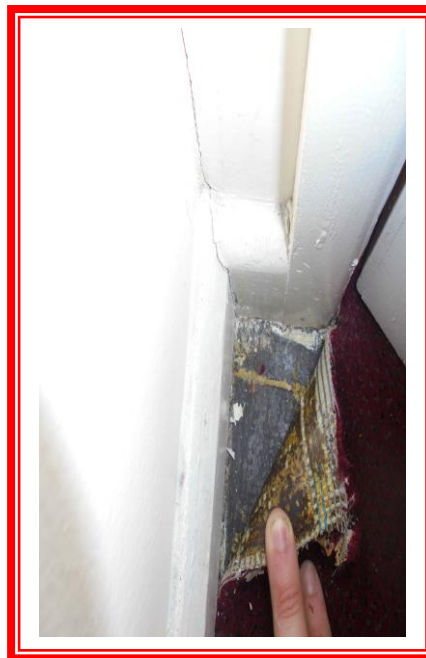
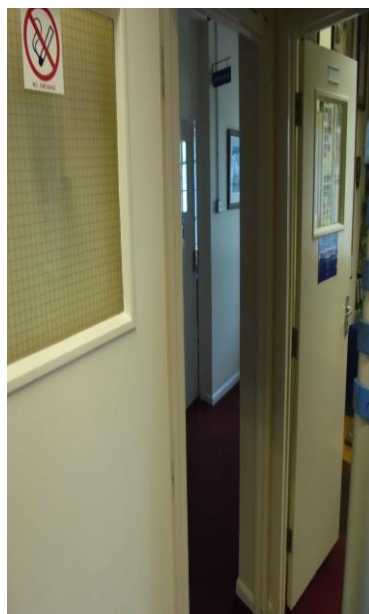
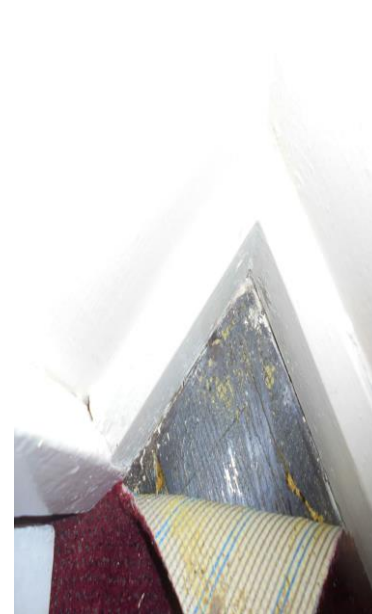
**Item No: 30****Sample No: N/A****Location: Offices x 3 – Ground Floor**

<b>Material Description:</b>	Floor tiles and adhesive under carpet	
<b>Identification:</b>	As Per Sample DK/10 – Asbestos Detected	
<b>Approx. quantity:</b>	40M2	
<b>Accessibility</b>	Low	<i>Assessment Score</i>
<b>Product type:</b>	Composite	1
<b>Extent of Damage:</b>	Minor	1
<b>Surface Treatment:</b>	Non-Friable	0
<b>Asbestos type:</b>	Chrysotile	1
<b>Material Assessment Score:</b>		3
<b>Priority Assessment Score:</b>		Negligible
<b>Action:</b>	Manage	
<b>Comments:</b>	N/A

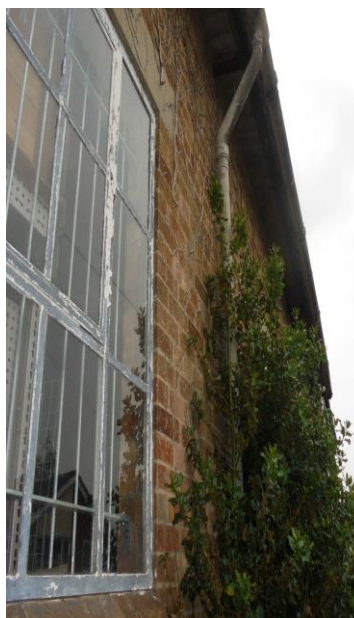
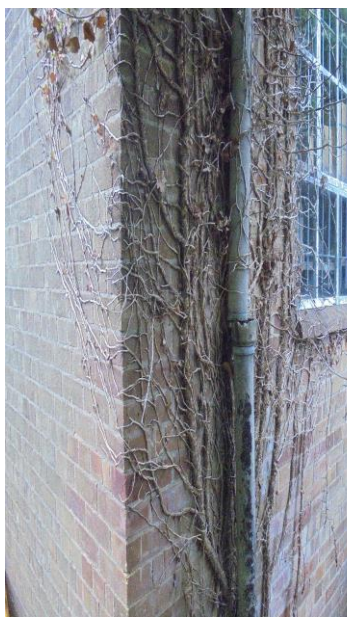
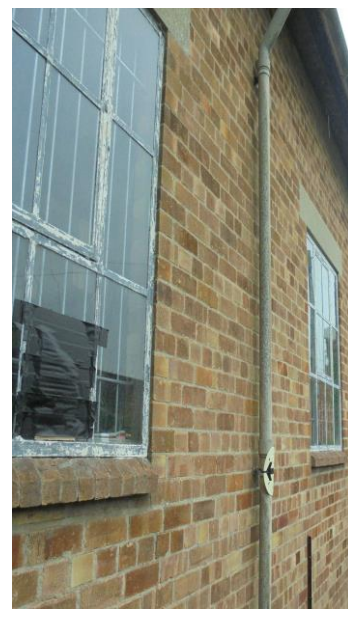
**Item No: 43****Sample No: DK/12****Location: External to garages**

<b>Material Description:</b>	Cement Downpipes	
<b>Identification:</b>	Sampled – Asbestos Detected	
<b>Approx. quantity:</b>	X 3 (6LM Each)	
<b>Accessibility</b>	Low	<i>Assessment Score</i>
<b>Product type:</b>	Cement	1
<b>Extent of Damage:</b>	Moderate	2
<b>Surface Treatment:</b>	Unsealed	1
<b>Asbestos type:</b>	Chrysotile	1
<b>Material Assessment Score:</b>		5
<b>Priority Assessment Score:</b>		Medium
<b>Action:</b>	Manage	
<b>Comments:</b>	N/A

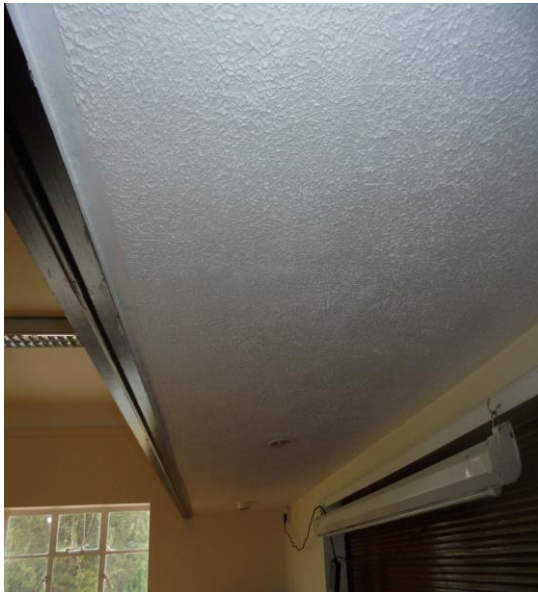
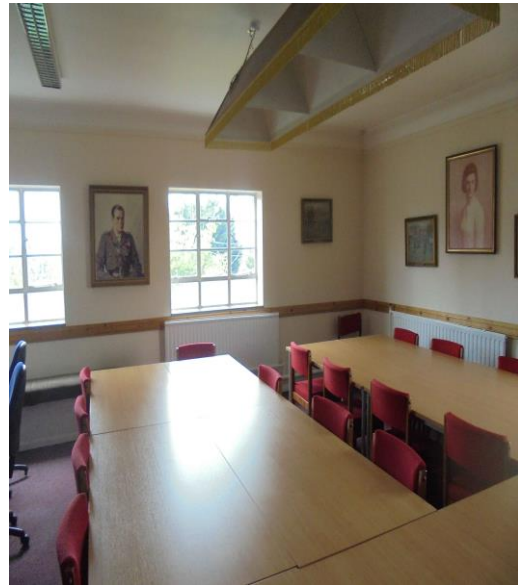
**Item No: 6****Sample No: DK/3****Location: Conference Room**

<b>Material Description:</b>	Textured coating to canopy	
<b>Identification:</b>	Sampled – No Asbestos Detected	
<b>Approx. quantity:</b>	5M2	
<b>Accessibility</b>	N/A	<i>Assessment Score</i>
<b>Product type:</b>		N/A
<b>Extent of Damage:</b>		N/A
<b>Surface Treatment:</b>		N/A
<b>Asbestos type:</b>		N/A
<b>Material Assessment Score:</b>		N/A
<b>Priority Assessment Score:</b>		N/A
<b>Action:</b>	N/A	
<b>Comments:</b>	N/A

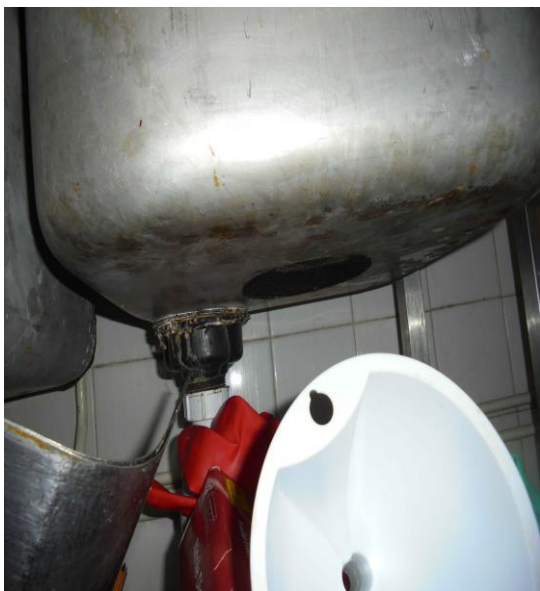
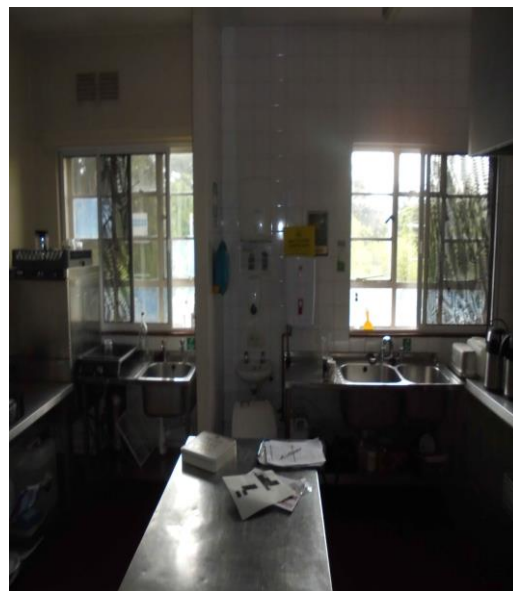
**Sample No: DK/5**

<b>Material Description:</b>	Sink pad	
<b>Identification:</b>	Sampled – No Asbestos Detected	
<b>Approx. quantity:</b>	X 3 Pads	
<b>Accessibility</b>	N/A	<i>Assessment Score</i>
<b>Product type:</b>		N/A
<b>Extent of Damage:</b>		N/A
<b>Surface Treatment:</b>		N/A
<b>Asbestos type:</b>		N/A
<b>Material Assessment Score:</b>		N/A
<b>Priority Assessment Score:</b>		N/A
<b>Action:</b>	N/A	
<b>Comments:</b>	N/A

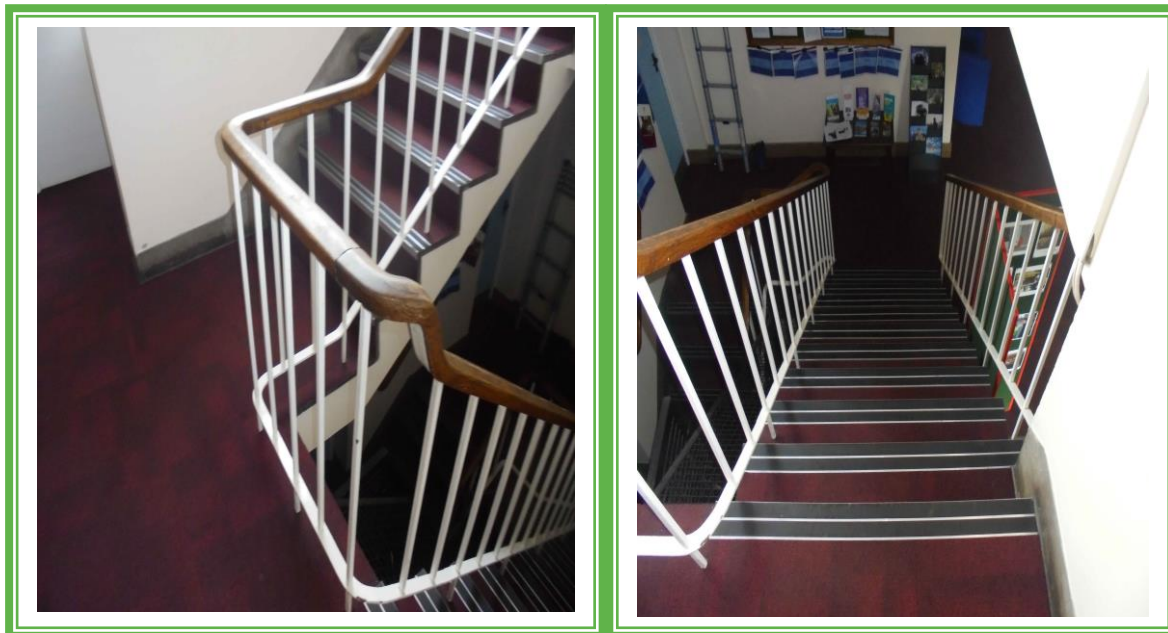
**Location: Stairwell – First to Ground Floor**

<b>Material Description:</b>	Visual Inspection – No Suspect Materials Found	
<b>Identification:</b>	N/A	
<b>Approx. quantity:</b>	N/A	
<b>Accessibility</b>	N/A	<i>Assessment Score</i>
<b>Product type:</b>		N/A
<b>Extent of Damage:</b>		N/A
<b>Surface Treatment:</b>		N/A
<b>Asbestos type:</b>		N/A
<b>Material Assessment Score:</b>		N/A
<b>Priority Assessment Score:</b>		N/A
<b>Action:</b>	N/A	
<b>Comments:</b>	Modern stair nosing

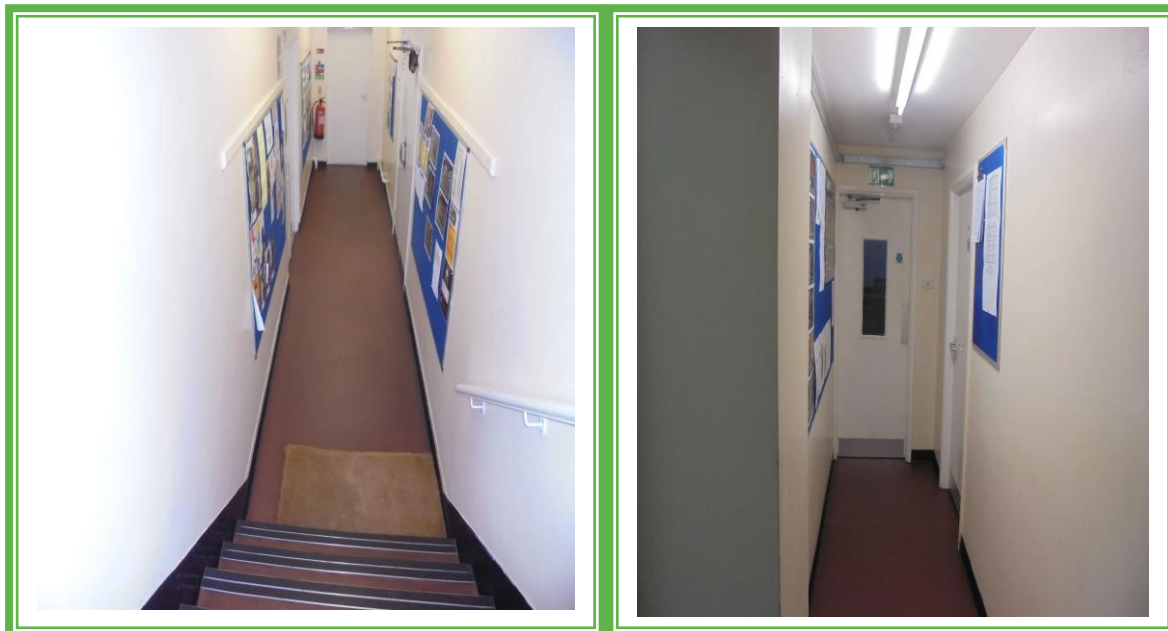
**Location: Corridor – Ground Floor**

<b>Material Description:</b>	Visual Inspection – No Suspect Materials Found	
<b>Identification:</b>	N/A	
<b>Approx. quantity:</b>	N/A	
<b>Accessibility</b>	N/A	<i>Assessment Score</i>
<b>Product type:</b>		N/A
<b>Extent of Damage:</b>		N/A
<b>Surface Treatment:</b>		N/A
<b>Asbestos type:</b>		N/A
<b>Material Assessment Score:</b>		N/A
<b>Priority Assessment Score:</b>		N/A
<b>Action:</b>	N/A	
<b>Comments:</b>	Modern Stair Nosing

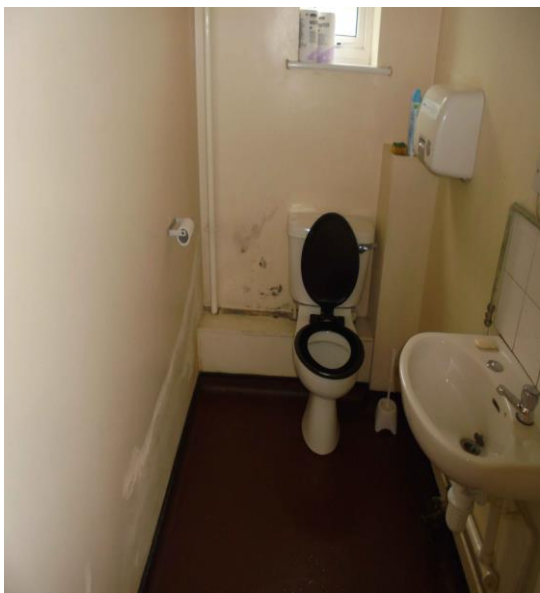
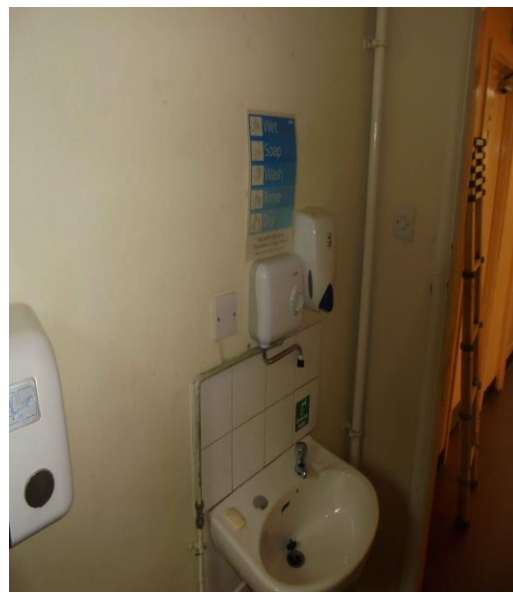
**Item No: 36****Sample No: N/A****Location: WC – Ground Floor**

<b>Material Description:</b>	Visual Inspection – No Suspect Materials Found	
<b>Identification:</b>	N/A	
<b>Approx. quantity:</b>	N/A	
<b>Accessibility</b>	N/A	<i>Assessment Score</i>
<b>Product type:</b>		N/A
<b>Extent of Damage:</b>		N/A
<b>Surface Treatment:</b>		N/A
<b>Asbestos type:</b>		N/A
<b>Material Assessment Score:</b>		N/A
<b>Priority Assessment Score:</b>		N/A
<b>Action:</b>	N/A	
<b>Comments:</b>	No access within timber boxing

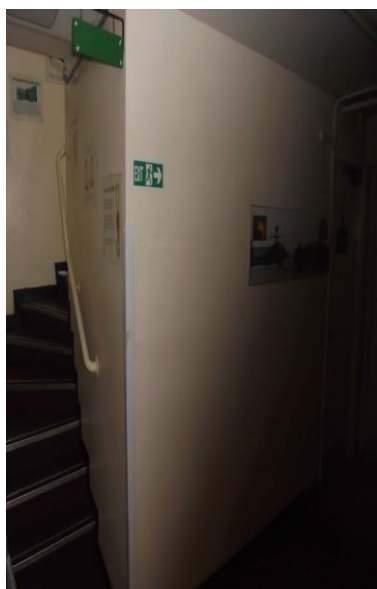
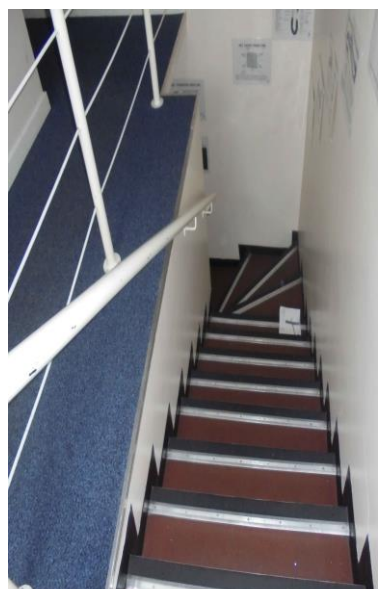
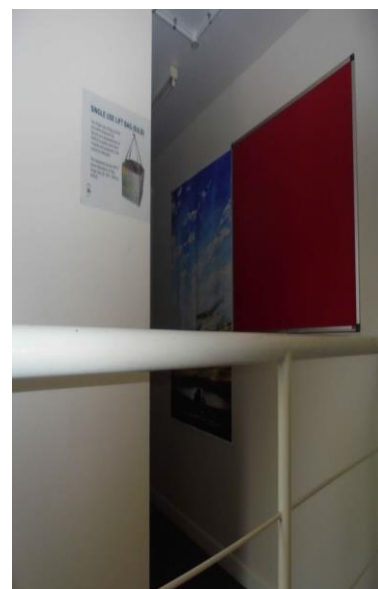
**Location: Corridor, Stairwell and Landing**

<b>Material Description:</b>	Visual Inspection – No Suspect Materials Found	
<b>Identification:</b>	N/A	
<b>Approx. quantity:</b>	N/A	
<b>Accessibility</b>	N/A	<i>Assessment Score</i>
<b>Product type:</b>		N/A
<b>Extent of Damage:</b>		N/A
<b>Surface Treatment:</b>		N/A
<b>Asbestos type:</b>		N/A
<b>Material Assessment Score:</b>		N/A
<b>Priority Assessment Score:</b>		N/A
<b>Action:</b>	N/A	
<b>Comments:</b>	No access under lino flooring

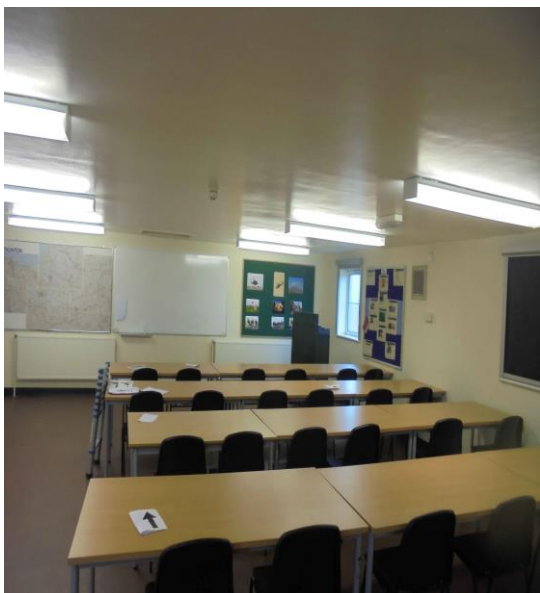
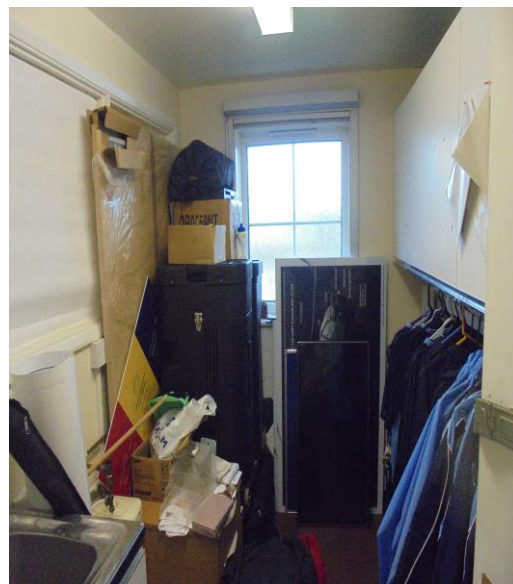
**Location: Classroom RF4 and Store – First Floor**

<b>Material Description:</b>	Visual Inspection – No Suspect Materials Found	
<b>Identification:</b>	N/A	
<b>Approx. quantity:</b>	N/A	
<b>Accessibility</b>	N/A	<i>Assessment Score</i>
<b>Product type:</b>		N/A
<b>Extent of Damage:</b>		N/A
<b>Surface Treatment:</b>		N/A
<b>Asbestos type:</b>		N/A
<b>Material Assessment Score:</b>		N/A
<b>Priority Assessment Score:</b>		N/A
<b>Action:</b>	N/A	
<b>Comments:</b>	Non-Asbestos sink pad in store

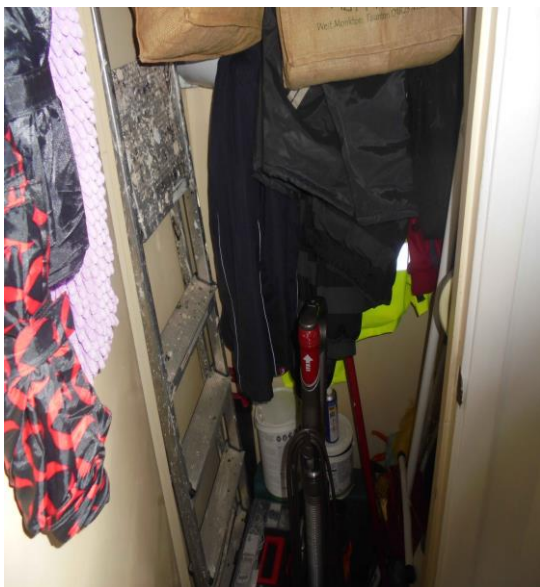
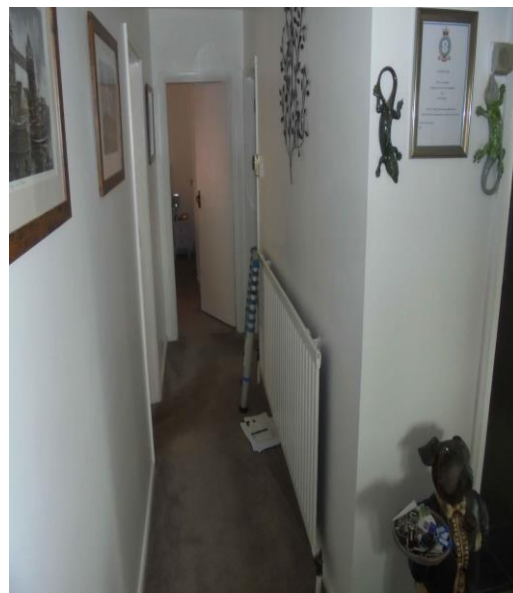
**Location: Hallway and Cupboard**

<b>Material Description:</b>	Visual Inspection – No Suspect Materials Found	
<b>Identification:</b>	N/A	
<b>Approx. quantity:</b>	N/A	
<b>Accessibility</b>	N/A	<i>Assessment Score</i>
<b>Product type:</b>		N/A
<b>Extent of Damage:</b>		N/A
<b>Surface Treatment:</b>		N/A
<b>Asbestos type:</b>		N/A
<b>Material Assessment Score:</b>		N/A
<b>Priority Assessment Score:</b>		N/A
<b>Action:</b>	N/A	
<b>Comments:</b>	No access under fixed carpet

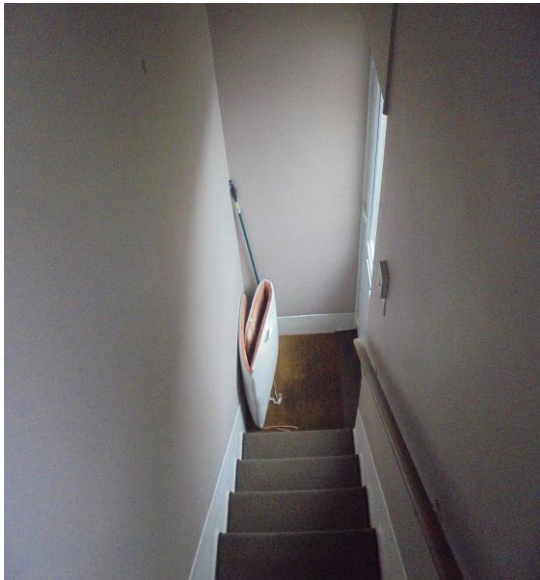
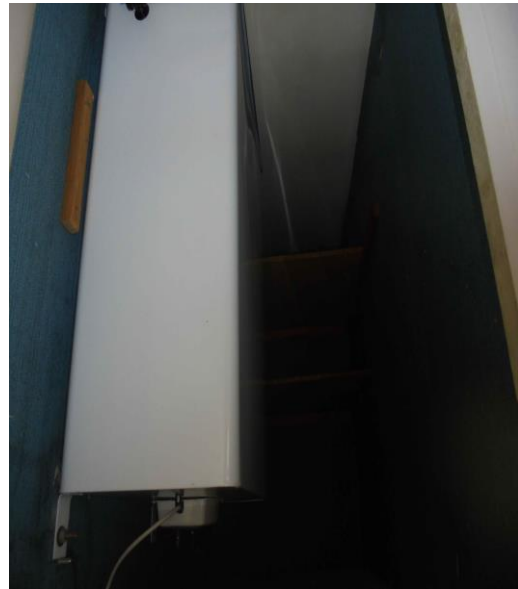
**Item No: 50****Sample No: N/A****Location: Stairwell and Cupboard**

<b>Material Description:</b>	Visual Inspection – No Suspect Materials Found	
<b>Identification:</b>	N/A	
<b>Approx. quantity:</b>	N/A	
<b>Accessibility</b>	N/A	<i>Assessment Score</i>
<b>Product type:</b>		N/A
<b>Extent of Damage:</b>		N/A
<b>Surface Treatment:</b>		N/A
<b>Asbestos type:</b>		N/A
<b>Material Assessment Score:</b>		N/A
<b>Priority Assessment Score:</b>		N/A
<b>Action:</b>	N/A	
<b>Comments:</b>	Modern water heater in cupboard

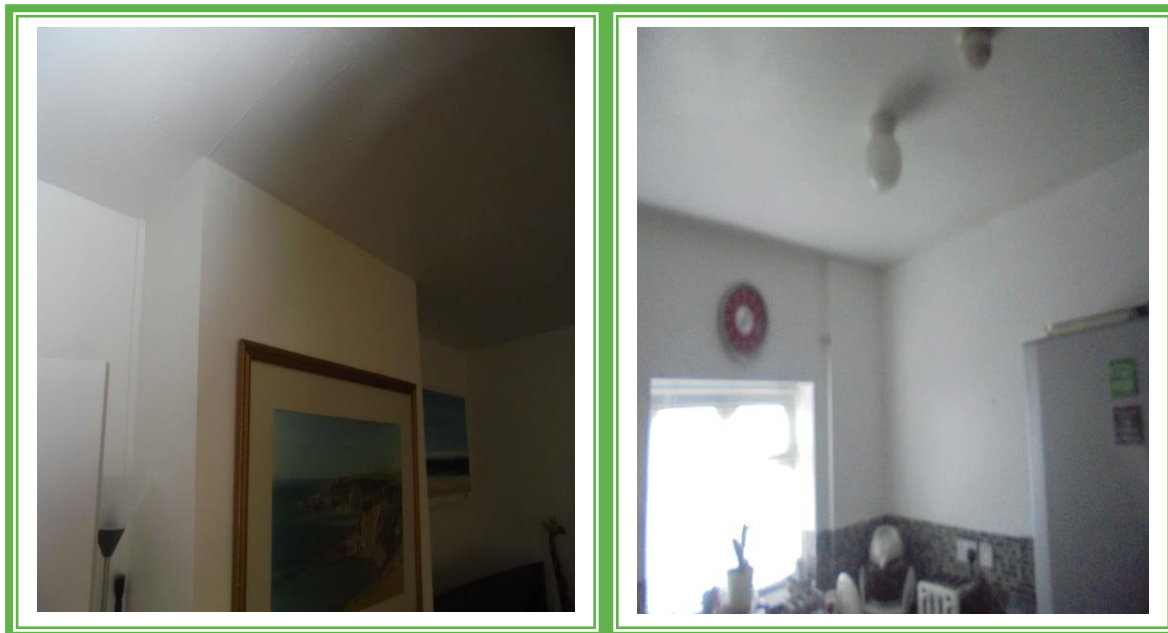
**Item No: 54**

<b>Material Description:</b>	Visual Inspection – No Suspect Materials Found	
<b>Identification:</b>	N/A	
<b>Approx. quantity:</b>	N/A	
<b>Accessibility</b>	N/A	<i>Assessment Score</i>
<b>Product type:</b>		N/A
<b>Extent of Damage:</b>		N/A
<b>Surface Treatment:</b>		N/A
<b>Asbestos type:</b>		N/A
<b>Material Assessment Score:</b>		N/A
<b>Priority Assessment Score:</b>		N/A
<b>Action:</b>	N/A	
<b>Comments:</b>	No access under fixed carpet or ceramic floor tiles. Non-Asbestos paint finish to ceiling

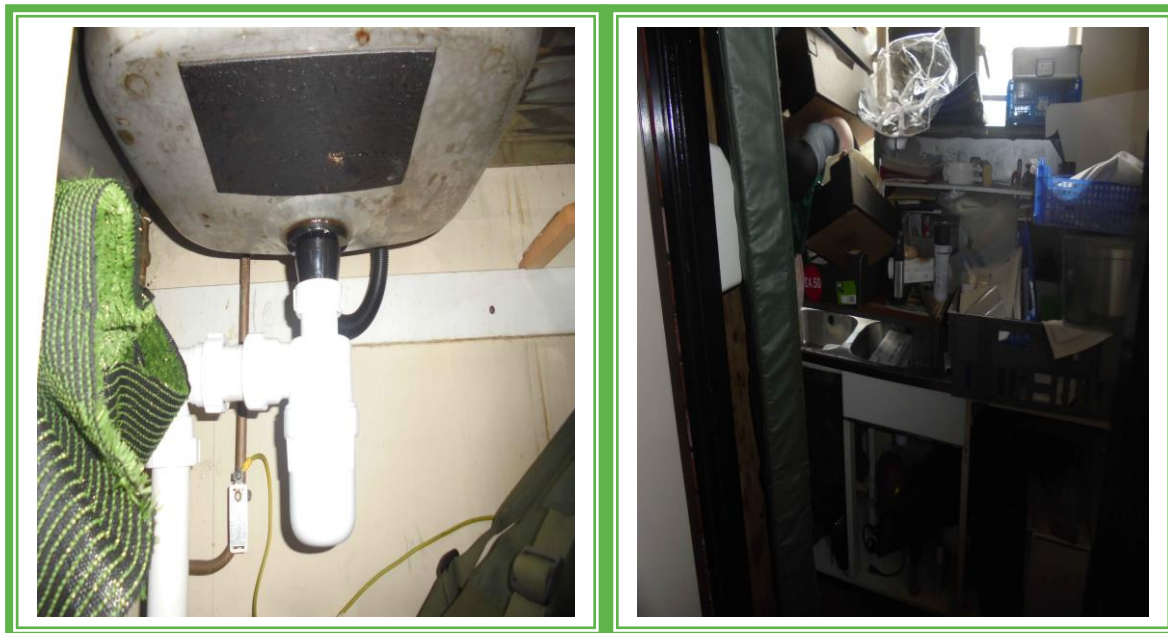
**Item No: 55**

<b>Material Description:</b>	Sink Pad	
<b>Identification:</b>	Sampled – No Asbestos Detected	
<b>Approx. quantity:</b>	X 1 Sink	
<b>Accessibility</b>	N/A	<i>Assessment Score</i>
<b>Product type:</b>		N/A
<b>Extent of Damage:</b>		N/A
<b>Surface Treatment:</b>		N/A
<b>Asbestos type:</b>		N/A
<b>Material Assessment Score:</b>		N/A
<b>Priority Assessment Score:</b>		N/A
<b>Action:</b>	N/A	
<b>Comments:</b>	Non-Asbestos fiberboard ceiling panels

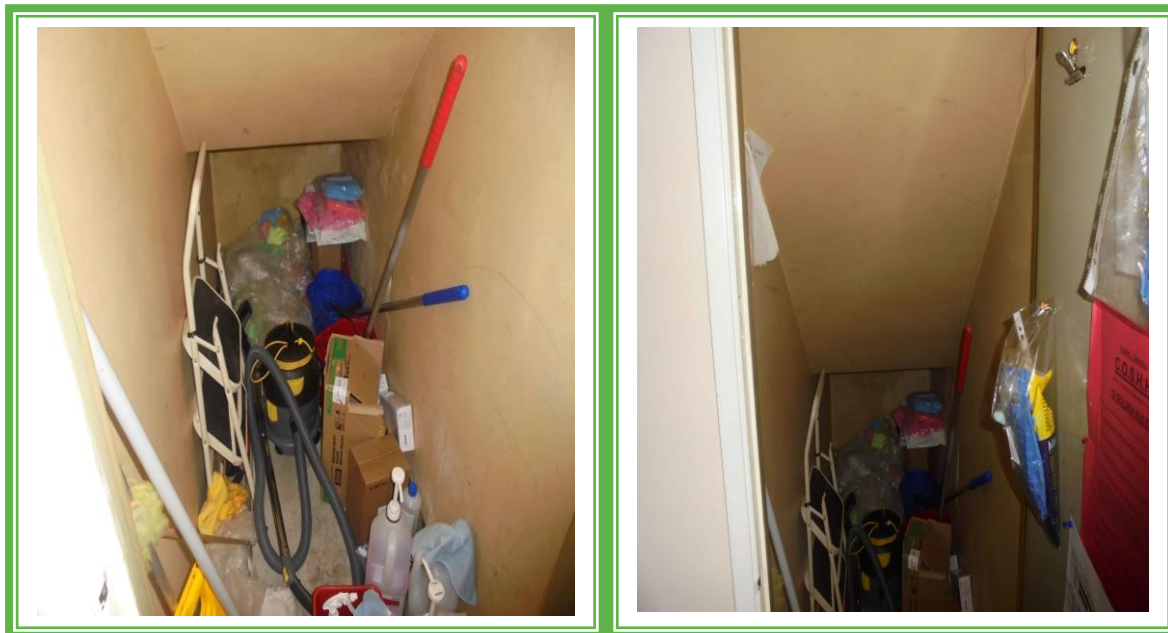
**Location: Cleaners Cupboard**

<b>Material Description:</b>	Visual Inspection – No Suspect Materials Found	
<b>Identification:</b>	N/A	
<b>Approx. quantity:</b>	N/A	
<b>Accessibility</b>	N/A	<i>Assessment Score</i>
<b>Product type:</b>		N/A
<b>Extent of Damage:</b>		N/A
<b>Surface Treatment:</b>		N/A
<b>Asbestos type:</b>		N/A
<b>Material Assessment Score:</b>		N/A
<b>Priority Assessment Score:</b>		N/A
<b>Action:</b>	N/A	
<b>Comments:</b>	N/A

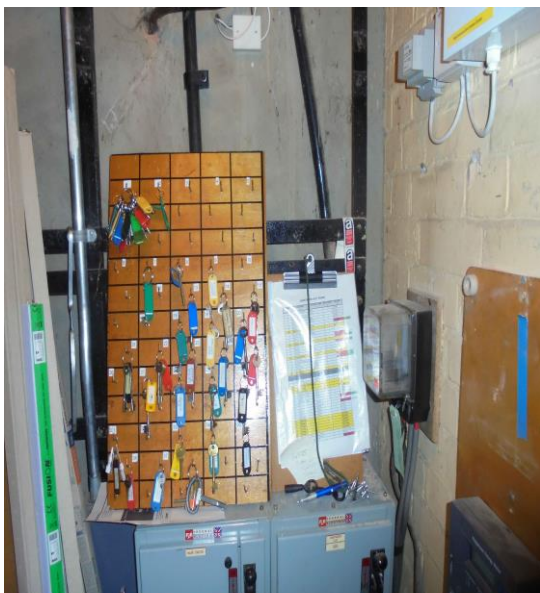
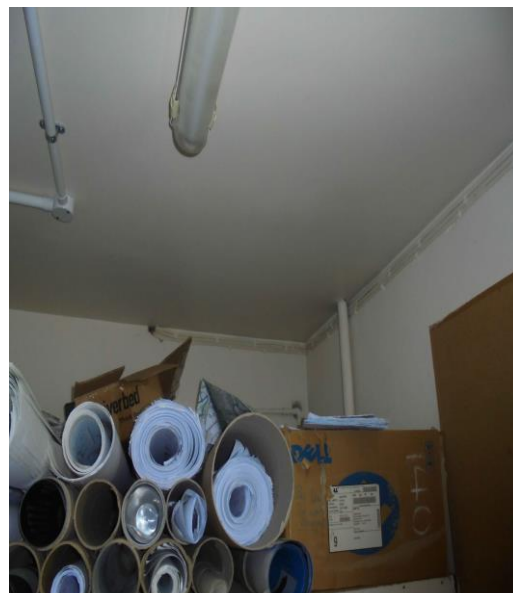
**Location: Electrics Cupboard – Ground Floor**

<b>Material Description:</b>	Visual Inspection – No Suspect Materials Found	
<b>Identification:</b>	N/A	
<b>Approx. quantity:</b>	N/A	
<b>Accessibility</b>	N/A	<i>Assessment Score</i>
<b>Product type:</b>		N/A
<b>Extent of Damage:</b>		N/A
<b>Surface Treatment:</b>		N/A
<b>Asbestos type:</b>		N/A
<b>Material Assessment Score:</b>		N/A
<b>Priority Assessment Score:</b>		N/A
<b>Action:</b>	N/A	
<b>Comments:</b>	Modern Electrics

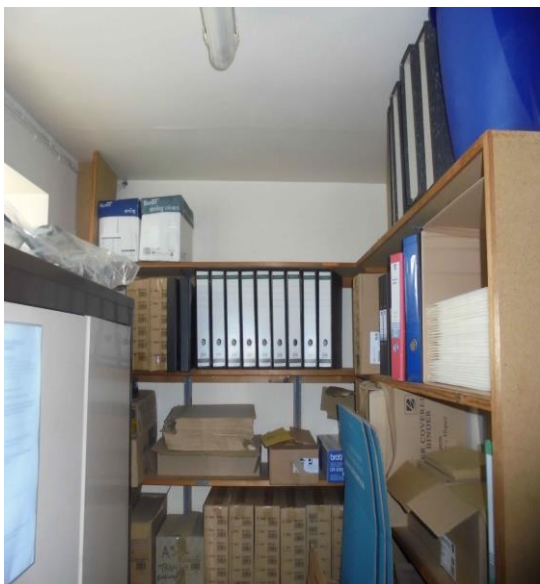
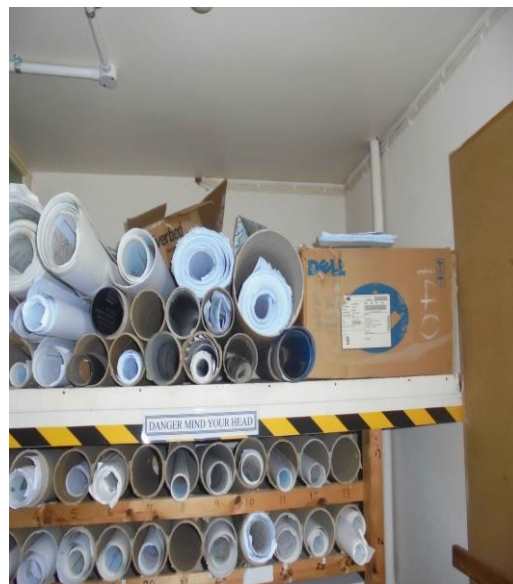
**Location: Store – Ground Floor**

<b>Material Description:</b>	Visual Inspection – No Suspect Materials Found	
<b>Identification:</b>	N/A	
<b>Approx. quantity:</b>	N/A	
<b>Accessibility</b>	N/A	<i>Assessment Score</i>
<b>Product type:</b>		N/A
<b>Extent of Damage:</b>		N/A
<b>Surface Treatment:</b>		N/A
<b>Asbestos type:</b>		N/A
<b>Material Assessment Score:</b>		N/A
<b>Priority Assessment Score:</b>		N/A
<b>Action:</b>	N/A	
<b>Comments:</b>	N/A

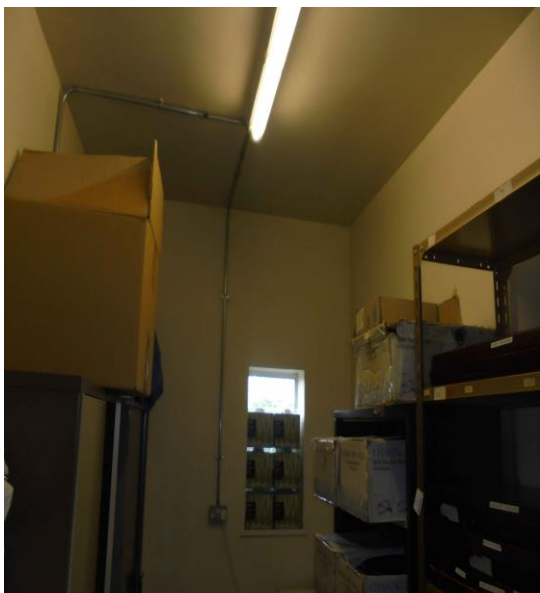
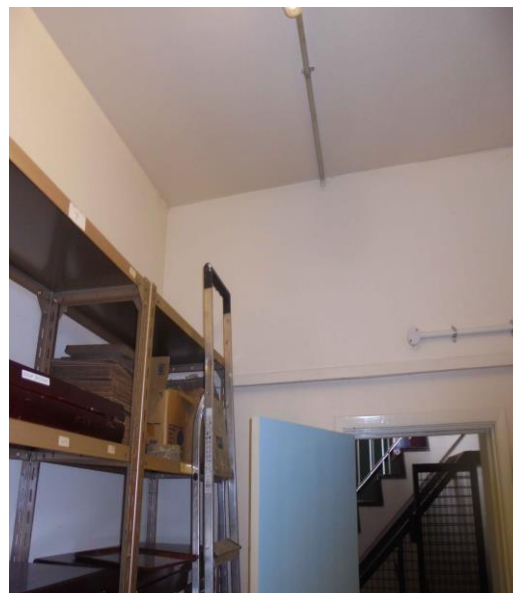
**Item No: 61****Sample No: N/A****Location: Store – Ground Floor**

<b>Material Description:</b>	Visual Inspection – No Suspect Materials Found	
<b>Identification:</b>	N/A	
<b>Approx. quantity:</b>	N/A	
<b>Accessibility</b>	N/A	<i>Assessment Score</i>
<b>Product type:</b>		N/A
<b>Extent of Damage:</b>		N/A
<b>Surface Treatment:</b>		N/A
<b>Asbestos type:</b>		N/A
<b>Material Assessment Score:</b>		N/A
<b>Priority Assessment Score:</b>		N/A
<b>Action:</b>	N/A	
<b>Comments:</b>	No access under fixed carpet

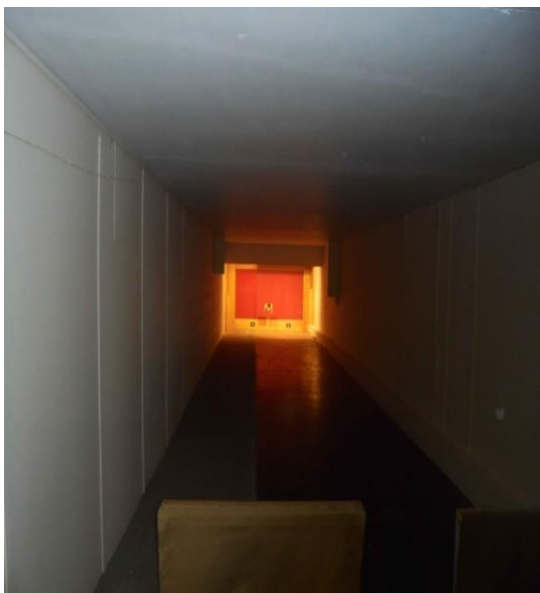
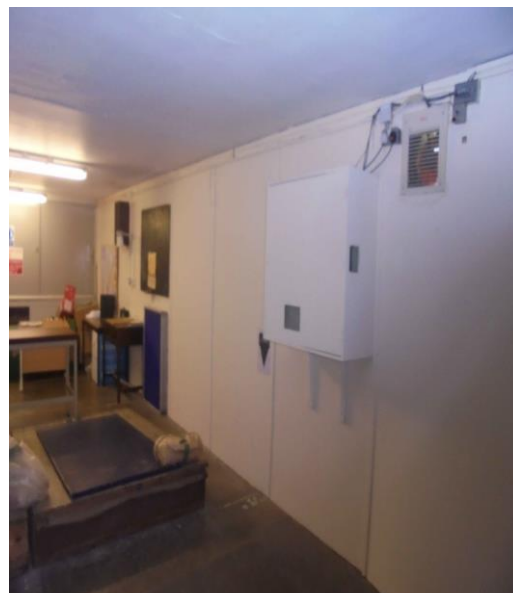
**Item No: 62****Sample No: N/A****Location: Shooting Range – Ground Floor**

<b>Material Description:</b>	Visual Inspection – No Suspect Materials Found	
<b>Identification:</b>	N/A	
<b>Approx. quantity:</b>	N/A	
<b>Accessibility</b>	N/A	<i>Assessment Score</i>
<b>Product type:</b>		N/A
<b>Extent of Damage:</b>		N/A
<b>Surface Treatment:</b>		N/A
<b>Asbestos type:</b>		N/A
<b>Material Assessment Score:</b>		N/A
<b>Priority Assessment Score:</b>		N/A
<b>Action:</b>	N/A	
<b>Comments:</b>	Non-Asbestos fiberboard wall panels. Modern electrics in cupboard

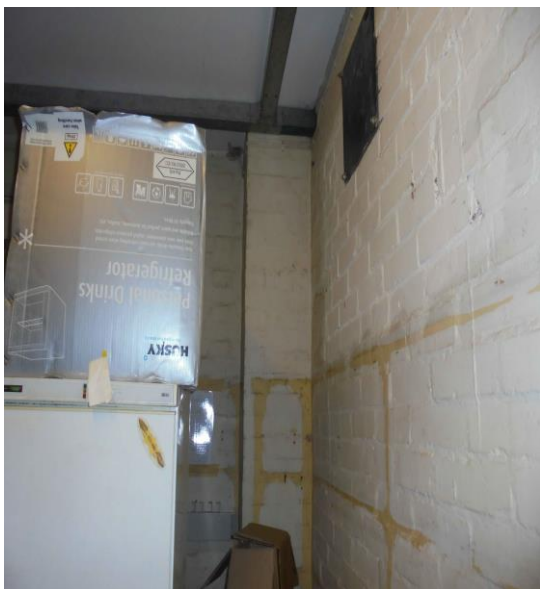
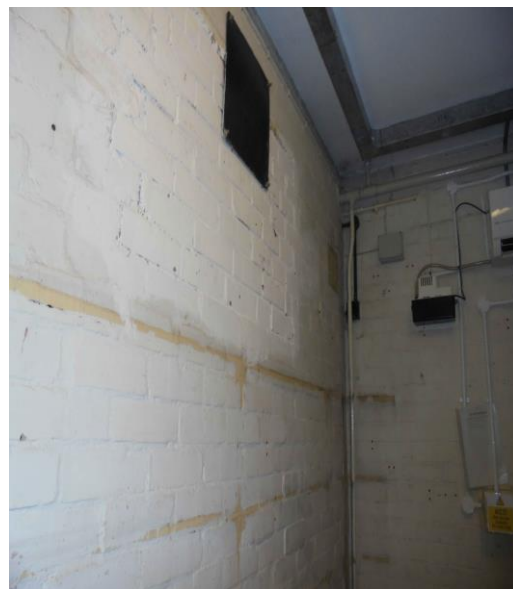
**Item No: 64****Sample No: N/A****Location: Server Room – Ground Floor**

<b>Material Description:</b>	Visual Inspection – No Suspect Materials Found	
<b>Identification:</b>	N/A	
<b>Approx. quantity:</b>	N/A	
<b>Accessibility</b>	N/A	<i>Assessment Score</i>
<b>Product type:</b>		N/A
<b>Extent of Damage:</b>		N/A
<b>Surface Treatment:</b>		N/A
<b>Asbestos type:</b>		N/A
<b>Material Assessment Score:</b>		N/A
<b>Priority Assessment Score:</b>		N/A
<b>Action:</b>	N/A	
<b>Comments:</b>	Modern Electrics

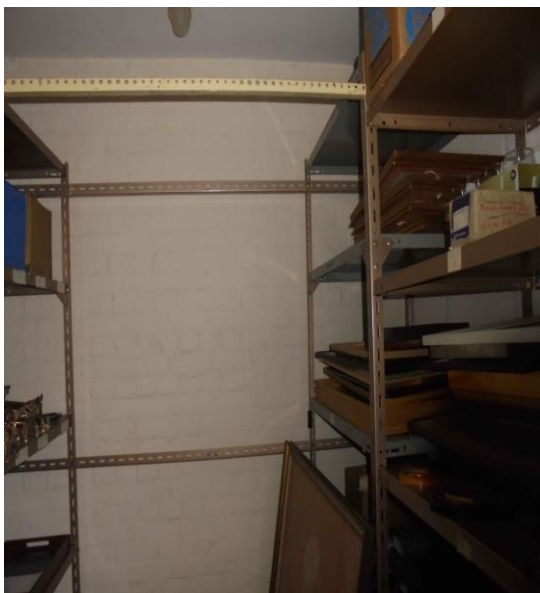
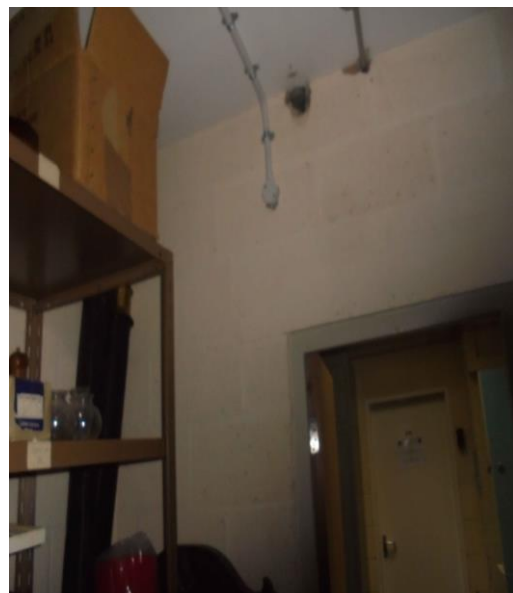
**Location: Silver store – Ground Floor**

<b>Material Description:</b>	Visual Inspection – No Suspect Materials Found	
<b>Identification:</b>	N/A	
<b>Approx. quantity:</b>	N/A	
<b>Accessibility</b>	N/A	<i>Assessment Score</i>
<b>Product type:</b>		N/A
<b>Extent of Damage:</b>		N/A
<b>Surface Treatment:</b>		N/A
<b>Asbestos type:</b>		N/A
<b>Material Assessment Score:</b>		N/A
<b>Priority Assessment Score:</b>		N/A
<b>Action:</b>	N/A	
<b>Comments:</b>	N/A

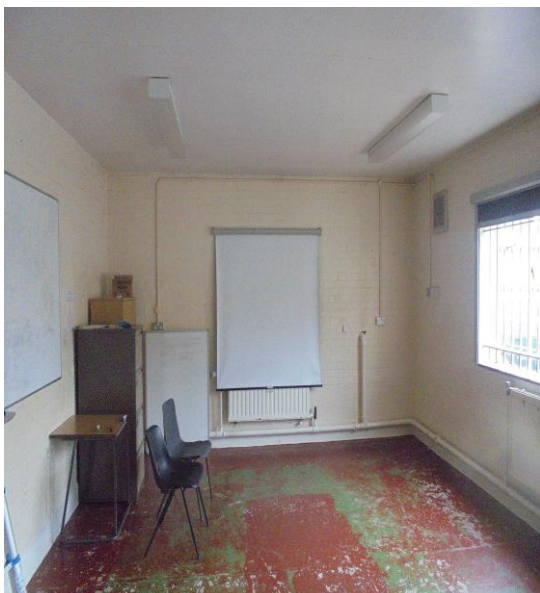
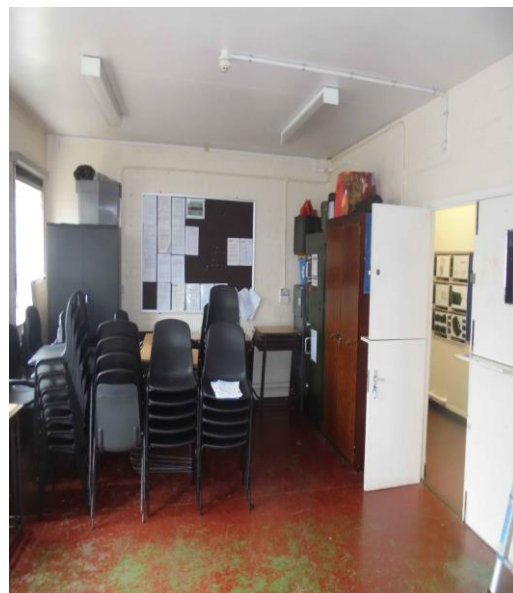
**Item No: 68****Sample No: N/A****Location: Cadet Classroom – Ground Floor**

<b>Material Description:</b>	Visual Inspection – No Suspect Materials Found	
<b>Identification:</b>	N/A	
<b>Approx. quantity:</b>	N/A	
<b>Accessibility</b>	N/A	<i>Assessment Score</i>
<b>Product type:</b>		N/A
<b>Extent of Damage:</b>		N/A
<b>Surface Treatment:</b>		N/A
<b>Asbestos type:</b>		N/A
<b>Material Assessment Score:</b>		N/A
<b>Priority Assessment Score:</b>		N/A
<b>Action:</b>	N/A	
<b>Comments:</b>	N/A

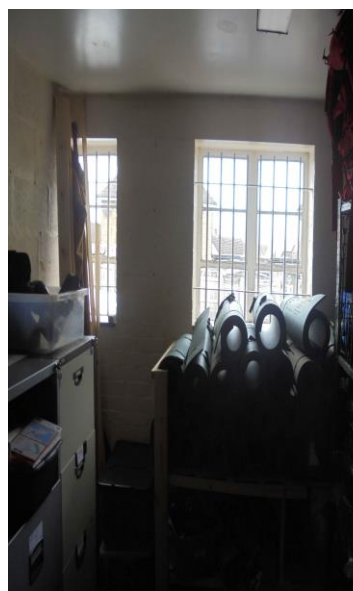
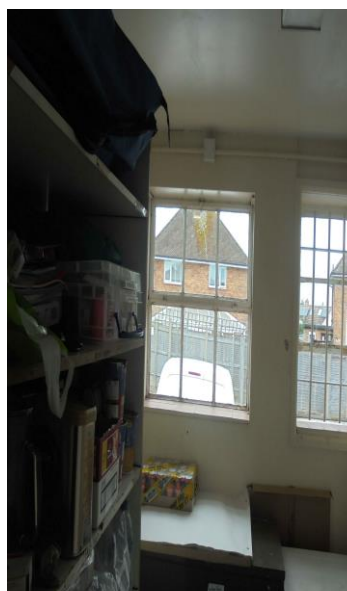
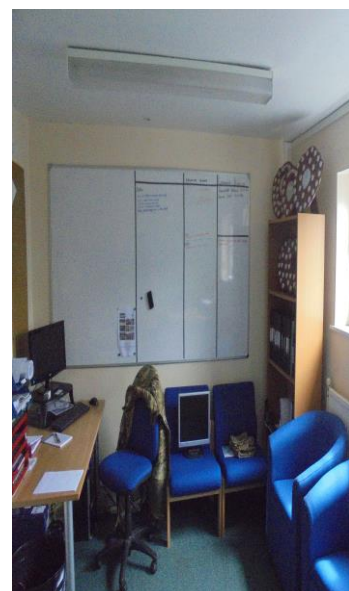
**Item No: 69****Sample No: N/A****Location: Offices x 3 – Ground Floor**

<b>Material Description:</b>	Visual Inspection – No Suspect Materials Found	
<b>Identification:</b>	N/A	
<b>Approx. quantity:</b>	N/A	
<b>Accessibility</b>	N/A	<i>Assessment Score</i>
<b>Product type:</b>		N/A
<b>Extent of Damage:</b>		N/A
<b>Surface Treatment:</b>		N/A
<b>Asbestos type:</b>		N/A
<b>Material Assessment Score:</b>		N/A
<b>Priority Assessment Score:</b>		N/A
<b>Action:</b>	N/A	
<b>Comments:</b>	N/A

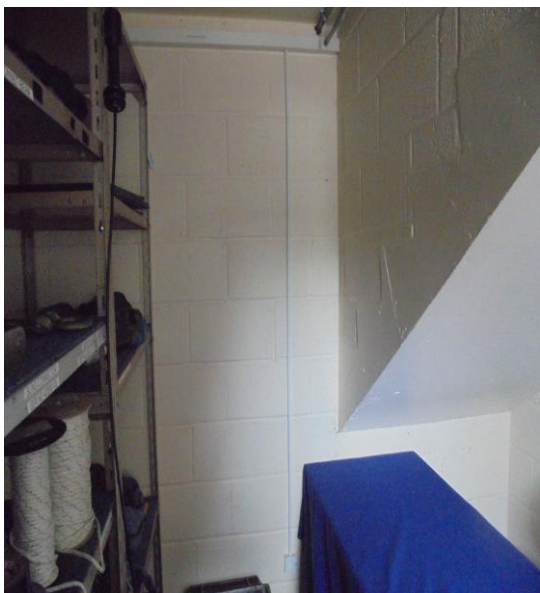
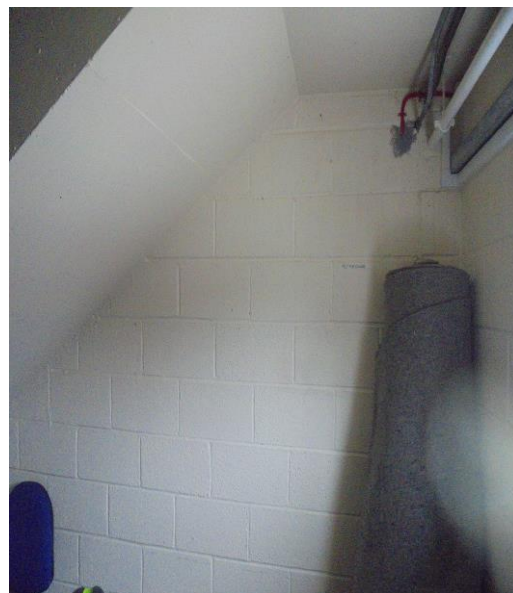
**Location: Hustle Store**

<b>Material Description:</b>	Visual Inspection – No Suspect Materials Found	
<b>Identification:</b>	N/A	
<b>Approx. quantity:</b>	N/A	
<b>Accessibility</b>	N/A	<i>Assessment Score</i>
<b>Product type:</b>		N/A
<b>Extent of Damage:</b>		N/A
<b>Surface Treatment:</b>		N/A
<b>Asbestos type:</b>		N/A
<b>Material Assessment Score:</b>		N/A
<b>Priority Assessment Score:</b>		N/A
<b>Action:</b>	N/A	
<b>Comments:</b>	N/A

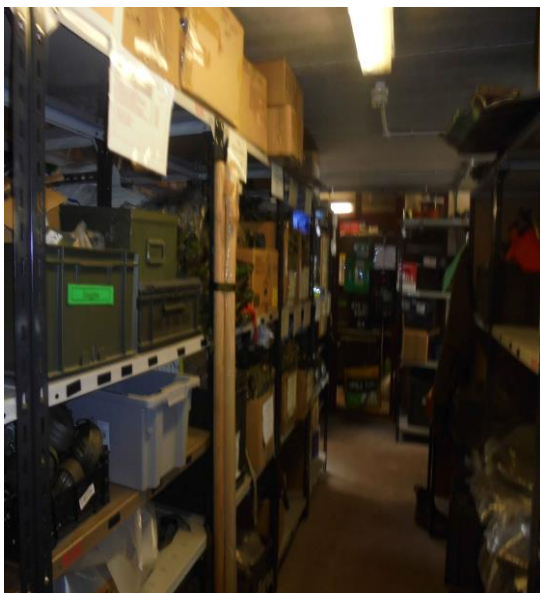
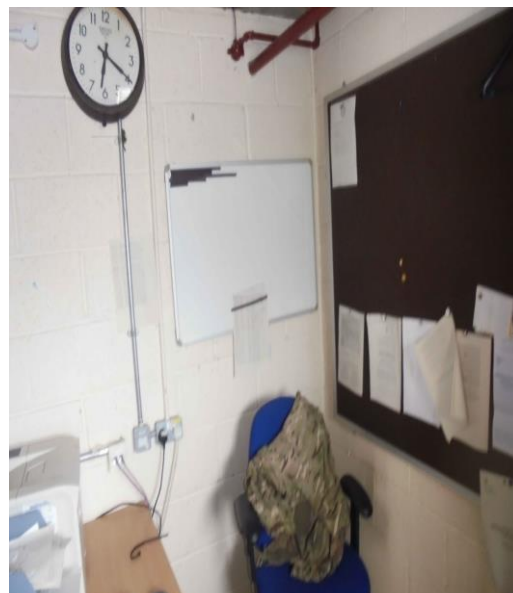
**Item No: 71****Sample No: N/A****Location: Stores and Office**

<b>Material Description:</b>	Visual Inspection – No Suspect Materials Found	
<b>Identification:</b>	N/A	
<b>Approx. quantity:</b>	N/A	
<b>Accessibility</b>	N/A	<i>Assessment Score</i>
<b>Product type:</b>		N/A
<b>Extent of Damage:</b>		N/A
<b>Surface Treatment:</b>		N/A
<b>Asbestos type:</b>		N/A
<b>Material Assessment Score:</b>		N/A
<b>Priority Assessment Score:</b>		N/A
<b>Action:</b>	N/A	
<b>Comments:</b>	Limited access to inspect due to stored items

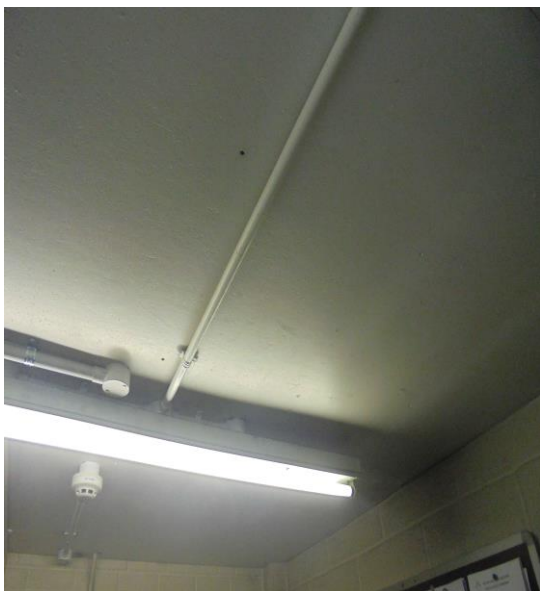
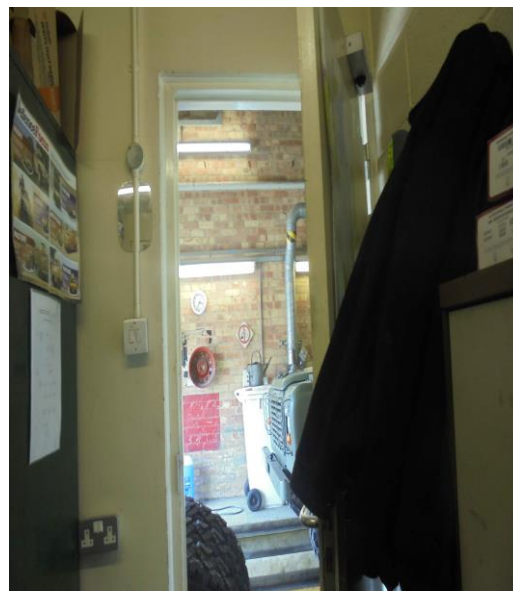
**Item No: 72****Sample No: DK/16****Location: Garage and Office R13**

<b>Material Description:</b>	Insulation board ceiling	
<b>Identification:</b>	Sampled – No Asbestos Detected	
<b>Approx. quantity:</b>	9M2	
<b>Accessibility</b>	N/A	<i>Assessment Score</i>
<b>Product type:</b>		N/A
<b>Extent of Damage:</b>		N/A
<b>Surface Treatment:</b>		N/A
<b>Asbestos type:</b>		N/A
<b>Material Assessment Score:</b>		N/A
<b>Priority Assessment Score:</b>		N/A
<b>Action:</b>	N/A	
<b>Comments:</b>	N/A

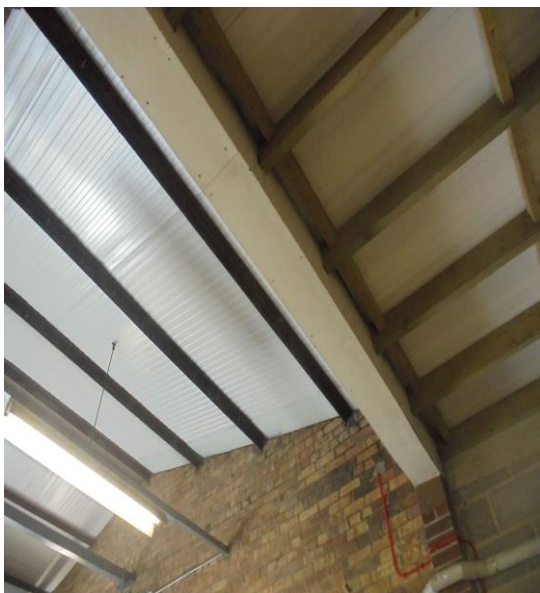
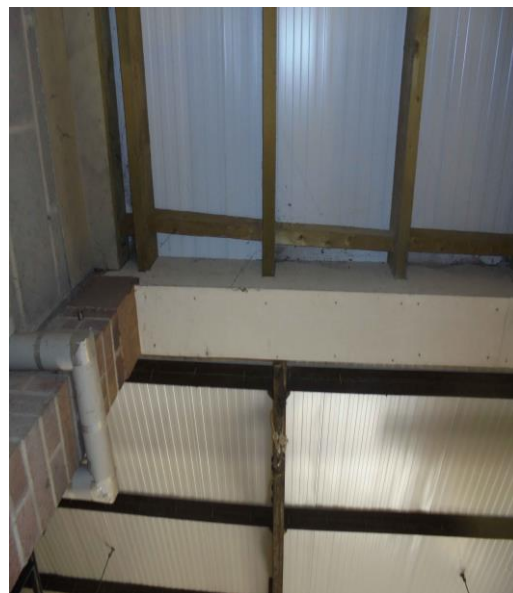
**Location: Garages – MT Workshop**

<b>Material Description:</b>	Insulation board boxing	
<b>Identification:</b>	As Per Sample DK/16 – No Asbestos Detected	
<b>Approx. quantity:</b>	6LM	
<b>Accessibility</b>	N/A	<i>Assessment Score</i>
<b>Product type:</b>		N/A
<b>Extent of Damage:</b>		N/A
<b>Surface Treatment:</b>		N/A
<b>Asbestos type:</b>		N/A
<b>Material Assessment Score:</b>		N/A
<b>Priority Assessment Score:</b>		N/A
<b>Action:</b>	N/A	
<b>Comments:</b>	N/A

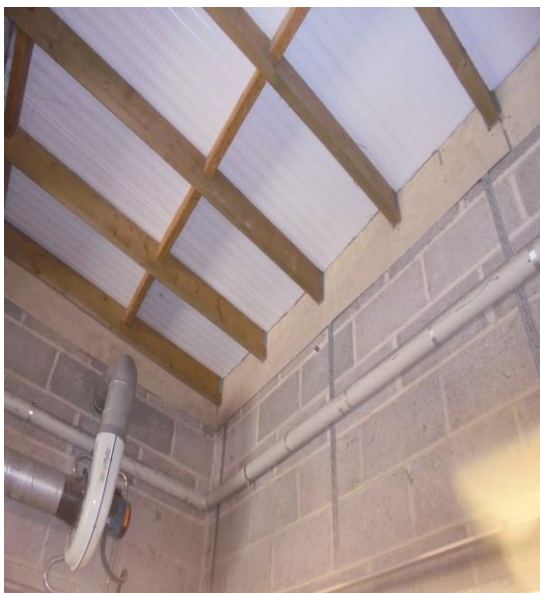
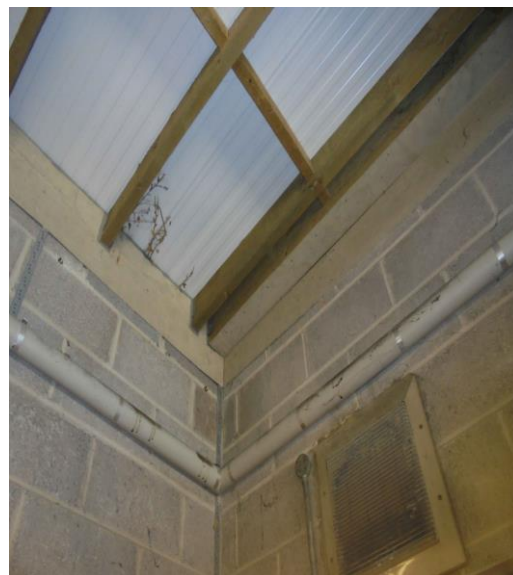
**Item No: 74****Sample No: DK/17****Location: Garages – MT Store**

<b>Material Description:</b>	Insulation board bulkhead panels	
<b>Identification:</b>	Sampled – No Asbestos Detected	
<b>Approx. quantity:</b>	8LM	
<b>Accessibility</b>	N/A	<i>Assessment Score</i>
<b>Product type:</b>		N/A
<b>Extent of Damage:</b>		N/A
<b>Surface Treatment:</b>		N/A
<b>Asbestos type:</b>		N/A
<b>Material Assessment Score:</b>		N/A
<b>Priority Assessment Score:</b>		N/A
<b>Action:</b>	N/A	
<b>Comments:</b>	N/A

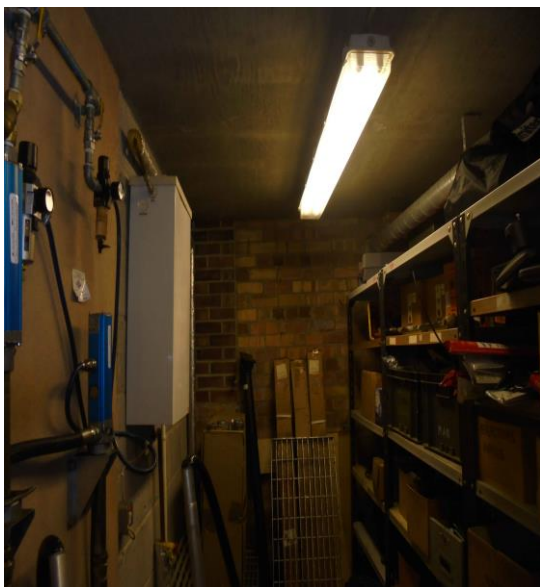
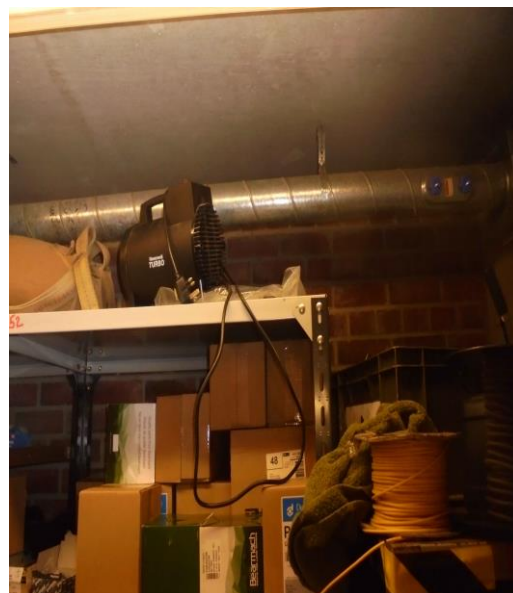
**Item No: 75****Sample No: N/A****Location: Garages and Store R12**

<b>Material Description:</b>	Visual Inspection – No Suspect Materials Found	
<b>Identification:</b>	N/A	
<b>Approx. quantity:</b>	N/A	
<b>Accessibility</b>	N/A	<i>Assessment Score</i>
<b>Product type:</b>		N/A
<b>Extent of Damage:</b>		N/A
<b>Surface Treatment:</b>		N/A
<b>Asbestos type:</b>		N/A
<b>Material Assessment Score:</b>		N/A
<b>Priority Assessment Score:</b>		N/A
<b>Action:</b>	N/A	
<b>Comments:</b>	N/A
