**Project Number 2481**

**Management  
Asbestos Survey Report**

**675 Army Air Corps, Somerset, TA1 5LJ**

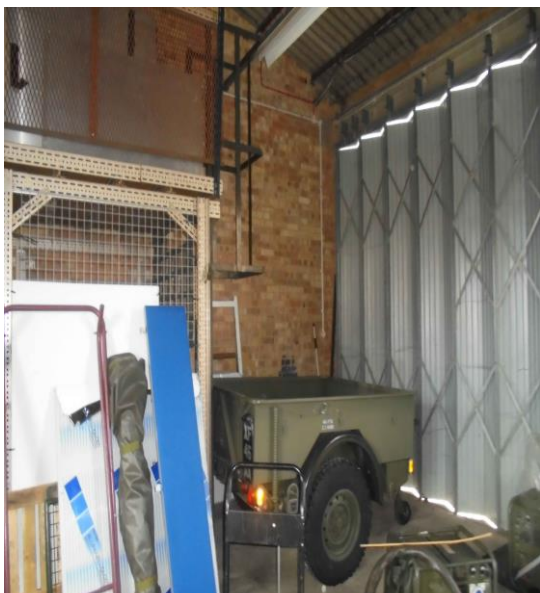
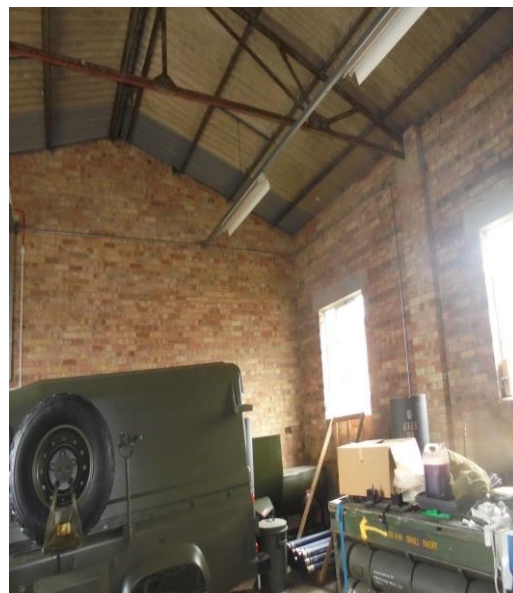
**Location: Garage 1**

<b>Material Description:</b>	Visual Inspection – No Suspect Materials Found	
<b>Identification:</b>	N/A	
<b>Approx. quantity:</b>	N/A	
<b>Accessibility</b>	N/A	<i>Assessment Score</i>
<b>Product type:</b>		N/A
<b>Extent of Damage:</b>		N/A
<b>Surface Treatment:</b>		N/A
<b>Asbestos type:</b>		N/A
<b>Material Assessment Score:</b>		N/A
<b>Priority Assessment Score:</b>		N/A
<b>Action:</b>	N/A	
<b>Comments:</b>	N/A

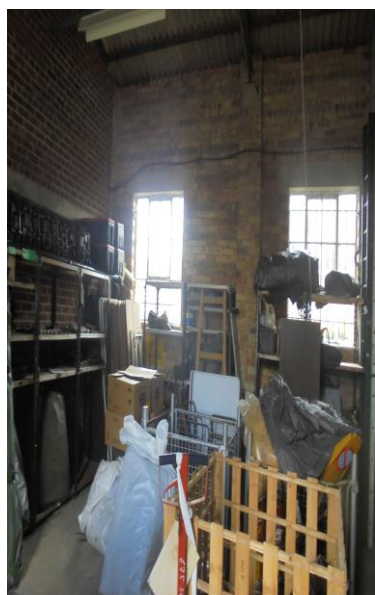
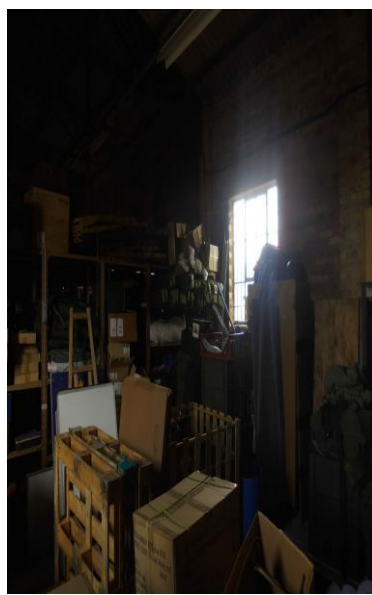
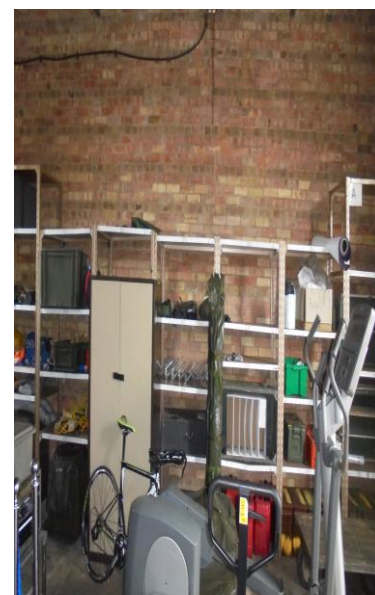
**Item No: 77****Sample No: N/A****Location: Garages 3,4 and 5**

<b>Material Description:</b>	Visual Inspection – No Suspect Materials Found	
<b>Identification:</b>	N/A	
<b>Approx. quantity:</b>	N/A	
<b>Accessibility</b>	N/A	<i>Assessment Score</i>
<b>Product type:</b>		N/A
<b>Extent of Damage:</b>		N/A
<b>Surface Treatment:</b>		N/A
<b>Asbestos type:</b>		N/A
<b>Material Assessment Score:</b>		N/A
<b>Priority Assessment Score:</b>		N/A
<b>Action:</b>	N/A	
<b>Comments:</b>	Limited access to inspect stores due to stored items

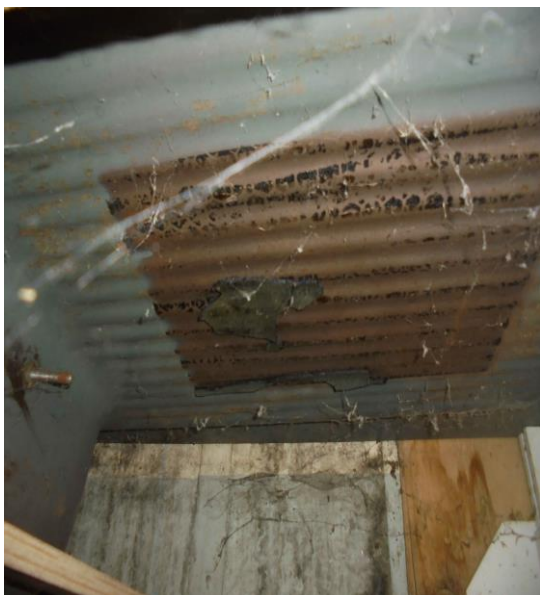
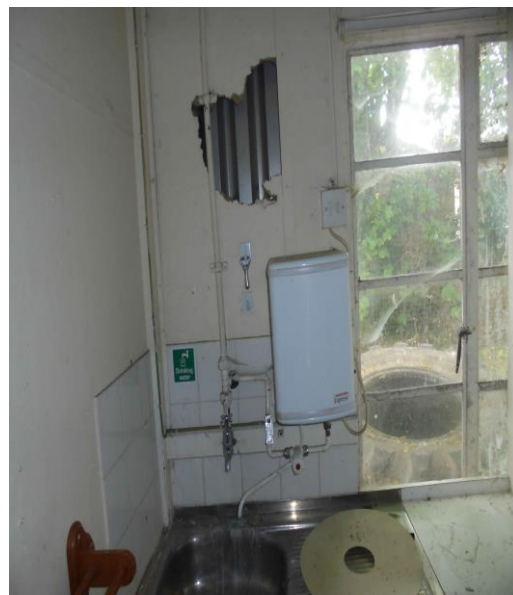
**Item No: 78****Sample No: DK/18****Location: Cadet Hut - Kitchen**

<b>Material Description:</b>	Remains of sink pad	
<b>Identification:</b>	Sampled – No Asbestos Detected	
<b>Approx. quantity:</b>	X 1 Sink	
<b>Accessibility</b>	N/A	<i>Assessment Score</i>
<b>Product type:</b>		N/A
<b>Extent of Damage:</b>		N/A
<b>Surface Treatment:</b>		N/A
<b>Asbestos type:</b>		N/A
<b>Material Assessment Score:</b>		N/A
<b>Priority Assessment Score:</b>		N/A
<b>Action:</b>	N/A	
<b>Comments:</b>	N/A

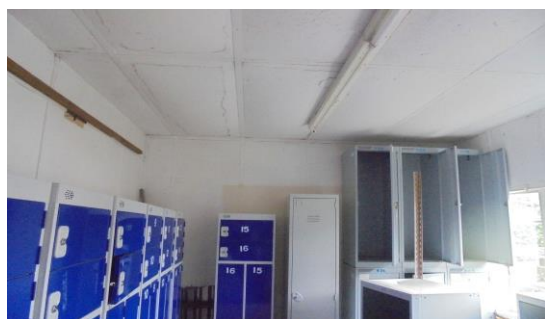
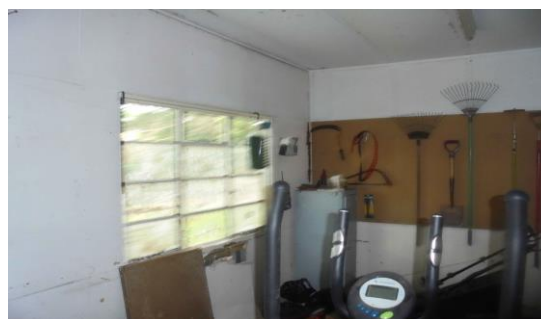
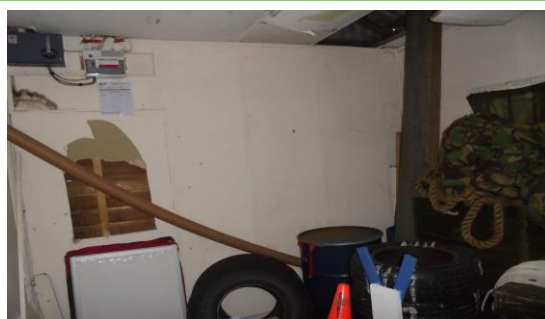
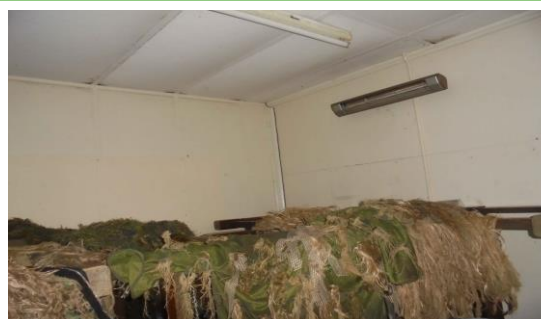
**Location: Cadet Hut – Four Rooms and Corridor**

<b>Material Description:</b>	Visual Inspection – No Suspect Materials Found	
<b>Identification:</b>	N/A	
<b>Approx. quantity:</b>	N/A	
<b>Accessibility</b>	N/A	<i>Assessment Score</i>
<b>Product type:</b>		N/A
<b>Extent of Damage:</b>		N/A
<b>Surface Treatment:</b>		N/A
<b>Asbestos type:</b>		N/A
<b>Material Assessment Score:</b>		N/A
<b>Priority Assessment Score:</b>		N/A
<b>Action:</b>	N/A	
<b>Comments:</b>	Non-Asbestos fiberboard ceiling and wall panels

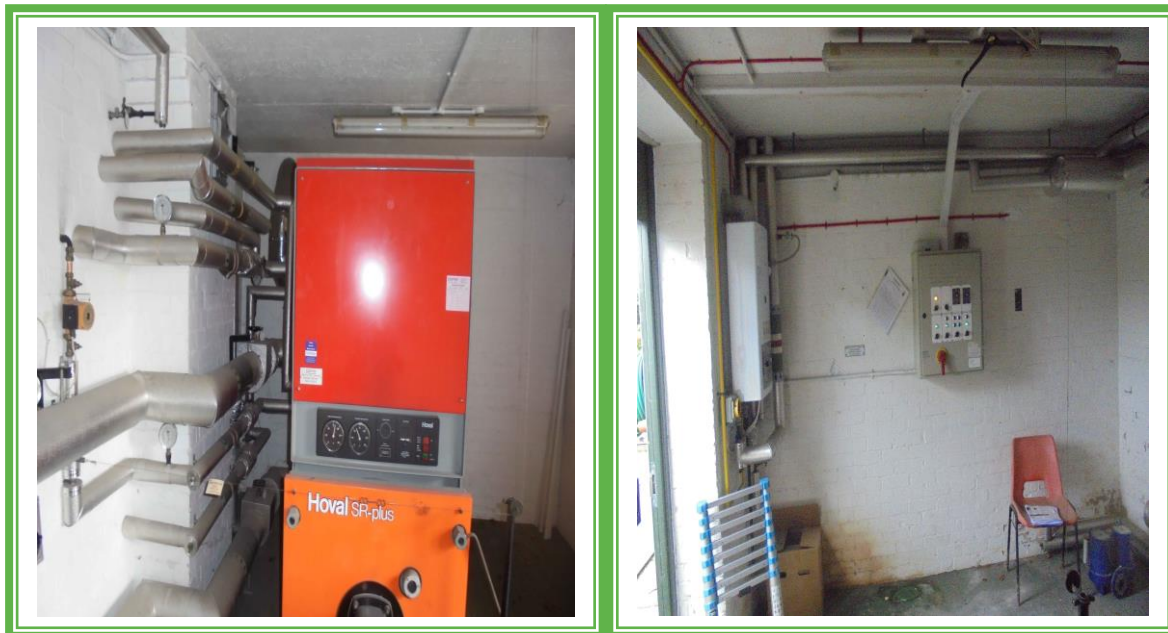
**Location: Boiler Room**

<b>Material Description:</b>	Visual Inspection – No Suspect Materials Found	
<b>Identification:</b>	N/A	
<b>Approx. quantity:</b>	N/A	
<b>Accessibility</b>	N/A	<i>Assessment Score</i>
<b>Product type:</b>		N/A
<b>Extent of Damage:</b>		N/A
<b>Surface Treatment:</b>		N/A
<b>Asbestos type:</b>		N/A
<b>Material Assessment Score:</b>		N/A
<b>Priority Assessment Score:</b>		N/A
<b>Action:</b>	N/A	
<b>Comments:</b>	Modern Boiler, Electrics and Pipework

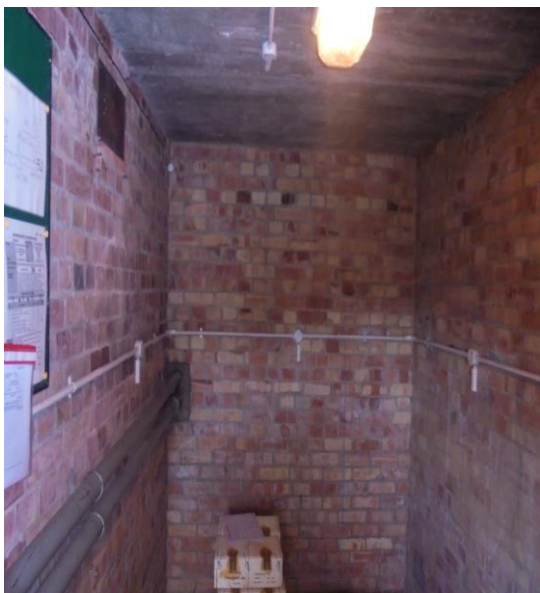
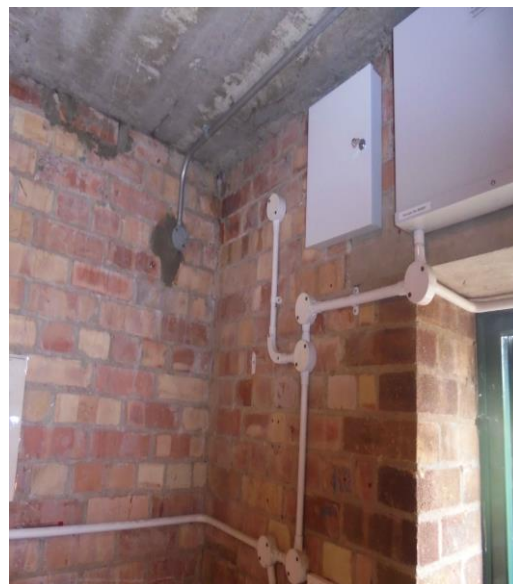
**Item No: 81****Sample No: N/A****Location: Ammunition Store**

<b>Material Description:</b>	Visual Inspection – No Suspect Materials Found	
<b>Identification:</b>	N/A	
<b>Approx. quantity:</b>	N/A	
<b>Accessibility</b>	N/A	<i>Assessment Score</i>
<b>Product type:</b>		N/A
<b>Extent of Damage:</b>		N/A
<b>Surface Treatment:</b>		N/A
<b>Asbestos type:</b>		N/A
<b>Material Assessment Score:</b>		N/A
<b>Priority Assessment Score:</b>		N/A
<b>Action:</b>	N/A	
<b>Comments:</b>	N/A
