**Project Number 3700**

**Re-Inspection  
Asbestos Survey Report**

**675 Army Air Corps  
Somerset  
TA1 5LJ**

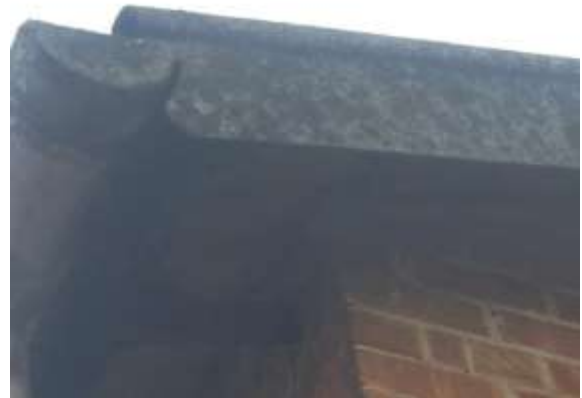
**Location:** External - Garages 032

<b>Material Description:</b>	Roof Edging - Cement Product	
<b>Identification:</b>	Previously Sampled - Asbestos Detected	
<b>Approx. quantity:</b>	8 LM	
<b>Accessibility</b>	Difficult	<i>Assessment Score</i>
<b>Product type:</b>	Cement	1
<b>Extent of Damage:</b>	Slight / minor damage	1
<b>Surface Treatment:</b>	Unsealed Cement	1
<b>Asbestos type:</b>	Chrysotile	1
<b>Material Assessment Score:</b>		4
<b>Priority Assessment Score:</b>		Negligible
<b>Action:</b>	Manage	
<b>Comments:</b>	No access to sample due to height restrictions
