**Project Number A-00520 (3700)**

**Re-Inspection  
Asbestos Survey Report - Revised**

**6th Battalion The Rifles C  
Poundbury Road  
Dorset  
DT1 1TA**

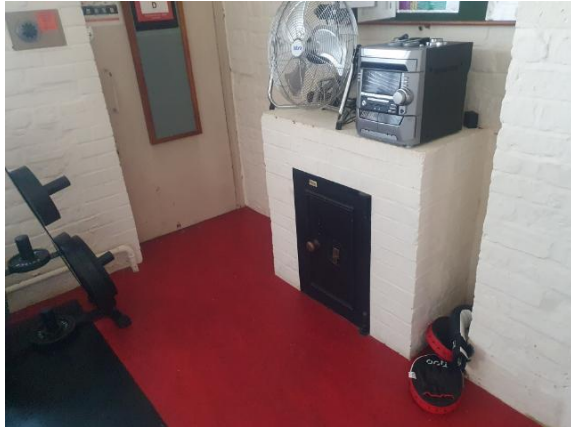
**Location:** Ground Floor - Building 1 - Boiler Room 008

<b>Material Description:</b>	Safe Casings - Insulating Board	
<b>Identification:</b>	Presumed to Contain Asbestos	
<b>Approx. quantity:</b>	1 no	
<b>Accessibility</b>	Difficult	<i>Assessment Score</i>
<b>Product type:</b>	Asbestos Insulating Board	2
<b>Extent of Damage:</b>	Major damage	3
<b>Surface Treatment:</b>	Unsealed Insulation	3
<b>Asbestos type:</b>	Amosite, Chrysotile	2
<b>Material Assessment Score:</b>		10
<b>Priority Assessment Score:</b>		High
<b>Action:</b>	Manage	
<b>Comments:</b>	No access within safe casings

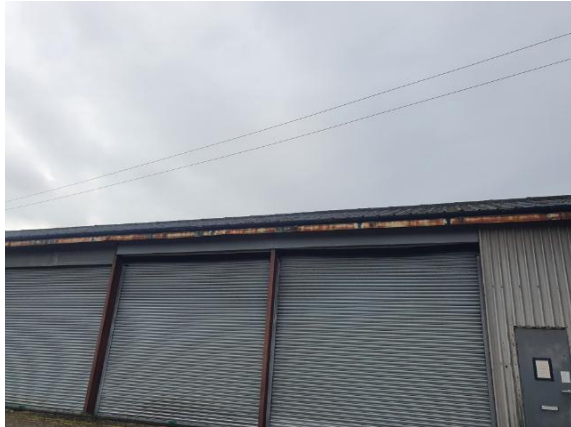
**Location:** Ground Floor - MT Garage 023

<b>Material Description:</b>	Roof Sheets - Cement Product	
<b>Identification:</b>	Previously Sampled - Asbestos Detected	
<b>Approx. quantity:</b>	280 m <sup>2</sup>	
<b>Accessibility</b>	Difficult	<i>Assessment Score</i>
<b>Product type:</b>	Cement	1
<b>Extent of Damage:</b>	Slight / minor damage	1
<b>Surface Treatment:</b>	Unsealed Cement	1
<b>Asbestos type:</b>	Chrysotile	1
<b>Material Assessment Score:</b>		4
<b>Priority Assessment Score:</b>		Negligible
<b>Action:</b>	Manage	
<b>Comments:</b>	Previously sampled ref: Armour Sample DK/21

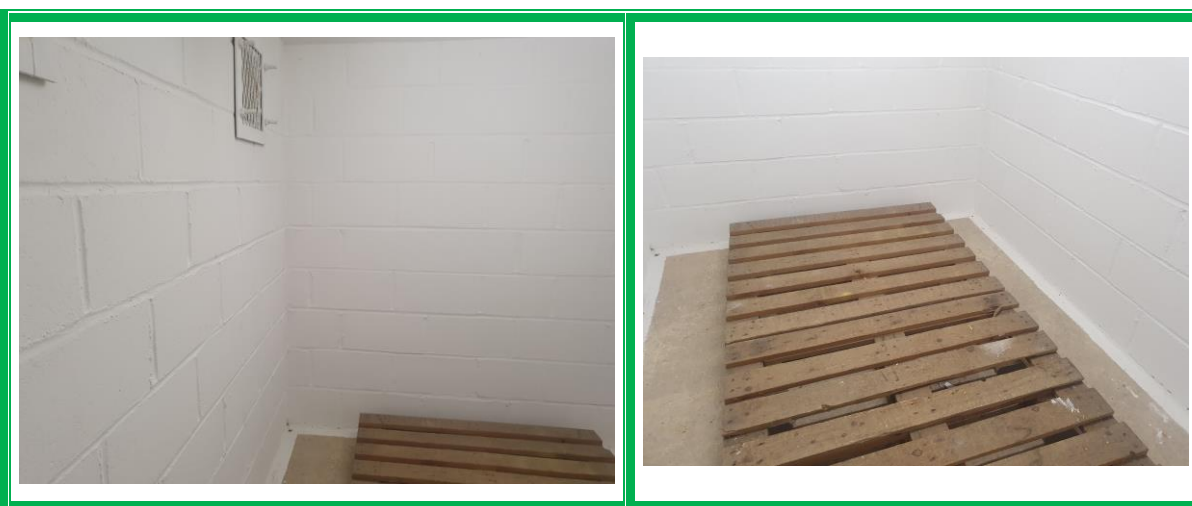
<b>Item No:</b>	<b>43</b>	<b>Sample No:</b>	<b>N/A</b>
<b>Location:</b>	Ground Floor - Building 1 - Armoury and Ammo Bunker 043

<b>Material Description:</b>	No Suspect Materials Found	
<b>Identification:</b>	N/A	
<b>Approx. quantity:</b>	N/A	
<b>Accessibility</b>	N/A	<i>Assessment Score</i>
<b>Product type:</b>	N/A	N/A
<b>Extent of Damage:</b>	N/A	N/A
<b>Surface Treatment:</b>	N/A	N/A
<b>Asbestos type:</b>	N/A	N/A
<b>Material Assessment Score:</b>		N/A
<b>Priority Assessment Score:</b>		N/A
<b>Action:</b>	N/A	
<b>Comments:</b>	Previously a no access area now accessed. No asbestos suspected.

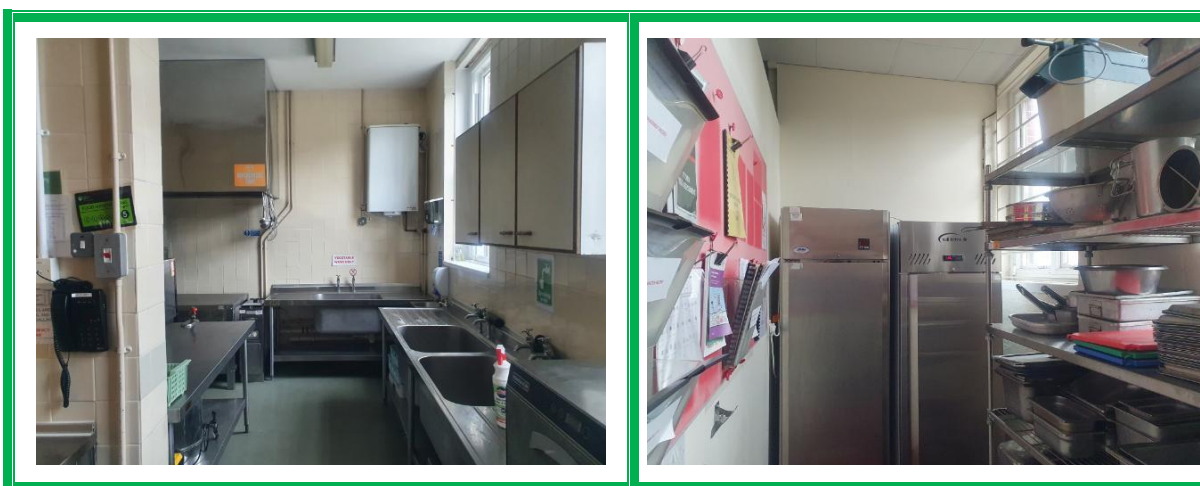
<b>Item No:</b>	<b>45</b>	<b>Sample No:</b>	<b>N/A</b>
<b>Location:</b>	Ground Floor - Building 1 - Main Kitchen 045

<b>Material Description:</b>	No Suspect Materials Found	
<b>Identification:</b>	N/A	
<b>Approx. quantity:</b>	N/A	
<b>Accessibility</b>	N/A	<i>Assessment Score</i>
<b>Product type:</b>	N/A	N/A
<b>Extent of Damage:</b>	N/A	N/A
<b>Surface Treatment:</b>	N/A	N/A
<b>Asbestos type:</b>	N/A	N/A
<b>Material Assessment Score:</b>		N/A
<b>Priority Assessment Score:</b>		N/A
<b>Action:</b>	N/A	
<b>Comments:</b>	N/A

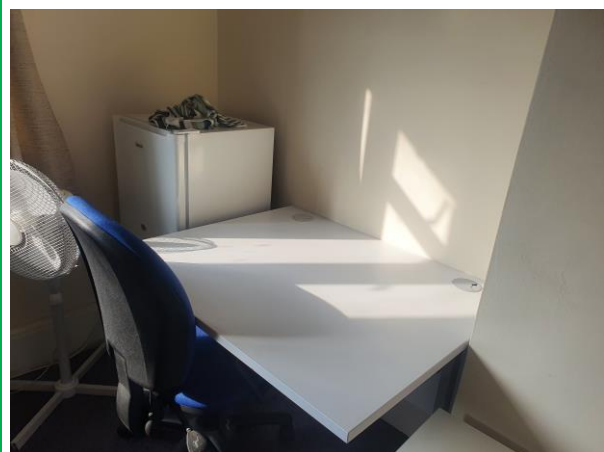
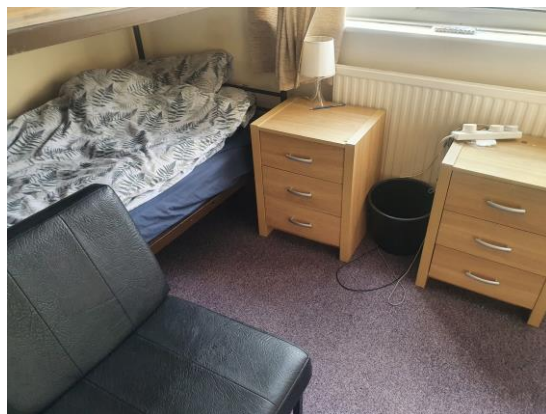
**Location:** First Floor - Adult Accommodation - Room 3 046

<b>Material Description:</b>	No Suspect Materials Found	
<b>Identification:</b>	N/A	
<b>Approx. quantity:</b>	N/A	
<b>Accessibility</b>	N/A	<i>Assessment Score</i>
<b>Product type:</b>	N/A	N/A
<b>Extent of Damage:</b>	N/A	N/A
<b>Surface Treatment:</b>	N/A	N/A
<b>Asbestos type:</b>	N/A	N/A
<b>Material Assessment Score:</b>		N/A
<b>Priority Assessment Score:</b>		N/A
<b>Action:</b>	N/A	
<b>Comments:</b>	Previously a no access area now accessed. No asbestos suspected.

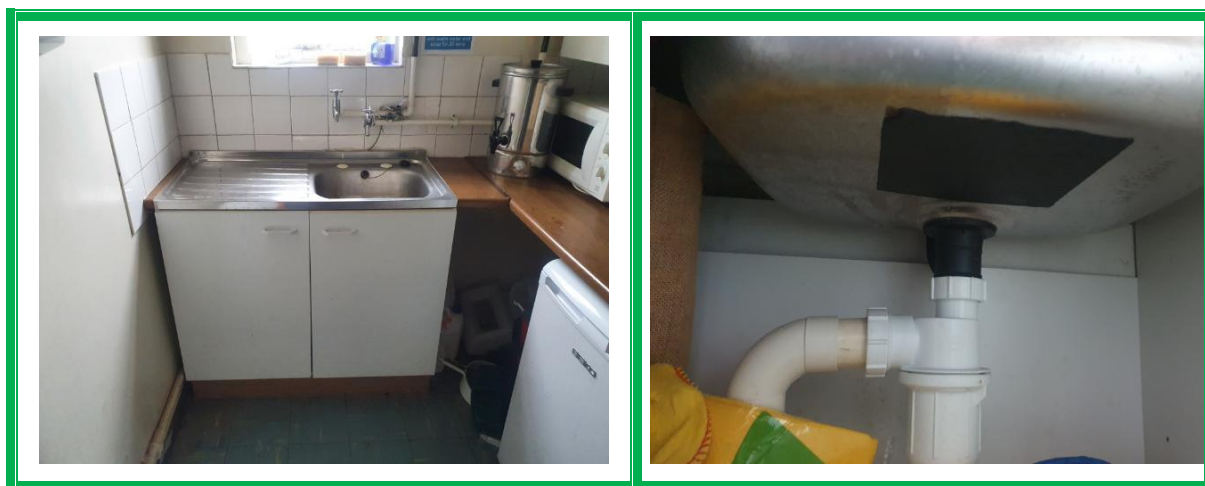
**Location:** First Floor - Building 1 - Canteen 047

<b>Material Description:</b>	Sink Pad - Bituminous Product	
<b>Identification:</b>	Sampled - No Asbestos Found	
<b>Approx. quantity:</b>	N/A	
<b>Accessibility</b>	N/A	<i>Assessment Score</i>
<b>Product type:</b>	N/A	N/A
<b>Extent of Damage:</b>	N/A	N/A
<b>Surface Treatment:</b>	N/A	N/A
<b>Asbestos type:</b>	N/A	N/A
<b>Material Assessment Score:</b>		N/A
<b>Priority Assessment Score:</b>		N/A
<b>Action:</b>	N/A	
<b>Comments:</b>	N/A

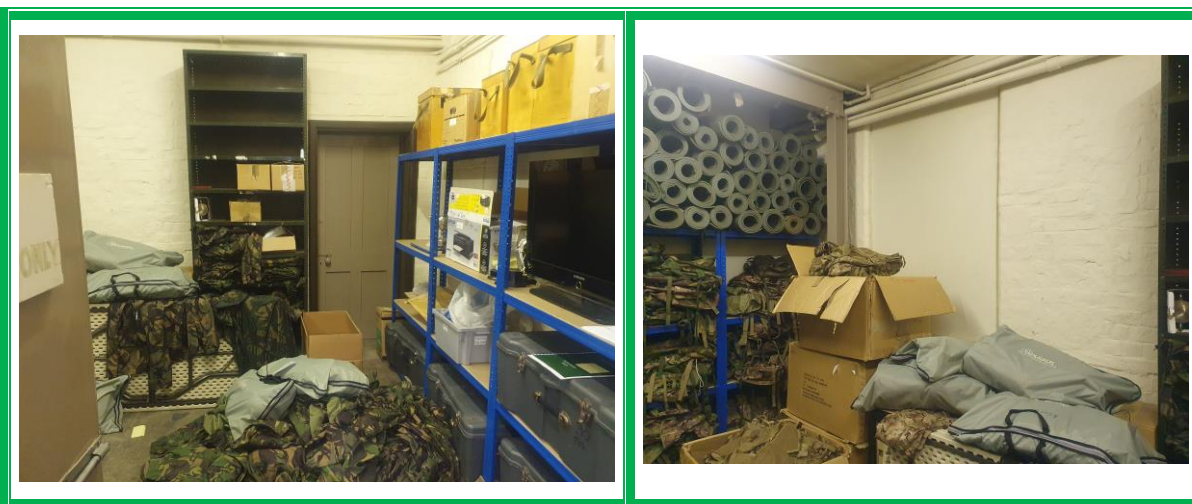
<b>Item No:</b>	<b>49</b>	<b>Sample No:</b>	<b>N/A</b>
<b>Location:</b>	ACF Stores x 2

<b>Material Description:</b>	No Asbestos Suspected	
<b>Identification:</b>	N/A	
<b>Approx. quantity:</b>	N/A	
<b>Accessibility</b>	N/A	<i>Assessment Score</i>
<b>Product type:</b>	N/A	N/A
<b>Extent of Damage:</b>	N/A	N/A
<b>Surface Treatment:</b>	N/A	N/A
<b>Asbestos type:</b>	N/A	N/A
<b>Material Assessment Score:</b>		N/A
<b>Priority Assessment Score:</b>		N/A
<b>Action:</b>	N/A	
<b>Comments:</b>	Previously a no access area now accessed. No asbestos suspected.
