Project Number 2481

**Management
Asbestos Survey Report**

**Shepton Mallet Platoon, Charlton Road,
Somerset, BA4 5AR**

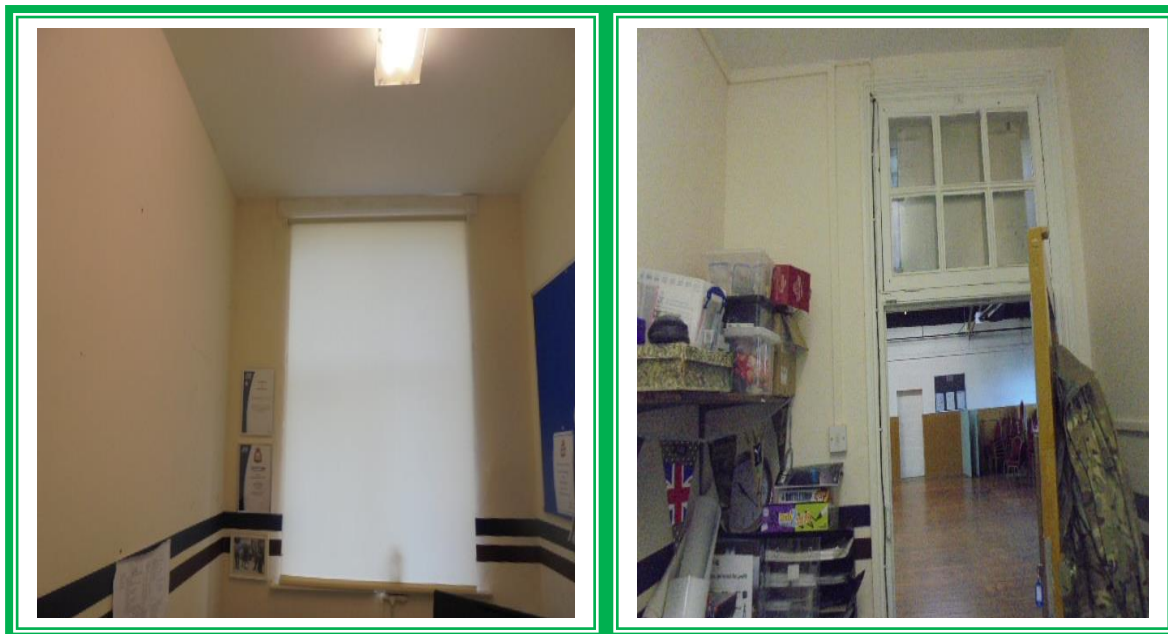
Location: Ground Floor - Office 2

Material Description:	Visual Inspection – No Suspect Materials Found	
Identification:	N/A	
Approx. quantity:	N/A	
Accessibility	N/A	<i>Assessment Score</i>
Product type:	N/A	N/A
Extent of Damage:	N/A	N/A
Surface Treatment:	N/A	N/A
Asbestos type:	N/A	N/A
Material Assessment Score:		N/A
Priority Assessment Score:		N/A
Action:	N/A	
Comments:	N/A

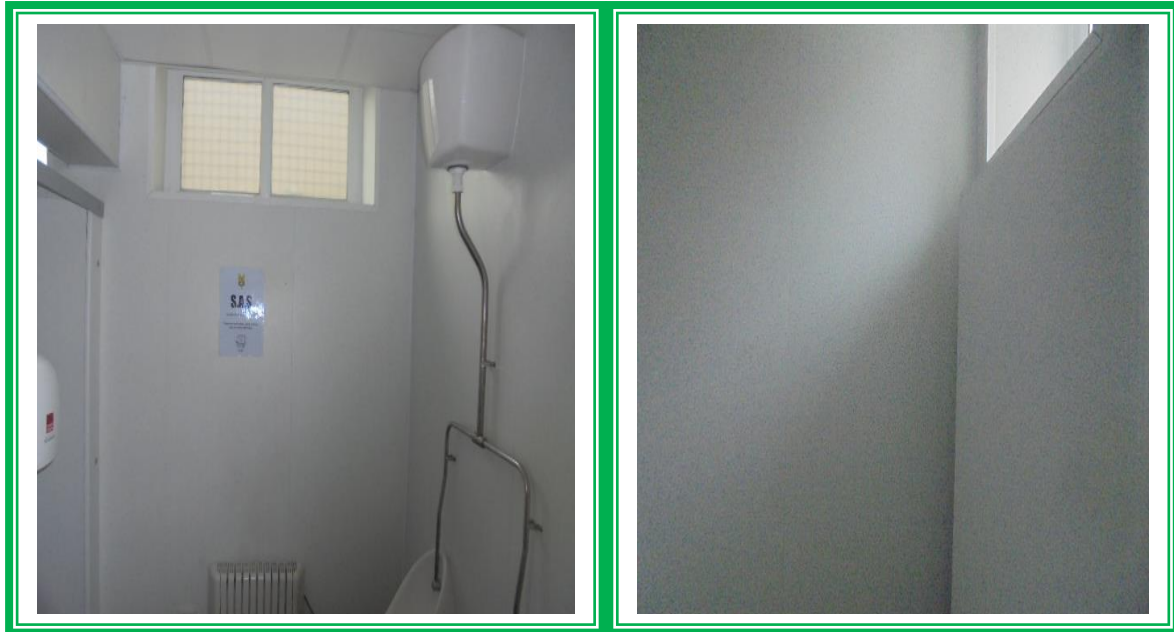
Location: Ground Floor - Men's WC

Material Description:	Visual Inspection – No Suspect Materials Found	
Identification:	N/A	
Approx. quantity:	N/A	
Accessibility	N/A	<i>Assessment Score</i>
Product type:	N/A	N/A
Extent of Damage:	N/A	N/A
Surface Treatment:	N/A	N/A
Asbestos type:	N/A	N/A
Material Assessment Score:		N/A
Priority Assessment Score:		N/A
Action:	N/A	
Comments:	N/A

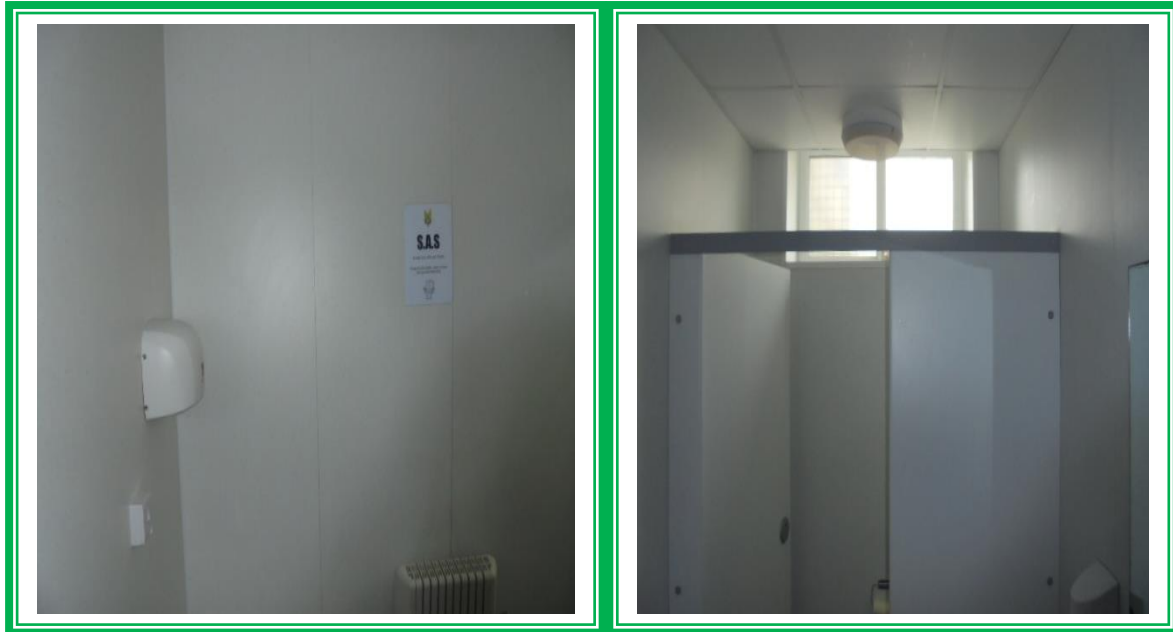
Location: Ground Floor - Ladies WC

Material Description:	Visual Inspection – No Suspect Materials Found	
Identification:	N/A	
Approx. quantity:	N/A	
Accessibility	N/A	<i>Assessment Score</i>
Product type:	N/A	N/A
Extent of Damage:	N/A	N/A
Surface Treatment:	N/A	N/A
Asbestos type:	N/A	N/A
Material Assessment Score:		N/A
Priority Assessment Score:		N/A
Action:	N/A	
Comments:	N/A

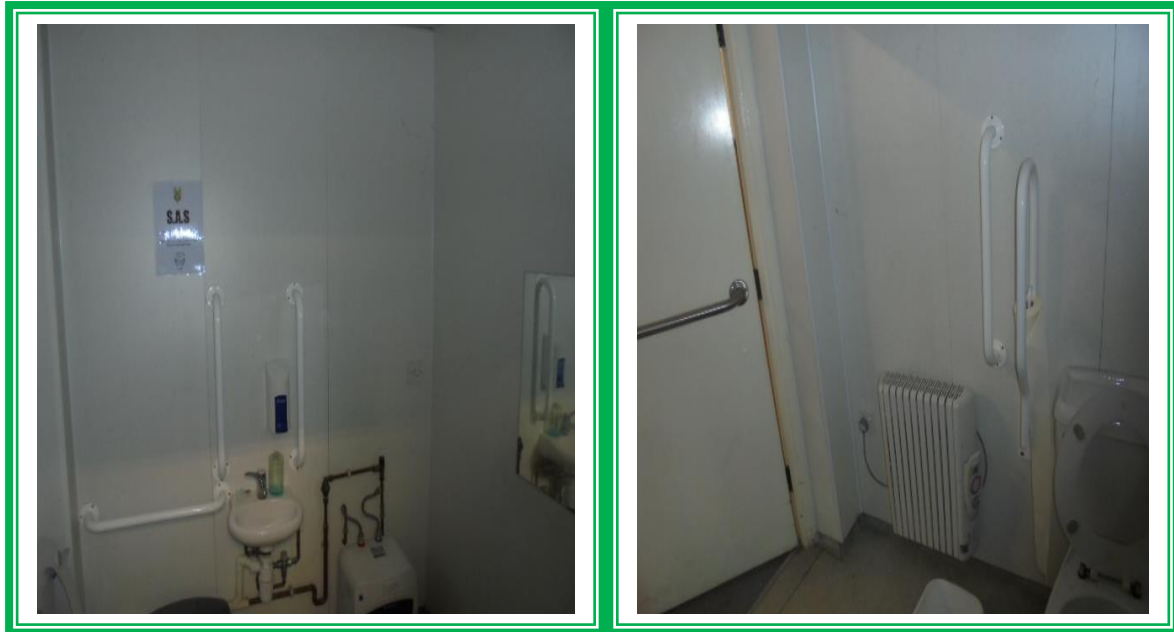
Location: Ground Floor - Staff WC

Material Description:	Visual Inspection – No Suspect Materials Found	
Identification:	N/A	
Approx. quantity:	N/A	
Accessibility	N/A	<i>Assessment Score</i>
Product type:	N/A	N/A
Extent of Damage:	N/A	N/A
Surface Treatment:	N/A	N/A
Asbestos type:	N/A	N/A
Material Assessment Score:		N/A
Priority Assessment Score:		N/A
Action:	N/A	
Comments:	N/A

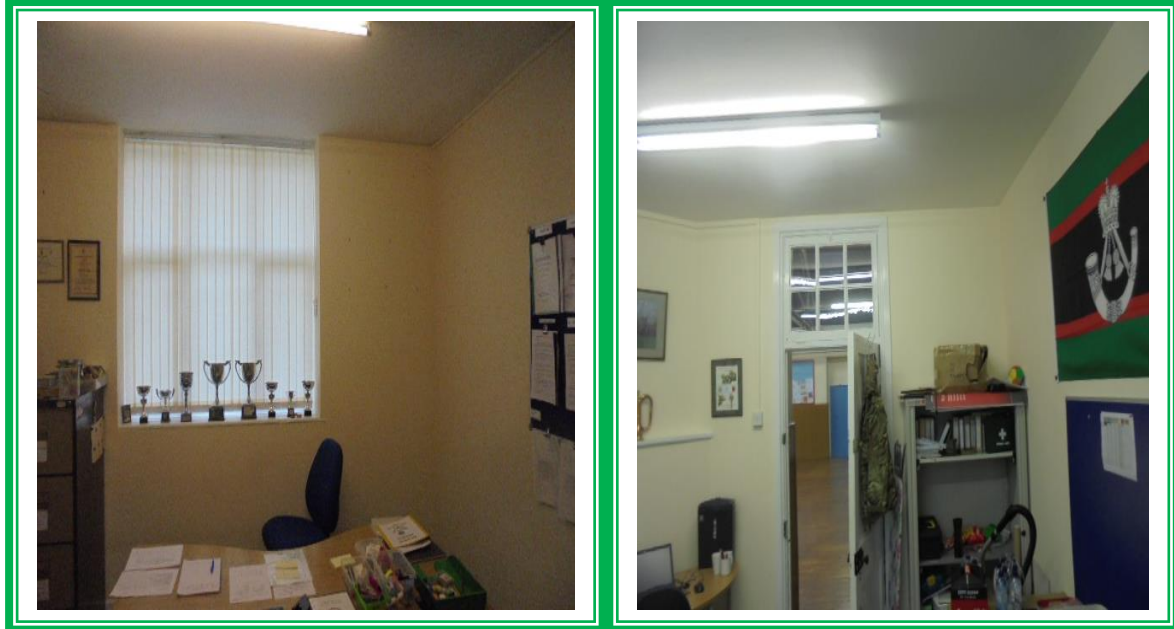
Location: Ground Floor - Platoon Office 13

Material Description:	Visual Inspection – No Suspect Materials Found	
Identification:	N/A	
Approx. quantity:	N/A	
Accessibility	N/A	<i>Assessment Score</i>
Product type:	N/A	N/A
Extent of Damage:	N/A	N/A
Surface Treatment:	N/A	N/A
Asbestos type:	N/A	N/A
Material Assessment Score:		N/A
Priority Assessment Score:		N/A
Action:	N/A	
Comments:	N/A

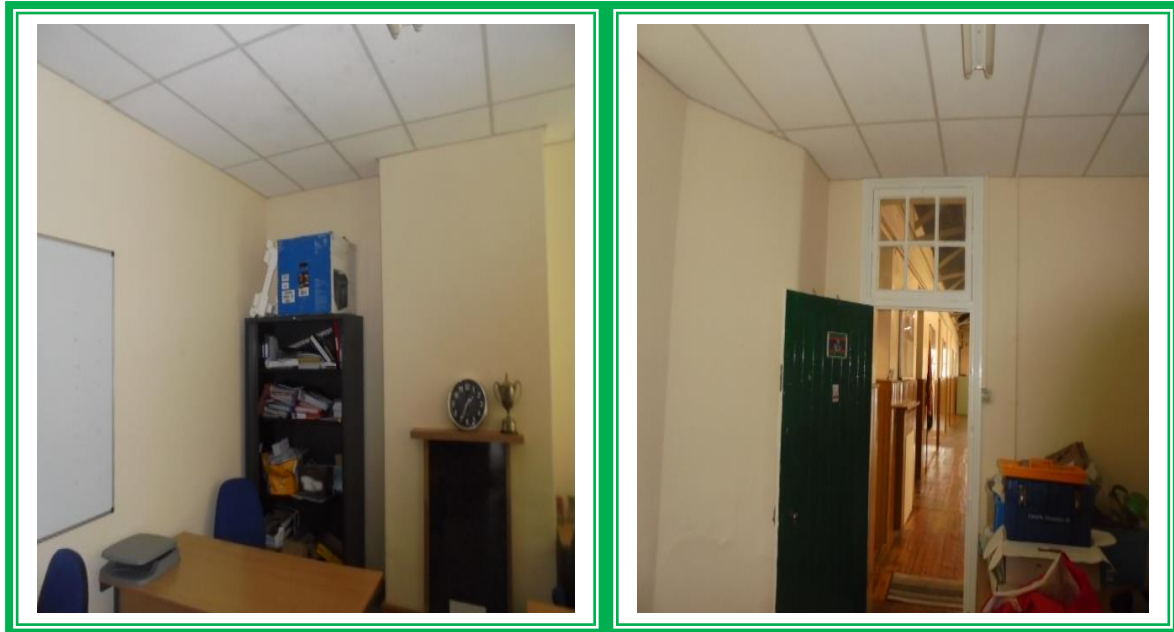
Location: Ground Floor - Office

Material Description:	Visual Inspection – No Suspect Materials Found	
Identification:	N/A	
Approx. quantity:	N/A	
Accessibility	N/A	Assessment Score
Product type:	N/A	N/A
Extent of Damage:	N/A	N/A
Surface Treatment:	N/A	N/A
Asbestos type:	N/A	N/A
Material Assessment Score:		N/A
Priority Assessment Score:		N/A
Action:	N/A	
Comments:	N/A

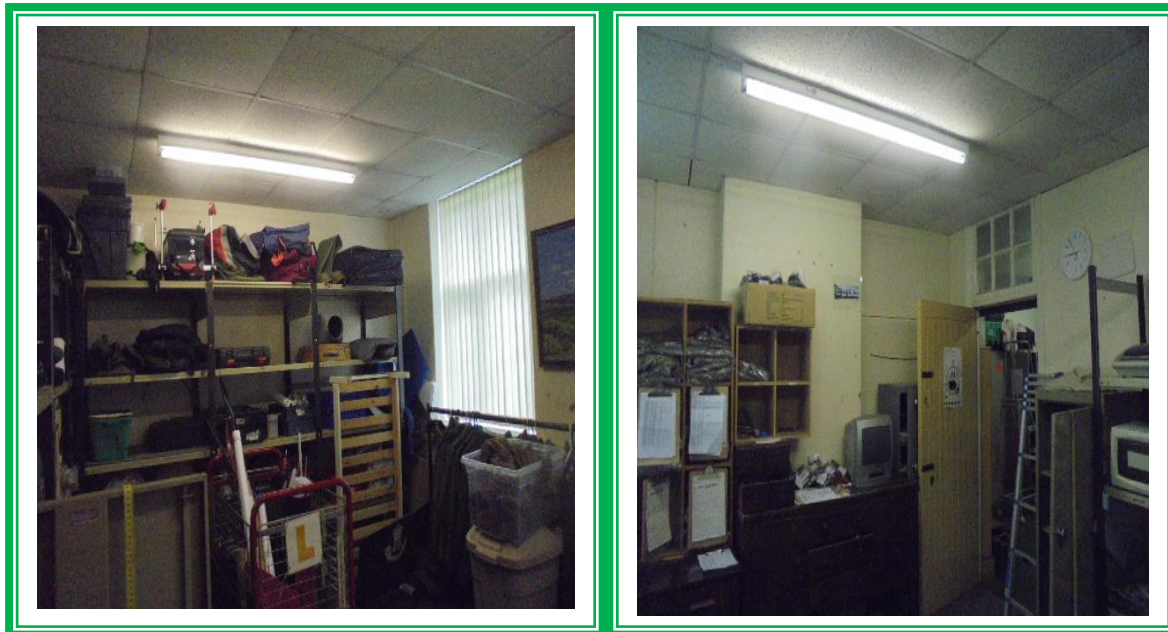
Location: Ground Floor - Stores

Material Description:	Visual Inspection – No Suspect Materials Found	
Identification:	N/A	
Approx. quantity:	N/A	
Accessibility	N/A	<i>Assessment Score</i>
Product type:	N/A	N/A
Extent of Damage:	N/A	N/A
Surface Treatment:	N/A	N/A
Asbestos type:	N/A	N/A
Material Assessment Score:		N/A
Priority Assessment Score:		N/A
Action:	N/A	
Comments:	N/A

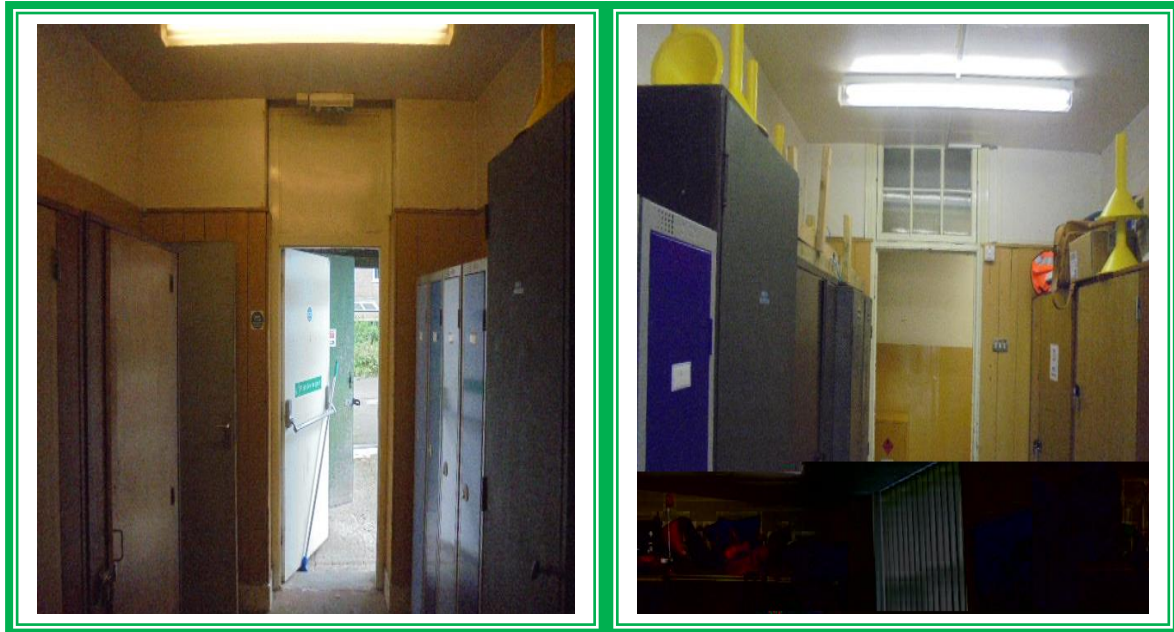
Location: Ground Floor - Lobby

Material Description:	Visual Inspection – No Suspect Materials Found	
Identification:	N/A	
Approx. quantity:	N/A	
Accessibility	N/A	<i>Assessment Score</i>
Product type:	N/A	N/A
Extent of Damage:	N/A	N/A
Surface Treatment:	N/A	N/A
Asbestos type:	N/A	N/A
Material Assessment Score:		N/A
Priority Assessment Score:		N/A
Action:	N/A	
Comments:	N/A

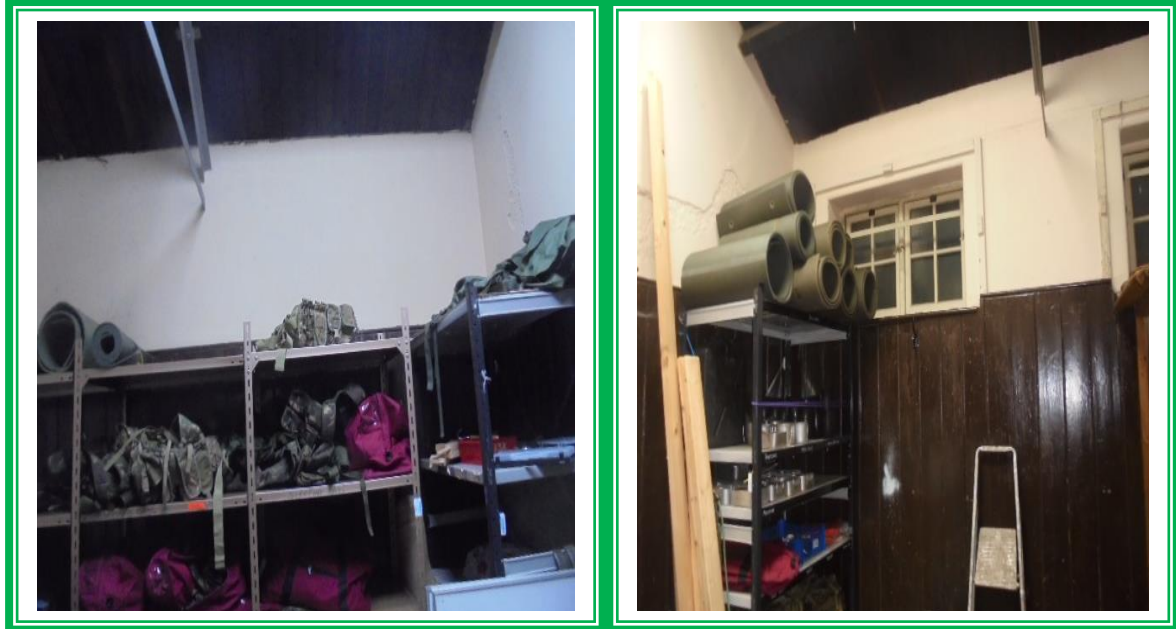
Location: Ground Floor - Store

Material Description:	Visual Inspection – No Suspect Materials Found	
Identification:	N/A	
Approx. quantity:	N/A	
Accessibility	N/A	<i>Assessment Score</i>
Product type:	N/A	N/A
Extent of Damage:	N/A	N/A
Surface Treatment:	N/A	N/A
Asbestos type:	N/A	N/A
Material Assessment Score:		N/A
Priority Assessment Score:		N/A
Action:	N/A	
Comments:	N/A

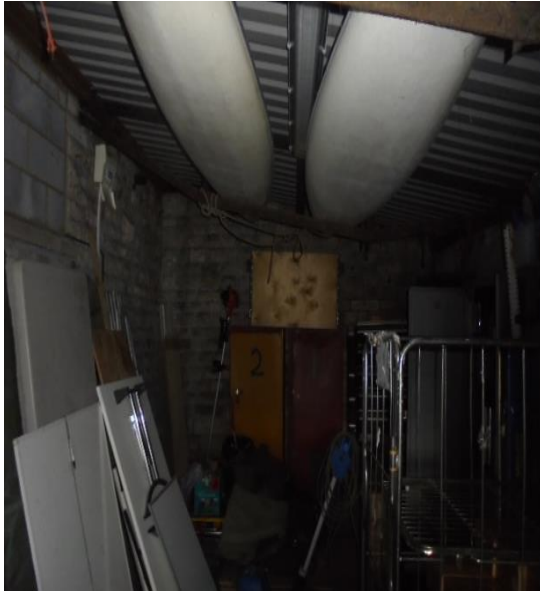
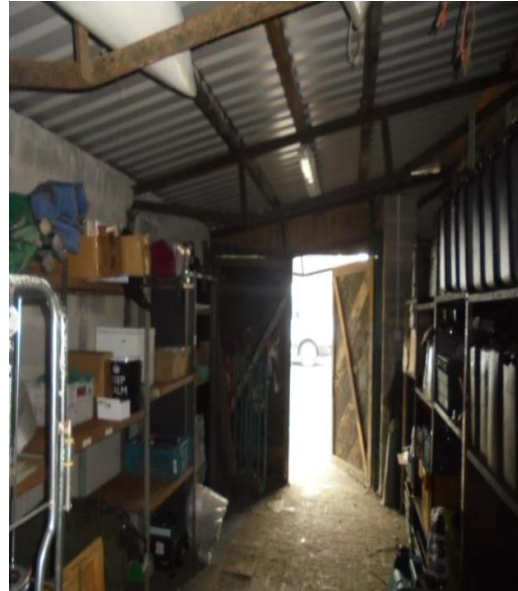
Location: Garage

Material Description:	Visual Inspection – No Suspect Materials Found	
Identification:	N/A	
Approx. quantity:	N/A	
Accessibility	N/A	<i>Assessment Score</i>
Product type:	N/A	N/A
Extent of Damage:	N/A	N/A
Surface Treatment:	N/A	N/A
Asbestos type:	N/A	N/A
Material Assessment Score:		N/A
Priority Assessment Score:		N/A
Action:	N/A	
Comments:	N/A

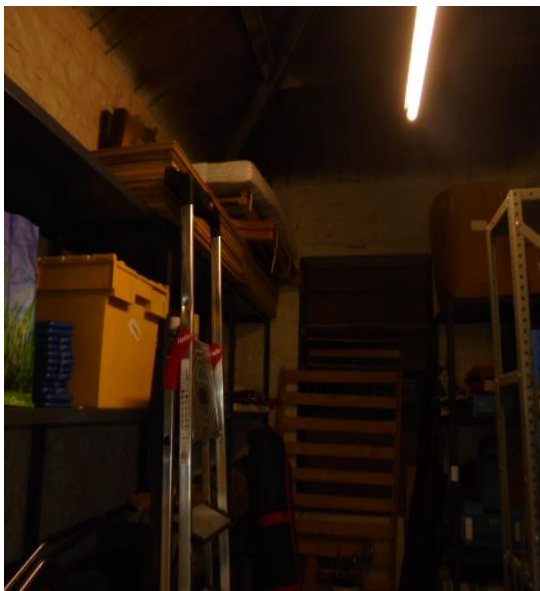
Location: Ground Floor - Store

Material Description:	Visual Inspection – No Suspect Materials Found	
Identification:	N/A	
Approx. quantity:	N/A	
Accessibility	N/A	<i>Assessment Score</i>
Product type:	N/A	N/A
Extent of Damage:	N/A	N/A
Surface Treatment:	N/A	N/A
Asbestos type:	N/A	N/A
Material Assessment Score:		N/A
Priority Assessment Score:		N/A
Action:	N/A	
Comments:	N/A

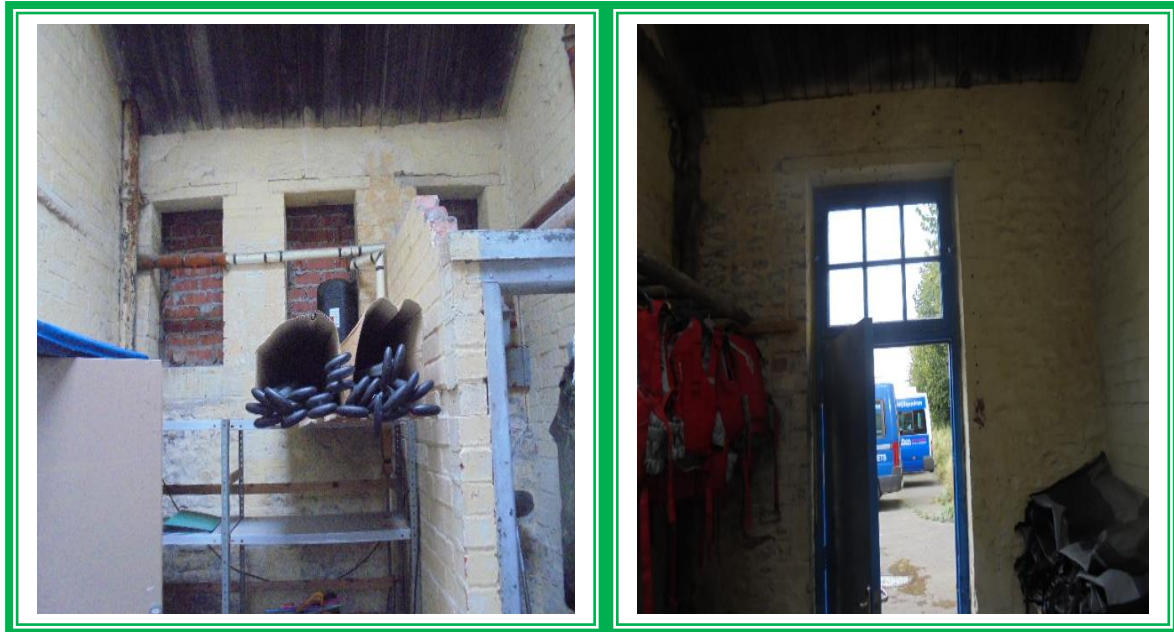
Location: Ground Floor - Store and WC

Material Description:	Visual Inspection – No Suspect Materials Found	
Identification:	N/A	
Approx. quantity:	N/A	
Accessibility	N/A	<i>Assessment Score</i>
Product type:	N/A	N/A
Extent of Damage:	N/A	N/A
Surface Treatment:	N/A	N/A
Asbestos type:	N/A	N/A
Material Assessment Score:		N/A
Priority Assessment Score:		N/A
Action:	N/A	
Comments:	N/A

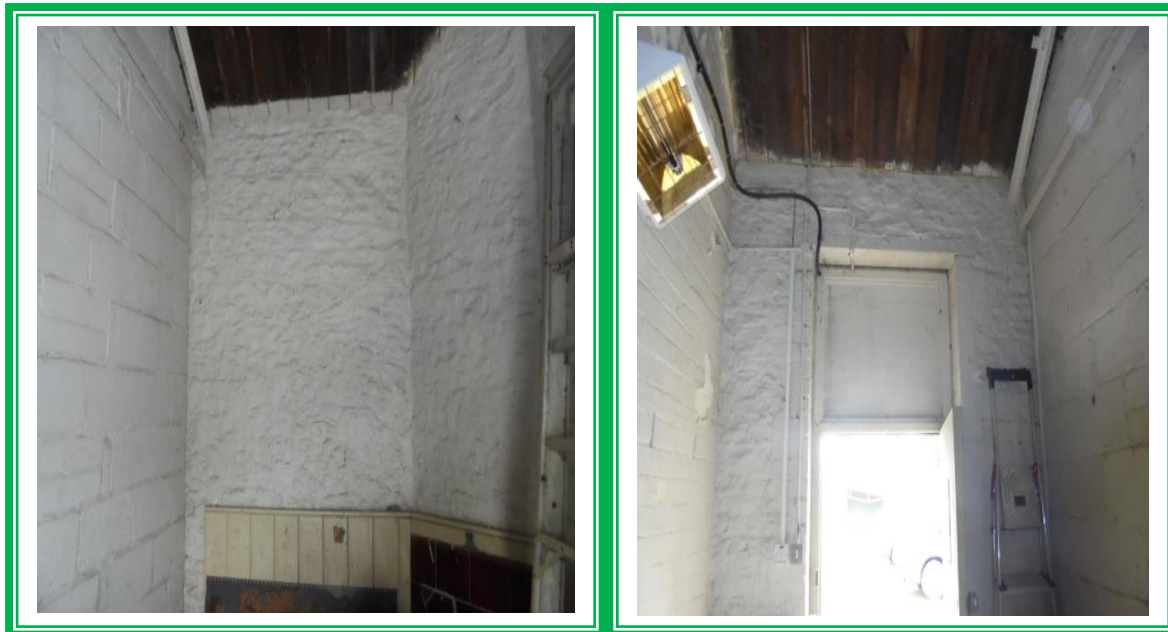
Location: Range Lobby

Material Description:	Visual Inspection – No Suspect Materials Found	
Identification:	N/A	
Approx. quantity:	N/A	
Accessibility	N/A	<i>Assessment Score</i>
Product type:	N/A	N/A
Extent of Damage:	N/A	N/A
Surface Treatment:	N/A	N/A
Asbestos type:	N/A	N/A
Material Assessment Score:		N/A
Priority Assessment Score:		N/A
Action:	N/A	
Comments:	N/A

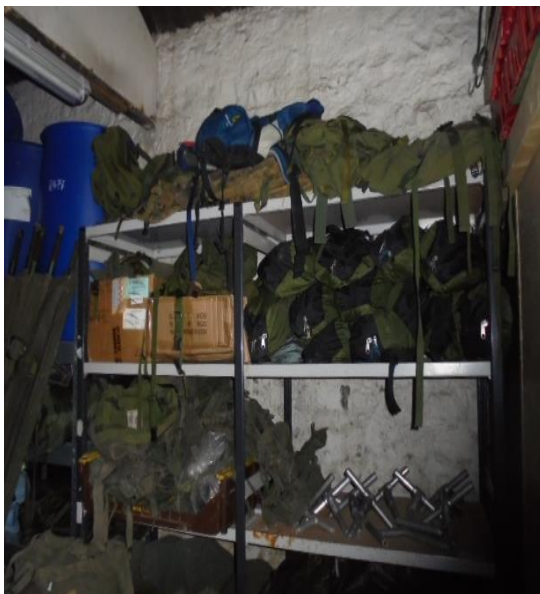
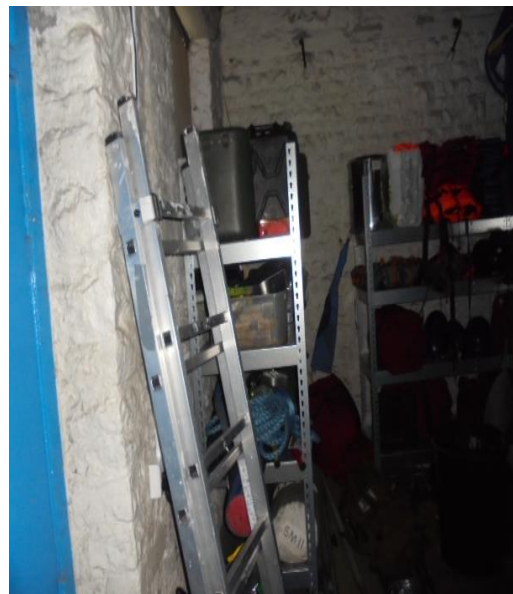
Location: Store

Material Description:	Visual Inspection – No Suspect Materials Found	
Identification:	N/A	
Approx. quantity:	N/A	
Accessibility	N/A	<i>Assessment Score</i>
Product type:	N/A	N/A
Extent of Damage:	N/A	N/A
Surface Treatment:	N/A	N/A
Asbestos type:	N/A	N/A
Material Assessment Score:		N/A
Priority Assessment Score:		N/A
Action:	N/A	
Comments:	N/A

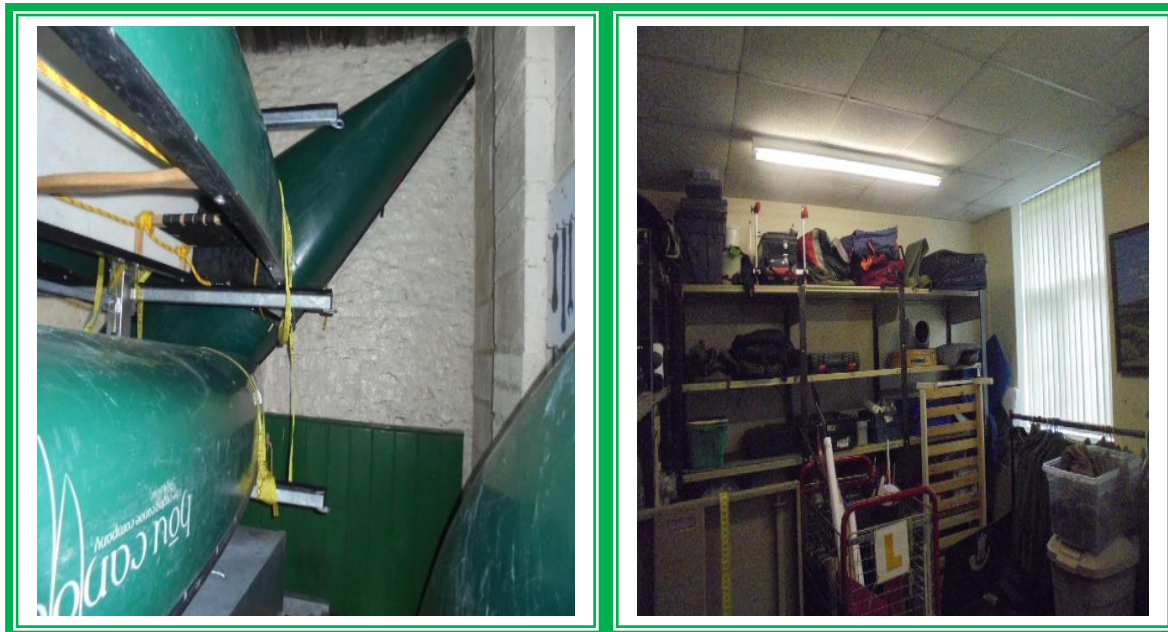
Location: Boat Store

Material Description:	Visual Inspection – No Suspect Materials Found	
Identification:	N/A	
Approx. quantity:	N/A	
Accessibility	N/A	<i>Assessment Score</i>
Product type:	N/A	N/A
Extent of Damage:	N/A	N/A
Surface Treatment:	N/A	N/A
Asbestos type:	N/A	N/A
Material Assessment Score:		N/A
Priority Assessment Score:		N/A
Action:	N/A	
Comments:	N/A
