Project Number 2481

**Management
Asbestos Survey Report**

**Wyvern Barracks, Barrack Road, Exeter, Devon,
EX2 6AE (Building 3)**

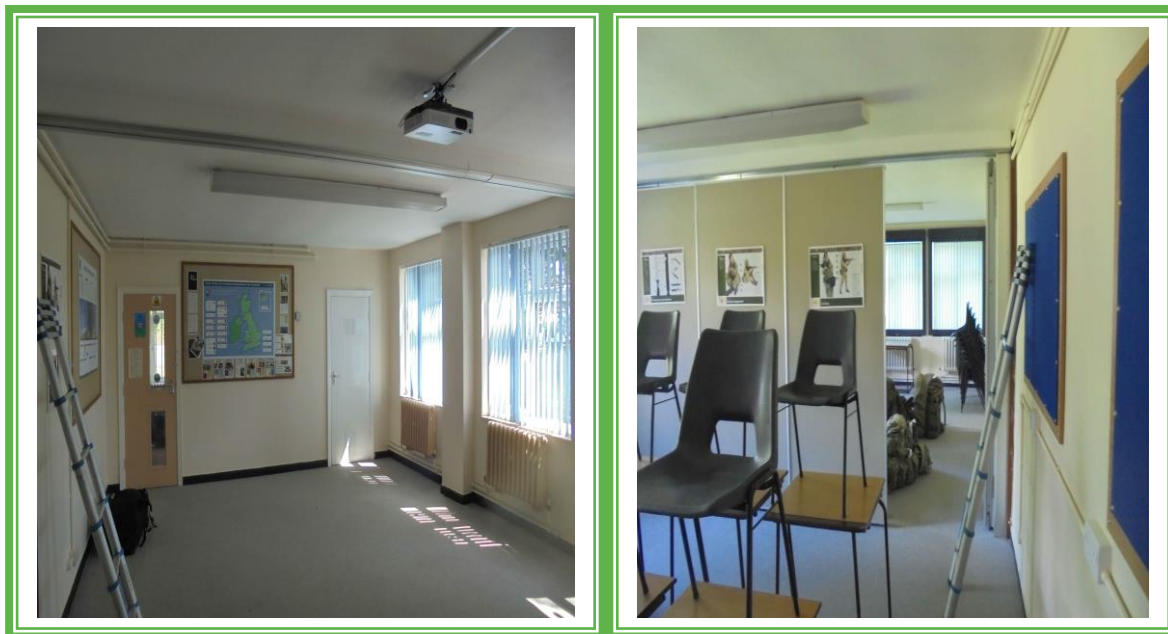
Location: Lecture Rooms 1,2 and 3 – Ground Floor

Material Description:	Visual Inspection – No Suspect Materials Found	
Identification:	N/A	
Approx. quantity:	N/A	
Accessibility	N/A	<i>Assessment Score</i>
Product type:		N/A
Extent of Damage:		N/A
Surface Treatment:		N/A
Asbestos type:		N/A
Material Assessment Score:		N/A
Priority Assessment Score:		N/A
Action:	N/A	
Comments:	N/A

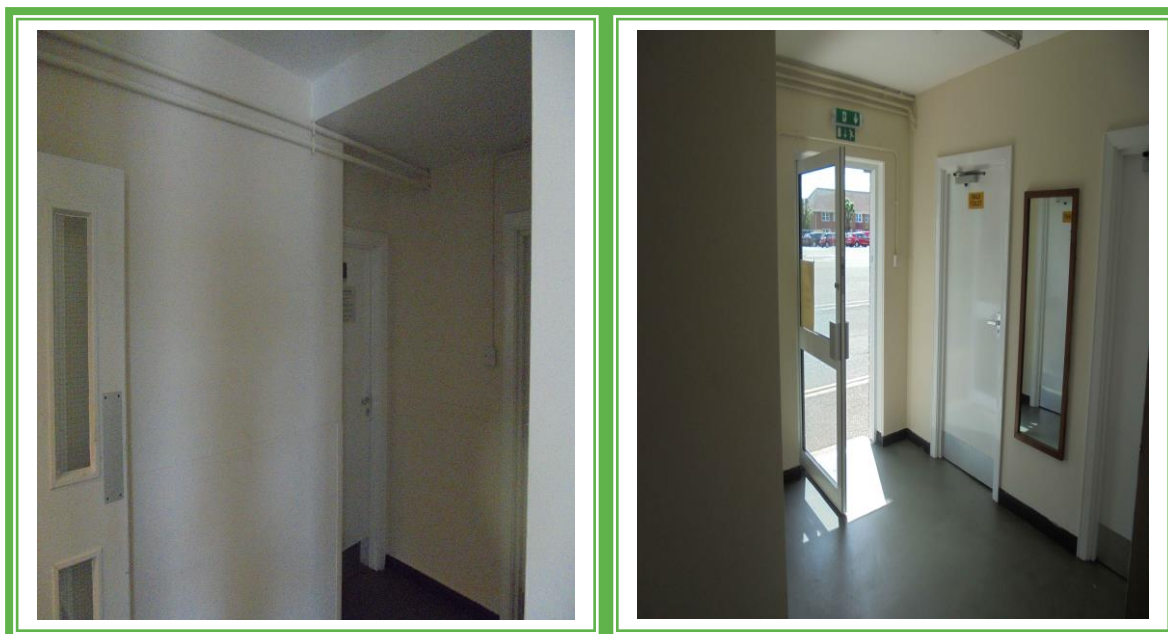
Location: Lobby/Circulation – Ground Floor

Material Description:	Visual Inspection – No Suspect Materials Found	
Identification:	N/A	
Approx. quantity:	N/A	
Accessibility	N/A	<i>Assessment Score</i>
Product type:		N/A
Extent of Damage:		N/A
Surface Treatment:		N/A
Asbestos type:		N/A
Material Assessment Score:		N/A
Priority Assessment Score:		N/A
Action:	N/A	
Comments:	N/A

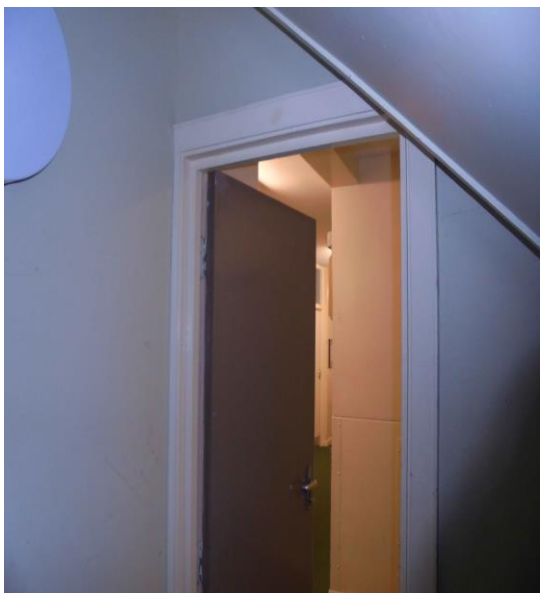
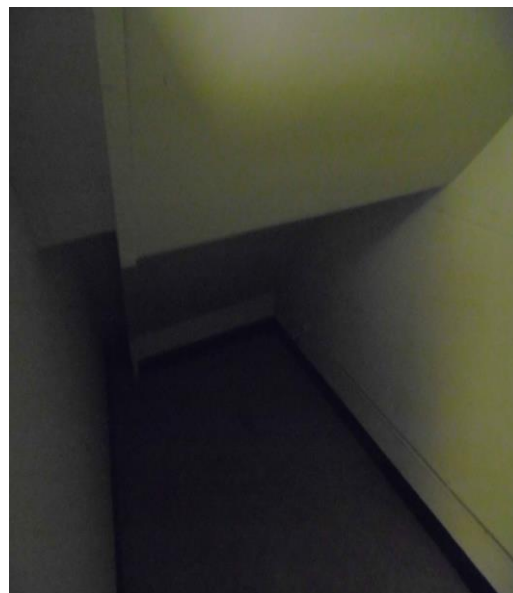
**Item No: 4****Sample No: N/A****Location: Store Cupboard**

Material Description:	Visual Inspection – No Suspect Materials Found	
Identification:	N/A	
Approx. quantity:	N/A	
Accessibility	N/A	<i>Assessment Score</i>
Product type:		N/A
Extent of Damage:		N/A
Surface Treatment:		N/A
Asbestos type:		N/A
Material Assessment Score:		N/A
Priority Assessment Score:		N/A
Action:	N/A	
Comments:	N/A

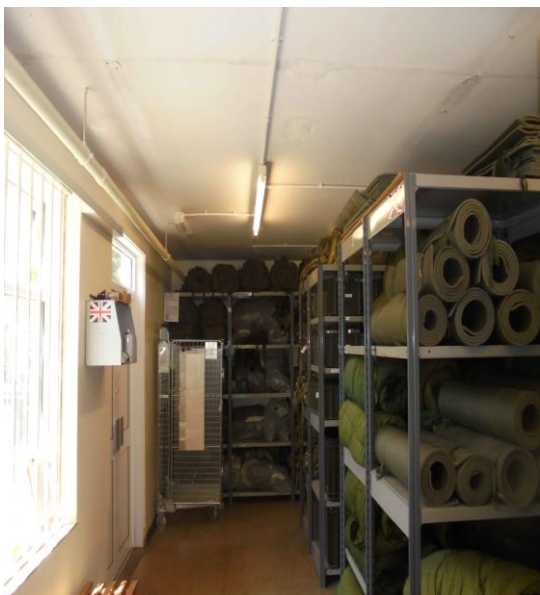
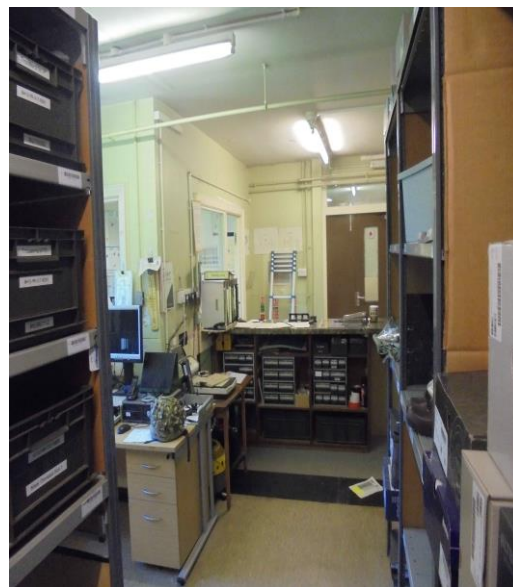
Location: Clothes Stores x 2 and Office

Material Description:	Visual Inspection – No Suspect Materials Found	
Identification:	N/A	
Approx. quantity:	N/A	
Accessibility	N/A	<i>Assessment Score</i>
Product type:		N/A
Extent of Damage:		N/A
Surface Treatment:		N/A
Asbestos type:		N/A
Material Assessment Score:		N/A
Priority Assessment Score:		N/A
Action:	N/A	
Comments:	N/A

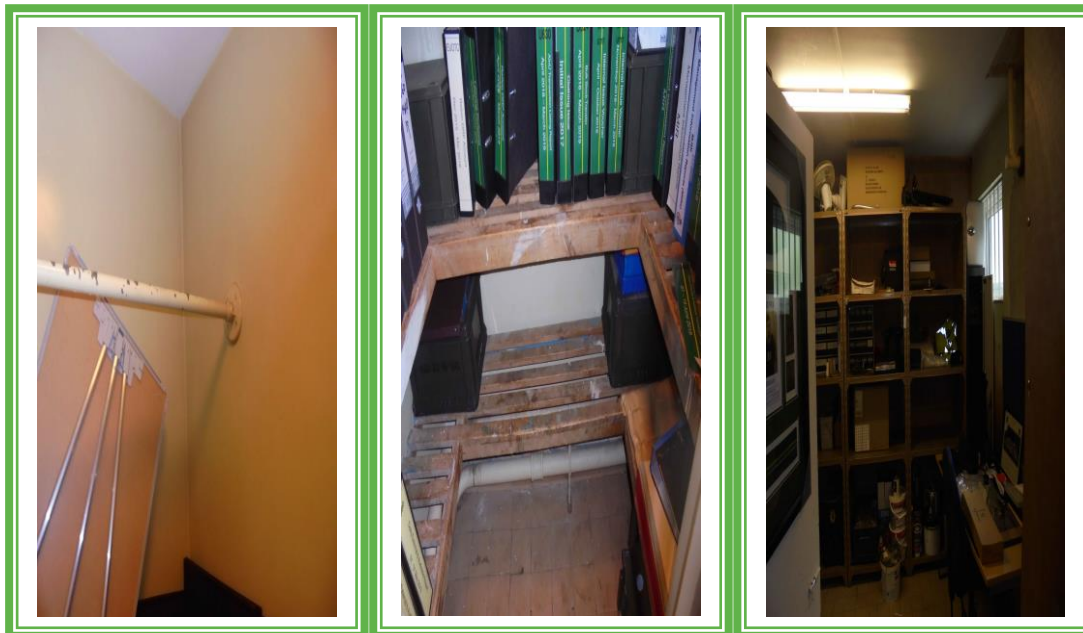
Location: Webbing Store, Cupboard and Drying Room

Material Description:	Visual Inspection – No Suspect Materials Found	
Identification:	N/A	
Approx. quantity:	N/A	
Accessibility	N/A	<i>Assessment Score</i>
Product type:		N/A
Extent of Damage:		N/A
Surface Treatment:		N/A
Asbestos type:		N/A
Material Assessment Score:		N/A
Priority Assessment Score:		N/A
Action:	N/A	
Comments:	N/A

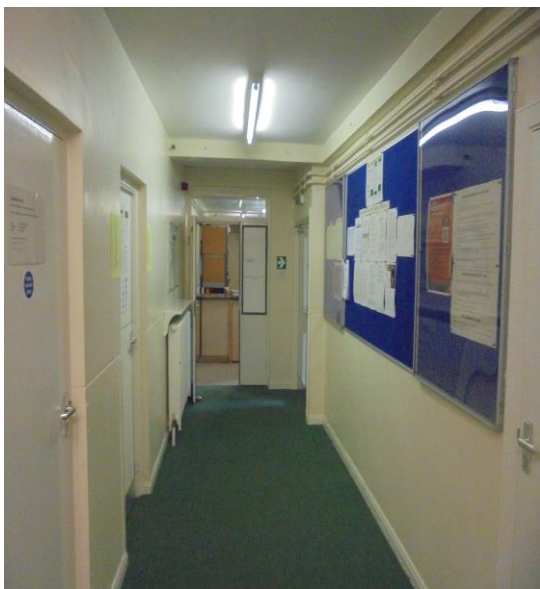
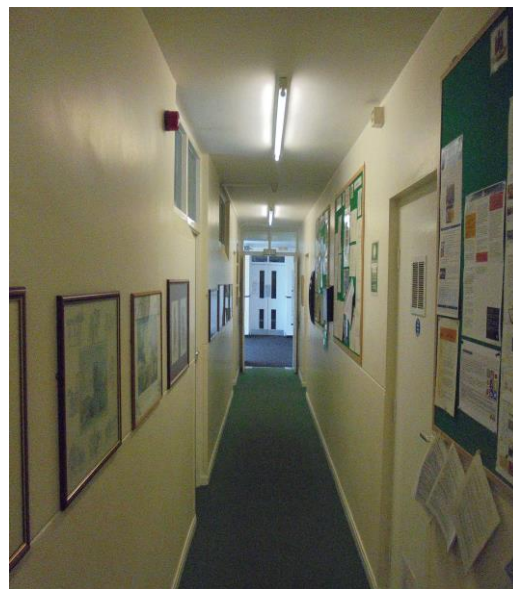
Location: Corridor – Ground Floor

Material Description:	Visual Inspection – No Suspect Materials Found	
Identification:	N/A	
Approx. quantity:	N/A	
Accessibility	N/A	<i>Assessment Score</i>
Product type:		N/A
Extent of Damage:		N/A
Surface Treatment:		N/A
Asbestos type:		N/A
Material Assessment Score:		N/A
Priority Assessment Score:		N/A
Action:	N/A	
Comments:	N/A

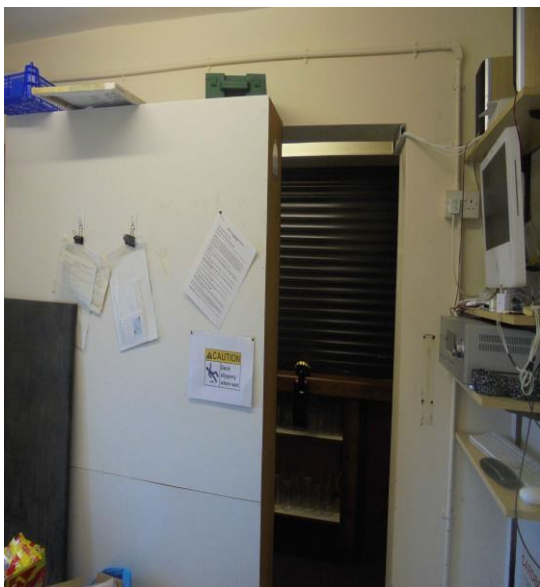
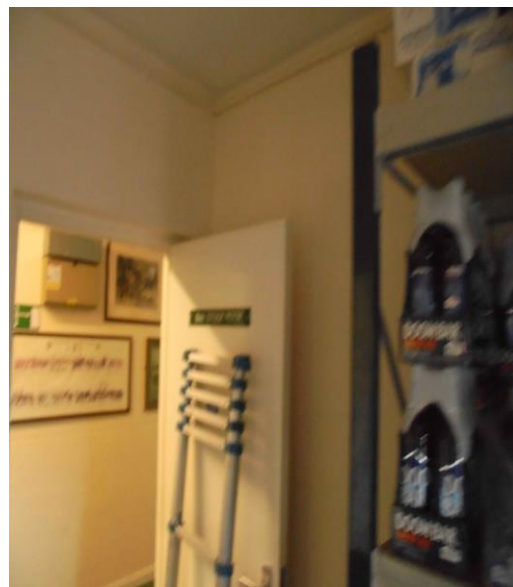
Location: Store, Servery and Bar – Ground Floor

Material Description:	Visual Inspection – No Suspect Materials Found	
Identification:	N/A	
Approx. quantity:	N/A	
Accessibility	N/A	<i>Assessment Score</i>
Product type:		N/A
Extent of Damage:		N/A
Surface Treatment:		N/A
Asbestos type:		N/A
Material Assessment Score:		N/A
Priority Assessment Score:		N/A
Action:	N/A	
Comments:	Modern sink pad

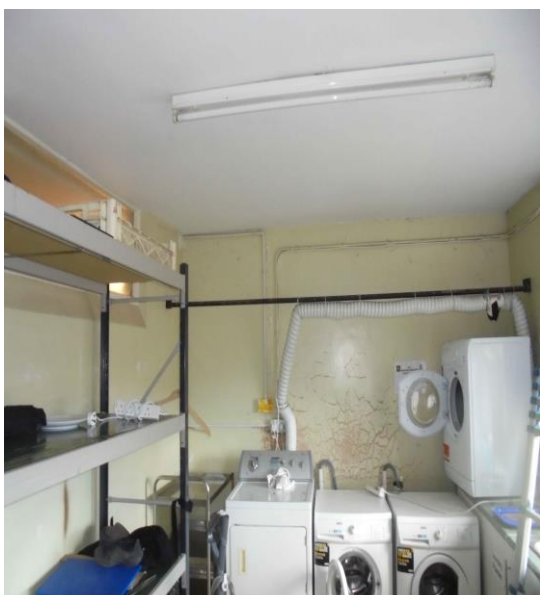
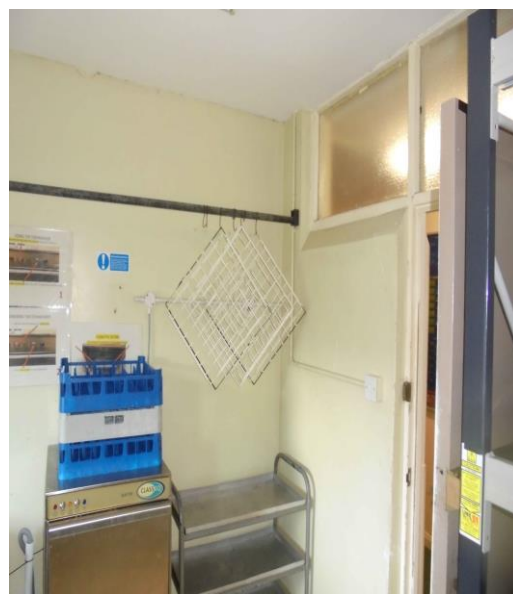
Location: Washroom

Material Description:	Visual Inspection – No Suspect Materials Found	
Identification:	N/A	
Approx. quantity:	N/A	
Accessibility	N/A	<i>Assessment Score</i>
Product type:		N/A
Extent of Damage:		N/A
Surface Treatment:		N/A
Asbestos type:		N/A
Material Assessment Score:		N/A
Priority Assessment Score:		N/A
Action:	N/A	
Comments:	N/A

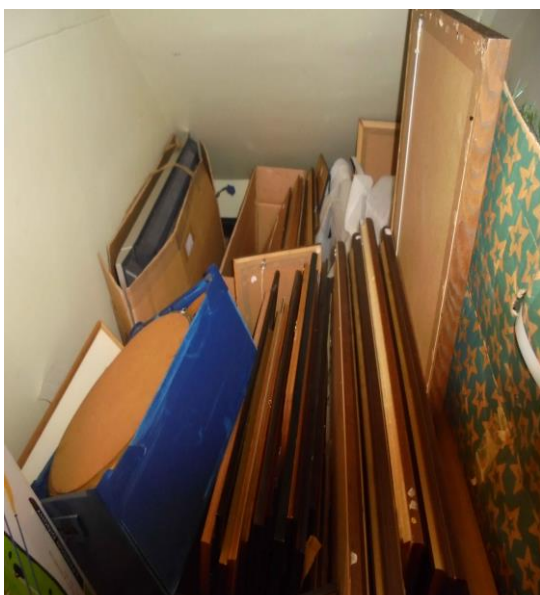
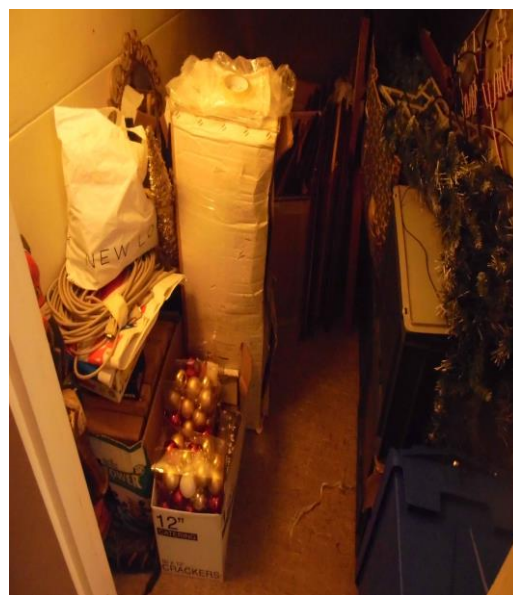
Location: Cupboard

Material Description:	Visual Inspection – No Suspect Materials Found	
Identification:	N/A	
Approx. quantity:	N/A	
Accessibility	N/A	<i>Assessment Score</i>
Product type:		N/A
Extent of Damage:		N/A
Surface Treatment:		N/A
Asbestos type:		N/A
Material Assessment Score:		N/A
Priority Assessment Score:		N/A
Action:	N/A	
Comments:	Limited access into store due to stored items

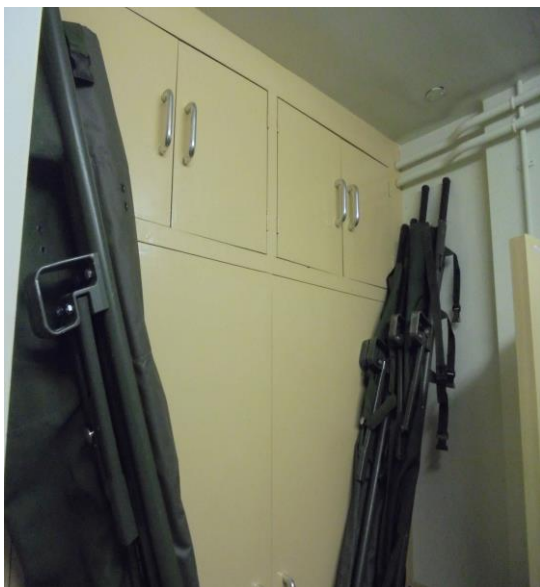
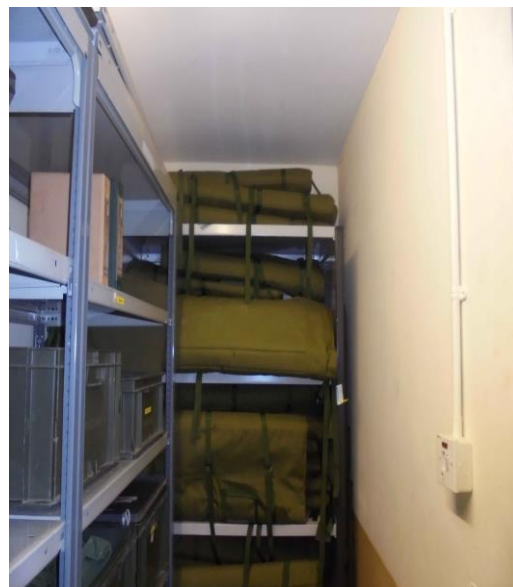
Location: Store

Material Description:	Visual Inspection – No Suspect Materials Found	
Identification:	N/A	
Approx. quantity:	N/A	
Accessibility	N/A	<i>Assessment Score</i>
Product type:		N/A
Extent of Damage:		N/A
Surface Treatment:		N/A
Asbestos type:		N/A
Material Assessment Score:		N/A
Priority Assessment Score:		N/A
Action:	N/A	
Comments:	N/A

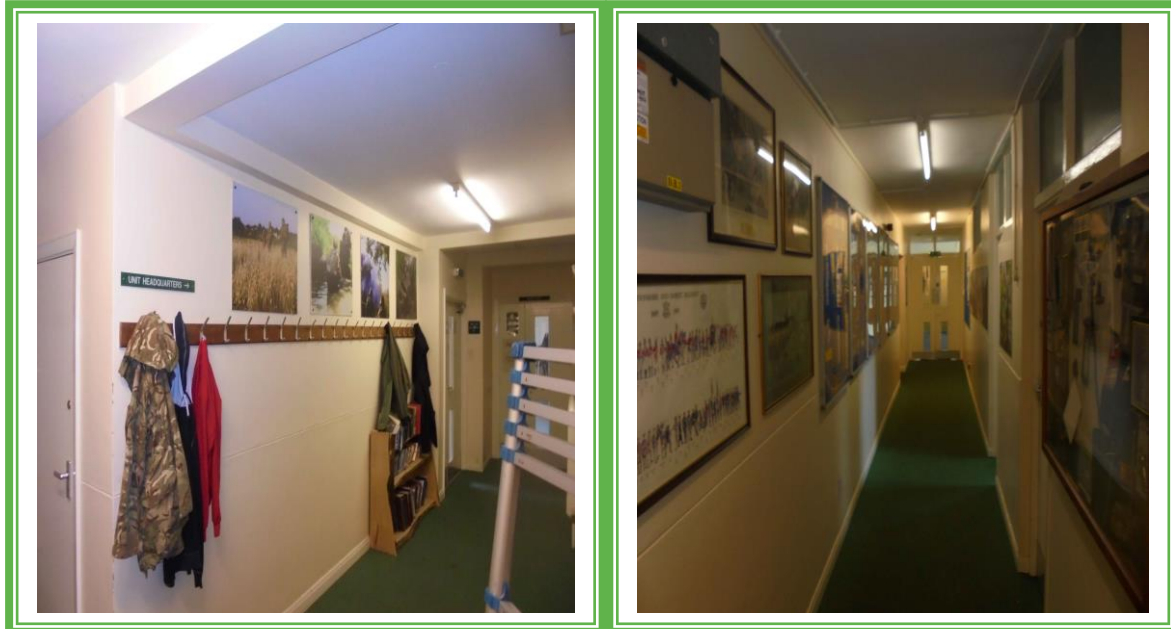
Location: Corridor – Ground Floor

Material Description:	Visual Inspection – No Suspect Materials Found	
Identification:	N/A	
Approx. quantity:	N/A	
Accessibility	N/A	<i>Assessment Score</i>
Product type:		N/A
Extent of Damage:		N/A
Surface Treatment:		N/A
Asbestos type:		N/A
Material Assessment Score:		N/A
Priority Assessment Score:		N/A
Action:	N/A	
Comments:	N/A

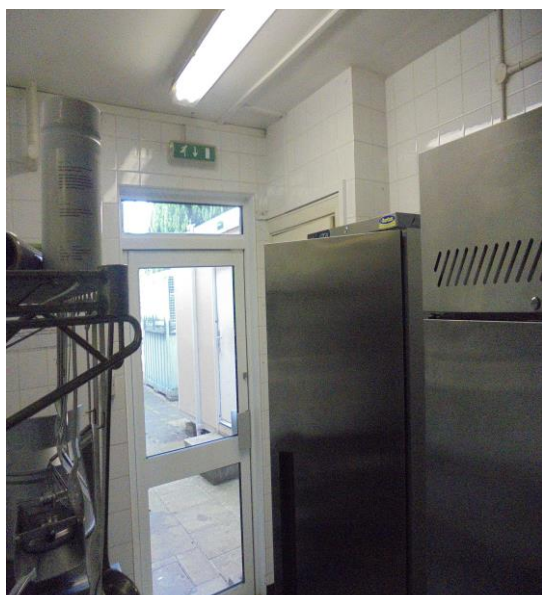
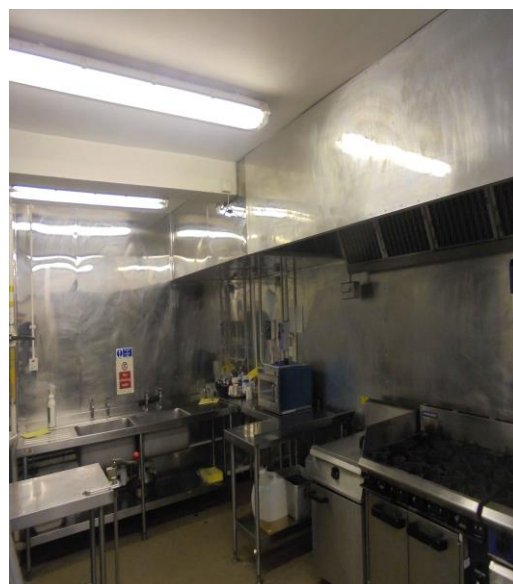
**Item No: 23****Sample No: N/A****Location: Kitchen – Ground Floor**

Material Description:	Visual Inspection – No Suspect Materials Found	
Identification:	N/A	
Approx. quantity:	N/A	
Accessibility	N/A	<i>Assessment Score</i>
Product type:		N/A
Extent of Damage:		N/A
Surface Treatment:		N/A
Asbestos type:		N/A
Material Assessment Score:		N/A
Priority Assessment Score:		N/A
Action:	N/A	
Comments:	Modern Sink Pad

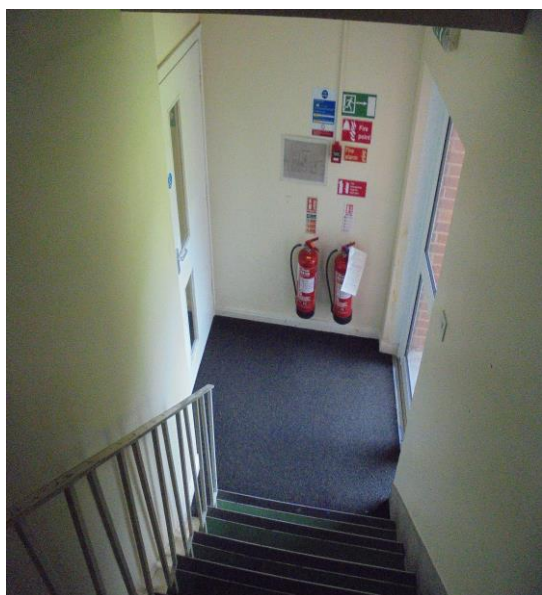
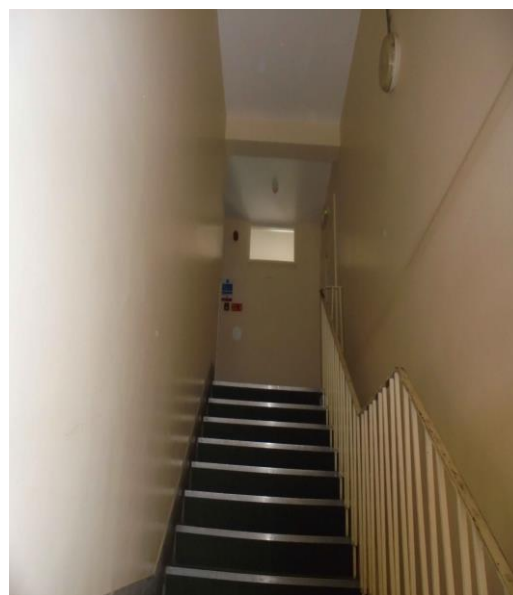
Location: Lobby, Stairwell and Landing

Material Description:	Visual Inspection – No Suspect Materials Found	
Identification:	N/A	
Approx. quantity:	N/A	
Accessibility	N/A	<i>Assessment Score</i>
Product type:		N/A
Extent of Damage:		N/A
Surface Treatment:		N/A
Asbestos type:		N/A
Material Assessment Score:		N/A
Priority Assessment Score:		N/A
Action:	N/A	
Comments:	Modern Stair Nosing

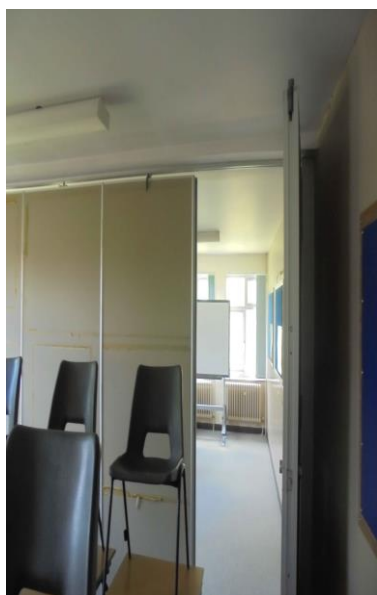
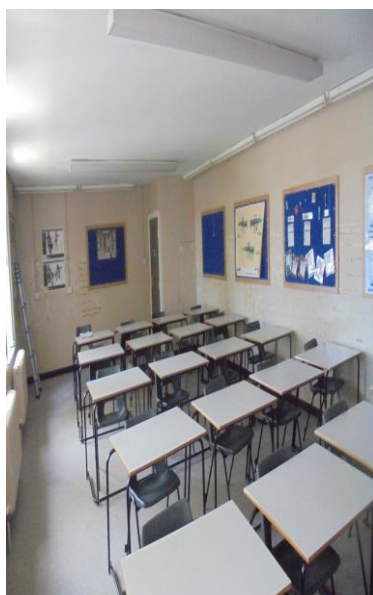
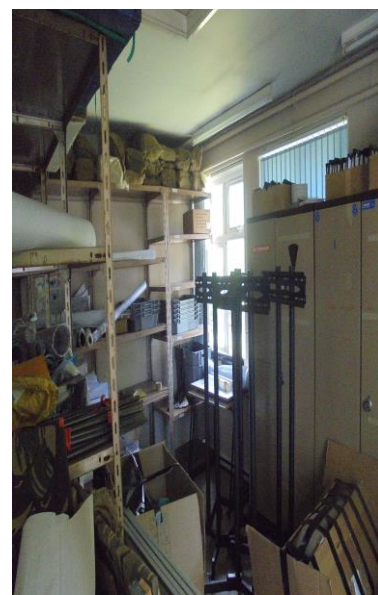
**Item No: 26****Sample No: N/A****Location: Lecture Room 2 and 3 – First Floor**

Material Description:	Visual Inspection – No Suspect Materials Found	
Identification:	N/A	
Approx. quantity:	N/A	
Accessibility	N/A	<i>Assessment Score</i>
Product type:		N/A
Extent of Damage:		N/A
Surface Treatment:		N/A
Asbestos type:		N/A
Material Assessment Score:		N/A
Priority Assessment Score:		N/A
Action:	N/A	
Comments:	N/A

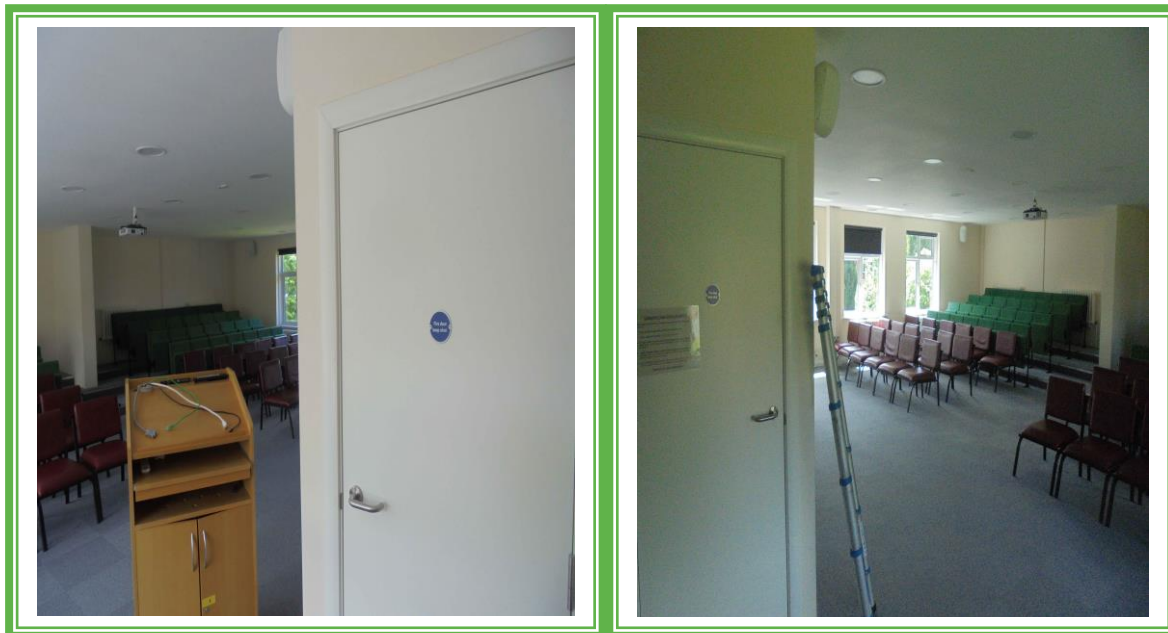
**Item No: 28****Sample No: N/A****Location: Cinema/ Lecture Room and Cupboards x 2**

Material Description:	Visual Inspection – No Suspect Materials Found	
Identification:	N/A	
Approx. quantity:	N/A	
Accessibility	N/A	<i>Assessment Score</i>
Product type:		N/A
Extent of Damage:		N/A
Surface Treatment:		N/A
Asbestos type:		N/A
Material Assessment Score:		N/A
Priority Assessment Score:		N/A
Action:	N/A	
Comments:	N/A

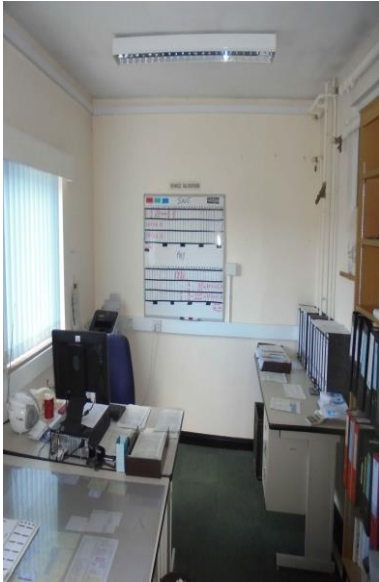
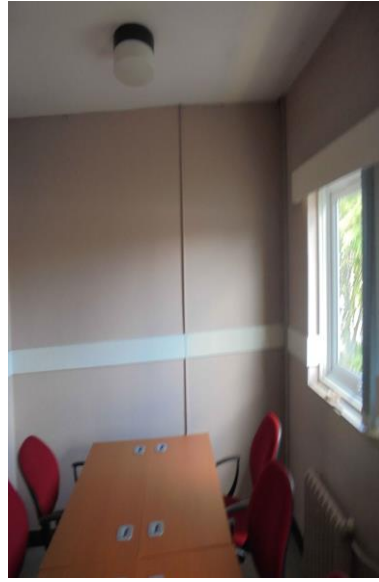
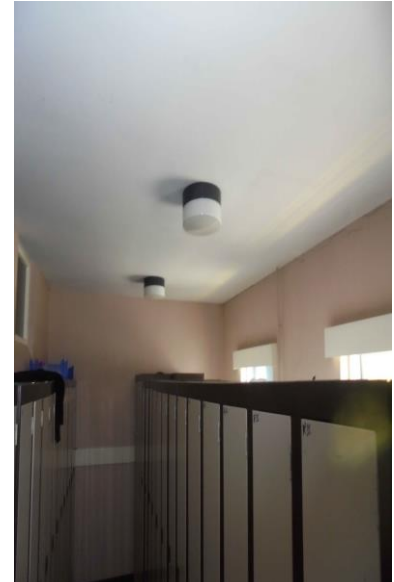
**Location: Meeting Room, Locker Rooms and Office –
First Floor**

Material Description:	Visual Inspection – No Suspect Materials Found	
Identification:	N/A	
Approx. quantity:	N/A	
Accessibility	N/A	<i>Assessment Score</i>
Product type:		N/A
Extent of Damage:		N/A
Surface Treatment:		N/A
Asbestos type:		N/A
Material Assessment Score:		N/A
Priority Assessment Score:		N/A
Action:	N/A	
Comments:	N/A

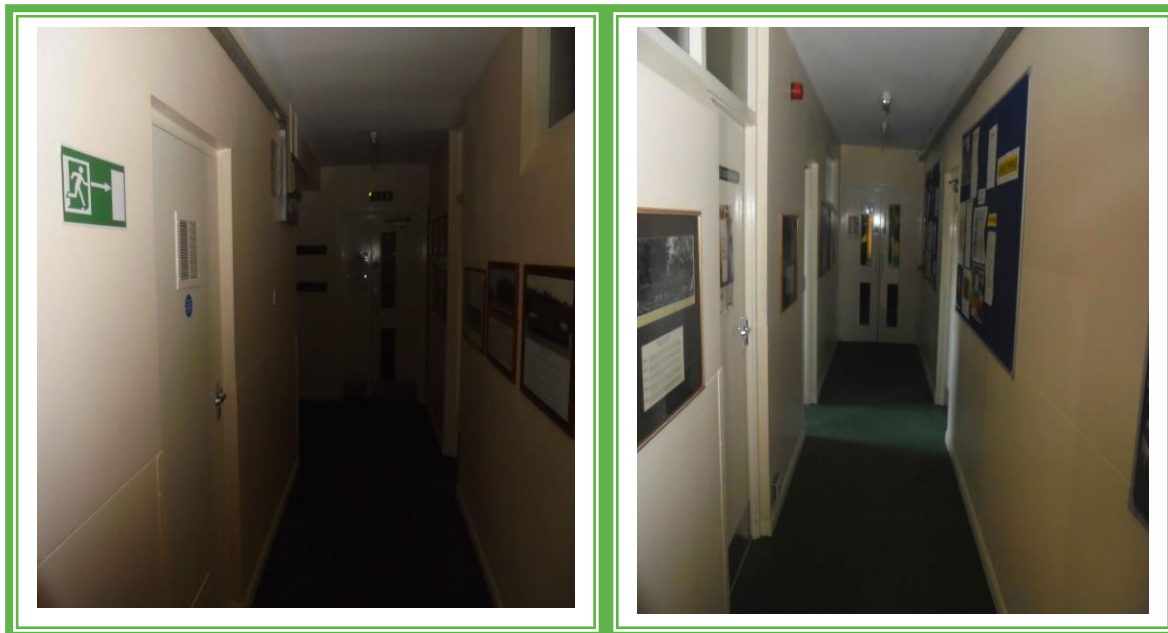
**Item No: 31****Sample No: N/A****Location: Corridor – First Floor**

Material Description:	Visual Inspection – No Suspect Materials Found	
Identification:	N/A	
Approx. quantity:	N/A	
Accessibility	N/A	<i>Assessment Score</i>
Product type:		N/A
Extent of Damage:		N/A
Surface Treatment:		N/A
Asbestos type:		N/A
Material Assessment Score:		N/A
Priority Assessment Score:		N/A
Action:	N/A	
Comments:	N/A

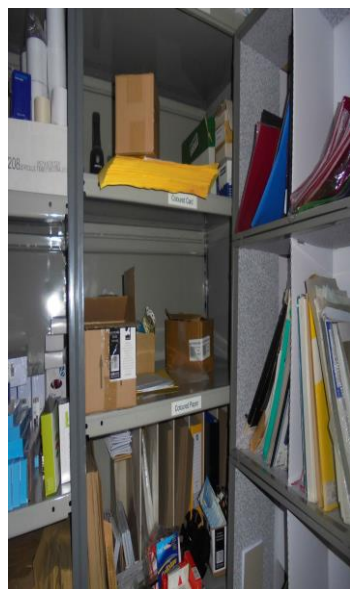
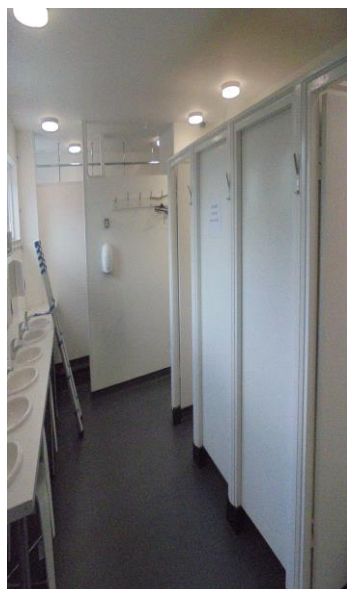
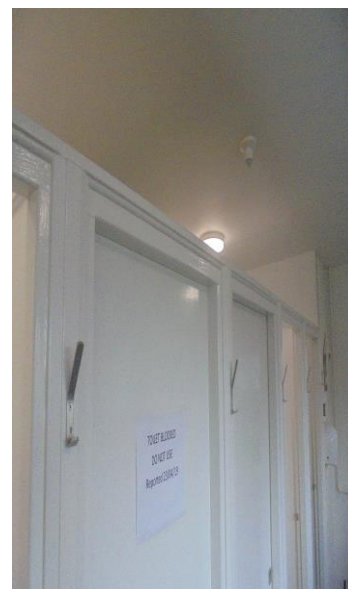
**Item No: 34****Sample No: N/A****Location: Male Shower/WC's and Drying Room – First Floor**

Material Description:	Visual Inspection – No Suspect Materials Found	
Identification:	N/A	
Approx. quantity:	N/A	
Accessibility	N/A	<i>Assessment Score</i>
Product type:		N/A
Extent of Damage:		N/A
Surface Treatment:		N/A
Asbestos type:		N/A
Material Assessment Score:		N/A
Priority Assessment Score:		N/A
Action:	N/A	
Comments:	No access within timber boxings

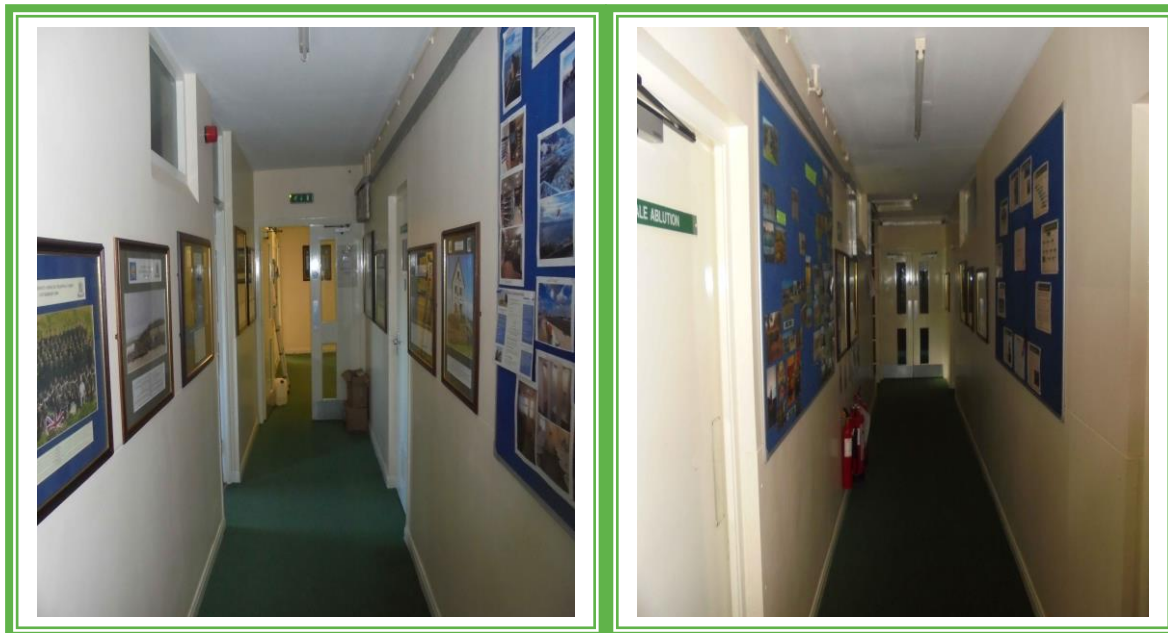
**Item No: 35****Sample No: N/A****Location: Corridor – First Floor**

Material Description:	Visual Inspection – No Suspect Materials Found	
Identification:	N/A	
Approx. quantity:	N/A	
Accessibility	N/A	<i>Assessment Score</i>
Product type:		N/A
Extent of Damage:		N/A
Surface Treatment:		N/A
Asbestos type:		N/A
Material Assessment Score:		N/A
Priority Assessment Score:		N/A
Action:	N/A	
Comments:	N/A

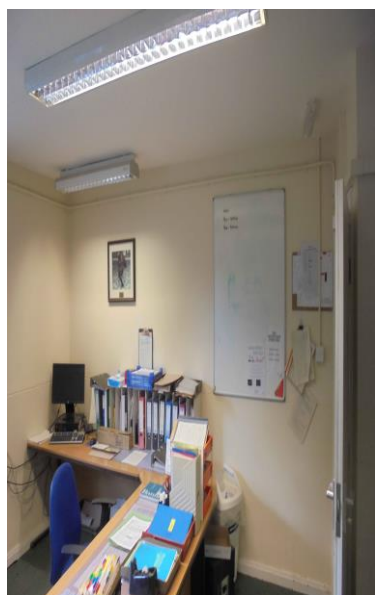
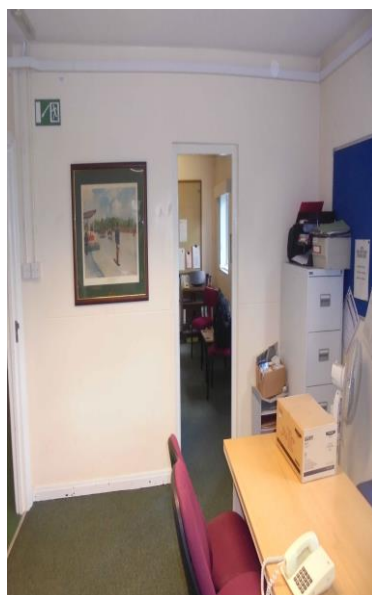
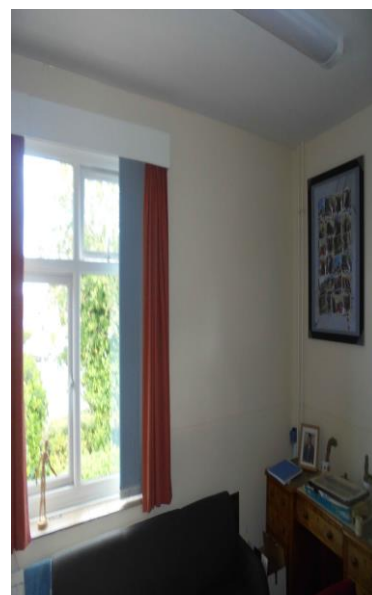
Location: Offices x 4

Material Description:	Visual Inspection – No Suspect Materials Found	
Identification:	N/A	
Approx. quantity:	N/A	
Accessibility	N/A	<i>Assessment Score</i>
Product type:		N/A
Extent of Damage:		N/A
Surface Treatment:		N/A
Asbestos type:		N/A
Material Assessment Score:		N/A
Priority Assessment Score:		N/A
Action:	N/A	
Comments:	N/A

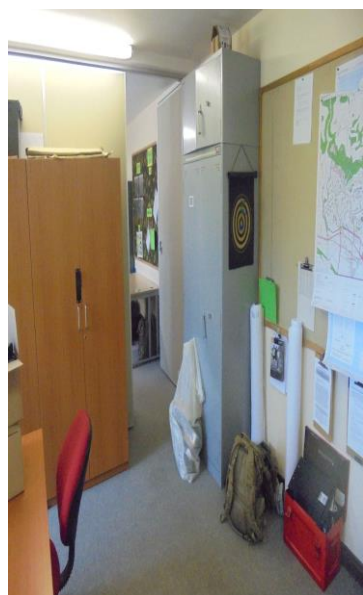
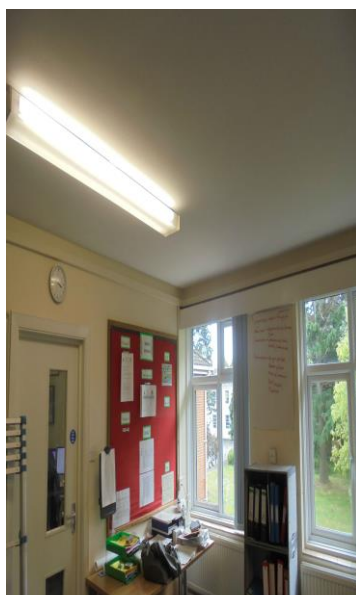
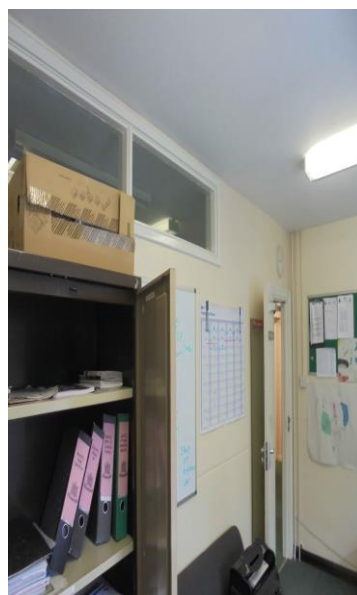
Location: Offices x 3 and Circulation

Material Description:	Visual Inspection – No Suspect Materials Found	
Identification:	N/A	
Approx. quantity:	N/A	
Accessibility	N/A	<i>Assessment Score</i>
Product type:		N/A
Extent of Damage:		N/A
Surface Treatment:		N/A
Asbestos type:		N/A
Material Assessment Score:		N/A
Priority Assessment Score:		N/A
Action:	N/A	
Comments:	N/A

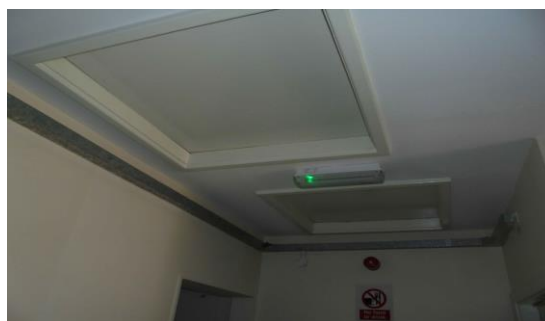
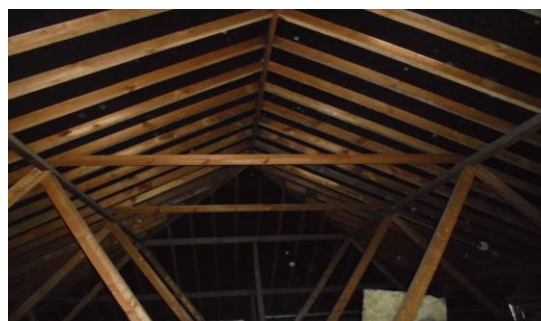
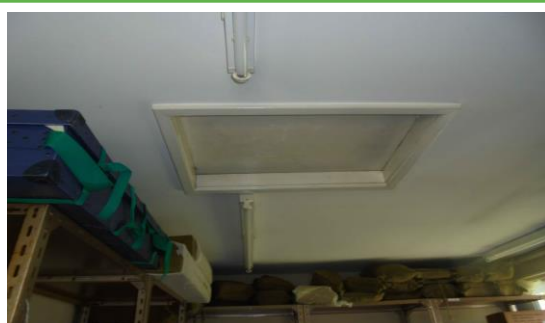
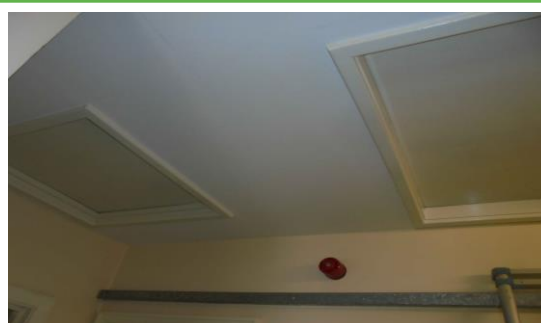
Location: Loft Spaces

Material Description:	Loft Hatch Panels	
Identification:	Sampled – No Asbestos Detected	
Approx. quantity:	X 5 Hatches	
Accessibility	N/A	<i>Assessment Score</i>
Product type:		N/A
Extent of Damage:		N/A
Surface Treatment:		N/A
Asbestos type:		N/A
Material Assessment Score:		N/A
Priority Assessment Score:		N/A
Action:	N/A	
Comments:	Limited access within loft spaces as no crawl boards available

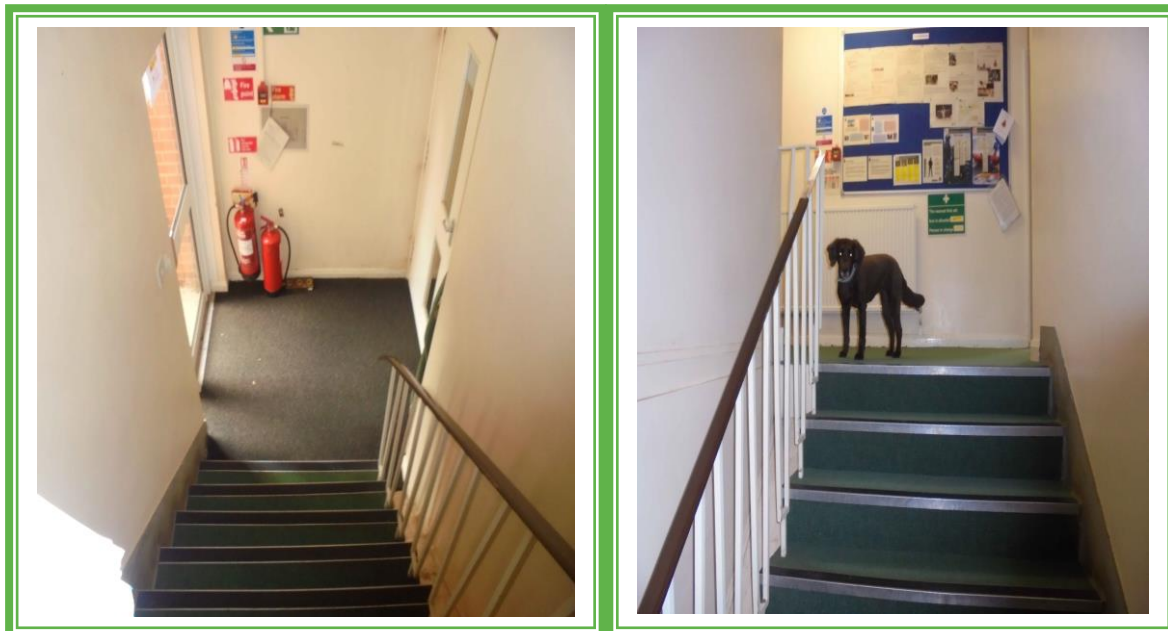
Location: Stairwell and Lobby

Material Description:	Visual Inspection – No Suspect Materials Found	
Identification:	N/A	
Approx. quantity:	N/A	
Accessibility	N/A	<i>Assessment Score</i>
Product type:		N/A
Extent of Damage:		N/A
Surface Treatment:		N/A
Asbestos type:		N/A
Material Assessment Score:		N/A
Priority Assessment Score:		N/A
Action:	N/A	
Comments:	N/A
