**Project Number 2481**

**Management  
Asbestos Survey Report**

**Royal Wessex Yeomanry, Salisbury, SP4 6BY**

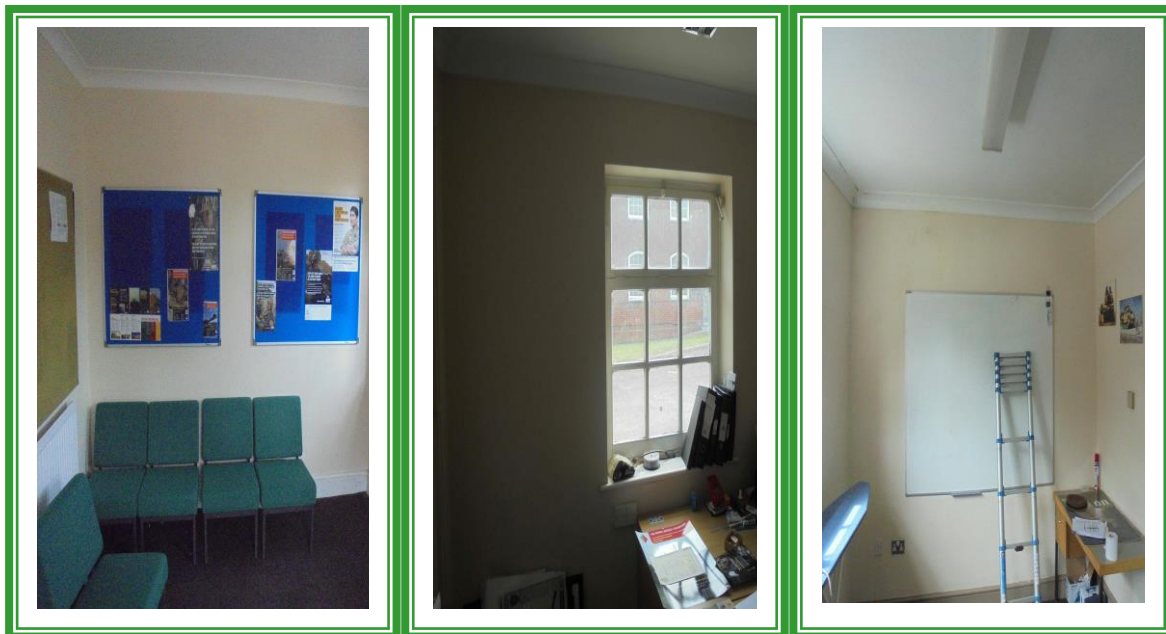
**Location: Recruit reception office-offices x2 and waiting room**

<b>Material Description:</b>	Visual Inspection – No Suspect Materials Found	
<b>Identification:</b>	N/A	
<b>Approx. quantity:</b>	N/A	
<b>Accessibility</b>	N/A	<i>Assessment Score</i>
<b>Product type:</b>		N/A
<b>Extent of Damage:</b>		N/A
<b>Surface Treatment:</b>		N/A
<b>Asbestos type:</b>		N/A
<b>Material Assessment Score:</b>		N/A
<b>Priority Assessment Score:</b>		N/A
<b>Action:</b>	N/A	
<b>Comments:</b>	N/A

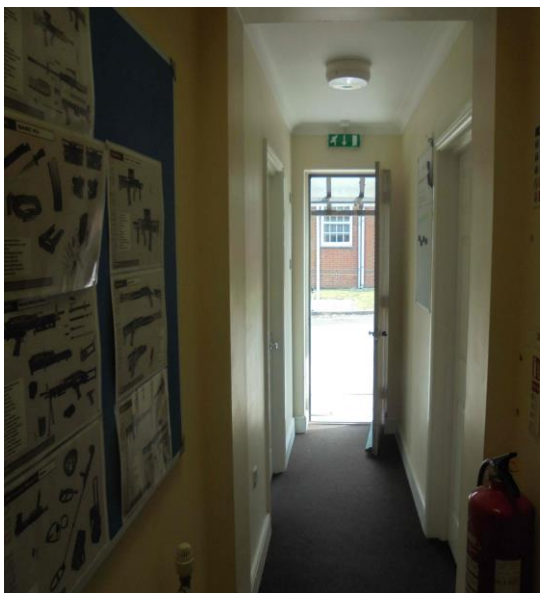
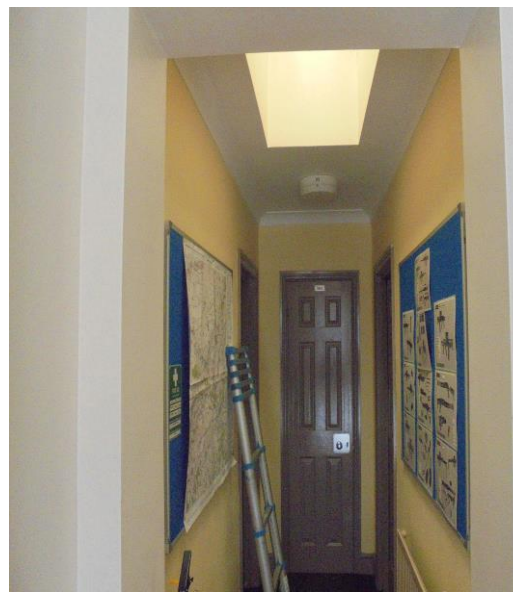
**Location: Circulation/lobby-recruit reception centre**

<b>Material Description:</b>	Visual Inspection – No Suspect Materials Found	
<b>Identification:</b>	N/A	
<b>Approx. quantity:</b>	N/A	
<b>Accessibility</b>	N/A	<i>Assessment Score</i>
<b>Product type:</b>		N/A
<b>Extent of Damage:</b>		N/A
<b>Surface Treatment:</b>		N/A
<b>Asbestos type:</b>		N/A
<b>Material Assessment Score:</b>		N/A
<b>Priority Assessment Score:</b>		N/A
<b>Action:</b>	N/A	
<b>Comments:</b>	No access within plasterboard boxings

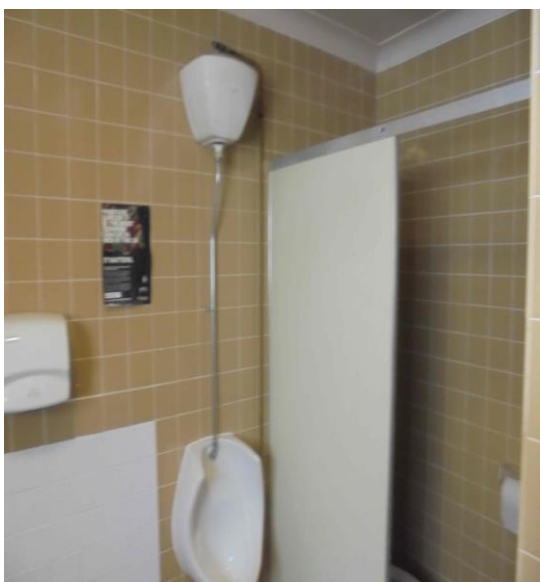
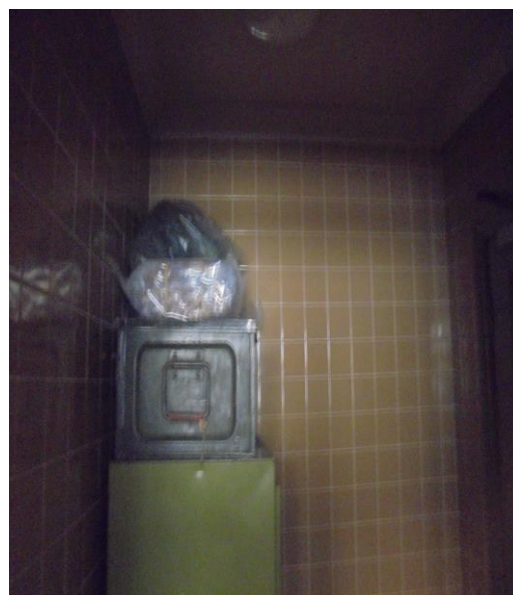
**Location: WC/lobby-recruit reception centre**

<b>Material Description:</b>	Visual Inspection – No Suspect Materials Found	
<b>Identification:</b>	N/A	
<b>Approx. quantity:</b>	N/A	
<b>Accessibility</b>	N/A	<i>Assessment Score</i>
<b>Product type:</b>		N/A
<b>Extent of Damage:</b>		N/A
<b>Surface Treatment:</b>		N/A
<b>Asbestos type:</b>		N/A
<b>Material Assessment Score:</b>		N/A
<b>Priority Assessment Score:</b>		N/A
<b>Action:</b>	N/A	
<b>Comments:</b>	N/A

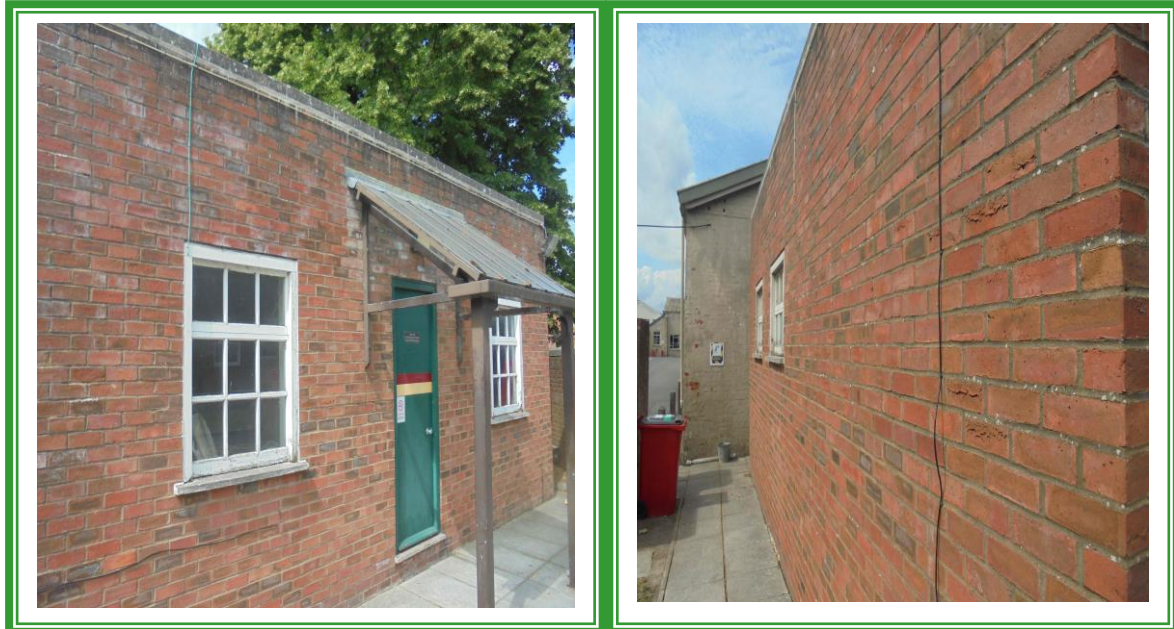
**Location: Recruit reception centre - External**

<b>Material Description:</b>	Visual Inspection – No Suspect Materials Found	
<b>Identification:</b>	N/A	
<b>Approx. quantity:</b>	N/A	
<b>Accessibility</b>	N/A	<i>Assessment Score</i>
<b>Product type:</b>		N/A
<b>Extent of Damage:</b>		N/A
<b>Surface Treatment:</b>		N/A
<b>Asbestos type:</b>		N/A
<b>Material Assessment Score:</b>		N/A
<b>Priority Assessment Score:</b>		N/A
<b>Action:</b>	N/A	
<b>Comments:</b>	N/A

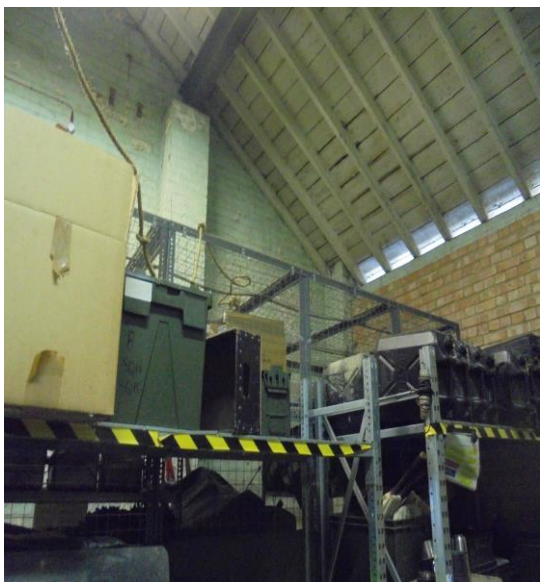
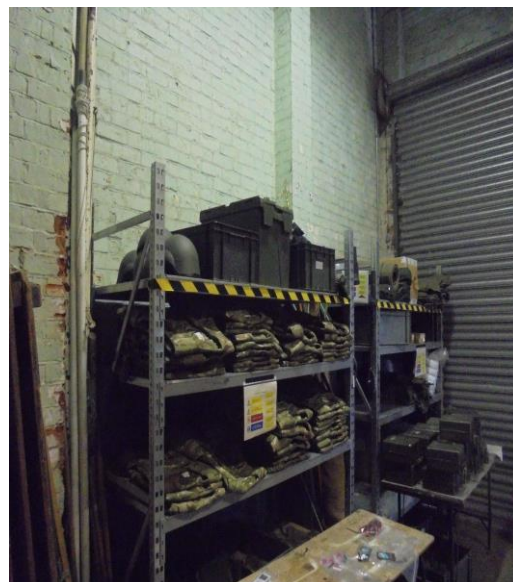
**Item No: 6****Sample No: N/A****Location: Storage garage - Internal**

<b>Material Description:</b>	Visual Inspection – No Suspect Materials Found	
<b>Identification:</b>	N/A	
<b>Approx. quantity:</b>	N/A	
<b>Accessibility</b>	N/A	<i>Assessment Score</i>
<b>Product type:</b>		N/A
<b>Extent of Damage:</b>		N/A
<b>Surface Treatment:</b>		N/A
<b>Asbestos type:</b>		N/A
<b>Material Assessment Score:</b>		N/A
<b>Priority Assessment Score:</b>		N/A
<b>Action:</b>	N/A	
<b>Comments:</b>	N/A

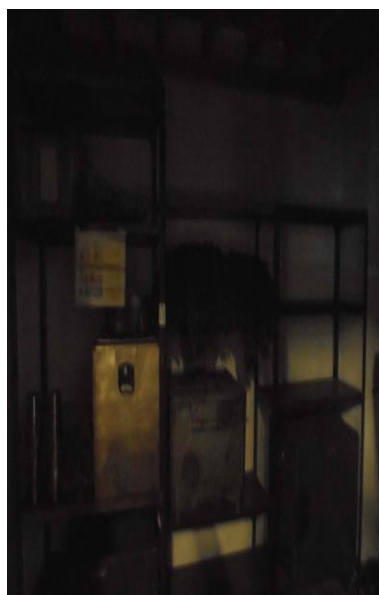
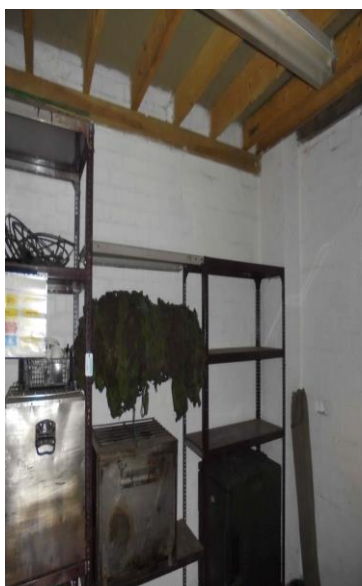
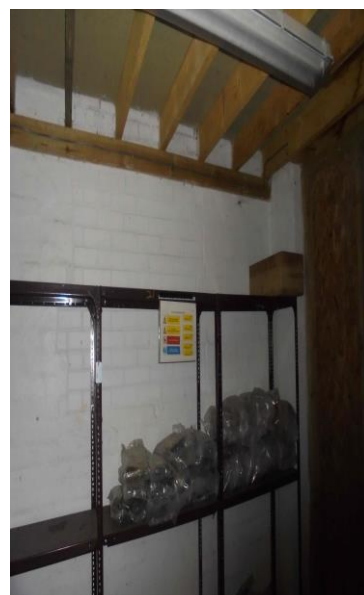
**Location: stores x 3 - garages 9,10 and 11**

<b>Material Description:</b>	Visual Inspection – No Suspect Materials Found	
<b>Identification:</b>	N/A	
<b>Approx. quantity:</b>	N/A	
<b>Accessibility</b>	N/A	<i>Assessment Score</i>
<b>Product type:</b>		N/A
<b>Extent of Damage:</b>		N/A
<b>Surface Treatment:</b>		N/A
<b>Asbestos type:</b>		N/A
<b>Material Assessment Score:</b>		N/A
<b>Priority Assessment Score:</b>		N/A
<b>Action:</b>	N/A	
<b>Comments:</b>	N/A

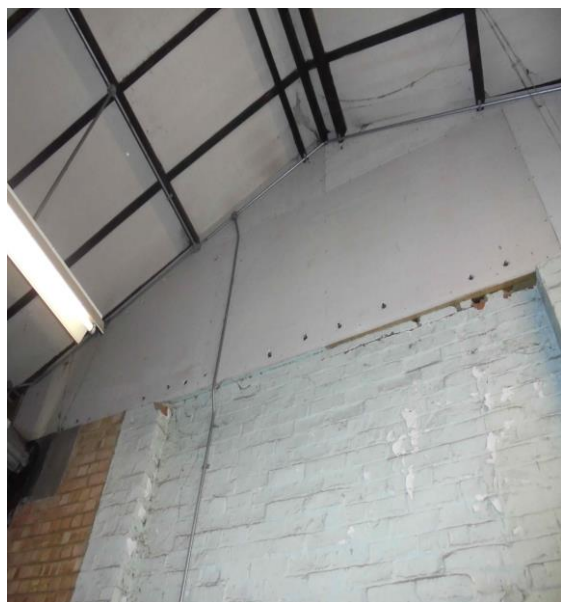
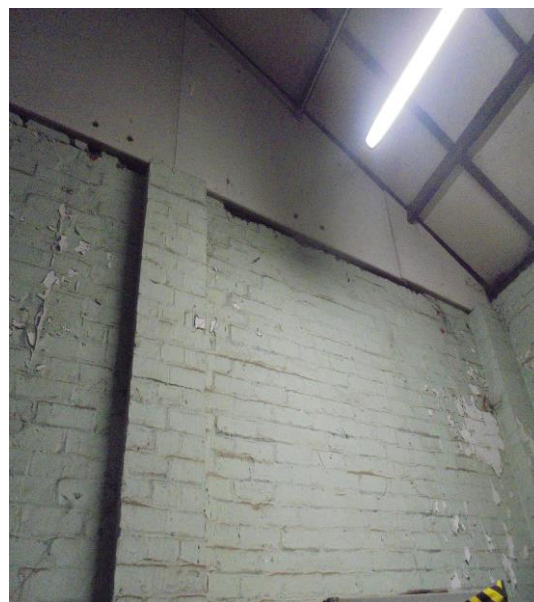
**Item No: 10****Sample No: 3****Location: Garage 8/Radio store**

<b>Material Description:</b>	Insulation board wall panels	
<b>Identification:</b>	Sampled – No Asbestos Detected	
<b>Approx. quantity:</b>	20M2	
<b>Accessibility</b>	Low	<i>Assessment Score</i>
<b>Product type:</b>	N/A	2
<b>Extent of Damage:</b>	N/A	2
<b>Surface Treatment:</b>	N/A	2
<b>Asbestos type:</b>	N/A	2
<b>Material Assessment Score:</b>		N/A
<b>Priority Assessment Score:</b>		N/A
<b>Action:</b>	N/A	
<b>Comments:</b>	N/A

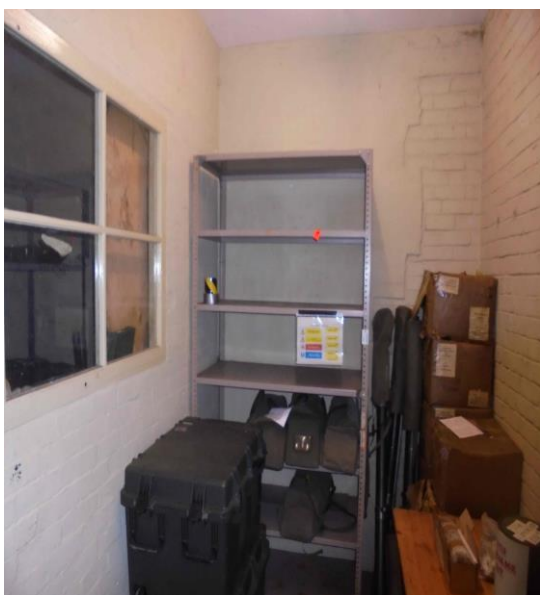
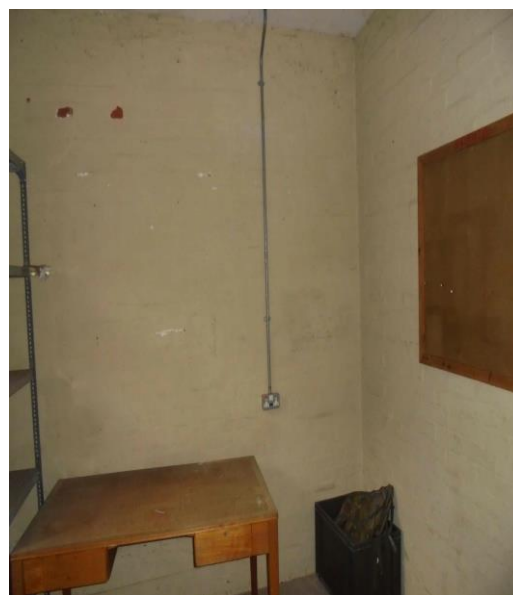
**Item No: 13****Sample No: N/A****Location: Garage 8 - Stores X3**

<b>Material Description:</b>	Visual Inspection – No Suspect Materials Found	
<b>Identification:</b>	N/A	
<b>Approx. quantity:</b>	N/A	
<b>Accessibility</b>	N/A	<i>Assessment Score</i>
<b>Product type:</b>		N/A
<b>Extent of Damage:</b>		N/A
<b>Surface Treatment:</b>		N/A
<b>Asbestos type:</b>		N/A
<b>Material Assessment Score:</b>		N/A
<b>Priority Assessment Score:</b>		N/A
<b>Action:</b>	N/A	
<b>Comments:</b>	N/A

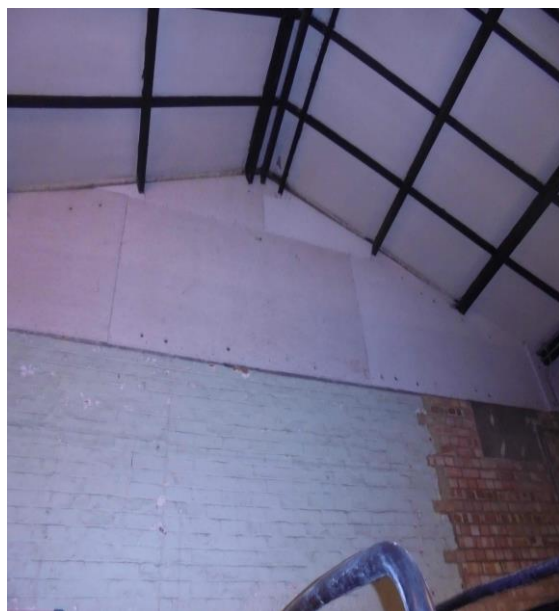
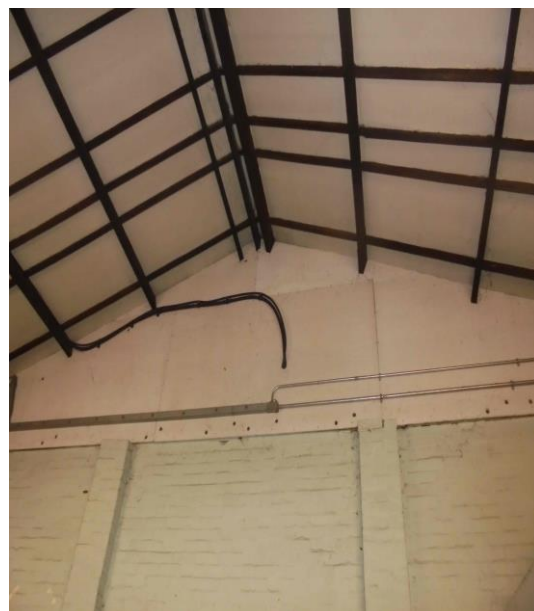
**Location: Vehicle Store - Garages 4,5,6 and 7**

<b>Material Description:</b>	Insulating board wall panels	
<b>Identification:</b>	As Sample 3 – No Asbestos Detected	
<b>Approx. quantity:</b>	40M2	
<b>Accessibility</b>	Low	<i>Assessment Score</i>
<b>Product type:</b>		N/A
<b>Extent of Damage:</b>		N/A
<b>Surface Treatment:</b>		N/A
<b>Asbestos type:</b>		N/A
<b>Material Assessment Score:</b>		N/A
<b>Priority Assessment Score:</b>		N/A
<b>Action:</b>	N/A	
<b>Comments:</b>	N/A

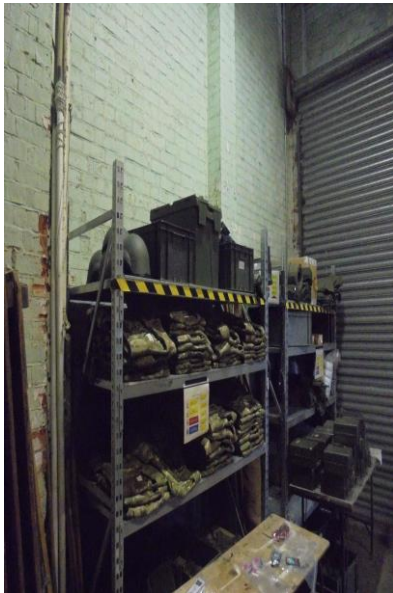
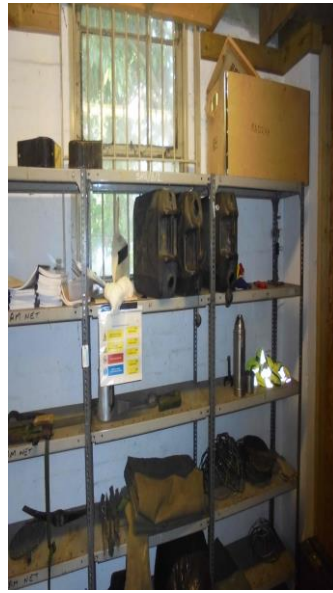
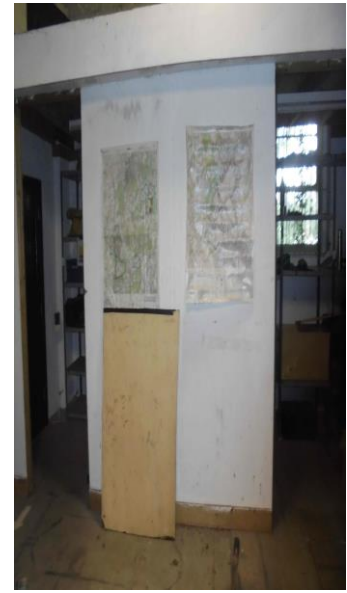
**Location: Garages 4,5,6 and 7 - Stores x 4**

<b>Material Description:</b>	Visual Inspection – No Suspect Materials Found	
<b>Identification:</b>	N/A	
<b>Approx. quantity:</b>	N/A	
<b>Accessibility</b>	N/A	<i>Assessment Score</i>
<b>Product type:</b>		N/A
<b>Extent of Damage:</b>		N/A
<b>Surface Treatment:</b>		N/A
<b>Asbestos type:</b>		N/A
<b>Material Assessment Score:</b>		N/A
<b>Priority Assessment Score:</b>		N/A
<b>Action:</b>	N/A	
<b>Comments:</b>	N/A

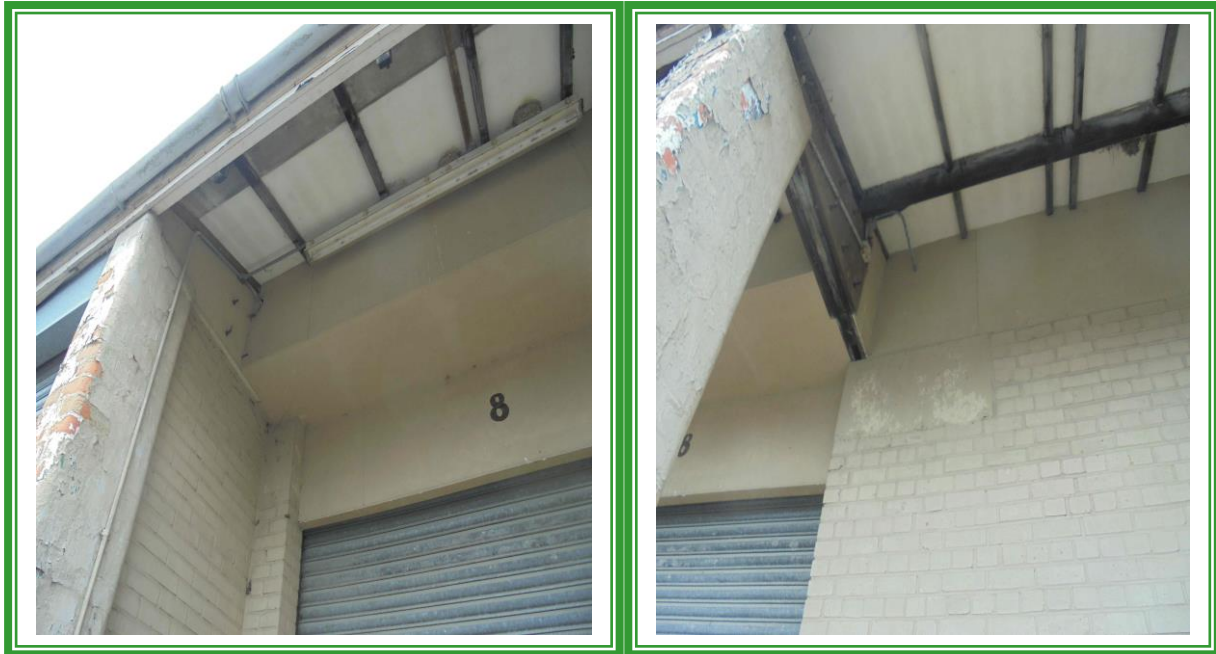
**Item No: 17****Sample No: N/A****Location: Garage 8 - Covered area**

<b>Material Description:</b>	Insulated board boxing and wall panels	
<b>Identification:</b>	As sample 3 – No Asbestos Detected	
<b>Approx. quantity:</b>	16M2	
<b>Accessibility</b>	Low	<i>Assessment Score</i>
<b>Product type:</b>		N/A
<b>Extent of Damage:</b>		N/A
<b>Surface Treatment:</b>		N/A
<b>Asbestos type:</b>		N/A
<b>Material Assessment Score:</b>		N/A
<b>Priority Assessment Score:</b>		N/A
<b>Action:</b>	N/A	
<b>Comments:</b>	N/A

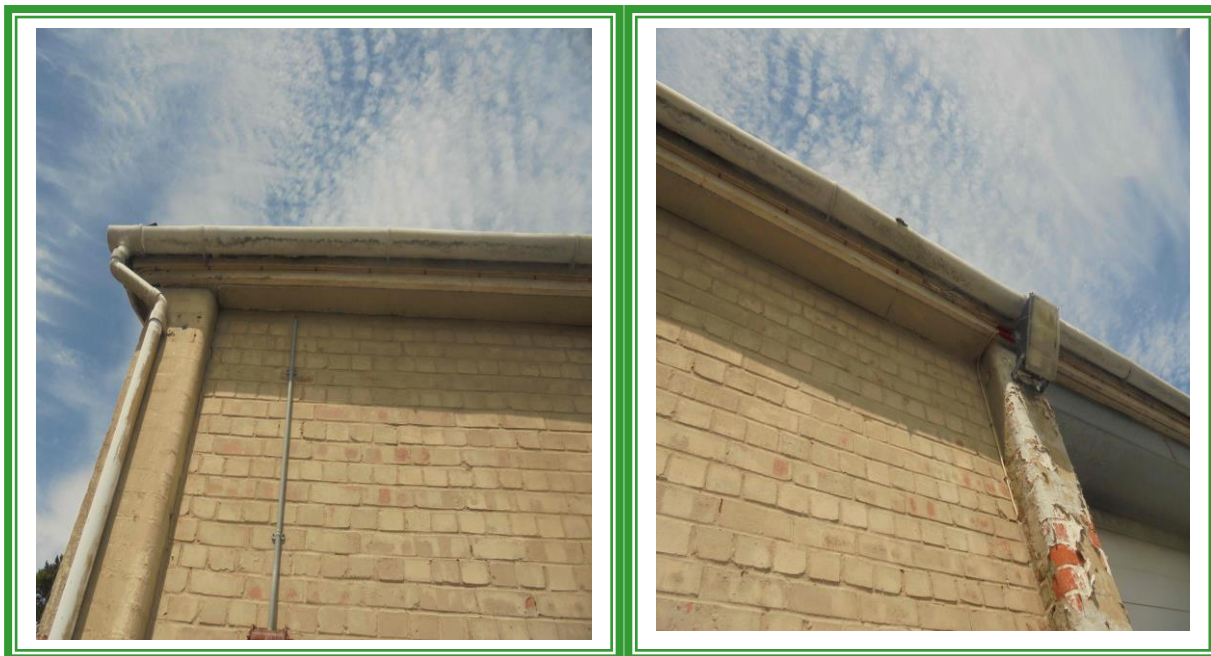
**Item No: 19****Sample No: N/A****Location: Garages 1-11 - External**

<b>Material Description:</b>	Insulation board soffit	
<b>Identification:</b>	As sample 3 – No Asbestos Detected	
<b>Approx. quantity:</b>	3LM	
<b>Accessibility</b>	Low	<i>Assessment Score</i>
<b>Product type:</b>		N/A
<b>Extent of Damage:</b>		N/A
<b>Surface Treatment:</b>		N/A
<b>Asbestos type:</b>		N/A
<b>Material Assessment Score:</b>		N/A
<b>Priority Assessment Score:</b>		N/A
<b>Action:</b>	N/A	
<b>Comments:</b>	N/A

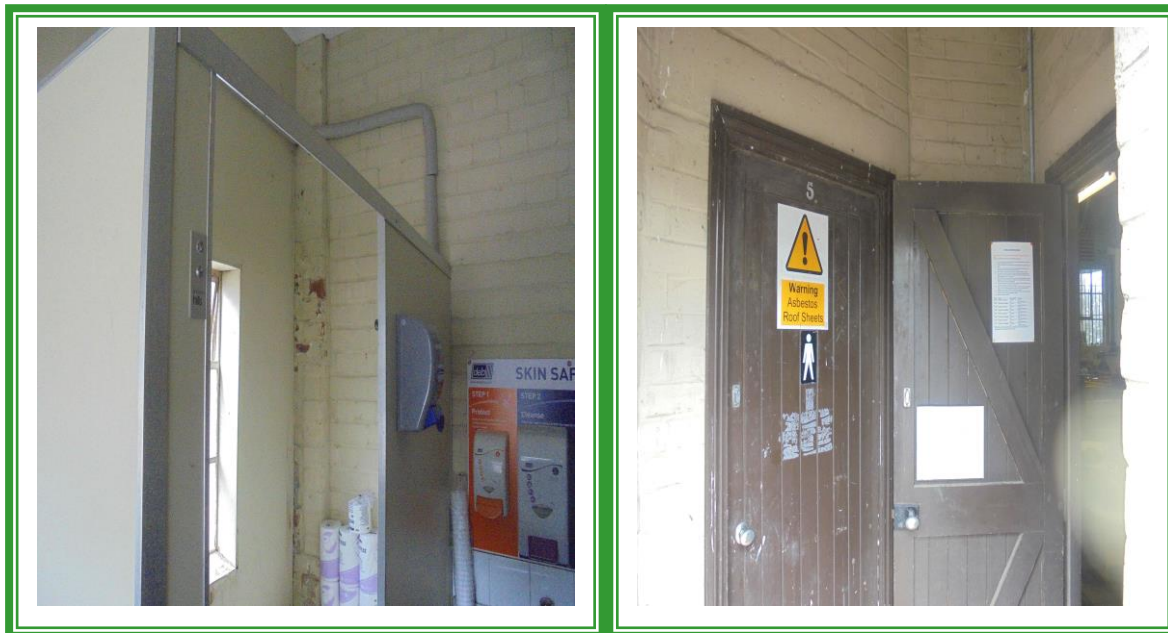
**Item No: 22****Sample No: N/A****Location: Garages 1,2 and 3-WC and porch**

<b>Material Description:</b>	Visual Inspection – No Suspect Materials Found	
<b>Identification:</b>	N/A	
<b>Approx. quantity:</b>	N/A	
<b>Accessibility</b>	N/A	<i>Assessment Score</i>
<b>Product type:</b>		N/A
<b>Extent of Damage:</b>		N/A
<b>Surface Treatment:</b>		N/A
<b>Asbestos type:</b>		N/A
<b>Material Assessment Score:</b>		N/A
<b>Priority Assessment Score:</b>		N/A
<b>Action:</b>	N/A	
<b>Comments:</b>	N/A

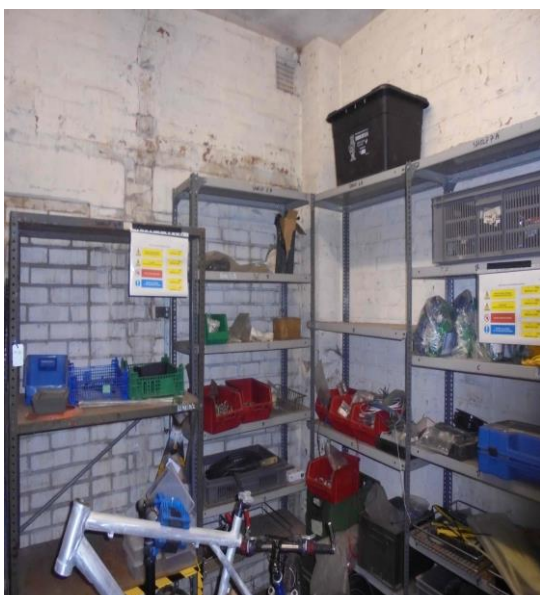
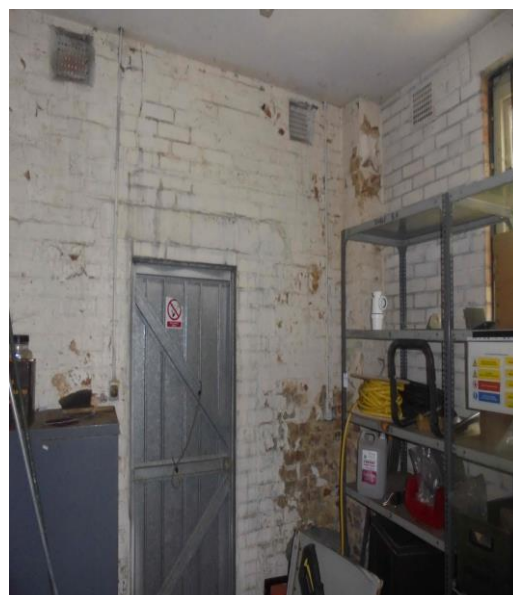
**Location: Garages 1,2 and 3 - Stores X2**

<b>Material Description:</b>	Visual Inspection – No Suspect Materials Found	
<b>Identification:</b>	N/A	
<b>Approx. quantity:</b>	N/A	
<b>Accessibility</b>	N/A	<i>Assessment Score</i>
<b>Product type:</b>		N/A
<b>Extent of Damage:</b>		N/A
<b>Surface Treatment:</b>		N/A
<b>Asbestos type:</b>		N/A
<b>Material Assessment Score:</b>		N/A
<b>Priority Assessment Score:</b>		N/A
<b>Action:</b>	N/A	
<b>Comments:</b>	N/A

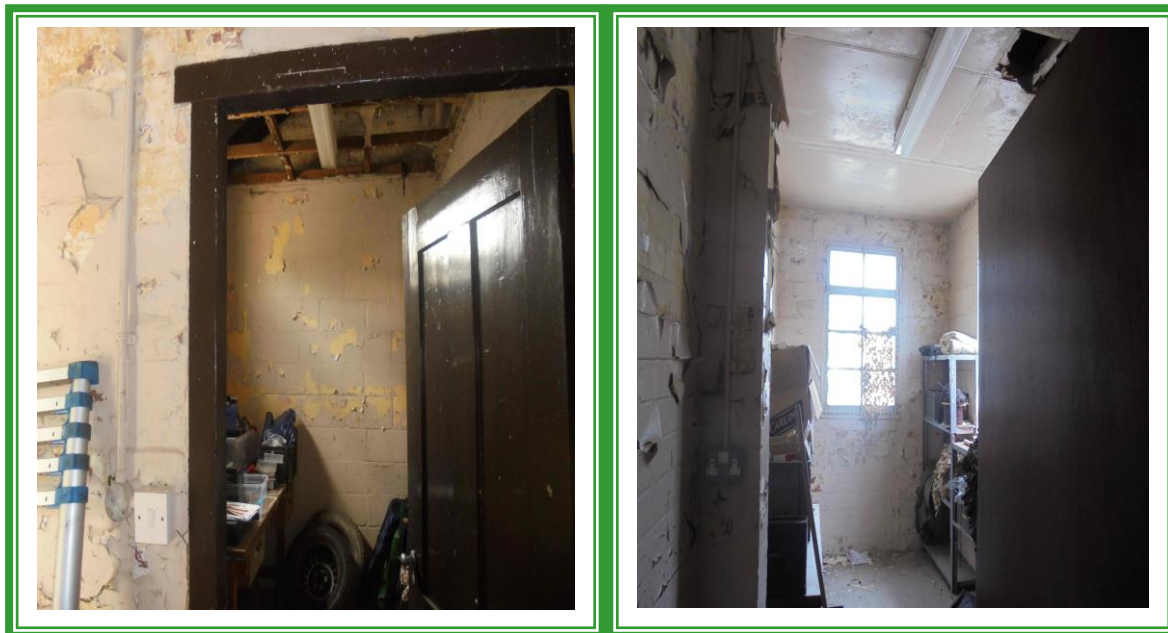
**Location: Armoured truck garage -Stores X2 and lobby**

<b>Material Description:</b>	Visual Inspection – No Suspect Materials Found	
<b>Identification:</b>	N/A	
<b>Approx. quantity:</b>	N/A	
<b>Accessibility</b>	N/A	<i>Assessment Score</i>
<b>Product type:</b>		N/A
<b>Extent of Damage:</b>		N/A
<b>Surface Treatment:</b>		N/A
<b>Asbestos type:</b>		N/A
<b>Material Assessment Score:</b>		N/A
<b>Priority Assessment Score:</b>		N/A
<b>Action:</b>	N/A	
<b>Comments:</b>	N/A

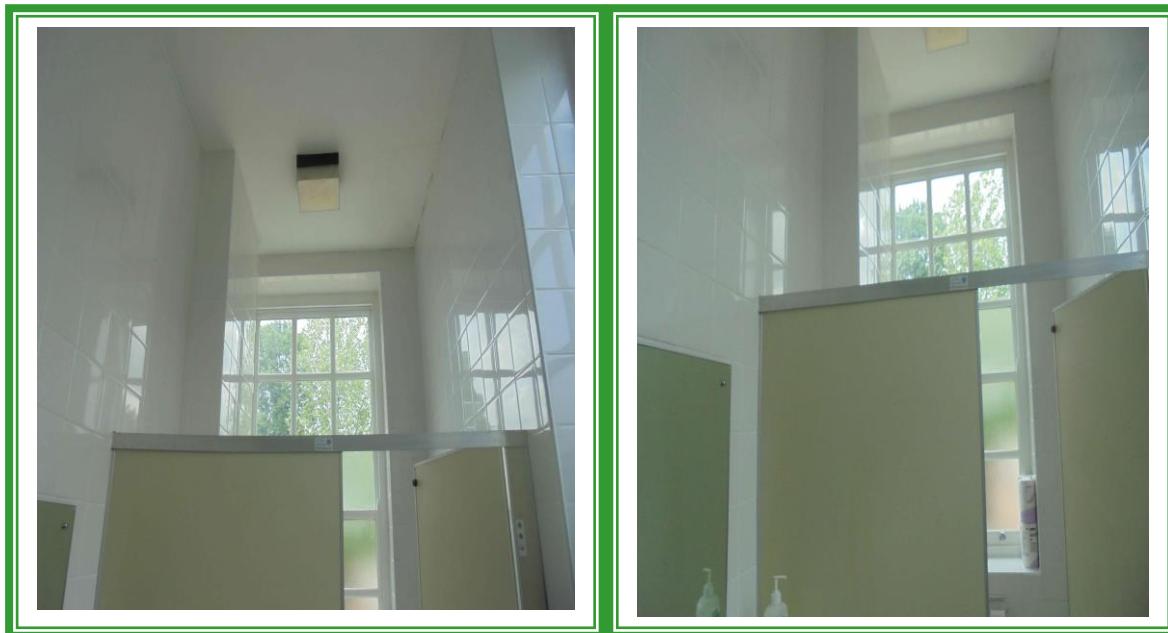
**Item No: 33****Sample No: N/A****Location: Main building-WC – First Floor**

<b>Material Description:</b>	Visual Inspection – No Suspect Materials Found	
<b>Identification:</b>	N/A	
<b>Approx. quantity:</b>	N/A	
<b>Accessibility</b>	N/A	<i>Assessment Score</i>
<b>Product type:</b>		N/A
<b>Extent of Damage:</b>		N/A
<b>Surface Treatment:</b>		N/A
<b>Asbestos type:</b>		N/A
<b>Material Assessment Score:</b>		N/A
<b>Priority Assessment Score:</b>		N/A
<b>Action:</b>	N/A	
<b>Comments:</b>	N/A

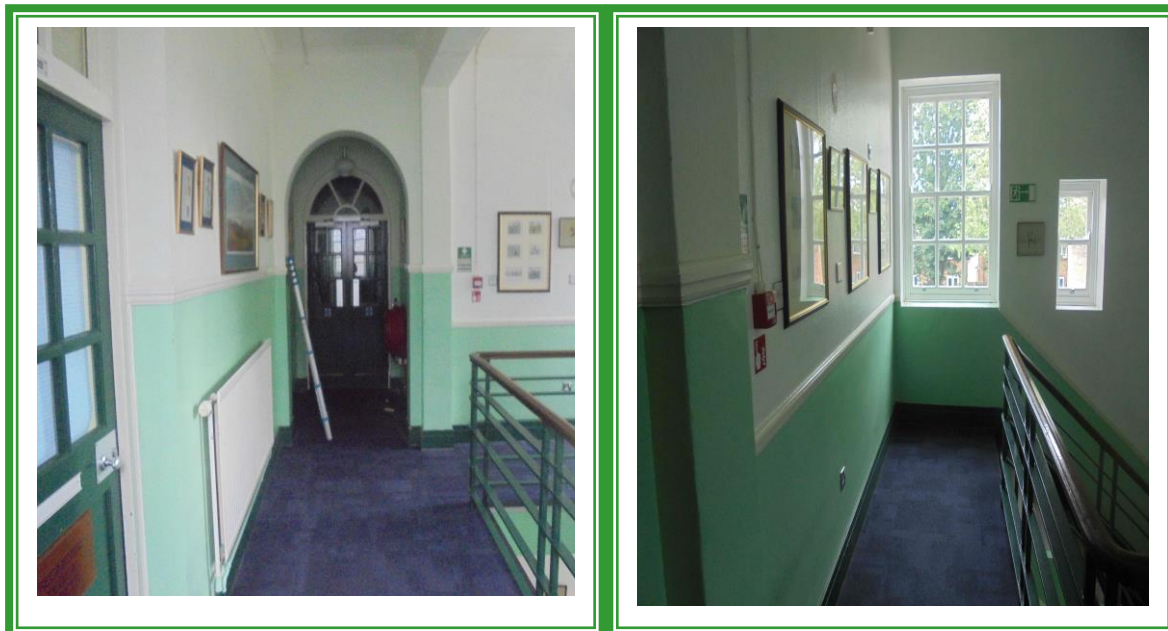
**Location: Landing – First Floor**

<b>Material Description:</b>	Visual Inspection – No Suspect Materials Found	
<b>Identification:</b>	N/A	
<b>Approx. quantity:</b>	N/A	
<b>Accessibility</b>	N/A	<i>Assessment Score</i>
<b>Product type:</b>		N/A
<b>Extent of Damage:</b>		N/A
<b>Surface Treatment:</b>		N/A
<b>Asbestos type:</b>		N/A
<b>Material Assessment Score:</b>		N/A
<b>Priority Assessment Score:</b>		N/A
<b>Action:</b>	N/A	
<b>Comments:</b>	N/A

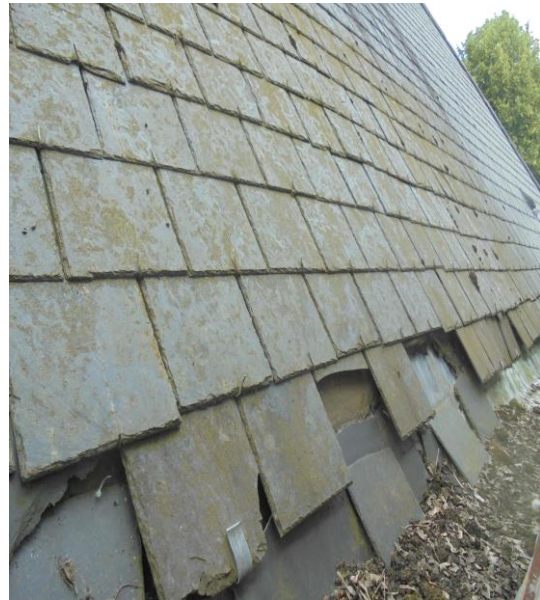
**Item No: 35****Sample No: 6****Location: Main Building - External**

<b>Material Description:</b>	Cement replacement roof tiles	
<b>Identification:</b>	Sampled – No Asbestos Detected	
<b>Approx. quantity:</b>	Unknown-all replacement tiles	
<b>Accessibility</b>	Low	<i>Assessment Score</i>
<b>Product type:</b>		N/A
<b>Extent of Damage:</b>		N/A
<b>Surface Treatment:</b>		N/A
<b>Asbestos type:</b>		N/A
<b>Material Assessment Score:</b>		N/A
<b>Priority Assessment Score:</b>		N/A
<b>Action:</b>	N/A	
<b>Comments:</b>	Tiles are natural slate apart from a number of cement replacement tiles

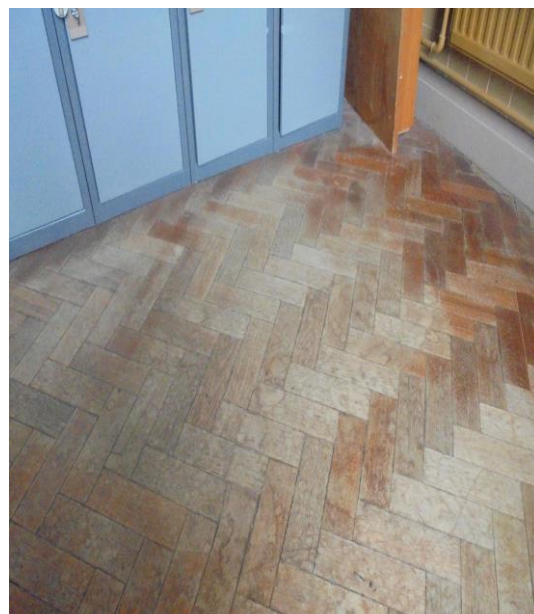
**Item No: 36****Sample No: 7****Location: Ladies WC and changing room – First Floor**

<b>Material Description:</b>	Bitumen under Parquet Flooring	
<b>Identification:</b>	Sampled – Asbestos Detected	
<b>Approx. quantity:</b>	Parquet flooring throughout building	
<b>Accessibility</b>	Low	<i>Assessment Score</i>
<b>Product type:</b>		N/A
<b>Extent of Damage:</b>		N/A
<b>Surface Treatment:</b>		N/A
<b>Asbestos type:</b>		N/A
<b>Material Assessment Score:</b>		N/A
<b>Priority Assessment Score:</b>		N/A
<b>Action:</b>	N/A	
<b>Comments:</b>	Treat as uniform to parquet flooring throughout building

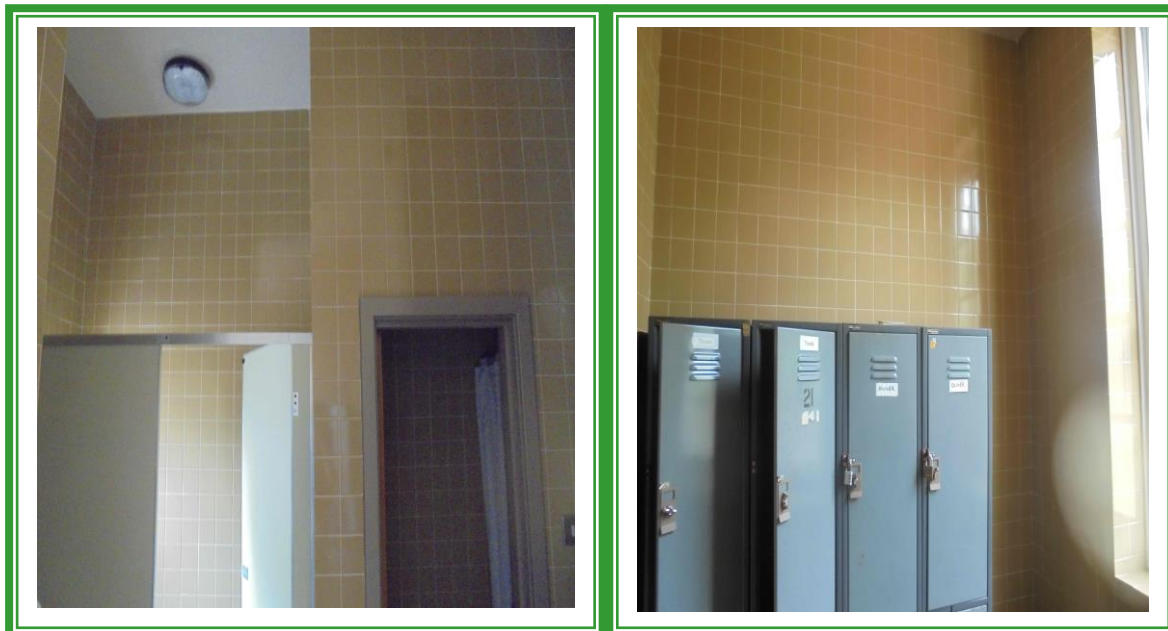
**Location: Men's WC – First Floor**

<b>Material Description:</b>	Visual Inspection – No Suspect Materials Found	
<b>Identification:</b>	N/A	
<b>Approx. quantity:</b>	N/A	
<b>Accessibility</b>	N/A	<i>Assessment Score</i>
<b>Product type:</b>		N/A
<b>Extent of Damage:</b>		N/A
<b>Surface Treatment:</b>		N/A
<b>Asbestos type:</b>		N/A
<b>Material Assessment Score:</b>		N/A
<b>Priority Assessment Score:</b>		N/A
<b>Action:</b>	N/A	
<b>Comments:</b>	N/A

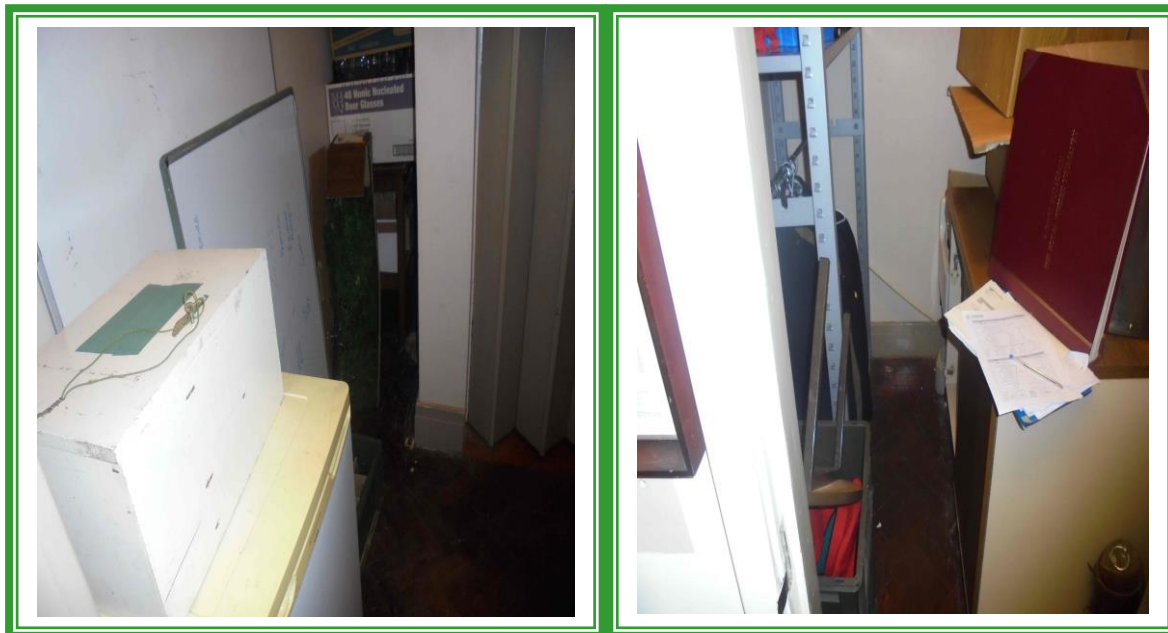
**Location: Stores X2**

<b>Material Description:</b>	Visual Inspection – No Suspect Materials Found	
<b>Identification:</b>	N/A	
<b>Approx. quantity:</b>	N/A	
<b>Accessibility</b>	N/A	<i>Assessment Score</i>
<b>Product type:</b>		N/A
<b>Extent of Damage:</b>		N/A
<b>Surface Treatment:</b>		N/A
<b>Asbestos type:</b>		N/A
<b>Material Assessment Score:</b>		N/A
<b>Priority Assessment Score:</b>		N/A
<b>Action:</b>	N/A	
<b>Comments:</b>	N/A

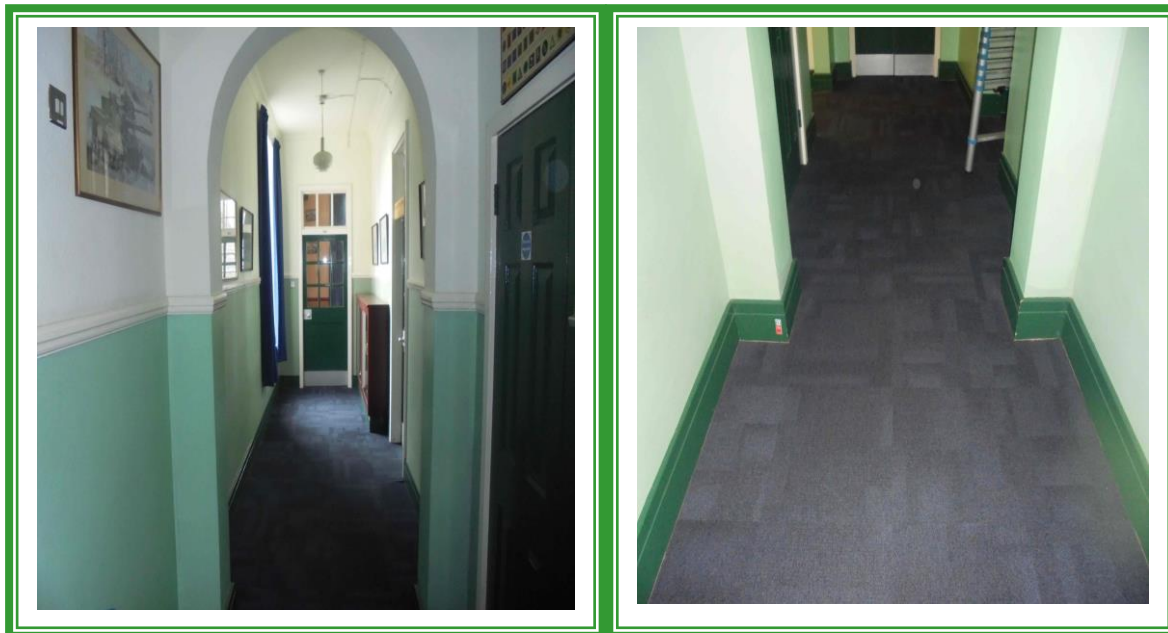
**Location: Corridor - First Floor**

<b>Material Description:</b>	Visual Inspection – No Suspect Materials Found	
<b>Identification:</b>	N/A	
<b>Approx. quantity:</b>	N/A	
<b>Accessibility</b>	N/A	<i>Assessment Score</i>
<b>Product type:</b>		N/A
<b>Extent of Damage:</b>		N/A
<b>Surface Treatment:</b>		N/A
<b>Asbestos type:</b>		N/A
<b>Material Assessment Score:</b>		N/A
<b>Priority Assessment Score:</b>		N/A
<b>Action:</b>	N/A	
<b>Comments:</b>	N/A

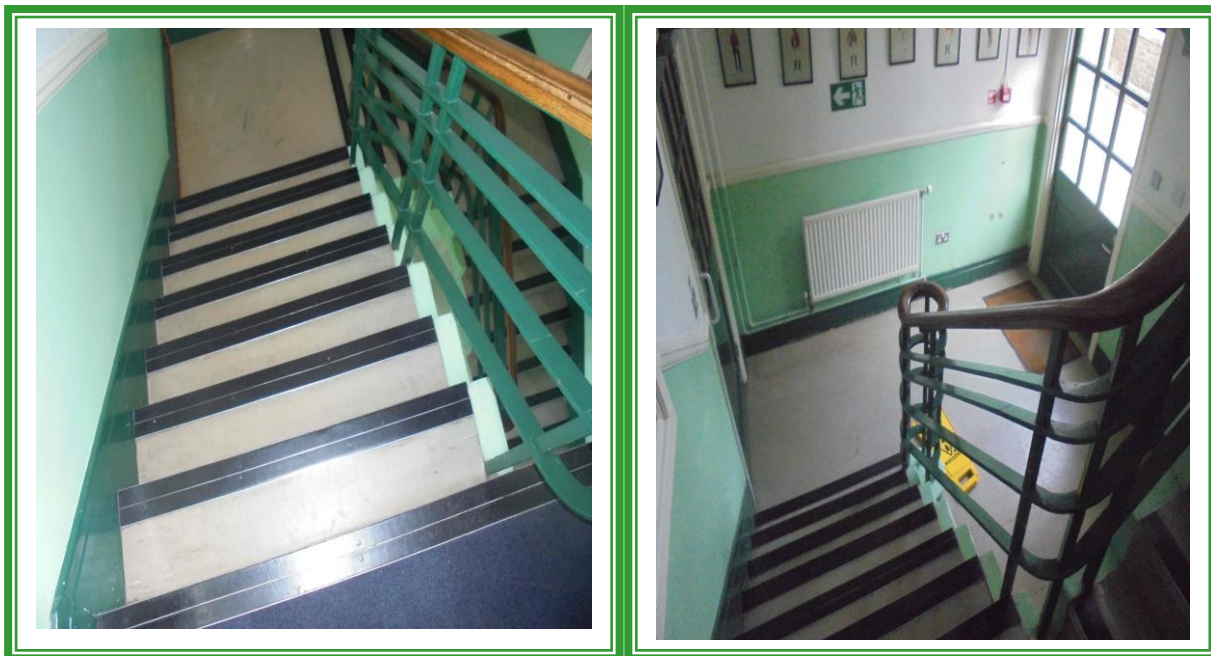
**Item No: 42****Sample No: 9****Location: Stairwell and lobby - Ground Floor**

<b>Material Description:</b>	Stair Nosing	
<b>Identification:</b>	Sampled – No Asbestos Detected	
<b>Approx. quantity:</b>	20LM	
<b>Accessibility</b>	High	<i>Assessment Score</i>
<b>Product type:</b>		N/A
<b>Extent of Damage:</b>		N/A
<b>Surface Treatment:</b>		N/A
<b>Asbestos type:</b>		N/A
<b>Material Assessment Score:</b>		N/A
<b>Priority Assessment Score:</b>		N/A
<b>Action:</b>	N/A	
<b>Comments:</b>	N/A

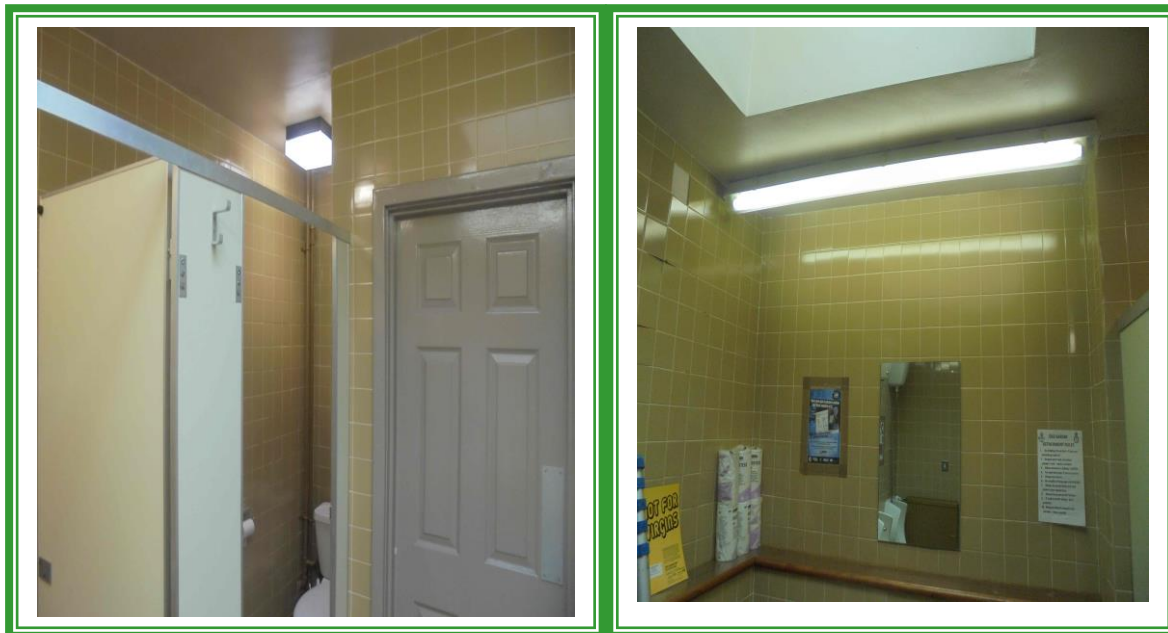
**Location: WC – Ground Floor**

<b>Material Description:</b>	Visual Inspection – No Suspect Materials Found	
<b>Identification:</b>	N/A	
<b>Approx. quantity:</b>	N/A	
<b>Accessibility</b>	N/A	<i>Assessment Score</i>
<b>Product type:</b>		N/A
<b>Extent of Damage:</b>		N/A
<b>Surface Treatment:</b>		N/A
<b>Asbestos type:</b>		N/A
<b>Material Assessment Score:</b>		N/A
<b>Priority Assessment Score:</b>		N/A
<b>Action:</b>	N/A	
<b>Comments:</b>	N/A

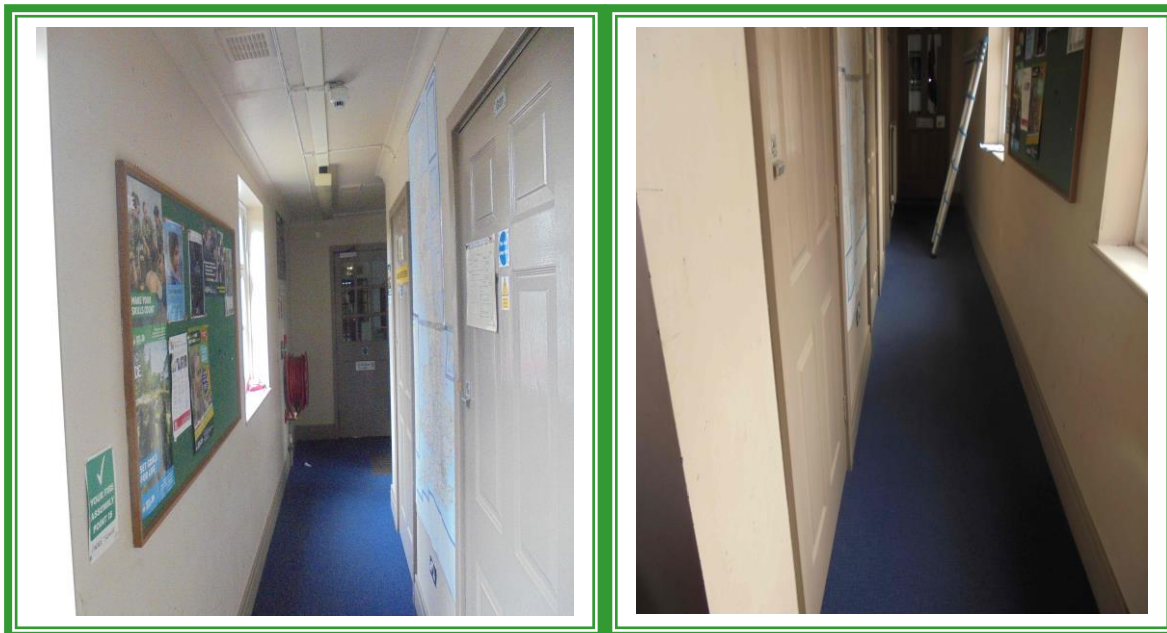
**Location: Corridor – Ground Floor**

<b>Material Description:</b>	Visual Inspection – No Suspect Materials Found	
<b>Identification:</b>	N/A	
<b>Approx. quantity:</b>	N/A	
<b>Accessibility</b>	N/A	<i>Assessment Score</i>
<b>Product type:</b>		N/A
<b>Extent of Damage:</b>		N/A
<b>Surface Treatment:</b>		N/A
<b>Asbestos type:</b>		N/A
<b>Material Assessment Score:</b>		N/A
<b>Priority Assessment Score:</b>		N/A
<b>Action:</b>	N/A	
<b>Comments:</b>	Bitumen under parquet flooring (as sample 7)

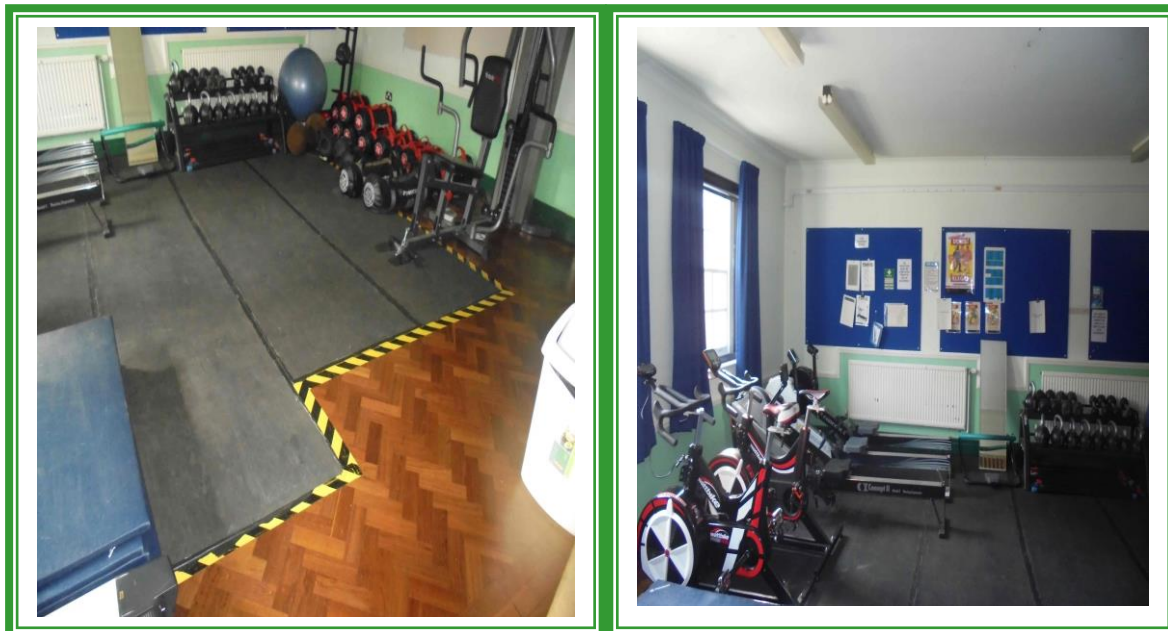
**Location: Gym – Ground Floor**

<b>Material Description:</b>	Visual Inspection – No Suspect Materials Found	
<b>Identification:</b>	N/A	
<b>Approx. quantity:</b>	N/A	
<b>Accessibility</b>	N/A	<i>Assessment Score</i>
<b>Product type:</b>		N/A
<b>Extent of Damage:</b>		N/A
<b>Surface Treatment:</b>		N/A
<b>Asbestos type:</b>		N/A
<b>Material Assessment Score:</b>		N/A
<b>Priority Assessment Score:</b>		N/A
<b>Action:</b>	N/A	
<b>Comments:</b>	Bitumen under parquet flooring as sample 7

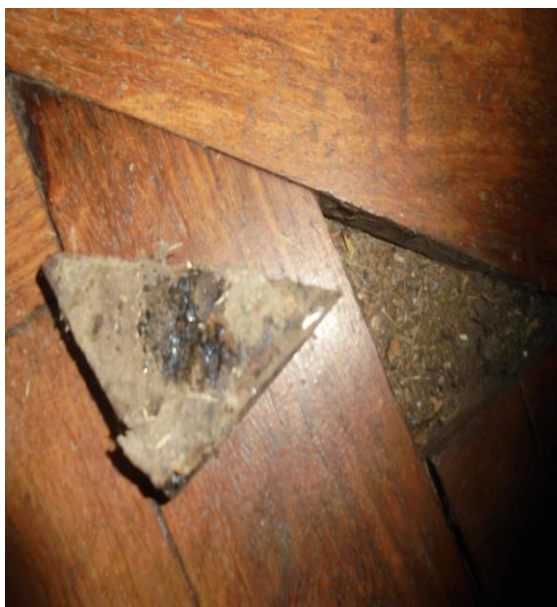
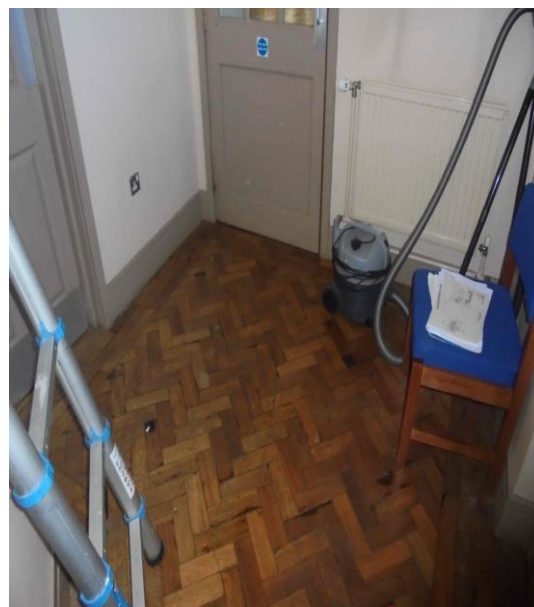
**Location: Lobby – Ground Floor**

<b>Material Description:</b>	Bitumen under parquet flooring	
<b>Identification:</b>	Sampled – No Asbestos Detected	
<b>Approx. quantity:</b>	8M2	
<b>Accessibility</b>	Low	<i>Assessment Score</i>
<b>Product type:</b>		N/A
<b>Extent of Damage:</b>		N/A
<b>Surface Treatment:</b>		N/A
<b>Asbestos type:</b>		N/A
<b>Material Assessment Score:</b>		N/A
<b>Priority Assessment Score:</b>		N/A
<b>Action:</b>	N/A	
<b>Comments:</b>	Treat as uniform under parquet flooring throughout building

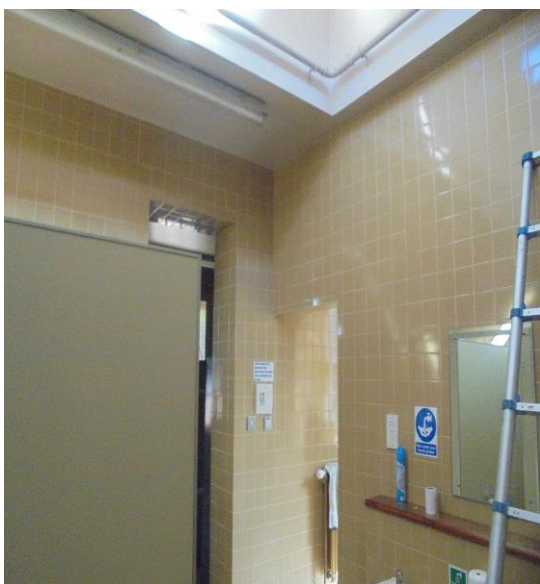
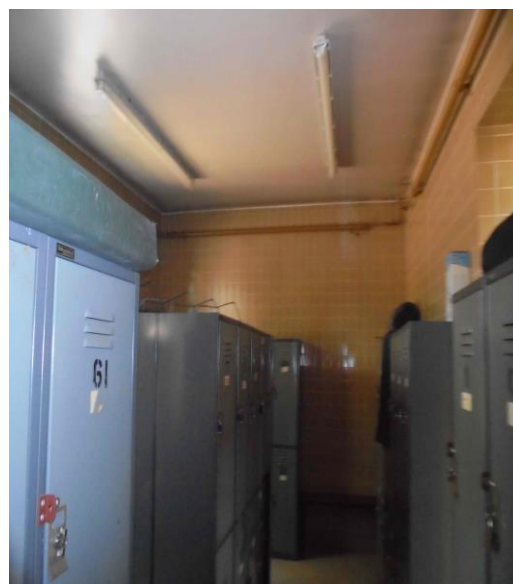
**Item No: 48****Sample No: N/A****Location: WC's, shower and Locker Room**

<b>Material Description:</b>	Visual Inspection – No Suspect Materials Found	
<b>Identification:</b>	N/A	
<b>Approx. quantity:</b>	N/A	
<b>Accessibility</b>	N/A	<i>Assessment Score</i>
<b>Product type:</b>		N/A
<b>Extent of Damage:</b>		N/A
<b>Surface Treatment:</b>		N/A
<b>Asbestos type:</b>		N/A
<b>Material Assessment Score:</b>		N/A
<b>Priority Assessment Score:</b>		N/A
<b>Action:</b>	N/A	
<b>Comments:</b>	N/A
