**Project Number 2481**

**Management  
Asbestos Survey Report**

**Royal Wessex Yeomanry, Salisbury, SP4 6BY**

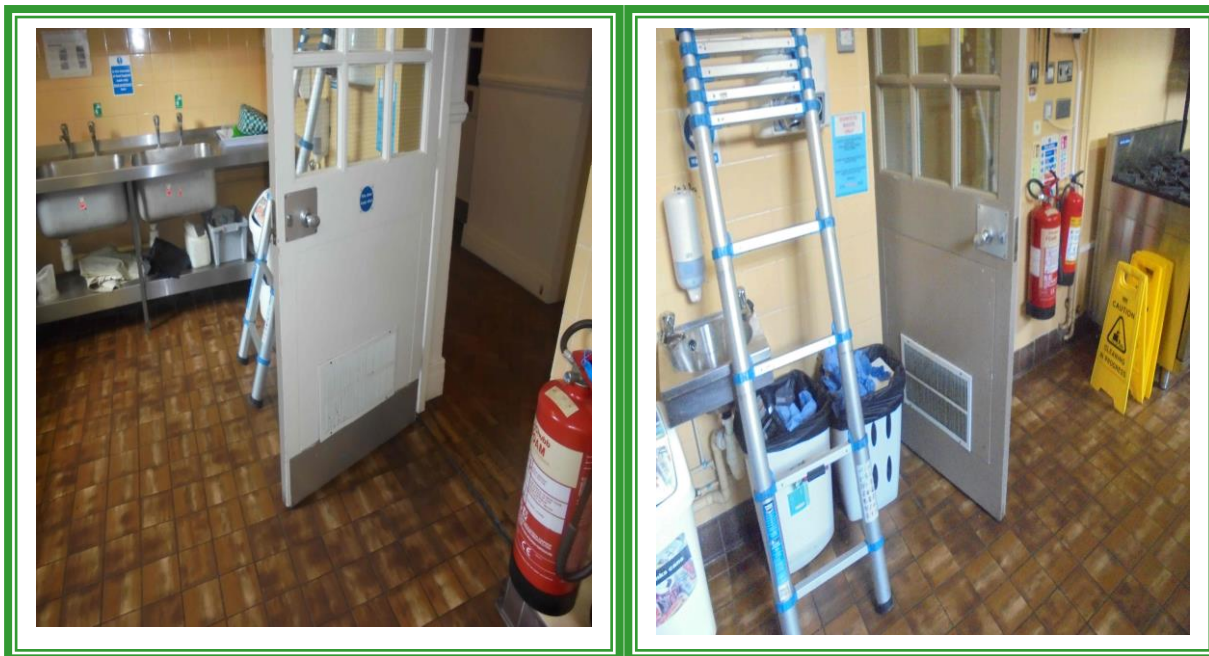
**Item No: 50****Sample No: 12****Location: Kitchen – Ground Floor**

<b>Material Description:</b>	Panels to door	
<b>Identification:</b>	Sampled – No Asbestos Detected	
<b>Approx. quantity:</b>	2M2	
<b>Accessibility</b>	Medium	<i>Assessment Score</i>
<b>Product type:</b>		N/A
<b>Extent of Damage:</b>		N/A
<b>Surface Treatment:</b>		N/A
<b>Asbestos type:</b>		N/A
<b>Material Assessment Score:</b>		N/A
<b>Priority Assessment Score:</b>		N/A
<b>Action:</b>	N/A	
<b>Comments:</b>	N/A

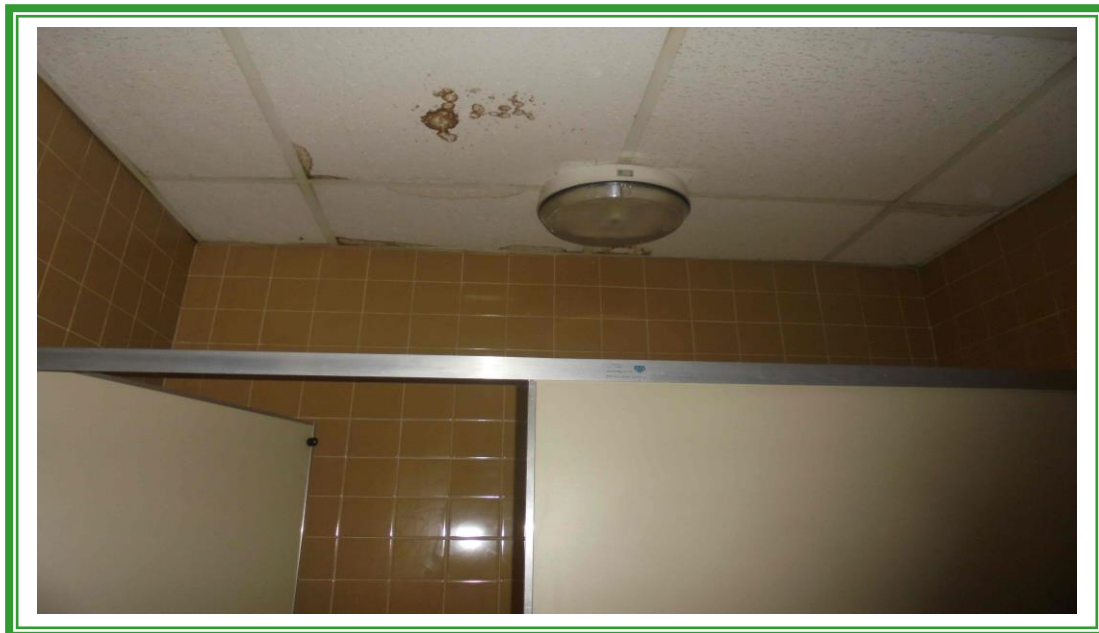
**Location: WC's X 3 – Ground Floor**

<b>Material Description:</b>	Visual Inspection – No Suspect Materials Found	
<b>Identification:</b>	N/A	
<b>Approx. quantity:</b>	N/A	
<b>Accessibility</b>	N/A	<i>Assessment Score</i>
<b>Product type:</b>		N/A
<b>Extent of Damage:</b>		N/A
<b>Surface Treatment:</b>		N/A
<b>Asbestos type:</b>		N/A
<b>Material Assessment Score:</b>		N/A
<b>Priority Assessment Score:</b>		N/A
<b>Action:</b>	N/A	
<b>Comments:</b>	N/A

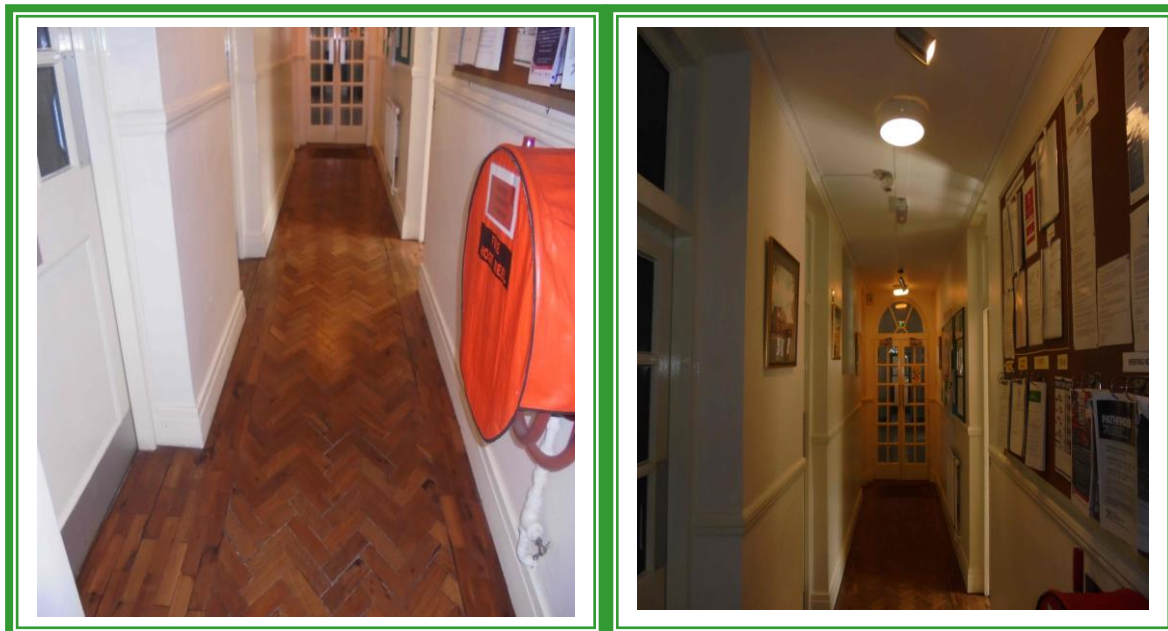
**Location: Corridor – Ground Floor**

<b>Material Description:</b>	Visual Inspection – No Suspect Materials Found	
<b>Identification:</b>	N/A	
<b>Approx. quantity:</b>	N/A	
<b>Accessibility</b>	N/A	<i>Assessment Score</i>
<b>Product type:</b>		N/A
<b>Extent of Damage:</b>		N/A
<b>Surface Treatment:</b>		N/A
<b>Asbestos type:</b>		N/A
<b>Material Assessment Score:</b>		N/A
<b>Priority Assessment Score:</b>		N/A
<b>Action:</b>	N/A	
<b>Comments:</b>	N/A

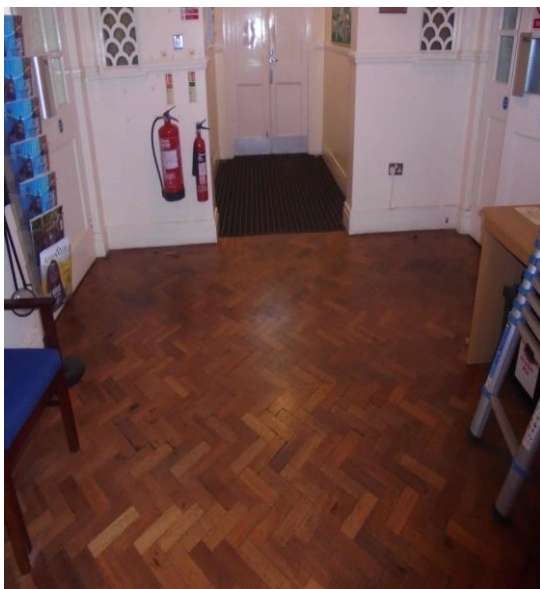
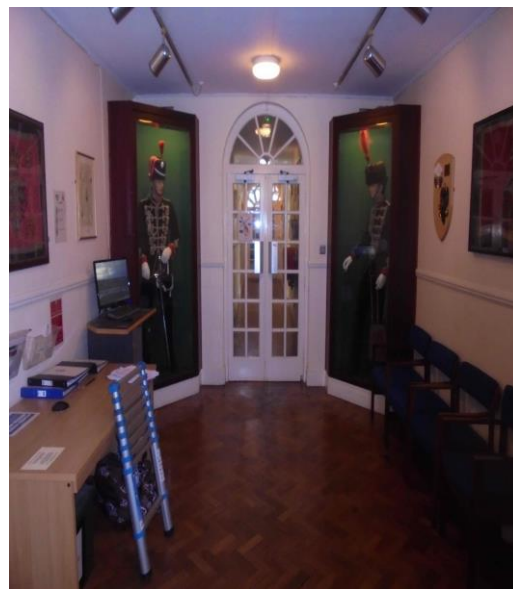
**Location: Lobby – Ground Floor**

<b>Material Description:</b>	Visual Inspection – No Suspect Materials Found	
<b>Identification:</b>	N/A	
<b>Approx. quantity:</b>	N/A	
<b>Accessibility</b>	N/A	<i>Assessment Score</i>
<b>Product type:</b>		N/A
<b>Extent of Damage:</b>		N/A
<b>Surface Treatment:</b>		N/A
<b>Asbestos type:</b>		N/A
<b>Material Assessment Score:</b>		N/A
<b>Priority Assessment Score:</b>		N/A
<b>Action:</b>	N/A	
<b>Comments:</b>	Bitumen under parquet flooring (as sample 10)

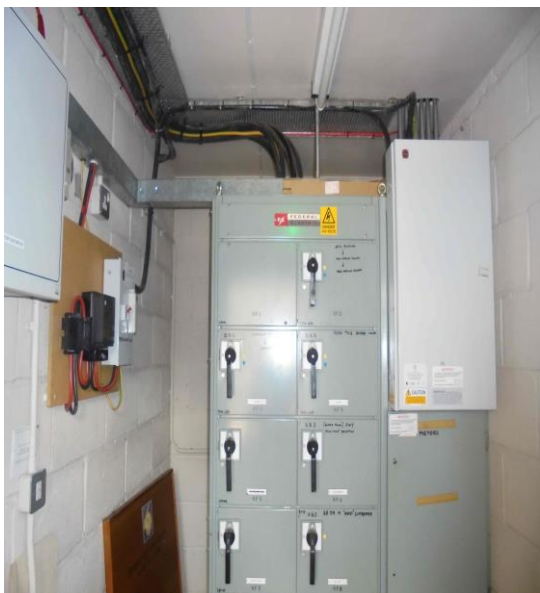
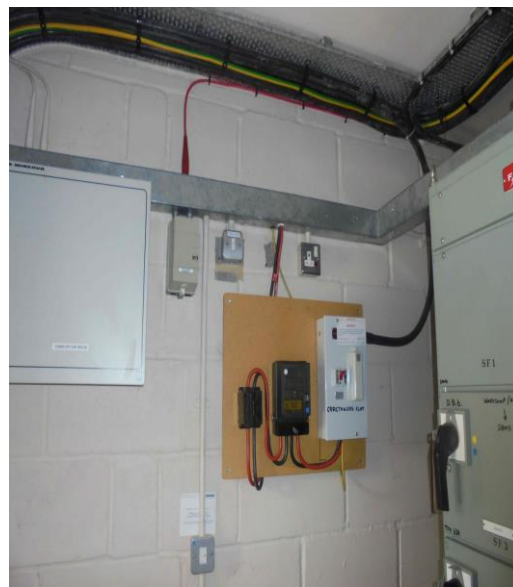
**Item No: 54****Sample No: N/A****Location: Electrics Room**

<b>Material Description:</b>	Visual Inspection – No Suspect Materials Found	
<b>Identification:</b>	N/A	
<b>Approx. quantity:</b>	N/A	
<b>Accessibility</b>	N/A	<i>Assessment Score</i>
<b>Product type:</b>		N/A
<b>Extent of Damage:</b>		N/A
<b>Surface Treatment:</b>		N/A
<b>Asbestos type:</b>		N/A
<b>Material Assessment Score:</b>		N/A
<b>Priority Assessment Score:</b>		N/A
<b>Action:</b>	N/A	
<b>Comments:</b>	Modern electrics

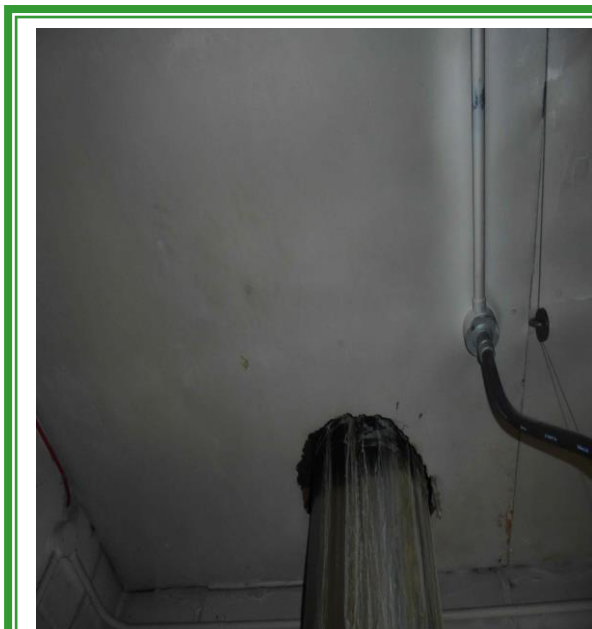
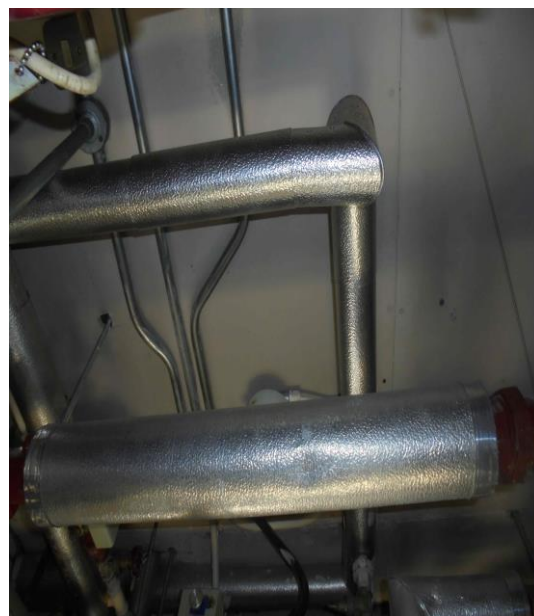
**Item No: 55**

<b>Material Description:</b>	Insulation board ceiling panels	
<b>Identification:</b>	Sampled – No Asbestos Detected	
<b>Approx. quantity:</b>	10M2	
<b>Accessibility</b>	Medium	<i>Assessment Score</i>
<b>Product type:</b>		N/A
<b>Extent of Damage:</b>		N/A
<b>Surface Treatment:</b>		N/A
<b>Asbestos type:</b>		N/A
<b>Material Assessment Score:</b>		N/A
<b>Priority Assessment Score:</b>		N/A
<b>Action:</b>	N/A	
<b>Comments:</b>	N/A

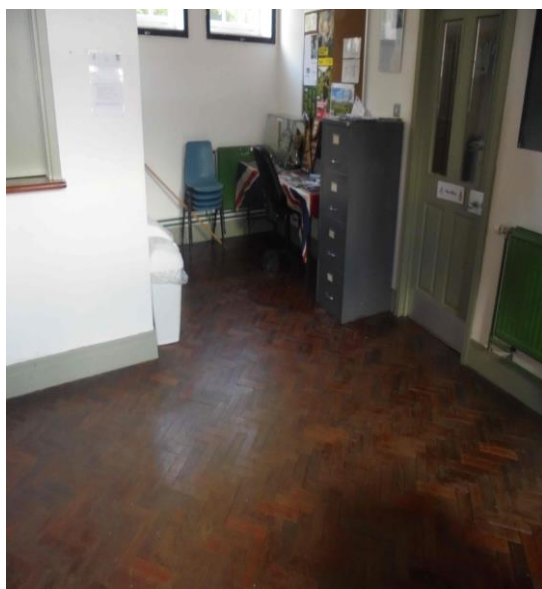
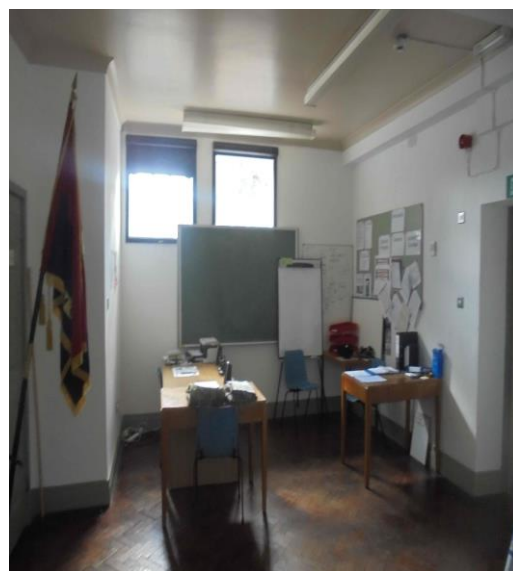
**Location: The Somme classroom – Ground Floor**

<b>Material Description:</b>	Visual Inspection – No Suspect Materials Found	
<b>Identification:</b>	N/A	
<b>Approx. quantity:</b>	N/A	
<b>Accessibility</b>	N/A	<i>Assessment Score</i>
<b>Product type:</b>		N/A
<b>Extent of Damage:</b>		N/A
<b>Surface Treatment:</b>		N/A
<b>Asbestos type:</b>		N/A
<b>Material Assessment Score:</b>		N/A
<b>Priority Assessment Score:</b>		N/A
<b>Action:</b>	N/A	
<b>Comments:</b>	Bitumen under parquet flooring (as sample 10)

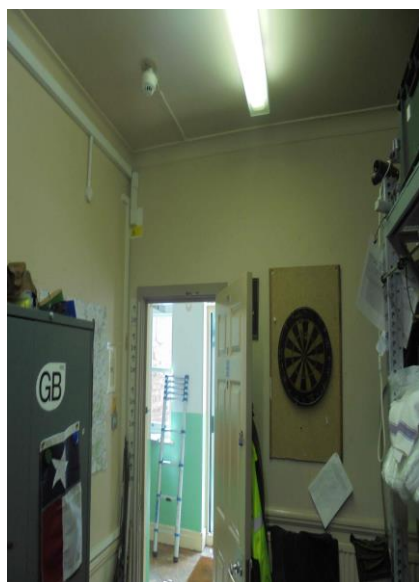
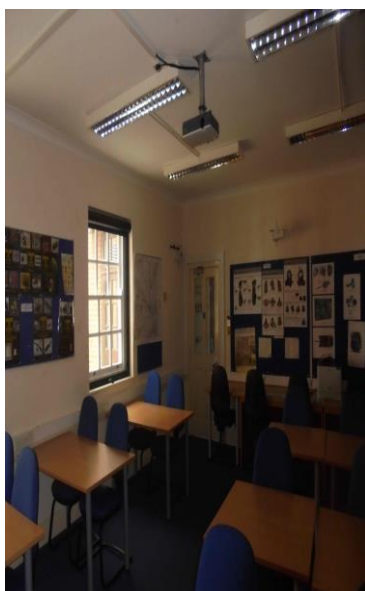
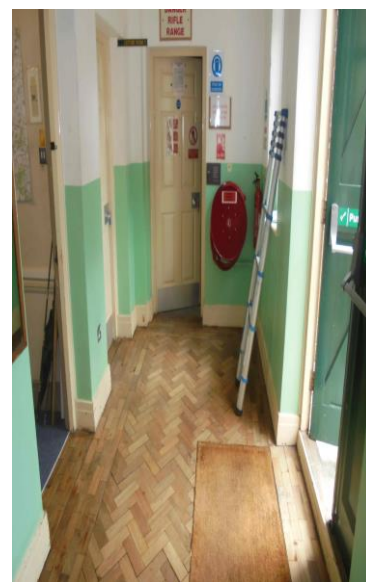
**Item No: 60****Sample No: N/A****Location: Classroom, Office and Lobby**

<b>Material Description:</b>	Visual Inspection – No Suspect Materials Found	
<b>Identification:</b>	N/A	
<b>Approx. quantity:</b>	N/A	
<b>Accessibility</b>	N/A	<i>Assessment Score</i>
<b>Product type:</b>		N/A
<b>Extent of Damage:</b>		N/A
<b>Surface Treatment:</b>		N/A
<b>Asbestos type:</b>		N/A
<b>Material Assessment Score:</b>		N/A
<b>Priority Assessment Score:</b>		N/A
<b>Action:</b>	N/A	
<b>Comments:</b>	Bitumen under parquet flooring (as sample 10)

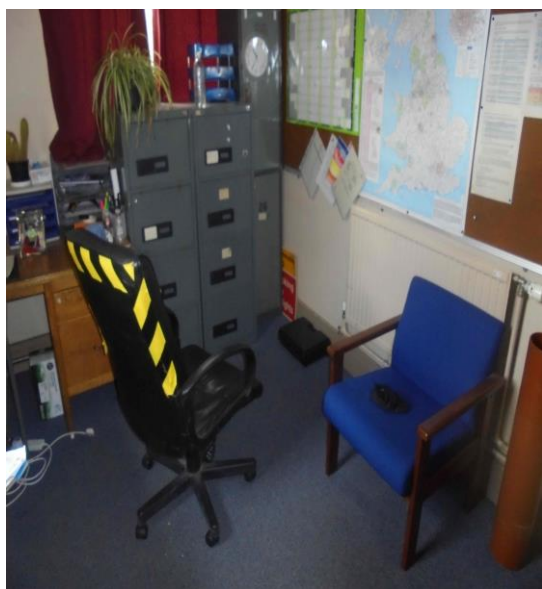
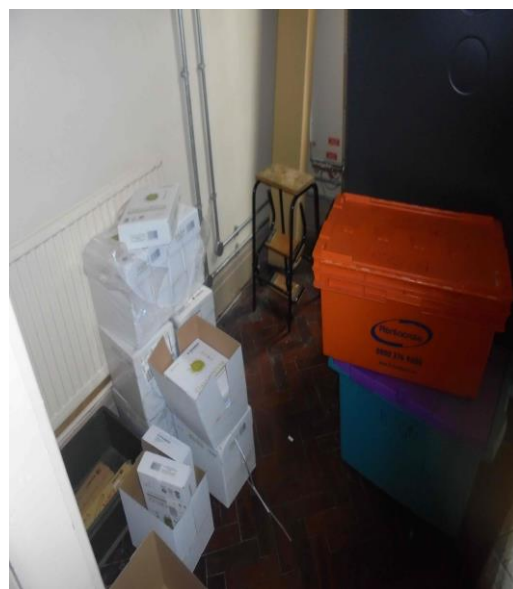
**Location: Office (g18) and server room – Ground Floor**

<b>Material Description:</b>	Visual Inspection – No Suspect Materials Found	
<b>Identification:</b>	N/A	
<b>Approx. quantity:</b>	N/A	
<b>Accessibility</b>	N/A	<i>Assessment Score</i>
<b>Product type:</b>		N/A
<b>Extent of Damage:</b>		N/A
<b>Surface Treatment:</b>		N/A
<b>Asbestos type:</b>		N/A
<b>Material Assessment Score:</b>		N/A
<b>Priority Assessment Score:</b>		N/A
<b>Action:</b>	N/A	
<b>Comments:</b>	Bitumen under parquet flooring as sample 10

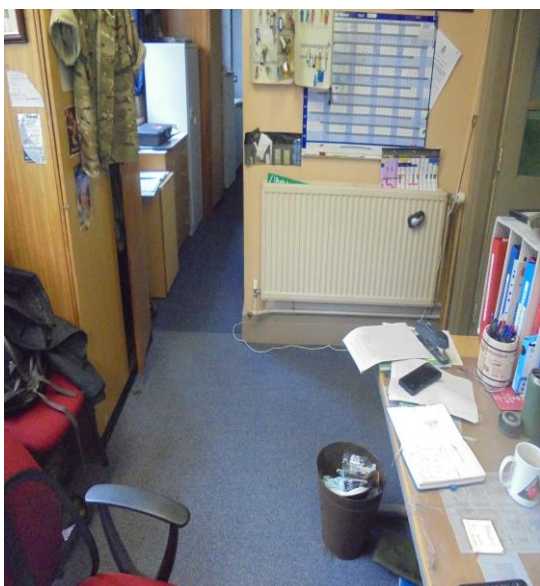
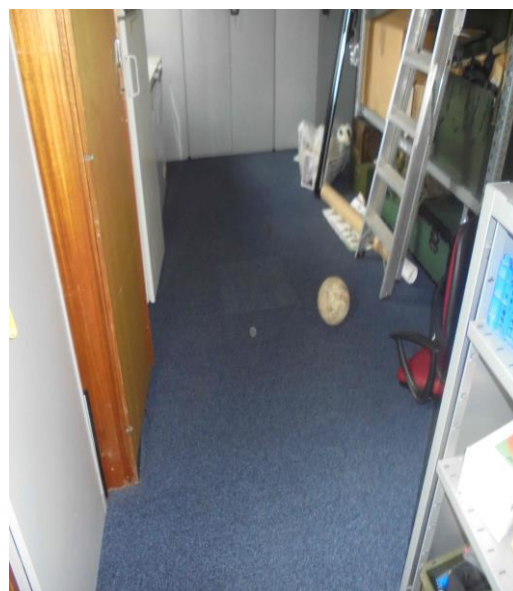
**Item No: 63****Sample No: N/A****Location: Office G18 and Store**

<b>Material Description:</b>	Visual Inspection – No Suspect Materials Found	
<b>Identification:</b>	N/A	
<b>Approx. quantity:</b>	N/A	
<b>Accessibility</b>	N/A	<i>Assessment Score</i>
<b>Product type:</b>		N/A
<b>Extent of Damage:</b>		N/A
<b>Surface Treatment:</b>		N/A
<b>Asbestos type:</b>		N/A
<b>Material Assessment Score:</b>		N/A
<b>Priority Assessment Score:</b>		N/A
<b>Action:</b>	N/A	
<b>Comments:</b>	Bitumen under parquet flooring as sample 10

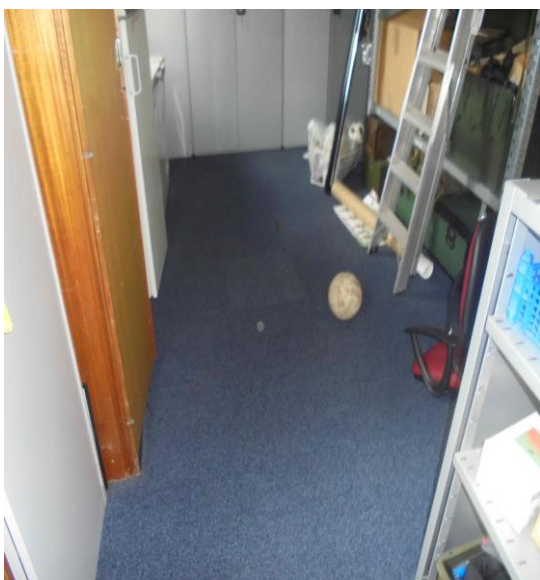
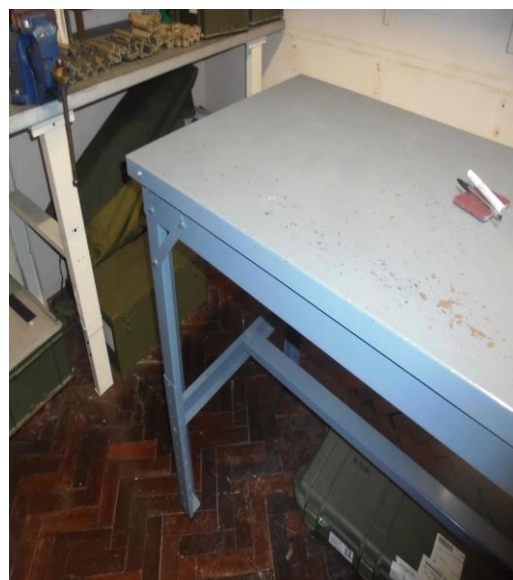
**Location: Armoury Store – Ground Floor**

<b>Material Description:</b>	Visual Inspection – No Suspect Materials Found	
<b>Identification:</b>	N/A	
<b>Approx. quantity:</b>	N/A	
<b>Accessibility</b>	N/A	<i>Assessment Score</i>
<b>Product type:</b>		N/A
<b>Extent of Damage:</b>		N/A
<b>Surface Treatment:</b>		N/A
<b>Asbestos type:</b>		N/A
<b>Material Assessment Score:</b>		N/A
<b>Priority Assessment Score:</b>		N/A
<b>Action:</b>	N/A	
<b>Comments:</b>	Bitumen under parquet flooring as sample 10

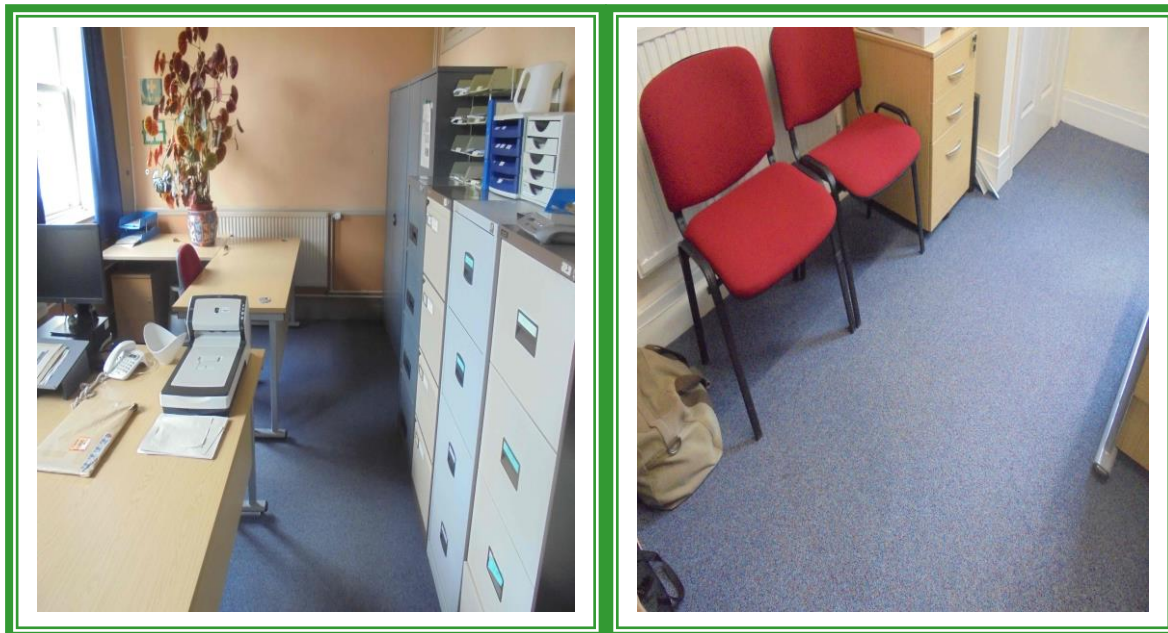
**Location: Offices G20 and G21 - Ground Floor**

<b>Material Description:</b>	Visual Inspection – No Suspect Materials Found	
<b>Identification:</b>	N/A	
<b>Approx. quantity:</b>	N/A	
<b>Accessibility</b>	N/A	<i>Assessment Score</i>
<b>Product type:</b>		N/A
<b>Extent of Damage:</b>		N/A
<b>Surface Treatment:</b>		N/A
<b>Asbestos type:</b>		N/A
<b>Material Assessment Score:</b>		N/A
<b>Priority Assessment Score:</b>		N/A
<b>Action:</b>	N/A	
<b>Comments:</b>	Bitumen under parquet flooring as sample 10

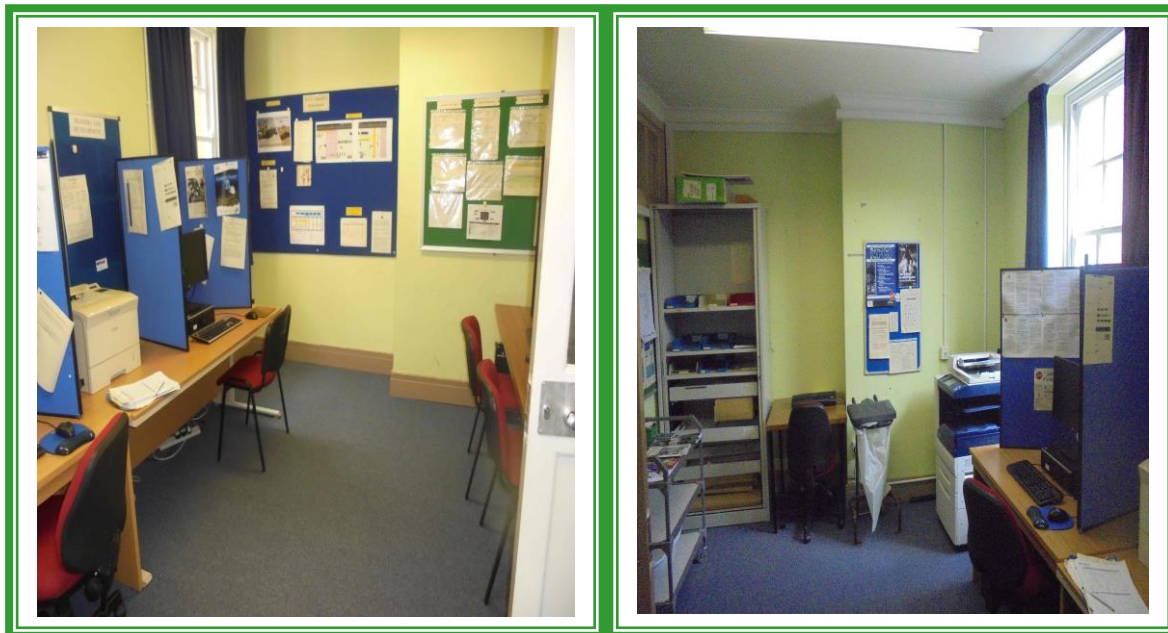
**Location: IT rooms - Ground Floor**

<b>Material Description:</b>	Visual Inspection – No Suspect Materials Found	
<b>Identification:</b>	N/A	
<b>Approx. quantity:</b>	N/A	
<b>Accessibility</b>	N/A	<i>Assessment Score</i>
<b>Product type:</b>		N/A
<b>Extent of Damage:</b>		N/A
<b>Surface Treatment:</b>		N/A
<b>Asbestos type:</b>		N/A
<b>Material Assessment Score:</b>		N/A
<b>Priority Assessment Score:</b>		N/A
<b>Action:</b>	N/A	
<b>Comments:</b>	Bitumen under parquet flooring as sample 10

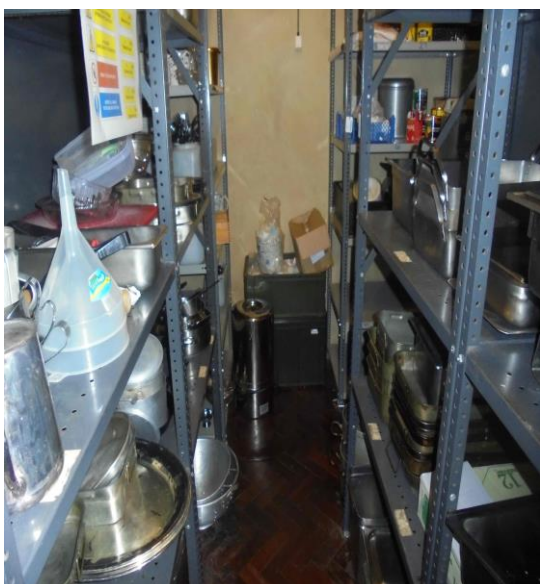
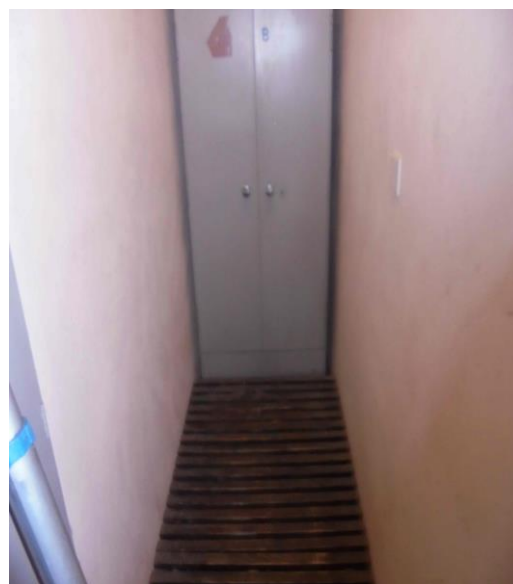
**Location: Secure stores X2**

<b>Material Description:</b>	Visual Inspection – No Suspect Materials Found	
<b>Identification:</b>	N/A	
<b>Approx. quantity:</b>	N/A	
<b>Accessibility</b>	N/A	<i>Assessment Score</i>
<b>Product type:</b>		N/A
<b>Extent of Damage:</b>		N/A
<b>Surface Treatment:</b>		N/A
<b>Asbestos type:</b>		N/A
<b>Material Assessment Score:</b>		N/A
<b>Priority Assessment Score:</b>		N/A
<b>Action:</b>	N/A	
<b>Comments:</b>	Bitumen under parquet flooring as sample 10

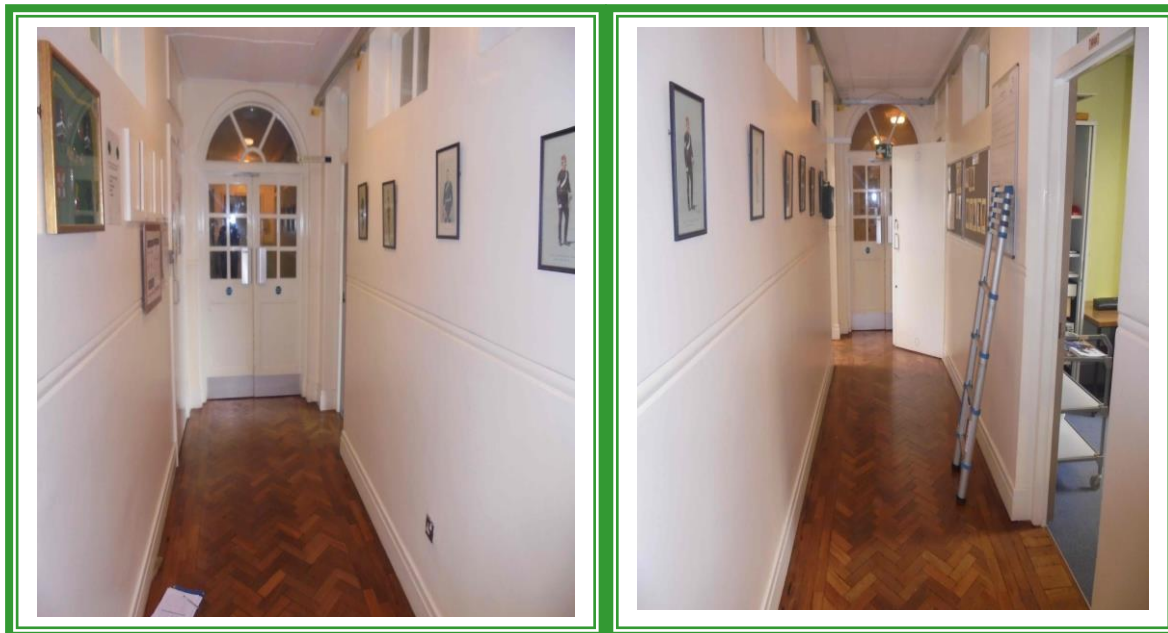
**Location: Corridors x 2 - Ground Floor**

<b>Material Description:</b>	Visual Inspection – No Suspect Materials Found	
<b>Identification:</b>	N/A	
<b>Approx. quantity:</b>	N/A	
<b>Accessibility</b>	N/A	<i>Assessment Score</i>
<b>Product type:</b>		N/A
<b>Extent of Damage:</b>		N/A
<b>Surface Treatment:</b>		N/A
<b>Asbestos type:</b>		N/A
<b>Material Assessment Score:</b>		N/A
<b>Priority Assessment Score:</b>		N/A
<b>Action:</b>	N/A	
<b>Comments:</b>	Bitumen under parquet flooring as sample 10

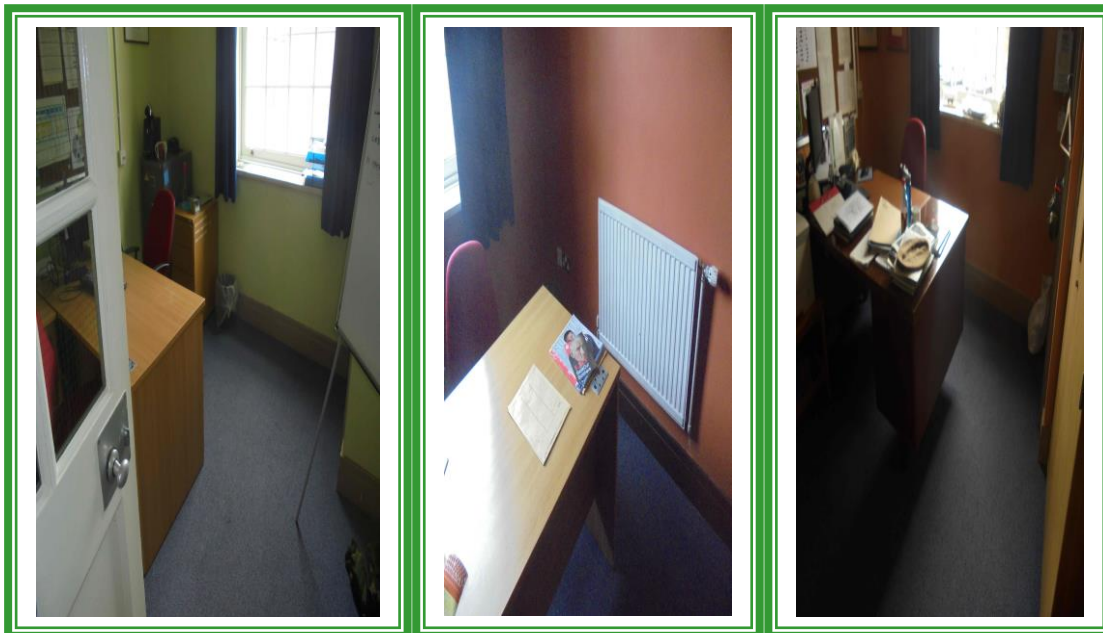
**Item No: 70****Sample No: N/A****Location: Offices G01, G02 and G03 - Ground Floor**

<b>Material Description:</b>	Visual Inspection – No Suspect Materials Found	
<b>Identification:</b>	N/A	
<b>Approx. quantity:</b>	N/A	
<b>Accessibility</b>	N/A	<i>Assessment Score</i>
<b>Product type:</b>		N/A
<b>Extent of Damage:</b>		N/A
<b>Surface Treatment:</b>		N/A
<b>Asbestos type:</b>		N/A
<b>Material Assessment Score:</b>		N/A
<b>Priority Assessment Score:</b>		N/A
<b>Action:</b>	N/A	
<b>Comments:</b>	Bitumen under parquet flooring as sample 10

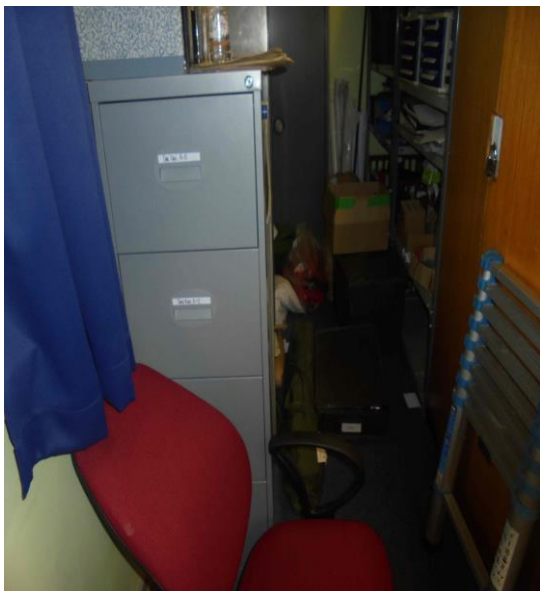
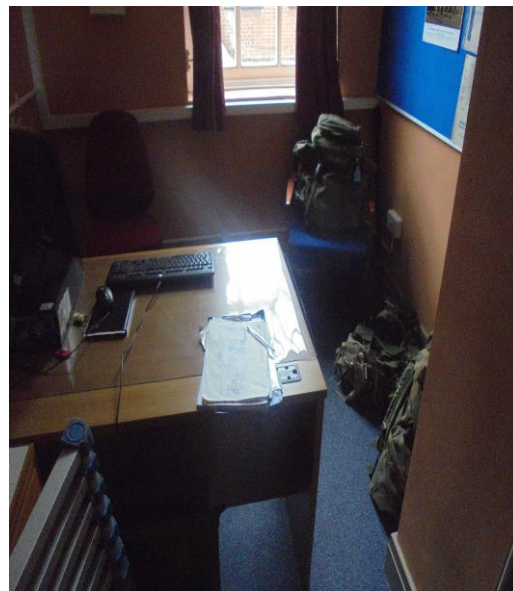
**Location: Offices G04, G05 and store G06 - Ground Floor**

<b>Material Description:</b>	Visual Inspection – No Suspect Materials Found	
<b>Identification:</b>	N/A	
<b>Approx. quantity:</b>	N/A	
<b>Accessibility</b>	N/A	<i>Assessment Score</i>
<b>Product type:</b>		N/A
<b>Extent of Damage:</b>		N/A
<b>Surface Treatment:</b>		N/A
<b>Asbestos type:</b>		N/A
<b>Material Assessment Score:</b>		N/A
<b>Priority Assessment Score:</b>		N/A
<b>Action:</b>	N/A	
<b>Comments:</b>	Bitumen under parquet flooring as sample 10

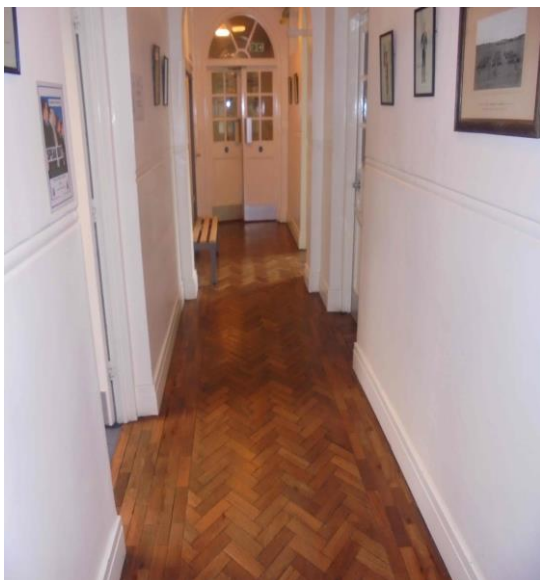
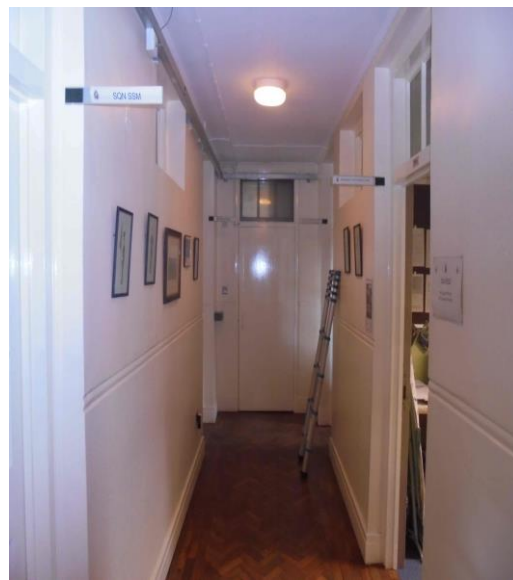
**Location: Corridor - Ground Floor**

<b>Material Description:</b>	Visual Inspection – No Suspect Materials Found	
<b>Identification:</b>	N/A	
<b>Approx. quantity:</b>	N/A	
<b>Accessibility</b>	N/A	<i>Assessment Score</i>
<b>Product type:</b>		N/A
<b>Extent of Damage:</b>		N/A
<b>Surface Treatment:</b>		N/A
<b>Asbestos type:</b>		N/A
<b>Material Assessment Score:</b>		N/A
<b>Priority Assessment Score:</b>		N/A
<b>Action:</b>	N/A	
<b>Comments:</b>	Bitumen under parquet flooring (as sample 10)

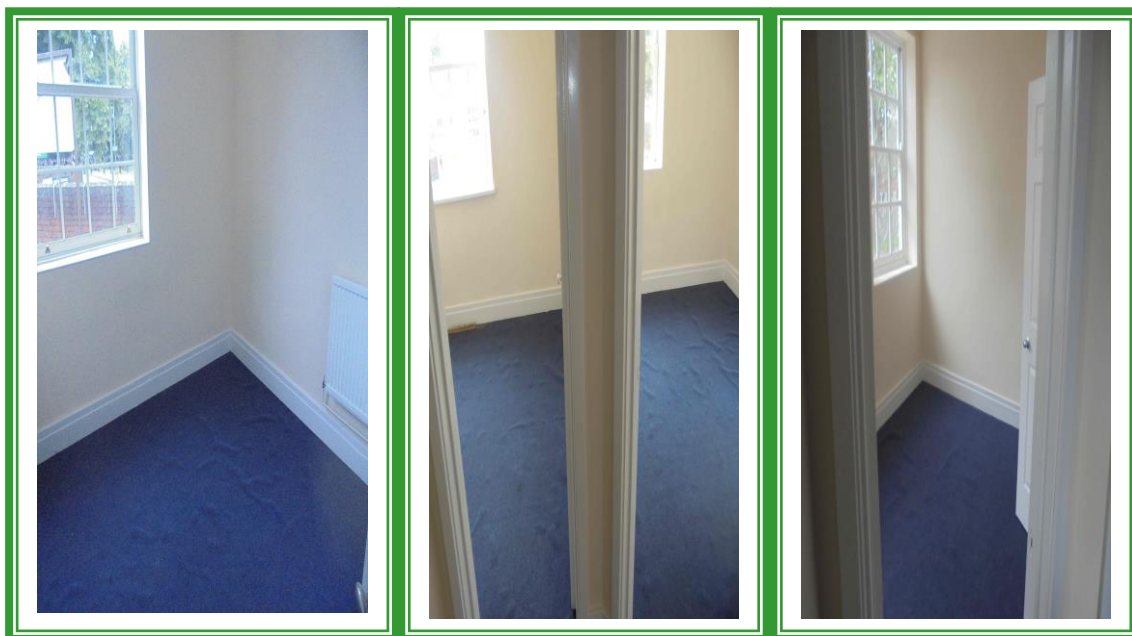
**Item No: 73****Sample No: N/A****Location: Bedrooms x 4 - Caretakers Flat - Ground Floor**

<b>Material Description:</b>	Visual Inspection – No Suspect Materials Found	
<b>Identification:</b>	N/A	
<b>Approx. quantity:</b>	N/A	
<b>Accessibility</b>	N/A	<i>Assessment Score</i>
<b>Product type:</b>		N/A
<b>Extent of Damage:</b>		N/A
<b>Surface Treatment:</b>		N/A
<b>Asbestos type:</b>		N/A
<b>Material Assessment Score:</b>		N/A
<b>Priority Assessment Score:</b>		N/A
<b>Action:</b>	N/A	
<b>Comments:</b>	Bitumen under parquet flooring as sample 10

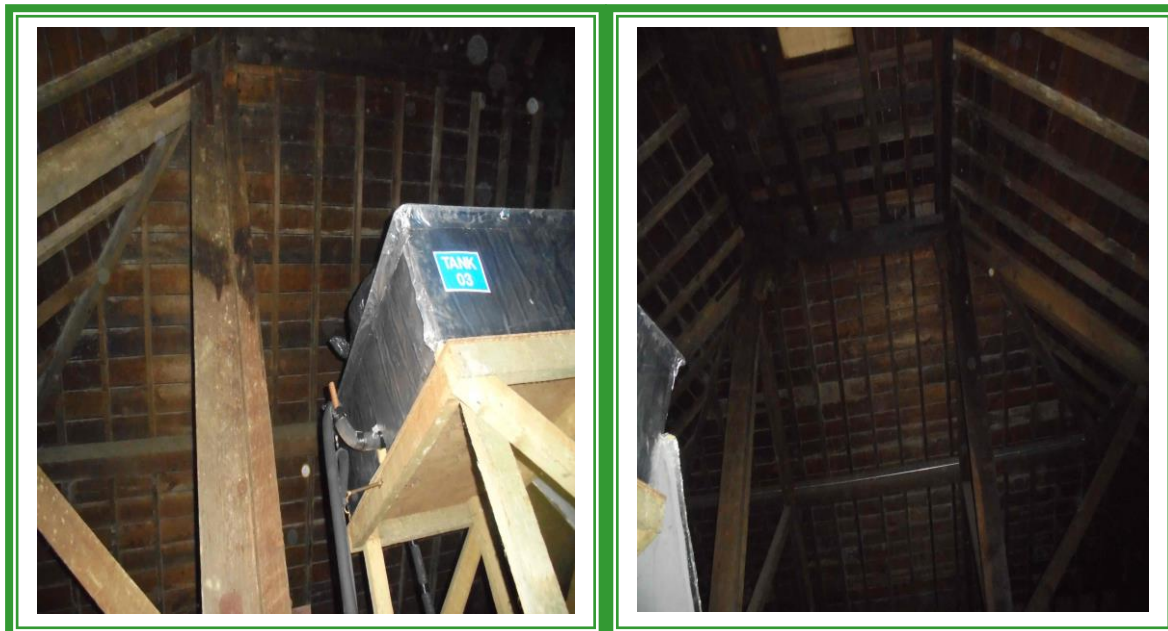
**Location: Loft space**

<b>Material Description:</b>	Visual Inspection – No Suspect Materials Found	
<b>Identification:</b>	N/A	
<b>Approx. quantity:</b>	N/A	
<b>Accessibility</b>	N/A	<i>Assessment Score</i>
<b>Product type:</b>		N/A
<b>Extent of Damage:</b>		N/A
<b>Surface Treatment:</b>		N/A
<b>Asbestos type:</b>		N/A
<b>Material Assessment Score:</b>		N/A
<b>Priority Assessment Score:</b>		N/A
<b>Action:</b>	N/A	
<b>Comments:</b>	No access to loft due to height of hatch

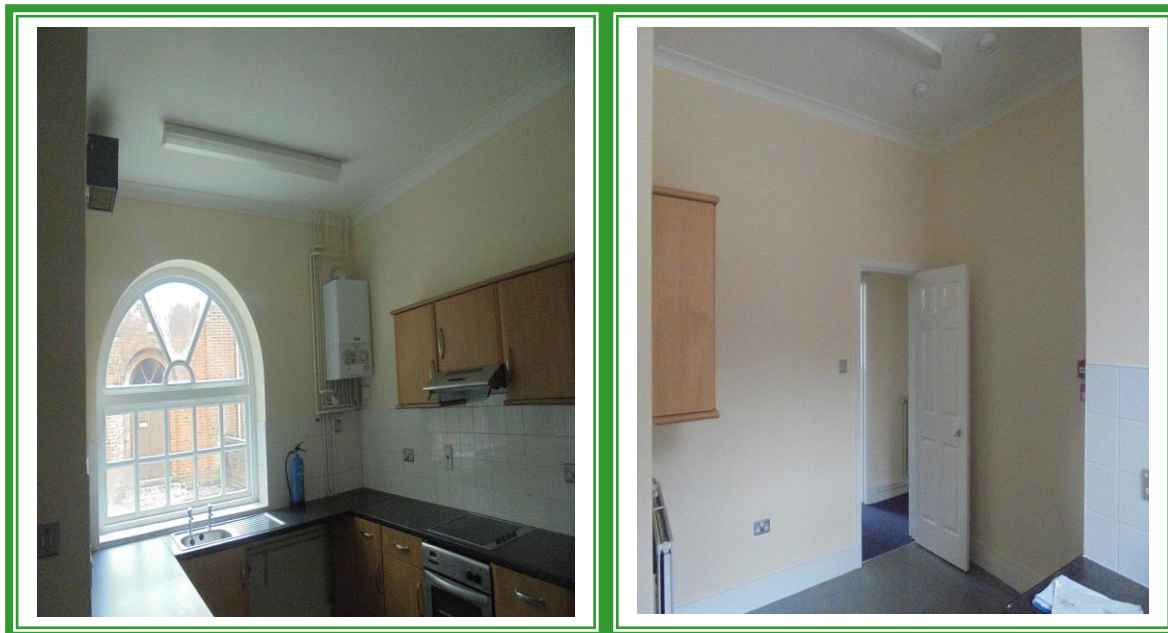
**Item No:76****Sample No: N/A****Location: Kitchen - Ground Floor**

<b>Material Description:</b>	Visual Inspection – No Suspect Materials Found	
<b>Identification:</b>	N/A	
<b>Approx. quantity:</b>	N/A	
<b>Accessibility</b>	N/A	<i>Assessment Score</i>
<b>Product type:</b>		N/A
<b>Extent of Damage:</b>		N/A
<b>Surface Treatment:</b>		N/A
<b>Asbestos type:</b>		N/A
<b>Material Assessment Score:</b>		N/A
<b>Priority Assessment Score:</b>		N/A
<b>Action:</b>	N/A	
<b>Comments:</b>	Modern sink pad and boiler

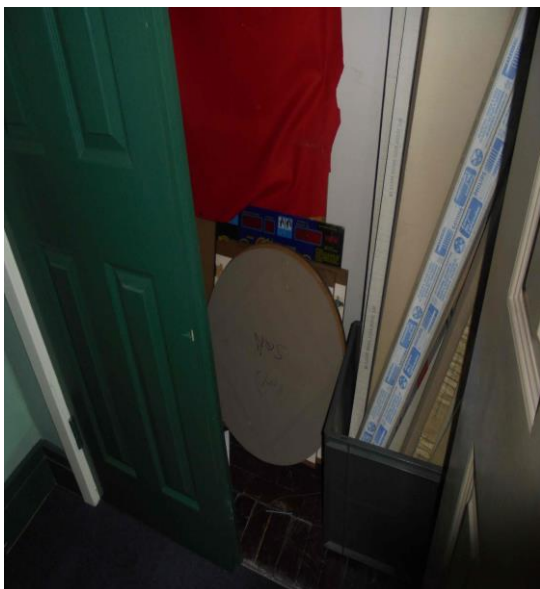
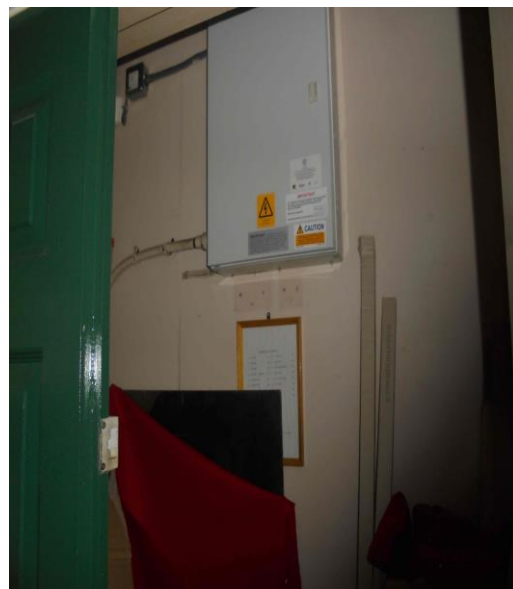
**Location: Electrical Cupboard**

<b>Material Description:</b>	Visual Inspection – No Suspect Materials Found	
<b>Identification:</b>	N/A	
<b>Approx. quantity:</b>	N/A	
<b>Accessibility</b>	N/A	<i>Assessment Score</i>
<b>Product type:</b>		N/A
<b>Extent of Damage:</b>		N/A
<b>Surface Treatment:</b>		N/A
<b>Asbestos type:</b>		N/A
<b>Material Assessment Score:</b>		N/A
<b>Priority Assessment Score:</b>		N/A
<b>Action:</b>	N/A	
<b>Comments:</b>	Bitumen under parquet flooring (as sample 10)

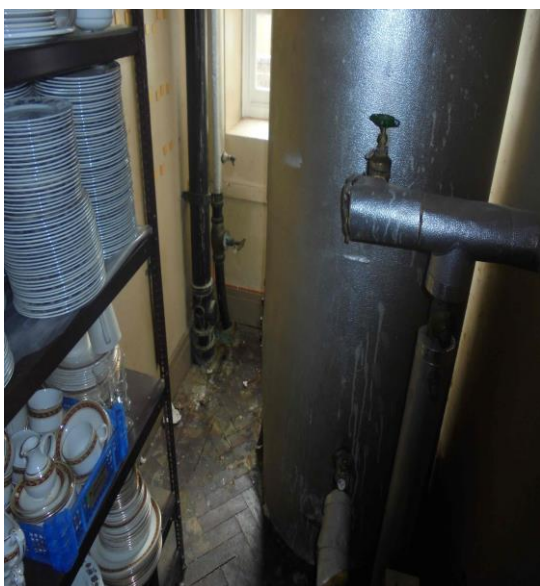
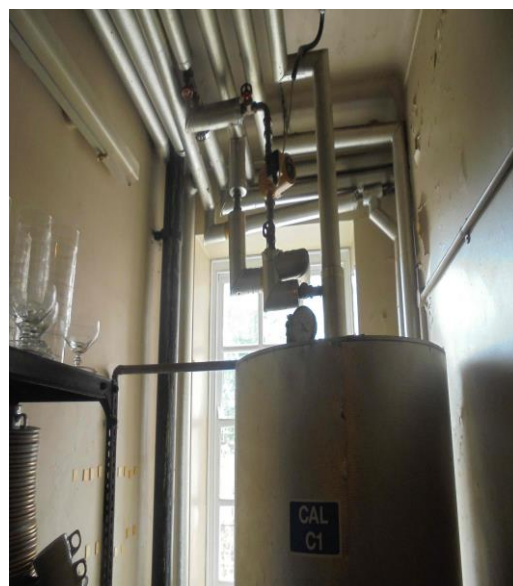
**Location: Water heater room - Ground Floor**

<b>Material Description:</b>	Visual Inspection – No Suspect Materials Found	
<b>Identification:</b>	N/A	
<b>Approx. quantity:</b>	N/A	
<b>Accessibility</b>	N/A	<i>Assessment Score</i>
<b>Product type:</b>		N/A
<b>Extent of Damage:</b>		N/A
<b>Surface Treatment:</b>		N/A
<b>Asbestos type:</b>		N/A
<b>Material Assessment Score:</b>		N/A
<b>Priority Assessment Score:</b>		N/A
<b>Action:</b>	N/A	
<b>Comments:</b>	Bitumen under parquet floor (as sample 10)

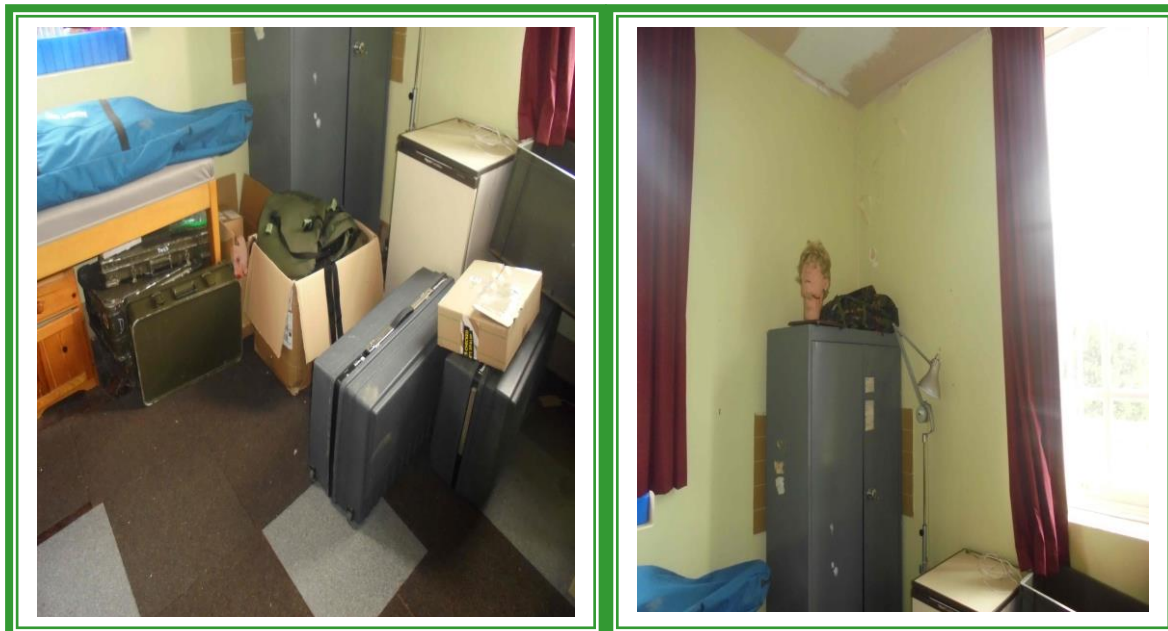
**Location: medics office - First Floor**

<b>Material Description:</b>	Visual Inspection – No Suspect Materials Found	
<b>Identification:</b>	N/A	
<b>Approx. quantity:</b>	N/A	
<b>Accessibility</b>	N/A	<i>Assessment Score</i>
<b>Product type:</b>		N/A
<b>Extent of Damage:</b>		N/A
<b>Surface Treatment:</b>		N/A
<b>Asbestos type:</b>		N/A
<b>Material Assessment Score:</b>		N/A
<b>Priority Assessment Score:</b>		N/A
<b>Action:</b>	N/A	
<b>Comments:</b>	Bitumen under parquet flooring as sample 10

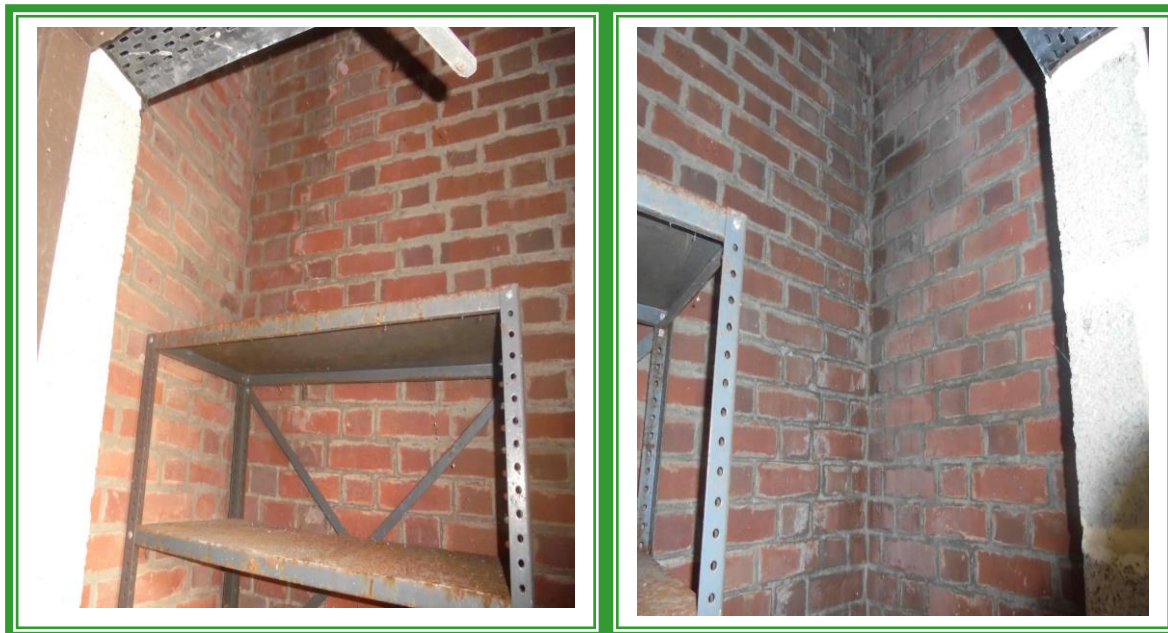
**Item No: 85****Sample No: N/A****Location: External Store - Ground Floor**

<b>Material Description:</b>	Visual Inspection – No Suspect Materials Found	
<b>Identification:</b>	N/A	
<b>Approx. quantity:</b>	N/A	
<b>Accessibility</b>	N/A	<i>Assessment Score</i>
<b>Product type:</b>		N/A
<b>Extent of Damage:</b>		N/A
<b>Surface Treatment:</b>		N/A
<b>Asbestos type:</b>		N/A
<b>Material Assessment Score:</b>		N/A
<b>Priority Assessment Score:</b>		N/A
<b>Action:</b>	N/A	
<b>Comments:</b>	N/A
