**ARMOUR**  
ANALYTICAL SERVICES

**Project Number 2481**

**Management  
Asbestos Survey Report**

**6<sup>th</sup> Battalion, Eastern Avenue, Gloucestershire  
GL4 3BD**

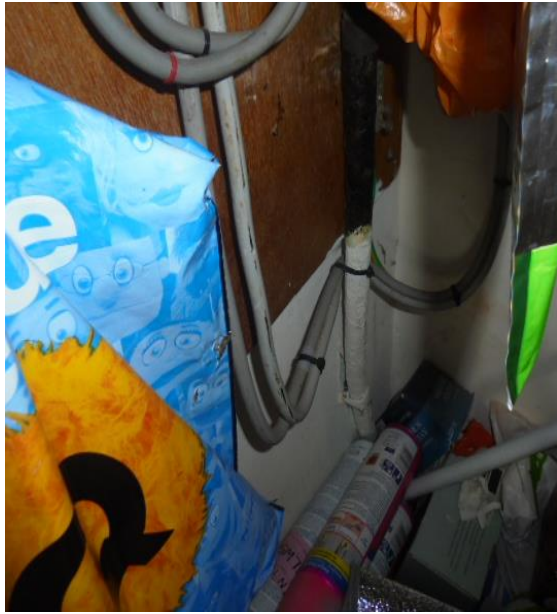
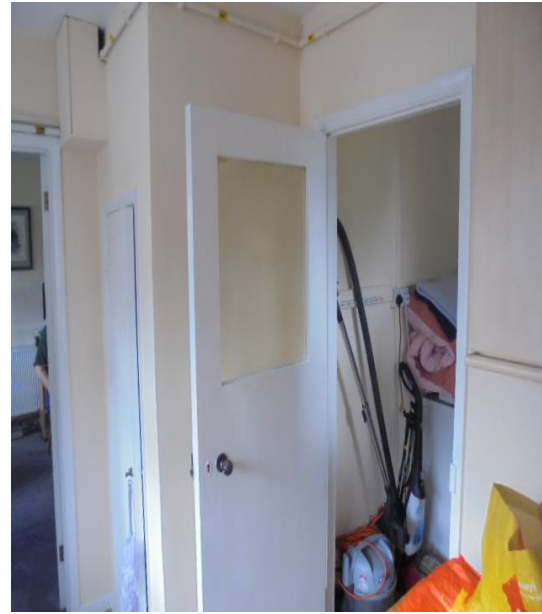
**Location: Ground Floor – House 5 – Kitchen and  
Cupboards x2**

<b>Material Description:</b>	Bitumen Wrap to Mains Cable	
<b>Identification:</b>	Presumed to Contain Asbestos	
<b>Approx. quantity:</b>	1LM	
<b>Accessibility</b>	Low	<i>Assessment Score</i>
<b>Product type:</b>	Bitumen	1
<b>Extent of Damage:</b>	Minor	1
<b>Surface Treatment:</b>	Non-Friable	0
<b>Asbestos type:</b>	Chrysotile	1
<b>Material Assessment Score:</b>		3
<b>Priority Assessment Score:</b>		Negligible
<b>Action:</b>	Manage	
<b>Comments:</b>	Modern Ideal Boiler and Sink Pad

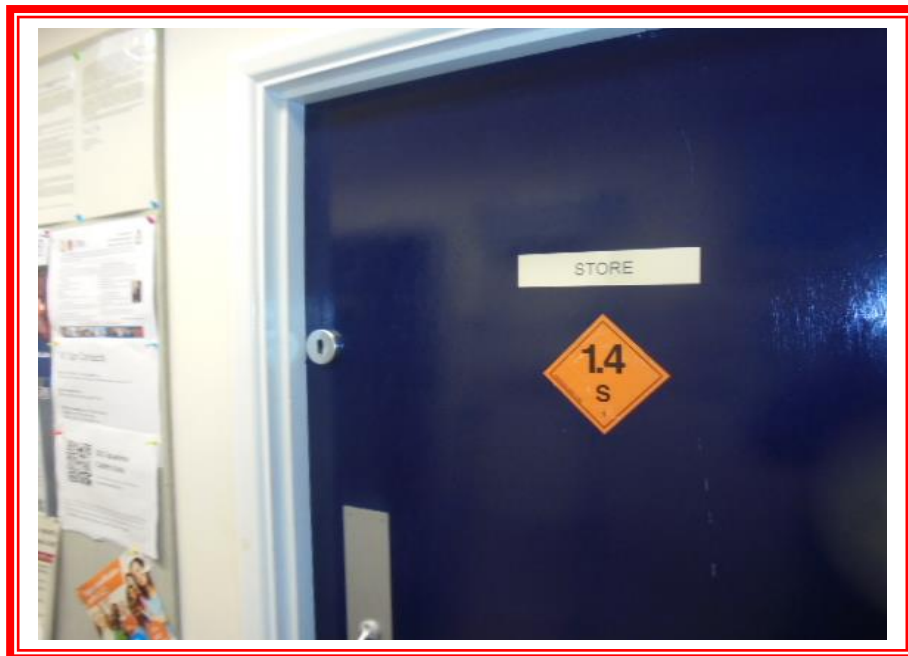
**Location: ATC Hut - Store**

<b>Material Description:</b>	No Access	
<b>Identification:</b>	Presumed to Contain Asbestos	
<b>Approx. quantity:</b>	1x Room	
<b>Accessibility</b>	Low	Assessment Score
<b>Product type:</b>	No Access	3
<b>Extent of Damage:</b>	No Access	3
<b>Surface Treatment:</b>	No Access	3
<b>Asbestos type:</b>	No Access	3
<b>Material Assessment Score:</b>		12
<b>Priority Assessment Score:</b>		High
<b>Action:</b>	Further Investigation Required	
<b>Comments:</b>	No Access within Locked Room – No Key Available During Survey

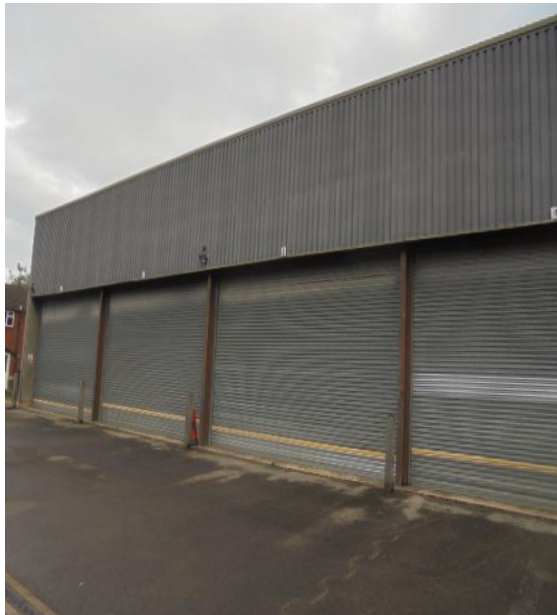
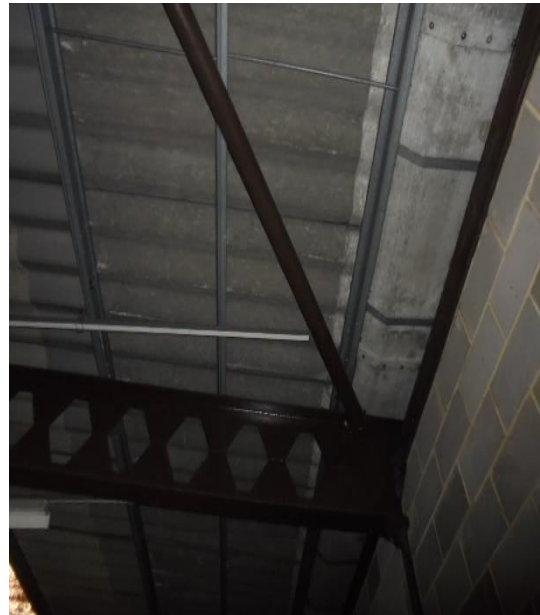
**Location: Garages 1-5**

<b>Material Description:</b>	Profiled Cement Roof and Cement Guttering	
<b>Identification:</b>	Strongly Presumed to Contain Asbestos	
<b>Approx. quantity:</b>	530M2 – Roof – 30LM Guttering	
<b>Accessibility</b>	Low	<i>Assessment Score</i>
<b>Product type:</b>	Cement	1
<b>Extent of Damage:</b>	Minor	1
<b>Surface Treatment:</b>	Unsealed	1
<b>Asbestos type:</b>	Chrysotile	1
<b>Material Assessment Score:</b>		4
<b>Priority Assessment Score:</b>		Negligible
<b>Action:</b>	Manage	
<b>Comments:</b>	N/A

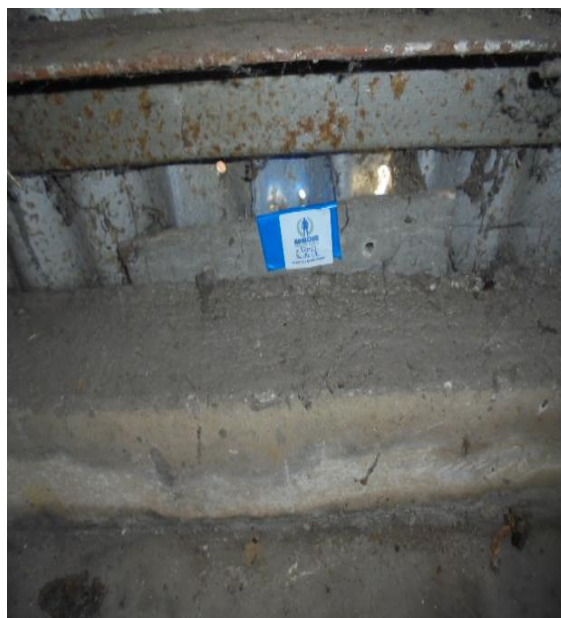
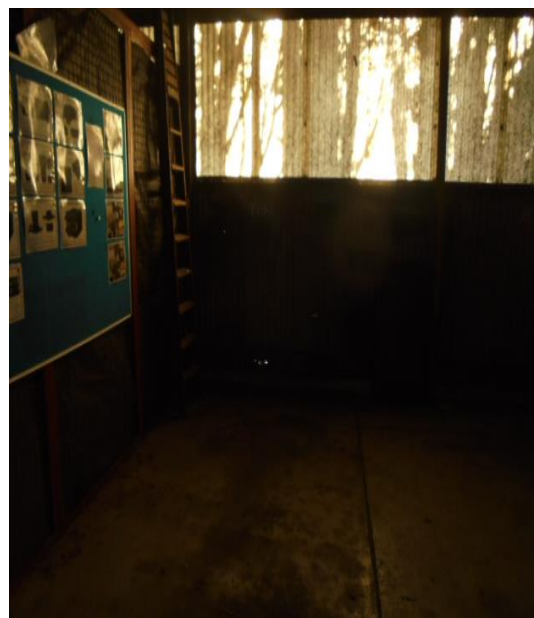
**Location: Garage – Drill Hall**

<b>Material Description:</b>	Cement Panel Packer	
<b>Identification:</b>	Sampled – Asbestos Detected	
<b>Approx. quantity:</b>	<1M2	
<b>Accessibility</b>	Low	Assessment Score
<b>Product type:</b>	Cement	1
<b>Extent of Damage:</b>	Minor	1
<b>Surface Treatment:</b>	Unsealed	1
<b>Asbestos type:</b>	Chrysotile/Crocidolite	3
<b>Material Assessment Score:</b>		6
<b>Priority Assessment Score:</b>		Low
<b>Action:</b>	Manage/Remove	
<b>Comments:</b>	Limited Access throughout Garages due to Stored Items and Locked Cages – Other packers may be present

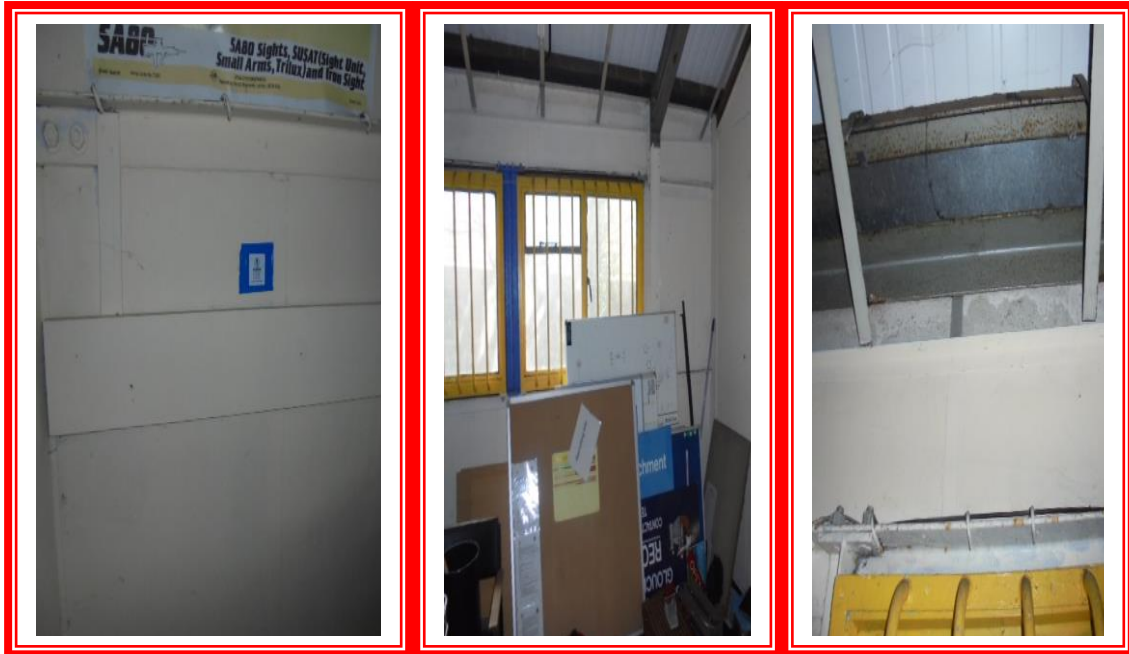
**Location: First Floor – Office – Off Drill Hall Garage**

<b>Material Description:</b>	Paper Lining to Fibreboard Wall Panels	
<b>Identification:</b>	Sampled – Asbestos Detected	
<b>Approx. quantity:</b>	24M2	
<b>Accessibility</b>	High	Assessment Score
<b>Product type:</b>	Paper	2
<b>Extent of Damage:</b>	Minor	1
<b>Surface Treatment:</b>	Unsealed	1
<b>Asbestos type:</b>	Chrysotile	1
<b>Material Assessment Score:</b>		5
<b>Priority Assessment Score:</b>		Low
<b>Action:</b>	Encapsulate/Remove	
<b>Comments:</b>	Located to Two Walls

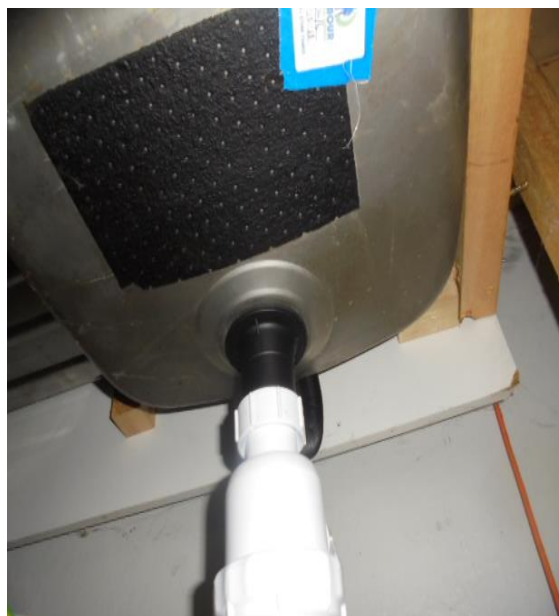
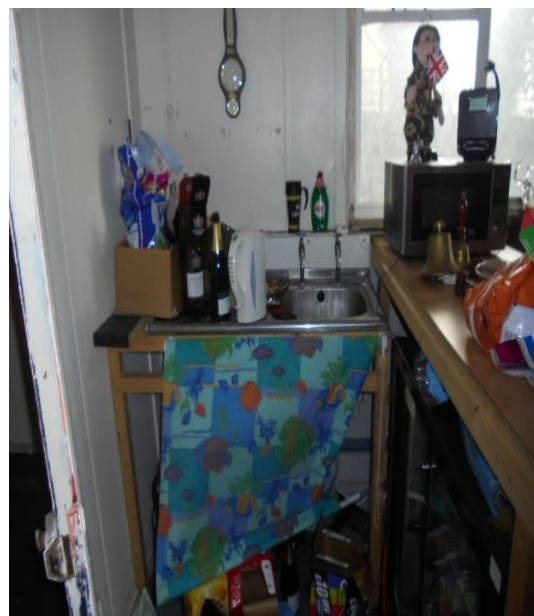
**Location: First Floor - Bar/Mess Room – Off of Garage**

<b>Material Description:</b>	Sink Pads	
<b>Identification:</b>	Sampled – Asbestos Detected	
<b>Approx. quantity:</b>	1 X Sink Pad	
<b>Accessibility</b>	Low	Assessment Score
<b>Product type:</b>	Bitumen	1
<b>Extent of Damage:</b>	Minor	1
<b>Surface Treatment:</b>	Non-Friable	0
<b>Asbestos type:</b>	Chrysotile	1
<b>Material Assessment Score:</b>		3
<b>Priority Assessment Score:</b>		Negligible
<b>Action:</b>	Manage	
<b>Comments:</b>	N/A

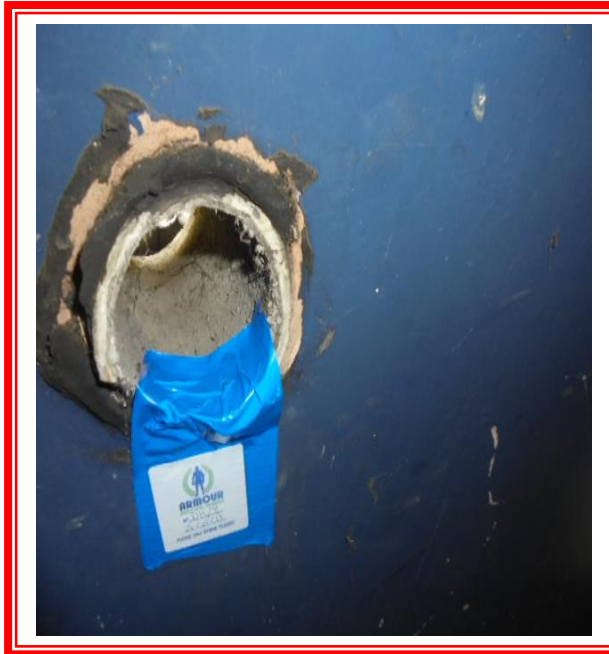
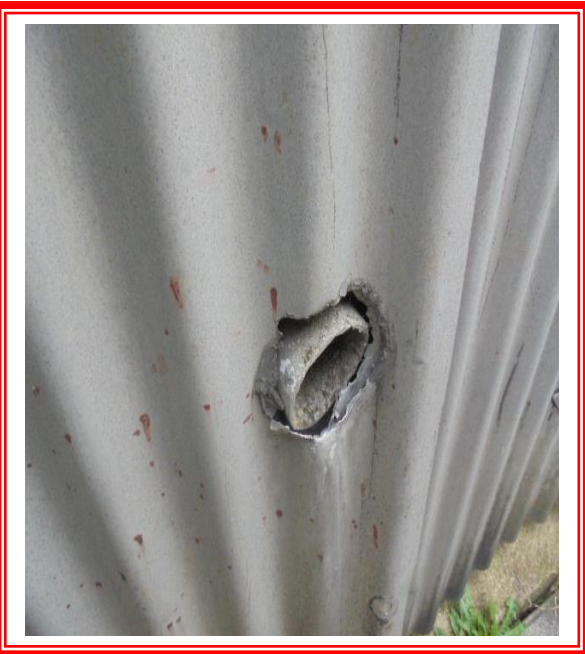
**Location: Service Garage**

<b>Material Description:</b>	Cement Pipe in Wall	
<b>Identification:</b>	Sampled – Asbestos Detected	
<b>Approx. quantity:</b>	<1LM	
<b>Accessibility</b>	Low	Assessment Score
<b>Product type:</b>	Cement	1
<b>Extent of Damage:</b>	Moderate	2
<b>Surface Treatment:</b>	Unsealed	1
<b>Asbestos type:</b>	Chrysotile	1
<b>Material Assessment Score:</b>		5
<b>Priority Assessment Score:</b>		Low
<b>Action:</b>	Manage	
<b>Comments:</b>	N/A

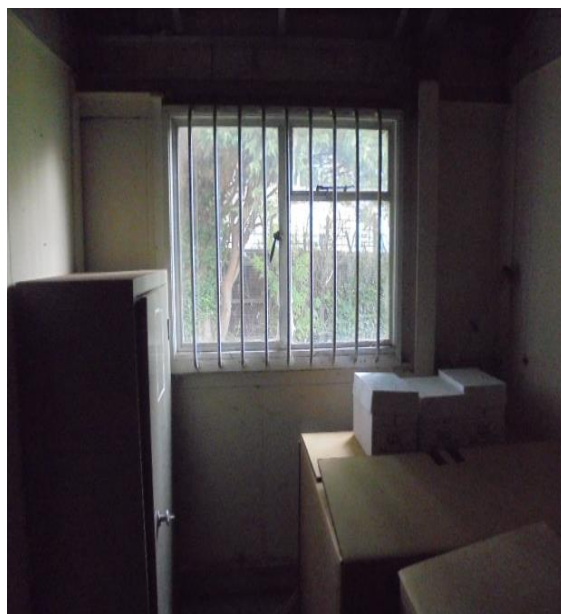
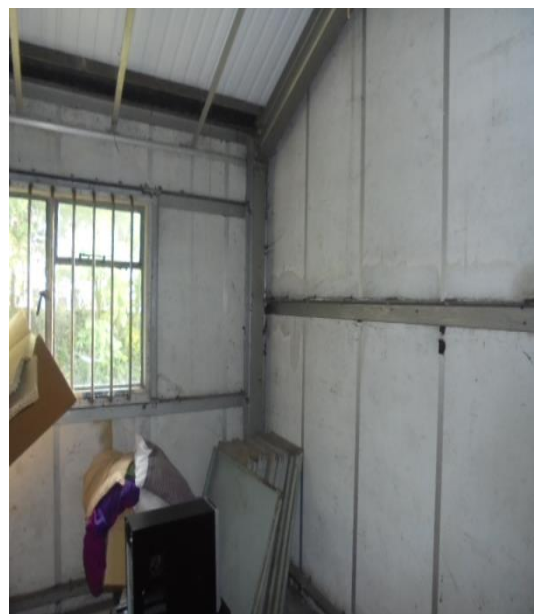
**Item No: 62****Sample No: N/A****Location: First Floor - Stores X2 – Off of Service Garage**

<b>Material Description:</b>	Paper Lining to Fibreboard Wall Panels	
<b>Identification:</b>	As Per Sample DK/5 – Asbestos Detected	
<b>Approx. quantity:</b>	24M2	
<b>Accessibility</b>	High	Assessment Score
<b>Product type:</b>	Paper	2
<b>Extent of Damage:</b>	Minor	1
<b>Surface Treatment:</b>	Unsealed	1
<b>Asbestos type:</b>	Chrysotile	1
<b>Material Assessment Score:</b>		5
<b>Priority Assessment Score:</b>		Low
<b>Action:</b>	Encapsulate/Remove	
<b>Comments:</b>	Located to 3 x Walls

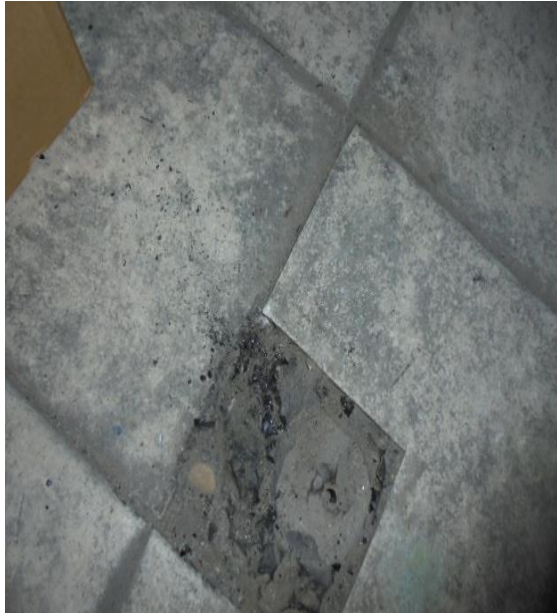
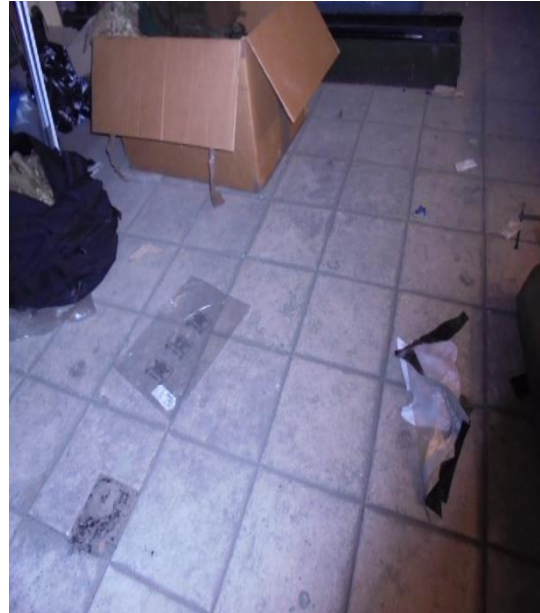
**Location: First Floor – Main Building - Stores – Mezzanine**

<b>Material Description:</b>	Prominade Floor Tiles and Adhesive	
<b>Identification:</b>	Sampled – Asbestos Detected	
<b>Approx. quantity:</b>	72M2	
<b>Accessibility</b>	High	Assessment Score
<b>Product type:</b>	Cement	1
<b>Extent of Damage:</b>	Moderate	2
<b>Surface Treatment:</b>	Unsealed	1
<b>Asbestos type:</b>	Chrysotile	1
<b>Material Assessment Score:</b>		5
<b>Priority Assessment Score:</b>		Low
<b>Action:</b>	Manage	
<b>Comments:</b>	N/A

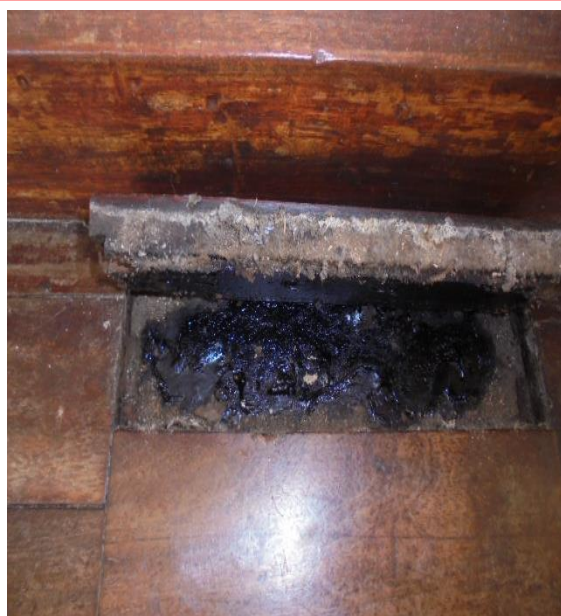
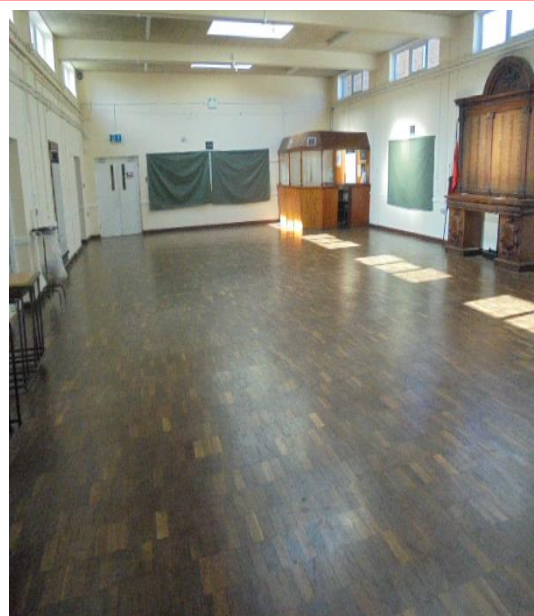
**Location: Ground Floor – Main Building - Drill Hall**

<b>Material Description:</b>	Adhesive Under Parquet Flooring	
<b>Identification:</b>	Sampled – Asbestos Detected	
<b>Approx. quantity:</b>	180M2	
<b>Accessibility</b>	Low	Assessment Score
<b>Product type:</b>	Bitumen	1
<b>Extent of Damage:</b>	Minor	1
<b>Surface Treatment:</b>	Non-Friable	0
<b>Asbestos type:</b>	Chrysotile	1
<b>Material Assessment Score:</b>		3
<b>Priority Assessment Score:</b>		Negligible
<b>Action:</b>	Manage	
<b>Comments:</b>	No Access above Fixed Ceiling Tiles

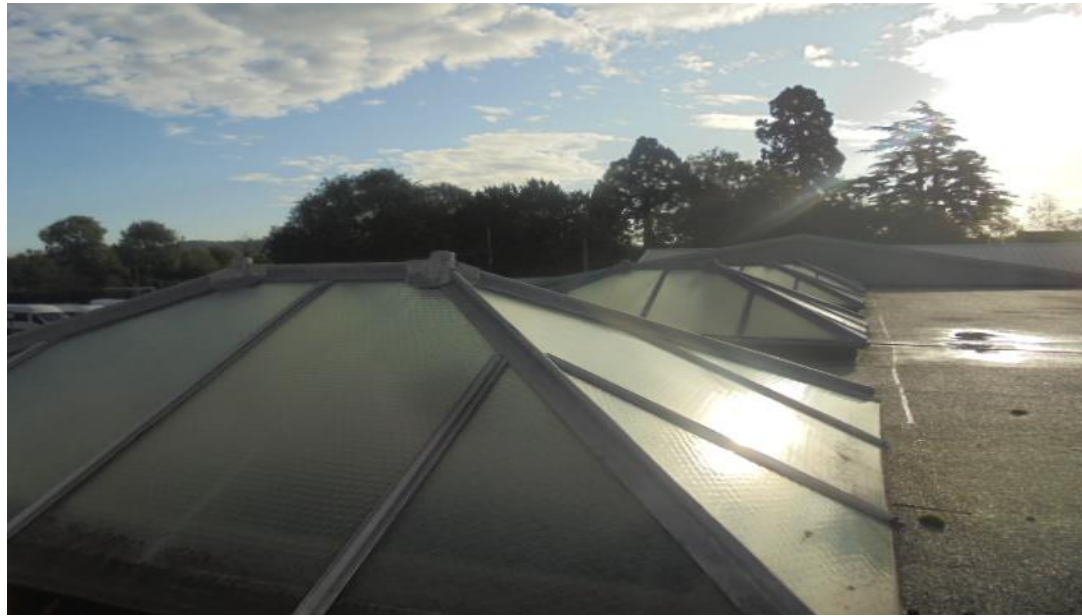
**Location: External to Drill Hall**

<b>Material Description:</b>	Rope Seals within Skylights	
<b>Identification:</b>	Presumed to Contain Asbestos	
<b>Approx. quantity:</b>	4 X Skylights	
<b>Accessibility</b>	Low	<i>Assessment Score</i>
<b>Product type:</b>	Rope	2
<b>Extent of Damage:</b>	Minor	1
<b>Surface Treatment:</b>	Unsealed	1
<b>Asbestos type:</b>	Chrysotile	1
<b>Material Assessment Score:</b>		5
<b>Priority Assessment Score:</b>		Low
<b>Action:</b>	Manage	
<b>Comments:</b>	No Access to Sample Due to Height

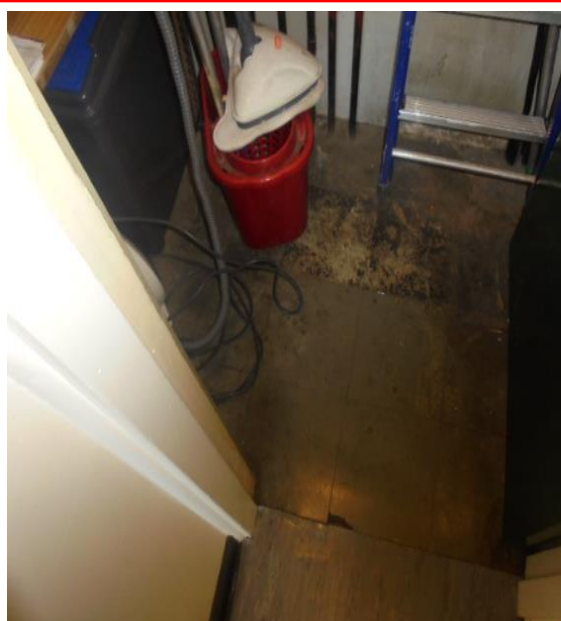
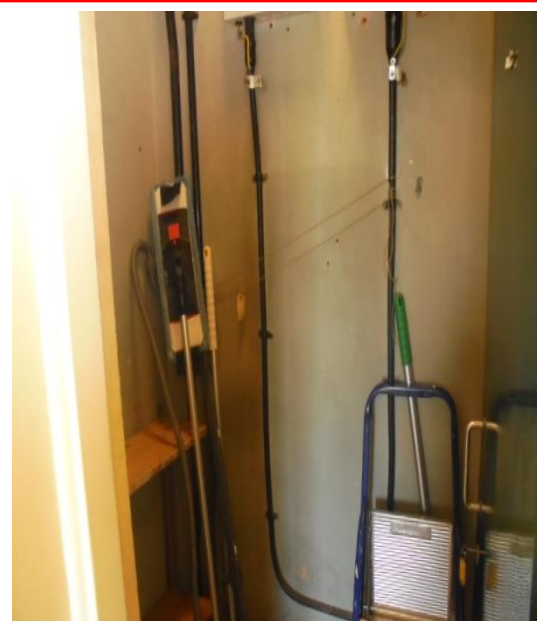
**Location: First Floor – Main Building - Cleaner Cupboard  
F12**

<b>Material Description:</b>	Floor Tiles and Adhesive	
<b>Identification:</b>	Sampled – Asbestos Detected	
<b>Approx. quantity:</b>	1M2	
<b>Accessibility</b>	High	<i>Assessment Score</i>
<b>Product type:</b>	Composite	1
<b>Extent of Damage:</b>	Moderate	2
<b>Surface Treatment:</b>	Non-Friable	0
<b>Asbestos type:</b>	Chrysotile	1
<b>Material Assessment Score:</b>		4
<b>Priority Assessment Score:</b>		Negligible
<b>Action:</b>	Manage	
<b>Comments:</b>	N/A

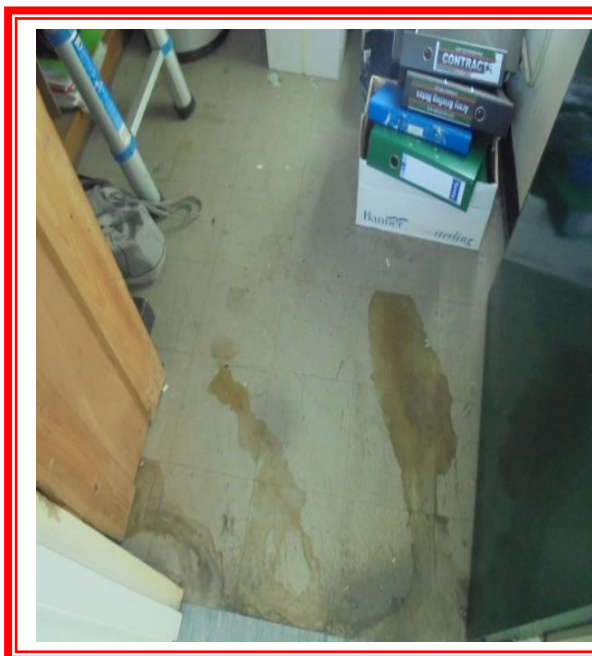
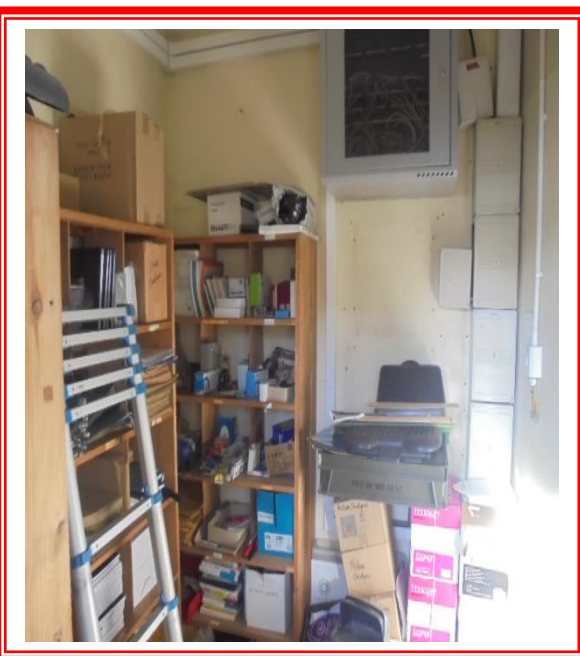
**Location: First Floor – Main Building - Store F17**

<b>Material Description:</b>	Floor Tiles and Adhesive	
<b>Identification:</b>	As Per Sample DK/16 – Asbestos Detected	
<b>Approx. quantity:</b>	4M2	
<b>Accessibility</b>	High	<i>Assessment Score</i>
<b>Product type:</b>	Composite	1
<b>Extent of Damage:</b>	Minor	1
<b>Surface Treatment:</b>	Non-Friable	0
<b>Asbestos type:</b>	Chrysotile	1
<b>Material Assessment Score:</b>		3
<b>Priority Assessment Score:</b>		Negligible
<b>Action:</b>	Manage	
<b>Comments:</b>	N/A

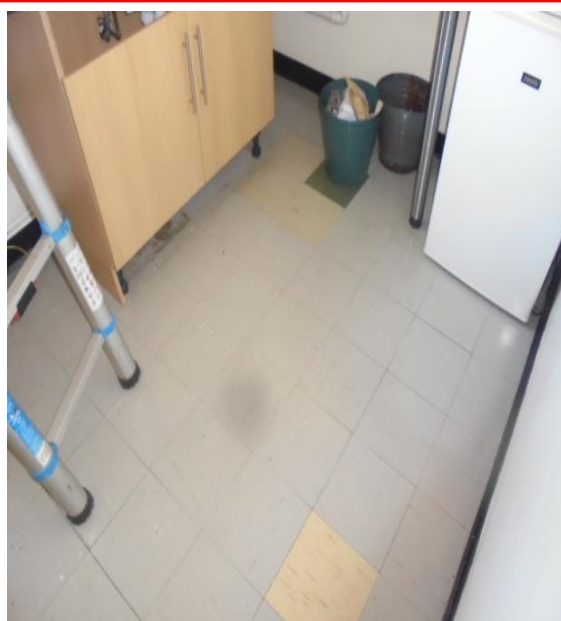
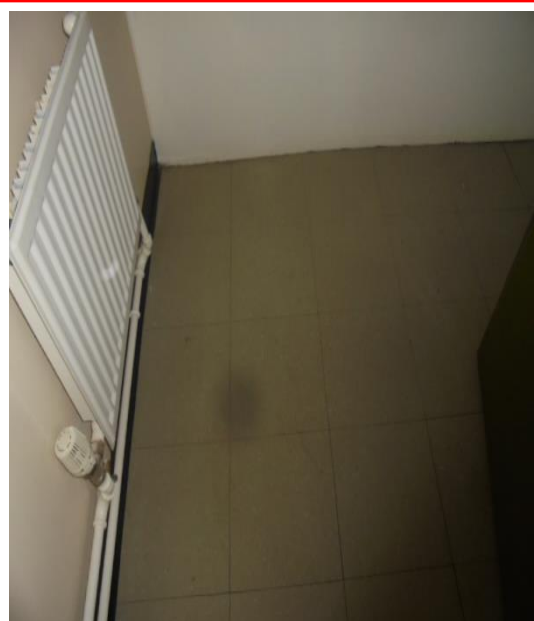
**Location: First Floor – Main Building – Kitchen, Cupboard and WC**

<b>Material Description:</b>	Floor Tiles and Adhesive	
<b>Identification:</b>	Sampled – Asbestos Detected	
<b>Approx. quantity:</b>	6M2	
<b>Accessibility</b>	High	<i>Assessment Score</i>
<b>Product type:</b>	Composite	1
<b>Extent of Damage:</b>	Minor	1
<b>Surface Treatment:</b>	Non-Friable	0
<b>Asbestos type:</b>	Chrysotile	1
<b>Material Assessment Score:</b>		3
<b>Priority Assessment Score:</b>		Negligible
<b>Action:</b>	Manage	
<b>Comments:</b>	N/A

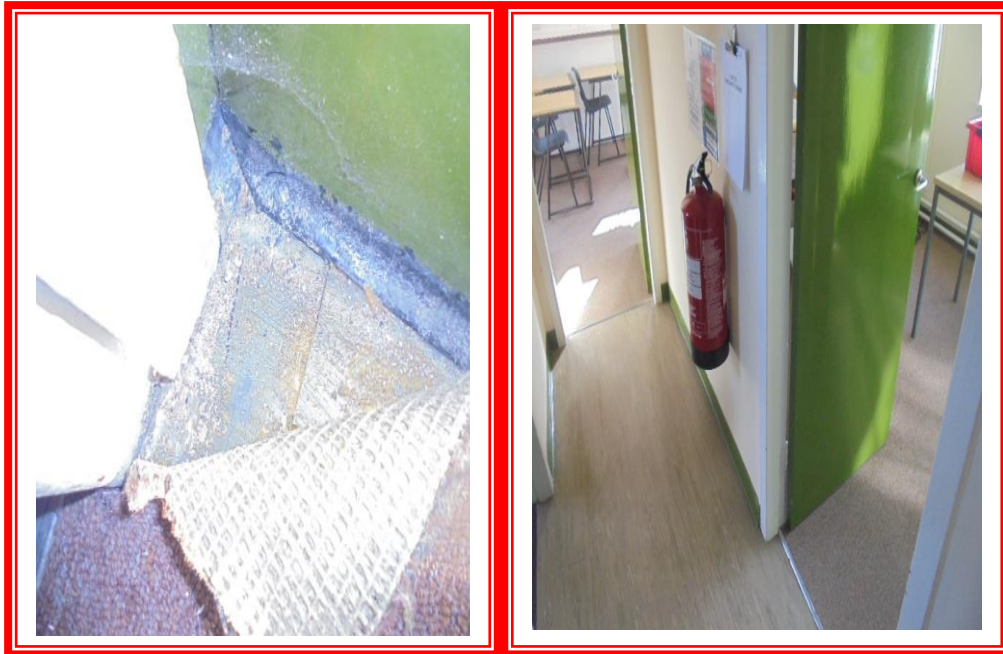
**Location: First Floor – Main Building – Office F7 and Classroom F10**

<b>Material Description:</b>	Floor Tiles and Adhesive	
<b>Identification:</b>	As Per Sample DK/21 – Asbestos Detected	
<b>Approx. quantity:</b>	25M2	
<b>Accessibility</b>	Low	<i>Assessment Score</i>
<b>Product type:</b>	Composite	1
<b>Extent of Damage:</b>	Minor	1
<b>Surface Treatment:</b>	Non-Friable	0
<b>Asbestos type:</b>	Chrysotile	1
<b>Material Assessment Score:</b>		3
<b>Priority Assessment Score:</b>		Negligible
<b>Action:</b>	Manage	
<b>Comments:</b>	N/A

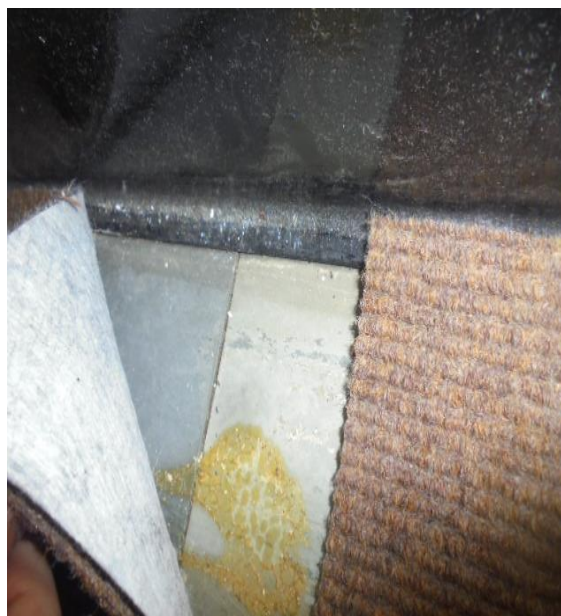
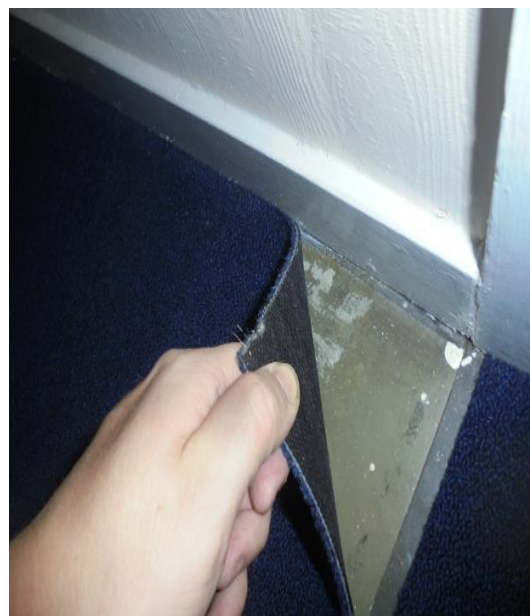
**Location: First Floor – Main Building – Offices X2**

<b>Material Description:</b>	Floor Tiles and Adhesive	
<b>Identification:</b>	As Per Sample DK/21 – Asbestos Detected	
<b>Approx. quantity:</b>	32M2	
<b>Accessibility</b>	Low	<i>Assessment Score</i>
<b>Product type:</b>	Composite	1
<b>Extent of Damage:</b>	Minor	1
<b>Surface Treatment:</b>	Non-Friable	0
<b>Asbestos type:</b>	Chrysotile	1
<b>Material Assessment Score:</b>		3
<b>Priority Assessment Score:</b>		Negligible
<b>Action:</b>	Manage	
<b>Comments:</b>	Located Under Carpet

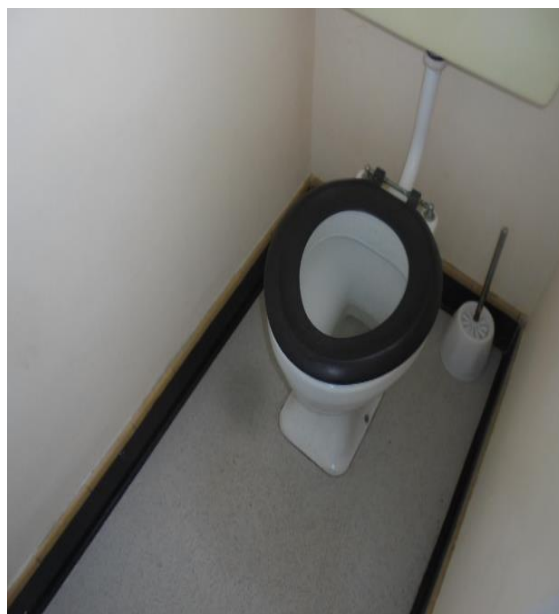
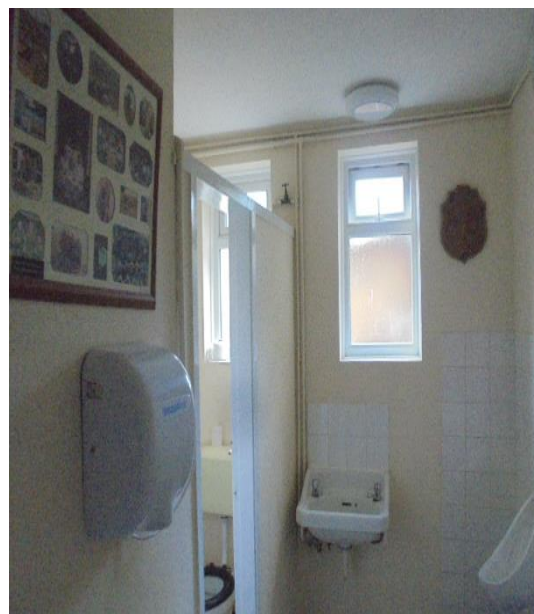
**Item No: 119****Sample No: N/A****Location: Ground Floor – Men's WC**

<b>Material Description:</b>	Toilet Seat	
<b>Identification:</b>	Presumed to Contain Asbestos	
<b>Approx. quantity:</b>	1 X Seat	
<b>Accessibility</b>	High	Assessment Score
<b>Product type:</b>	Composite	1
<b>Extent of Damage:</b>	Good	0
<b>Surface Treatment:</b>	Non-Friable	0
<b>Asbestos type:</b>	Chrysotile	1
<b>Material Assessment Score:</b>		2
<b>Priority Assessment Score:</b>		Negligible
<b>Action:</b>	Manage	
<b>Comments:</b>	N/A

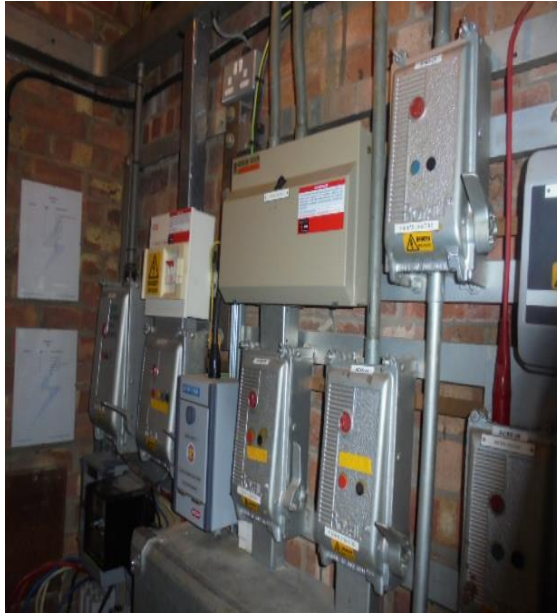
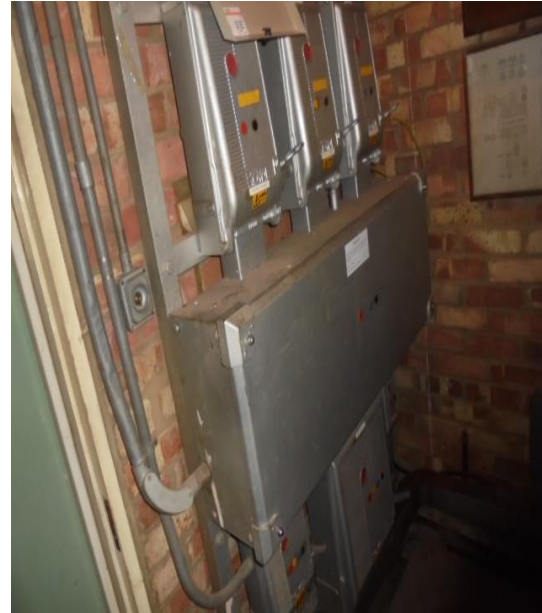
**Location: Ground Floor – Main Building - Switch Room**

<b>Material Description:</b>	Flashguards within Electrical Panels	
<b>Identification:</b>	Presumed to Contain Asbestos	
<b>Approx. quantity:</b>	16 x Boxes	
<b>Accessibility</b>	Low	Assessment Score
<b>Product type:</b>	No Access	2
<b>Extent of Damage:</b>	No Access	1
<b>Surface Treatment:</b>	No Access	1
<b>Asbestos type:</b>	No Access	1
<b>Material Assessment Score:</b>		5
<b>Priority Assessment Score:</b>		Low
<b>Action:</b>	Manage	
<b>Comments:</b>	Not Sampled as Live

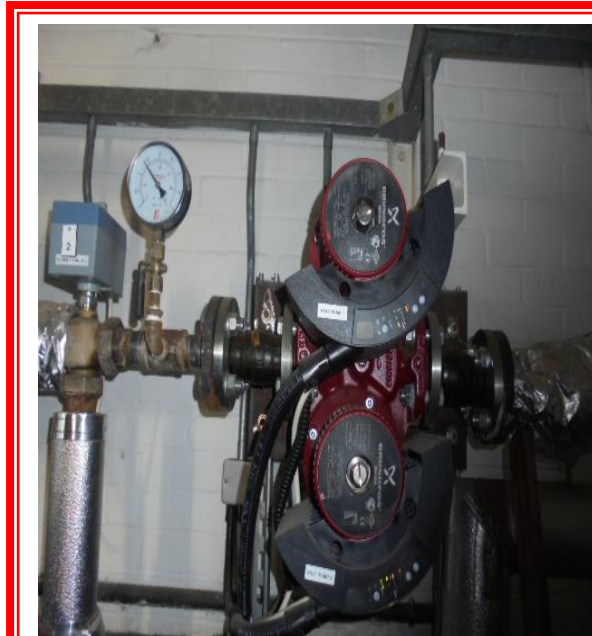
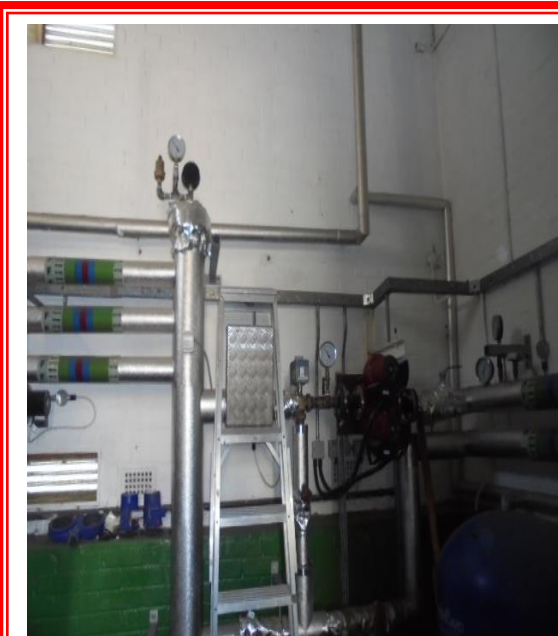
**Location: Ground Floor – Boiler Room**

<b>Material Description:</b>	Gaskets	
<b>Identification:</b>	Presumed to Contain Asbestos	
<b>Approx. quantity:</b>	4 X Gaskets	
<b>Accessibility</b>	Low	Assessment Score
<b>Product type:</b>	Textiles	2
<b>Extent of Damage:</b>	Minor	1
<b>Surface Treatment:</b>	Unsealed	1
<b>Asbestos type:</b>	Chrysotile	1
<b>Material Assessment Score:</b>		5
<b>Priority Assessment Score:</b>		Low
<b>Action:</b>	Manage	
<b>Comments:</b>	Gaskets are too Inset within Flanges to be Sampled

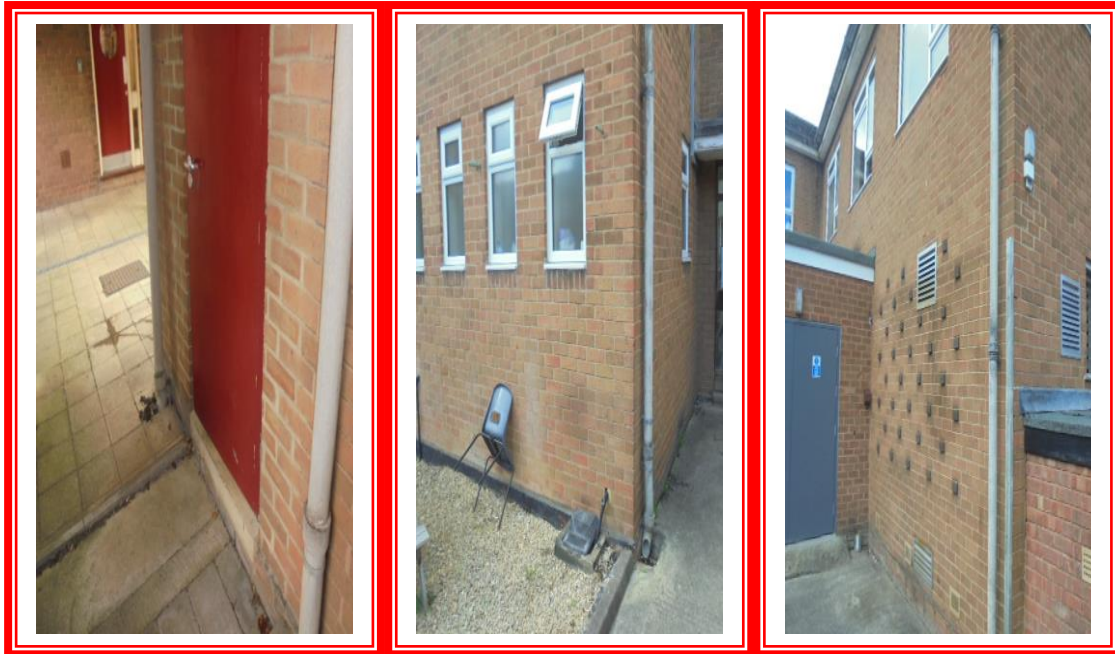
**Item No: 126****Sample No: DK/25****Location: Ground Floor – Main Building - External**

<b>Material Description:</b>	Cement Downpipes	
<b>Identification:</b>	Sampled – Asbestos Detected	
<b>Approx. quantity:</b>	11 X Pipes (60LM Total)	
<b>Accessibility</b>	Low	Assessment Score
<b>Product type:</b>	Cement	1
<b>Extent of Damage:</b>	Moderate	2
<b>Surface Treatment:</b>	Unsealed	1
<b>Asbestos type:</b>	Chrysotile/Amosite	2
<b>Material Assessment Score:</b>		6
<b>Priority Assessment Score:</b>		Low
<b>Action:</b>	Manage	
<b>Comments:</b>	Located in several location around the main building

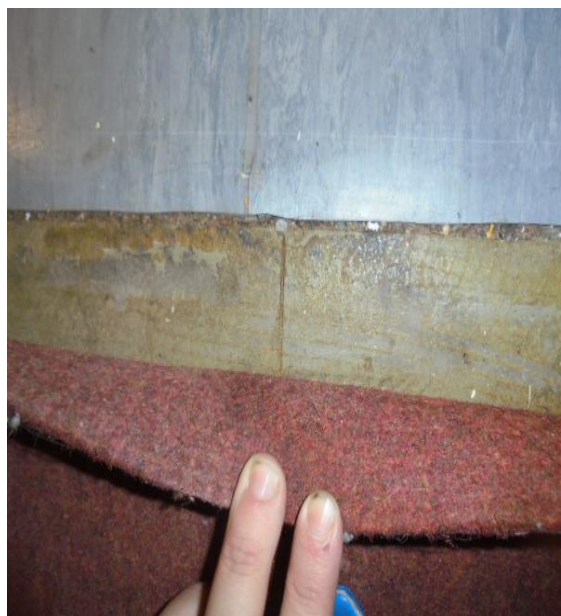
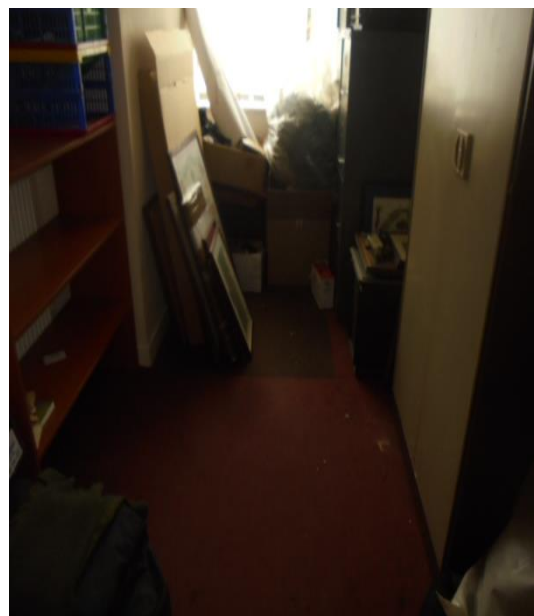
**Location: Ground Floor – Main Building - Office**

<b>Material Description:</b>	Floor Tiles and Adhesive Under Carpet	
<b>Identification:</b>	As Per Sample DK/23 – Asbestos Detected	
<b>Approx. quantity:</b>	10M2	
<b>Accessibility</b>	Low	Assessment Score
<b>Product type:</b>	Composite	1
<b>Extent of Damage:</b>	Minor	1
<b>Surface Treatment:</b>	Non-Friable	0
<b>Asbestos type:</b>	Chrysotile	1
<b>Material Assessment Score:</b>		3
<b>Priority Assessment Score:</b>		Negligible
<b>Action:</b>	Manage	
<b>Comments:</b>	N/A

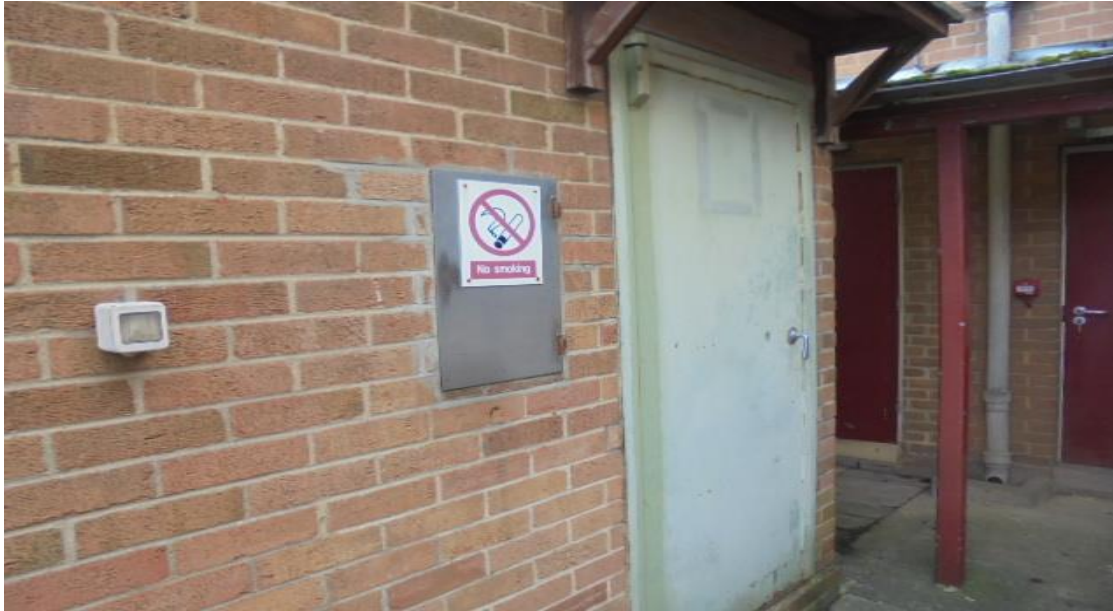
**Location: External - Armoury**

<b>Material Description:</b>	No Access within Locked Room	
<b>Identification:</b>	Presumed to Contain Asbestos	
<b>Approx. quantity:</b>	1 X Room	
<b>Accessibility</b>	Low	<i>Assessment Score</i>
<b>Product type:</b>	No Access	3
<b>Extent of Damage:</b>	No Access	3
<b>Surface Treatment:</b>	No Access	3
<b>Asbestos type:</b>	No Access	3
<b>Material Assessment Score:</b>		12
<b>Priority Assessment Score:</b>		High
<b>Action:</b>	Further Investigation Required	
<b>Comments:</b>	No Key Available during the Survey

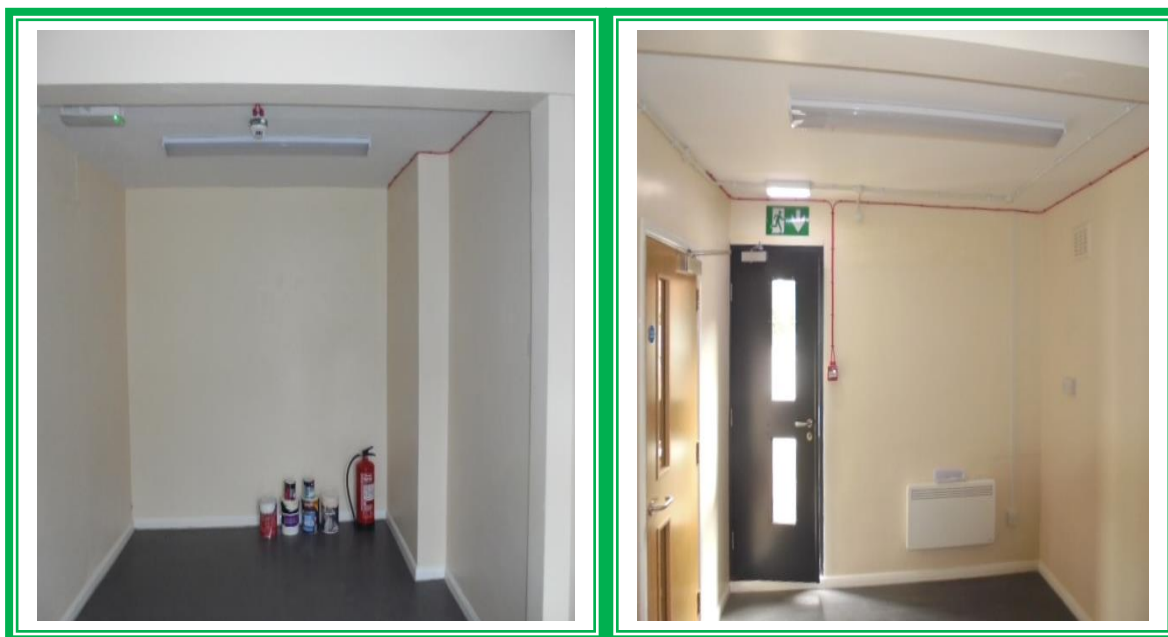
**Location: Ground Floor – House 4 - Store**

<b>Material Description:</b>	Visual Inspection – No Suspect Materials Found	
<b>Identification:</b>	N/A	
<b>Approx. quantity:</b>	N/A	
<b>Accessibility</b>	N/A	Assessment Score
<b>Product type:</b>	N/A	N/A
<b>Extent of Damage:</b>	N/A	N/A
<b>Surface Treatment:</b>	N/A	N/A
<b>Asbestos type:</b>	N/A	N/A
<b>Material Assessment Score:</b>		N/A
<b>Priority Assessment Score:</b>		N/A
<b>Action:</b>	N/A	
<b>Comments:</b>	N/A

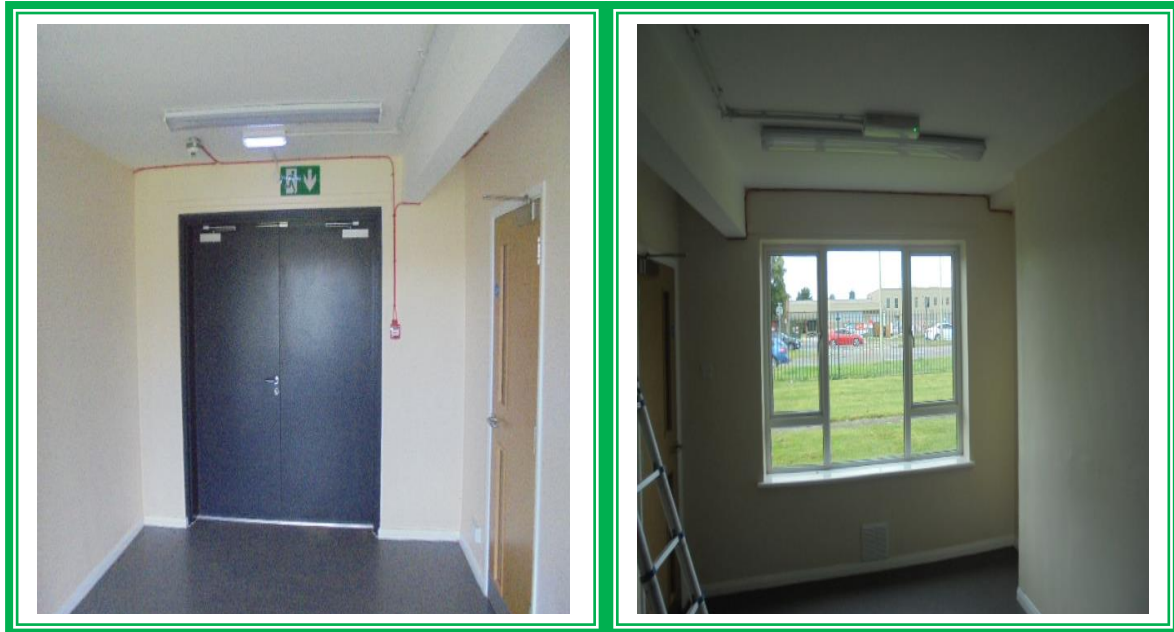
**Location: Ground Floor – House 4 – Store**

<b>Material Description:</b>	Visual Inspection – No Suspect Materials Found	
<b>Identification:</b>	N/A	
<b>Approx. quantity:</b>	N/A	
<b>Accessibility</b>	N/A	<i>Assessment Score</i>
<b>Product type:</b>	N/A	N/A
<b>Extent of Damage:</b>	N/A	N/A
<b>Surface Treatment:</b>	N/A	N/A
<b>Asbestos type:</b>	N/A	N/A
<b>Material Assessment Score:</b>		N/A
<b>Priority Assessment Score:</b>		N/A
<b>Action:</b>	N/A	
<b>Comments:</b>	N/A

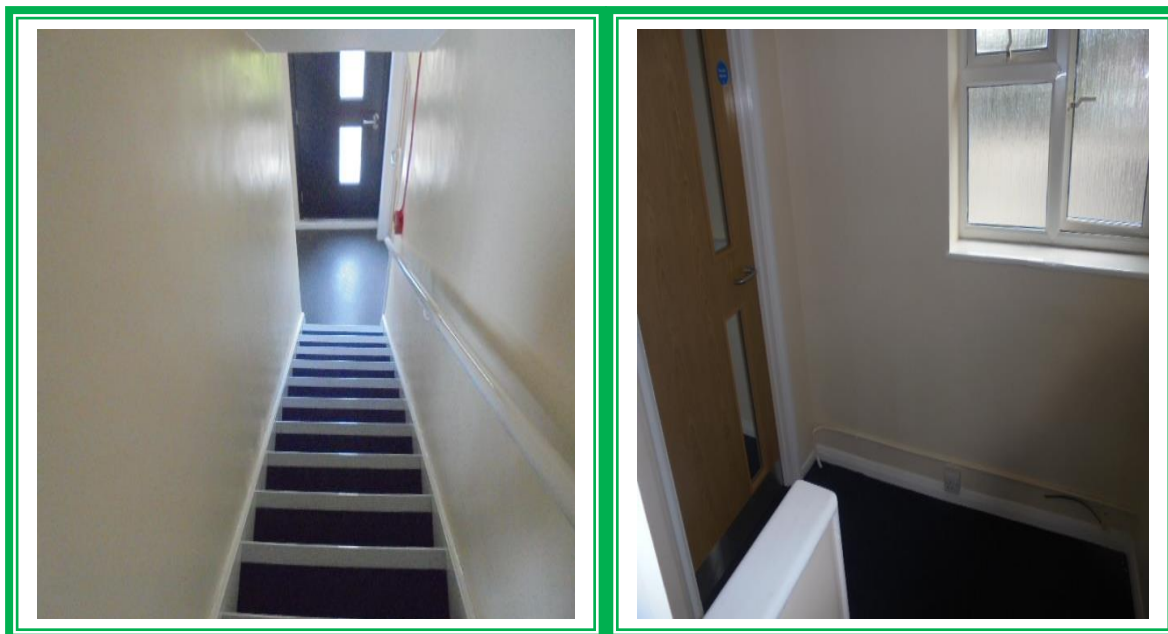
**Location: Ground Floor/First Floor – House 4 – Lobby,  
Stairwell and Landing**

<b>Material Description:</b>	Visual Inspection – No Suspect Materials Found	
<b>Identification:</b>	N/A	
<b>Approx. quantity:</b>	N/A	
<b>Accessibility</b>	N/A	<i>Assessment Score</i>
<b>Product type:</b>	N/A	N/A
<b>Extent of Damage:</b>	N/A	N/A
<b>Surface Treatment:</b>	N/A	N/A
<b>Asbestos type:</b>	N/A	N/A
<b>Material Assessment Score:</b>		N/A
<b>Priority Assessment Score:</b>		N/A
<b>Action:</b>	N/A	
<b>Comments:</b>	N/A

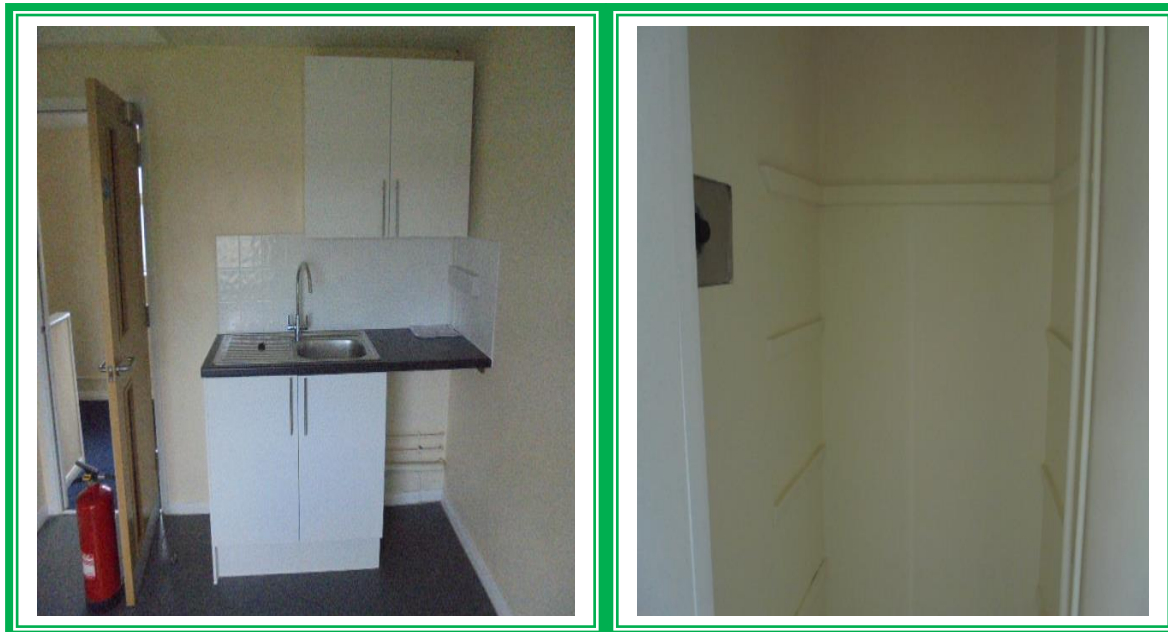
**Location: First Floor – House 4 – Kitchen and Cupboard**

<b>Material Description:</b>	Visual Inspection – No Suspect Materials Found	
<b>Identification:</b>	N/A	
<b>Approx. quantity:</b>	N/A	
<b>Accessibility</b>	N/A	<i>Assessment Score</i>
<b>Product type:</b>	N/A	N/A
<b>Extent of Damage:</b>	N/A	N/A
<b>Surface Treatment:</b>	N/A	N/A
<b>Asbestos type:</b>	N/A	N/A
<b>Material Assessment Score:</b>		N/A
<b>Priority Assessment Score:</b>		N/A
<b>Action:</b>	N/A	
<b>Comments:</b>	Modern Sink Pads

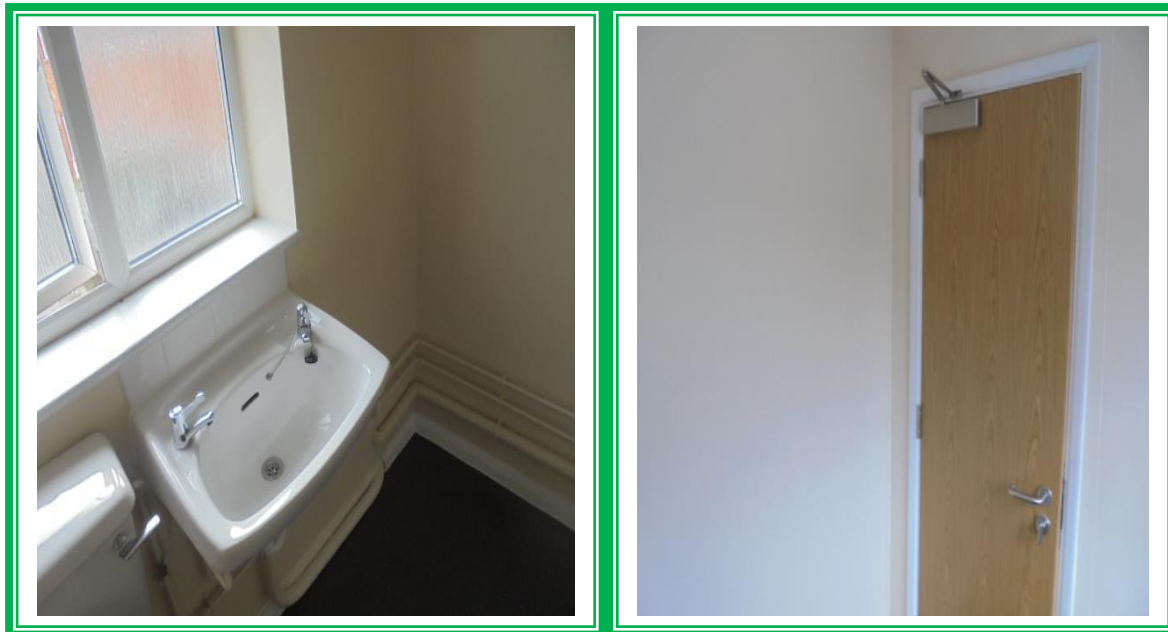
**Location: First Floor – House 4 - WC**

<b>Material Description:</b>	Visual Inspection – No Suspect Materials Found	
<b>Identification:</b>	N/A	
<b>Approx. quantity:</b>	N/A	
<b>Accessibility</b>	N/A	<i>Assessment Score</i>
<b>Product type:</b>	N/A	N/A
<b>Extent of Damage:</b>	N/A	N/A
<b>Surface Treatment:</b>	N/A	N/A
<b>Asbestos type:</b>	N/A	N/A
<b>Material Assessment Score:</b>		N/A
<b>Priority Assessment Score:</b>		N/A
<b>Action:</b>	N/A	
<b>Comments:</b>	N/A
