**ARMOUR**  
ANALYTICAL SERVICES

**Project Number 2481**

**Management  
Asbestos Survey Report**

**6<sup>th</sup> Battalion, Eastern Avenue, Gloucestershire  
GL4 3BD**

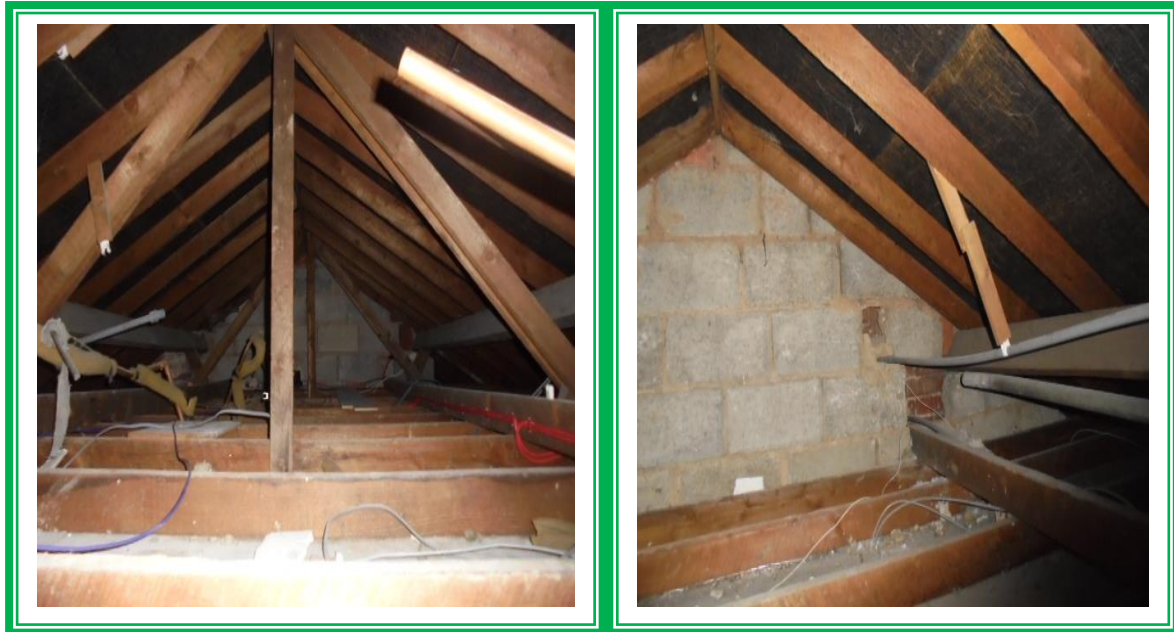
**Location: First Floor – House 4 – Loft Space**

<b>Material Description:</b>	Visual Inspection – No Suspect Materials Found	
<b>Identification:</b>	N/A	
<b>Approx. quantity:</b>	N/A	
<b>Accessibility</b>	N/A	<i>Assessment Score</i>
<b>Product type:</b>	N/A	N/A
<b>Extent of Damage:</b>	N/A	N/A
<b>Surface Treatment:</b>	N/A	N/A
<b>Asbestos type:</b>	N/A	N/A
<b>Material Assessment Score:</b>		N/A
<b>Priority Assessment Score:</b>		N/A
<b>Action:</b>	N/A	
<b>Comments:</b>	Non-Asbestos Felt to Underside of Roof

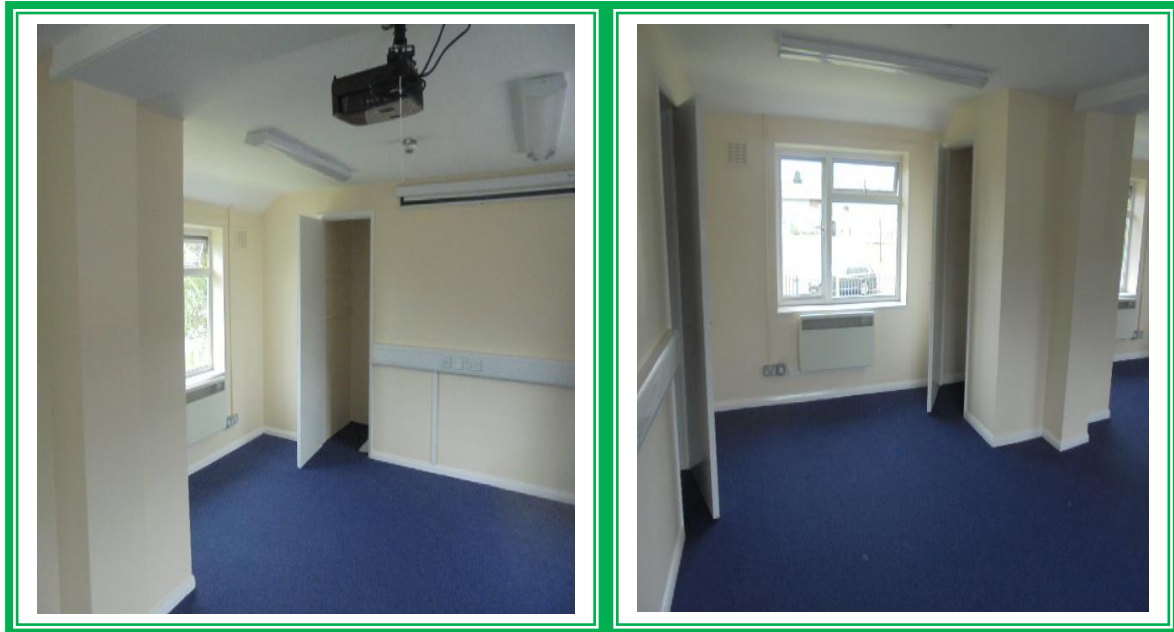
**Location: First Floor – Houses 3 and 4 - Office**

<b>Material Description:</b>	Visual Inspection – No Suspect Materials Found	
<b>Identification:</b>	N/A	
<b>Approx. quantity:</b>	N/A	
<b>Accessibility</b>	N/A	<i>Assessment Score</i>
<b>Product type:</b>	N/A	N/A
<b>Extent of Damage:</b>	N/A	N/A
<b>Surface Treatment:</b>	N/A	N/A
<b>Asbestos type:</b>	N/A	N/A
<b>Material Assessment Score:</b>		N/A
<b>Priority Assessment Score:</b>		N/A
<b>Action:</b>	N/A	
<b>Comments:</b>	N/A

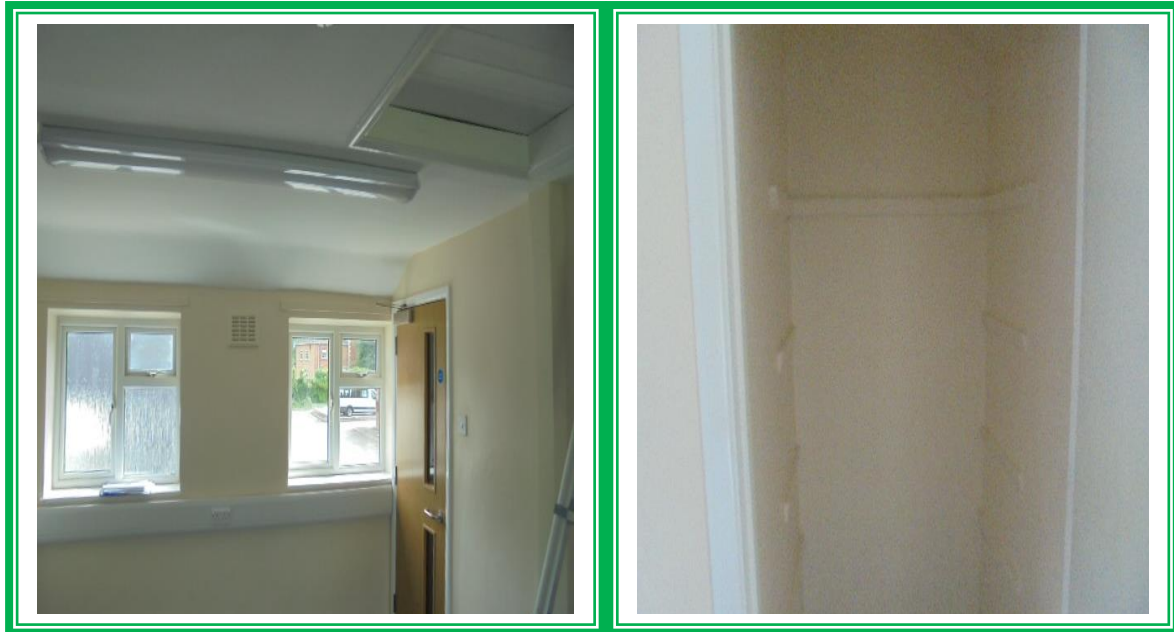
**Location: First Floor – House 3 - Office**

<b>Material Description:</b>	Visual Inspection – No Suspect Materials Found	
<b>Identification:</b>	N/A	
<b>Approx. quantity:</b>	N/A	
<b>Accessibility</b>	N/A	<i>Assessment Score</i>
<b>Product type:</b>	N/A	N/A
<b>Extent of Damage:</b>	N/A	N/A
<b>Surface Treatment:</b>	N/A	N/A
<b>Asbestos type:</b>	N/A	N/A
<b>Material Assessment Score:</b>		N/A
<b>Priority Assessment Score:</b>		N/A
<b>Action:</b>	N/A	
<b>Comments:</b>	N/A

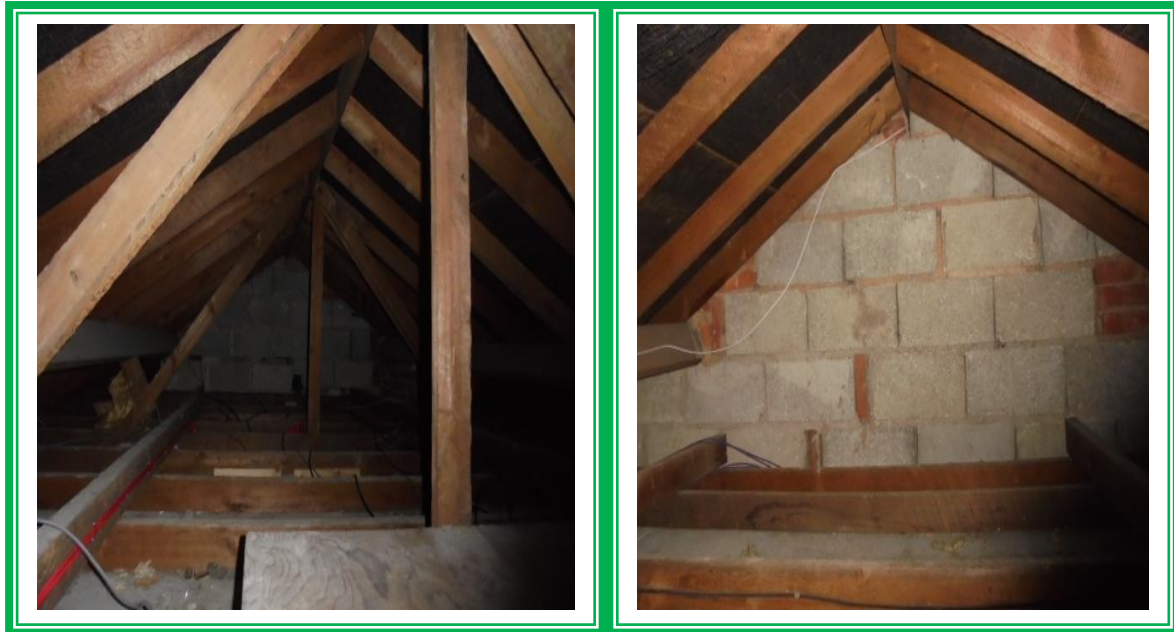
**Location: First Floor – House 3 – Loft Space**

<b>Material Description:</b>	Visual Inspection – No Suspect Materials Found	
<b>Identification:</b>	N/A	
<b>Approx. quantity:</b>	N/A	
<b>Accessibility</b>	N/A	<i>Assessment Score</i>
<b>Product type:</b>	N/A	N/A
<b>Extent of Damage:</b>	N/A	N/A
<b>Surface Treatment:</b>	N/A	N/A
<b>Asbestos type:</b>	N/A	N/A
<b>Material Assessment Score:</b>		N/A
<b>Priority Assessment Score:</b>		N/A
<b>Action:</b>	N/A	
<b>Comments:</b>	N/A

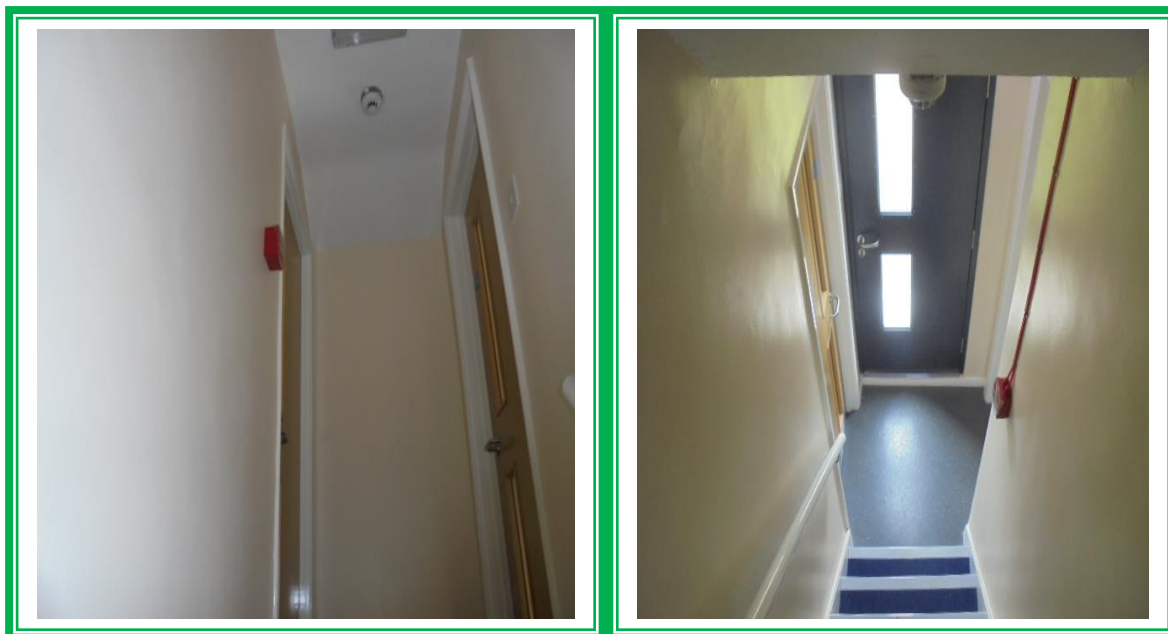
**Location: Ground Floor – House 3 – Lobby, Stairwell and Landing**

<b>Material Description:</b>	Visual Inspection – No Suspect Materials Found	
<b>Identification:</b>	N/A	
<b>Approx. quantity:</b>	N/A	
<b>Accessibility</b>	N/A	<i>Assessment Score</i>
<b>Product type:</b>	N/A	N/A
<b>Extent of Damage:</b>	N/A	N/A
<b>Surface Treatment:</b>	N/A	N/A
<b>Asbestos type:</b>	N/A	N/A
<b>Material Assessment Score:</b>		N/A
<b>Priority Assessment Score:</b>		N/A
<b>Action:</b>	N/A	
<b>Comments:</b>	Modern Sink Pads

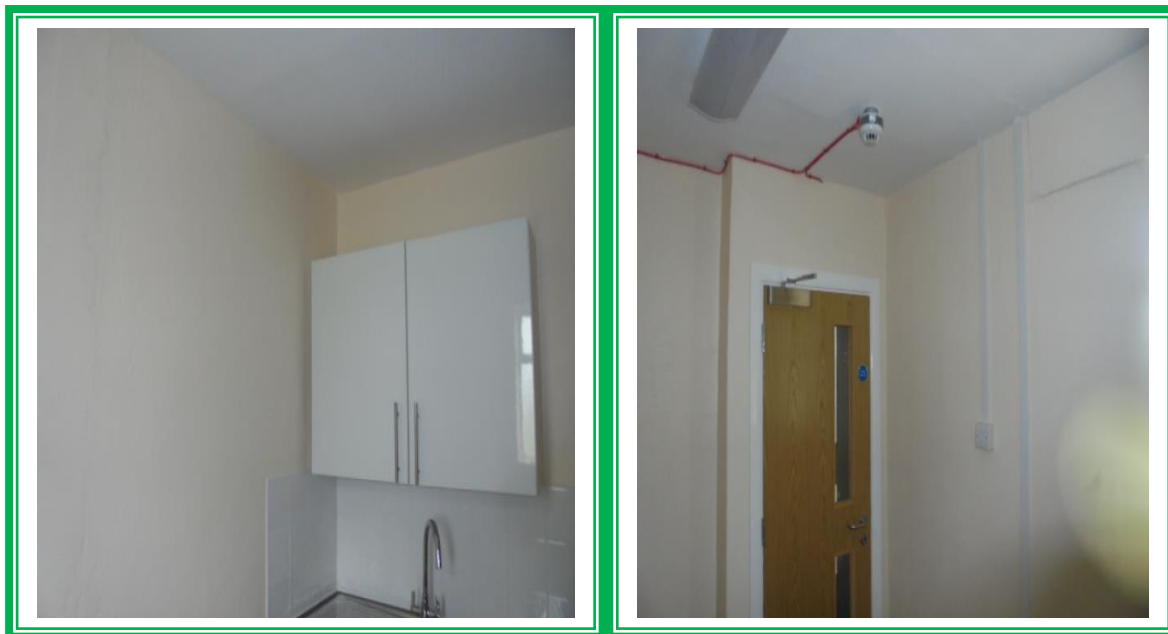
**Location: Ground Floor – House 3 - Kitchen**

<b>Material Description:</b>	Visual Inspection – No Suspect Materials Found	
<b>Identification:</b>	N/A	
<b>Approx. quantity:</b>	N/A	
<b>Accessibility</b>	N/A	<i>Assessment Score</i>
<b>Product type:</b>	N/A	N/A
<b>Extent of Damage:</b>	N/A	N/A
<b>Surface Treatment:</b>	N/A	N/A
<b>Asbestos type:</b>	N/A	N/A
<b>Material Assessment Score:</b>		N/A
<b>Priority Assessment Score:</b>		N/A
<b>Action:</b>	N/A	
<b>Comments:</b>	Modern Sink Pad

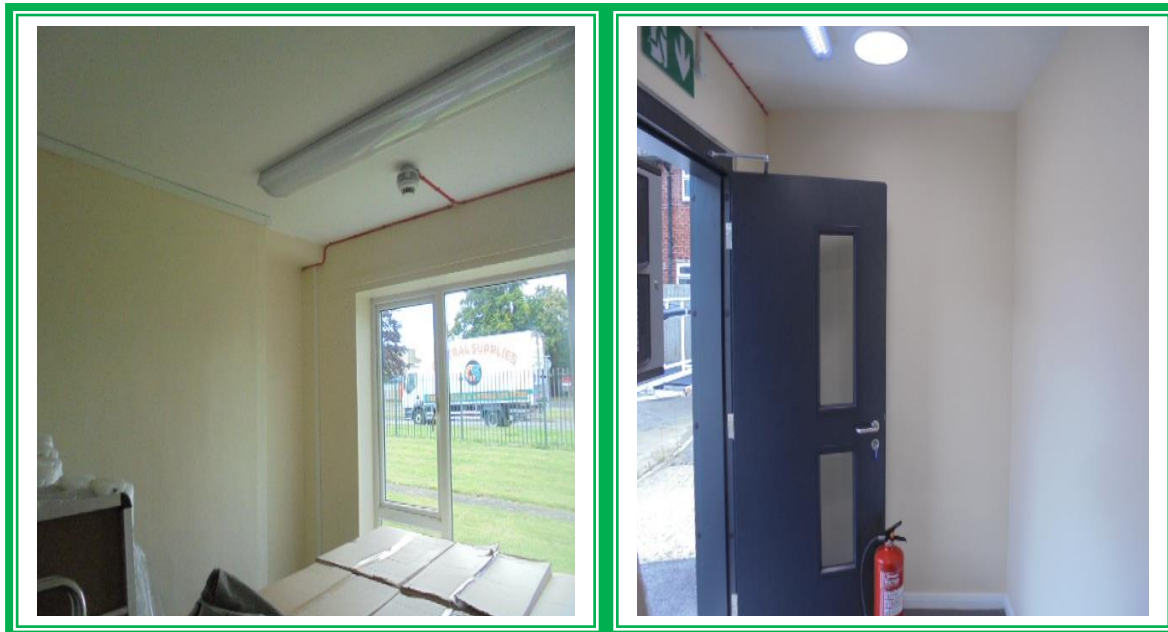
**Location: Ground Floor – House 3 – Classroom and Lobby**

<b>Material Description:</b>	Visual Inspection – No Suspect Materials Found	
<b>Identification:</b>	N/A	
<b>Approx. quantity:</b>	N/A	
<b>Accessibility</b>	N/A	<i>Assessment Score</i>
<b>Product type:</b>	N/A	N/A
<b>Extent of Damage:</b>	N/A	N/A
<b>Surface Treatment:</b>	N/A	N/A
<b>Asbestos type:</b>	N/A	N/A
<b>Material Assessment Score:</b>		N/A
<b>Priority Assessment Score:</b>		N/A
<b>Action:</b>	N/A	
<b>Comments:</b>	N/A

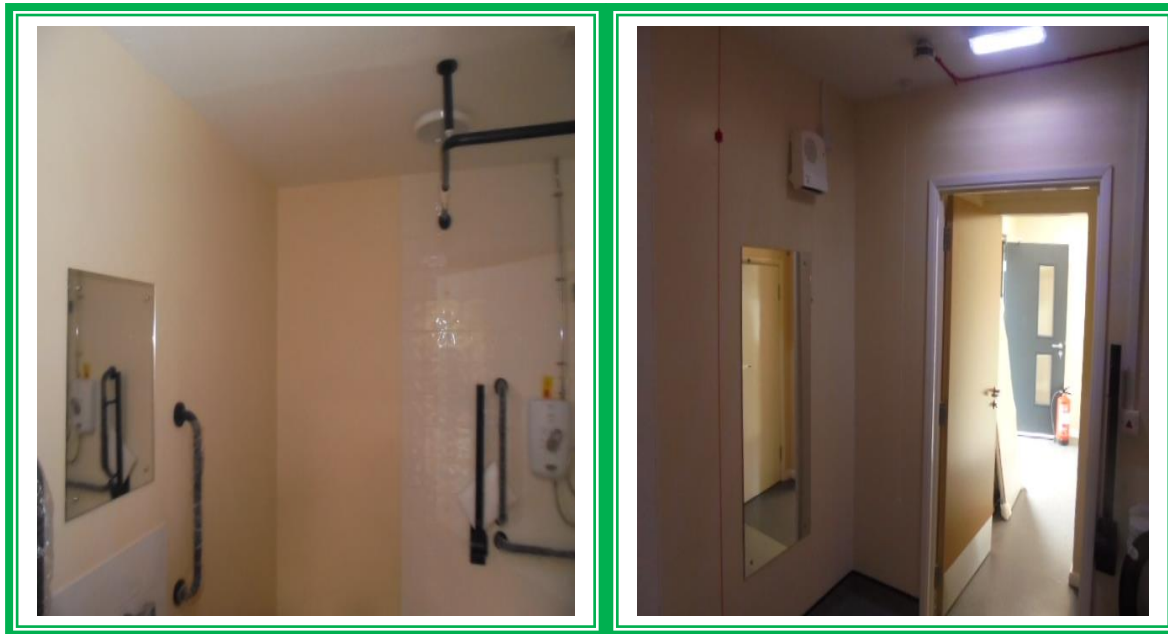
**Location: Ground Floor - House 3 - WC**

<b>Material Description:</b>	Visual Inspection – No Suspect Materials Found	
<b>Identification:</b>	N/A	
<b>Approx. quantity:</b>	N/A	
<b>Accessibility</b>	N/A	<i>Assessment Score</i>
<b>Product type:</b>	N/A	N/A
<b>Extent of Damage:</b>	N/A	N/A
<b>Surface Treatment:</b>	N/A	N/A
<b>Asbestos type:</b>	N/A	N/A
<b>Material Assessment Score:</b>		N/A
<b>Priority Assessment Score:</b>		N/A
<b>Action:</b>	N/A	
<b>Comments:</b>	N/A

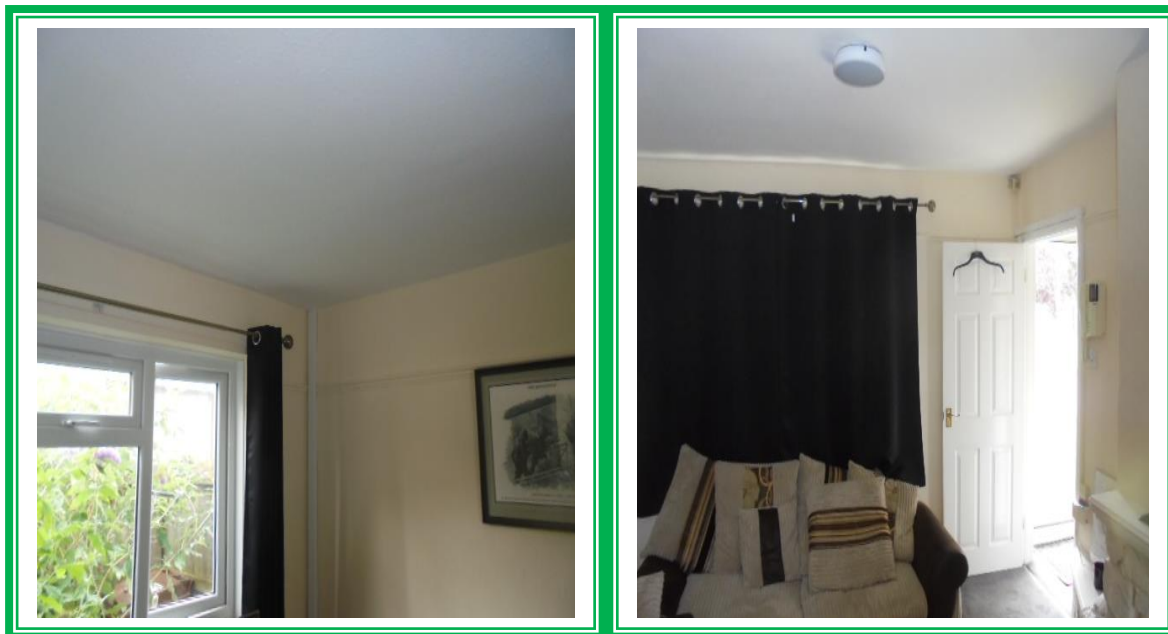
**Location: Ground Floor – House 5 – Living Room**

<b>Material Description:</b>	Visual Inspection – No Suspect Materials Found	
<b>Identification:</b>	N/A	
<b>Approx. quantity:</b>	N/A	
<b>Accessibility</b>	N/A	<i>Assessment Score</i>
<b>Product type:</b>	N/A	N/A
<b>Extent of Damage:</b>	N/A	N/A
<b>Surface Treatment:</b>	N/A	N/A
<b>Asbestos type:</b>	N/A	N/A
<b>Material Assessment Score:</b>		N/A
<b>Priority Assessment Score:</b>		N/A
<b>Action:</b>	N/A	
<b>Comments:</b>	No Access behind Non-Asbestos Masterboard Panel in Fireplace – No Access Under Fixed Carpets

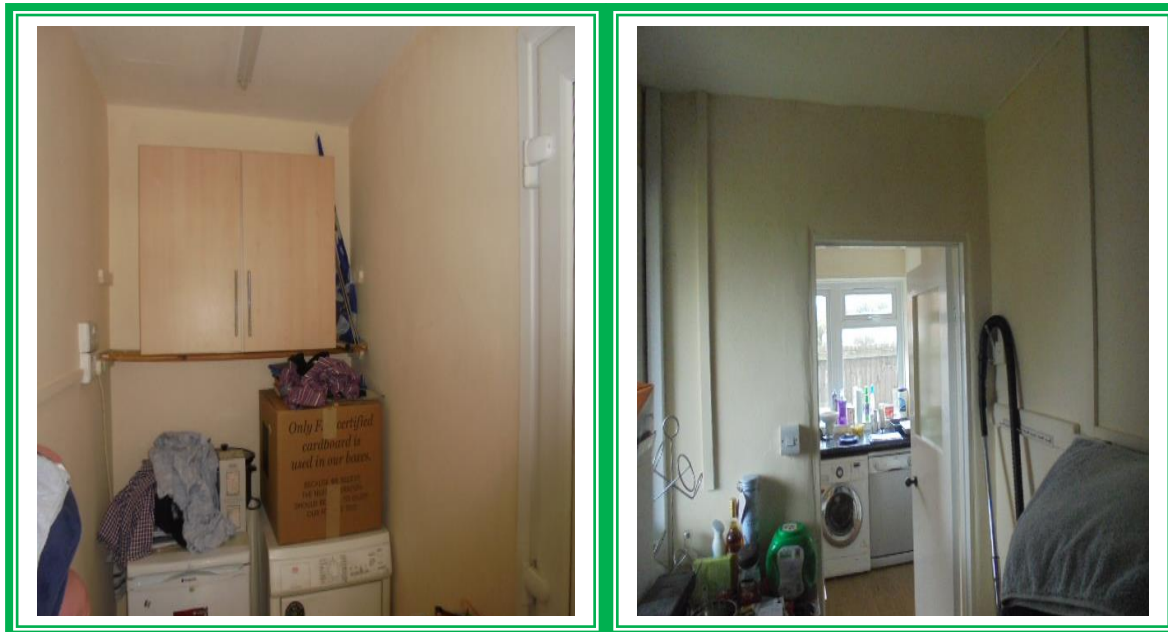
**Location: Ground Floor – House 5 – Utility Room**

<b>Material Description:</b>	Visual Inspection – No Suspect Materials Found	
<b>Identification:</b>	N/A	
<b>Approx. quantity:</b>	N/A	
<b>Accessibility</b>	N/A	Assessment Score
<b>Product type:</b>	N/A	N/A
<b>Extent of Damage:</b>	N/A	N/A
<b>Surface Treatment:</b>	N/A	N/A
<b>Asbestos type:</b>	N/A	N/A
<b>Material Assessment Score:</b>		N/A
<b>Priority Assessment Score:</b>		N/A
<b>Action:</b>	N/A	
<b>Comments:</b>	N/A

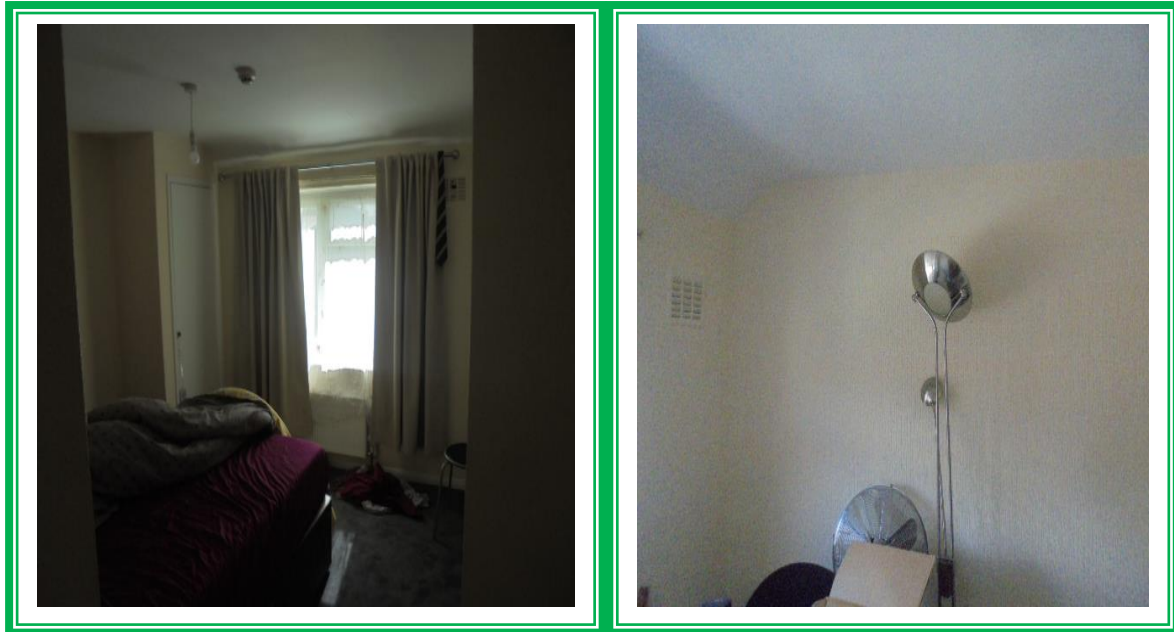
**Location: First Floor – House 5 – Bedrooms X 2**

<b>Material Description:</b>	Visual Inspection – No Suspect Materials Found	
<b>Identification:</b>	N/A	
<b>Approx. quantity:</b>	N/A	
<b>Accessibility</b>	N/A	<i>Assessment Score</i>
<b>Product type:</b>	N/A	N/A
<b>Extent of Damage:</b>	N/A	N/A
<b>Surface Treatment:</b>	N/A	N/A
<b>Asbestos type:</b>	N/A	N/A
<b>Material Assessment Score:</b>		N/A
<b>Priority Assessment Score:</b>		N/A
<b>Action:</b>	N/A	
<b>Comments:</b>	N/A

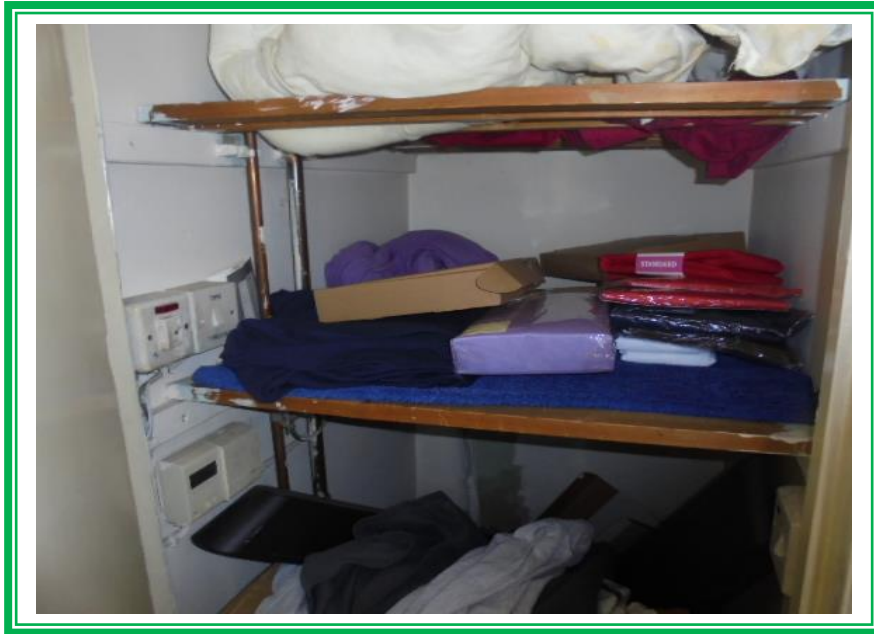
**Location: First Floor – House 5 – Cupboard**

<b>Material Description:</b>	Visual Inspection – No Suspect Materials Found	
<b>Identification:</b>	N/A	
<b>Approx. quantity:</b>	N/A	
<b>Accessibility</b>	N/A	<i>Assessment Score</i>
<b>Product type:</b>	N/A	N/A
<b>Extent of Damage:</b>	N/A	N/A
<b>Surface Treatment:</b>	N/A	N/A
<b>Asbestos type:</b>	N/A	N/A
<b>Material Assessment Score:</b>		N/A
<b>Priority Assessment Score:</b>		N/A
<b>Action:</b>	N/A	
<b>Comments:</b>	N/A

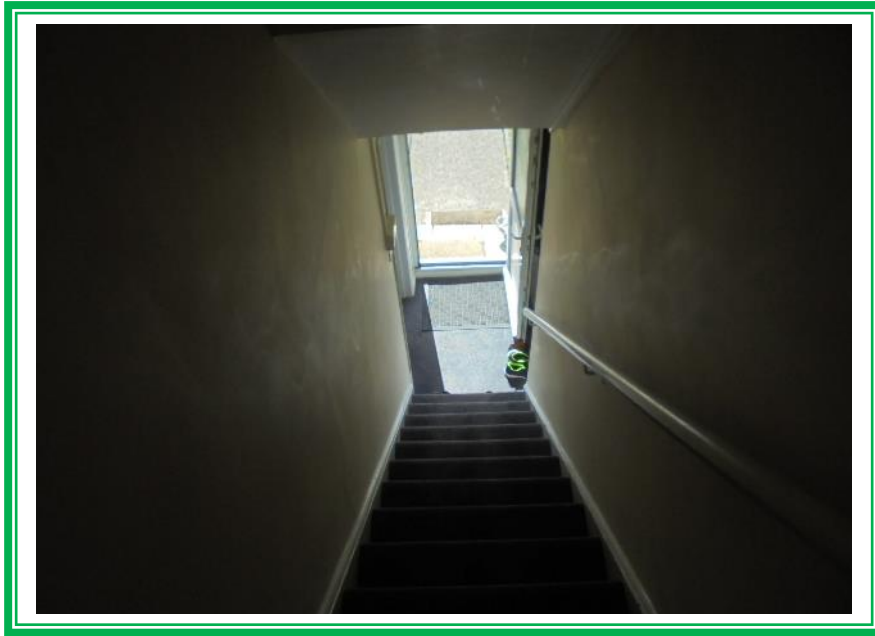
**Location: First Floor – House 5 – Lobby, Stairwell & Landing**

<b>Material Description:</b>	Visual Inspection – No Suspect Materials Found	
<b>Identification:</b>	N/A	
<b>Approx. quantity:</b>	N/A	
<b>Accessibility</b>	N/A	<i>Assessment Score</i>
<b>Product type:</b>	N/A	N/A
<b>Extent of Damage:</b>	N/A	N/A
<b>Surface Treatment:</b>	N/A	N/A
<b>Asbestos type:</b>	N/A	N/A
<b>Material Assessment Score:</b>		N/A
<b>Priority Assessment Score:</b>		N/A
<b>Action:</b>	N/A	
<b>Comments:</b>	N/A

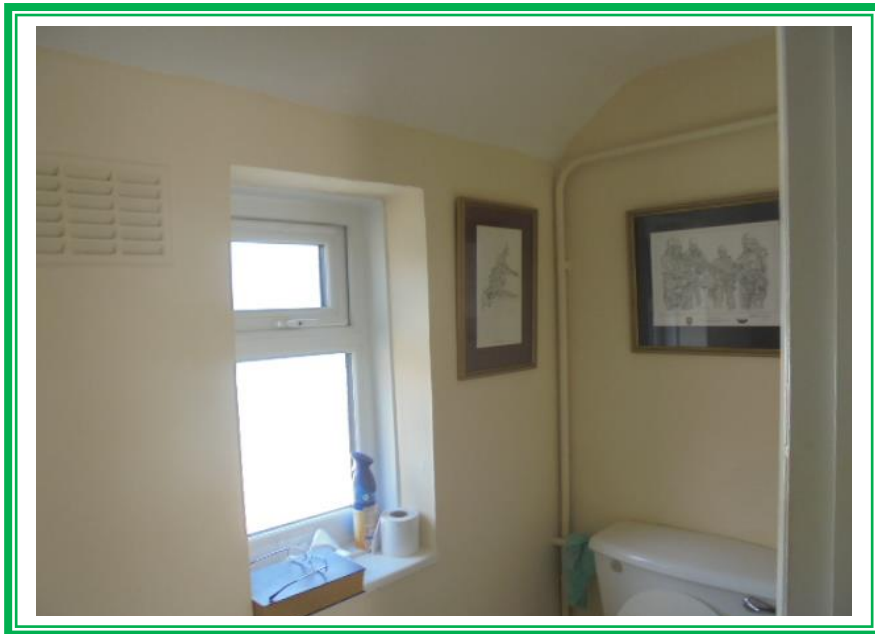
**Location: First Floor – House 5 –WC & Bathroom**

<b>Material Description:</b>	Visual Inspection – No Suspect Materials Found	
<b>Identification:</b>	N/A	
<b>Approx. quantity:</b>	N/A	
<b>Accessibility</b>	N/A	<i>Assessment Score</i>
<b>Product type:</b>	N/A	N/A
<b>Extent of Damage:</b>	N/A	N/A
<b>Surface Treatment:</b>	N/A	N/A
<b>Asbestos type:</b>	N/A	N/A
<b>Material Assessment Score:</b>		N/A
<b>Priority Assessment Score:</b>		N/A
<b>Action:</b>	N/A	
<b>Comments:</b>	N/A

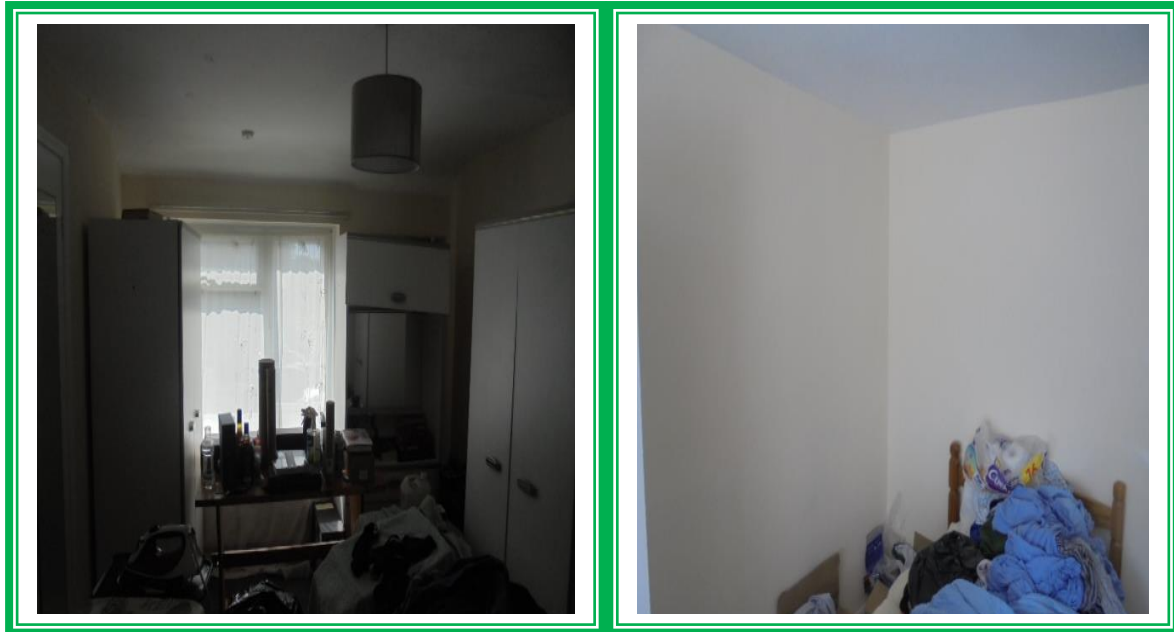
**Location: First Floor – House 5 – Bedroom**

<b>Material Description:</b>	Visual Inspection – No Suspect Materials Found	
<b>Identification:</b>	N/A	
<b>Approx. quantity:</b>	N/A	
<b>Accessibility</b>	N/A	<i>Assessment Score</i>
<b>Product type:</b>	N/A	N/A
<b>Extent of Damage:</b>	N/A	N/A
<b>Surface Treatment:</b>	N/A	N/A
<b>Asbestos type:</b>	N/A	N/A
<b>Material Assessment Score:</b>		N/A
<b>Priority Assessment Score:</b>		N/A
<b>Action:</b>	N/A	
<b>Comments:</b>	N/A

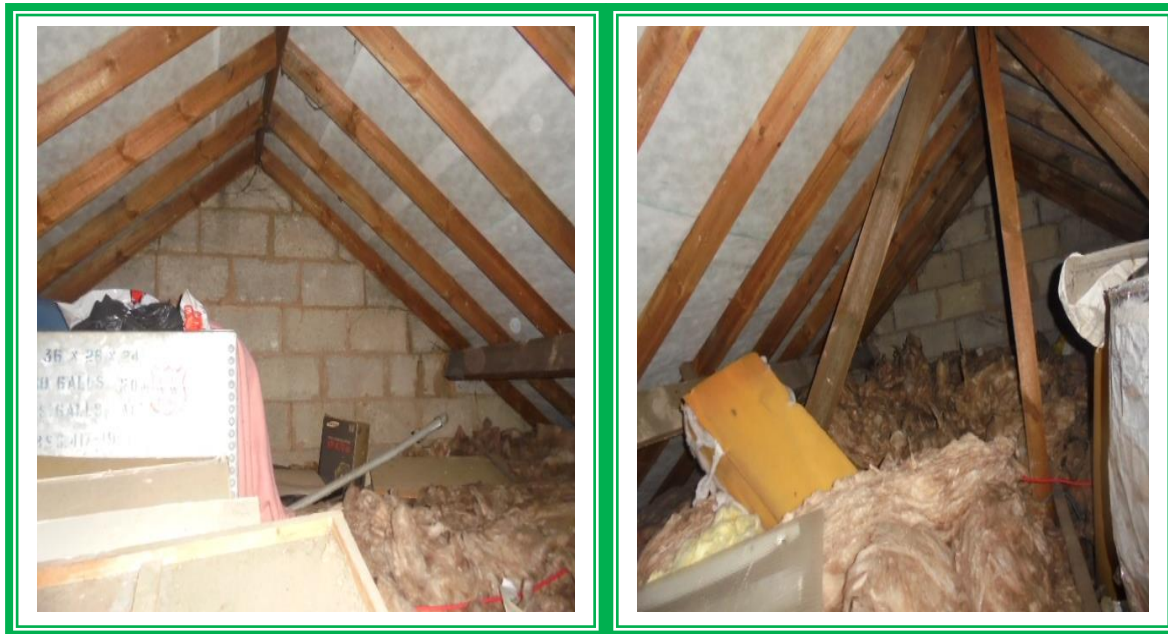
**Location: First Floor – House 5 – Loft Space**

<b>Material Description:</b>	Visual Inspection – No Suspect Materials Found	
<b>Identification:</b>	N/A	
<b>Approx. quantity:</b>	N/A	
<b>Accessibility</b>	N/A	<i>Assessment Score</i>
<b>Product type:</b>	N/A	N/A
<b>Extent of Damage:</b>	N/A	N/A
<b>Surface Treatment:</b>	N/A	N/A
<b>Asbestos type:</b>	N/A	N/A
<b>Material Assessment Score:</b>		N/A
<b>Priority Assessment Score:</b>		N/A
<b>Action:</b>	N/A	
<b>Comments:</b>	Limited Access into Loft Due to Stored Items and No Crawl Boards

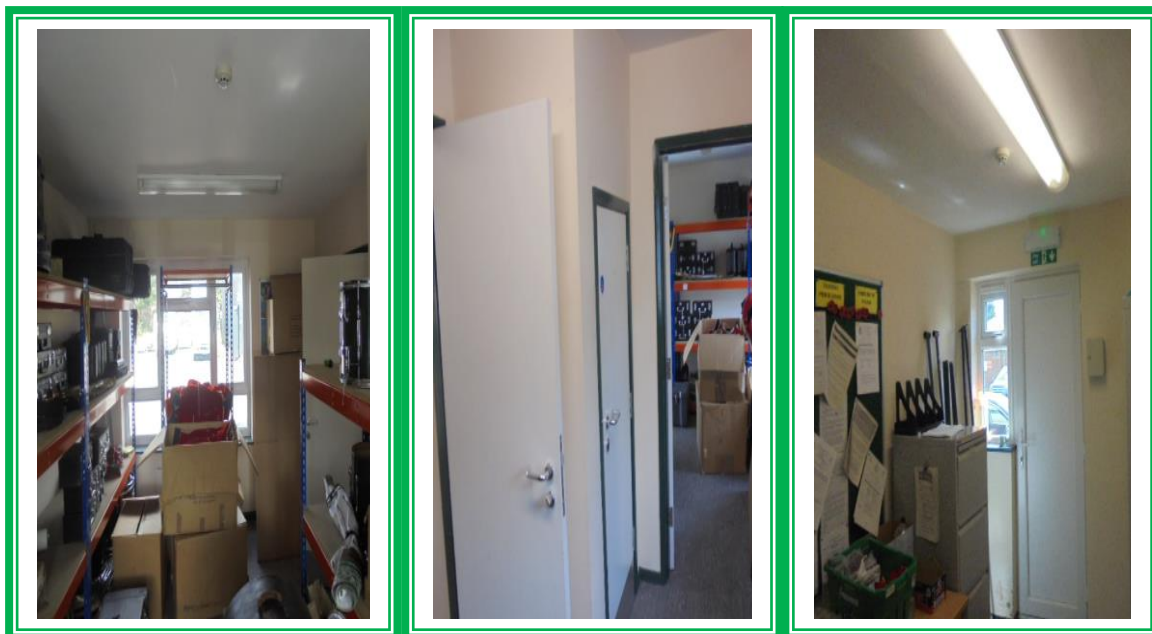
**Location: Ground Floor – House 6 – Stores X 2, Office and Cupboards**

<b>Material Description:</b>	Visual Inspection – No Suspect Materials Found	
<b>Identification:</b>	N/A	
<b>Approx. quantity:</b>	N/A	
<b>Accessibility</b>	N/A	Assessment Score
<b>Product type:</b>	N/A	N/A
<b>Extent of Damage:</b>	N/A	N/A
<b>Surface Treatment:</b>	N/A	N/A
<b>Asbestos type:</b>	N/A	N/A
<b>Material Assessment Score:</b>		N/A
<b>Priority Assessment Score:</b>		N/A
<b>Action:</b>	N/A	
<b>Comments:</b>	N/A

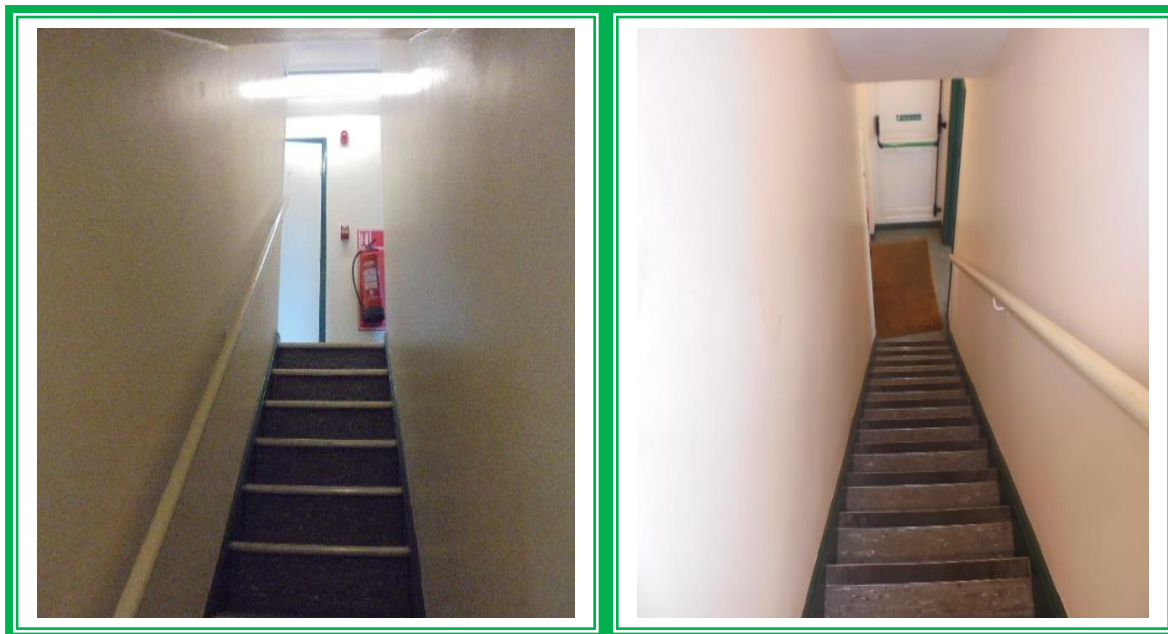
**Location: Ground Floor – House 6 - Stairwell**

<b>Material Description:</b>	Visual Inspection – No Suspect Materials Found	
<b>Identification:</b>	N/A	
<b>Approx. quantity:</b>	N/A	
<b>Accessibility</b>	N/A	<i>Assessment Score</i>
<b>Product type:</b>	N/A	N/A
<b>Extent of Damage:</b>	N/A	N/A
<b>Surface Treatment:</b>	N/A	N/A
<b>Asbestos type:</b>	N/A	N/A
<b>Material Assessment Score:</b>		N/A
<b>Priority Assessment Score:</b>		N/A
<b>Action:</b>	N/A	
<b>Comments:</b>	N/A

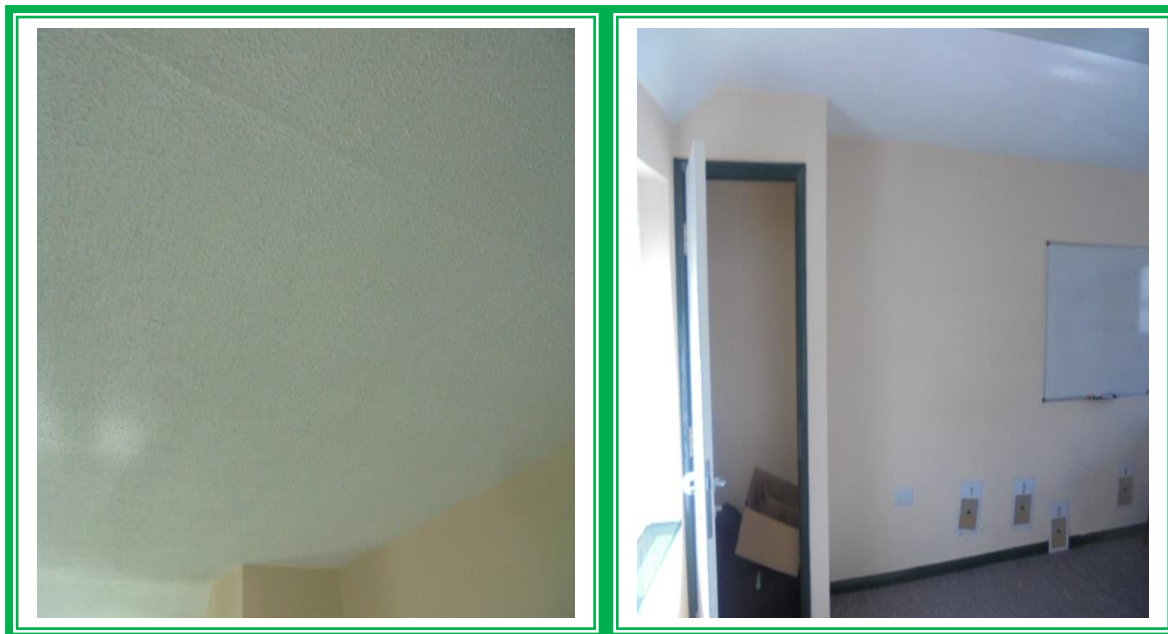
**Location: First Floor – House 6 - Office**

<b>Material Description:</b>	Textured Coating to Ceiling	
<b>Identification:</b>	Sampled – No Asbestos Detected	
<b>Approx. quantity:</b>	20M2	
<b>Accessibility</b>	N/A	<i>Assessment Score</i>
<b>Product type:</b>	N/A	N/A
<b>Extent of Damage:</b>	N/A	N/A
<b>Surface Treatment:</b>	N/A	N/A
<b>Asbestos type:</b>	N/A	N/A
<b>Material Assessment Score:</b>		N/A
<b>Priority Assessment Score:</b>		N/A
<b>Action:</b>	N/A	
<b>Comments:</b>	No Access within Loft Space as Locked

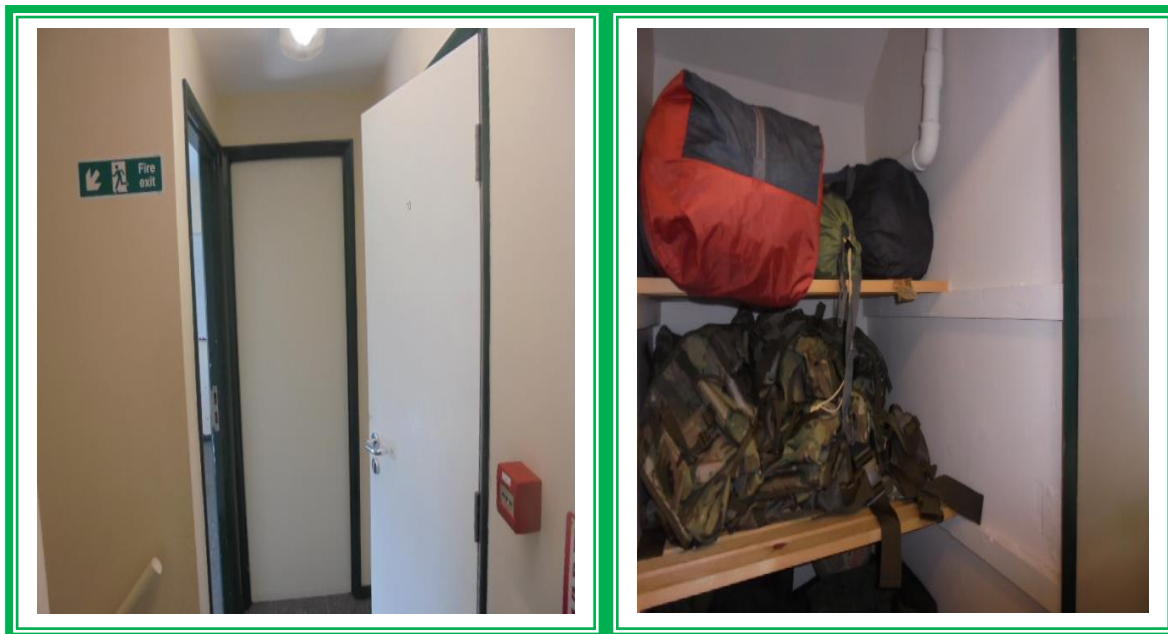
**Location: First Floor – House 6 – Landing and Cupboard**

<b>Material Description:</b>	Visual Inspection – No Suspect Materials Found	
<b>Identification:</b>	N/A	
<b>Approx. quantity:</b>	N/A	
<b>Accessibility</b>	N/A	<i>Assessment Score</i>
<b>Product type:</b>	N/A	N/A
<b>Extent of Damage:</b>	N/A	N/A
<b>Surface Treatment:</b>	N/A	N/A
<b>Asbestos type:</b>	N/A	N/A
<b>Material Assessment Score:</b>		N/A
<b>Priority Assessment Score:</b>		N/A
<b>Action:</b>	N/A	
<b>Comments:</b>	N/A

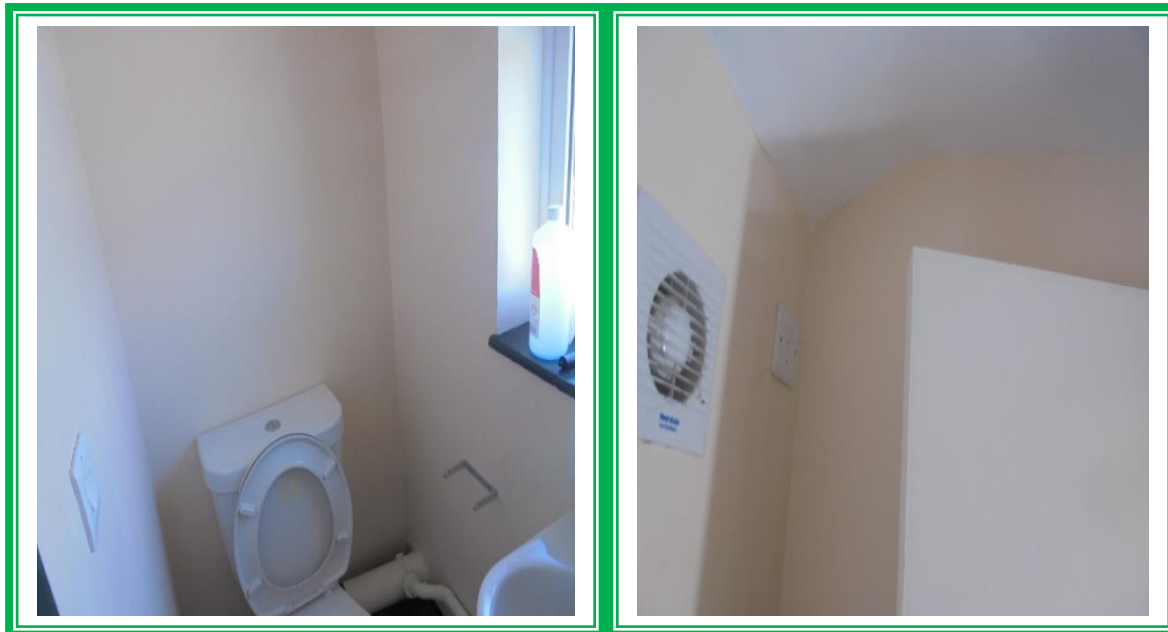
**Location: First Floor – House 6 - WC**

<b>Material Description:</b>	Visual Inspection – No Suspect Materials Found	
<b>Identification:</b>	N/A	
<b>Approx. quantity:</b>	N/A	
<b>Accessibility</b>	N/A	<i>Assessment Score</i>
<b>Product type:</b>	N/A	N/A
<b>Extent of Damage:</b>	N/A	N/A
<b>Surface Treatment:</b>	N/A	N/A
<b>Asbestos type:</b>	N/A	N/A
<b>Material Assessment Score:</b>		N/A
<b>Priority Assessment Score:</b>		N/A
<b>Action:</b>	N/A	
<b>Comments:</b>	N/A

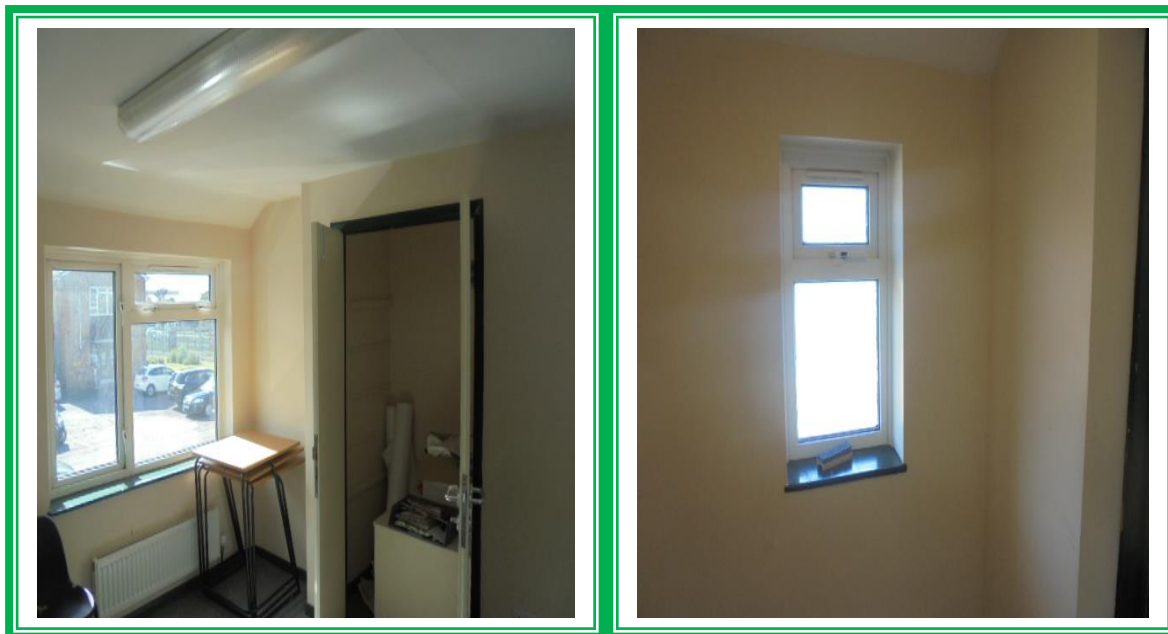
**Location: First Floor – House 6 – Office and Lobby**

<b>Material Description:</b>	Visual Inspection – No Suspect Materials Found	
<b>Identification:</b>	N/A	
<b>Approx. quantity:</b>	N/A	
<b>Accessibility</b>	N/A	Assessment Score
<b>Product type:</b>	N/A	N/A
<b>Extent of Damage:</b>	N/A	N/A
<b>Surface Treatment:</b>	N/A	N/A
<b>Asbestos type:</b>	N/A	N/A
<b>Material Assessment Score:</b>		N/A
<b>Priority Assessment Score:</b>		N/A
<b>Action:</b>	N/A	
<b>Comments:</b>	N/A

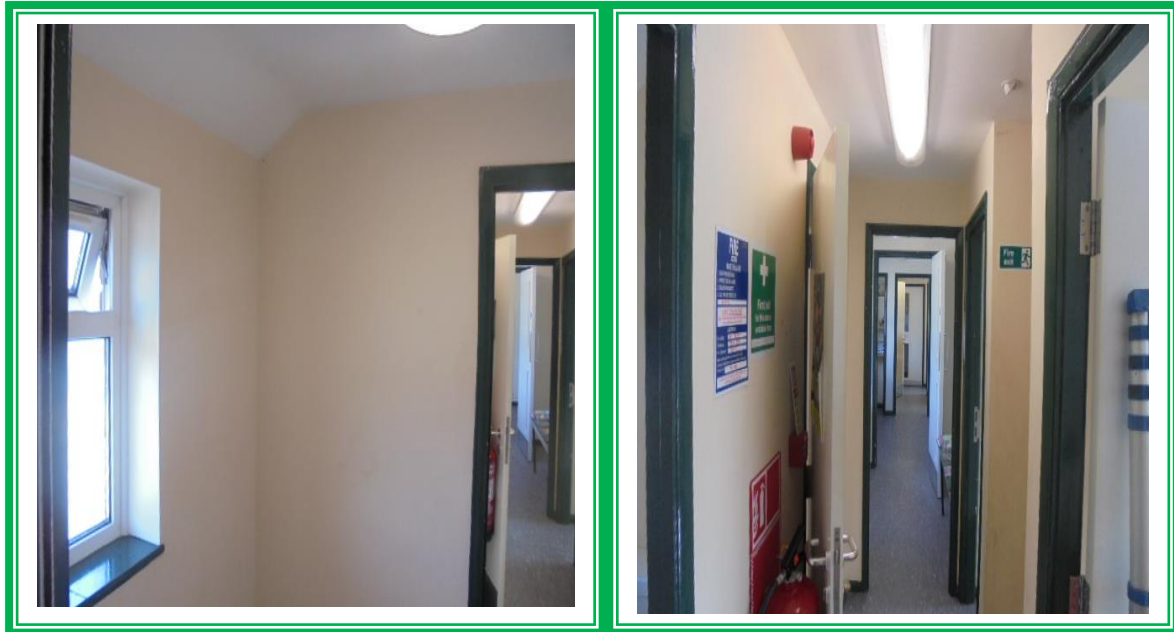
**Location: First Floor – House 7 – Lobby and Landing**

<b>Material Description:</b>	Visual Inspection – No Suspect Materials Found	
<b>Identification:</b>	N/A	
<b>Approx. quantity:</b>	N/A	
<b>Accessibility</b>	N/A	Assessment Score
<b>Product type:</b>	N/A	N/A
<b>Extent of Damage:</b>	N/A	N/A
<b>Surface Treatment:</b>	N/A	N/A
<b>Asbestos type:</b>	N/A	N/A
<b>Material Assessment Score:</b>		N/A
<b>Priority Assessment Score:</b>		N/A
<b>Action:</b>	N/A	
<b>Comments:</b>	Modern Boiler

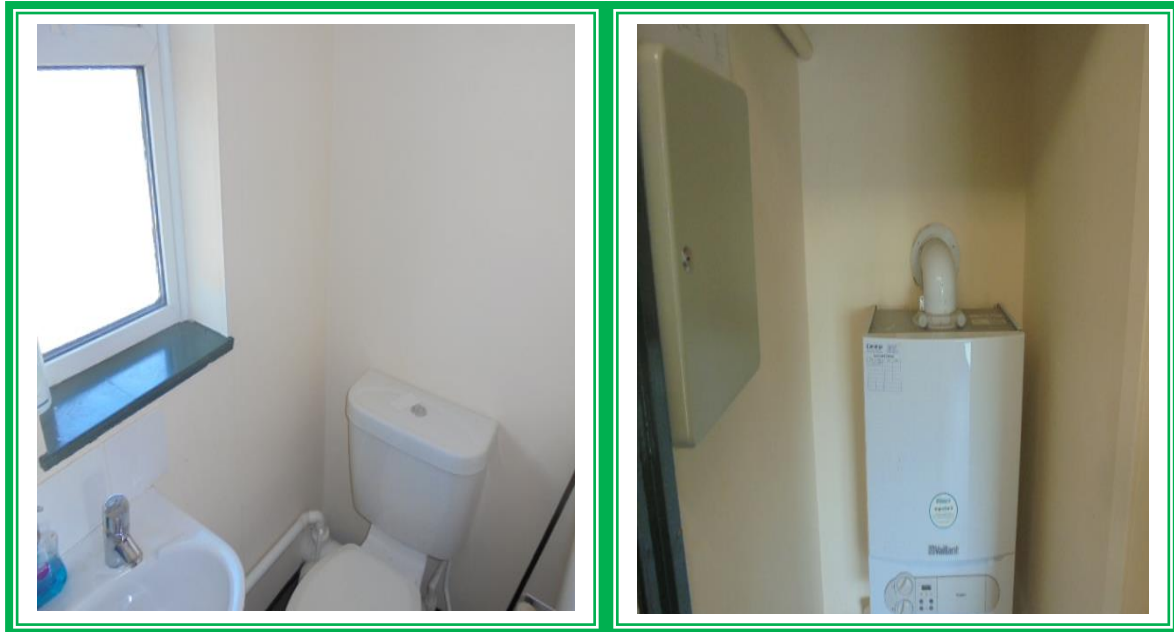
**Location: First Floor – House 7 – WC & Cupboard**

<b>Material Description:</b>	Visual Inspection – No Suspect Materials Found	
<b>Identification:</b>	N/A	
<b>Approx. quantity:</b>	N/A	
<b>Accessibility</b>	N/A	<i>Assessment Score</i>
<b>Product type:</b>	N/A	N/A
<b>Extent of Damage:</b>	N/A	N/A
<b>Surface Treatment:</b>	N/A	N/A
<b>Asbestos type:</b>	N/A	N/A
<b>Material Assessment Score:</b>		N/A
<b>Priority Assessment Score:</b>		N/A
<b>Action:</b>	N/A	
<b>Comments:</b>	N/A

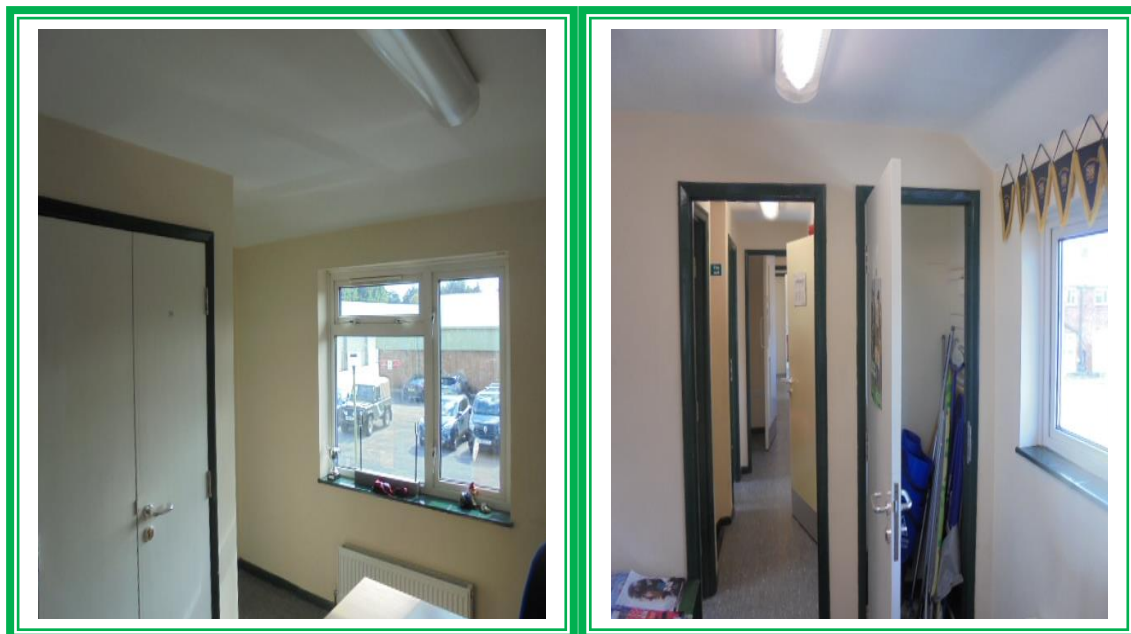
**Location: First Floor – House 7 – Offices X2, Cupboards and Lobby**

<b>Material Description:</b>	Visual Inspection – No Suspect Materials Found	
<b>Identification:</b>	N/A	
<b>Approx. quantity:</b>	N/A	
<b>Accessibility</b>	N/A	<i>Assessment Score</i>
<b>Product type:</b>	N/A	N/A
<b>Extent of Damage:</b>	N/A	N/A
<b>Surface Treatment:</b>	N/A	N/A
<b>Asbestos type:</b>	N/A	N/A
<b>Material Assessment Score:</b>		N/A
<b>Priority Assessment Score:</b>		N/A
<b>Action:</b>	N/A	
<b>Comments:</b>	N/A

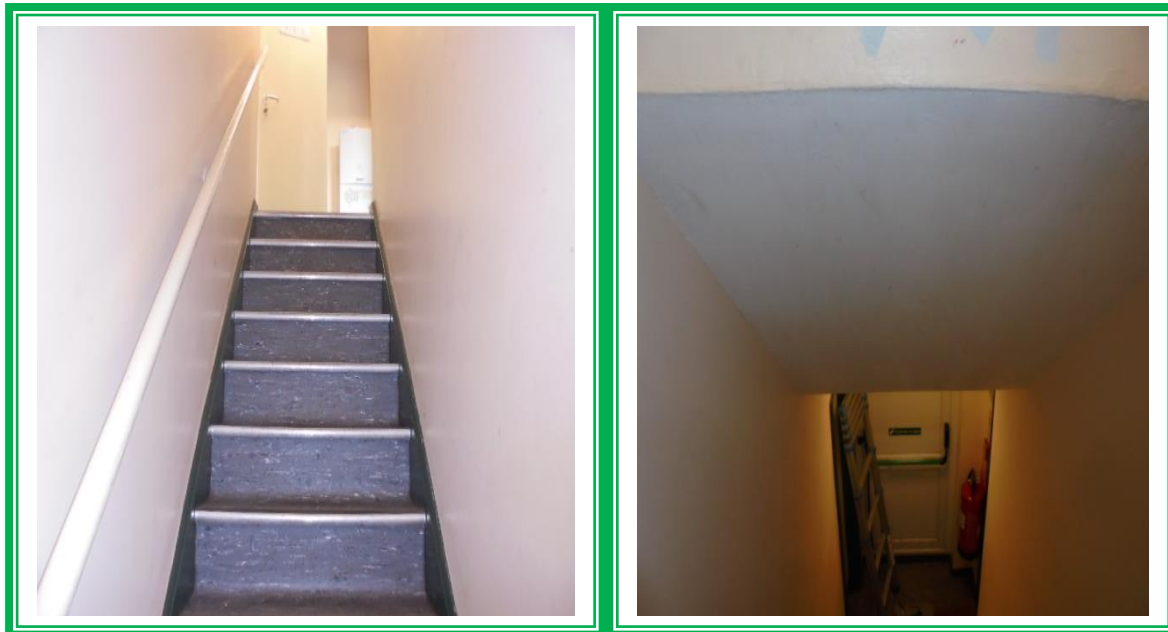
**Location: House 7 – Lobby and Stairwell**

<b>Material Description:</b>	Visual Inspection – No Suspect Materials Found	
<b>Identification:</b>	N/A	
<b>Approx. quantity:</b>	N/A	
<b>Accessibility</b>	N/A	<i>Assessment Score</i>
<b>Product type:</b>	N/A	N/A
<b>Extent of Damage:</b>	N/A	N/A
<b>Surface Treatment:</b>	N/A	N/A
<b>Asbestos type:</b>	N/A	N/A
<b>Material Assessment Score:</b>		N/A
<b>Priority Assessment Score:</b>		N/A
<b>Action:</b>	N/A	
<b>Comments:</b>	Modern Stair Nosing
