**ARMOUR**  
ANALYTICAL SERVICES

**Project Number 2481**

**Management  
Asbestos Survey Report**

**6<sup>th</sup> Battalion, Eastern Avenue, Gloucestershire  
GL4 3BD**

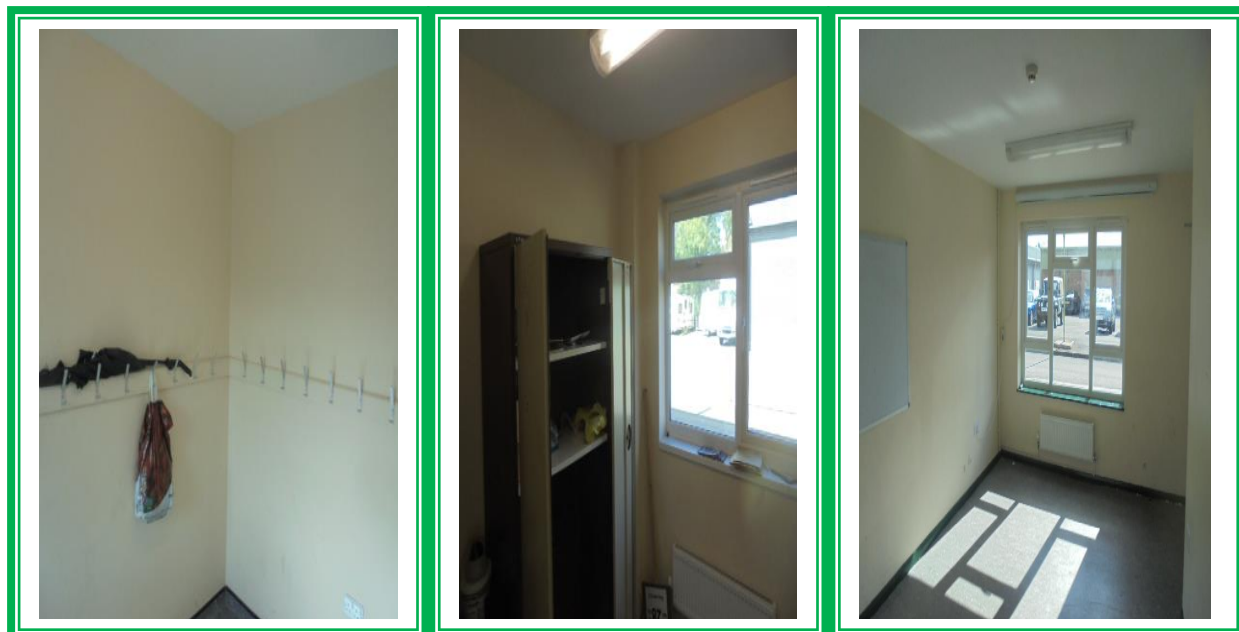
**Location: Ground Floor – House 7 – Office, Store and Classroom**

<b>Material Description:</b>	Visual Inspection – No Suspect Materials Found	
<b>Identification:</b>	N/A	
<b>Approx. quantity:</b>	N/A	
<b>Accessibility</b>	N/A	<i>Assessment Score</i>
<b>Product type:</b>	N/A	N/A
<b>Extent of Damage:</b>	N/A	N/A
<b>Surface Treatment:</b>	N/A	N/A
<b>Asbestos type:</b>	N/A	N/A
<b>Material Assessment Score:</b>		N/A
<b>Priority Assessment Score:</b>		N/A
<b>Action:</b>	N/A	
<b>Comments:</b>	N/A

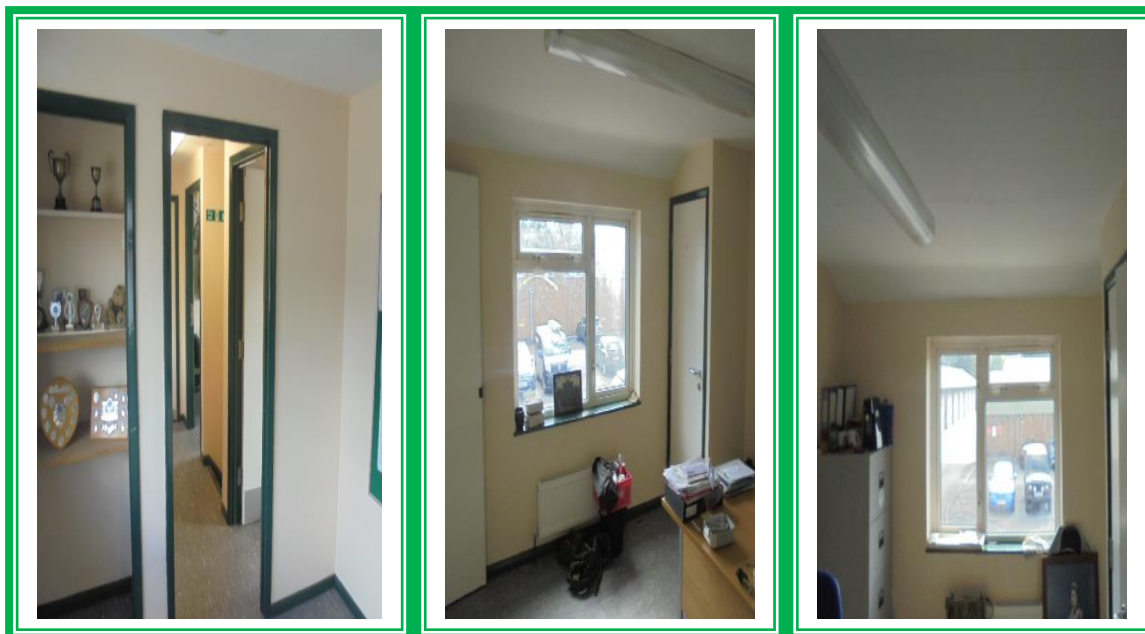
**Location: First Floor – House 8 – Lobby, Offices X2 and Cupboards**

<b>Material Description:</b>	Visual Inspection – No Suspect Materials Found	
<b>Identification:</b>	N/A	
<b>Approx. quantity:</b>	N/A	
<b>Accessibility</b>	N/A	<i>Assessment Score</i>
<b>Product type:</b>	N/A	N/A
<b>Extent of Damage:</b>	N/A	N/A
<b>Surface Treatment:</b>	N/A	N/A
<b>Asbestos type:</b>	N/A	N/A
<b>Material Assessment Score:</b>		N/A
<b>Priority Assessment Score:</b>		N/A
<b>Action:</b>	N/A	
<b>Comments:</b>	N/A

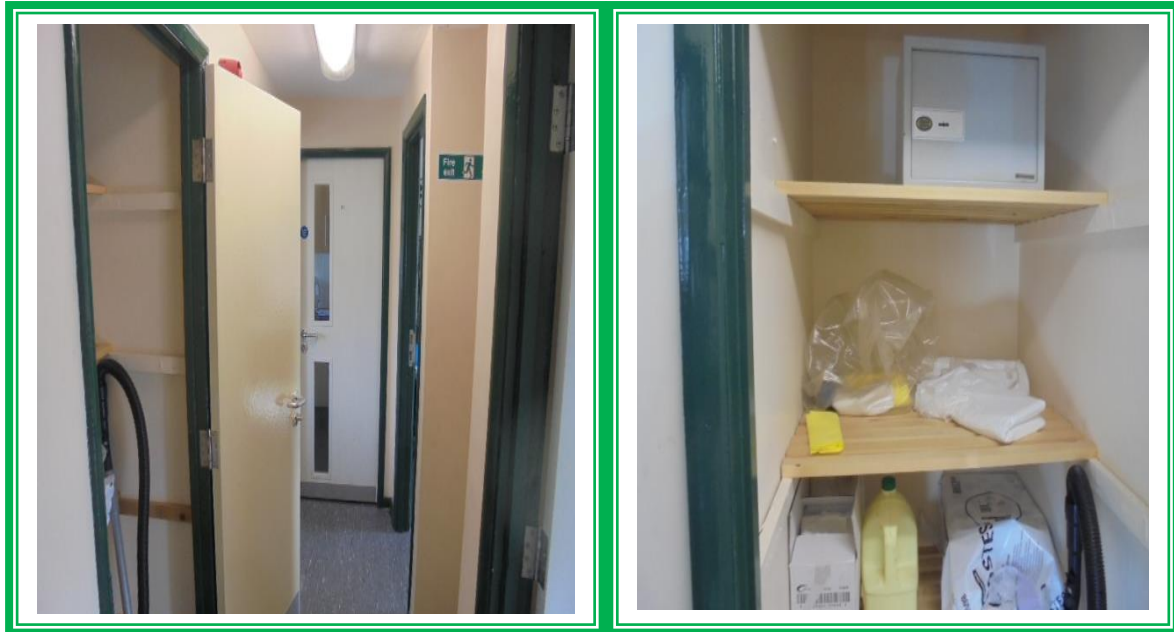
**Location: First Floor – House 8 – Landing and Cupboard**

<b>Material Description:</b>	Visual Inspection – No Suspect Materials Found	
<b>Identification:</b>	N/A	
<b>Approx. quantity:</b>	N/A	
<b>Accessibility</b>	N/A	<i>Assessment Score</i>
<b>Product type:</b>	N/A	N/A
<b>Extent of Damage:</b>	N/A	N/A
<b>Surface Treatment:</b>	N/A	N/A
<b>Asbestos type:</b>	N/A	N/A
<b>Material Assessment Score:</b>		N/A
<b>Priority Assessment Score:</b>		N/A
<b>Action:</b>	N/A	
<b>Comments:</b>	N/A

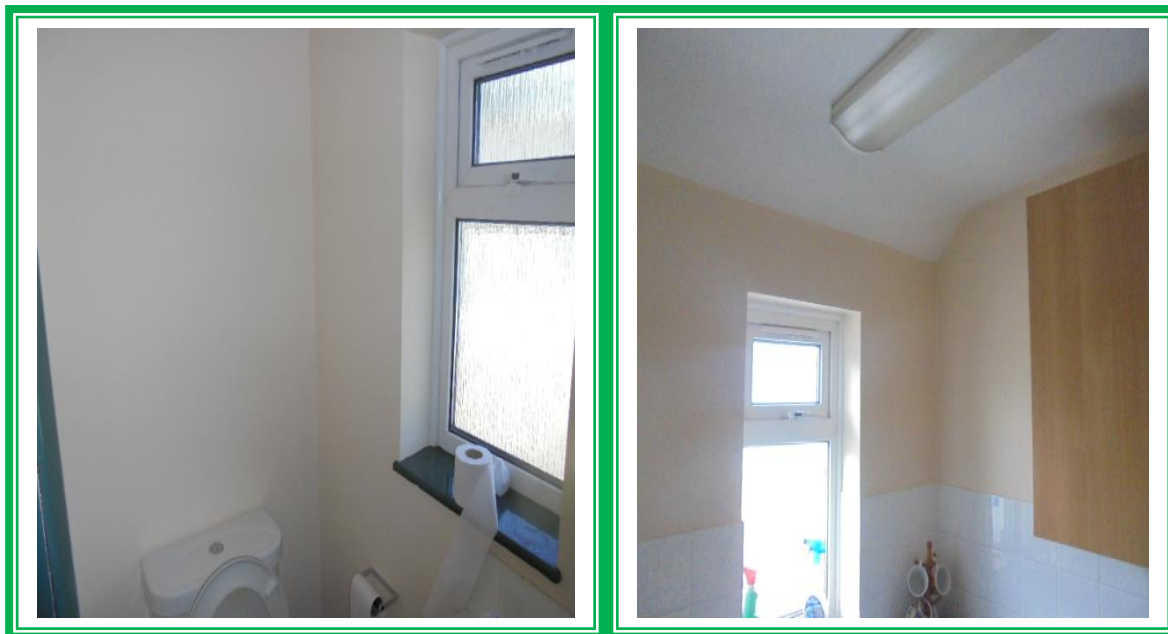
**Location: First Floor – House 8 – WC and Kitchen**

<b>Material Description:</b>	Visual Inspection – No Suspect Materials Found	
<b>Identification:</b>	N/A	
<b>Approx. quantity:</b>	N/A	
<b>Accessibility</b>	N/A	<i>Assessment Score</i>
<b>Product type:</b>	N/A	N/A
<b>Extent of Damage:</b>	N/A	N/A
<b>Surface Treatment:</b>	N/A	N/A
<b>Asbestos type:</b>	N/A	N/A
<b>Material Assessment Score:</b>		N/A
<b>Priority Assessment Score:</b>		N/A
<b>Action:</b>	N/A	
<b>Comments:</b>	Modern Sink pad in Kitchen

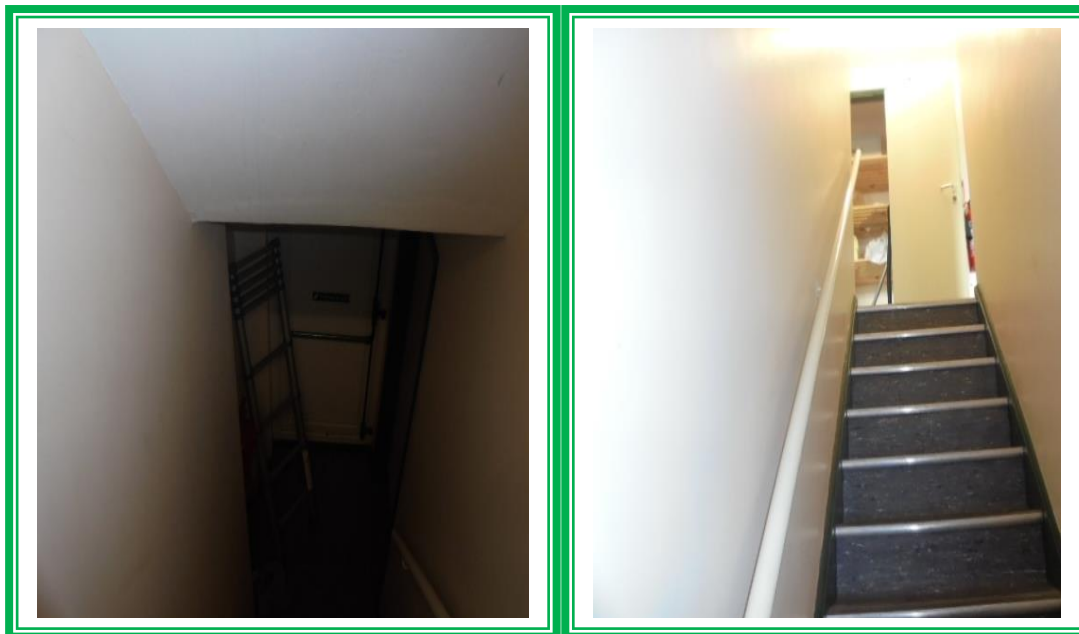
**Location: Ground Floor – House 8 – Lobby & Stairwell**

<b>Material Description:</b>	Visual Inspection – No Suspect Materials Found	
<b>Identification:</b>	N/A	
<b>Approx. quantity:</b>	N/A	
<b>Accessibility</b>	N/A	<i>Assessment Score</i>
<b>Product type:</b>	N/A	N/A
<b>Extent of Damage:</b>	N/A	N/A
<b>Surface Treatment:</b>	N/A	N/A
<b>Asbestos type:</b>	N/A	N/A
<b>Material Assessment Score:</b>		N/A
<b>Priority Assessment Score:</b>		N/A
<b>Action:</b>	N/A	
<b>Comments:</b>	N/A

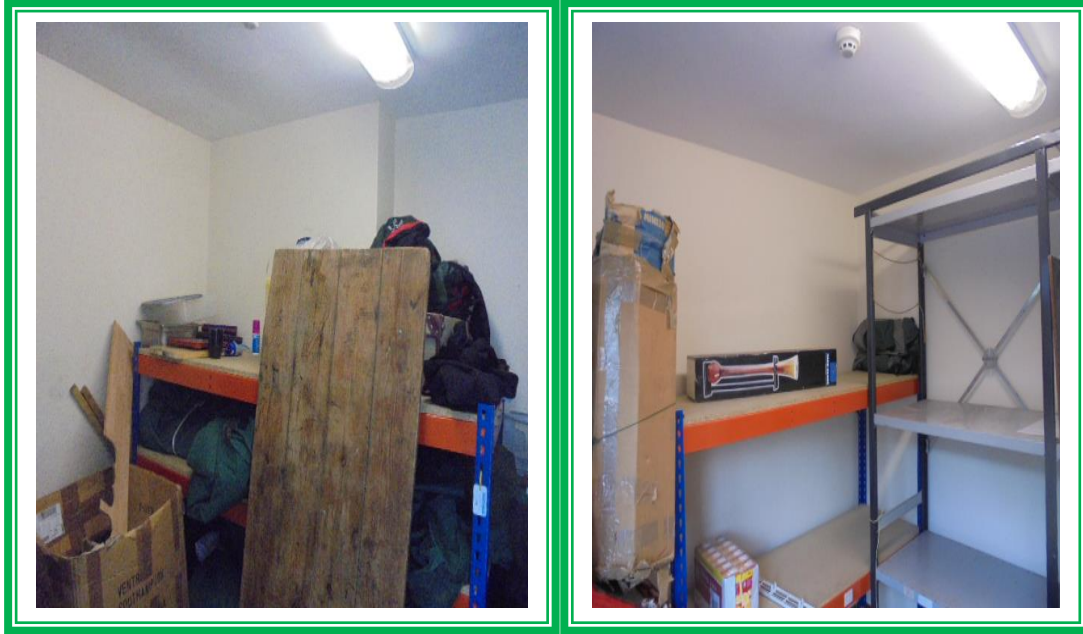
**Location: Ground Floor – House 8 – Classroom, Stores X2 and Cupboard**

<b>Material Description:</b>	Visual Inspection – No Suspect Materials Found	
<b>Identification:</b>	N/A	
<b>Approx. quantity:</b>	N/A	
<b>Accessibility</b>	N/A	Assessment Score
<b>Product type:</b>	N/A	N/A
<b>Extent of Damage:</b>	N/A	N/A
<b>Surface Treatment:</b>	N/A	N/A
<b>Asbestos type:</b>	N/A	N/A
<b>Material Assessment Score:</b>		N/A
<b>Priority Assessment Score:</b>		N/A
<b>Action:</b>	N/A	
<b>Comments:</b>	N/A

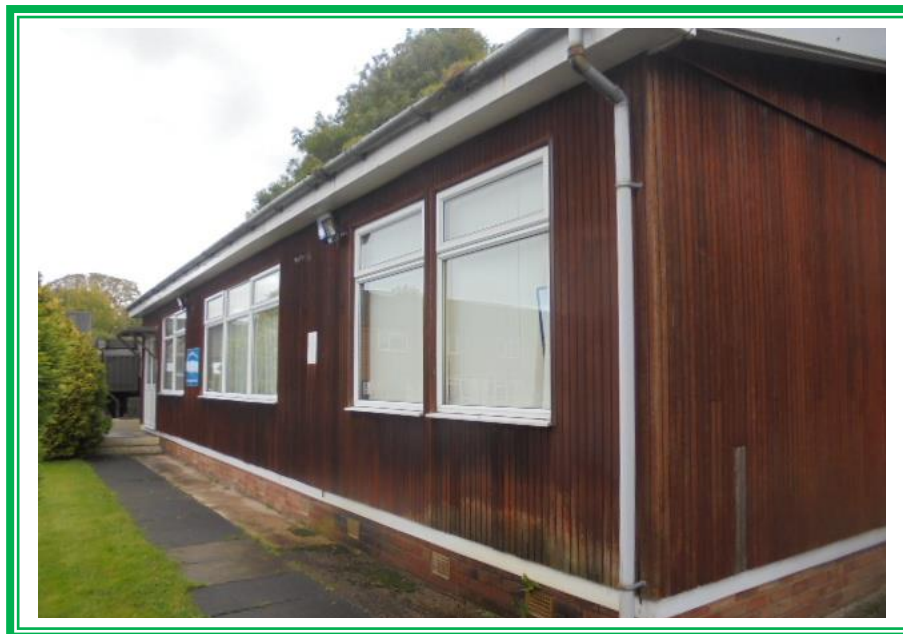
**Location: ATC Hut - External**

<b>Material Description:</b>	Visual Inspection – No Suspect Materials Found	
<b>Identification:</b>	N/A	
<b>Approx. quantity:</b>	N/A	
<b>Accessibility</b>	N/A	<i>Assessment Score</i>
<b>Product type:</b>	N/A	N/A
<b>Extent of Damage:</b>	N/A	N/A
<b>Surface Treatment:</b>	N/A	N/A
<b>Asbestos type:</b>	N/A	N/A
<b>Material Assessment Score:</b>		N/A
<b>Priority Assessment Score:</b>		N/A
<b>Action:</b>	N/A	
<b>Comments:</b>	N/A

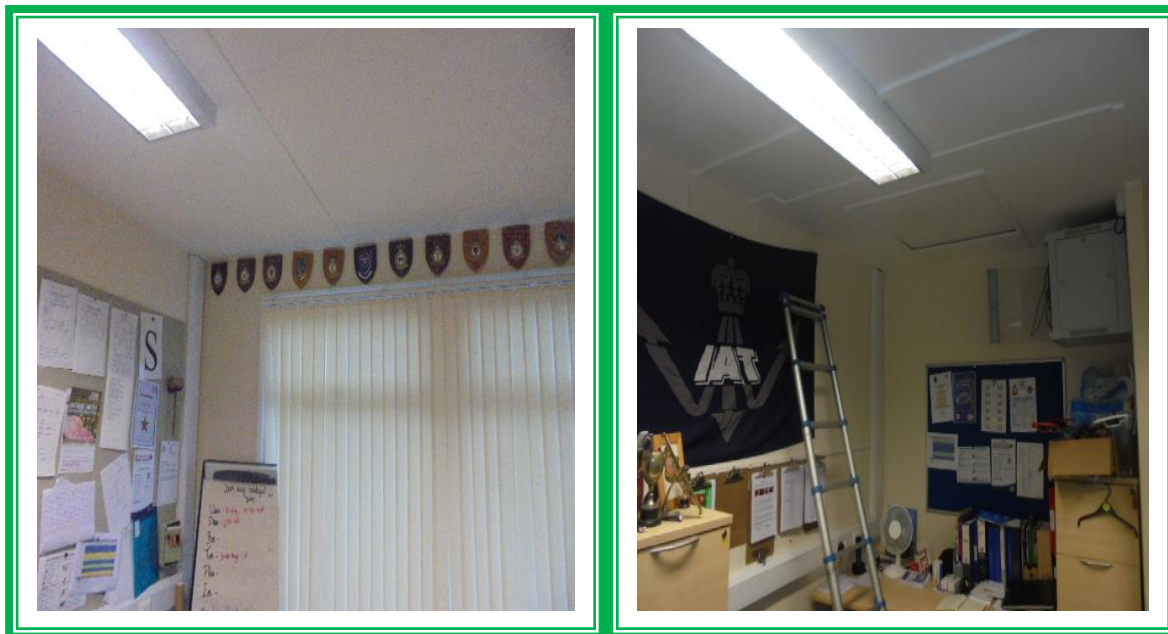
**Location: ATC Hut - Office**

<b>Material Description:</b>	Visual Inspection – No Suspect Materials Found	
<b>Identification:</b>	N/A	
<b>Approx. quantity:</b>	N/A	
<b>Accessibility</b>	N/A	Assessment Score
<b>Product type:</b>	N/A	N/A
<b>Extent of Damage:</b>	N/A	N/A
<b>Surface Treatment:</b>	N/A	N/A
<b>Asbestos type:</b>	N/A	N/A
<b>Material Assessment Score:</b>		N/A
<b>Priority Assessment Score:</b>		N/A
<b>Action:</b>	N/A	
<b>Comments:</b>	N/A

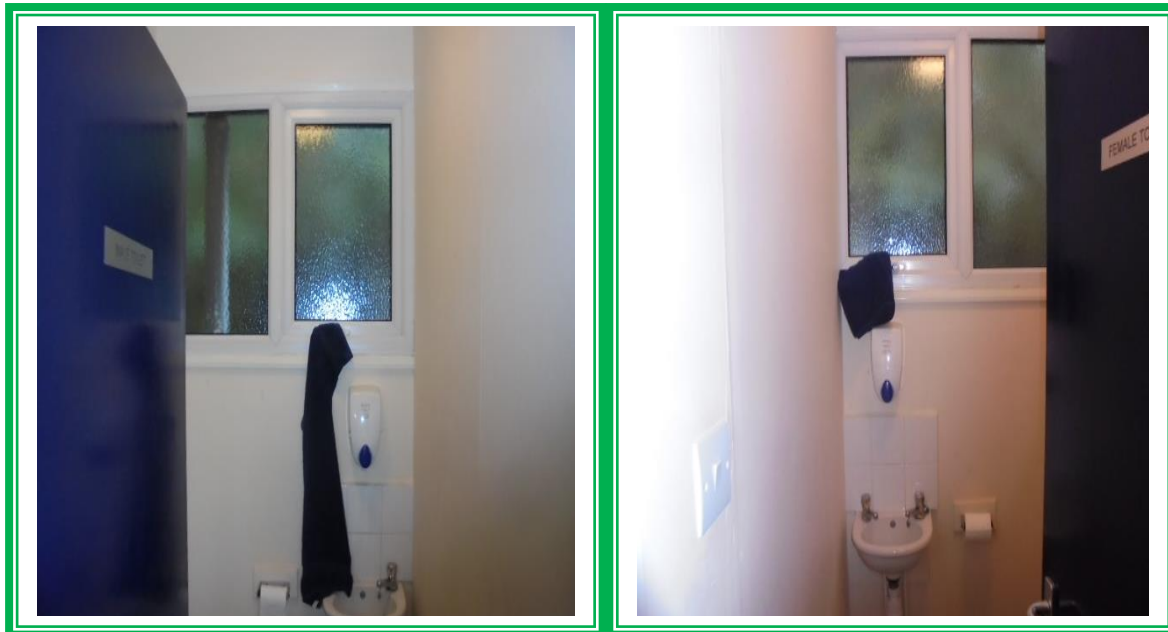
**Location: ATC Hut – WC's X2**

<b>Material Description:</b>	Visual Inspection – No Suspect Materials Found	
<b>Identification:</b>	N/A	
<b>Approx. quantity:</b>	N/A	
<b>Accessibility</b>	N/A	<i>Assessment Score</i>
<b>Product type:</b>	N/A	N/A
<b>Extent of Damage:</b>	N/A	N/A
<b>Surface Treatment:</b>	N/A	N/A
<b>Asbestos type:</b>	N/A	N/A
<b>Material Assessment Score:</b>		N/A
<b>Priority Assessment Score:</b>		N/A
<b>Action:</b>	N/A	
<b>Comments:</b>	N/A

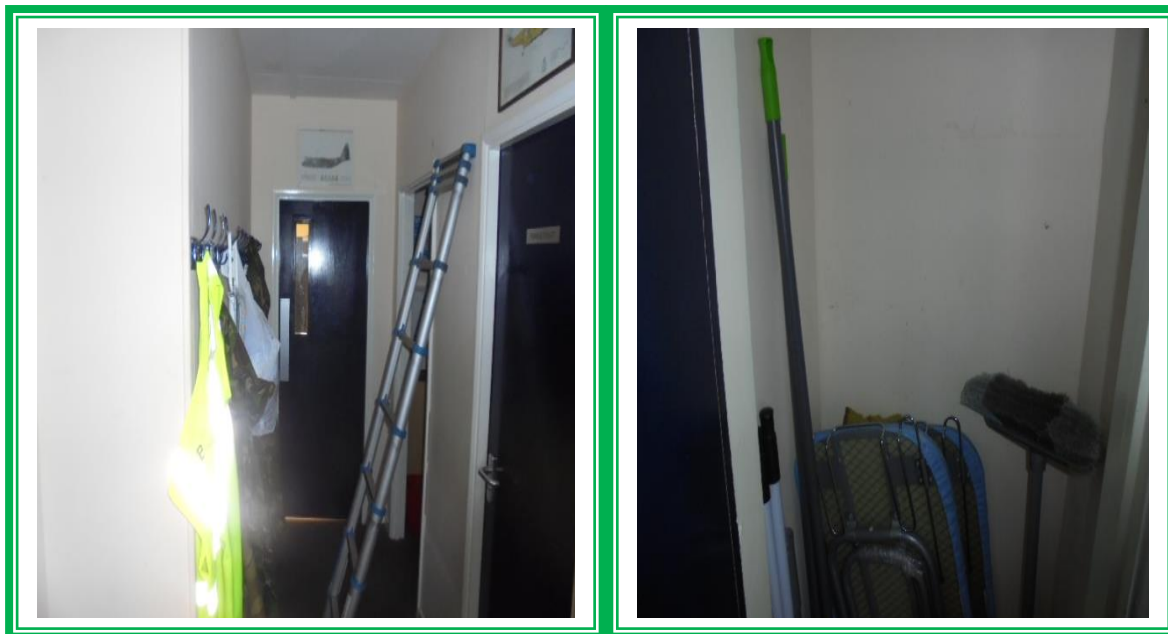
**Location: ATC Hut – Lobby and Cupboard**

<b>Material Description:</b>	Visual Inspection – No Suspect Materials Found	
<b>Identification:</b>	N/A	
<b>Approx. quantity:</b>	N/A	
<b>Accessibility</b>	N/A	<i>Assessment Score</i>
<b>Product type:</b>	N/A	N/A
<b>Extent of Damage:</b>	N/A	N/A
<b>Surface Treatment:</b>	N/A	N/A
<b>Asbestos type:</b>	N/A	N/A
<b>Material Assessment Score:</b>		N/A
<b>Priority Assessment Score:</b>		N/A
<b>Action:</b>	N/A	
<b>Comments:</b>	N/A

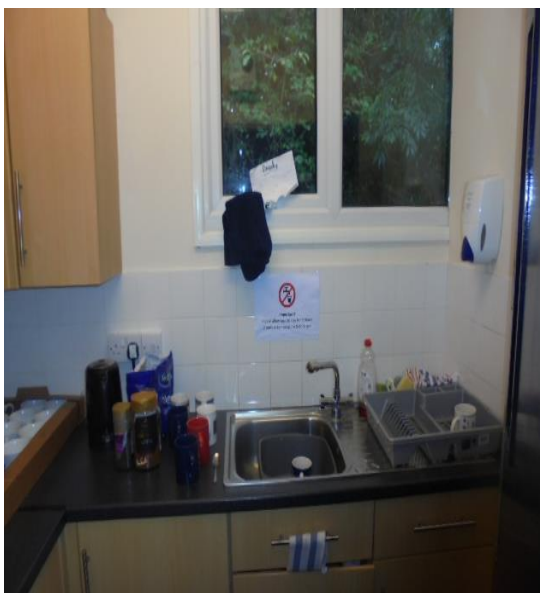
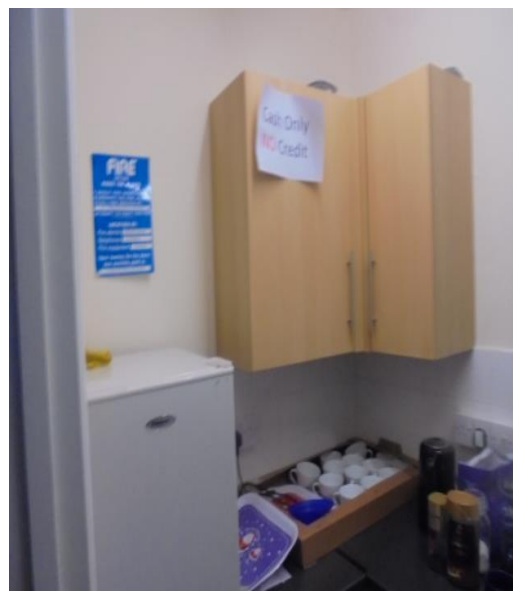
**Location: ATC Hut - Kitchen**

<b>Material Description:</b>	Visual Inspection – No Suspect Materials Found	
<b>Identification:</b>	N/A	
<b>Approx. quantity:</b>	N/A	
<b>Accessibility</b>	N/A	Assessment Score
<b>Product type:</b>	N/A	N/A
<b>Extent of Damage:</b>	N/A	N/A
<b>Surface Treatment:</b>	N/A	N/A
<b>Asbestos type:</b>	N/A	N/A
<b>Material Assessment Score:</b>		N/A
<b>Priority Assessment Score:</b>		N/A
<b>Action:</b>	N/A	
<b>Comments:</b>	Modern Sink Pad

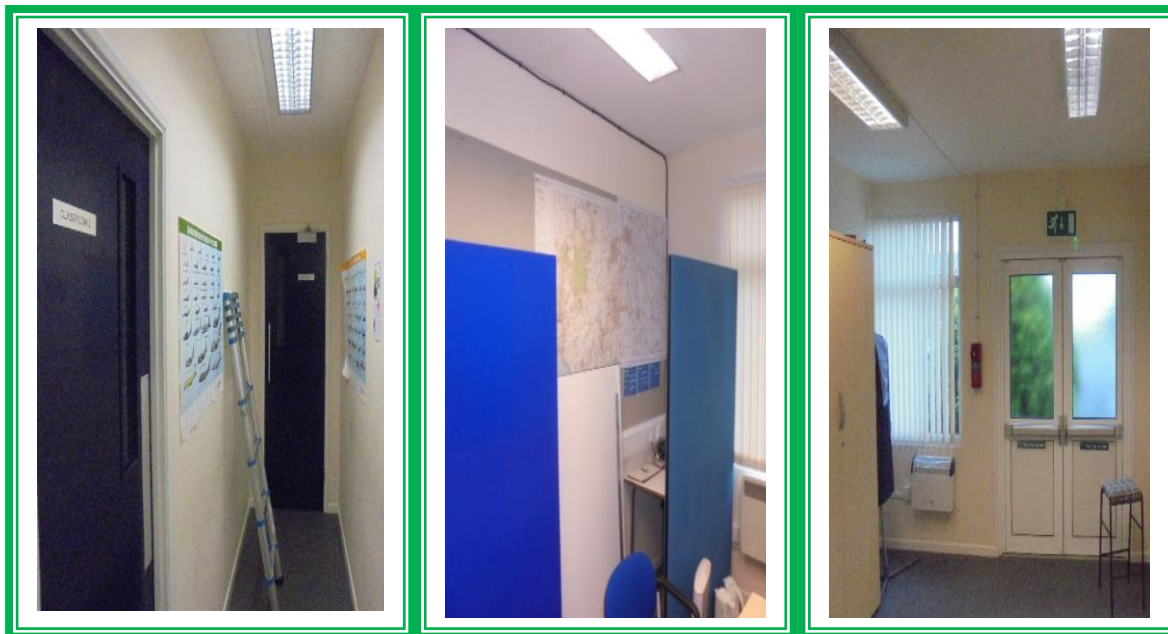
**Location: ATC Hut – Classroom X2. Drill Hall and Corridor**

<b>Material Description:</b>	Visual Inspection – No Suspect Materials Found	
<b>Identification:</b>	N/A	
<b>Approx. quantity:</b>	N/A	
<b>Accessibility</b>	N/A	Assessment Score
<b>Product type:</b>	N/A	N/A
<b>Extent of Damage:</b>	N/A	N/A
<b>Surface Treatment:</b>	N/A	N/A
<b>Asbestos type:</b>	N/A	N/A
<b>Material Assessment Score:</b>		N/A
<b>Priority Assessment Score:</b>		N/A
<b>Action:</b>	N/A	
<b>Comments:</b>	N/A

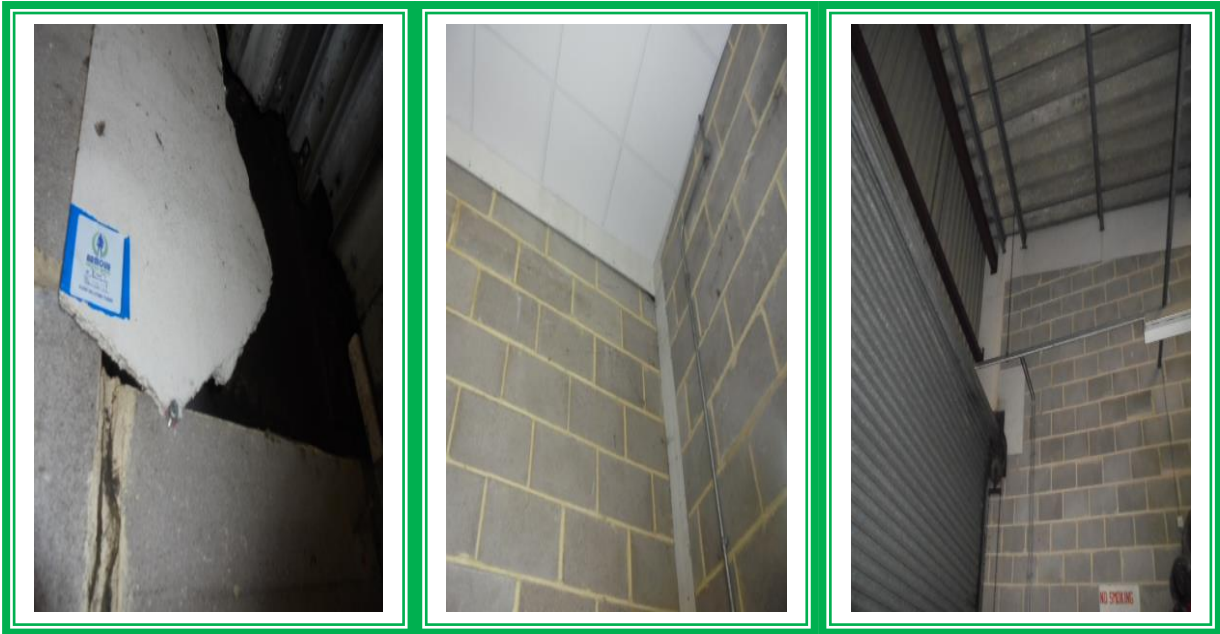
**Location: Garages 1-5 - Internal**

<b>Material Description:</b>	Insulation Board Wall and Bulkhead Panels	
<b>Identification:</b>	Sampled – No Asbestos Detected	
<b>Approx. quantity:</b>	100M2 +	
<b>Accessibility</b>	N/A	<i>Assessment Score</i>
<b>Product type:</b>	N/A	N/A
<b>Extent of Damage:</b>	N/A	N/A
<b>Surface Treatment:</b>	N/A	N/A
<b>Asbestos type:</b>	N/A	N/A
<b>Material Assessment Score:</b>		N/A
<b>Priority Assessment Score:</b>		N/A
<b>Action:</b>	N/A	
<b>Comments:</b>	Located throughout building

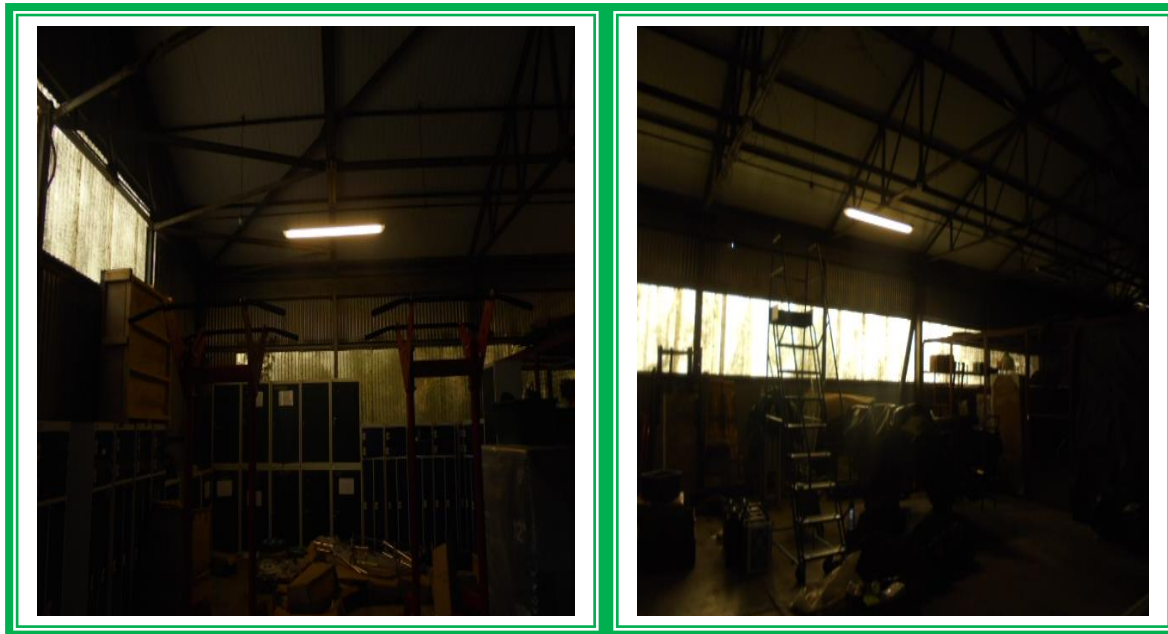
**Location: Locker Garage and Armoured Truck Garage**

<b>Material Description:</b>	Visual Inspection – No Suspect Materials Found	
<b>Identification:</b>	N/A	
<b>Approx. quantity:</b>	N/A	
<b>Accessibility</b>	N/A	<i>Assessment Score</i>
<b>Product type:</b>	N/A	N/A
<b>Extent of Damage:</b>	N/A	N/A
<b>Surface Treatment:</b>	N/A	N/A
<b>Asbestos type:</b>	N/A	N/A
<b>Material Assessment Score:</b>		N/A
<b>Priority Assessment Score:</b>		N/A
<b>Action:</b>	N/A	
<b>Comments:</b>	N/A

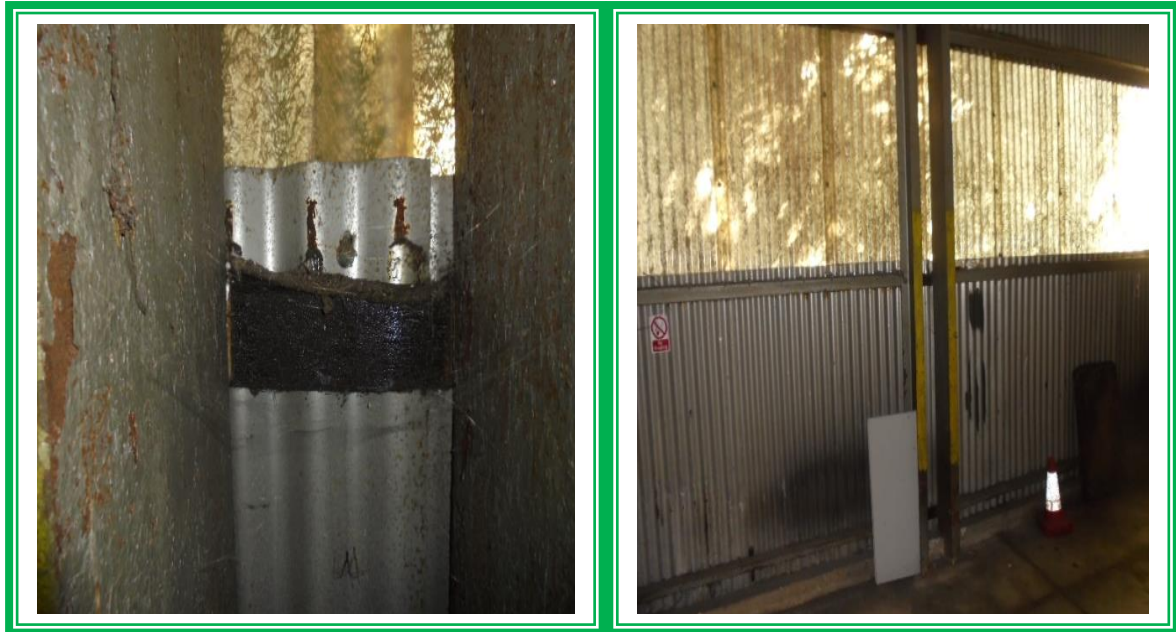
**Location: Garage – Drill Hall**

<b>Material Description:</b>	Bitumen Damp Proof Course to Wall	
<b>Identification:</b>	Sampled – No Asbestos Detected	
<b>Approx. quantity:</b>	Throughout Building	
<b>Accessibility</b>	N/A	<i>Assessment Score</i>
<b>Product type:</b>	N/A	N/A
<b>Extent of Damage:</b>	N/A	N/A
<b>Surface Treatment:</b>	N/A	N/A
<b>Asbestos type:</b>	N/A	N/A
<b>Material Assessment Score:</b>		N/A
<b>Priority Assessment Score:</b>		N/A
<b>Action:</b>	N/A	
<b>Comments:</b>	N/A

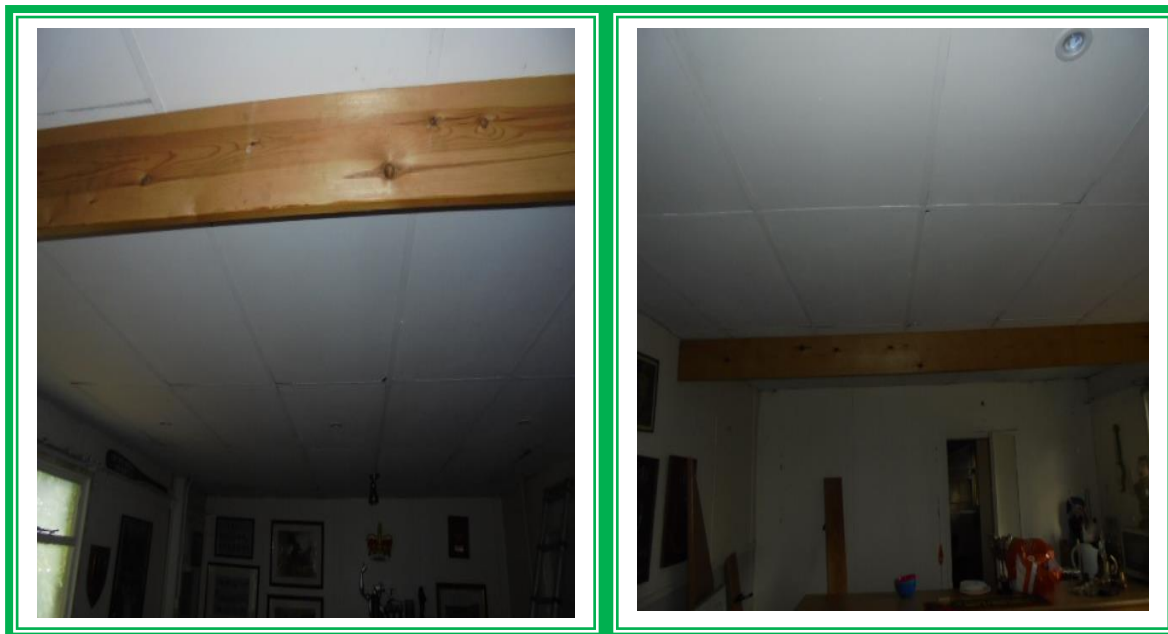
**Location: Garages – Bar/Mess Room**

<b>Material Description:</b>	Suspended Ceiling Tiles	
<b>Identification:</b>	Sampled – No Asbestos Detected	
<b>Approx. quantity:</b>	28M2	
<b>Accessibility</b>	N/A	<i>Assessment Score</i>
<b>Product type:</b>	N/A	N/A
<b>Extent of Damage:</b>	N/A	N/A
<b>Surface Treatment:</b>	N/A	N/A
<b>Asbestos type:</b>	N/A	N/A
<b>Material Assessment Score:</b>		N/A
<b>Priority Assessment Score:</b>		N/A
<b>Action:</b>	N/A	
<b>Comments:</b>	N/A

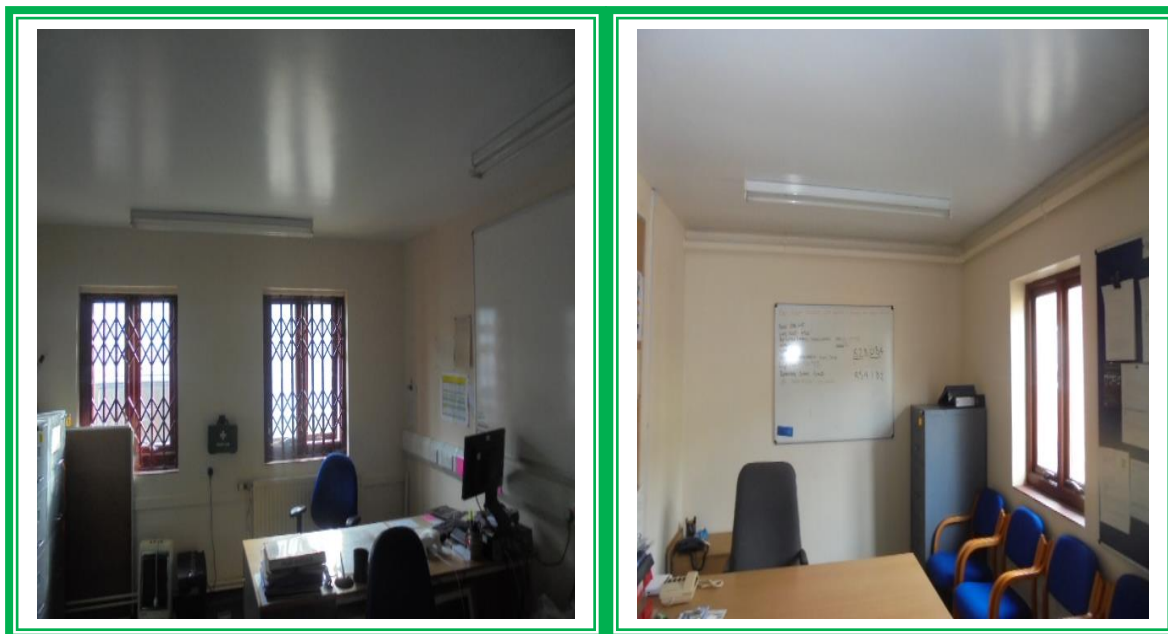
**Location: Ground Floor – Main Building Annexe – Offices 1,2 and Lobby**

<b>Material Description:</b>	Visual Inspection – No Suspect Materials Found	
<b>Identification:</b>	N/A	
<b>Approx. quantity:</b>	N/A	
<b>Accessibility</b>	N/A	<i>Assessment Score</i>
<b>Product type:</b>	N/A	N/A
<b>Extent of Damage:</b>	N/A	N/A
<b>Surface Treatment:</b>	N/A	N/A
<b>Asbestos type:</b>	N/A	N/A
<b>Material Assessment Score:</b>		N/A
<b>Priority Assessment Score:</b>		N/A
<b>Action:</b>	N/A	
<b>Comments:</b>	N/A

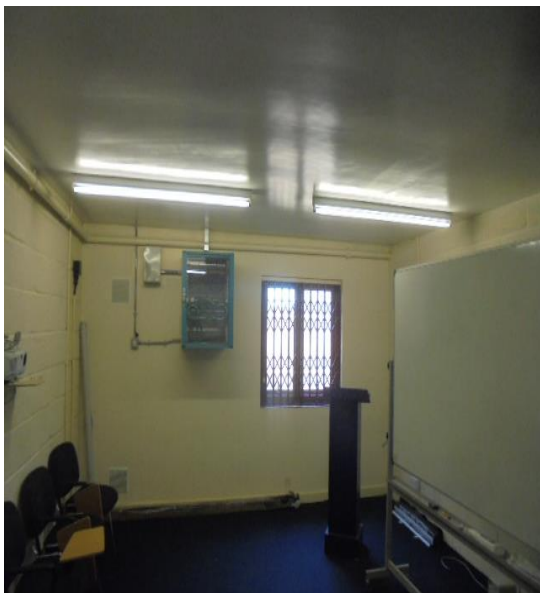
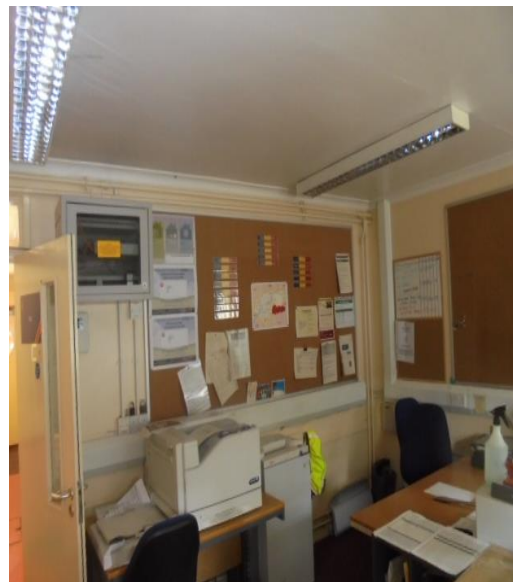
**Location: Ground Floor – Main Building Annexe –  
Classroom 3 and Office 4**

<b>Material Description:</b>	Visual Inspection – No Suspect Materials Found	
<b>Identification:</b>	N/A	
<b>Approx. quantity:</b>	N/A	
<b>Accessibility</b>	N/A	<i>Assessment Score</i>
<b>Product type:</b>	N/A	N/A
<b>Extent of Damage:</b>	N/A	N/A
<b>Surface Treatment:</b>	N/A	N/A
<b>Asbestos type:</b>	N/A	N/A
<b>Material Assessment Score:</b>		N/A
<b>Priority Assessment Score:</b>		N/A
<b>Action:</b>	N/A	
<b>Comments:</b>	N/A

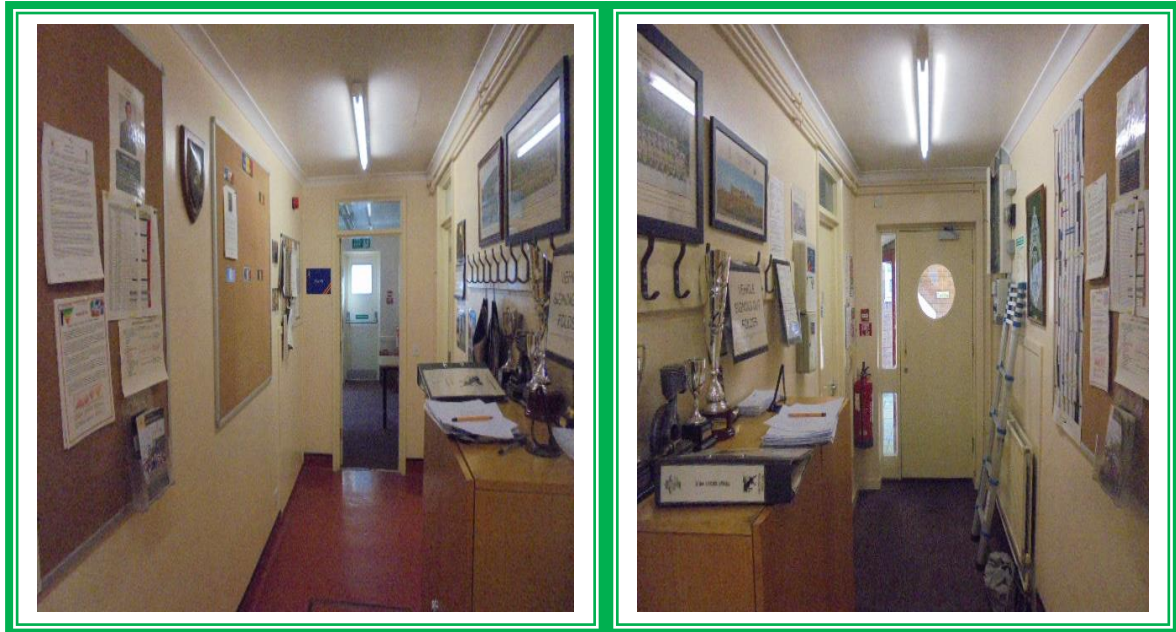
**Location: Ground Floor – Main Building Annexe - Lobby**

<b>Material Description:</b>	Visual Inspection – No Suspect Materials Found	
<b>Identification:</b>	N/A	
<b>Approx. quantity:</b>	N/A	
<b>Accessibility</b>	N/A	<i>Assessment Score</i>
<b>Product type:</b>	N/A	N/A
<b>Extent of Damage:</b>	N/A	N/A
<b>Surface Treatment:</b>	N/A	N/A
<b>Asbestos type:</b>	N/A	N/A
<b>Material Assessment Score:</b>		N/A
<b>Priority Assessment Score:</b>		N/A
<b>Action:</b>	N/A	
<b>Comments:</b>	N/A

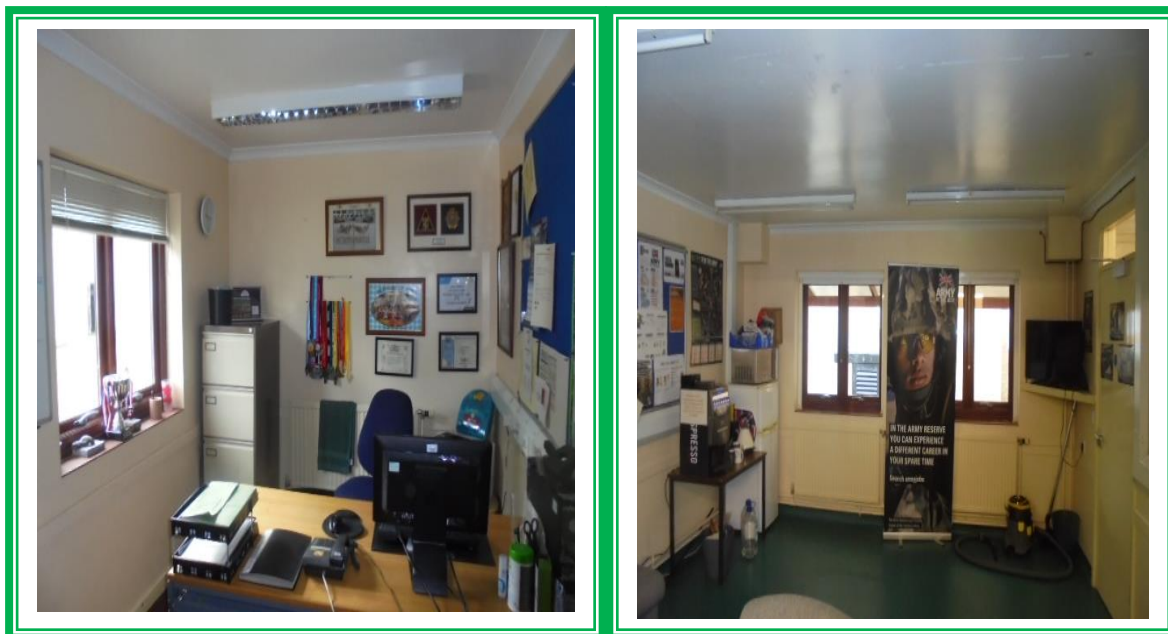
**Location: Ground Floor – Main Building Annexe – Offices 5 and 6**

<b>Material Description:</b>	Visual Inspection – No Suspect Materials Found	
<b>Identification:</b>	N/A	
<b>Approx. quantity:</b>	N/A	
<b>Accessibility</b>	N/A	Assessment Score
<b>Product type:</b>	N/A	N/A
<b>Extent of Damage:</b>	N/A	N/A
<b>Surface Treatment:</b>	N/A	N/A
<b>Asbestos type:</b>	N/A	N/A
<b>Material Assessment Score:</b>		N/A
<b>Priority Assessment Score:</b>		N/A
<b>Action:</b>	N/A	
<b>Comments:</b>	N/A

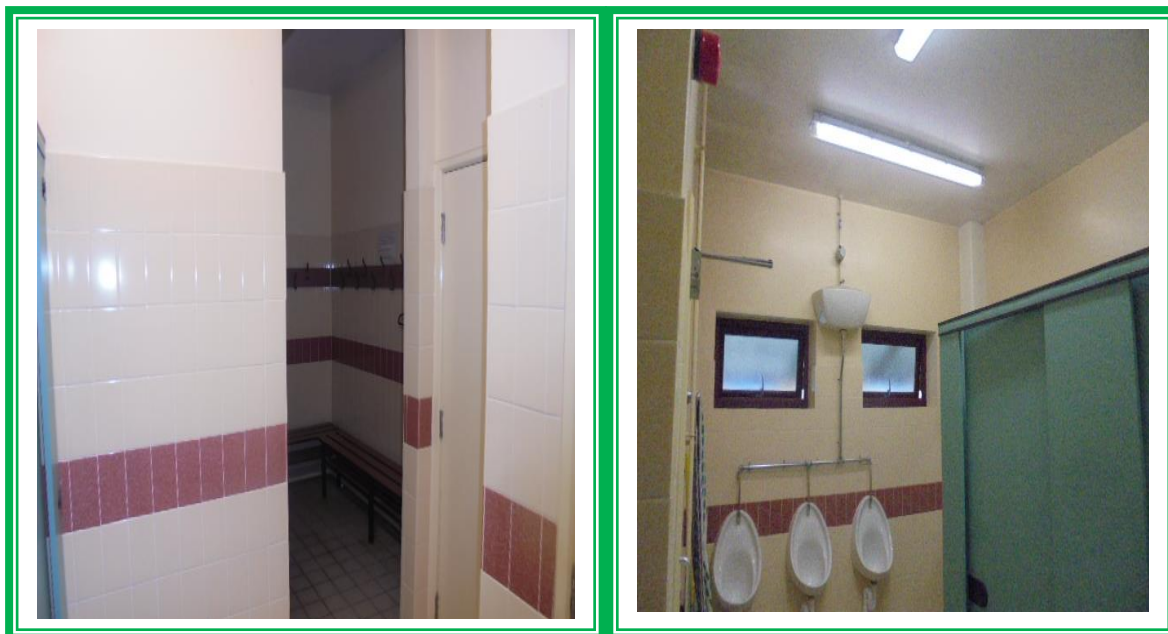
**Location: Ground Floor – Main Building Annexe – WC,  
Boiler Room and Cupboard**

<b>Material Description:</b>	Visual Inspection – No Suspect Materials Found	
<b>Identification:</b>	N/A	
<b>Approx. quantity:</b>	N/A	
<b>Accessibility</b>	N/A	<i>Assessment Score</i>
<b>Product type:</b>	N/A	N/A
<b>Extent of Damage:</b>	N/A	N/A
<b>Surface Treatment:</b>	N/A	N/A
<b>Asbestos type:</b>	N/A	N/A
<b>Material Assessment Score:</b>		N/A
<b>Priority Assessment Score:</b>		N/A
<b>Action:</b>	N/A	
<b>Comments:</b>	Modern Equipment

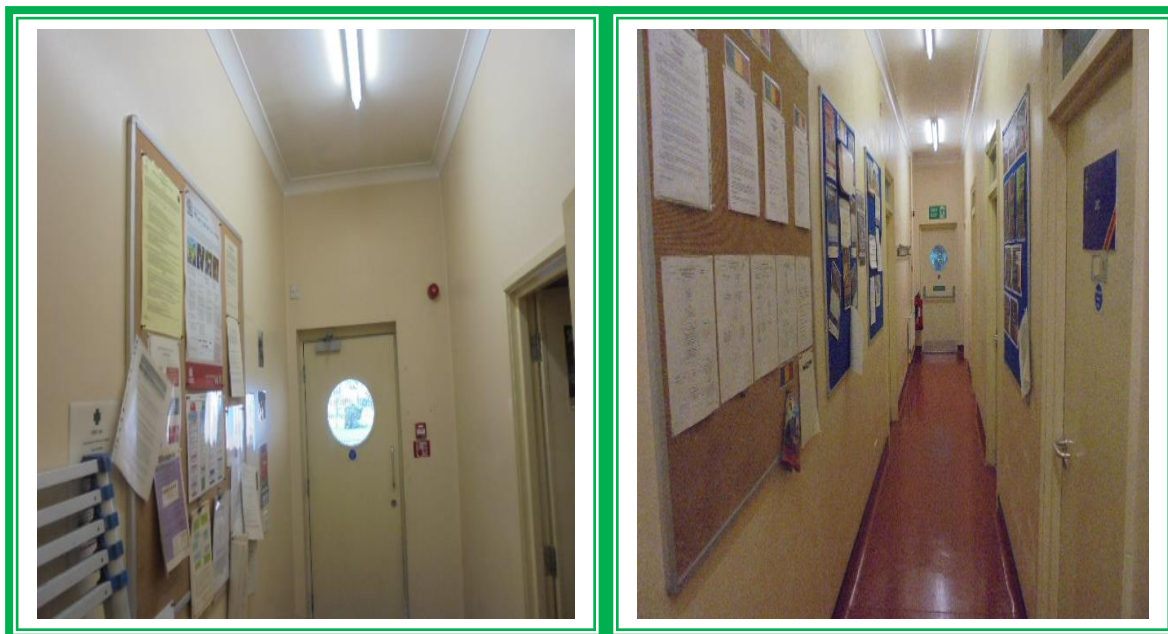
**Location: Ground Floor – Main Building Annexe – Lobby and Corridor**

<b>Material Description:</b>	Visual Inspection – No Suspect Materials Found	
<b>Identification:</b>	N/A	
<b>Approx. quantity:</b>	N/A	
<b>Accessibility</b>	N/A	<i>Assessment Score</i>
<b>Product type:</b>	N/A	N/A
<b>Extent of Damage:</b>	N/A	N/A
<b>Surface Treatment:</b>	N/A	N/A
<b>Asbestos type:</b>	N/A	N/A
<b>Material Assessment Score:</b>		N/A
<b>Priority Assessment Score:</b>		N/A
<b>Action:</b>	N/A	
<b>Comments:</b>	N/A

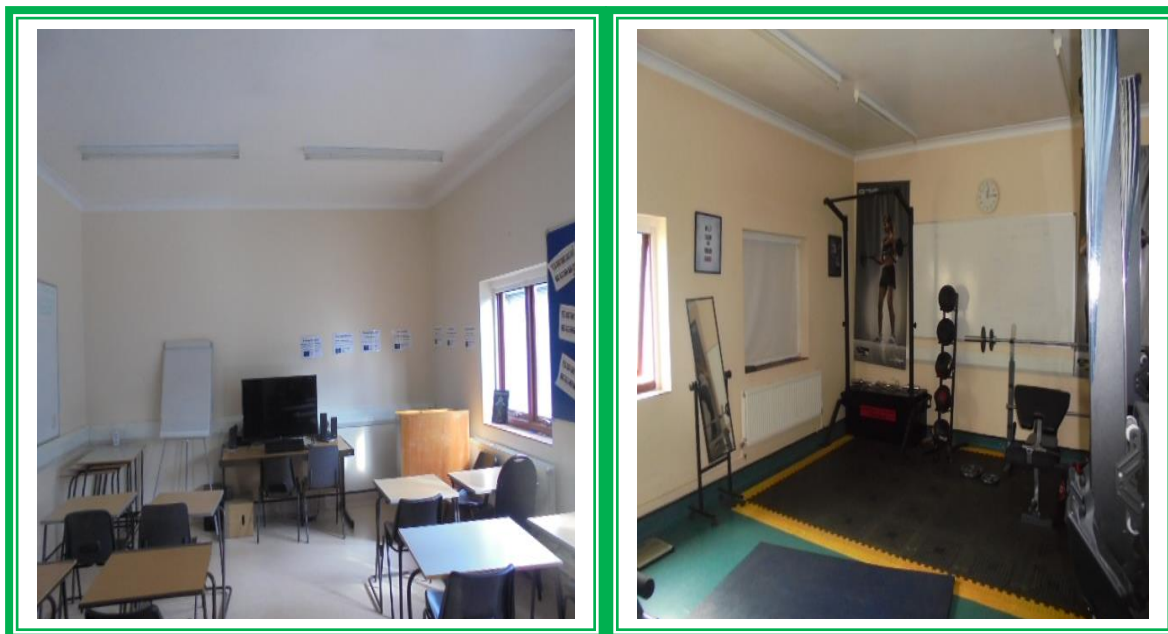
**Location: Ground Floor -Main Building Annexe –  
Classroom 7 and Gym 12**

<b>Material Description:</b>	Visual Inspection – No Suspect Materials Found	
<b>Identification:</b>	N/A	
<b>Approx. quantity:</b>	N/A	
<b>Accessibility</b>	N/A	<i>Assessment Score</i>
<b>Product type:</b>	N/A	N/A
<b>Extent of Damage:</b>	N/A	N/A
<b>Surface Treatment:</b>	N/A	N/A
<b>Asbestos type:</b>	N/A	N/A
<b>Material Assessment Score:</b>		N/A
<b>Priority Assessment Score:</b>		N/A
<b>Action:</b>	N/A	
<b>Comments:</b>	N/A

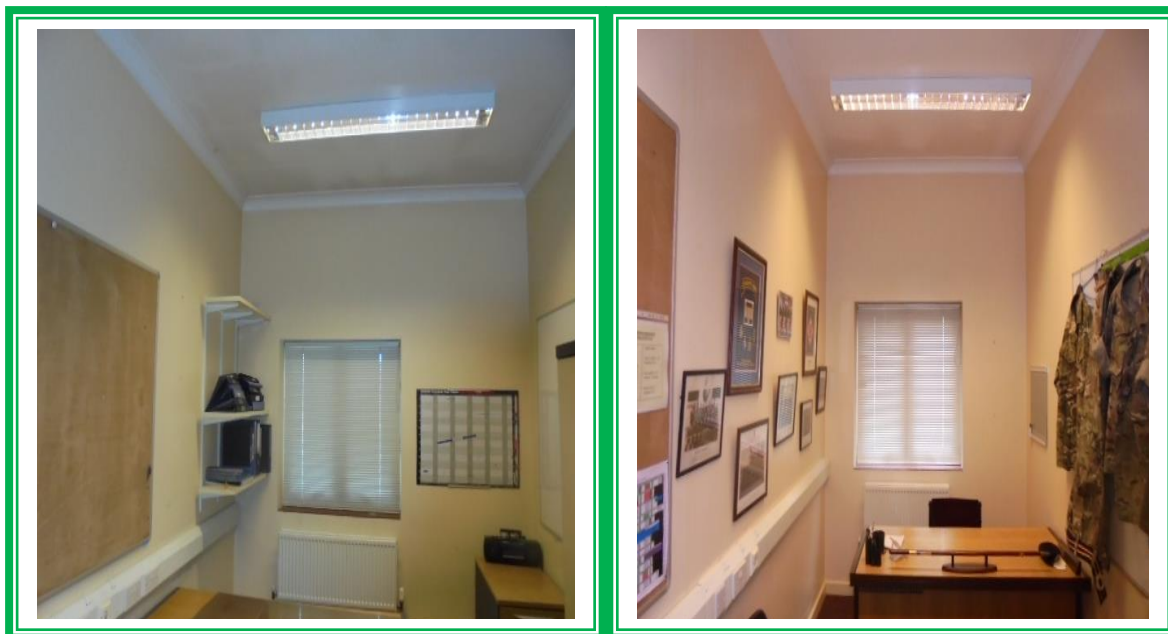
**Location: Ground Floor – Main Building Annexe – Offices 8,9,10 and Store 11**

<b>Material Description:</b>	Visual Inspection – No Suspect Materials Found	
<b>Identification:</b>	N/A	
<b>Approx. quantity:</b>	N/A	
<b>Accessibility</b>	N/A	Assessment Score
<b>Product type:</b>	N/A	N/A
<b>Extent of Damage:</b>	N/A	N/A
<b>Surface Treatment:</b>	N/A	N/A
<b>Asbestos type:</b>	N/A	N/A
<b>Material Assessment Score:</b>		N/A
<b>Priority Assessment Score:</b>		N/A
<b>Action:</b>	N/A	
<b>Comments:</b>	N/A

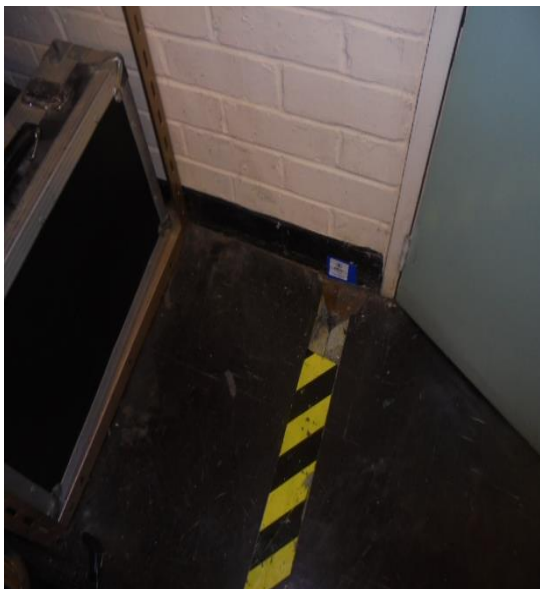
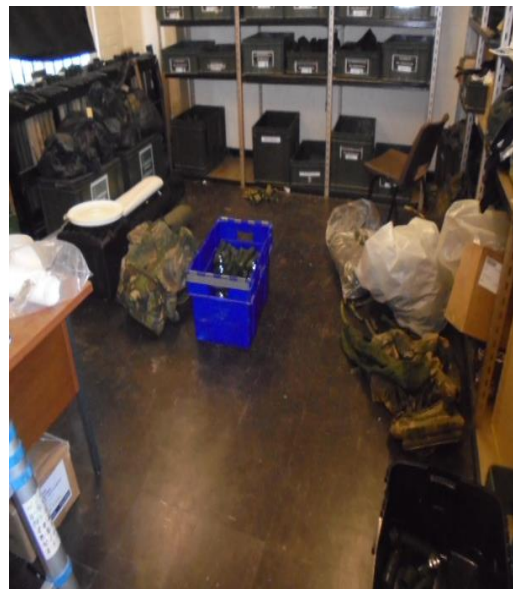
**Location: Ground Floor – Main Building – Clothes Store**

<b>Material Description:</b>	Brown Floor Tiles	
<b>Identification:</b>	Sampled – No Asbestos Detected	
<b>Approx. quantity:</b>	30M2	
<b>Accessibility</b>	N/A	<i>Assessment Score</i>
<b>Product type:</b>	N/A	N/A
<b>Extent of Damage:</b>	N/A	N/A
<b>Surface Treatment:</b>	N/A	N/A
<b>Asbestos type:</b>	N/A	N/A
<b>Material Assessment Score:</b>		N/A
<b>Priority Assessment Score:</b>		N/A
<b>Action:</b>	N/A	
<b>Comments:</b>	N/A

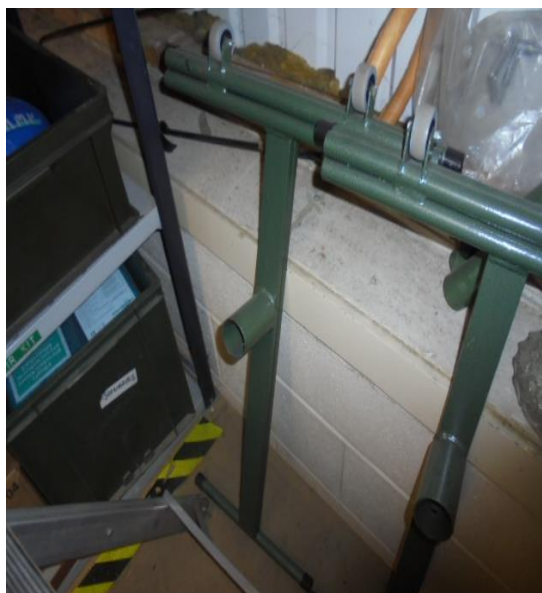
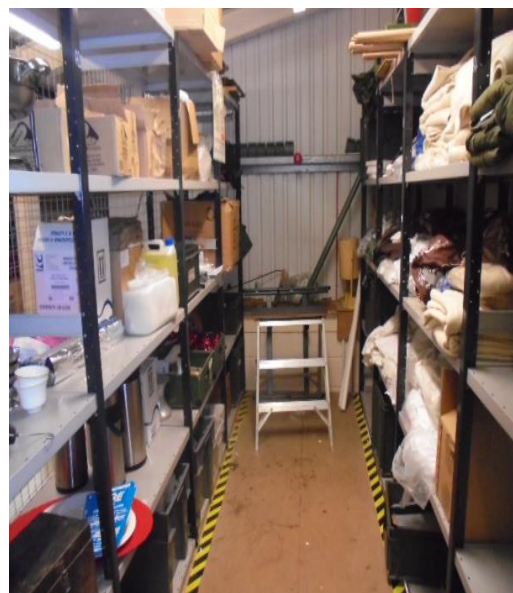
**Location: First Floor – Main Building – Stores Mezzanine**

<b>Material Description:</b>	Insulation Board above Blockwork	
<b>Identification:</b>	Sampled – No Asbestos Detected	
<b>Approx. quantity:</b>	4LM	
<b>Accessibility</b>	N/A	<i>Assessment Score</i>
<b>Product type:</b>	N/A	N/A
<b>Extent of Damage:</b>	N/A	N/A
<b>Surface Treatment:</b>	N/A	N/A
<b>Asbestos type:</b>	N/A	N/A
<b>Material Assessment Score:</b>		N/A
<b>Priority Assessment Score:</b>		N/A
<b>Action:</b>	N/A	
<b>Comments:</b>	N/A

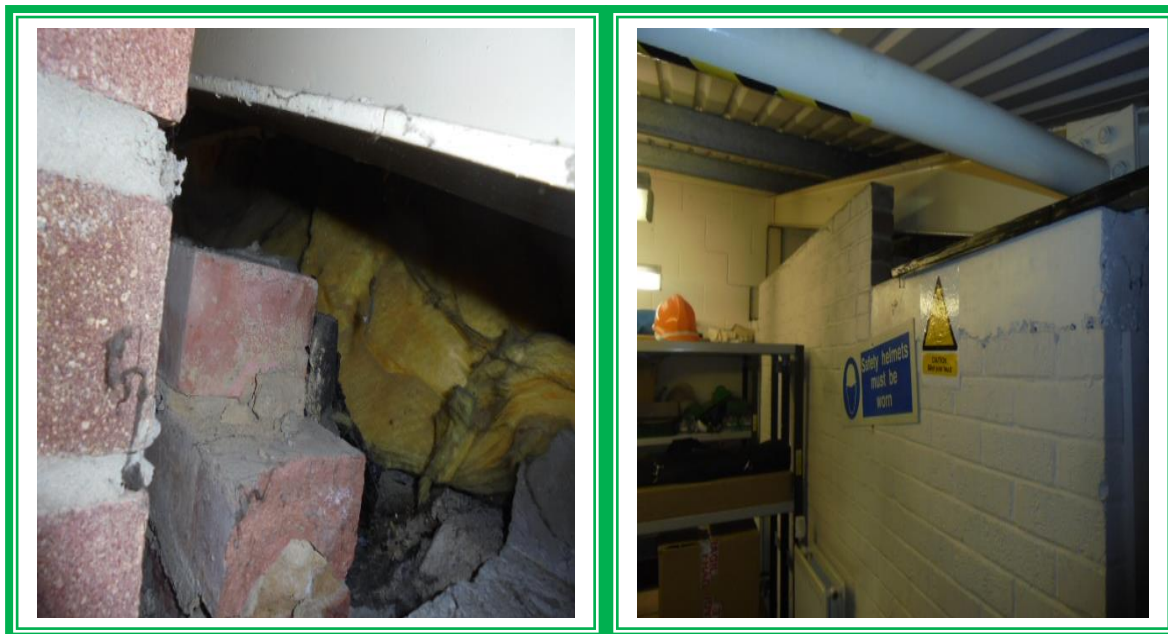
**Location: First Floor – Main Building – Stores Mezzanine**

<b>Material Description:</b>	Bitumen Damp Proof Course in Wall Cavity	
<b>Identification:</b>	Sampled – No Asbestos Detected	
<b>Approx. quantity:</b>	Non – Quantifiable	
<b>Accessibility</b>	N/A	<i>Assessment Score</i>
<b>Product type:</b>	N/A	N/A
<b>Extent of Damage:</b>	N/A	N/A
<b>Surface Treatment:</b>	N/A	N/A
<b>Asbestos type:</b>	N/A	N/A
<b>Material Assessment Score:</b>		N/A
<b>Priority Assessment Score:</b>		N/A
<b>Action:</b>	N/A	
<b>Comments:</b>	N/A
