**ARMOUR**  
ANALYTICAL SERVICES

**Project Number 2481**

**Management  
Asbestos Survey Report**

**6<sup>th</sup> Battalion, Eastern Avenue, Gloucestershire  
GL4 3BD**

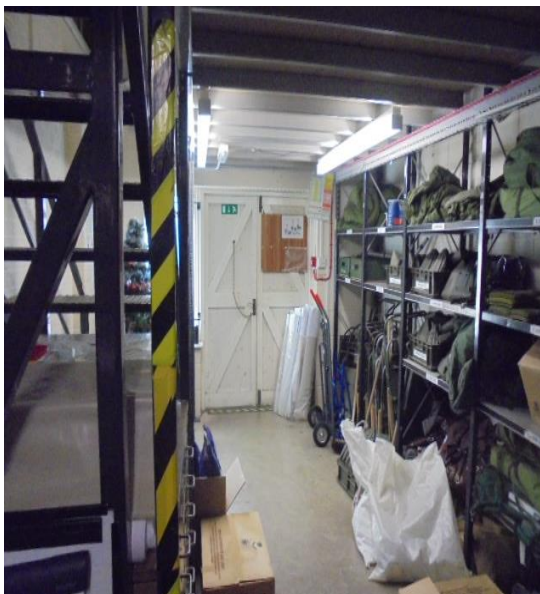
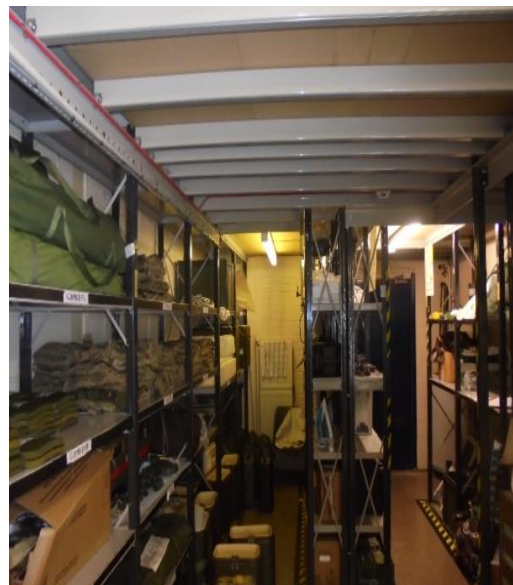
**Location: Ground Floor – Main Building – Store**

<b>Material Description:</b>	Visual Inspection – No Suspect Materials Found	
<b>Identification:</b>	N/A	
<b>Approx. quantity:</b>	N/A	
<b>Accessibility</b>	N/A	<i>Assessment Score</i>
<b>Product type:</b>	N/A	N/A
<b>Extent of Damage:</b>	N/A	N/A
<b>Surface Treatment:</b>	N/A	N/A
<b>Asbestos type:</b>	N/A	N/A
<b>Material Assessment Score:</b>		N/A
<b>Priority Assessment Score:</b>		N/A
<b>Action:</b>	N/A	
<b>Comments:</b>	N/A

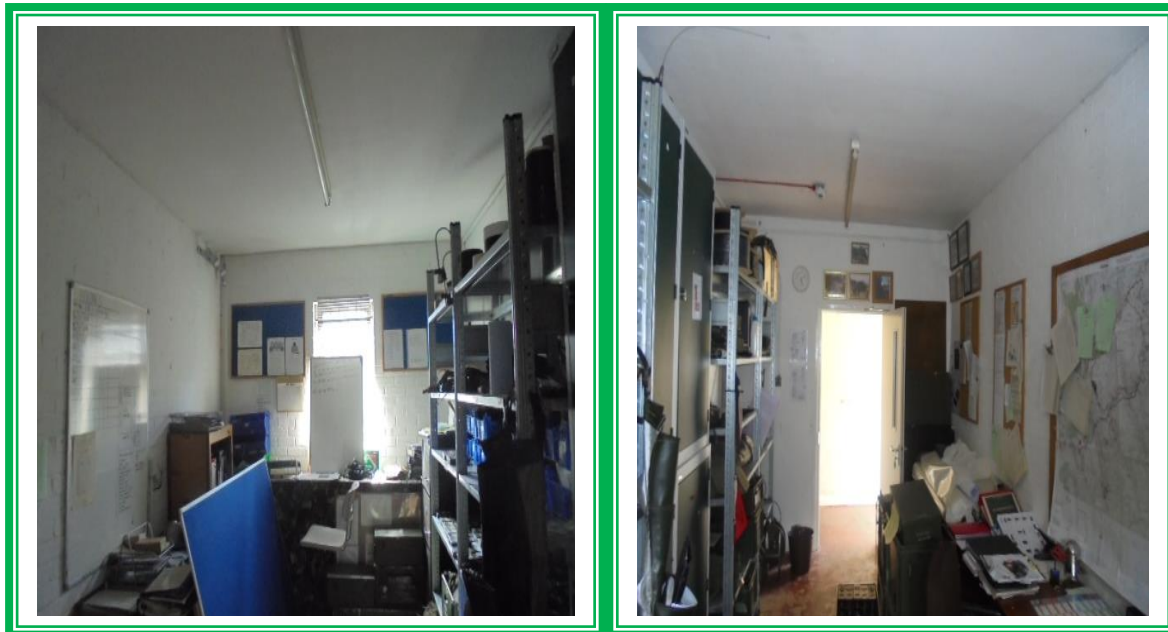
**Location: Ground Floor – Main Building - Stores**

<b>Material Description:</b>	Visual Inspection – No Suspect Materials Found	
<b>Identification:</b>	N/A	
<b>Approx. quantity:</b>	N/A	
<b>Accessibility</b>	N/A	<i>Assessment Score</i>
<b>Product type:</b>	N/A	N/A
<b>Extent of Damage:</b>	N/A	N/A
<b>Surface Treatment:</b>	N/A	N/A
<b>Asbestos type:</b>	N/A	N/A
<b>Material Assessment Score:</b>		N/A
<b>Priority Assessment Score:</b>		N/A
<b>Action:</b>	N/A	
<b>Comments:</b>	N/A

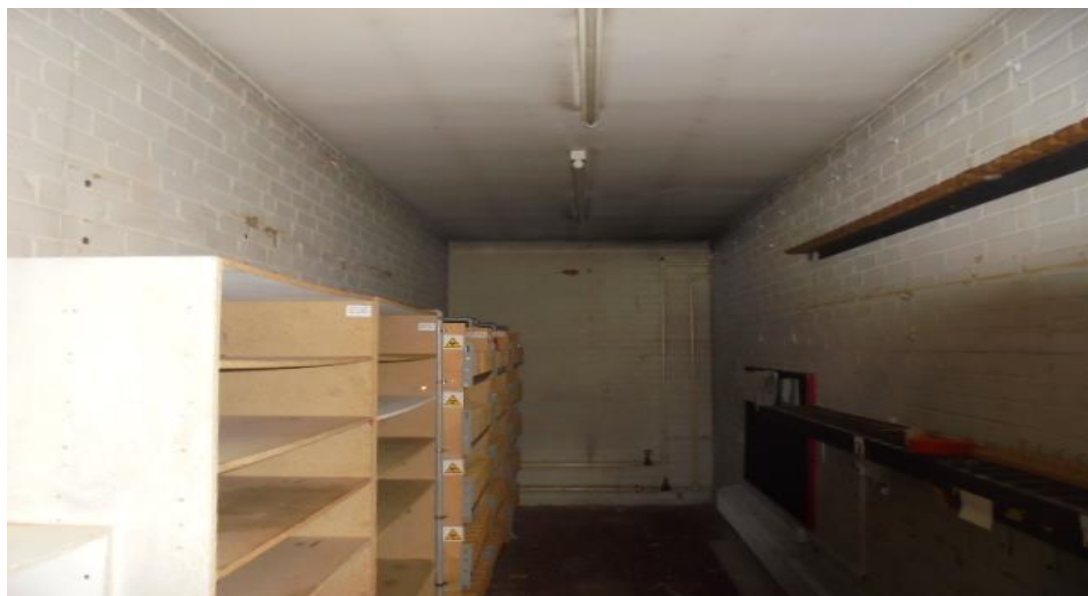
**Item No: 80****Sample No: N/A****Location: Ground Floor – Main Building Stores - Armoury**

<b>Material Description:</b>	Visual Inspection – No Suspect Materials Found	
<b>Identification:</b>	N/A	
<b>Approx. quantity:</b>	N/A	
<b>Accessibility</b>	N/A	<i>Assessment Score</i>
<b>Product type:</b>	N/A	N/A
<b>Extent of Damage:</b>	N/A	N/A
<b>Surface Treatment:</b>	N/A	N/A
<b>Asbestos type:</b>	N/A	N/A
<b>Material Assessment Score:</b>		N/A
<b>Priority Assessment Score:</b>		N/A
<b>Action:</b>	N/A	
<b>Comments:</b>	N/A

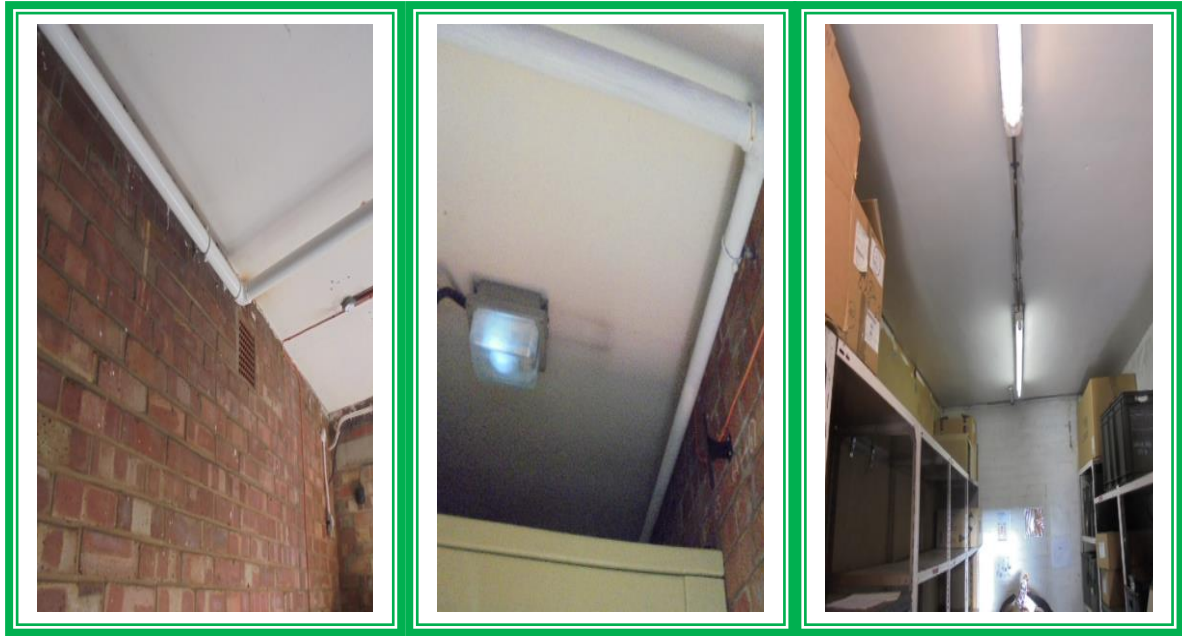
**Location: Ground Floor – Main Building – Drill Hall –  
Ammo Bunker – Armoury and Signal Store**

<b>Material Description:</b>	Visual Inspection – No Suspect Materials Found	
<b>Identification:</b>	N/A	
<b>Approx. quantity:</b>	N/A	
<b>Accessibility</b>	N/A	<i>Assessment Score</i>
<b>Product type:</b>	N/A	N/A
<b>Extent of Damage:</b>	N/A	N/A
<b>Surface Treatment:</b>	N/A	N/A
<b>Asbestos type:</b>	N/A	N/A
<b>Material Assessment Score:</b>		N/A
<b>Priority Assessment Score:</b>		N/A
<b>Action:</b>	N/A	
<b>Comments:</b>	N/A

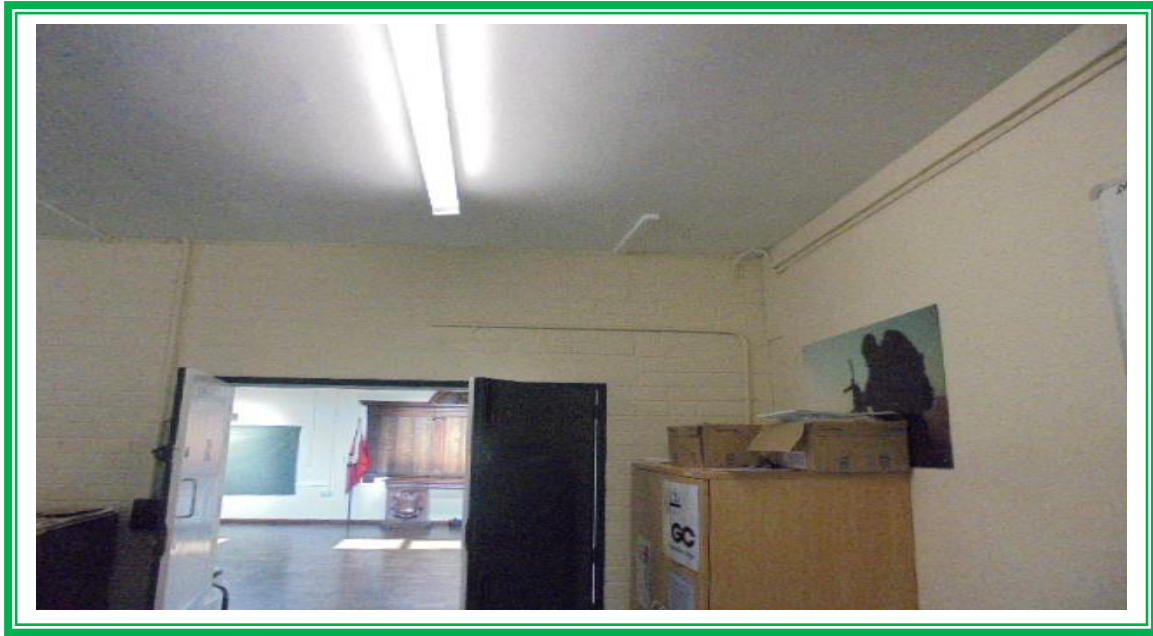
**Location: Ground Floor – Main Building – Drill Hall - Office**

<b>Material Description:</b>	Visual Inspection – No Suspect Materials Found	
<b>Identification:</b>	N/A	
<b>Approx. quantity:</b>	N/A	
<b>Accessibility</b>	N/A	<i>Assessment Score</i>
<b>Product type:</b>	N/A	N/A
<b>Extent of Damage:</b>	N/A	N/A
<b>Surface Treatment:</b>	N/A	N/A
<b>Asbestos type:</b>	N/A	N/A
<b>Material Assessment Score:</b>		N/A
<b>Priority Assessment Score:</b>		N/A
<b>Action:</b>	N/A	
<b>Comments:</b>	N/A

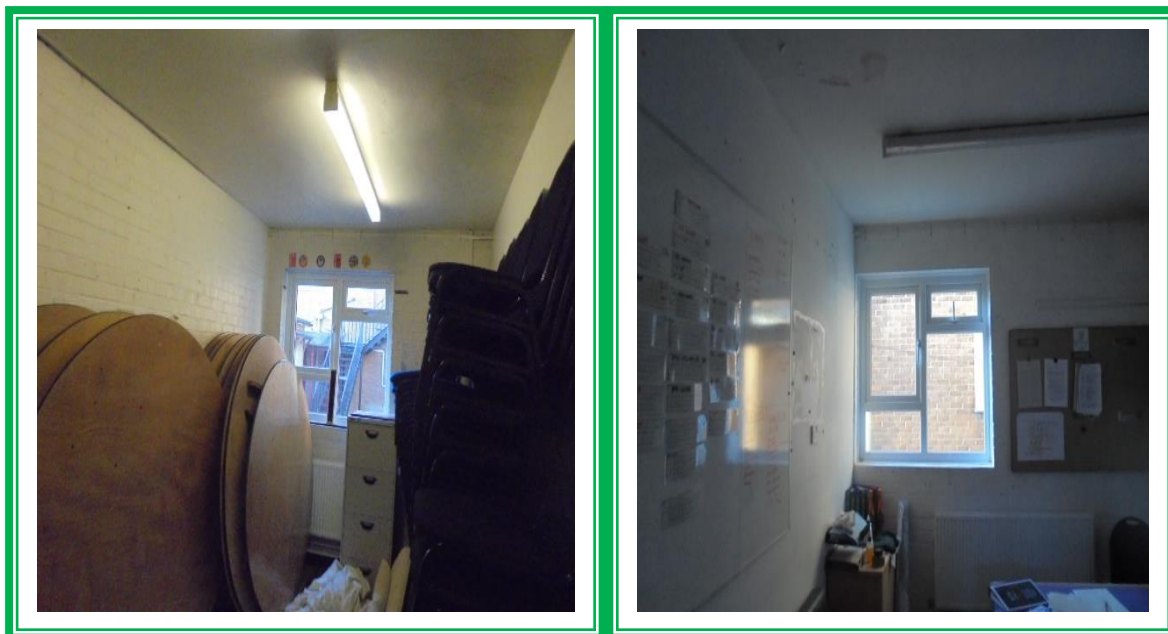
**Location: Ground Floor – Main Building – Drill Hall –  
Store, Lobby and NCO's Office**

<b>Material Description:</b>	Visual Inspection – No Suspect Materials Found	
<b>Identification:</b>	N/A	
<b>Approx. quantity:</b>	N/A	
<b>Accessibility</b>	N/A	<i>Assessment Score</i>
<b>Product type:</b>	N/A	N/A
<b>Extent of Damage:</b>	N/A	N/A
<b>Surface Treatment:</b>	N/A	N/A
<b>Asbestos type:</b>	N/A	N/A
<b>Material Assessment Score:</b>		N/A
<b>Priority Assessment Score:</b>		N/A
<b>Action:</b>	N/A	
<b>Comments:</b>	N/A

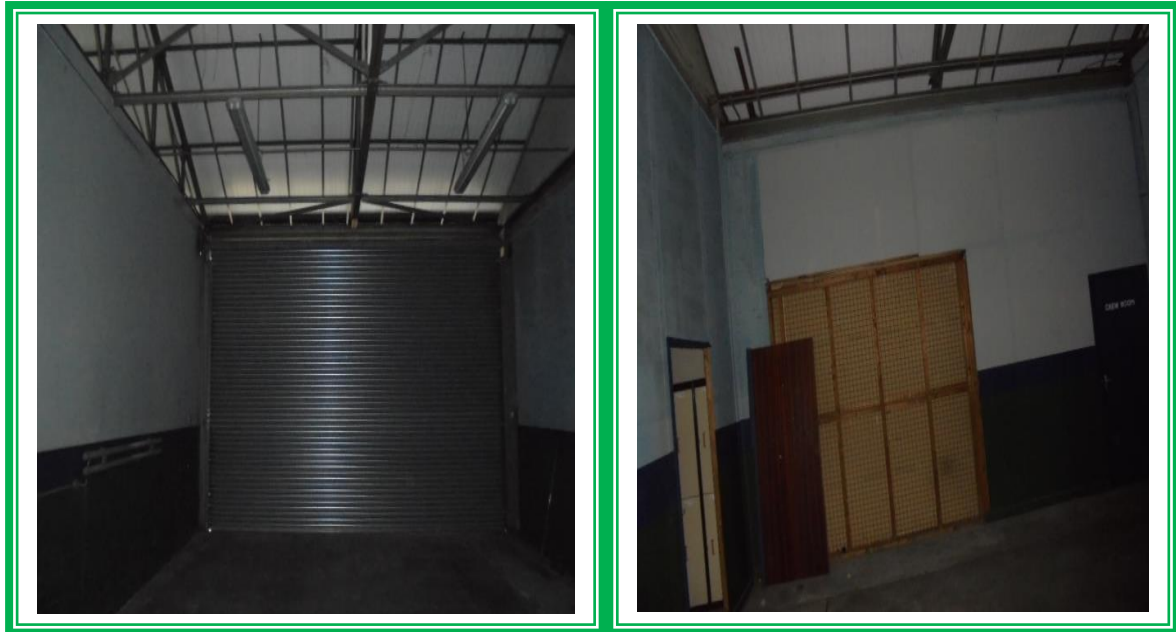
**Item No: 85**

<b>Material Description:</b>	Visual Inspection – No Suspect Materials Found	
<b>Identification:</b>	N/A	
<b>Approx. quantity:</b>	N/A	
<b>Accessibility</b>	N/A	<i>Assessment Score</i>
<b>Product type:</b>	N/A	N/A
<b>Extent of Damage:</b>	N/A	N/A
<b>Surface Treatment:</b>	N/A	N/A
<b>Asbestos type:</b>	N/A	N/A
<b>Material Assessment Score:</b>		N/A
<b>Priority Assessment Score:</b>		N/A
<b>Action:</b>	N/A	
<b>Comments:</b>	N/A

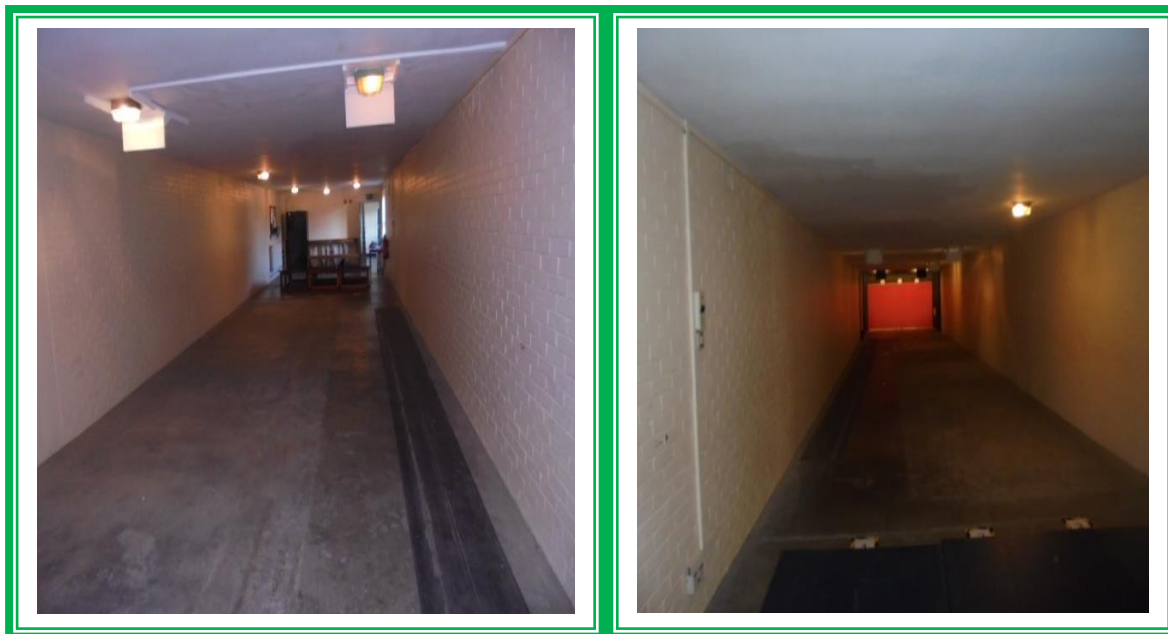
**Item No: 86**

<b>Material Description:</b>	Visual Inspection – No Suspect Materials Found	
<b>Identification:</b>	N/A	
<b>Approx. quantity:</b>	N/A	
<b>Accessibility</b>	N/A	<i>Assessment Score</i>
<b>Product type:</b>	N/A	N/A
<b>Extent of Damage:</b>	N/A	N/A
<b>Surface Treatment:</b>	N/A	N/A
<b>Asbestos type:</b>	N/A	N/A
<b>Material Assessment Score:</b>		N/A
<b>Priority Assessment Score:</b>		N/A
<b>Action:</b>	N/A	
<b>Comments:</b>	N/A

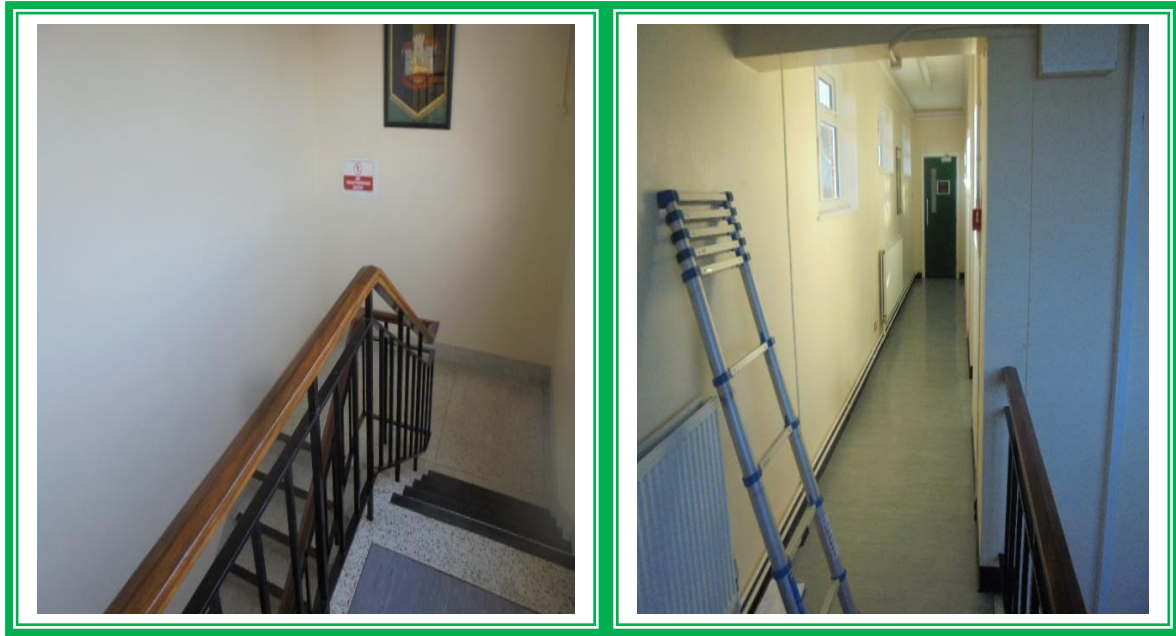
**Item No: 87**

<b>Material Description:</b>	Visual Inspection – No Suspect Materials Found	
<b>Identification:</b>	N/A	
<b>Approx. quantity:</b>	N/A	
<b>Accessibility</b>	N/A	<i>Assessment Score</i>
<b>Product type:</b>	N/A	N/A
<b>Extent of Damage:</b>	N/A	N/A
<b>Surface Treatment:</b>	N/A	N/A
<b>Asbestos type:</b>	N/A	N/A
<b>Material Assessment Score:</b>		N/A
<b>Priority Assessment Score:</b>		N/A
<b>Action:</b>	N/A	
<b>Comments:</b>	N/A

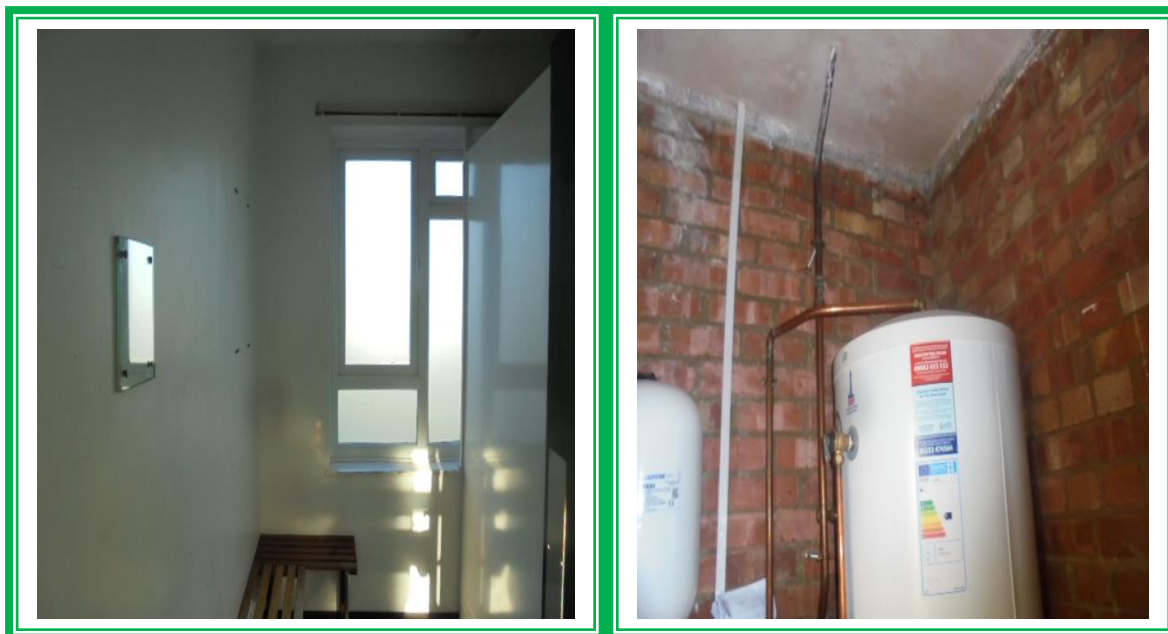
**Item No: 88**

<b>Material Description:</b>	Visual Inspection – No Suspect Materials Found	
<b>Identification:</b>	N/A	
<b>Approx. quantity:</b>	N/A	
<b>Accessibility</b>	N/A	Assessment Score
<b>Product type:</b>	N/A	N/A
<b>Extent of Damage:</b>	N/A	N/A
<b>Surface Treatment:</b>	N/A	N/A
<b>Asbestos type:</b>	N/A	N/A
<b>Material Assessment Score:</b>		N/A
<b>Priority Assessment Score:</b>		N/A
<b>Action:</b>	N/A	
<b>Comments:</b>	N/A

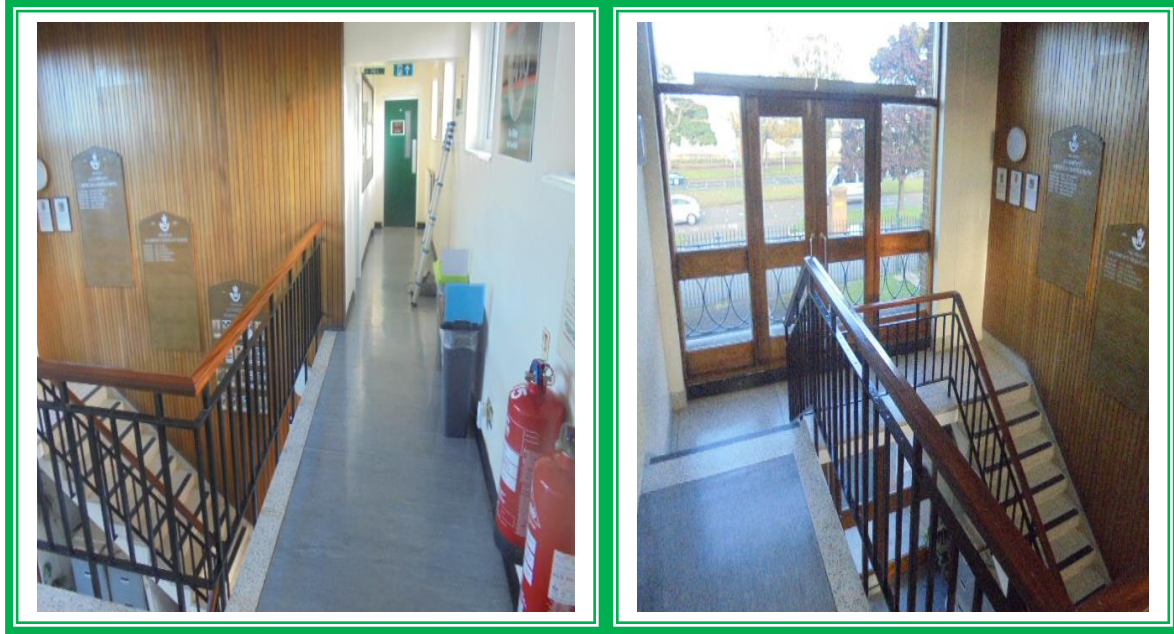
**Item No: 91**

<b>Material Description:</b>	Visual Inspection – No Suspect Materials Found	
<b>Identification:</b>	N/A	
<b>Approx. quantity:</b>	N/A	
<b>Accessibility</b>	N/A	Assessment Score
<b>Product type:</b>	N/A	N/A
<b>Extent of Damage:</b>	N/A	N/A
<b>Surface Treatment:</b>	N/A	N/A
<b>Asbestos type:</b>	N/A	N/A
<b>Material Assessment Score:</b>		N/A
<b>Priority Assessment Score:</b>		N/A
<b>Action:</b>	N/A	
<b>Comments:</b>	Timber Riser Panels – No Access within Risers

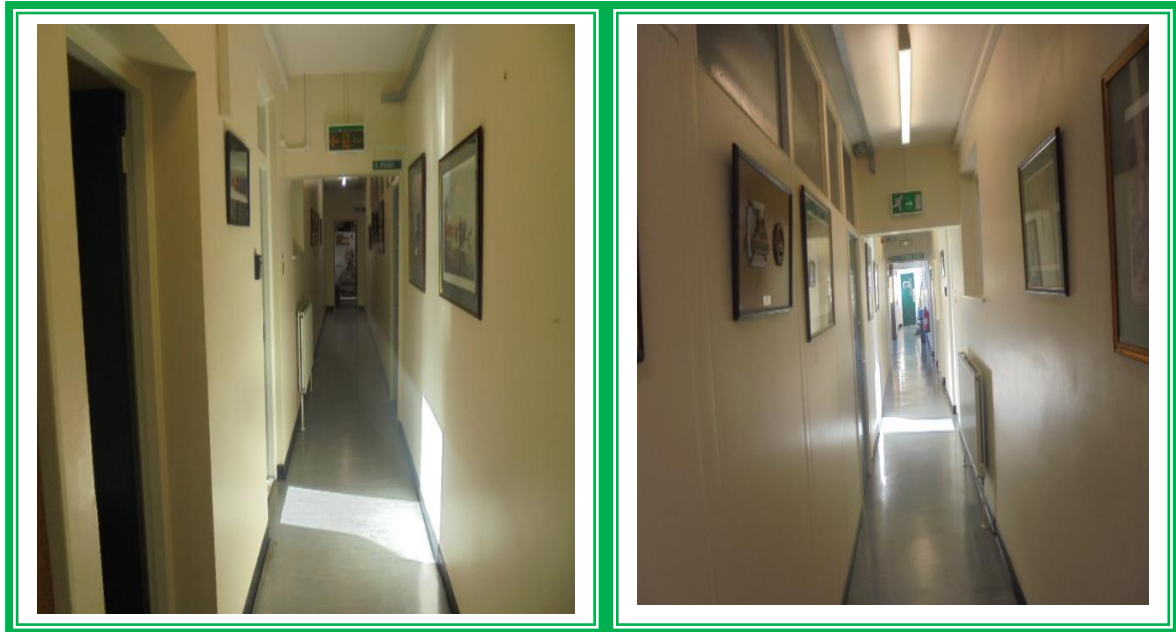
**Item No: 92**

<b>Material Description:</b>	Visual Inspection – No Suspect Materials Found	
<b>Identification:</b>	N/A	
<b>Approx. quantity:</b>	N/A	
<b>Accessibility</b>	N/A	<i>Assessment Score</i>
<b>Product type:</b>	N/A	N/A
<b>Extent of Damage:</b>	N/A	N/A
<b>Surface Treatment:</b>	N/A	N/A
<b>Asbestos type:</b>	N/A	N/A
<b>Material Assessment Score:</b>		N/A
<b>Priority Assessment Score:</b>		N/A
<b>Action:</b>	N/A	
<b>Comments:</b>	N/A

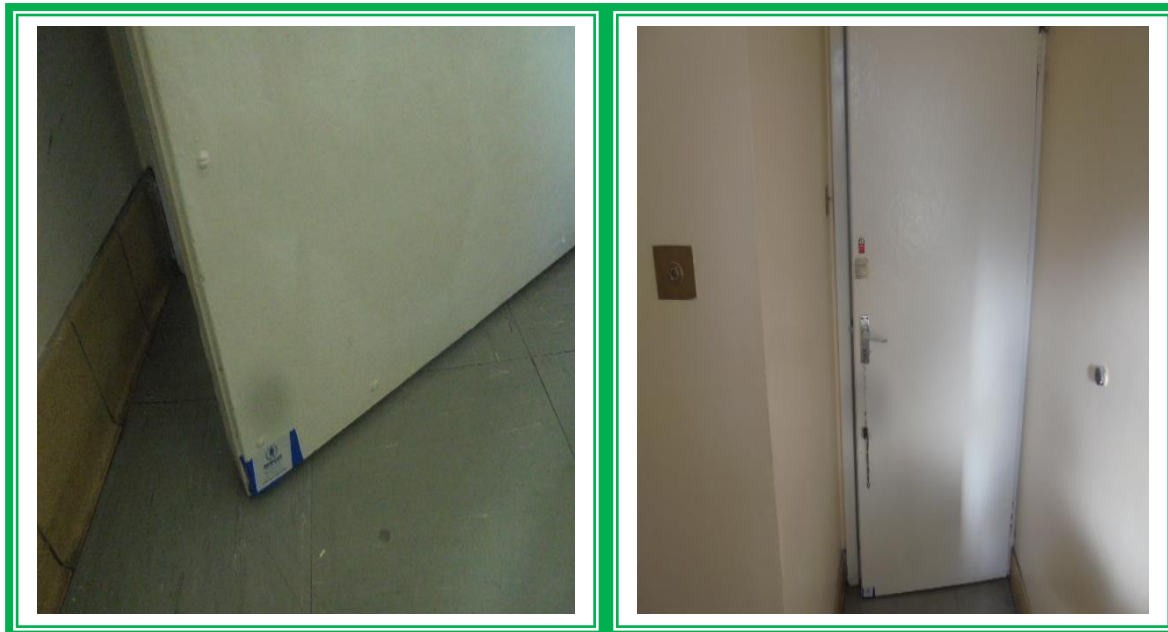
**Location: First Floor – Main Building – WC F13**

<b>Material Description:</b>	Insulation Board Panel to Door	
<b>Identification:</b>	Sampled – No Asbestos Detected	
<b>Approx. quantity:</b>	2M2 – 1X Door	
<b>Accessibility</b>	N/A	<i>Assessment Score</i>
<b>Product type:</b>	N/A	N/A
<b>Extent of Damage:</b>	N/A	N/A
<b>Surface Treatment:</b>	N/A	N/A
<b>Asbestos type:</b>	N/A	N/A
<b>Material Assessment Score:</b>		N/A
<b>Priority Assessment Score:</b>		N/A
<b>Action:</b>	N/A	
<b>Comments:</b>	N/A

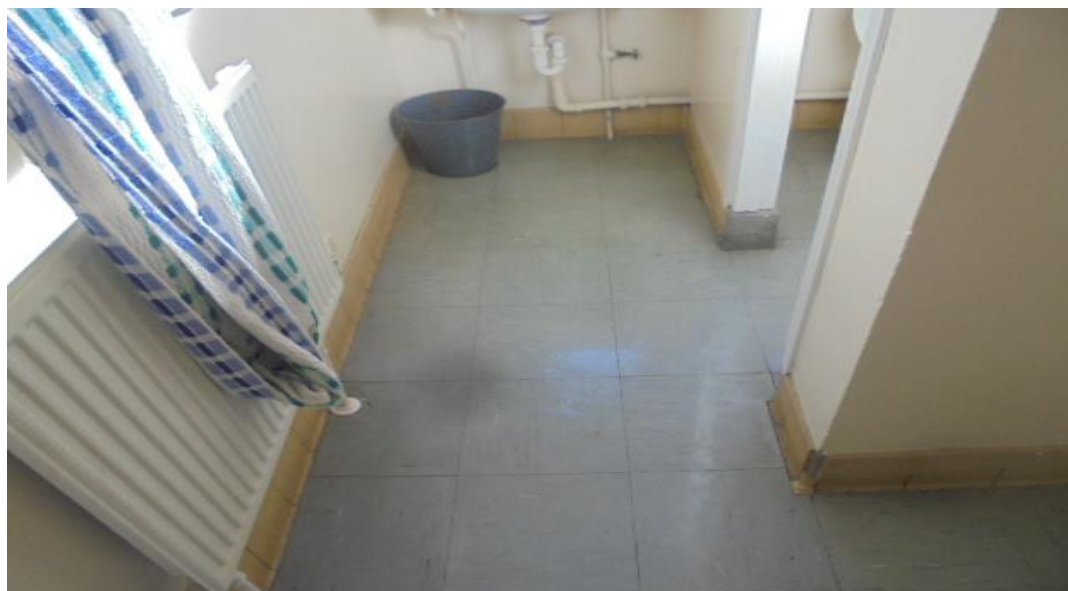
**Item No: 95****Sample No: DK/19****Location: First Floor – Main Building – Ladies WC F13**

<b>Material Description:</b>	Floor Tiles	
<b>Identification:</b>	Sampled – No Asbestos Detected	
<b>Approx. quantity:</b>	6M2	
<b>Accessibility</b>	N/A	<i>Assessment Score</i>
<b>Product type:</b>	N/A	N/A
<b>Extent of Damage:</b>	N/A	N/A
<b>Surface Treatment:</b>	N/A	N/A
<b>Asbestos type:</b>	N/A	N/A
<b>Material Assessment Score:</b>		N/A
<b>Priority Assessment Score:</b>		N/A
<b>Action:</b>	N/A	
<b>Comments:</b>	N/A

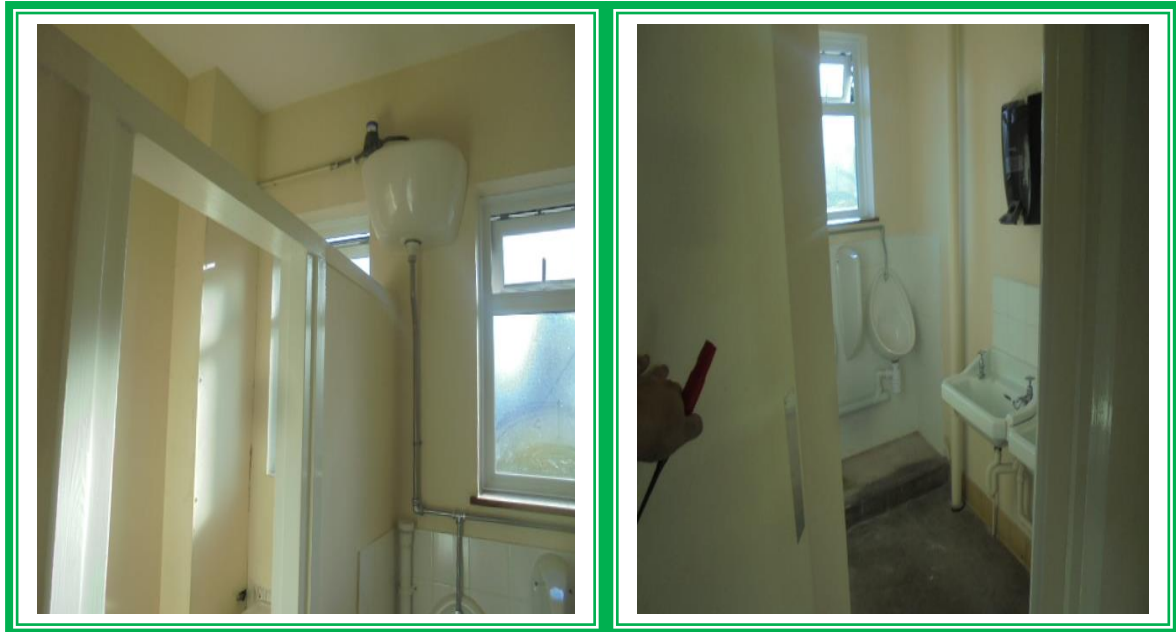
**Location: First Floor – Main Building – Men's WC F11**

<b>Material Description:</b>	Visual Inspection – No Suspect Materials Found	
<b>Identification:</b>	N/A	
<b>Approx. quantity:</b>	N/A	
<b>Accessibility</b>	N/A	<i>Assessment Score</i>
<b>Product type:</b>	N/A	N/A
<b>Extent of Damage:</b>	N/A	N/A
<b>Surface Treatment:</b>	N/A	N/A
<b>Asbestos type:</b>	N/A	N/A
<b>Material Assessment Score:</b>		N/A
<b>Priority Assessment Score:</b>		N/A
<b>Action:</b>	N/A	
<b>Comments:</b>	N/A

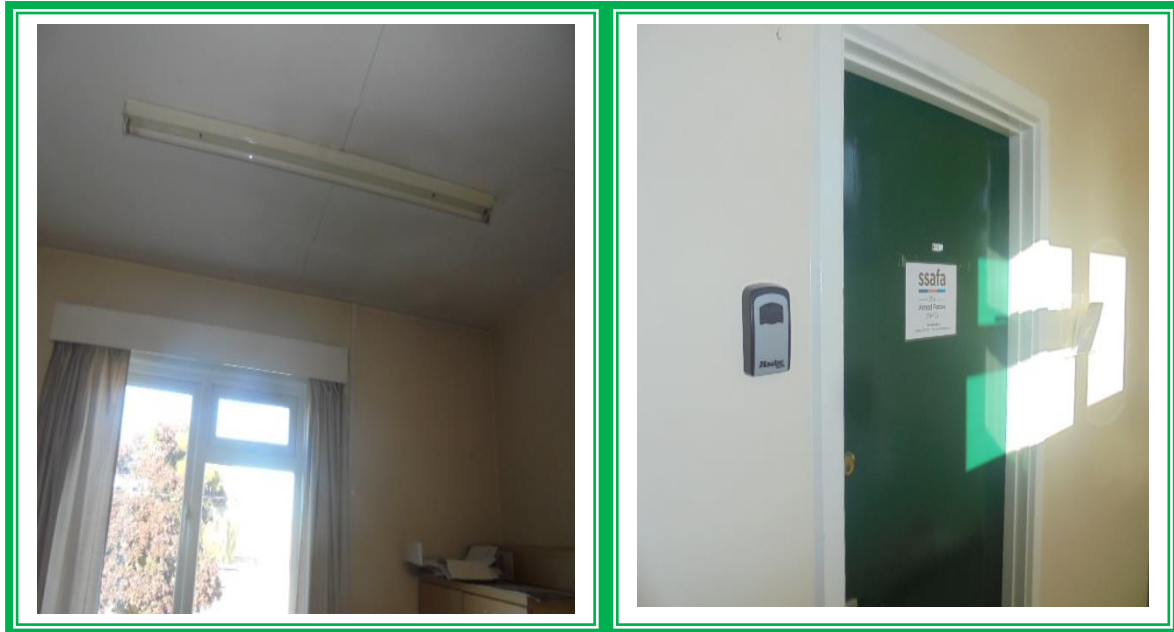
**Location: First Floor – Main Building – Office F18**

<b>Material Description:</b>	Visual Inspection – No Suspect Materials Found	
<b>Identification:</b>	N/A	
<b>Approx. quantity:</b>	N/A	
<b>Accessibility</b>	N/A	<i>Assessment Score</i>
<b>Product type:</b>	N/A	N/A
<b>Extent of Damage:</b>	N/A	N/A
<b>Surface Treatment:</b>	N/A	N/A
<b>Asbestos type:</b>	N/A	N/A
<b>Material Assessment Score:</b>		N/A
<b>Priority Assessment Score:</b>		N/A
<b>Action:</b>	N/A	
<b>Comments:</b>	Non-Asbestos Lino Flooring

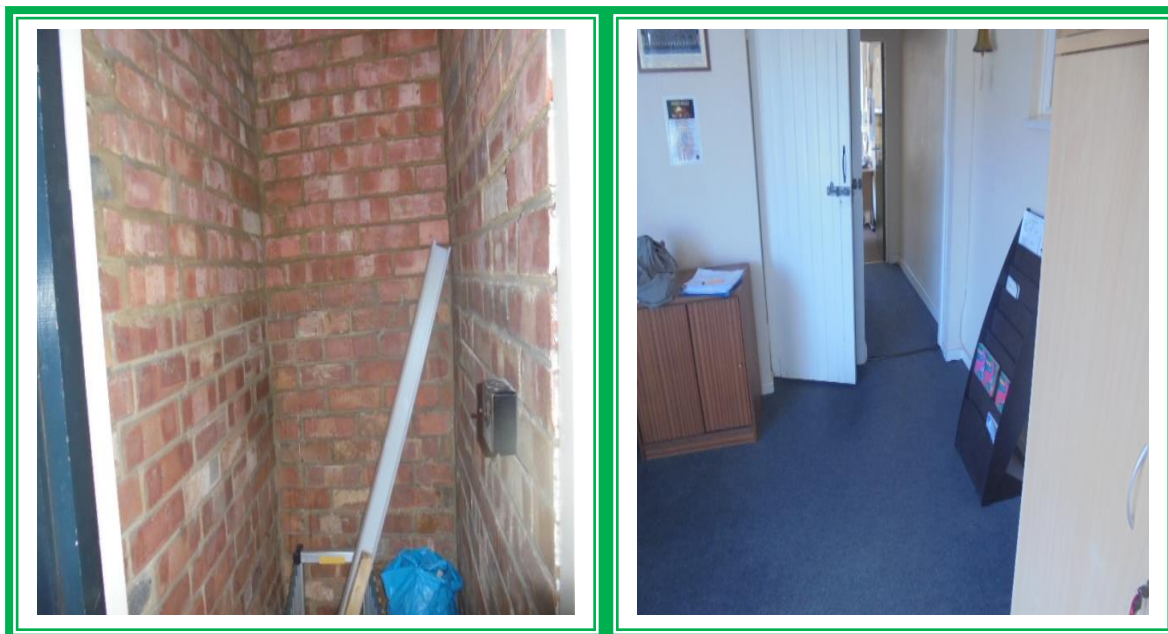
**Location: First Floor – Main Building – Waiting Room F5 and Cupboard**

<b>Material Description:</b>	Visual Inspection – No Suspect Materials Found	
<b>Identification:</b>	N/A	
<b>Approx. quantity:</b>	N/A	
<b>Accessibility</b>	N/A	<i>Assessment Score</i>
<b>Product type:</b>	N/A	N/A
<b>Extent of Damage:</b>	N/A	N/A
<b>Surface Treatment:</b>	N/A	N/A
<b>Asbestos type:</b>	N/A	N/A
<b>Material Assessment Score:</b>		N/A
<b>Priority Assessment Score:</b>		N/A
<b>Action:</b>	N/A	
<b>Comments:</b>	N/A

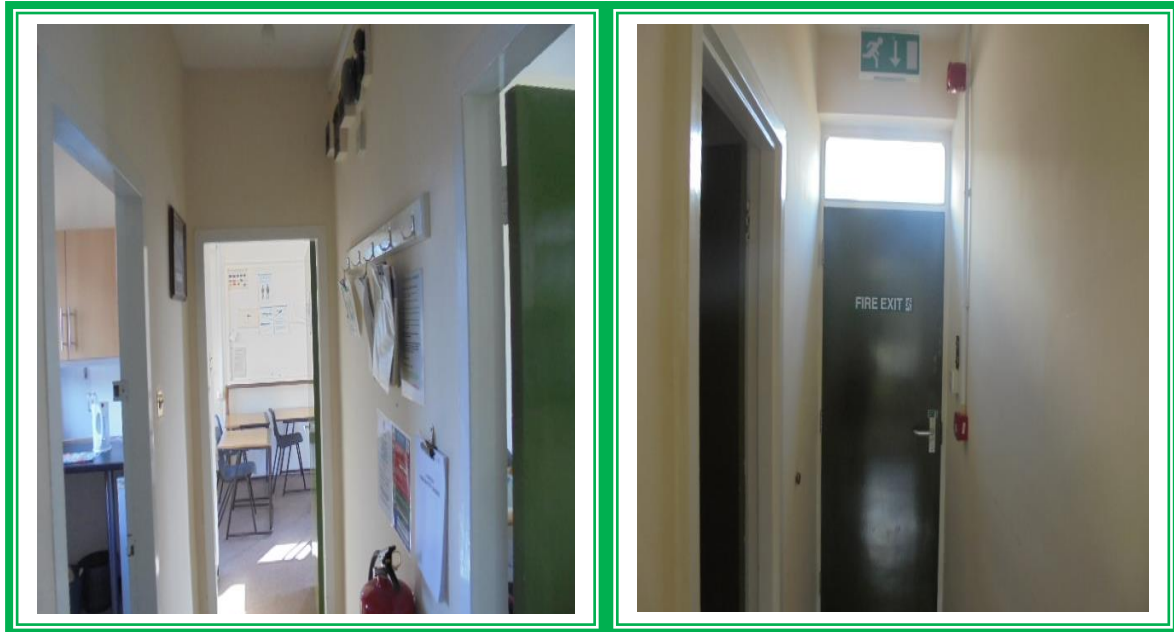
**Location: First Floor – Main Building – Corridor**

<b>Material Description:</b>	Visual Inspection – No Suspect Materials Found	
<b>Identification:</b>	N/A	
<b>Approx. quantity:</b>	N/A	
<b>Accessibility</b>	N/A	<i>Assessment Score</i>
<b>Product type:</b>	N/A	N/A
<b>Extent of Damage:</b>	N/A	N/A
<b>Surface Treatment:</b>	N/A	N/A
<b>Asbestos type:</b>	N/A	N/A
<b>Material Assessment Score:</b>		N/A
<b>Priority Assessment Score:</b>		N/A
<b>Action:</b>	N/A	
<b>Comments:</b>	N/A

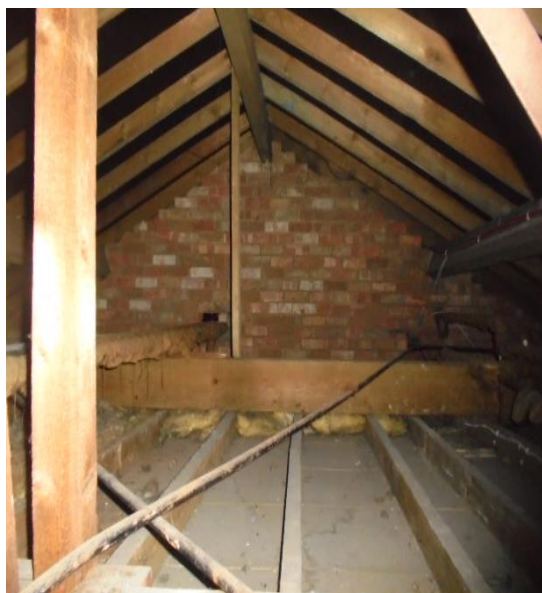
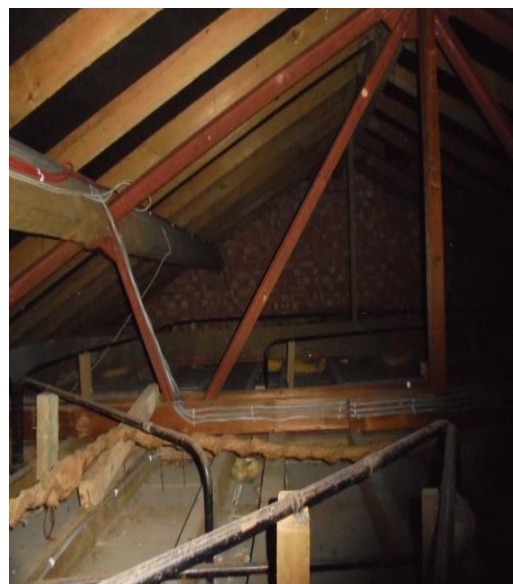
**Location: First Floor – Main Building – Loft Space**

<b>Material Description:</b>	Visual Inspection – No Suspect Materials Found	
<b>Identification:</b>	N/A	
<b>Approx. quantity:</b>	N/A	
<b>Accessibility</b>	N/A	<i>Assessment Score</i>
<b>Product type:</b>	N/A	N/A
<b>Extent of Damage:</b>	N/A	N/A
<b>Surface Treatment:</b>	N/A	N/A
<b>Asbestos type:</b>	N/A	N/A
<b>Material Assessment Score:</b>		N/A
<b>Priority Assessment Score:</b>		N/A
<b>Action:</b>	N/A	
<b>Comments:</b>	Non-Asbestos hessian Insulation to Pipework

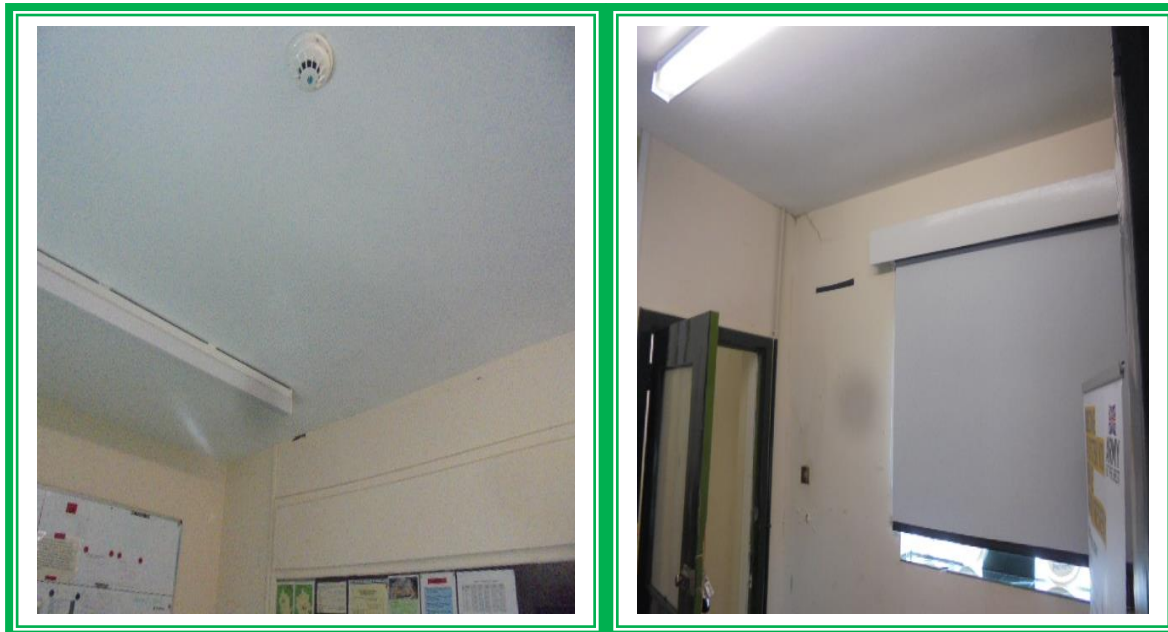
**Location: First Floor – Main Building – Recruit Cell F1**

<b>Material Description:</b>	Visual Inspection – No Suspect Materials Found	
<b>Identification:</b>	N/A	
<b>Approx. quantity:</b>	N/A	
<b>Accessibility</b>	N/A	<i>Assessment Score</i>
<b>Product type:</b>	N/A	N/A
<b>Extent of Damage:</b>	N/A	N/A
<b>Surface Treatment:</b>	N/A	N/A
<b>Asbestos type:</b>	N/A	N/A
<b>Material Assessment Score:</b>		N/A
<b>Priority Assessment Score:</b>		N/A
<b>Action:</b>	N/A	
<b>Comments:</b>	N/A

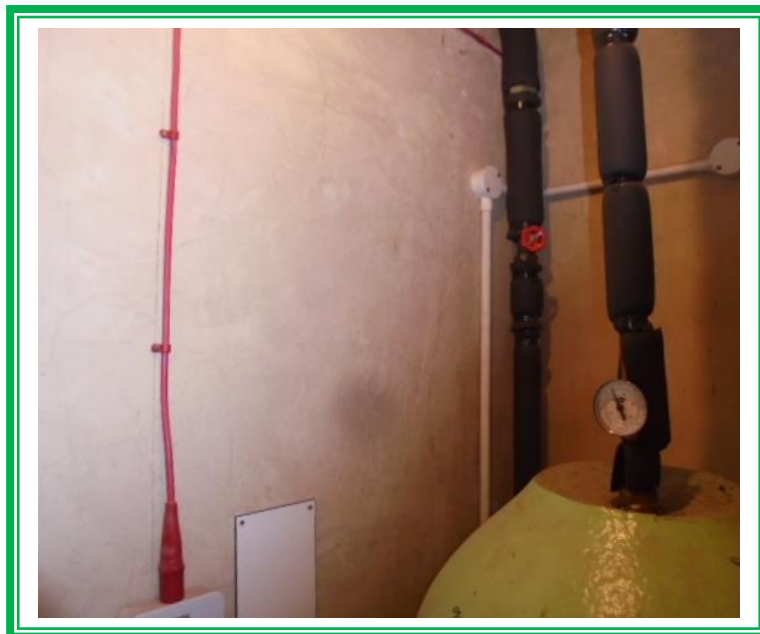
**Location: Ground Floor – Cupboard**

<b>Material Description:</b>	Visual Inspection – No Suspect Materials Found	
<b>Identification:</b>	N/A	
<b>Approx. quantity:</b>	N/A	
<b>Accessibility</b>	N/A	<i>Assessment Score</i>
<b>Product type:</b>	N/A	N/A
<b>Extent of Damage:</b>	N/A	N/A
<b>Surface Treatment:</b>	N/A	N/A
<b>Asbestos type:</b>	N/A	N/A
<b>Material Assessment Score:</b>		N/A
<b>Priority Assessment Score:</b>		N/A
<b>Action:</b>	N/A	
<b>Comments:</b>	N/A

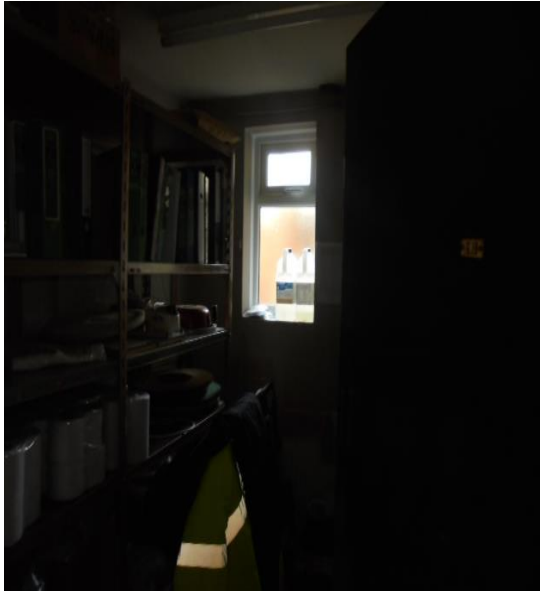
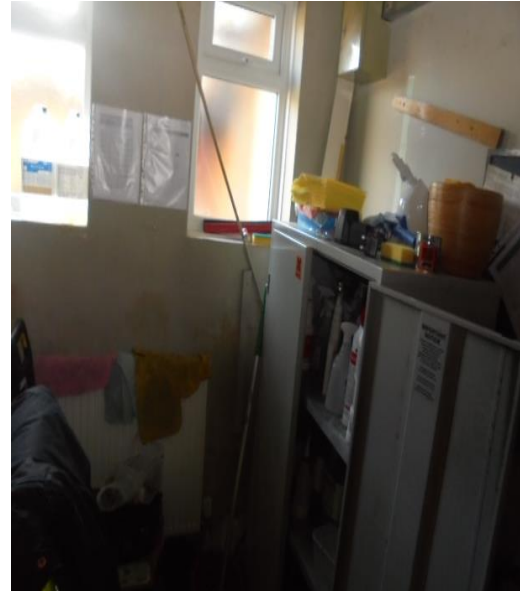
**Location: Ground Floor – Main Building – Store G18**

<b>Material Description:</b>	Visual Inspection – No Suspect Materials Found	
<b>Identification:</b>	N/A	
<b>Approx. quantity:</b>	N/A	
<b>Accessibility</b>	N/A	<i>Assessment Score</i>
<b>Product type:</b>	N/A	N/A
<b>Extent of Damage:</b>	N/A	N/A
<b>Surface Treatment:</b>	N/A	N/A
<b>Asbestos type:</b>	N/A	N/A
<b>Material Assessment Score:</b>		N/A
<b>Priority Assessment Score:</b>		N/A
<b>Action:</b>	N/A	
<b>Comments:</b>	N/A

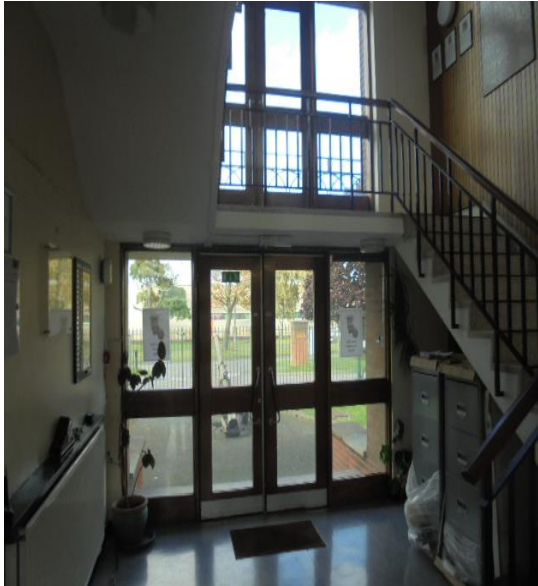
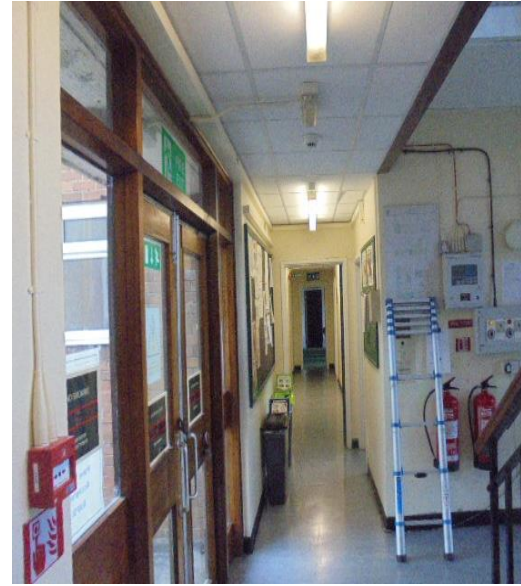
**Location: Ground Floor – Main Building – Entrance Lobby**

<b>Material Description:</b>	Visual Inspection – No Suspect Materials Found	
<b>Identification:</b>	N/A	
<b>Approx. quantity:</b>	N/A	
<b>Accessibility</b>	N/A	<i>Assessment Score</i>
<b>Product type:</b>	N/A	N/A
<b>Extent of Damage:</b>	N/A	N/A
<b>Surface Treatment:</b>	N/A	N/A
<b>Asbestos type:</b>	N/A	N/A
<b>Material Assessment Score:</b>		N/A
<b>Priority Assessment Score:</b>		N/A
<b>Action:</b>	N/A	
<b>Comments:</b>	N/A

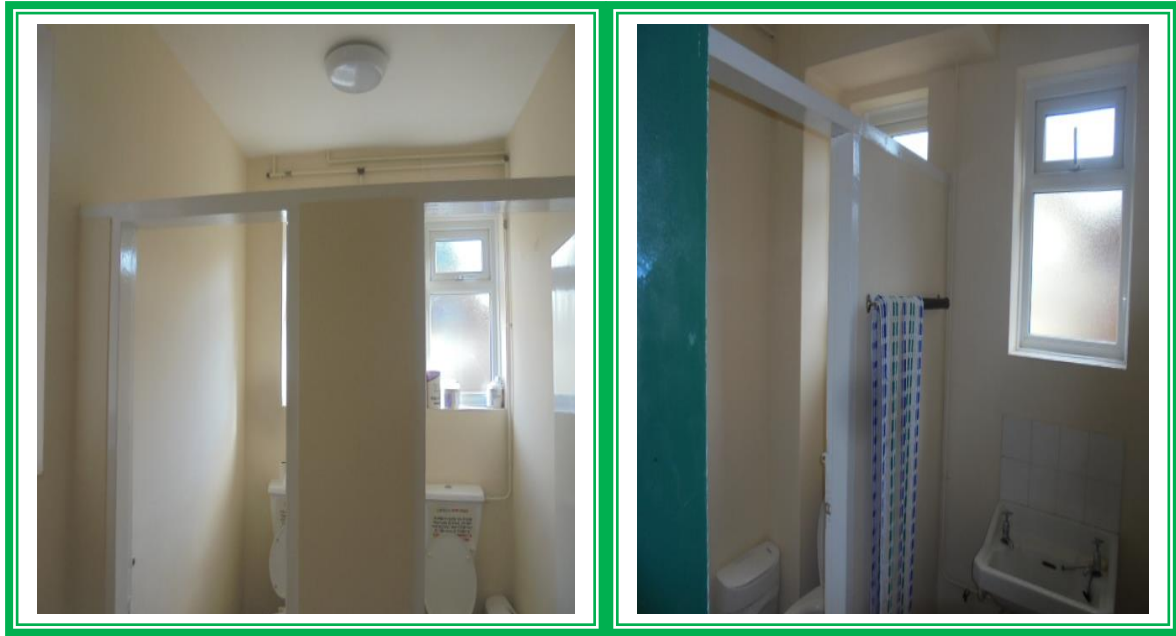
**Location: Ground Floor – Main Building – Ladies WC's  
G16 and G16A**

<b>Material Description:</b>	Visual Inspection – No Suspect Materials Found	
<b>Identification:</b>	N/A	
<b>Approx. quantity:</b>	N/A	
<b>Accessibility</b>	N/A	Assessment Score
<b>Product type:</b>	N/A	N/A
<b>Extent of Damage:</b>	N/A	N/A
<b>Surface Treatment:</b>	N/A	N/A
<b>Asbestos type:</b>	N/A	N/A
<b>Material Assessment Score:</b>		N/A
<b>Priority Assessment Score:</b>		N/A
<b>Action:</b>	N/A	
<b>Comments:</b>	N/A

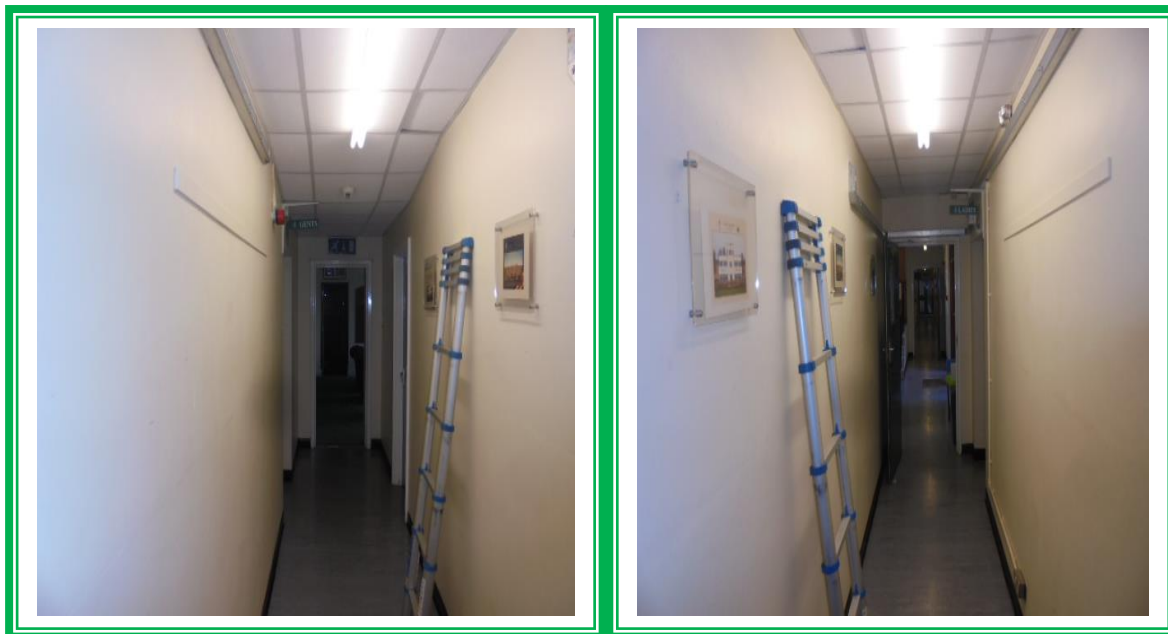
**Location: Ground Floor – Main Building – Corridor**

<b>Material Description:</b>	Visual Inspection – No Suspect Materials Found	
<b>Identification:</b>	N/A	
<b>Approx. quantity:</b>	N/A	
<b>Accessibility</b>	N/A	<i>Assessment Score</i>
<b>Product type:</b>	N/A	N/A
<b>Extent of Damage:</b>	N/A	N/A
<b>Surface Treatment:</b>	N/A	N/A
<b>Asbestos type:</b>	N/A	N/A
<b>Material Assessment Score:</b>		N/A
<b>Priority Assessment Score:</b>		N/A
<b>Action:</b>	N/A	
<b>Comments:</b>	N/A

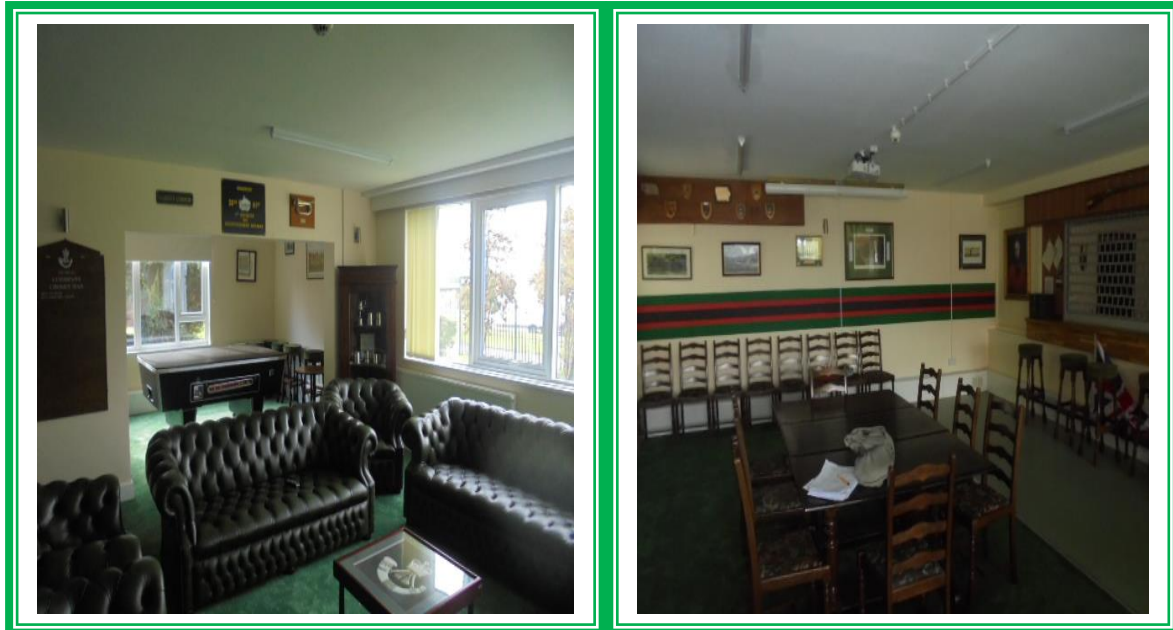
**Location: Ground Floor – Main Building – Mess Room**

<b>Material Description:</b>	Visual Inspection – No Suspect Materials Found	
<b>Identification:</b>	N/A	
<b>Approx. quantity:</b>	N/A	
<b>Accessibility</b>	N/A	<i>Assessment Score</i>
<b>Product type:</b>	N/A	N/A
<b>Extent of Damage:</b>	N/A	N/A
<b>Surface Treatment:</b>	N/A	N/A
<b>Asbestos type:</b>	N/A	N/A
<b>Material Assessment Score:</b>		N/A
<b>Priority Assessment Score:</b>		N/A
<b>Action:</b>	N/A	
<b>Comments:</b>	N/A

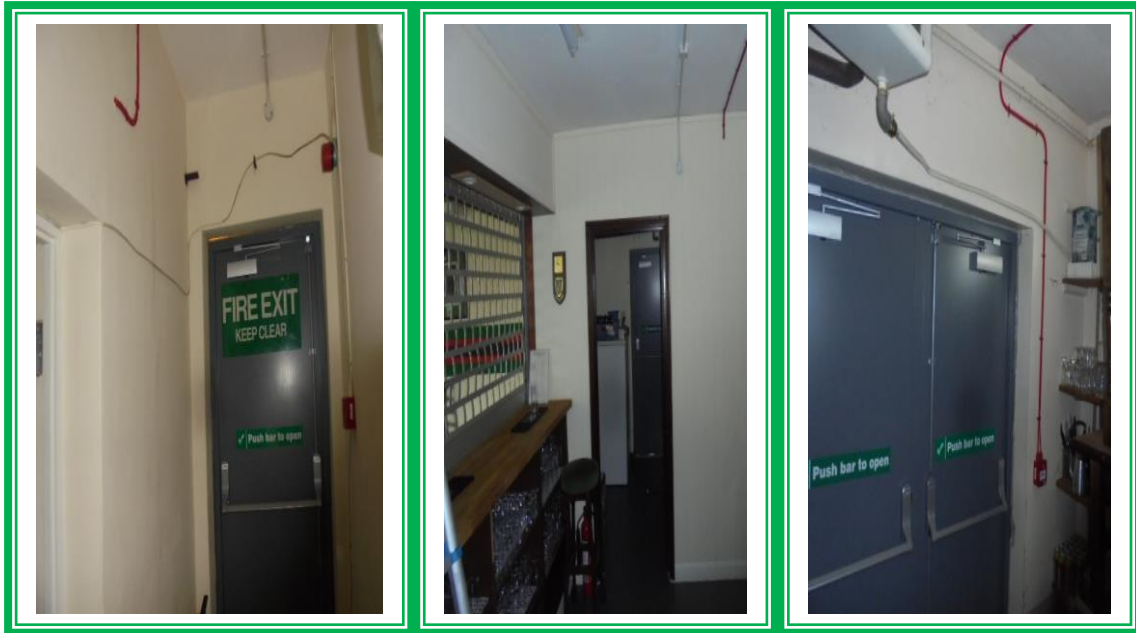
**Location: Ground Floor – Main Building – Lobby, Bar and Store**

<b>Material Description:</b>	Visual Inspection – No Suspect Materials Found	
<b>Identification:</b>	N/A	
<b>Approx. quantity:</b>	N/A	
<b>Accessibility</b>	N/A	Assessment Score
<b>Product type:</b>	N/A	N/A
<b>Extent of Damage:</b>	N/A	N/A
<b>Surface Treatment:</b>	N/A	N/A
<b>Asbestos type:</b>	N/A	N/A
<b>Material Assessment Score:</b>		N/A
<b>Priority Assessment Score:</b>		N/A
<b>Action:</b>	N/A	
<b>Comments:</b>	N/A
