**ARMOUR**  
ANALYTICAL SERVICES

**Project Number 2481**

**Management  
Asbestos Survey Report**

**6<sup>th</sup> Battalion, Eastern Avenue, Gloucestershire  
GL4 3BD**

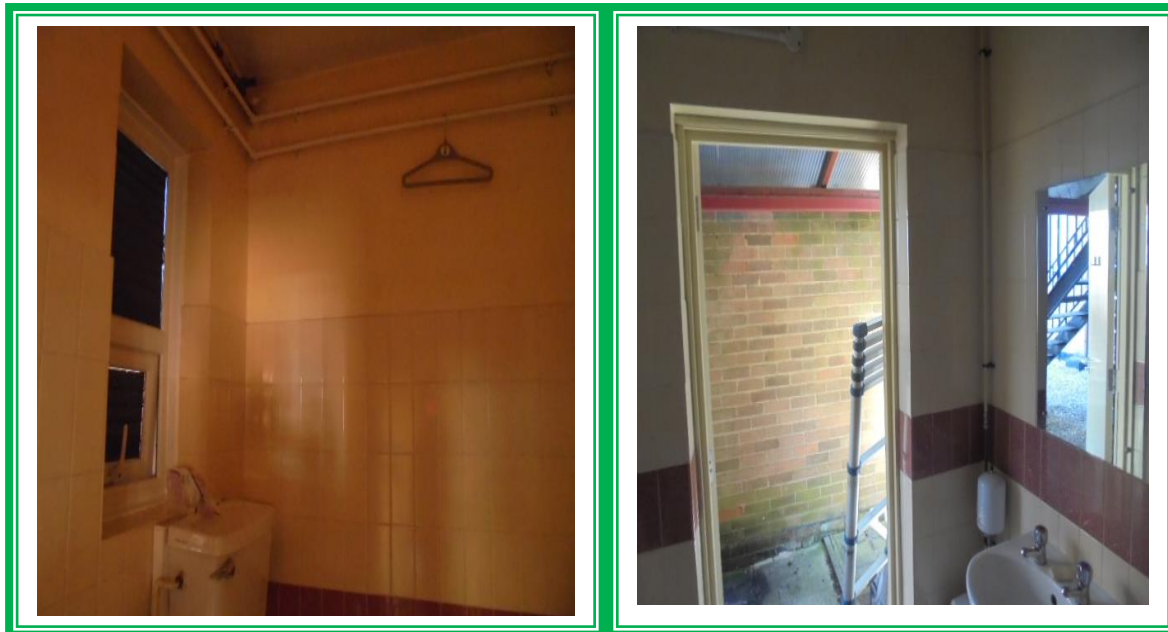
**Item No: 123**

<b>Material Description:</b>	Visual Inspection – No Suspect Materials Found	
<b>Identification:</b>	N/A	
<b>Approx. quantity:</b>	N/A	
<b>Accessibility</b>	N/A	<i>Assessment Score</i>
<b>Product type:</b>	N/A	N/A
<b>Extent of Damage:</b>	N/A	N/A
<b>Surface Treatment:</b>	N/A	N/A
<b>Asbestos type:</b>	N/A	N/A
<b>Material Assessment Score:</b>		N/A
<b>Priority Assessment Score:</b>		N/A
<b>Action:</b>	N/A	
<b>Comments:</b>	N/A

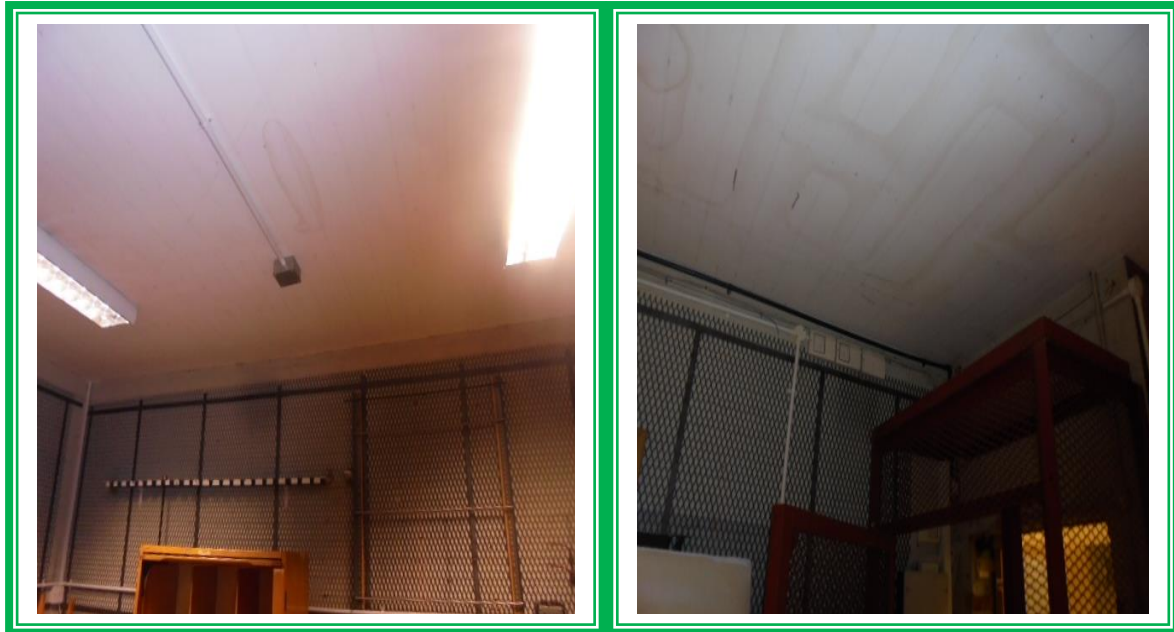
**Location: Ground Floor – Main Building – Armoury**

<b>Material Description:</b>	Visual Inspection – No Suspect Materials Found	
<b>Identification:</b>	N/A	
<b>Approx. quantity:</b>	N/A	
<b>Accessibility</b>	N/A	<i>Assessment Score</i>
<b>Product type:</b>	N/A	N/A
<b>Extent of Damage:</b>	N/A	N/A
<b>Surface Treatment:</b>	N/A	N/A
<b>Asbestos type:</b>	N/A	N/A
<b>Material Assessment Score:</b>		N/A
<b>Priority Assessment Score:</b>		N/A
<b>Action:</b>	N/A	
<b>Comments:</b>	N/A
